**641-KS-06-MB-SH-A-90910 – P01**
**Temple Dinsley Level 0, GA – Ground Floor – Common Areas – Entrance Hall**

**641-KS-06-MB-SH-A-90920 – P01**  
**Temple Dinsley Level 1, GA – First Floor – Common Areas**

**641-KS-06-MB-SH-A-90930 – P01****Temple Dinsley Levels 0 & 1, GA – Middle Entrance – Common Areas – Ground & First Floors**

**641-KS-06-MB-SH-A-90940 – P01**  
**Temple Dinsley Levels B1, 0 & 1, GA – East Stair + Lift**

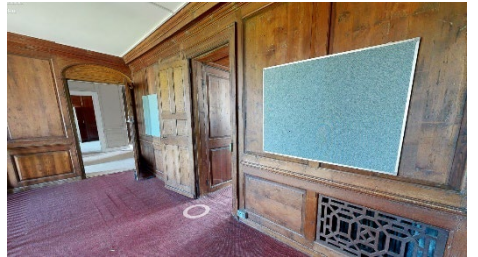
| Reference | Proposal | Significance of affected fabric | Impact | Reasoning and mitigation |
|---|---|---|---|---|
| A-Walls<br>WME1-<br>A.R1 | Pine wall panelling and timber coving to stairwell and landing to be repaired as necessary and new finish applied. | High<br>Early C20 (1909)<br>Lutyens | Low<br>Impact<br><br>Enhance | <p>Wall panelling to stairwell</p> <p>Wall panelling at 1<sup>st</sup> floor landing</p> <p>Historic photographs indicate that the panelling originally had a painted finish. The existing finish will be investigated to confirm that it is a modern varnish product, which will be removed and replaced with a flame retardant breathable paint finish which complies with Building Regulations Part B1 requirements.</p> <p>Remove all surface mounted electrical sockets and fixtures on timber panelling. Carry out repairs to make good any fixing holes/penetration holes.</p> |

| Reference | Proposal | Significance of affected fabric | Impact | Reasoning and mitigation |
|---|---|---|---|---|
| | | | | <p>Repairs to all damaged timber, holes, dents and surface scratches to be filled and the existing surface prepared to receive new painted finish.</p> <p>The proposed panelling finish will be restored to the original 1909 Lutyens painted finish and will comply with Building Regulations Part B1 requirements.</p> |

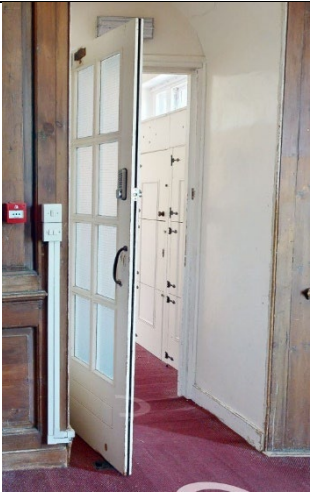
| Reference | Proposal | Significance of affected fabric | Impact | Reasoning and mitigation |
|---|---|---|---|---|
| D-Doors<br>WME1-D.D1 | C20 glazed door to be removed. | Neutral<br>C20 alteration. | Low<br>Impact | <p>C20 fire door</p> <p>Existing door to be replaced with fire rated door with vision panel.</p> |

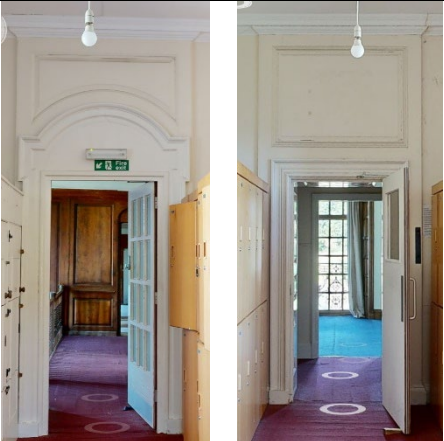
| Reference | Proposal | Significance of affected fabric | Impact | Reasoning and mitigation |
|---|---|---|---|---|
| D-Doors<br>WME1-D.R2 | Repairs and redecoration to timber doorcases. | High<br>Early C20 (1909)<br>Lutyens | Low<br>Impact<br><br>Enhance | |

| Reference | Proposal | Significance of affected fabric | Impact | Reasoning and mitigation |
|---|---|---|---|---|
| | | | | <p>Link corridor doorcases</p> <p>Conservation repairs to cracks/open joints in doorcase joinery. Prepare surface for redecoration with flame retardant breathable paint.</p> |

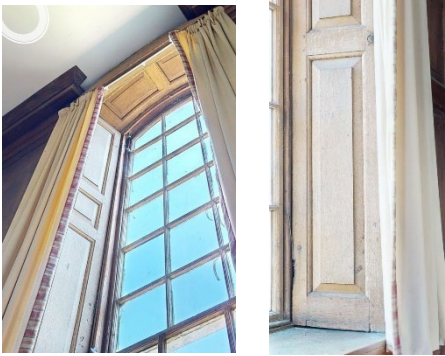
| Reference | Proposal | Significance of affected fabric | Impact | Reasoning and mitigation |
|---|---|---|---|---|
| E-Windows<br>WME1-E.R1 | Renovation of 2no C19 oak sash windows and oak shutters | High<br>C19 oak sash windows | Low<br>Impact<br><br>Benefit & Enhance | <p>WME1-W01 &amp; 2</p> <p>2no C19 sash windows and shutters within stairwell</p> <p>External view of stairwell windows</p> |

| Reference | Proposal | Significance of affected fabric | Impact | Reasoning and mitigation |
|---|---|---|---|---|
| | | | | <p>Following remedial repair works to rainwater pipe and cleaning of masonry, investigate condition of timber. Allow for replacement of both timber sills, bottom sections of frame and lower sashes.</p> <p>Oak multi-pane sash windows, shutters and window boards will be repaired/renovated and redecorated internally and externally.</p> <p>Splice repairs to be carried out where required. Resin for more localised repair. Perished putty replacement. Easing of window as required. Original sash fasteners and shutter knobs and hinges to be retained for re-use.</p> <p>New security ironmongery to comply with building regulations where required tbc.</p> <p>Existing paint finish to retained timber externally to be prepared for new breathable paint finish. New and existing timber internally to be prepared for application of a flame retardant breathable varnish.</p> <p>Any necessary repairs/replacement and redecoration will improve the appearance and longevity of the window.</p> |

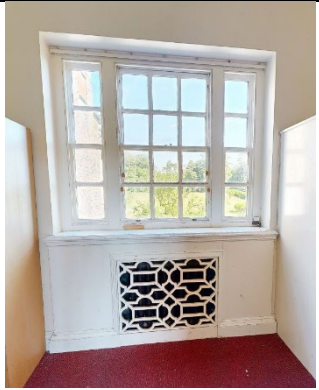
| Reference | Proposal | Significance of affected fabric | Impact | Reasoning and mitigation |
|---|---|---|---|---|
| E-Windows WME1-E.R2 | Repairs to link corridor window | <p>High Early C20 (1909) Lutyens sash window</p> <p>Neutral C20 decorative radiator screen</p> | Low Impact Enhance | <p>Internal view looking north</p> |

| Reference | Proposal | Significance of affected fabric | Impact | Reasoning and mitigation |
|---|---|---|---|---|
| | | | | <p>External view of 1<sup>st</sup> floor window</p> <p>Painted timber multi-pane sash window, will be repaired/renovated and redecorated internally and externally as necessary.</p> <p>Splice repairs to be carried out where required. Resin for more localised repair. Perished putty replacement. Easing of window as required. Original sash fasteners and shutter knobs and hinges to be retained for re-use.</p> <p>New security ironmongery to comply with building regulations where required tbc.</p> <p>Existing paint finish externally to be prepared for new breathable paint finish. New and existing timber internally to be prepared for application of a flame retardant breathable paint finish.</p> <p>Any necessary repairs/replacement and redecoration will improve the appearance and longevity of the window.</p> |

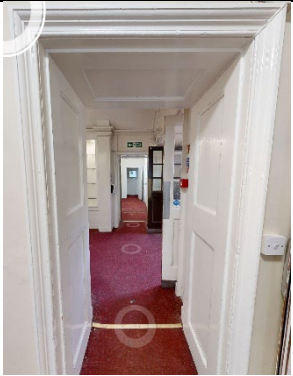
| Reference | Proposal | Significance of affected fabric | Impact | Reasoning and mitigation |
|---|---|---|---|---|
| A-Walls<br>ME-A.R1 | Repairs and redecoration to doorcase | Moderate<br>EC20 Lutyens | Low<br>Impact<br><br>Enhance | <p>Doorcase</p> <p>Sand oil based paint back to a smooth finish and redecorate with flame retardant breathable paint.</p> |

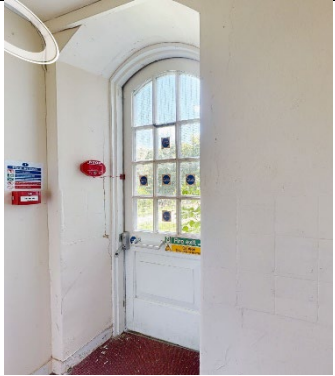
| Reference | Proposal | Significance of affected fabric | Impact | Reasoning and mitigation |
|---|---|---|---|---|
| A-Walls<br>ME-A.R2 | Investigate wall tiles and carry out repairs to internal plaster around external door. | | | <p>External door at Middle Entrance</p> <p>Rake out cracked plaster behind door frame and repair with lime plaster. Remove paint to investigate wall tiles.</p> |

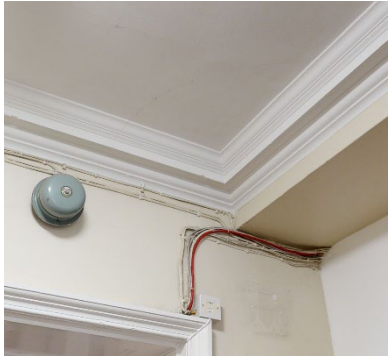
| Reference | Proposal | Significance of affected fabric | Impact | Reasoning and mitigation |
|---|---|---|---|---|
| C-Ceilings<br>ME-C. R1 | Investigate lath and plaster ceilings to all areas of entrance, corridor and below stairs cupboard. | High<br>Early C20<br>1909 Lutyens | Low<br>Impact | <p>Lath and plaster ceiling to be opened up to determine thickness of plaster. If underlining with plasterboard is necessary to achieve Building Regulations requirements for compartmentation, the existing ceiling will be retained. If underlining is not necessary carry out repairs to areas of cracking. Pin back laths and rake out cracks. Repair with lime plaster.</p> <p>Coving to be repaired as necessary and redecorated.</p> <p>Coving to corridor</p> |

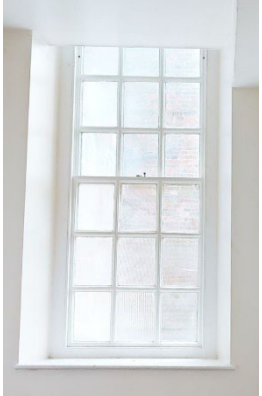
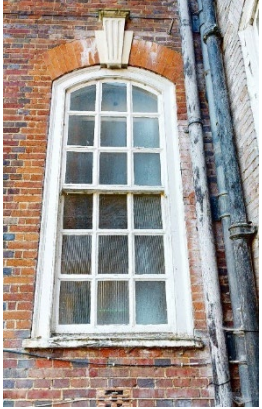
| Reference | Proposal | Significance of affected fabric | Impact | Reasoning and mitigation |
|---|---|---|---|---|
| E-Windows<br>ME-E.R1 | Renovation of EC20 timber sash window | High<br>EC20 (1909)<br>Lutyens | Low Impact<br><br>Benefit & Enhance | <p>Window ME-W01</p> <p>External view</p> <p>The existing timber multi-pane sash window will be repaired/renovated/redecorated and upgraded with slim-line double glazing which will improve the comfort of the internal environment and the viability of the historic building for future use. Splice repairs to be carried out where required. Resin for more localised repair. Perished putty replacement. Easing of window as required. Original sash catches to be retained for reuse. New ironmongery/locking is to comply with building regulations where required. The repairs will improve the appearance and longevity of the window.</p> |

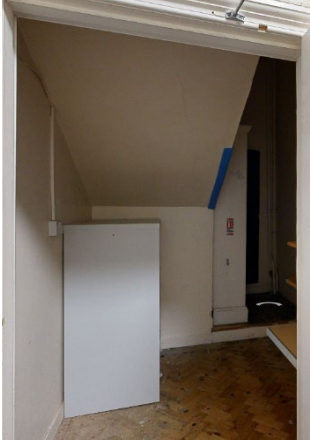
| Reference | Proposal | Significance of affected fabric | Impact | Reasoning and mitigation |
|---|---|---|---|---|
| | | | | <p>Stairs rising in adjacent cupboard/store room</p> <p>Investigate plaster lining and repair cracks to vertical section of stairs. Underline and line sides of stair construction to comply with Building Regulations requirements for fire protection.</p> |

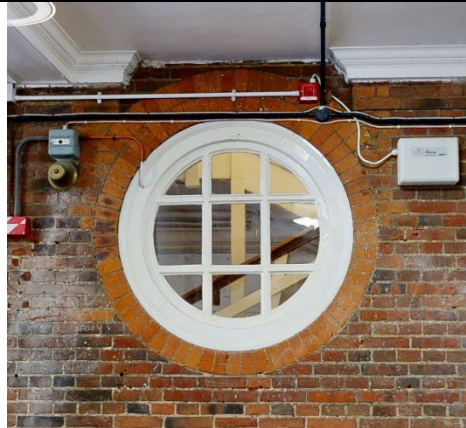
| Reference | Proposal | Significance of affected fabric | Impact | Reasoning and mitigation |
|---|---|---|---|---|
| E-Windows<br>ES-E.R1 | Renovation of 2no C20 round multi-pane timber windows to stairwell and store room | High<br>C20 (1909) Lutyens | Low<br>Impact<br><br>Benefit & Enhance | <p>Round windows (1 of 2no)<br/>ES WG01 &amp; WG02</p> <p>Timber multi-pane round windows will be repaired/renovated/redecorated and upgraded with slim-line double glazing which will improve the comfort of the internal environment and the viability of the historic building for future use. Splice repairs to be carried out where required. Resin for more localised repair. Perished putty replacement. Easing of window as required. The repairs will improve the appearance and longevity of the window.</p> |

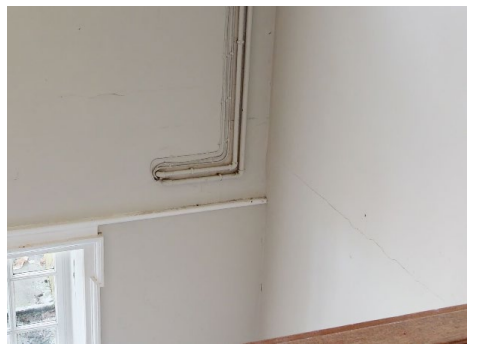
| Reference | Proposal | Significance of affected fabric | Impact | Reasoning and mitigation |
|---|---|---|---|---|
| A-Walls<br>ME-A. R1 | Repair to minor cracks to Early C20/MC20 plaster to stairwell walls. | High<br>Early C20 Plaster to level of head of window likely to be Lutyens 1909 original construction.<br><br><i>Neutral</i><br>Masonry above landing window level is MC20th. | Benefit | <br>Plaster to stairwell walls |

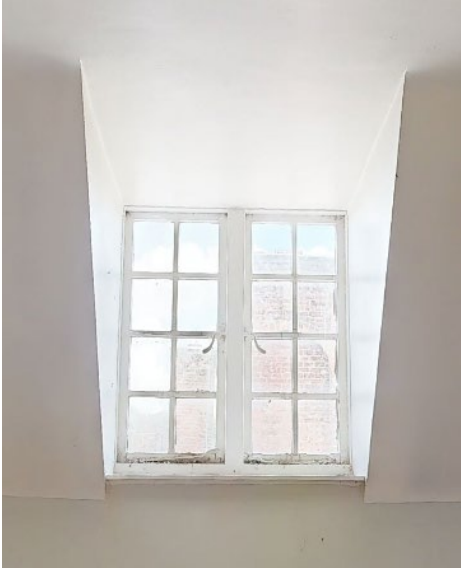
| Reference | Proposal | Significance of affected fabric | Impact | Reasoning and mitigation |
|---|---|---|---|---|
| E-Windows<br>ME-E.R1 | Renovation of C20 timber casement dormer window | Neutral<br>C20 (1935) alterations | Low Impact<br><br>Benefit & Enhance | <p>MC20 dormer window above stairwell<br/>EW W02</p> <p>The existing timber multi-pane window will be repaired/renovated/redecorated and upgraded with slim-line double glazing which will improve the comfort of the</p> |

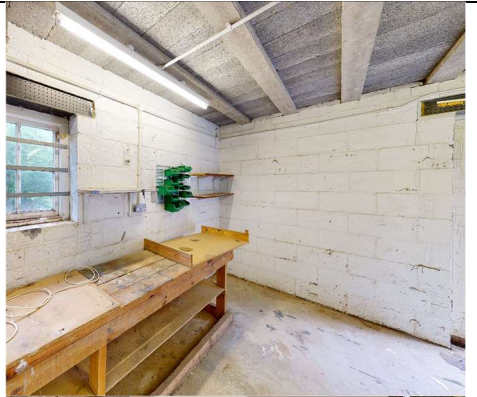
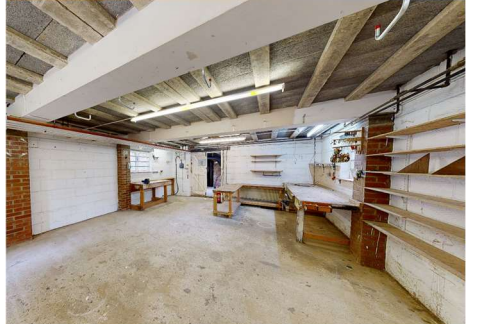
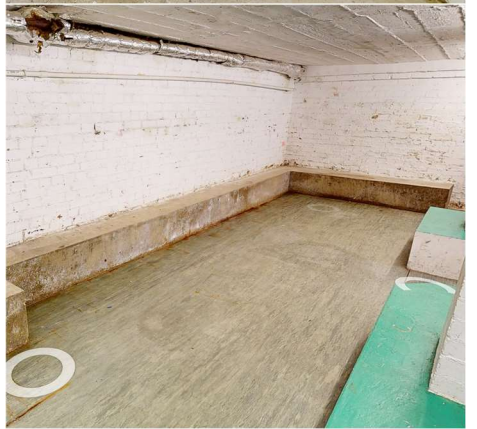
| Reference | Proposal | Significance of affected fabric | Impact | Reasoning and mitigation |
|---|---|---|---|---|
| A.R1 | Exposed brickwork walls to be clean off existing paint, to carry out brick repairs if required. To be drylined internally with insulated plasterboard on battens. | Late 20th Century, no significance | Neutral impact<br>Benefit. | <p>Brickwork is left unaltered and the walls are drylined to provide smooth wall surfaces, to run services within, and to minimize thermal transmission. Allow for</p> |

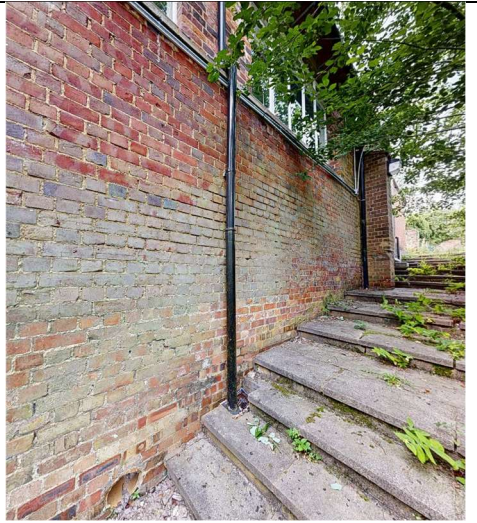
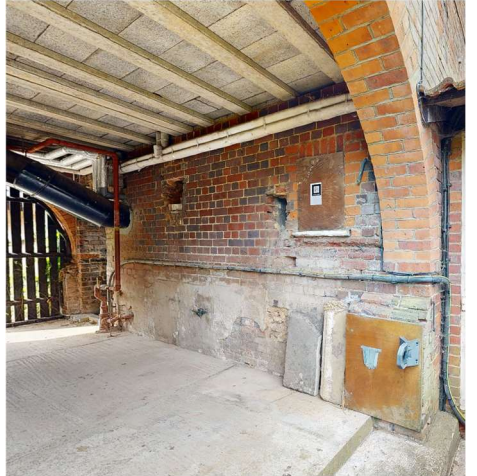
| Reference | Proposal | Significance of affected fabric | Impact | Reasoning and mitigation |
|---|---|---|---|---|
| A.R2 | Carefully restoring the 1910 Lutyens garden wall. | Moderate – Neutral<br>Multiple phases of rebuild and construction including C19 garden wall, c1910 Lutyens' garage, early C20 Lander, Late C20 and Early C21. | Positive impact.<br><br>Benefit. | <p>Areas especially at low level are deteriorated and poorly repaired in cement in the past. The undercroft section has been damaged for installation of services.</p> <p>Minimal like-for-like conservation repair of brick and joints is necessary to retain the evidence of phasing and areas of penny struck pointing. This approach not only maintains the wall's structural integrity but also protects its historical significance.</p> <p>Benefit: This will improve its longevity, appearance, and use, and add to its understanding.</p> |

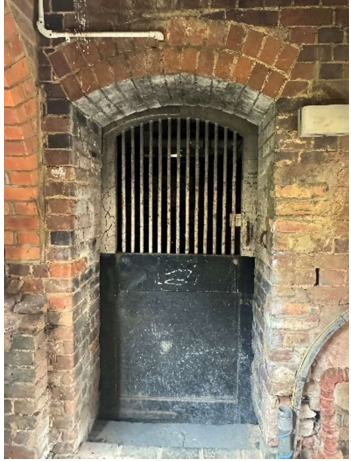
| Reference | Proposal | Significance of affected fabric | Impact | Reasoning and mitigation |
|---|---|---|---|---|
| D.P6 | Retain and repair Machine Room door and make good ironmongery like-for-like with upgraded added security lock. | Moderate – altered door and opening probably 1910 Lutyens | Positive impact. | <p>The door and frame of early C20 is to be preserved with minimal like-for-like conservation repairs to door, ironmongery, surround and arched opening. This will be of visual benefit with the loss of no historic fabric.</p> |

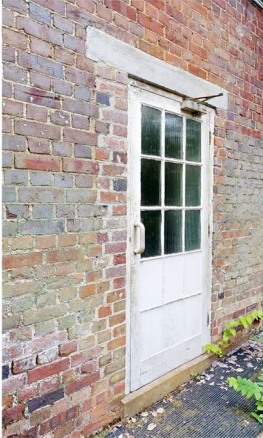
| Reference | Proposal | Significance of affected fabric | Impact | Reasoning and mitigation |
|---|---|---|---|---|
| D.P10 | Existing poorly detailed Late 20 <sup>th</sup> Century door, be replaced with a new hardwood painted panelled door with putty fixed glazing to the top half and traditional ironmongery. | Neutral. Late 20 <sup>th</sup> Century | Positive impact | <p>Benefit: The existing late 20<sup>th</sup> Century Door is of poor quality design. The glazing is bead-fixed externally with pins that are rusting. Allow for a new solid-painted timber door inspired by Lutyens details with putty-fixed glazing within traditional glazing bars and a moulded lower panel to match the status and detailing of the building. This will be of visual benefit with the loss of no historic fabric.</p> |

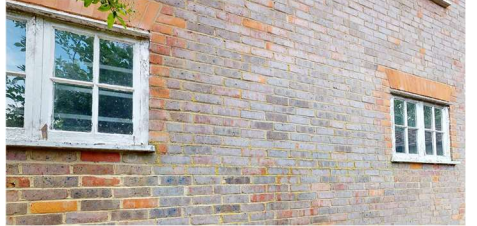
| Reference | Proposal | Significance of affected fabric | Impact | Reasoning and mitigation |
|---|---|---|---|---|
| W01-02, W04-05 | All windows are to be retained and repaired like-for-like. | Neutral significance. Late 20 <sup>th</sup> Century | Positive impact. Benefit. | <p>Conservation methods are to be used to preserve the windows and repair like-for-like:<br/> Splice repairs carried out where required.<br/> Resin repairs for more localised repair.<br/> Replacement lights for any broken panes.<br/> Perished putty replacement. Easing of windows and weights adjusted as required.<br/> Original ironmongery retained. New ironmongery shall be required to comply with building regulations. Renewal of finishes.<br/> Benefit: These repairs will aid the longevity of these windows.</p> |

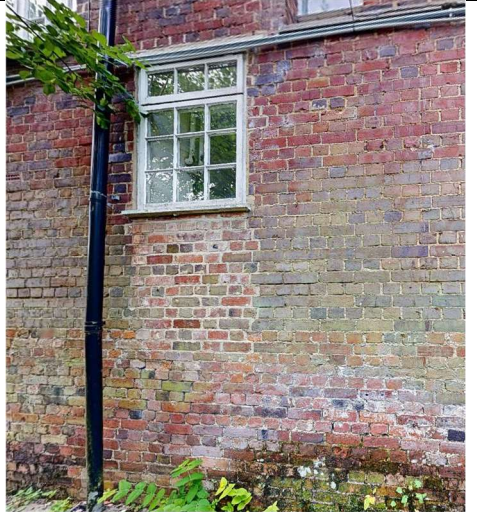
| Reference | Proposal | Significance of affected fabric | Impact | Reasoning and mitigation |
|---|---|---|---|---|
| W06 | <p>All windows are to be retained and repaired like-for-like.</p> <p>Allow to replace unsightly window with top hung casement with a sliding sash window.</p> | Moderate – Neutral<br>Multiple phases of rebuild and construction including C19 garden wall, c1910 Lutyens' garage, early C20 Lander, Late C20 and Early C21. | Positive impact. Benefit. | <p>As above<br/> The window to be replaced is standard catalogue and not sympathetic to the historic character of the site. Its small opening limits the use of this space.<br/> No historic fabric is affected and opportunity will be taken to improve the quality of previous repairs.</p> |

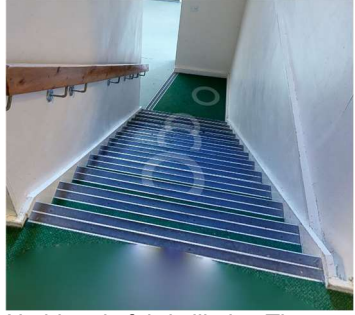
| Reference | Proposal | Significance of affected fabric | Impact | Reasoning and mitigation |
|---|---|---|---|---|
| H.D1 | Removing the 20 <sup>th</sup> century carpets laid by the school. Allow to inspect, retain and carry out minimal like-for-like repairs to substrate. Upgrading of LC20 stair and balustrade. | Neutral significance. Late C20 stairs | Neutral impact | <p>No historic fabric likely. The proposal will upgrade the use of the stairs.</p> |
