**641-KS-06-MB-SH-A-90270– P02****Temple Dinsley Level 0, GA – Apartment 27 – Assembly Hall**

**641-KS-06-MB-SH-A-90280– P01**

**641-KS-06-MB-SH-A-90330– P01****Temple Dinsley Level 1, GA – Apartment 33 - Scullery**

**641-KS-06-MB-SH-A-90900 – P01****Temple Dinsley Level 0, GA – Ground Floor - Common Areas - Vestibule**

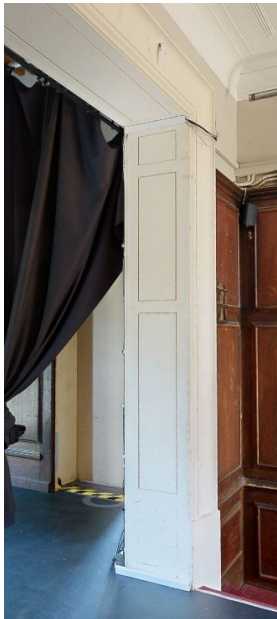
| Reference | Proposal | Significance of affected fabric | Impact | Reasoning and mitigation |
|---|---|---|---|---|
| L-Panelling<br>27L.P1 | Timber lining and architraves around the stage opening to remain. | Low significance<br>Late C20 addition<br>by the School. | Neutral | <p>This provides evidence of the use of the space, by the school as the assembly hall.</p> |

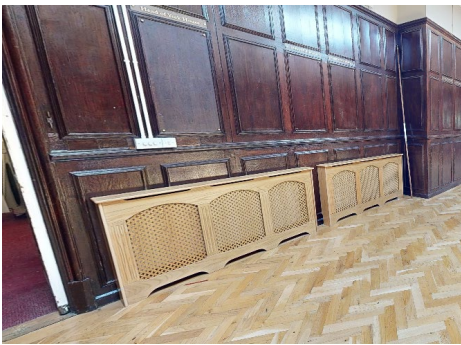
| Reference | Proposal | Significance of affected fabric | Impact | Reasoning and mitigation |
|---|---|---|---|---|
| S-Services<br>27S.D1 | To decommission and remove existing rad covers and radiators. | Neutral/negative.<br>Late C20 addition<br>by the School. | Neutral | <p>The proposal involves laying new underfloor heating system.</p> |

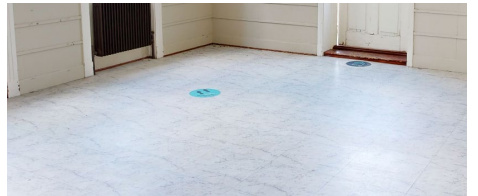
| Reference | Proposal | Significance of affected fabric | Impact | Reasoning and mitigation |
|---|---|---|---|---|
| <u>B-Floors</u><br>28B.R1 | <p>Remove C20 soft flooring (vinyl) throughout. Existing flooring below to be confirmed. Assumed to be suspended timber flooring.</p> <p>It is proposed to carefully lift the existing boards to allow for inspection and repair of timber floor joists, and insertion of new breathable insulation between the joists, Fire and Sound proofing treatment. Existing boards to then be re-laid and left as finish flooring.<br/>New tiled flooring laid including decoupling membrane on bathroom and kitchen.</p> | Low.<br>Mid - late C20 extension. | Low | <p>The floor becomes a compartment floor with the apartment below.</p> |

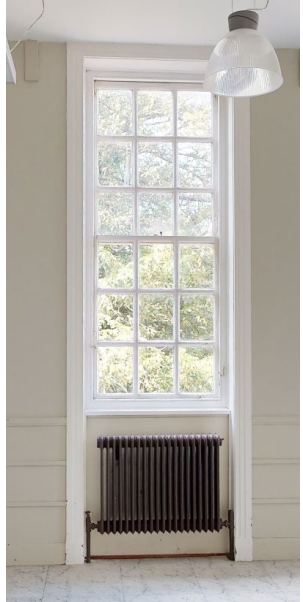
| Reference | Proposal | Significance of affected fabric | Impact | Reasoning and mitigation |
|---|---|---|---|---|
| <u>E-Windows</u><br>28E.R1<br><br>WG01<br>WG02 | Mid C20 timber sash windows repairs. Splice repairs when required. Resin repairs for localized repairs. Replacement of broken glass panes. Perished putty replacement. Easing of window sashes and adjusting of window weights. Original ironmongery to be retained. Ease and adjust as required. New ironmongery to comply with Building Regulations. To redecorate internally and externally. | Low.<br>Late C20 fabric. | Low.<br>Benefit | <p>Sash windows are to be retained and repaired carefully. Ironmongery retained and repaired. The like-for-like repairs are beneficial for the viability and appearance of the building. Replacement of non-original ironmongery to sympathetically reflect the style of the window will improve their appearance.</p> |

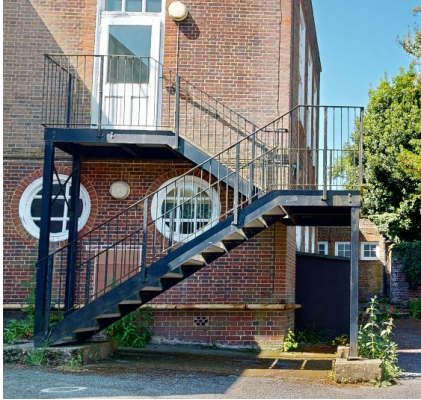
| Reference | Proposal | Significance of affected fabric | Impact | Reasoning and mitigation |
|---|---|---|---|---|
| <u>H-Stairs</u><br>28H.D1 | Remove modern metal staircase serving access to floor above. | Low.<br>Late C20 extension. | Low.<br>Benefit | <p>The industrial style metal staircase is out of character with the setting. Its replacement for a more in keeping brickwork construction staircase is thought to be an enhancement.</p> |

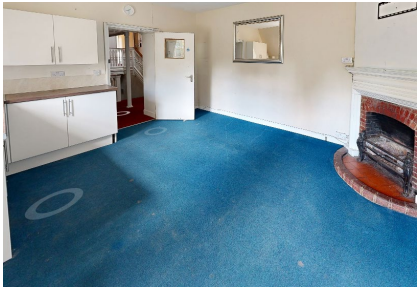
| Reference | Proposal | Significance of affected fabric | Impact | Reasoning and mitigation |
|---|---|---|---|---|
| <u>B-Floors. 33B.R1</u> | <p>C20 modern soft flooring to be stripped and exposed existing wood flooring throughout.</p> <p>Wood flooring to be carefully lifted, to upgrade it thermally and fireproofing. To run services within it. Then to re-lay floorboards and carry out like-for-like repairs if required.</p> | <p>Low.<br/>Soft flooring to be late C20 finishes by the School.</p> <p>High.<br/>Wood flooring to be C20 Lutyens</p> | Benefit. | <p>Benefit: revealing the historic timber flooring enables like-for-like repairs to be</p> |

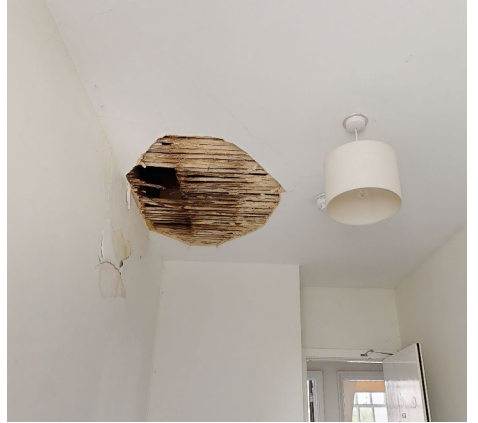
| Reference | Proposal | Significance of affected fabric | Impact | Reasoning and mitigation |
|---|---|---|---|---|
| <u>C-Ceilings</u><br>33C.R1 | Ceiling lime and lath plaster to be repaired generally, and to be decorated. | High.<br>Early C20 Lutyens | Benefit | <p>The proposal involves repairs to the damaged lath and plaster ceiling. Damage has been due to rainwater ingress because of lead theft.</p> |

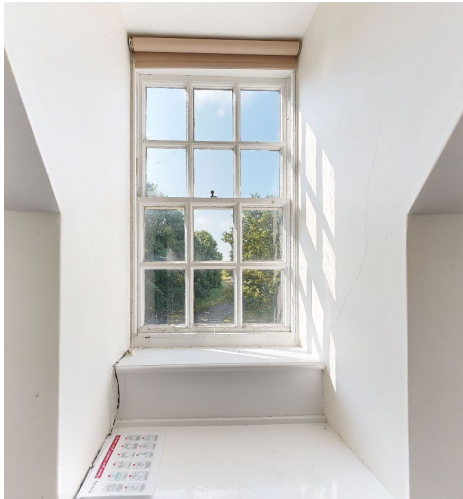
| Reference | Proposal | Significance of affected fabric | Impact | Reasoning and mitigation |
|---|---|---|---|---|
| <u>E-Windows</u><br>33E.R1 | EC20 'Lutyens' timber sash windows repairs and later windows to be splice repairs when required. Resin repairs for localized repairs. Replacement of broken glass panes. Perished putty replacement. Easing of window sashes and adjusting of window weights. Original ironmongery to be retained. Ease and adjust as required. New ironmongery to comply with Building Regulations. To redecorate internally and externally. | High.<br>Early C20 Lutyens | Benefit | |

| Reference | Proposal | Significance of affected fabric | Impact | Reasoning and mitigation |
|---|---|---|---|---|
| | | | | Original sash windows are to be retained and repaired carefully. Ironmongery retained and repaired.<br>The like-for-like repairs are beneficial for the viability and appearance of the building. Replacement of non-original ironmongery to sympathetically reflect the style of the window will improve their appearance. |

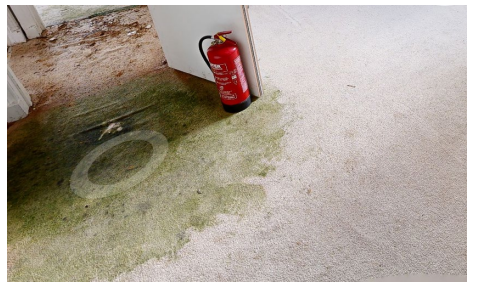
| Reference | Proposal | Significance of affected fabric | Impact | Reasoning and mitigation |
|---|---|---|---|---|
| <u>B-Floors</u><br>34B.R1 | <p>C20 modern soft flooring to be stripped and exposed existing wood flooring throughout.</p> <p>Wood flooring to be carefully lifted, carry out repairs if required, to upgrade it thermally and fireproofing. To run services within it. Then to re-lay floorboards and carry out like-for-like repairs if required.</p> <p>To lay a decoupling layer when new flooring is to be laid.</p> | <p>Low.<br/>Soft flooring to be late C20 finishes by the School.</p> <p>High.<br/>Wood flooring to be early C20 Lutyens</p> | Benefit. | <p>Benefit: revealing the historic timber flooring enables like-for-like repairs to be carried out. This improves breathability and enables its appearance to be appreciated.</p> |

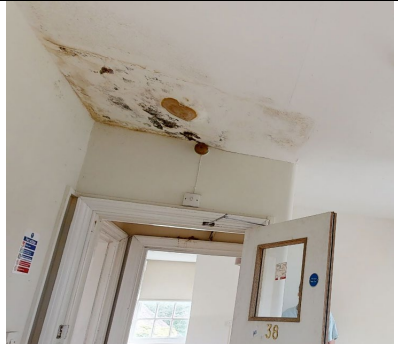
| Reference | Proposal | Significance of affected fabric | Impact | Reasoning and mitigation |
|---|---|---|---|---|
| <u>C-Ceilings</u><br>34C.R1 | Like for like repairs when possible and/or replacement to severely damaged lath and plaster ceiling. | High.<br>Early C20 Lutyens | Benefit | |

| Reference | Proposal | Significance of affected fabric | Impact | Reasoning and mitigation |
|---|---|---|---|---|
| | | | | <p>Due to rainwater ingress the lath and plaster ceiling has been badly damaged, beyond repair in some parts of the ceiling.</p> |

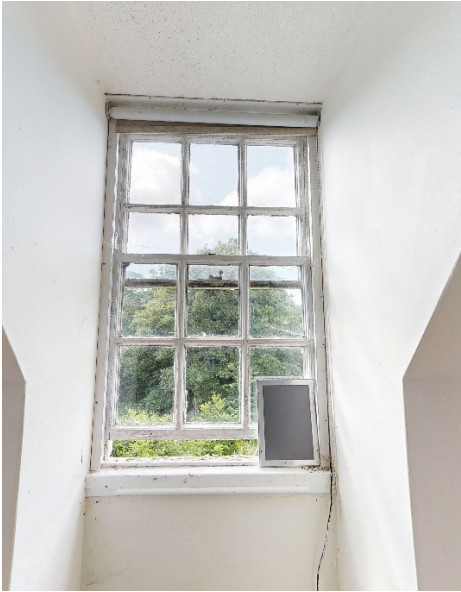
| Reference | Proposal | Significance of affected fabric | Impact | Reasoning and mitigation |
|---|---|---|---|---|
| E-<br>Windows<br>34E.R1 | EC20 'Lutyens' timber sash and casement windows repairs. Splice repairs when required. Resin repairs for localized repairs. Replacement of broken glass panes. Perished putty replacement. Easing of window sashes and adjusting of window weights. Original ironmongery to be retained. Ease and adjust as required. New ironmongery to comply with Building Regulations. To redecorate internally and externally. | High.<br>Early C20 Lutyens | Benefit | <p>Windows are to be retained and repaired carefully. Ironmongery retained and repaired.<br/>The like-for-like repairs are beneficial for the viability and appearance of the building. Replacement of non-original ironmongery to sympathetically reflect the style of the window will improve their appearance.</p> |

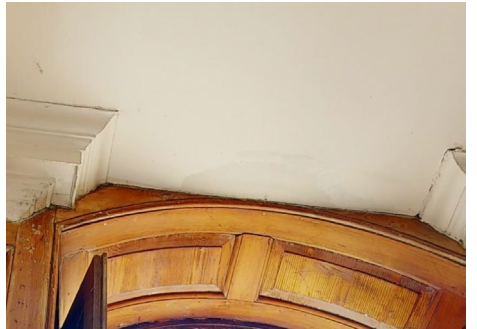
| Reference | Proposal | Significance of affected fabric | Impact | Reasoning and mitigation |
|---|---|---|---|---|
| C-Ceilings<br>WME-V-<br>C.R1 | Repair to continuous crack in plasterboard ceiling. | Low<br>Plasterboard linings<br>Neutral/Negative<br>C20 alterations | Low<br>Impact | <p>Crack in vestibule ceiling</p> <p>Damp on ceiling above window</p> <p>Floors are to be upgraded from above. Ceiling clining to be investigated to confirm presence of lath and plaster above plasterboard lining. C20 plasterboard ceiling will be retained to avoid distrubance to plaster coving. Pin back boards to either side of crack. Rake out crack and fill joint with flexible joint compound. Remove smoke alarm and associated cables and make good to ceiling.</p> <p>Investigate cause of damp and carry out repairs as necessary.</p> |

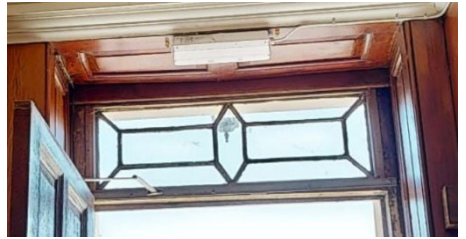
| Reference | Proposal | Significance of affected fabric | Impact | Reasoning and mitigation |
|---|---|---|---|---|
| | | | | <p>Glazed lead light panel at head of door appears to be in good condition and will be retained. Proposal to line internally with toughened glass panel for security purposes (?) will maintain internal view and daylight and will not affect the glazing. Fixing details tbc</p> |

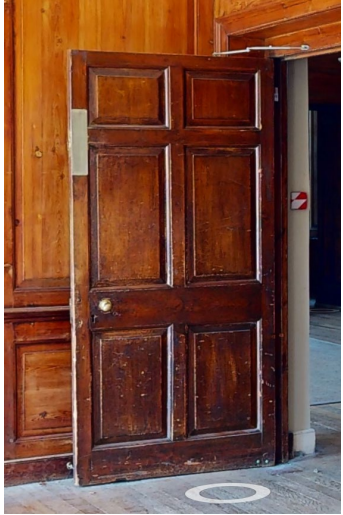
| Reference | Proposal | Significance of affected fabric | Impact | Reasoning and mitigation |
|---|---|---|---|---|
| D-Doors<br>WME-V-D.R2 | Oak panelled internal door between vestibule and entrance hall to be refurbished | High<br>C18 door | Low<br>Impact<br><br>Benefit | <p>Entrance Hall door<br/>WMEV-FD02</p> <p>Door to be removed from frame and existing ironmongery removed. Investigate existing finish and remove/clean with suitable product as necessary. Fill any deep scratches/dents to both sides of door with wood wax to match timber colour. Upgrade to be fire rated. Apply new flame retardant breathable varnish</p> |

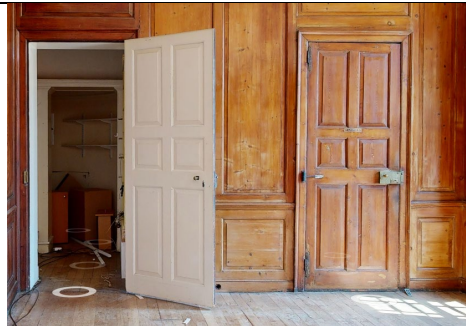
| Reference | Proposal | Significance of affected fabric | Impact | Reasoning and mitigation |
|---|---|---|---|---|
| D-Doors<br>WME-V-D.R3 | Pine (?) panelled internal doors to be refurbished | High<br>C18 doors | Low<br>Impact<br><br>Benefit | <p>2no internal doors east wall of vestibule</p> |

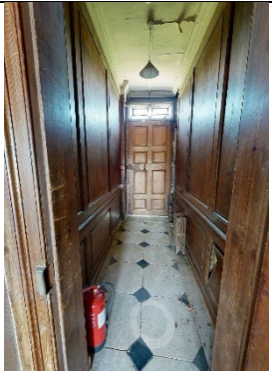
| Reference | Proposal | Significance of affected fabric | Impact | Reasoning and mitigation |
|---|---|---|---|---|
| A-Walls<br>WME-EH-<br>A.R2 | Repairs to timber panelling along north corridor. | High<br>Early C20 (1909)<br>Lutyens | Low<br>Impact<br><br>Benefit & Enhance | <p>North corridor</p> <p>Remove all surface mounted electrical fixtures on timber panelling. Carry out repairs to make good all fixing holes/penetration holes.</p> |

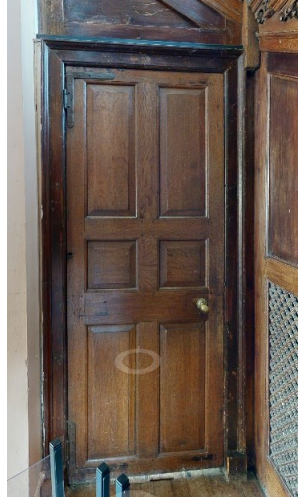
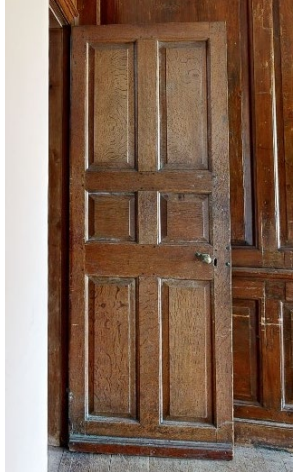
| Reference | Proposal | Significance of affected fabric | Impact | Reasoning and mitigation |
|---|---|---|---|---|
| D-Doors<br>WME-EH-D.R1 | Oak panelled internal doors to be refurbished and redecorated. | High<br>C18 and EC20<br>(1909) Lutyens | Low<br>Impact<br><br>Enhance | <p>Door to understairs room<br/>WME-EH-FD01</p> <p>Door to north exit corridor<br/>WME-EH-FD02</p> <p>Doors to be removed from frames and existing ironmongery removed. Surface of doors, linings and architraves to be lightly sanded to remove existing finish. Upgrade to be fire doors. Flame retardant and breathable varnish to be applied. Door to be re-hung with all original ironmongery/lock cases of historic value and modern security fittings tbc.</p> |
