First Floor – Plan of Significance

**641-KS-06-MB-SH-A-90920 – P01**  
**Temple Dinsley Level 1, GA – First Floor – Common Areas**

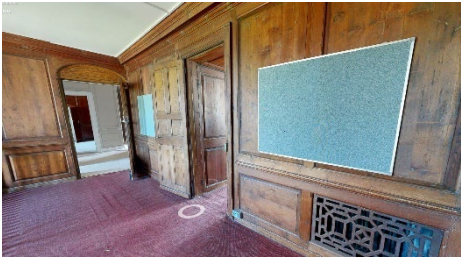
| Reference | Proposal | Significance of affected fabric | Impact | Reasoning and mitigation |
|---|---|---|---|---|
| A-Walls<br>WME1-<br>A.R1 | Pine wall panelling and timber coving to stairwell and landing to be repaired as necessary and new finish applied. | High<br>Early C20 (1909)<br>Lutyens | Low<br>Impact<br><br>Enhance | <p>Wall panelling to stairwell</p> <p>Wall panelling at 1<sup>st</sup> floor landing</p> <p>Historic photographs indicate that the panelling originally had a painted finish. The existing finish will be investigated to confirm that it is a modern varnish product, which will be removed and replaced with a flame retardant breathable paint finish which complies with Building Regulations Part B1 requirements.</p> <p>Remove all surface mounted electrical sockets and fixtures on timber panelling. Carry out repairs to make good any fixing holes/penetration holes.</p> |

| Reference | Proposal | Significance of affected fabric | Impact | Reasoning and mitigation |
|---|---|---|---|---|
| | | | | <p>Repairs to all damaged timber, holes, dents and surface scratches to be filled and the existing surface prepared to receive new painted finish.</p> <p>The proposed panelling finish will be restored to the original 1909 Lutyens painted finish and will comply with Building Regulations Part B1 requirements.</p> |

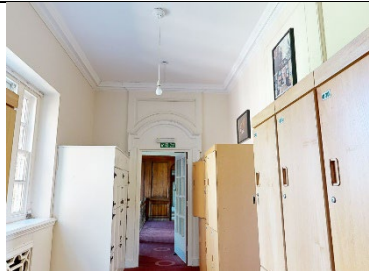
| Reference | Proposal | Significance of affected fabric | Impact | Reasoning and mitigation |
|---|---|---|---|---|
| A-Walls WME1-A.R3 | Repairs to plaster to link corridor | High<br>Early C20 lime plaster<br><br>Neutral<br>C20 gypsum plaster | Moderate<br>-Low Impact | <p>Lutyens link corridor</p> <p>Crack at high level</p> <p>Cracks possibly associated with movement following early C20 alterations to be investigated by conservation structural engineer and remedial proposals carried out as necessary<br/>Lime plaster repairs to walls as necessary.<br/>Conservation repairs to cracks in plaster coving.</p> |

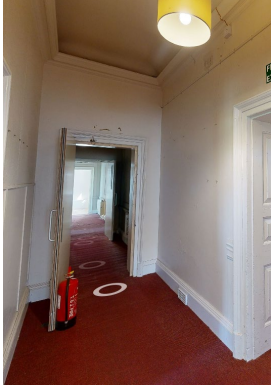
| Reference | Proposal | Significance of affected fabric | Impact | Reasoning and mitigation |
|---|---|---|---|---|
| A-Walls<br>WME1-<br>A.D1 | Partial demolition and reconstruction of partitions to form compartment to Apartment 2 | Moderate<br>Early C20 partitions extensively altered<br>MC20 | Low<br>Impact | <p>West Wing 1<sup>st</sup> Floor corridor</p> <p>Linings to be formed around existing cornice and coving at ceiling level. The intervention is reversible.</p> <p>Refer to apartment 2 Impact Table</p> |

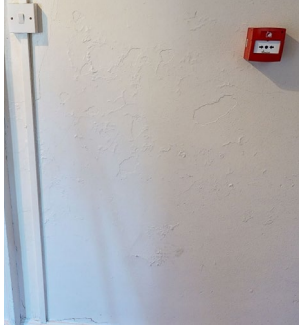
| Reference | Proposal | Significance of affected fabric | Impact | Reasoning and mitigation |
|---|---|---|---|---|
| A-Walls<br>WME1-<br>A.R5 | Removal of degraded paint to masonry corridor walls. | High<br>Early C20<br>1909 Lutyens | Low<br>Impact<br><br>Benefit | <p>Plaster to corridor and stairwell walls</p> <p>Peeled and flaking layers of paint to be scraped back to a smooth surface suitable</p> |

| Reference | Proposal | Significance of affected fabric | Impact | Reasoning and mitigation |
|---|---|---|---|---|
| | | | | for redecoration with a breathable paint finish. Plaster repairs<br><br>A breathable paint system will protect the Early C20 plaster from deterioration. |

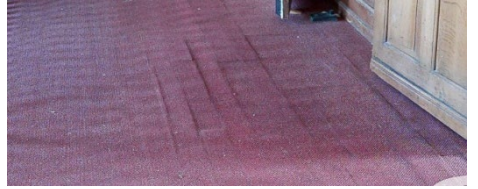
| Reference | Proposal | Significance of affected fabric | Impact | Reasoning and mitigation |
|---|---|---|---|---|
| B-Floors<br>WME1-<br>B.P1 | Removal of carpet. Oak strip floorboards/softwood floorboards to be lifted to allow upgrading of floor to landing area, link corridor and west wing corridor | High<br>Early C20 (1909) Lutyens oak strip floorboards<br><br>Neutral C20 carpet | Low<br>Impact<br><br>Enhance | <p>Carpet over oak boards on landing</p> <p>The oak boards/softwood boards are to be lifted to allow the floor construction to be inspected, repaired/upgraded.</p> <p>Upgrading of floor construction is necessary to comply with Building Regulations Part B and Part E.</p> |

| Reference | Proposal | Significance of affected fabric | Impact | Reasoning and mitigation |
|---|---|---|---|---|
| B-Floors<br>WME1-<br>B.R1 | Replacement and refurbishment of C20 oak strip floorboards. | High<br>Early C20 (1909) Lutyens oak strip floorboards<br><br>Neutral<br>C20 clear varnish finish | Low<br>Impact<br><br>Enhance | <p>Conservation repairs will be carried out to any damaged oak boards. The boards will be sanded to restore the surface of the timber and will be finished with a breathable flame retardant varnish.</p> <p>The proposal to finish the oak boards with a varnish will restore the surface of the timber and comply with Building Regulations Part B1.</p> |

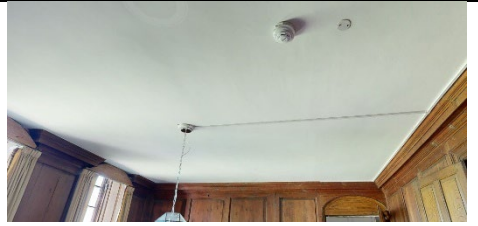
| Reference | Proposal | Significance of affected fabric | Impact | Reasoning and mitigation |
|---|---|---|---|---|
| C-Ceilings<br>WME1-<br>C.D1 | Removal of electrical services and surface mounted conduit from lath and plaster ceiling. | High<br>Early 20 Lutyens plaster<br><br>Neutral<br>C20 electrical services | Low -<br>moderate<br>Impact<br><br>Enhance | <p>Ceiling above landing</p> <p>Lime plaster repairs following removal of services.</p> |

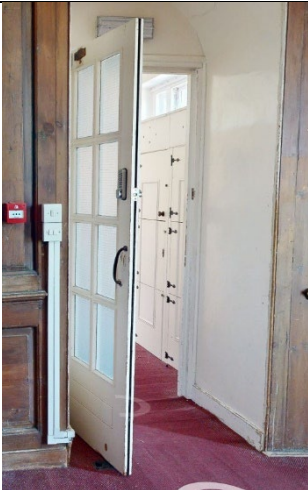
| Reference | Proposal | Significance of affected fabric | Impact | Reasoning and mitigation |
|---|---|---|---|---|
| D-Doors<br>WME1-D.D1 | C20 glazed door to be removed. | Neutral<br>C20 alteration. | Low<br>Impact | <p>C20 fire door</p> <p>Existing door to be replaced with fire rated door with vision panel.</p> |

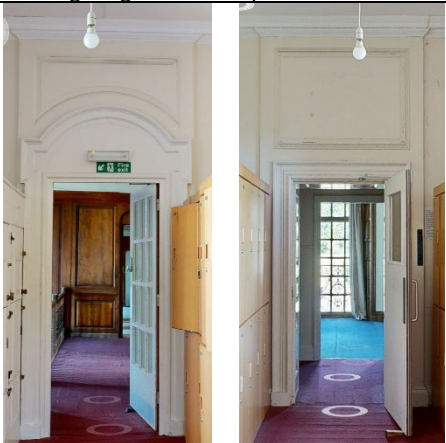
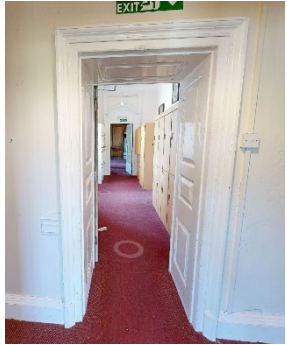
| Reference | Proposal | Significance of affected fabric | Impact | Reasoning and mitigation |
|---|---|---|---|---|
| D-Doors<br>WME1-D.R2 | Repairs and redecoration to timber doorcases. | High<br>Early C20 (1909)<br>Lutyens | Low<br>Impact<br><br>Enhance | |

| Reference | Proposal | Significance of affected fabric | Impact | Reasoning and mitigation |
|---|---|---|---|---|
| | | | | <p>Link corridor doorcases</p> <p>Conservation repairs to cracks/open joints in doorcase joinery. Prepare surface for redecoration with flame retardant breathable paint.</p> |

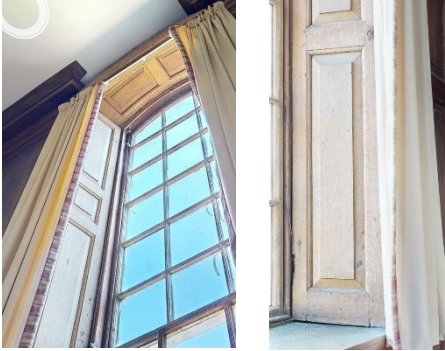
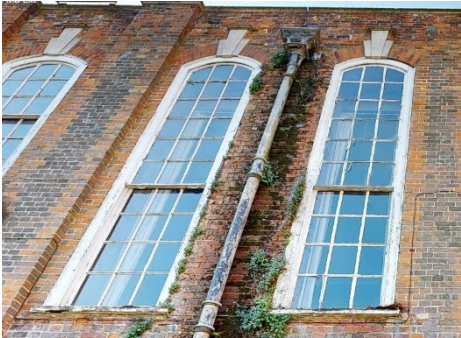
| Reference | Proposal | Significance of affected fabric | Impact | Reasoning and mitigation |
|---|---|---|---|---|
| E-Windows<br>WME1-E.R1 | Renovation of 2no C19 oak sash windows and oak shutters | High<br>C19 oak sash windows | Low<br>Impact<br><br>Benefit & Enhance | <p>WME1-W01 &amp; 2</p> <p>2no C19 sash windows and shutters within stairwell</p> <p>External view of stairwell windows</p> |

| Reference | Proposal | Significance of affected fabric | Impact | Reasoning and mitigation |
|---|---|---|---|---|
| | | | | <p>Following remedial repair works to rainwater pipe and cleaning of masonry, investigate condition of timber. Allow for replacement of both timber sills, bottom sections of frame and lower sashes.</p> <p>Oak multi-pane sash windows, shutters and window boards will be repaired/renovated and redecorated internally and externally.</p> <p>Splice repairs to be carried out where required. Resin for more localised repair. Perished putty replacement. Easing of window as required. Original sash fasteners and shutter knobs and hinges to be retained for re-use.</p> <p>New security ironmongery to comply with building regulations where required tbc.</p> <p>Existing paint finish to retained timber externally to be prepared for new breathable paint finish. New and existing timber internally to be prepared for application of a flame retardant breathable varnish.</p> <p>Any necessary repairs/replacement and redecoration will improve the appearance and longevity of the window.</p> |

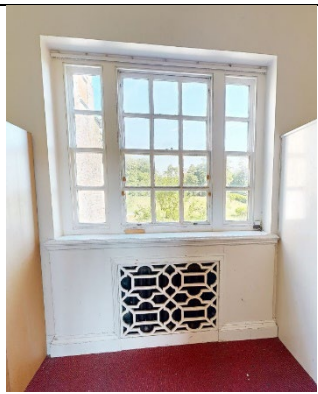
| Reference | Proposal | Significance of affected fabric | Impact | Reasoning and mitigation |
|---|---|---|---|---|
| E-Windows WME1-E.R2 | Repairs to link corridor window | <p>High Early C20 (1909) Lutyens sash window</p> <p>Neutral C20 decorative radiator screen</p> | Low Impact Enhance | <p>Internal view looking north</p> |

| Reference | Proposal | Significance of affected fabric | Impact | Reasoning and mitigation |
|---|---|---|---|---|
| | | | | <p>External view of 1<sup>st</sup> floor window</p> <p>Painted timber multi-pane sash window, will be repaired/renovated and redecorated internally and externally as necessary.</p> <p>Splice repairs to be carried out where required. Resin for more localised repair. Perished putty replacement. Easing of window as required. Original sash fasteners and shutter knobs and hinges to be retained for re-use.</p> <p>New security ironmongery to comply with building regulations where required tbc.</p> <p>Existing paint finish externally to be prepared for new breathable paint finish. New and existing timber internally to be prepared for application of a flame retardant breathable paint finish.</p> <p>Any necessary repairs/replacement and redecoration will improve the appearance and longevity of the window.</p> |

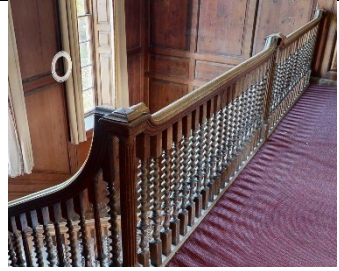
| Reference | Proposal | Significance of affected fabric | Impact | Reasoning and mitigation |
|---|---|---|---|---|
| H-Stairs<br>WME1-<br>H.P1 | Necessary repairs and redecoration to oak staircase | High<br>C18 stair altered<br>Early C20 (1909) by<br>Lutyens | Low<br>Impact | <p>Oak stairs. Flight above 1<sup>st</sup> landing</p> <p>Oak stair, balustrading and handrail are to be inspected to ensure stability and any repairs/strengthening works carried out as necessary.</p> <p>Surface to treads/risers/balusters/handrail to be lightly sanded back and suitably prepared for new breathable and flame retardant varnish finish.</p> |

| Reference | Proposal | Significance of affected fabric | Impact | Reasoning and mitigation |
|---|---|---|---|---|
| | | | | <p>1<sup>st</sup> floor balustrade</p> <p>Necessary repairs and redecoration will improve the appearance of the staircase and will comply with Building Regulations B1.</p> <p>Carpet tbc.</p> |

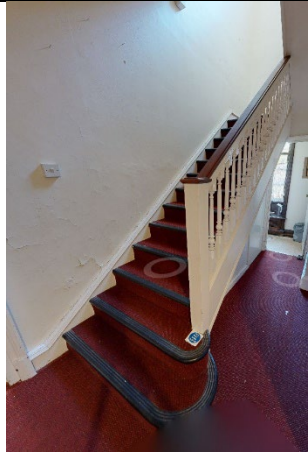
| Reference | Proposal | Significance of affected fabric | Impact | Reasoning and mitigation |
|---|---|---|---|---|
| H-Stairs<br>WME1-<br>H.P2 | Alterations to MC20 stairs and balustrading | Neutral<br>MC20 alteration by school | Low<br>Impact | <p>West wing stairs to 2<sup>nd</sup> floor</p> <p>Refer to apartment 2 Impact Table for layout and construction of new partitions affecting existing stair.</p> |
