## Second Floor – Proposed Landing – Plan of Significance

**641-KS-06-MB-SH-A-90950 – P01**
**Temple Dinsley Level 2, GA – Second Floor - Common Areas**

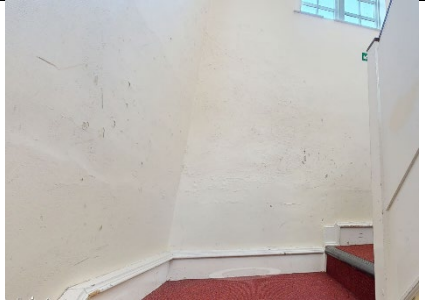
| Reference | Proposal | Significance of affected fabric | Impact | Reasoning and mitigation |
|---|---|---|---|---|
| A-Walls<br>WME2-<br>A.D1 | Removal of MC20 plaster finish and timber skirtings to masonry walls to external and south sides enclosing stairs. | <b>Moderate</b><br>Lutyens 1909 roof raised c1935<br><br><b>Neutral</b><br>Masonry above half-landing level is MC20th. | Neutral Benefit | <p>Evidence of damp ingress at stair half-landing</p> <p>It is expected that damp ingress is occurring due to failure of the copper parapet capping and/or the lead flashing at the junction of the capping with the wall. Investigation and repair of the external copper/leadwork will be necessary to prevent further ingress of moisture. All areas of plaster and timber skirtings will be removed to allow the masonry to fully dry out.</p> <p>Removal of damp plaster and repair of external copper and leadwork will prevent further deterioration of the masonry wall and is considered a benefit.</p> |

| Reference | Proposal | Significance of affected fabric | Impact | Reasoning and mitigation |
|---|---|---|---|---|
| A-Walls<br>WME2-A.R1 | Repairs to upstand wall, hung tiles, copper gutter and lead flashings | Neutral<br>1935 alterations | Benefit | The construction of the upstand wall and associated copper gutter, lead flashings and hung tiles are to be investigated where evidence of damp ingress is apparent. Proposals for repairs will be submitted for approval. |

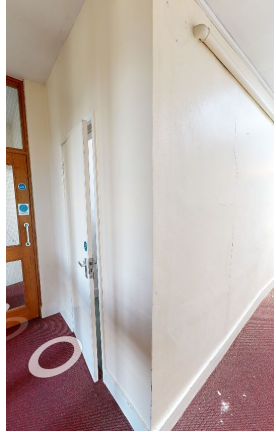
| Reference | Proposal | Significance of affected fabric | Impact | Reasoning and mitigation |
|---|---|---|---|---|
| A-Walls<br>WME2-A.D2 | Removal of C20 timber stud partitions forming corridor cupboard. | Neutral<br>C20 alterations | Neutral | <p>Corridor cupboard<br/>No historic fabric affected.</p> |

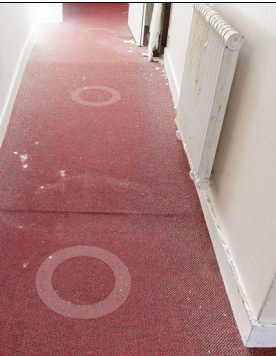
| Reference | Proposal | Significance of affected fabric | Impact | Reasoning and mitigation |
|---|---|---|---|---|
| B-Floors<br>WME2-B.P2 | Removal of existing C20 ramp construction and relocation of steps to allow for proposed removal of wall. | Neutral C20 alterations | Neutral likely subject to investigation | |

| Reference | Proposal | Significance of affected fabric | Impact | Reasoning and mitigation |
|---|---|---|---|---|
| | | | | <p>Corridor ramp</p> <p>Original C20 corridor steps have been overlaid with a ramp construction as part of the C20 alterations. The existing wall (RHS) will be removed as part of the proposed works to for the Apartment 5 Lander entrance enclosure. The C20 ramp construction will be removed and the existing steps recorded and left in place/replaced following the upgrading works necessary to the floor construction to comply with Building Regulations. New steps will be formed further into the corridor.</p> |

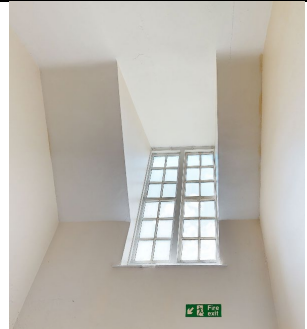
| Reference | Proposal | Significance of affected fabric | Impact | Reasoning and mitigation |
|---|---|---|---|---|
| C-Ceilings WME2-C. D1 | Removal of MC20 plasterboard linings to sloping section of ceiling adjacent to dormer window. | <p>Moderate Lutyens 1909 roof raised c1935</p> <p>Neutral C20 alterations Plasterboard linings</p> | <p>Low Impact</p> <p>Benefit likely</p> <p>Benefit</p> | <p>Dormer window over starwell</p> <p>Plasterboard linings to sloping sections of ceiling are to be removed to allow the roof structure to be assessed and condition investigated and the roof void insulated. This is considered to be a positive impact which will benefit the building fabric, the internal environment and the viability of the building for future use.</p> <p>The coved/rolled plaster junction between the flat and sloping ceiling will be reinstated.</p> |

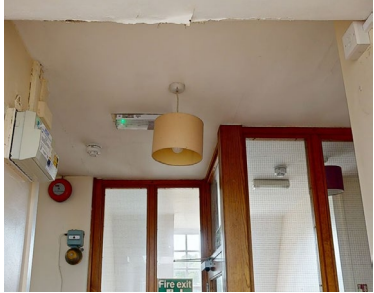
| Reference | Proposal | Significance of affected fabric | Impact | Reasoning and mitigation |
|---|---|---|---|---|
| | | | | <p>Flat ceiling in corridor and over stairwell beyond</p> <p>Cracks in plasterboard visible throughout are to be repaired.<br/>No historic fabric affected.</p> |

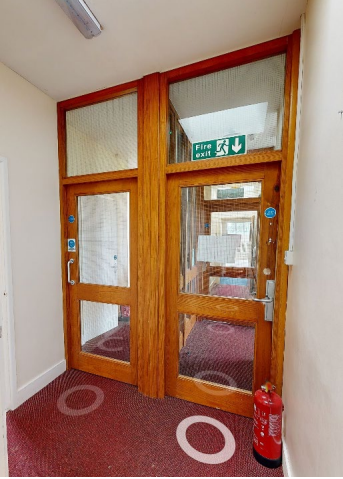
| Reference | Proposal | Significance of affected fabric | Impact | Reasoning and mitigation |
|---|---|---|---|---|
| D-Doors<br>WME2-D.<br>D1 | Varnished softwood timber top and bottom glazed C20 fire rated doors (3no) and full height glazed screens forming compartment at top of stairs. | Neutral/Negative<br>Late C20 alterations | Enhance | <p>C20 compartment doors and glazed screens to be removed.</p> |

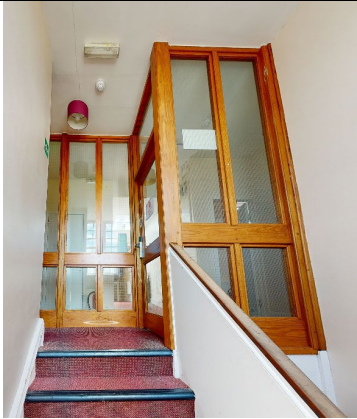
| Reference | Proposal | Significance of affected fabric | Impact | Reasoning and mitigation |
|---|---|---|---|---|
| | | | | <p>Compartment screen at stairwell landing</p> <p>The partition intrudes into the volume and views.</p> |

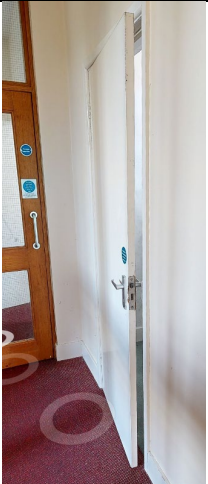
| Reference | Proposal | Significance of affected fabric | Impact | Reasoning and mitigation |
|---|---|---|---|---|
| D-Doors<br>WME2-<br>D.D2 | Painted flush panel<br>C20 cupboard door<br>ironmongery in corridor | Neutral/Negative<br>Late C20 alterations | Neutral | <p>Corridor cupboard door to be removed</p> |

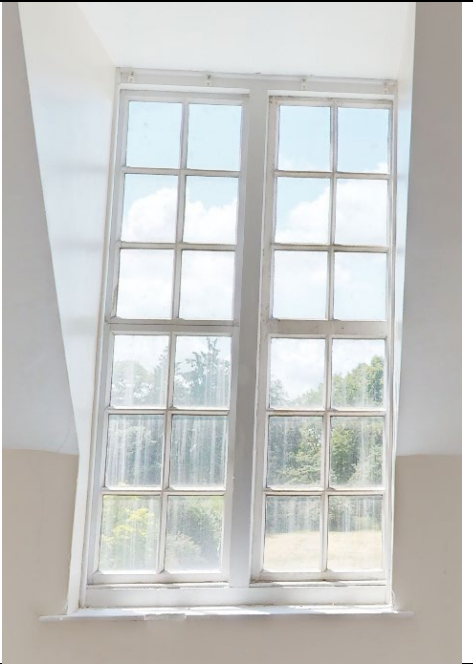
| Reference | Proposal | Significance of affected fabric | Impact | Reasoning and mitigation |
|---|---|---|---|---|
| E-Windows<br>Common<br>WME2-<br>E.R1 | Renovation of C20<br>timber casement<br>dormer window | Low<br>C20 (1935)<br>alterations | Benefit &<br>Enhance | |

| Reference | Proposal | Significance of affected fabric | Impact | Reasoning and mitigation |
|---|---|---|---|---|
| | | | | <p>MC20 dormer window above stairwell<br/>WW W01</p> <p><b>No historic fabric affected.</b><br/>The existing timber multi-pane window will be repaired/renovated/redecorated and upgraded with slim-line double glazing which will improve the comfort of the internal environment and the viability of the historic building for future use. Splice repairs to be carried out where required. Resin for more localised repair. Perished putty replacement. Easing of window as required. Original 'monkey tail' casement latches to be retained for reuse. New ironmongery/locking is to comply with building regulations where required. The repairs will improve the appearance and longevity of the window.</p> |

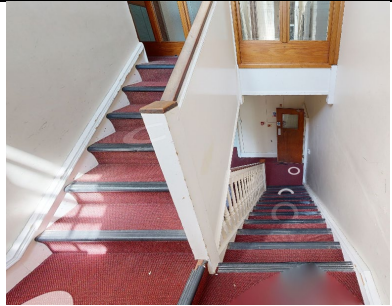
| Reference | Proposal | Significance of affected fabric | Impact | Reasoning and mitigation |
|---|---|---|---|---|
| H-Stairs<br>WME2-<br>H.P1 | Upgrading of MC20 stair and balustrade between 1 <sup>st</sup> and 2 <sup>nd</sup> floor levels. | Low<br>MC20 (1935)<br>alterations | Low<br>impact<br>Benefit | <p>Common stair to 2<sup>nd</sup> floor</p> <p>Existing carpet covering and nosings to be removed to allow investigation of construction. Upgrading works will be carried out to the stair to comply with Building Regulations fire protection and sound separation requirements. Improves viability of the building use.</p> |

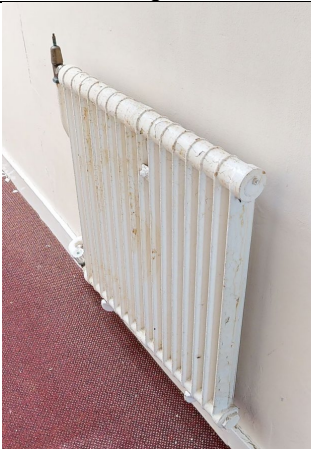
| Reference | Proposal | Significance of affected fabric | Impact | Reasoning and mitigation |
|---|---|---|---|---|
| J-Internal<br>fixtures<br>and fittings<br>WME2-<br>J.D1 | Renovation / removal of C20 cast iron wall mounted radiator | Neutral C20 | Neutral<br>Impact | <p>C20 radiator to be removed or renovated</p> |

| Reference | Proposal | Significance of affected fabric | Impact | Reasoning and mitigation |
|---|---|---|---|---|
| | | | | Radiators to be removed or restored/redecorated and relocated within new layout as required.<br><i>No historic fabric affected in this part of the building.</i> |
