## **The Old Manor Shaftenhoe End**

A Design, Access and Heritage Statement September 2026

Alterations and refurbishment of the Old Manor

Remedial Works to existing West Wall.

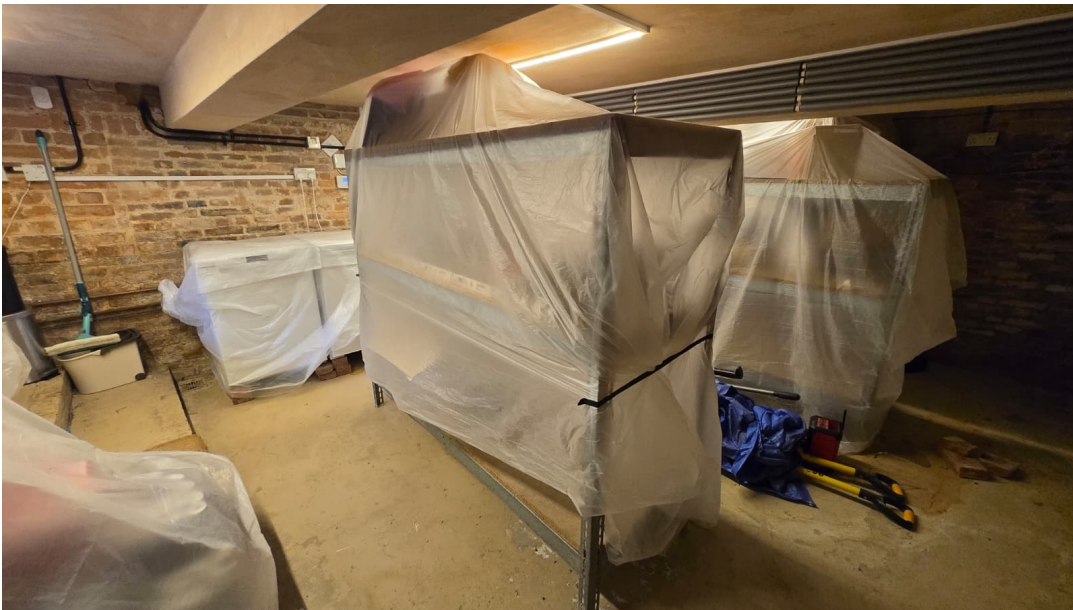
The cellar has clearly undergone substantial alterations in recent years, likely during the 1990s phase of work. The floor is concrete, there is a board encased steel beam supporting the ground floor sitting room, a new window has been created on the northern wall with modern red brick jambs and a concrete lintel above, and many of the cellar's walls have been rebuilt with modern red bricks.

Evidence of the former window on the western wall of the cellar remains and is currently used to route ducting from the garden room.

*contemporary photo of cellar*

- 1.1 Underpinning of the existing retaining walls to the existing cellar.
- 1.2 Installation of a steel frame on top of the existing retaining walls to the existing cellar.
- 1.3 Re-support of one end of the existing main beam over the dining room.
- 1.4 Re-support of one end of one of the secondary timber beams over the dining room.

A method statement prepared by the main contractor Bakers of Danbury Heritage Ltd for the sequential underpinning of the cellar walls is included with this application. Operatives will be made aware of the listed building status of the building and will be instructed not to remove or damage the existing brickwork when excavating or underpinning with concrete.

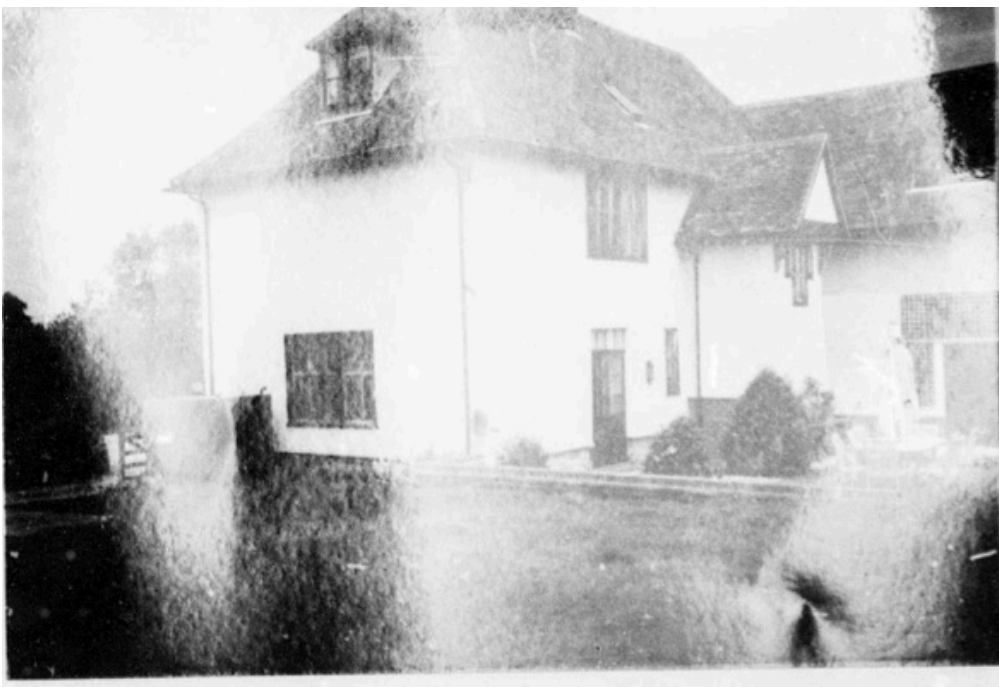
The existing historic timber-framed wall has set within it two historic 5-light timber framed windows; one at ground floor level and another above and aligned with the ground floor window which has recently been discovered behind panelling (see North Herts ref 26/00519/DOC).

The ground floor window is glazed with diamond-shaped leaded glazing.

*historic photo of west wall (prior to addition of garden room c.2000)*

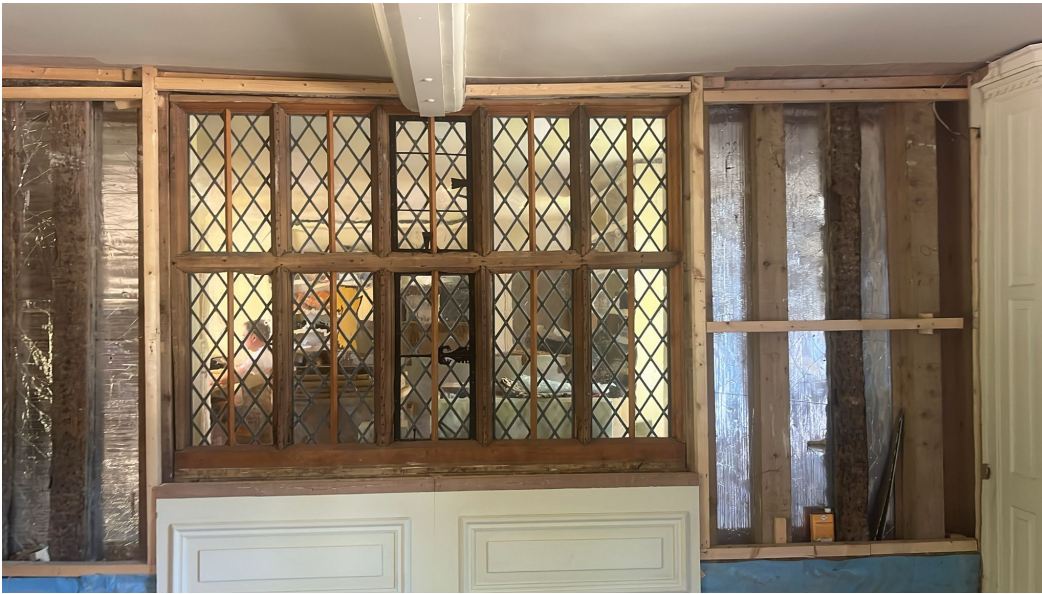
The first floor window is glazed with flat plate glass.

*contemporary internal photo of existing window in west wall*

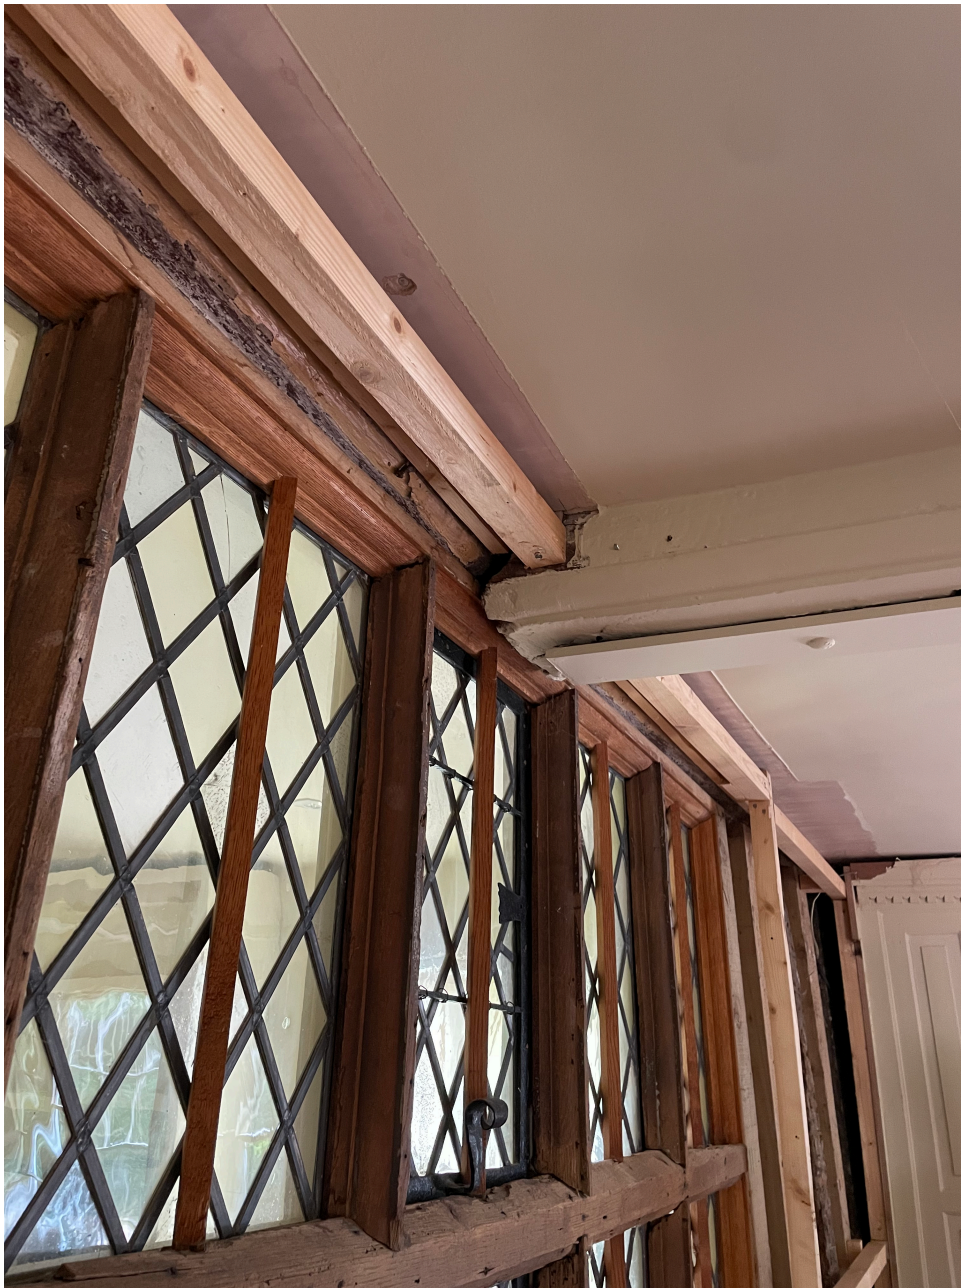
The opening-up inspected on site confirms that the affected beam has already been substantially cut/notched and altered. Its effective section has been materially reduced; there is a significant gap/loss of support at the affected end; and there is no adequate permanent bearing supporting the bedroom floor at this location.

The ceiling has historic ovolo moulded beams, which date from the 17th century. We can see that a strengthening steel has been installed to the beam adjoining the fireplace.

The beam ends and the first floor they support, have dropped over time sloping down from the fireplace to the west wall.

The main beam appears to be bearing onto the head frame of the ground floor window.

The secondary beam bears onto a small timber packing piece within the south wall timber frame which may have been inserted as a temporary measure.

The proposed remedy is a purpose-made external steel shoe carried by the independent new steelwork. The shoe is to cradle the existing beam, with plates to the beam faces and a continuous flat underside bearing plate. Its edges are to be flush with the existing beam faces where the verified site geometry permits.

The shoe must not require any further cutting, notching, drilling, chasing or recessing of the historic timber. Its final geometry, plate thicknesses, welds, connections, bearings, packing and finishes remain subject to a measured survey of the fully exposed beam, structural calculations and fabrication coordination. The attached information records the design principle only and is not for construction or fabrication.
