# HERITAGE NETWORK

**Mill Farm, Charlton, Hertfordshire, SG5 2AE**

**HN1635**

## **HERITAGE STATEMENT**

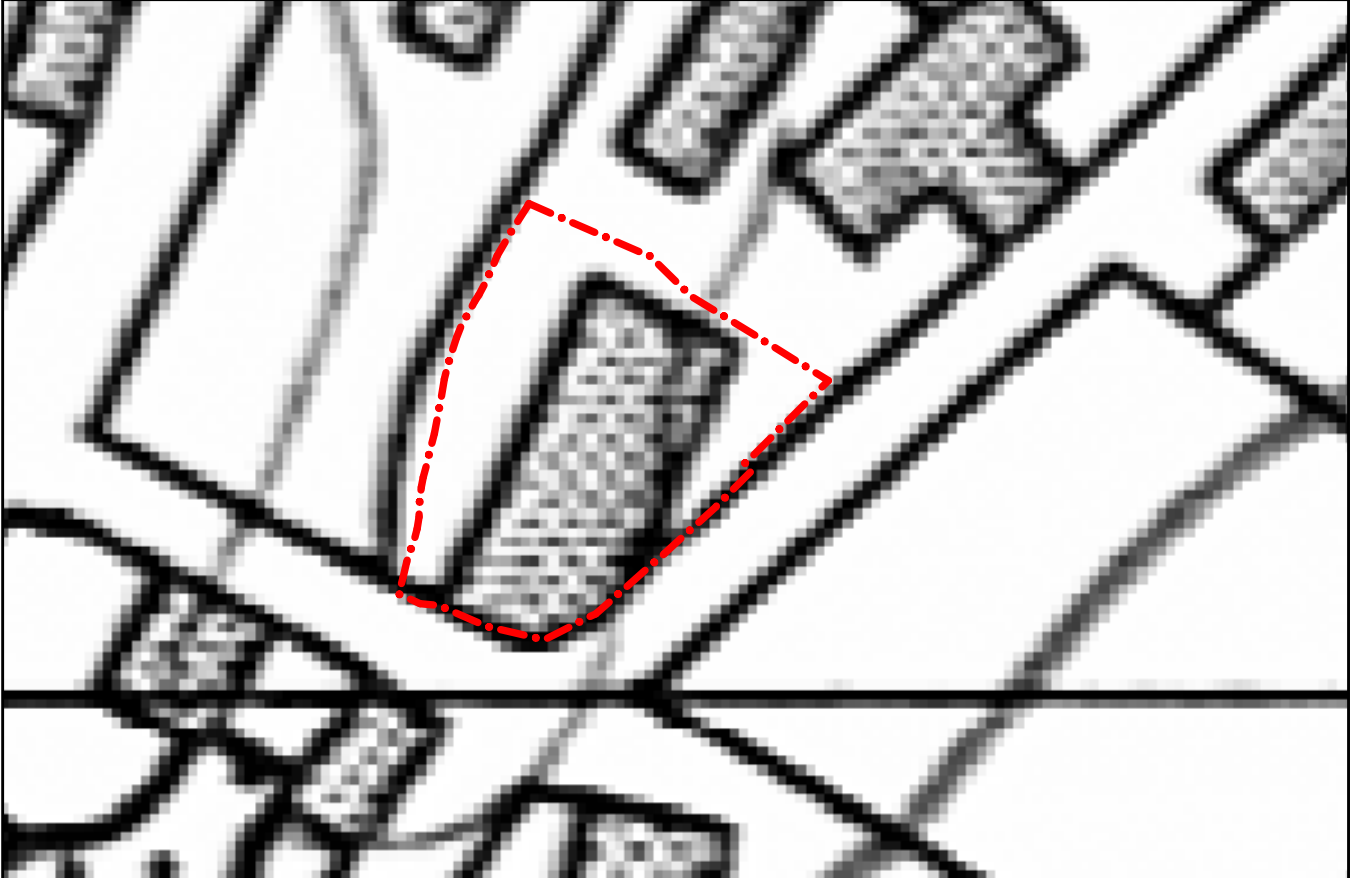
Scale 1:750  
Figure 9

The present layout of the farmyard is likely to have been established by 1982 (Figure 9).

Ordnance Survey, 1:10,000 series, 1982  
Crown Copyright & Landmark Information Group 2024

The historic mapping suggests that Barns 2a, 2b and 3 post-date 1976. Barn 2a appears to be an enclosed pole barn, of similar construction to the various structures occupying the northern farmyard, but the interior was not readily accessible on the site visit to confirm this. It is likely to predate Barn 2b, which is a more formal structure that could be contemporary with Barn 3. Barn 3 was built by Tyler Concrete Buildings Ltd, which was active between 1959 and 2020. It is likely that all three buildings, and the buildings occupying the northern farmyard, were in place by 1982 (see Figure 9).

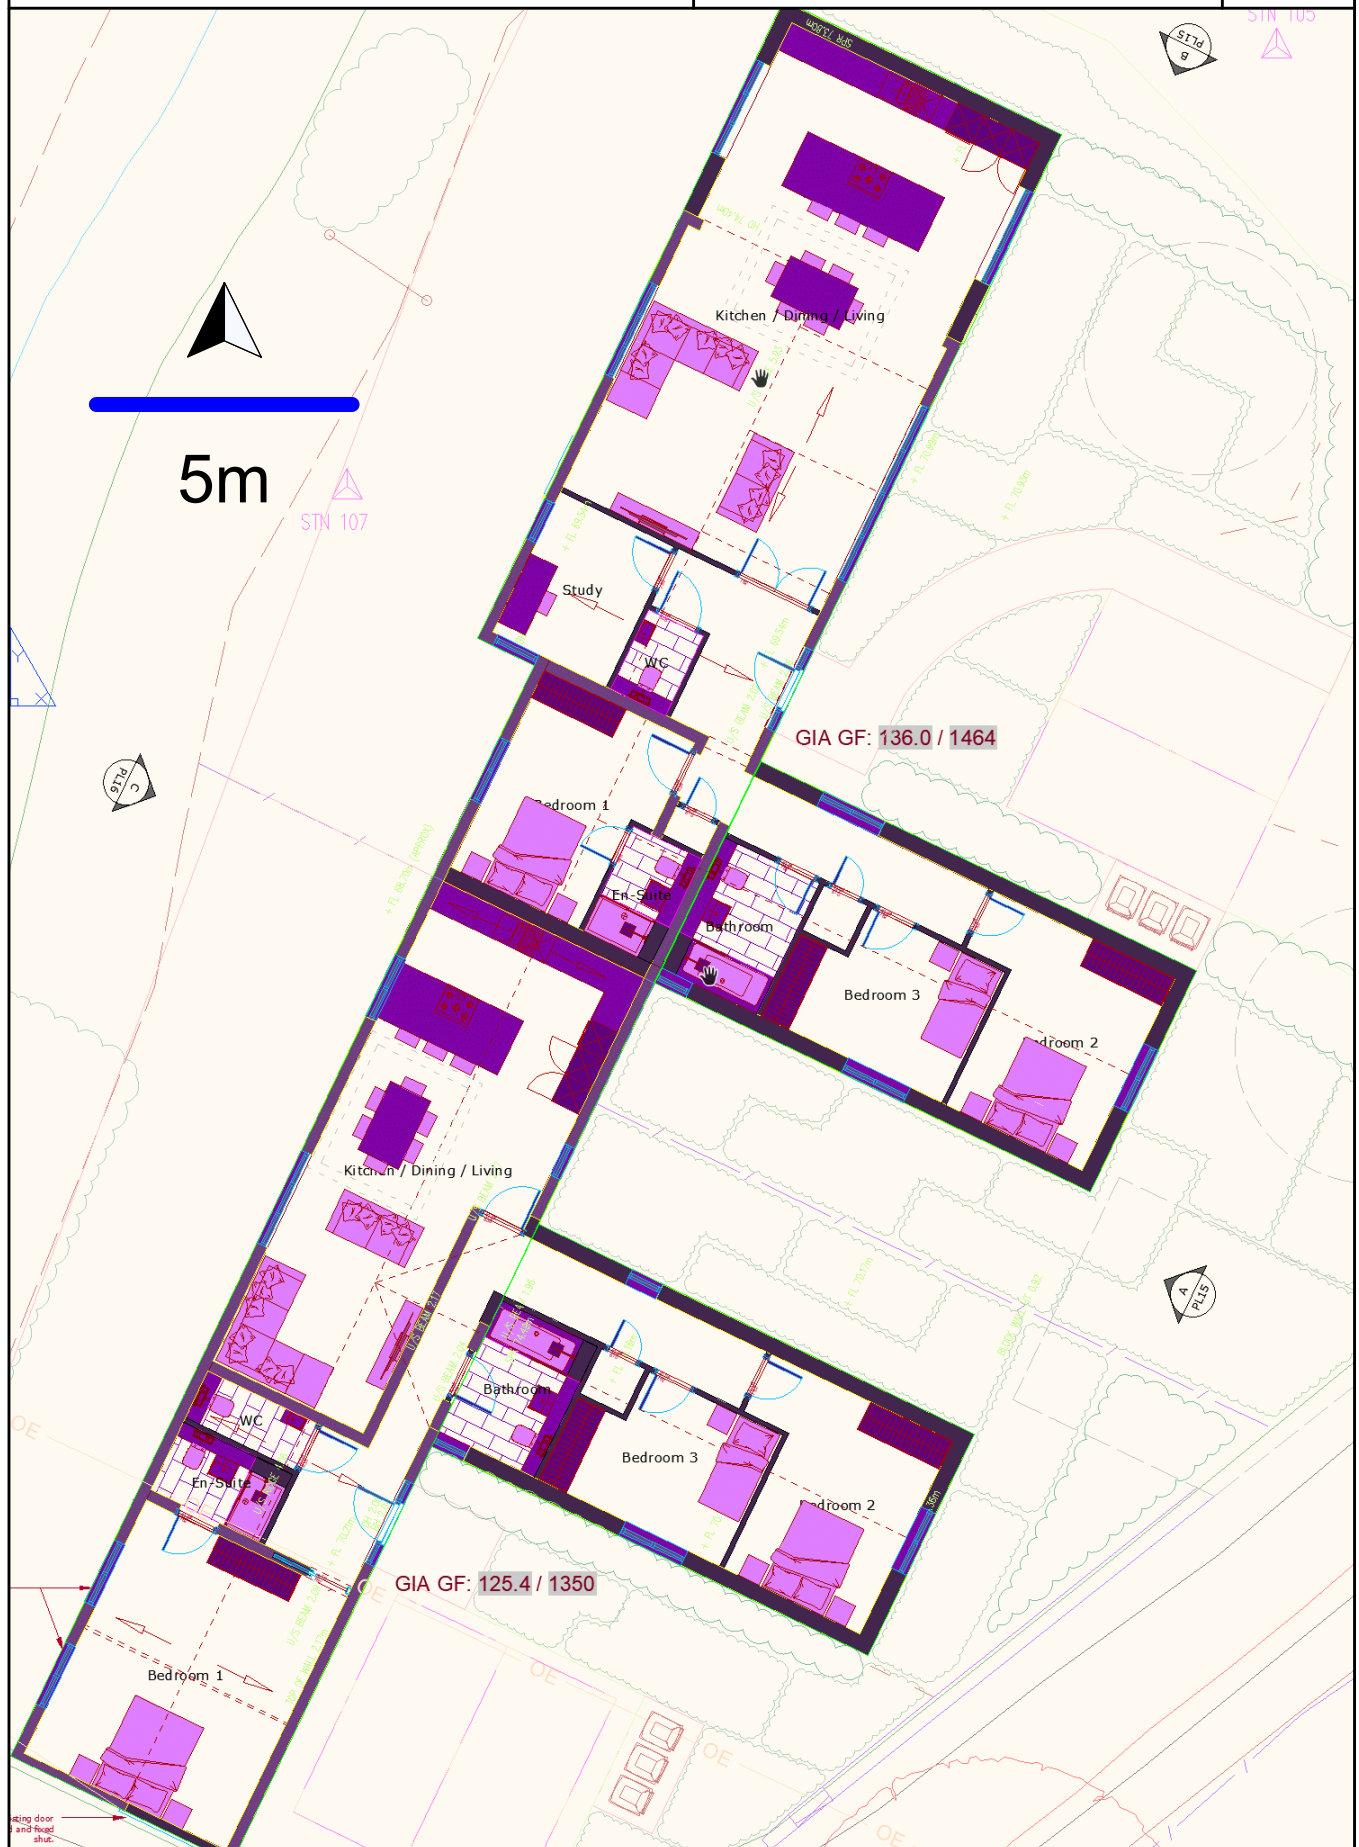
Figure 11

- (1) the demolition of Barns 2a, 2b, 3 and 4 and the adjacent grain silos;
- (2) the conversion of Barns 1 and 2 to residential use and the construction of two right-angled extensions to the eastern elevation of Barn 1;
- (3) the provision of associated services, car-parking and landscaping.

The principal view of the farmyard from the farmhouse encompasses Barns 1 and 2. The proposed development would remove the lean-to duct housing on the west side of Barn 1 and introduce a series of casement and French windows in the western elevations of Barn 1 and 2. Both barns would be re-roofed in natural slate with matching ridge tiles, as currently provided on Barn 4.

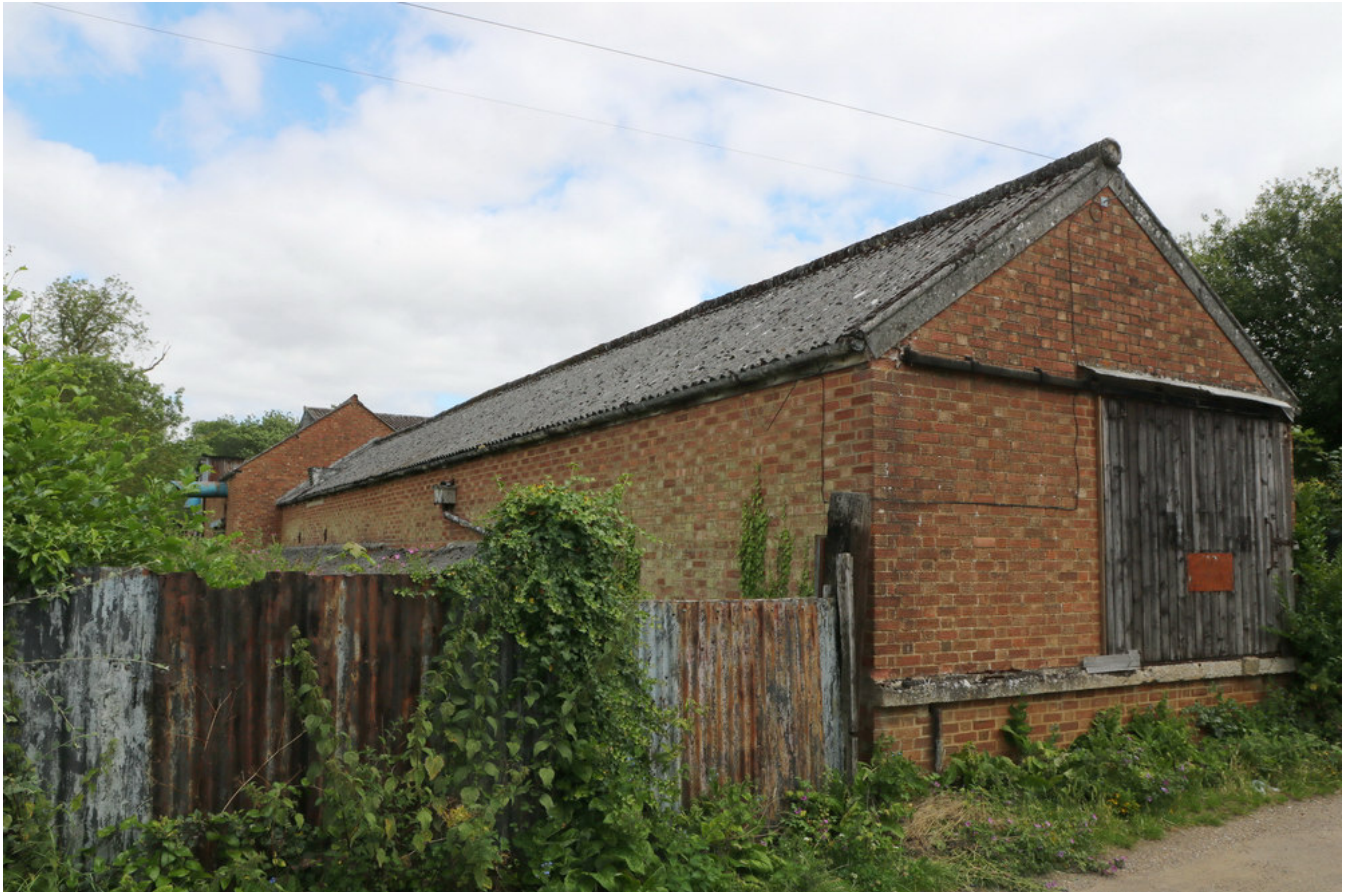
A site visit was undertaken on 22 July 2024. On the west side of the farmyard is a long, narrow barn, Barn 1, built of London Brick Company 'Rustic' bricks with a ridged roof covered in corrugated cement asbestos sheets, extending north from the lane frontage, with a sliding wooden door on the east side of the south elevation closing a loading bay (Plate 1). The interior was not accessible at the time of the site visit, but a survey plan provided by the architects shows the first two bays as open, with a corridor running the remaining length of the building on the eastern side (Figure 10). A one bay wide room is accessed off the corridor at its southern end, but the remaining space could not be accessed by the surveyors; this space may contain grain bins. Against the west elevation of Barn 1, a roofed lean-to carries a duct that extends 18m south from the junction of Barns 1 and 2 (Plate 2).

Plate 01 - Barn 1, south & west elevations, facing NE

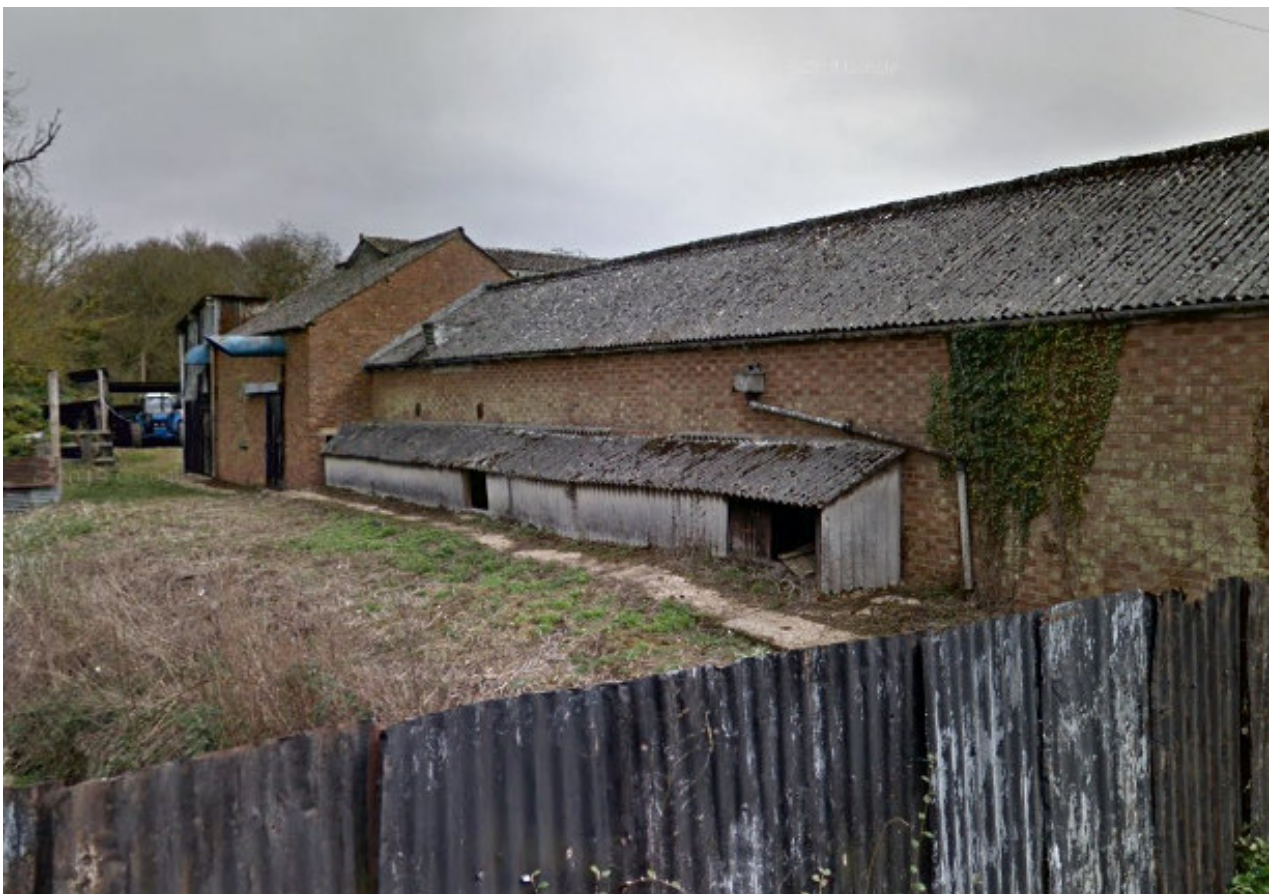
Plate 02 - Lean-to carrying duct alongside Barn 1, facing NE (Courtesy Google Streetview)

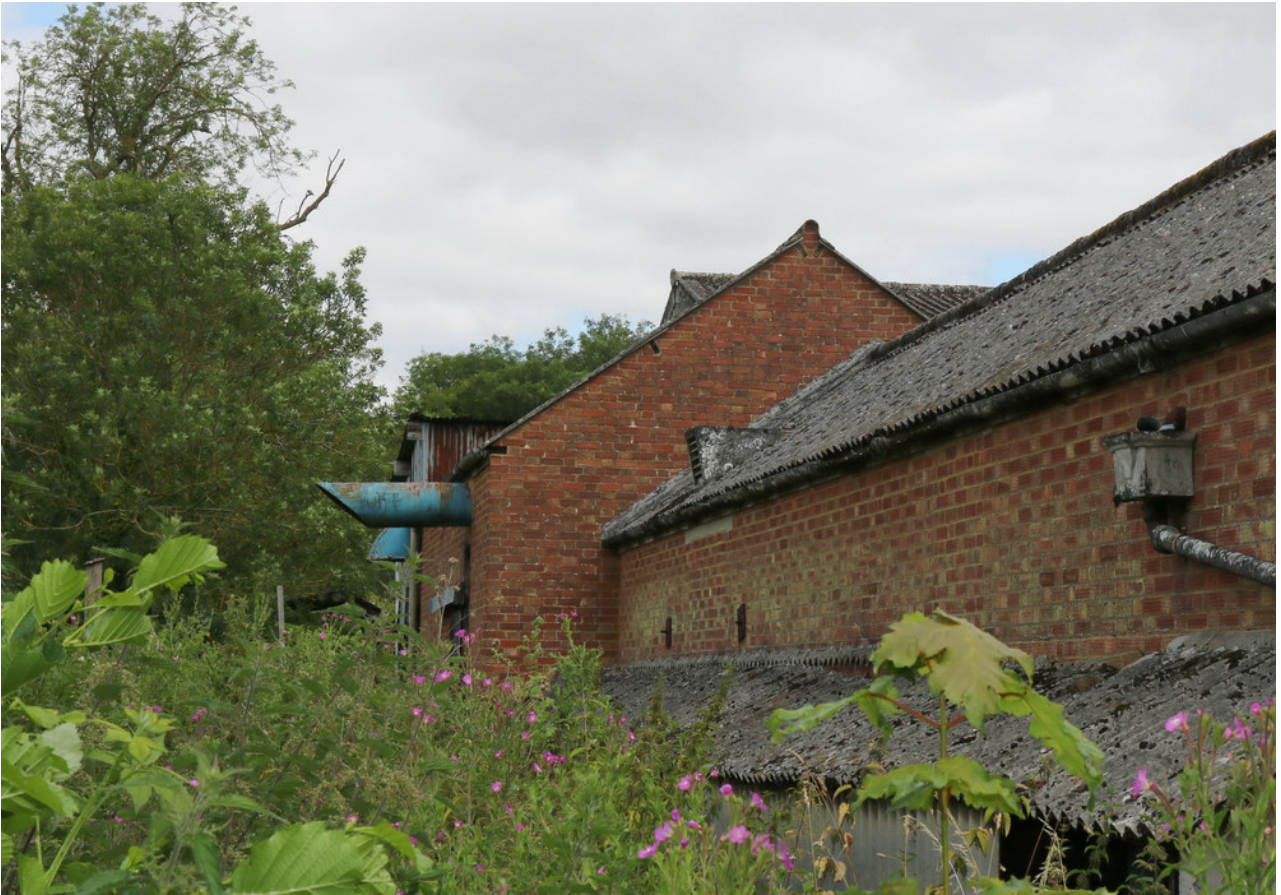
A taller and wider block (Barn 2), also built of 'Rustic' bricks with a ridged cement asbestos roof, abuts Barn 1 on the northern side (Plate 3). This forms a single open space occupied by a corn dryer. Barn 2 has been extended to the north by a single bay structure (Barn 2a) faced and roofed in corrugated iron sheeting (Plate 4), and to the east by a single-bay, steel framed structure (Barn 2b), open to the east but otherwise faced and roofed in corrugated cement asbestos sheeting (Plate 5).

Plate 03 - Barn 2, south and west elevations, facing NE

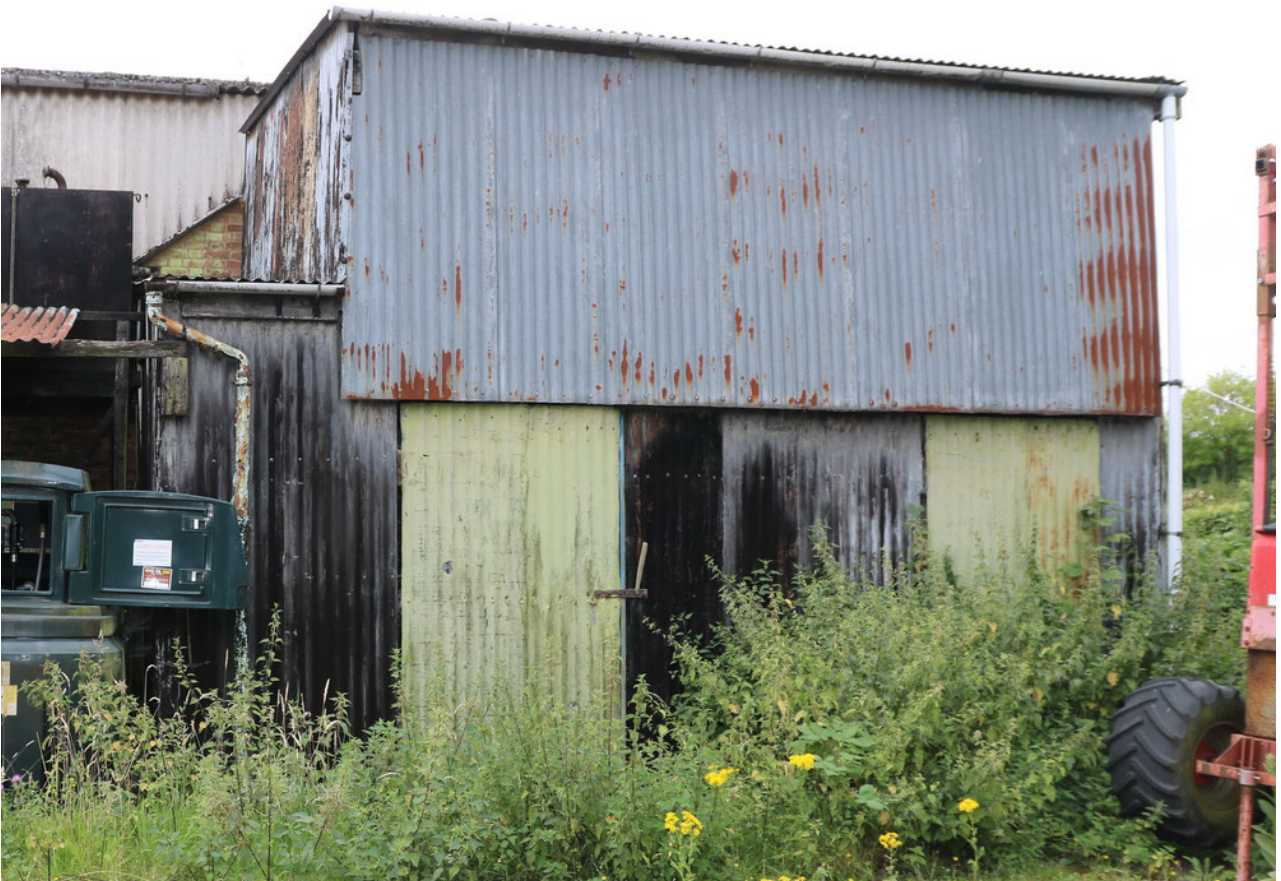
Plate 04 - Barn 2a, north elevation, facing SW

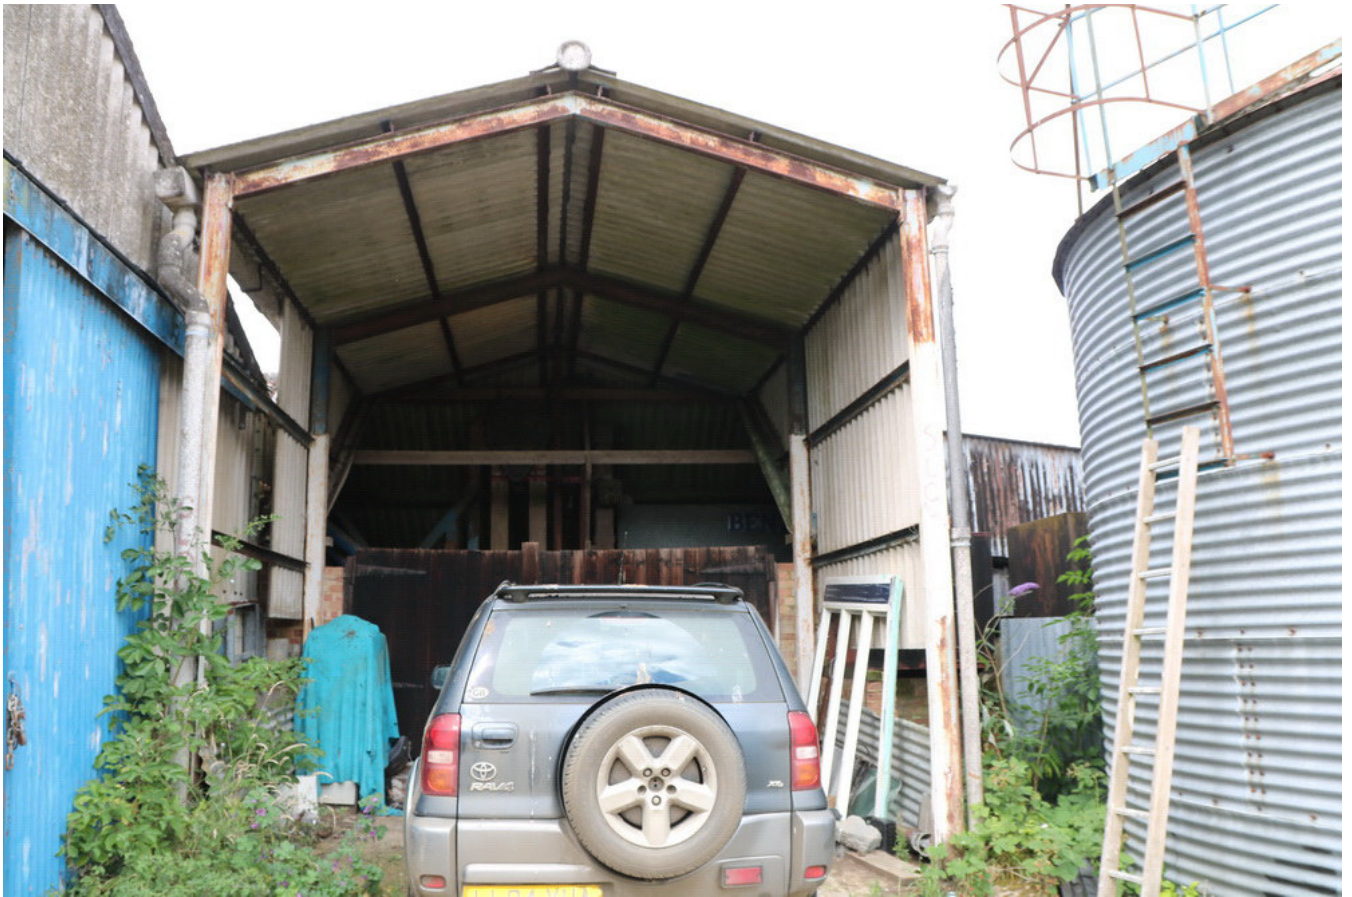
Plate 05 - Barn 2b, east elevation, facing W

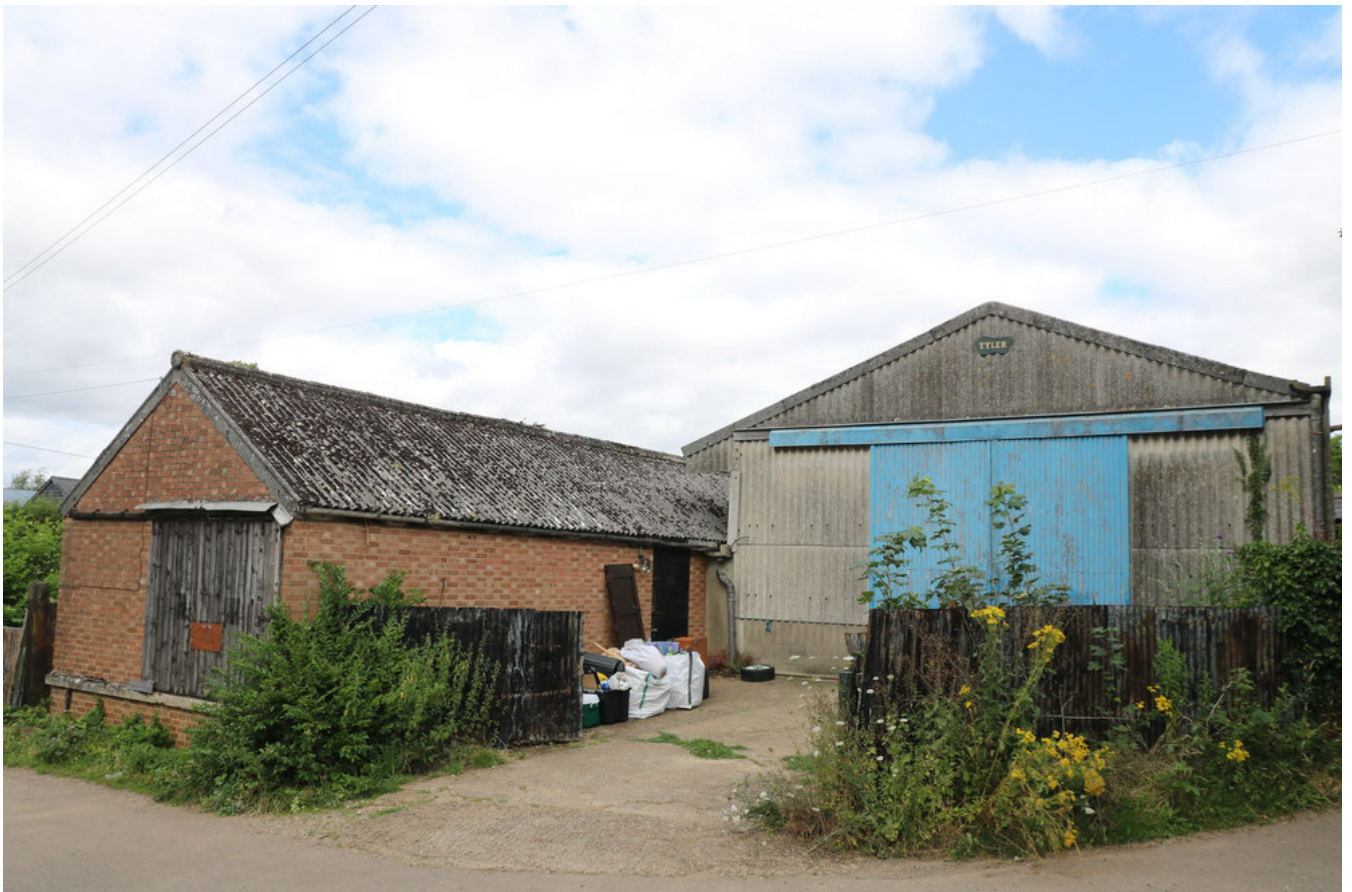
To the west of Barns 1 and 2 is Barn 3, a 4-bay concrete Tyler portal frame building (Plate 6) faced and roofed in corrugated cement asbestos sheeting with access from the north and south, used for hay bales and general storage.

Plate 06 - Barns 1 & 3, facing N

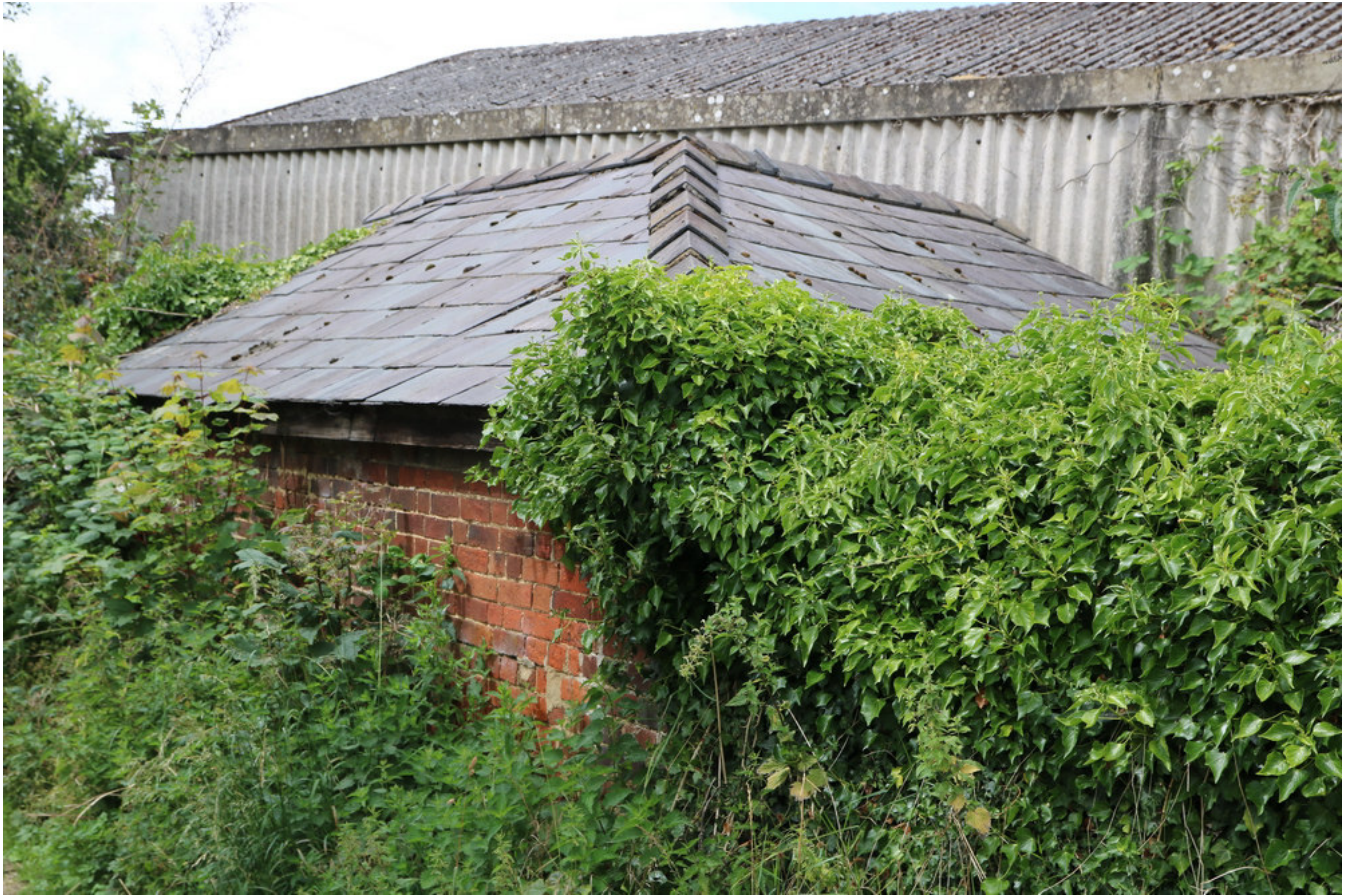
On the east side of Barn 3, abutting the eastern farmyard boundary wall, is a small brick-built structure (Barn 4) with a hipped slate roof, which could be observed from the lane (Plate 7) and, to a limited extent from the yard to the south of Barn 3 (Plate 8), but was otherwise inaccessible.

Apart from the eastern boundary wall, which is likely to be of 19<sup>th</sup> century date, the earliest structure within the proposed development site is Barn 4, a brick-built structure with a hipped slate roof that abuts the boundary wall and is first shown on OS mapping in 1922. Some earlier brickwork that is now incorporated in the eastern elevation of Barn 1 (Plate 12) was also noted in the site walkover, but its relationship to the earlier buildings on the site, as recorded on the 25-inch OS maps, could not be readily ascertained.

Plate 07 - Barn 4, facing SW

The present proposals would see the retention of the boundary wall but the demolition of Barn 4. These changes would represent a slight change to the boundary wall that would be hardly noticeable, but the complete loss of Barn 4.

Following ICOMOS guidance, the proposed development would represent a *Negligible* direct impact on the significance of the boundary wall, but a *Major* direct impact on the significance of Barn 4.

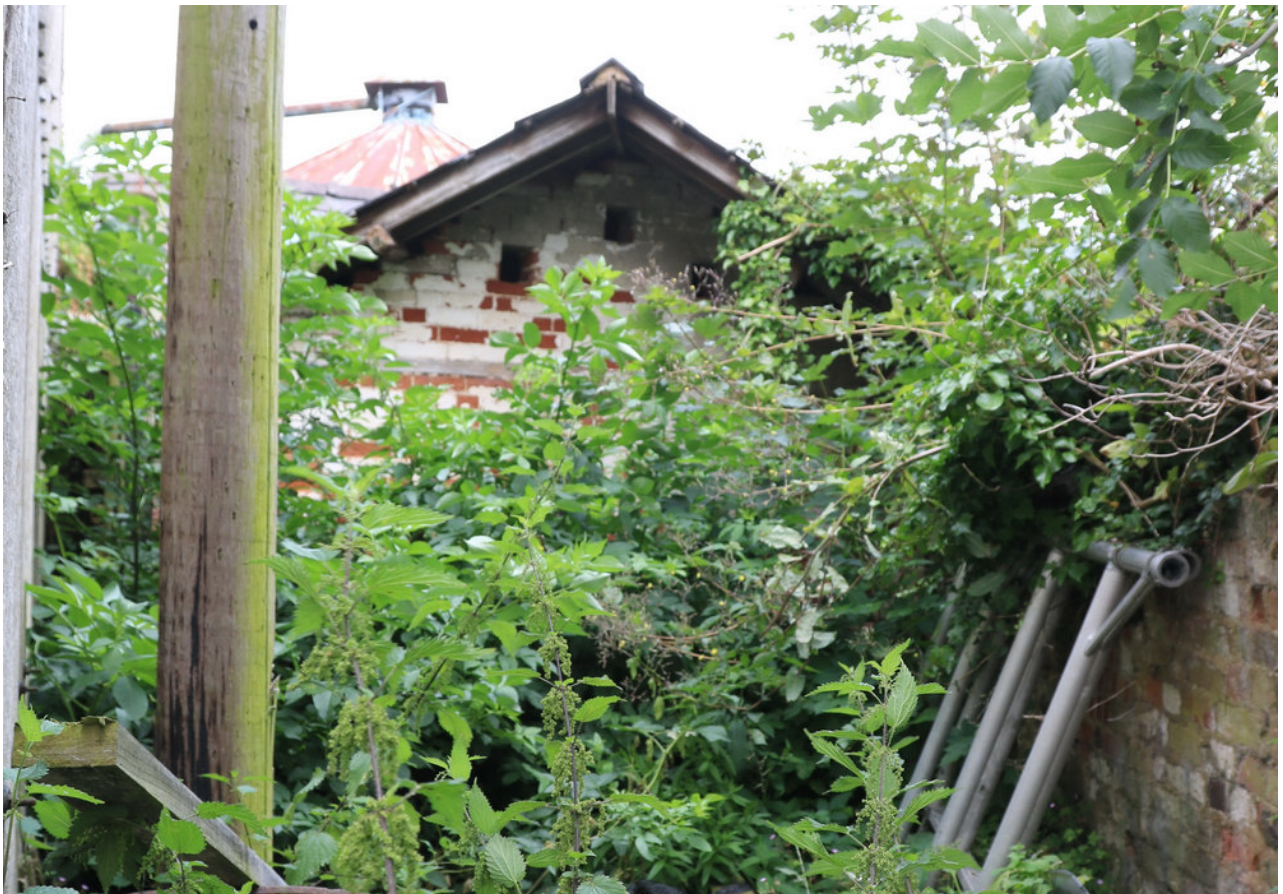
Plate 08 - Barn 4, south elevation, facing N

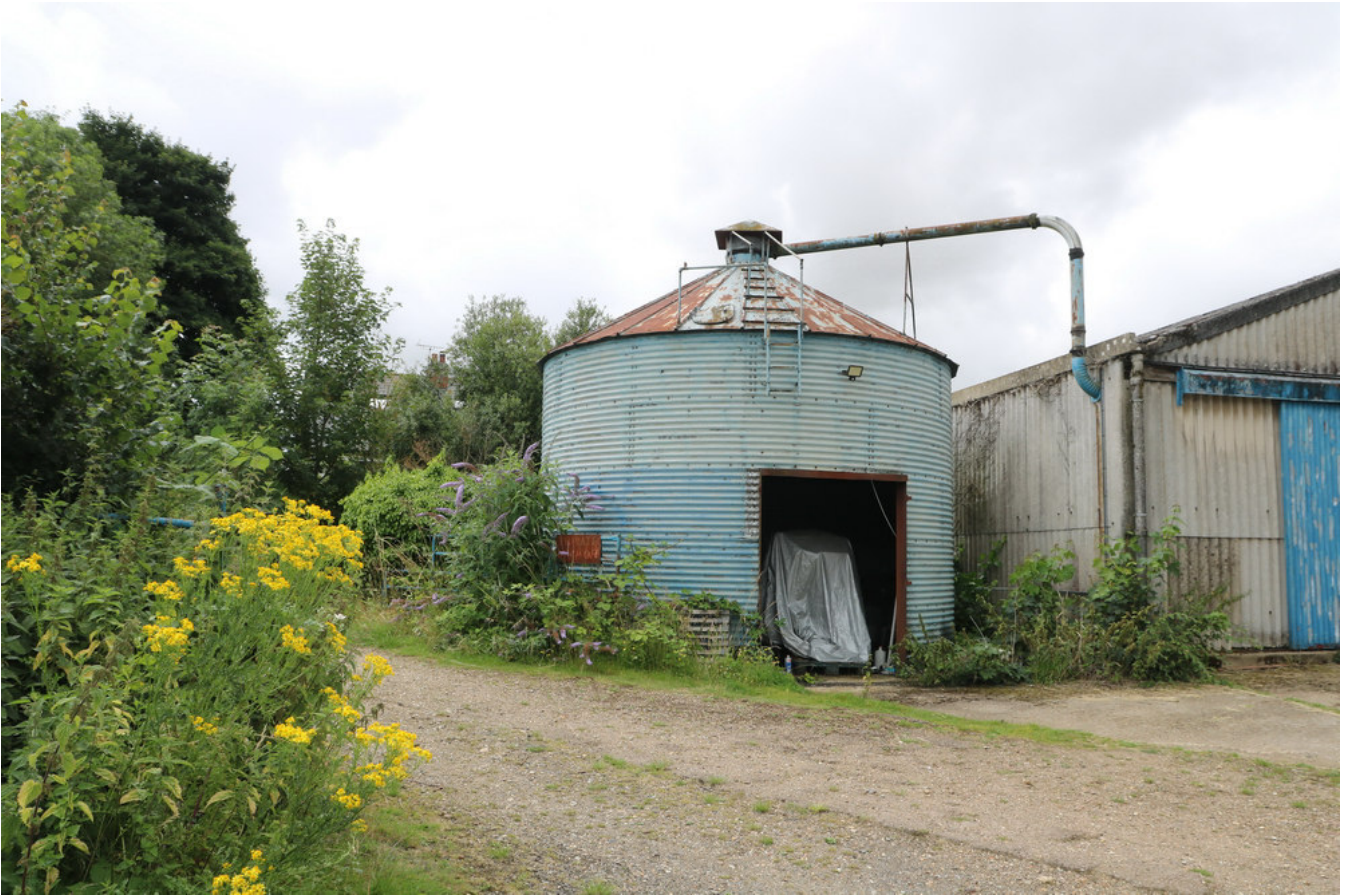
In the northern angle between Barns 3 and 4 is a circular grain silo (Plate 9), with another smaller silo in the angle between Barns 2a and 2b (Plate 10). The farmyard to the north of the present site, is occupied by an Atcost portal frame barn and a variety of corrugated iron roofed pole barns (Plate 11).

Plate 09 - Grain silo in N angle of Barns 3 & 4, facing S

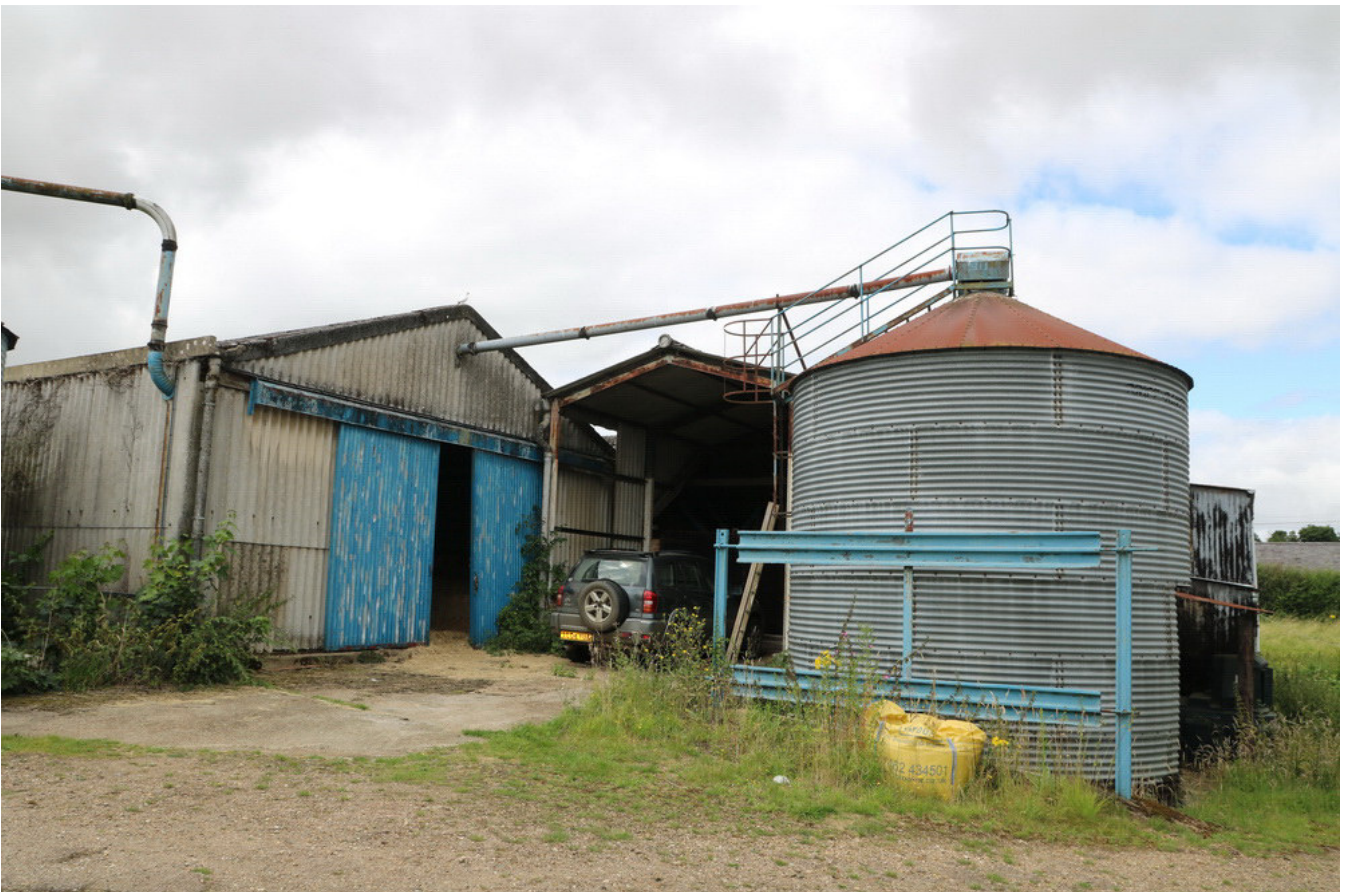
Plate 10 - Grain silo in angle between Barns 2a & 2b, facing SW

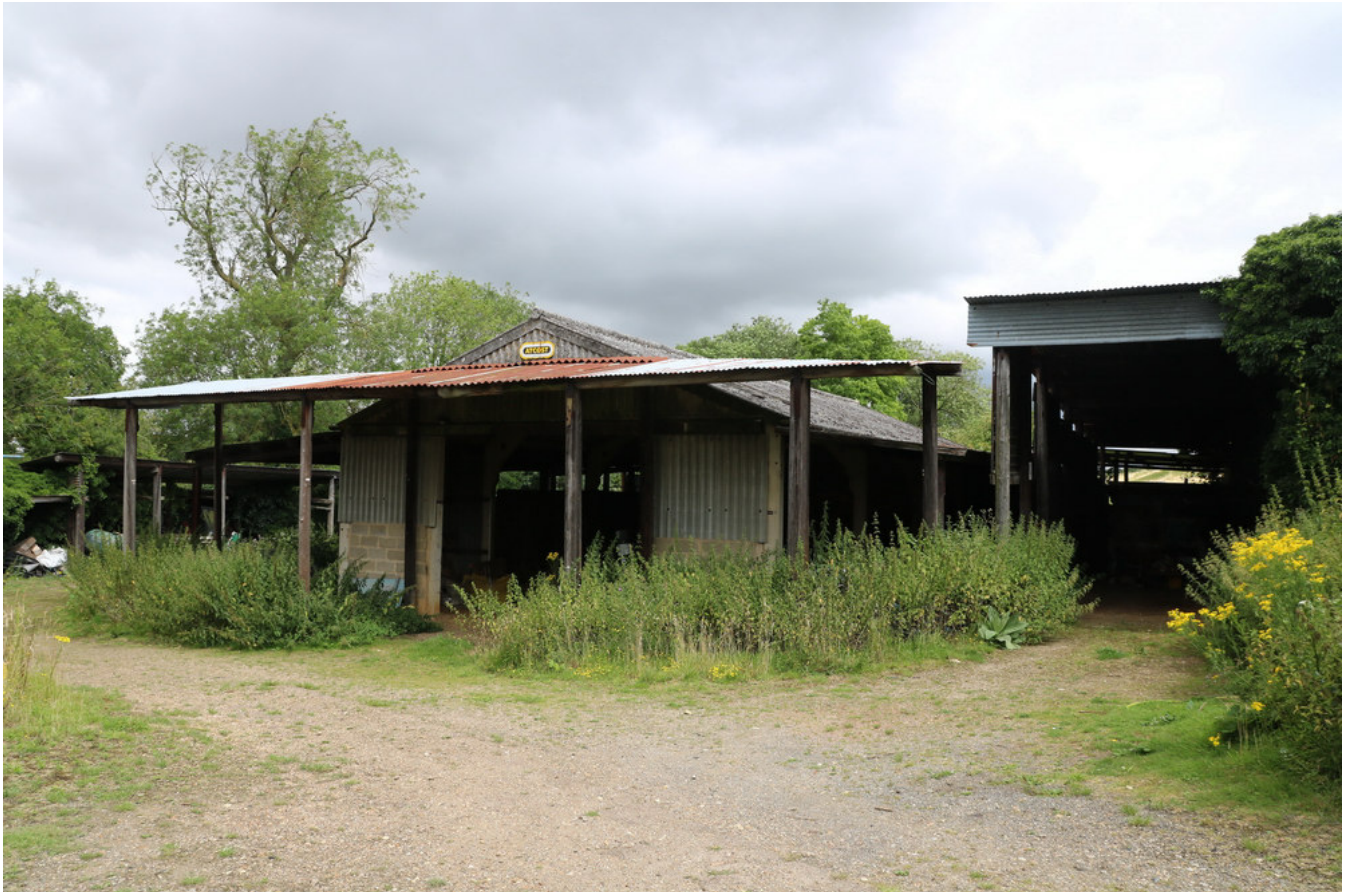
Plate 11 - Farmyard to the N of the present site, facing N

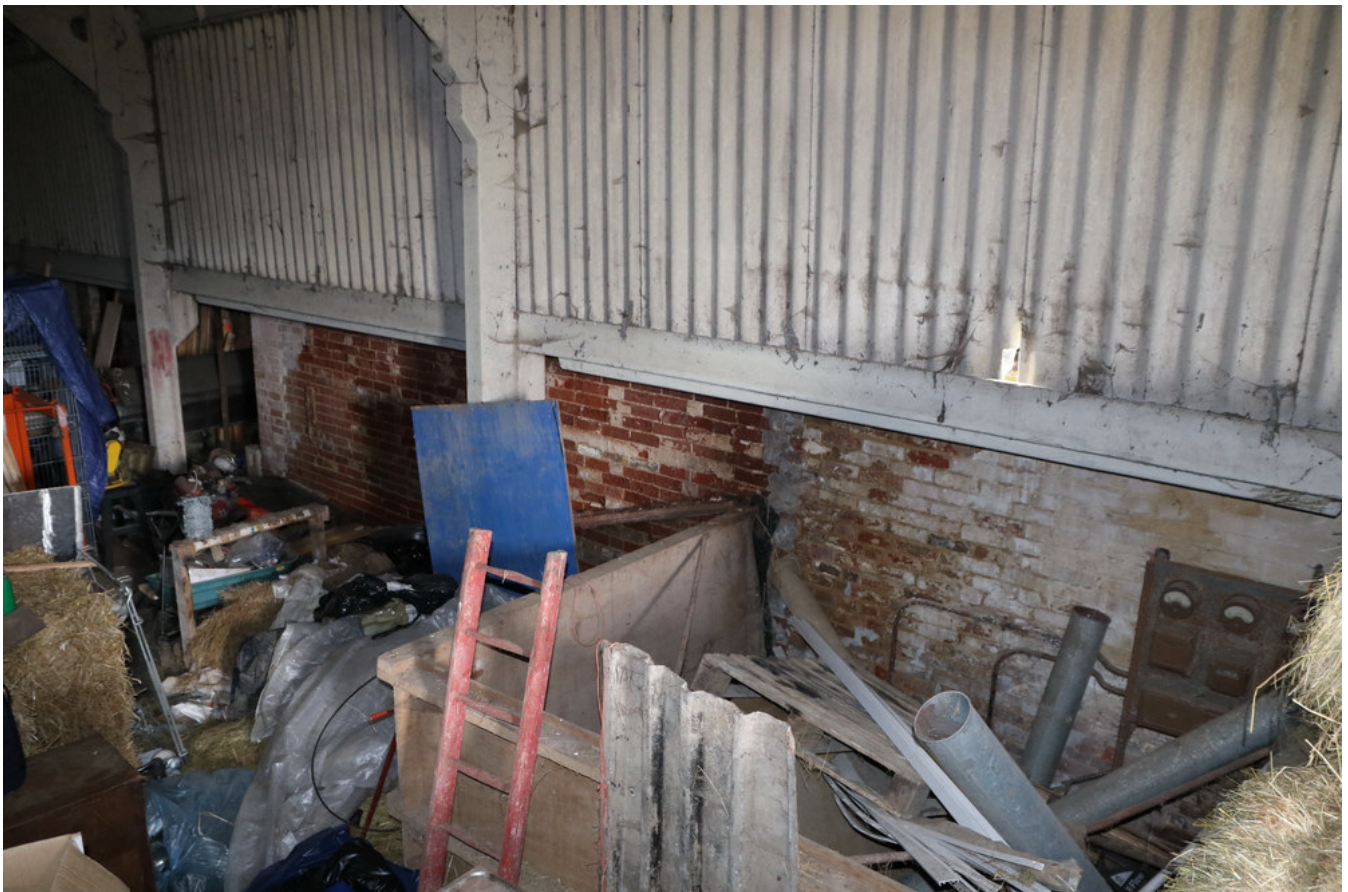
Plate 12 - Earlier brickwork in east elevation of Barn 1, facing SW
