# Phase 1, Geo- Environmental Desk Study

## Milksey Lane, Graveley

**BRD3930-OR1-A**

**June 2021**

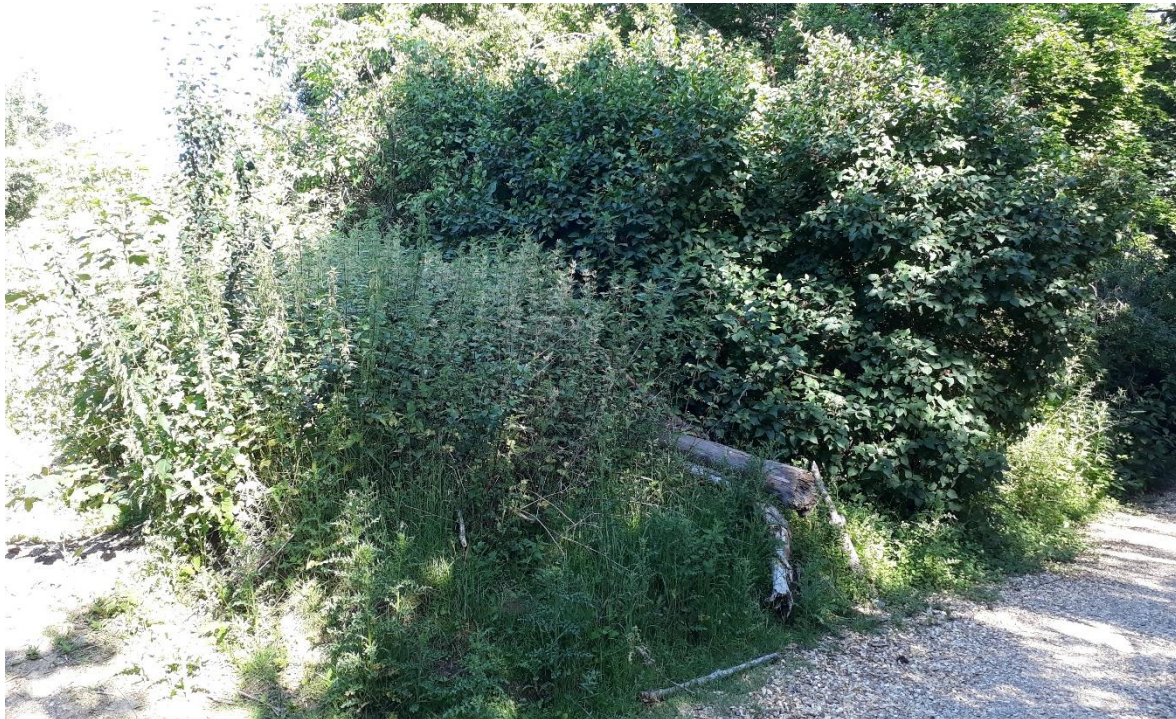
Plate 2: Overgrown embankment towards driveway.

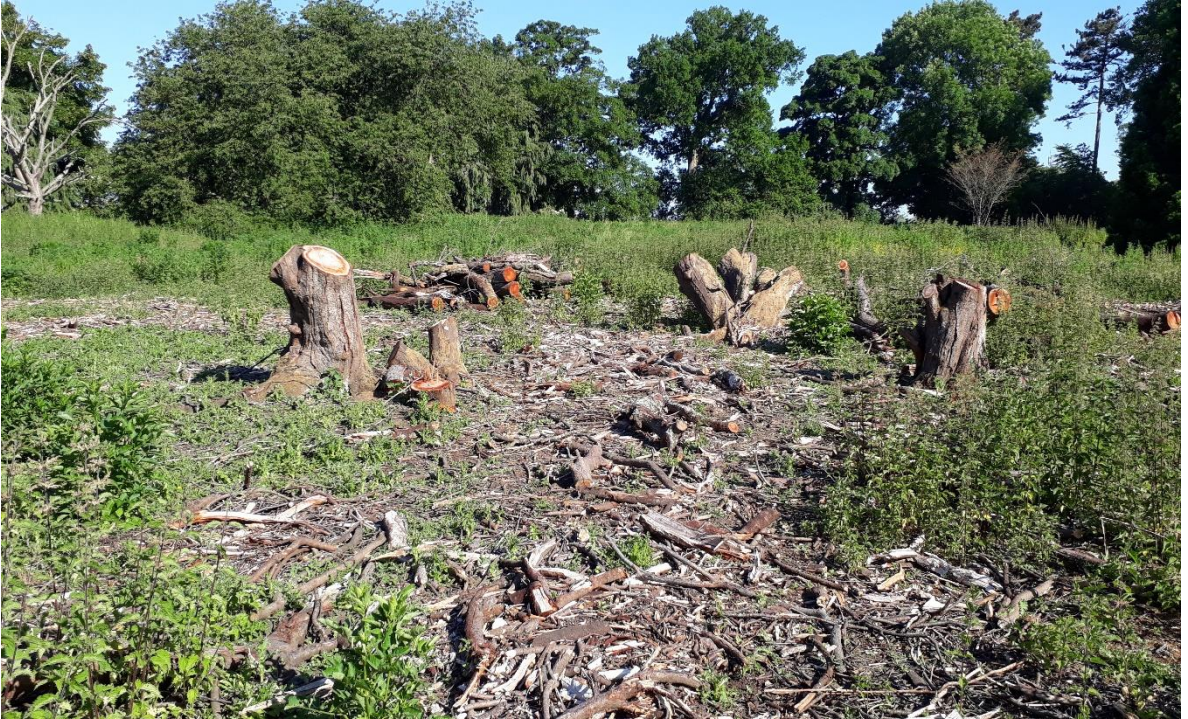
| <b>NOTABLE FEATURES AND OBSERVATIONS</b> | <p>Some tree stumps and felled trees were observed in the central area of the site.</p> <p>Soils stockpiles present in the central area of the site covering an area of approximately 1,250m<sup>2</sup> and were found to contain demolition materials such as bricks, stones, timber and metal scrap. The stockpiles appear to have been placed on site when the adjacent homes east of the site where redeveloped.</p> |

Plate 7: View of stumps of recently felled trees looking northwest.

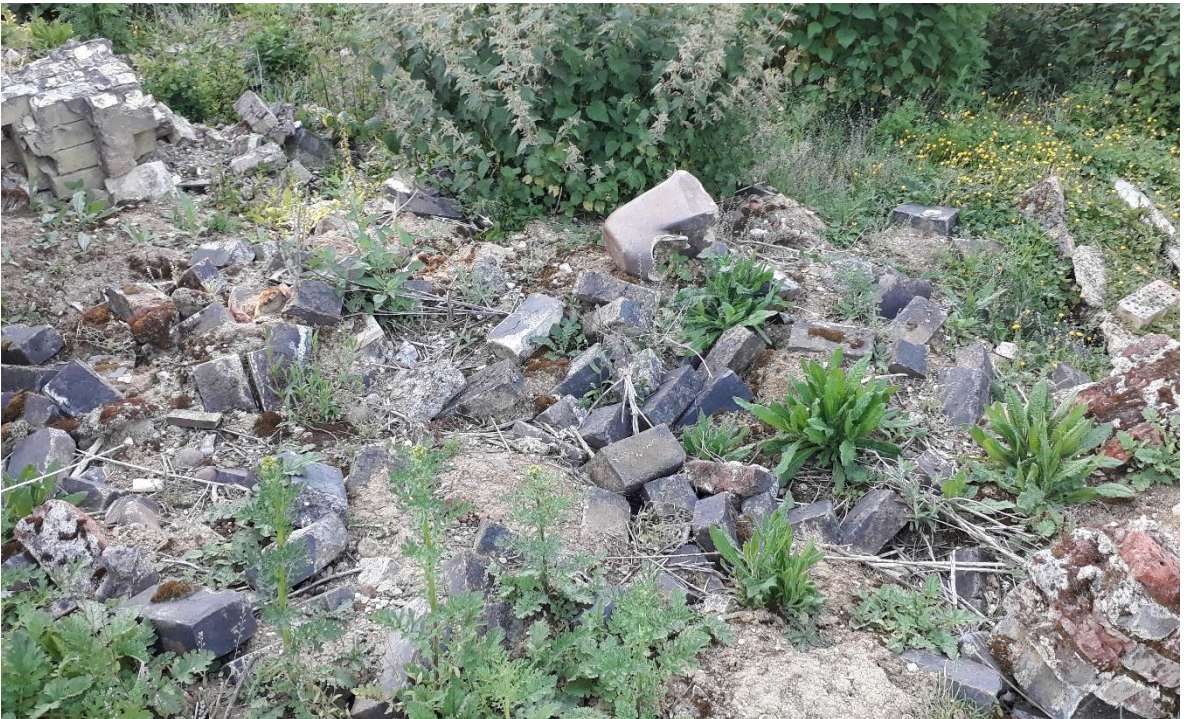
| POTENTIAL ON SITE SOURCES | | |
|---|---|---|
| Soils and rubble stockpiles. | Several stockpile of soils and rubble have been recorded on site. Such disposal activities may also be a cause of soil contamination hazards. | <p>Metals.</p> <p>Petroleum hydrocarbons (diesel, lubricating oils, greases and/or petrol).</p> <p>Polycyclic Aromatic Hydrocarbons (PAH).</p> <p>Asbestos containing materials (e.g. cement asbestos building products).</p> |

Plate 8: Detailed view of one of the mounds present on site showing rubble and mixed soils.

Potential contamination risks have been identified by this Phase 1 Desk Study and therefore a Phase 2 Contamination Assessment is recommended to assess the significance of these potential pollutant linkages. An intrusive ground investigation incorporating a Phase 2 Contamination Assessment is being undertaken by BRD and shall be reported separately.
