# Archaeological Standing Building Recording

On Behalf of  
**Netherdown**

Concerning  
**Lordship Farm Barns**  
**Pirton Road**  
**Holwell**  
**Hertfordshire**  
**SG5 3SS**

**November 2024**

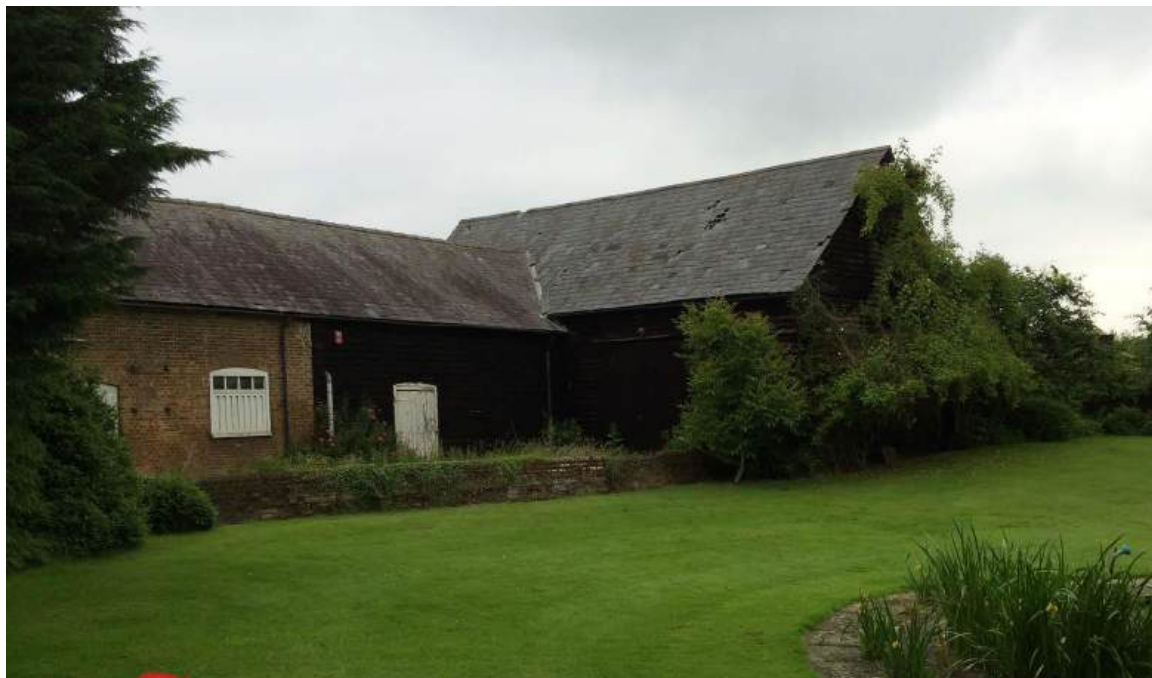
*Plate 1: General view looking NW towards E gable end of Barn 1 with E elevation of Barn 2 visible to left of picture*

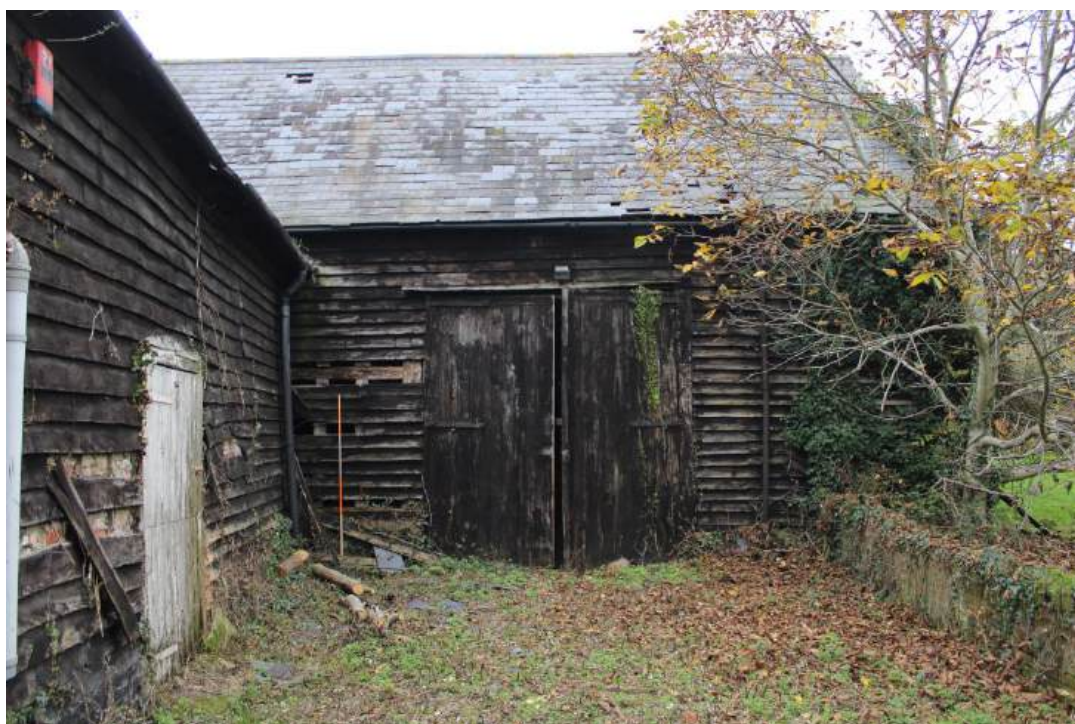
*Plate 2: View looking N towards eastern end of S-facing elevation of Barn 1, showing double doors*

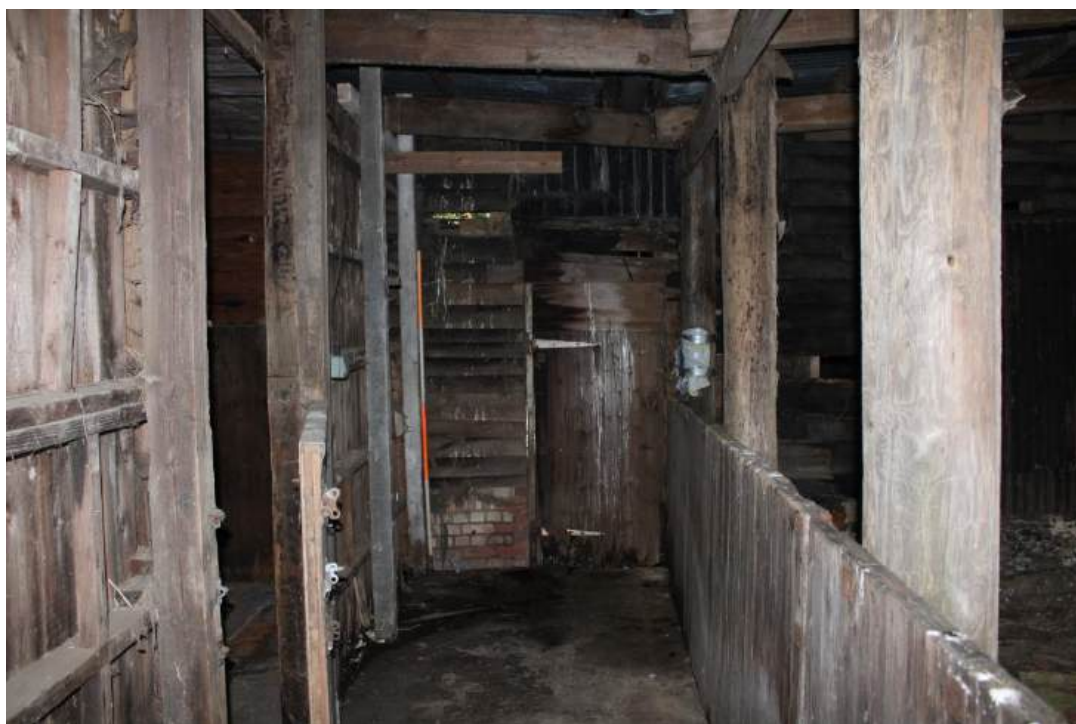
*Plate 3: View looking S from open fronted shed showing 'winnowing door' in N-facing elevation of Barn 1 with loading bay hatch above*

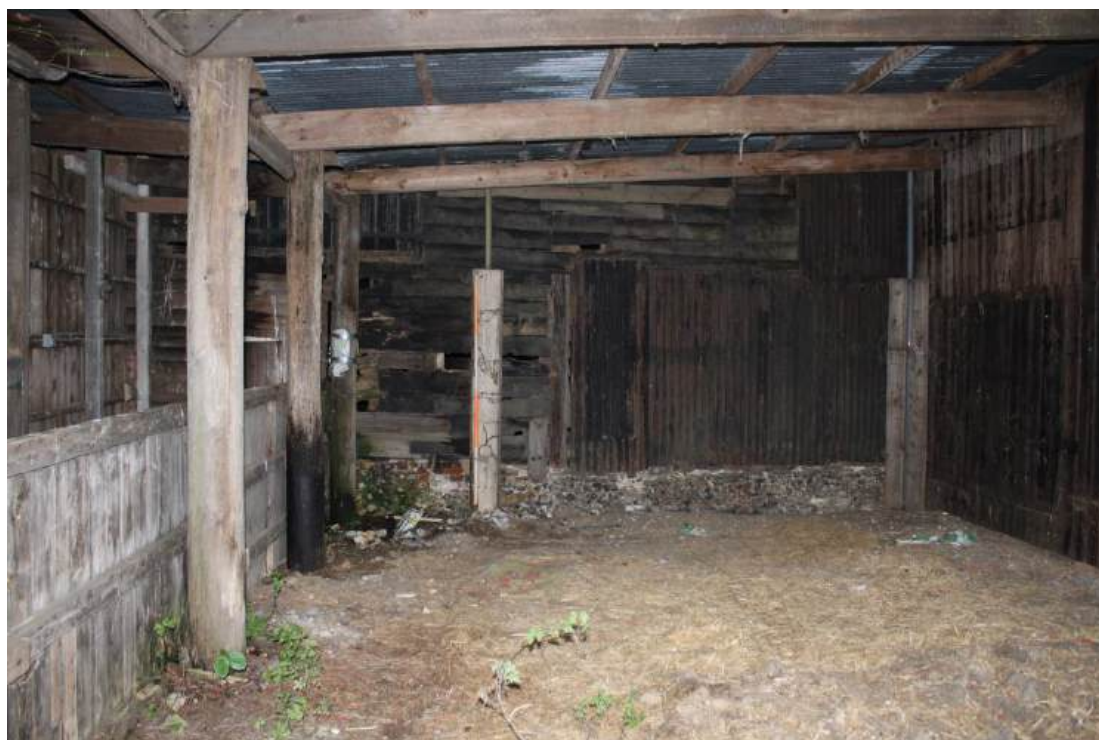
*Plate 4: View looking S showing central portion of N-facing elevation of Barn 1 with timber framed structure resting on stone masonry plinth and weatherboard cladding partially replaced by modern corrugated metal sheeting*

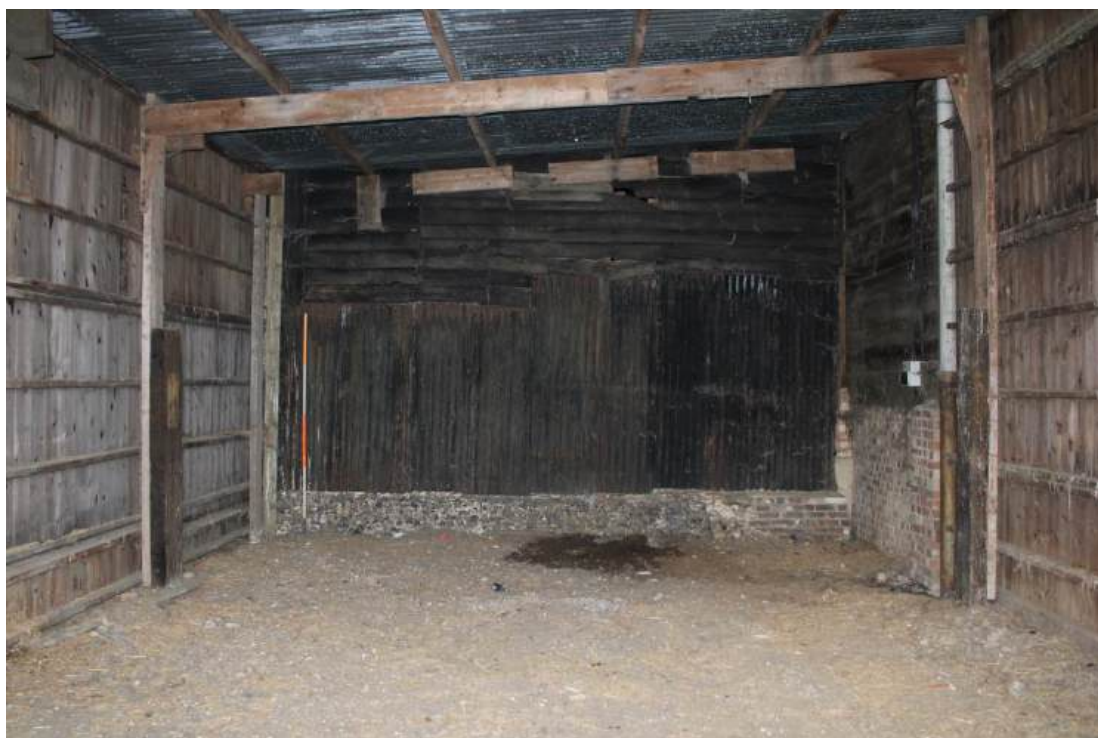
*Plate 5: View looking S from open fronted shed showing W end of N-facing elevation of Barn 1 with stone plinth visible beneath weatherboarding and corrugated metal cladding*

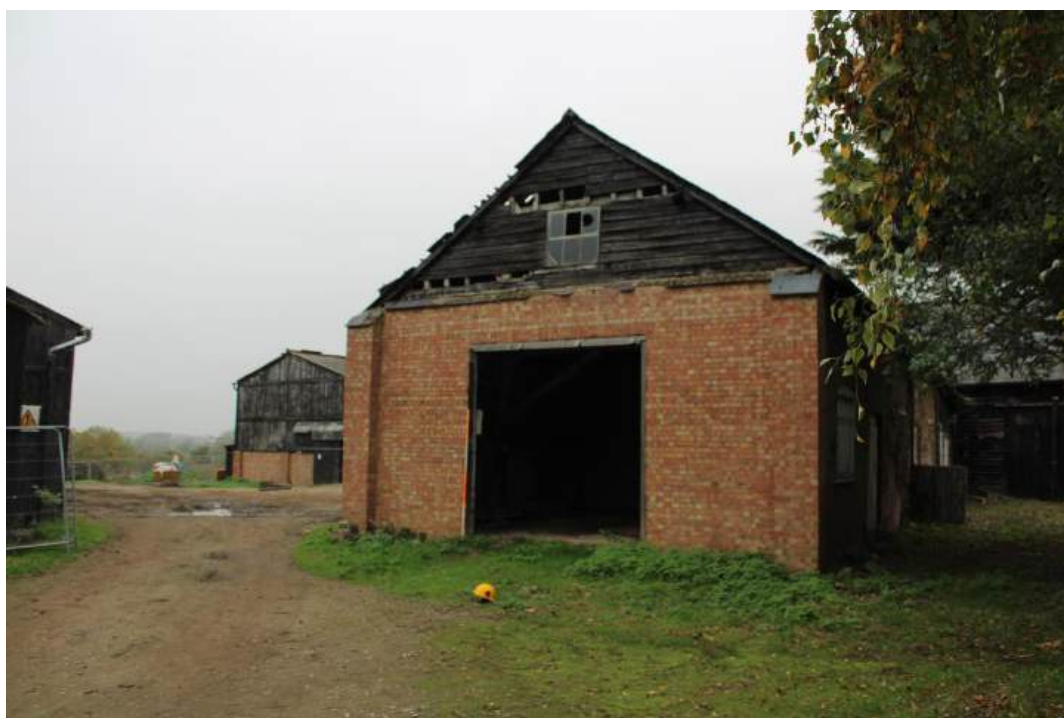
*Plate 6: General view looking NNW showing S gable end of Barn 2, reconstructed in modern brick with late 20<sup>th</sup> century barns visible in background to left of picture*

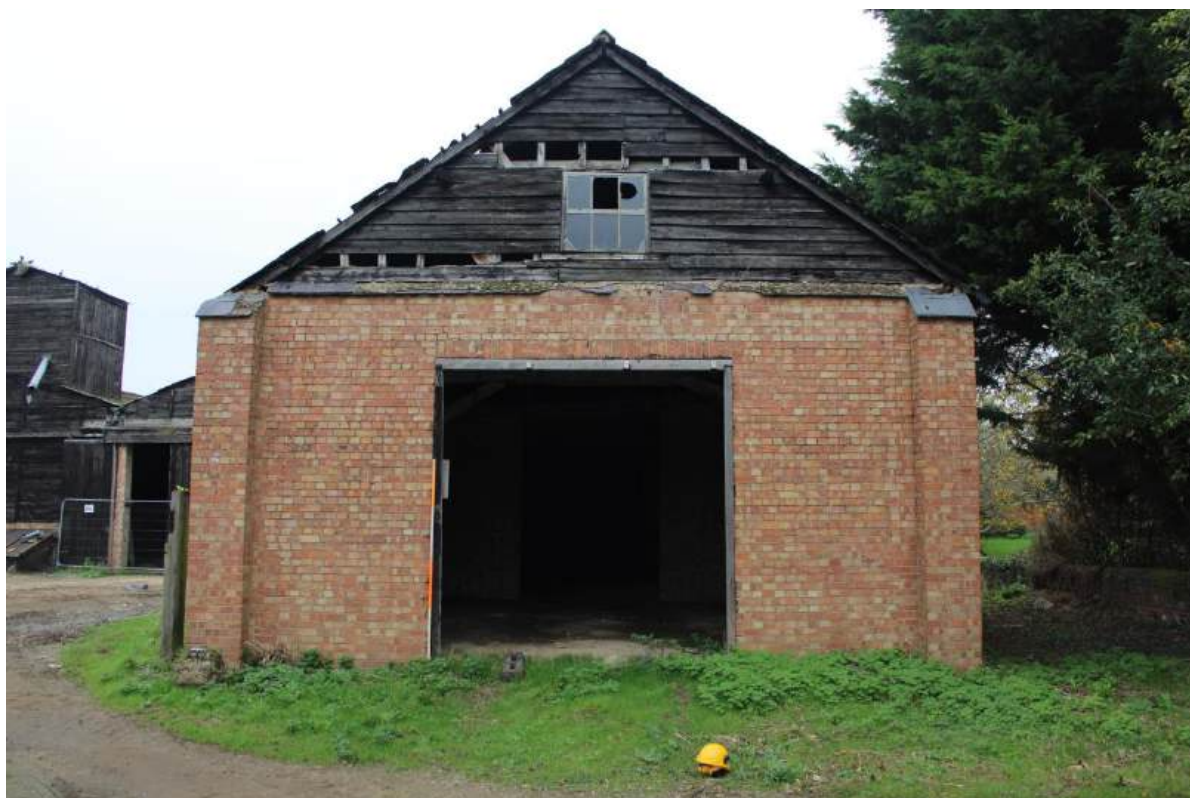
*Plate 7: View N showing S gable elevation of Barn 2, reconstructed in the mid-late 20<sup>th</sup> century*

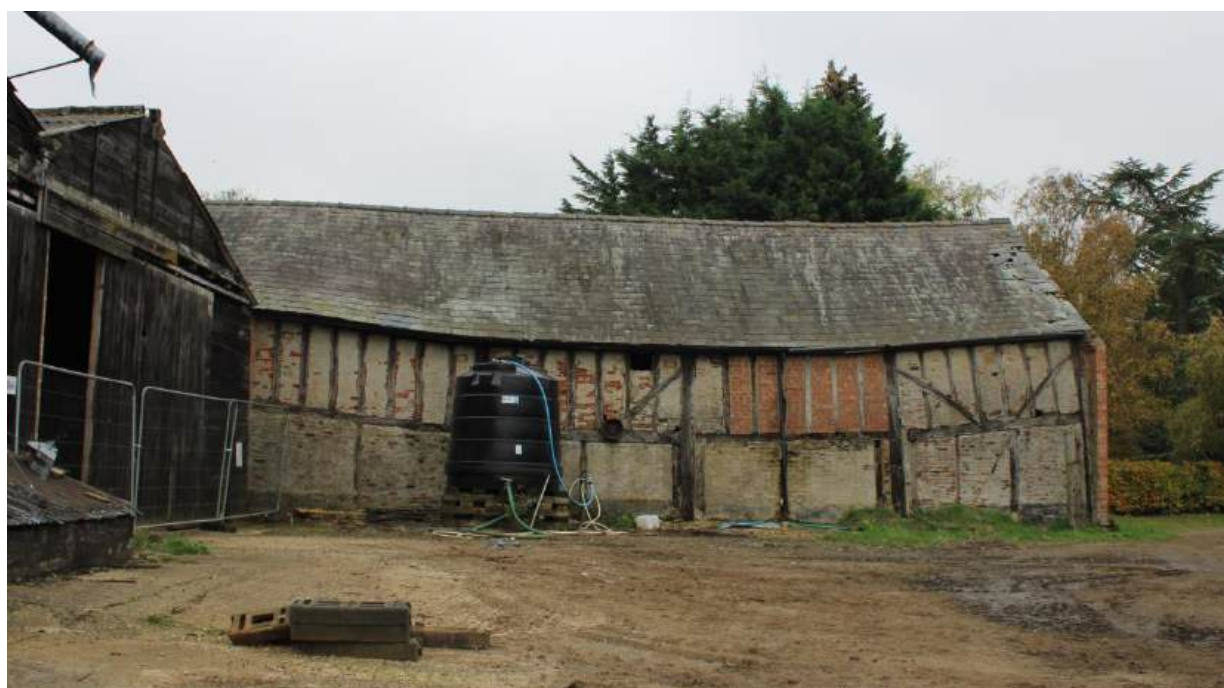
*Plate 8: General view looking E showing W-facing elevation of Barn 2*

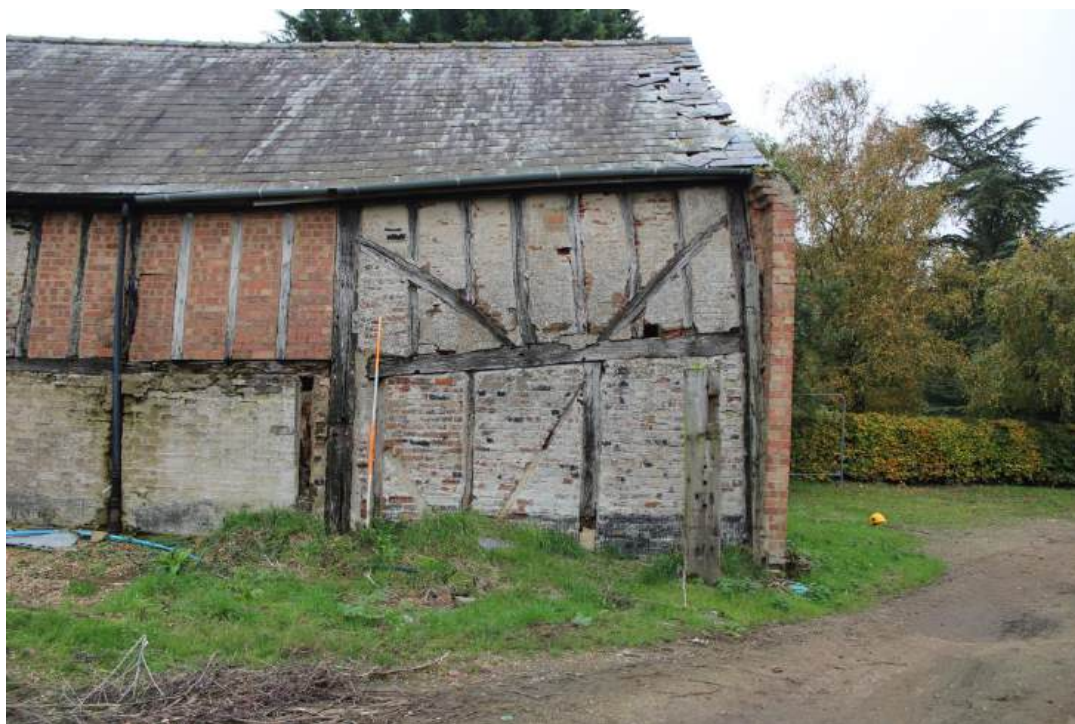
*Plate 9: W-facing elevation of Barn 2 – view looking E showing detail of timber-framing with brick nogging in southernmost bays*

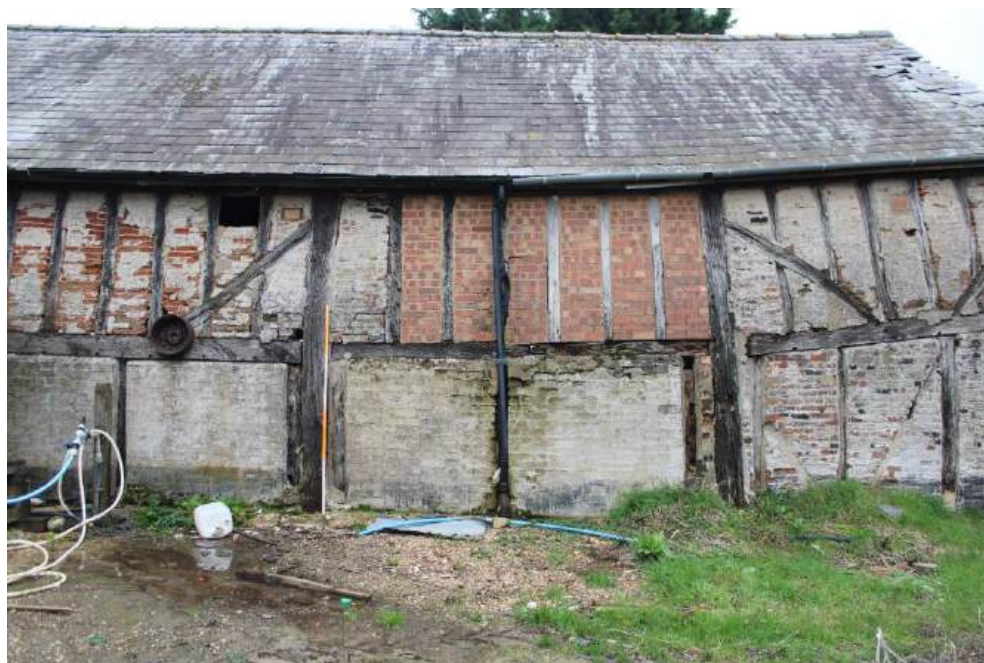
*Plate 10: W-facing elevation of Barn 2 – view looking E showing timber-framed panels with close studding above and different phases of brick infill*

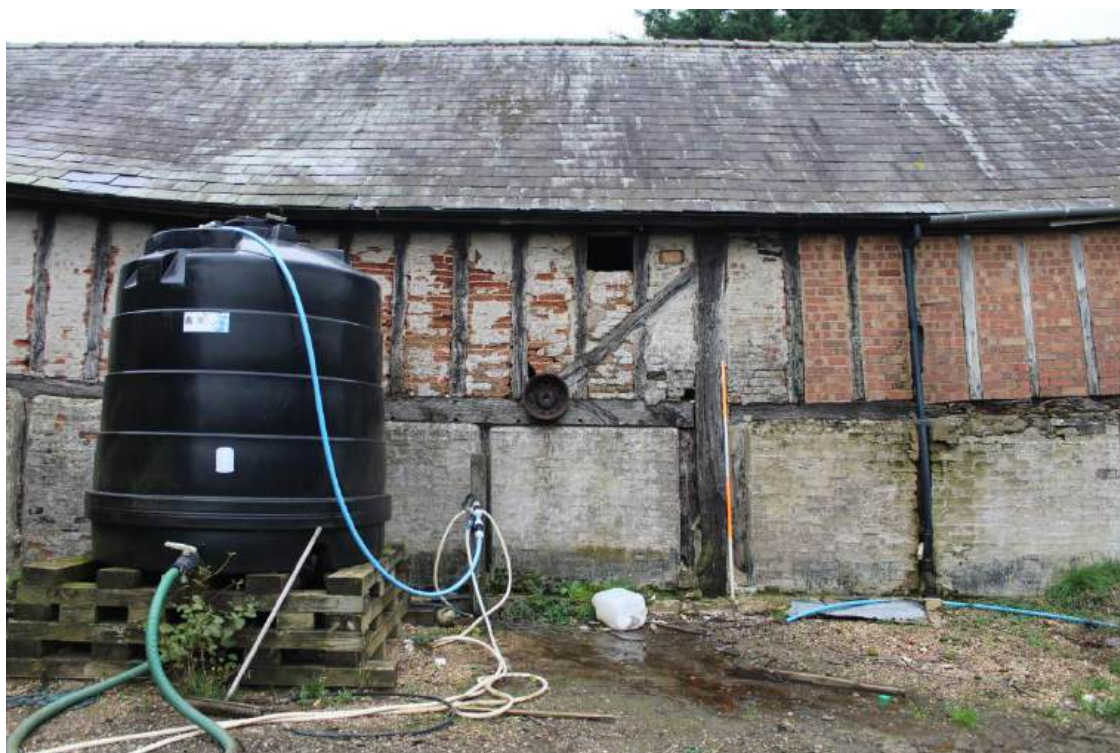
*Plate 11: W-facing elevation of Barn 2 - view looking E showing detail of cast iron shaft and flywheel for engine*

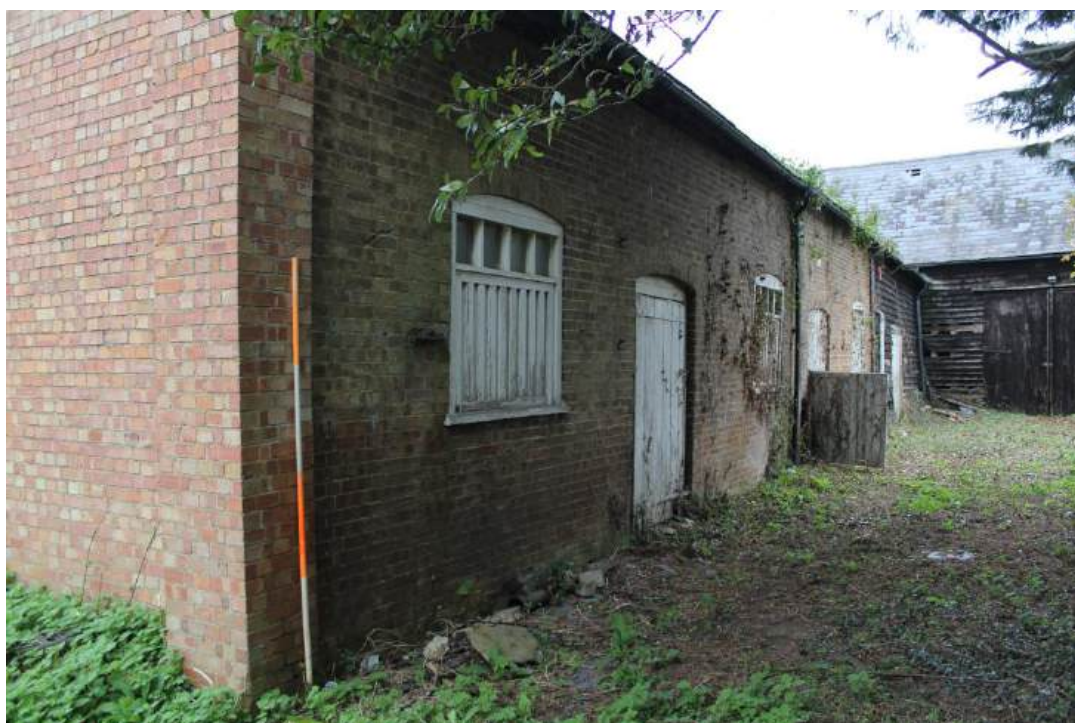
The E-facing elevation of Barn 2 (*Plate 12*) is six bays long, with the northernmost two bays clad in dark weatherboarding and devoid of fenestration except for a flat-headed doorway with plank-and-batten double-leaf door leading to the N end of the barn (*Plate 18*). A clear distinction is noted between the northernmost two bays and the remaining four bays of the E-facing elevation which have been completely rebuilt in yellowish-brown stock brick. This section of the E-facing wall is pierced by two low, broad segmental arched plank-and-batten doors (the central door being of double-leaf form) flanked by broad segmental-arched windows with 'hit and miss' vents and upper glazed lights (*Plates 13-17*).

*Plate 12: Oblique view NNW showing E-facing elevation of Barn 2 rebuilt in stock brick in 1873*

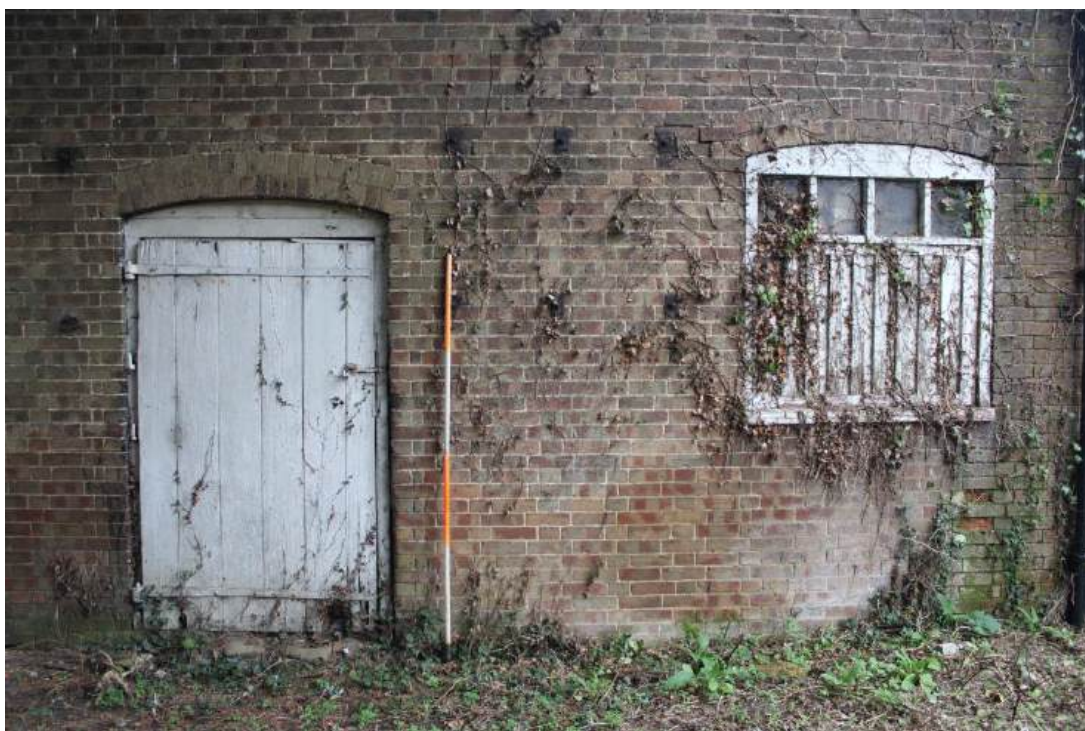
*Plate 13: E-facing elevation of Barn 2 – view looking W showing detail of segmental arched doorway with plank and batten door and window with glazed upper light and wooden 'hit and miss' vents in second bay to N of the southern end of barn*

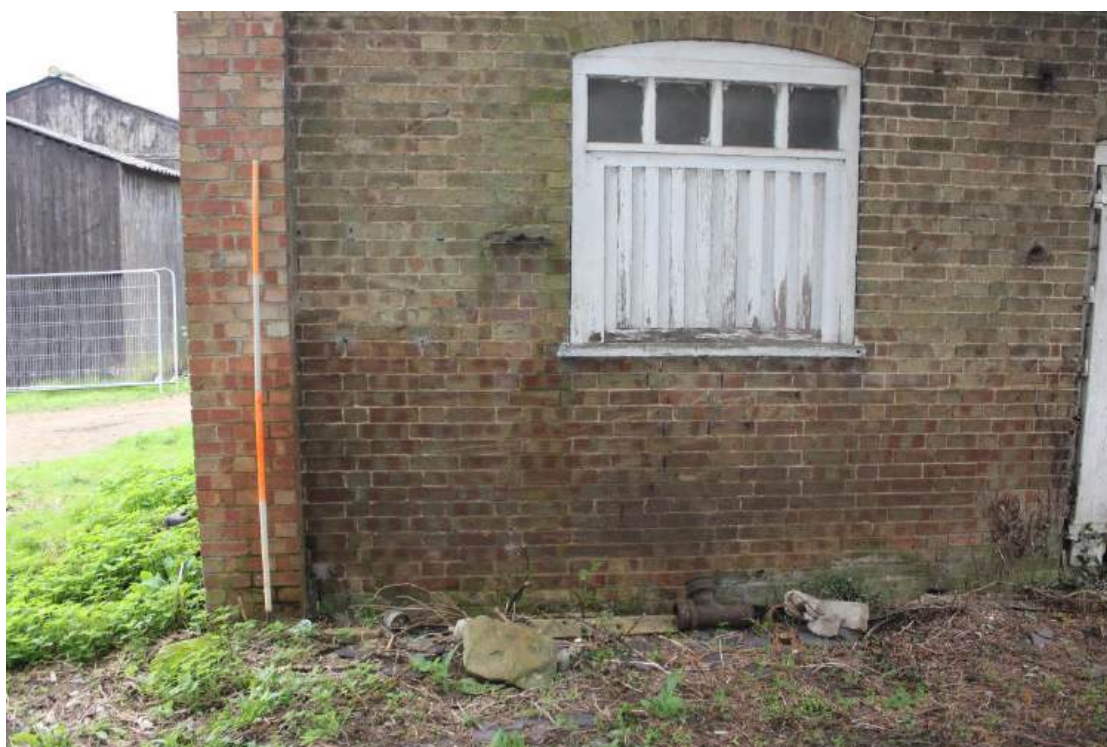
*Plate 14: E-facing elevation of Barn 2 - view looking W showing detail of segmental arched window with glazed upper light and wooden 'hit and miss' vents to left of doorway at southern end of barn*

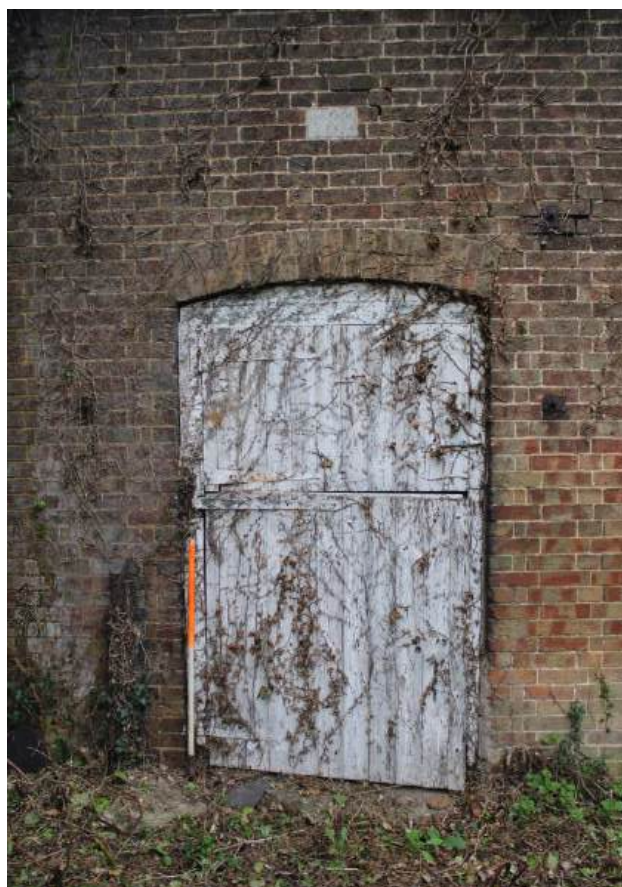
*Plate 15: E-facing elevation of Barn 2 – view looking W showing detail of segmental arched doorway with double-leaf door in central bay with stone plaque above*

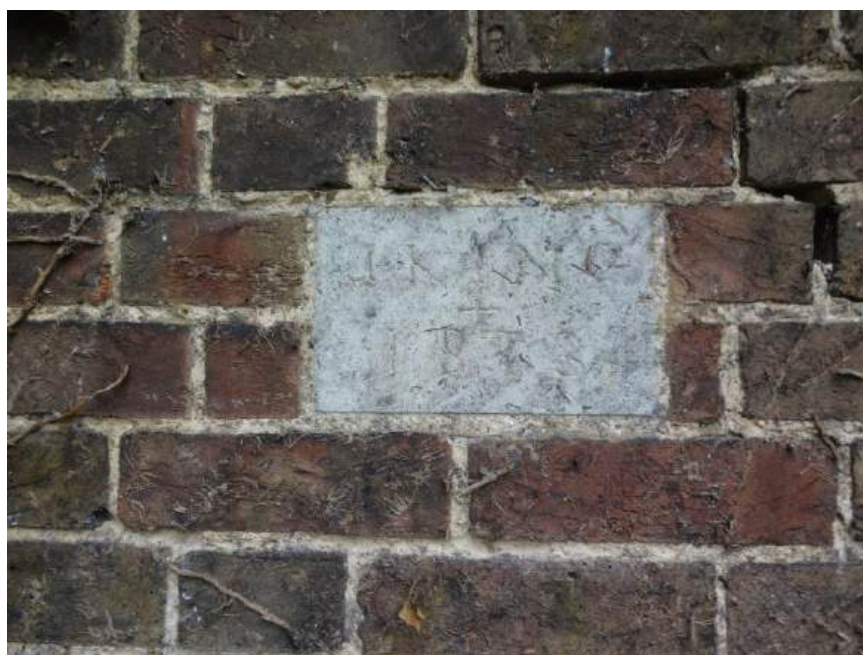
*Plate 16: E-facing elevation of Barn 2 -detail of stone plaque above central doorway inscribed 'J. King 1873'*

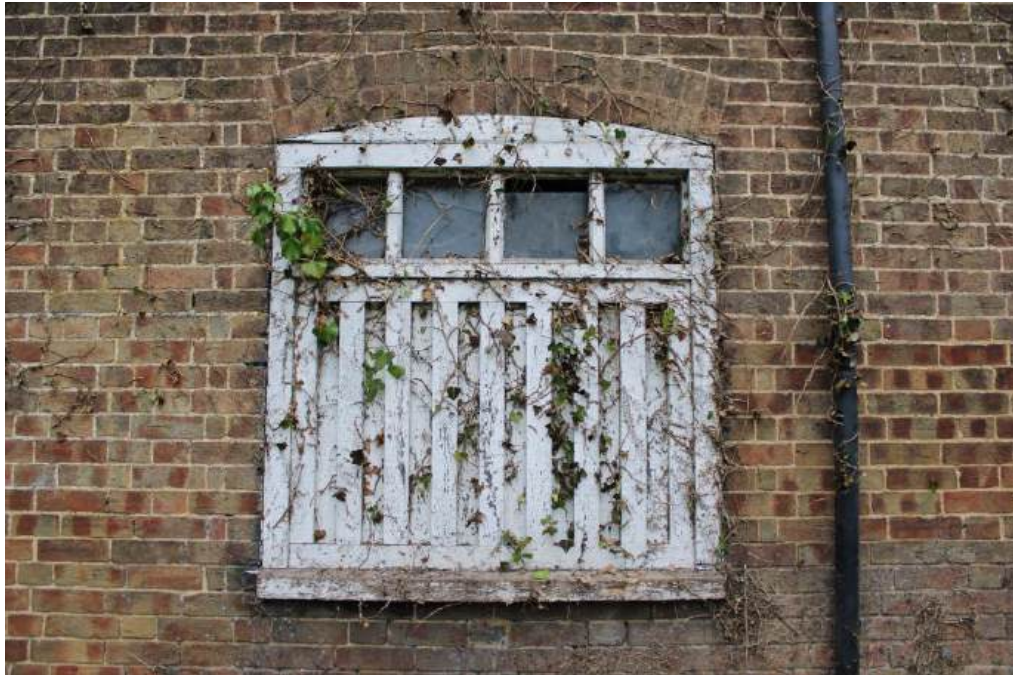
*Plate 17: E-facing elevation of Barn 2 – view looking W showing detail of window to right of central doorway with glazed upper lights and 'hit and miss' vents*

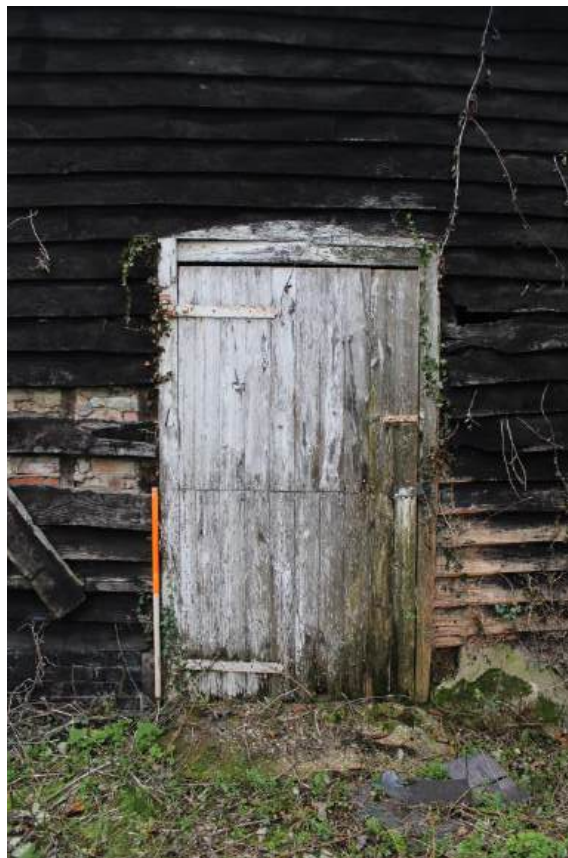
*Plate 18: E-facing elevation – View W showing detail of doorway in northernmost section of Barn 2*

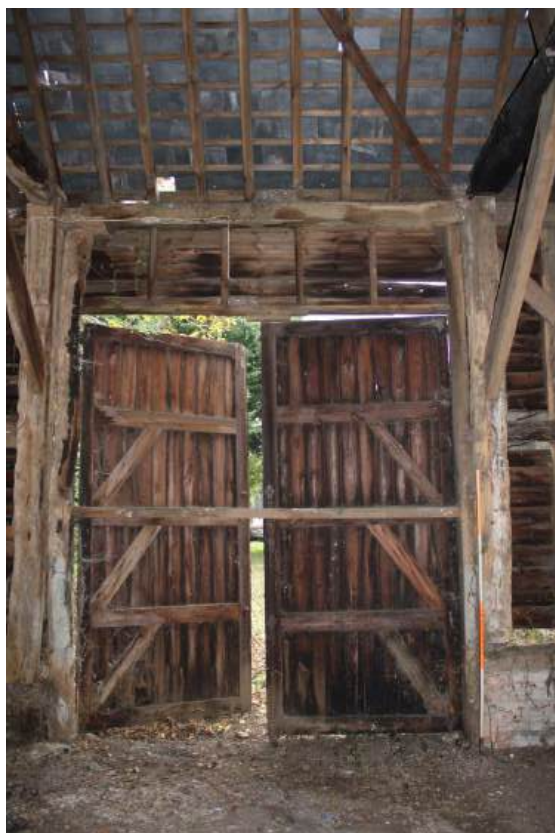
*Plate 19: Internal view Barn 1 – view S showing double doors to threshing floor in Bay B*

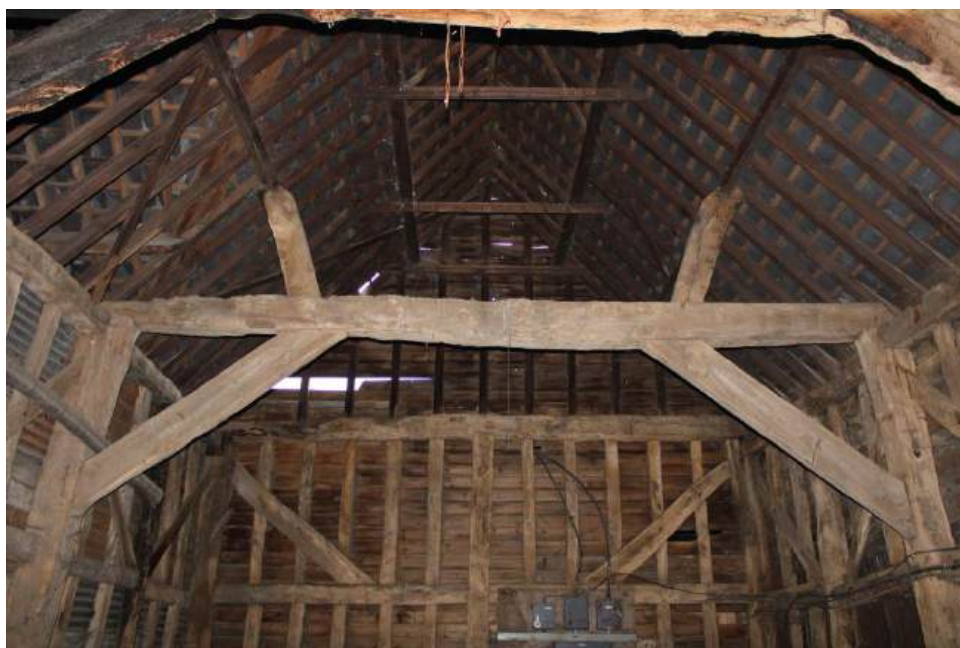
The roof structure of the barn consists of four queen-post roof trusses, each truss comprising slightly tapering tie-beams supported on heavy jowelled wall-posts, which, in turn, are connected to the posts by angled braces at either end. Each tie-beams is linked by two heavy inclined queen struts to a pair of clasped purlins running longitudinally along the roof slope which carry the principal rafters. Evidence of fire damage was noted to the roof trusses along the N side of the barn (*Plates 21, 29, 32, 35*)

*Plate 21: View looking E showing detail of Truss 1 at eastern of Barn 1*

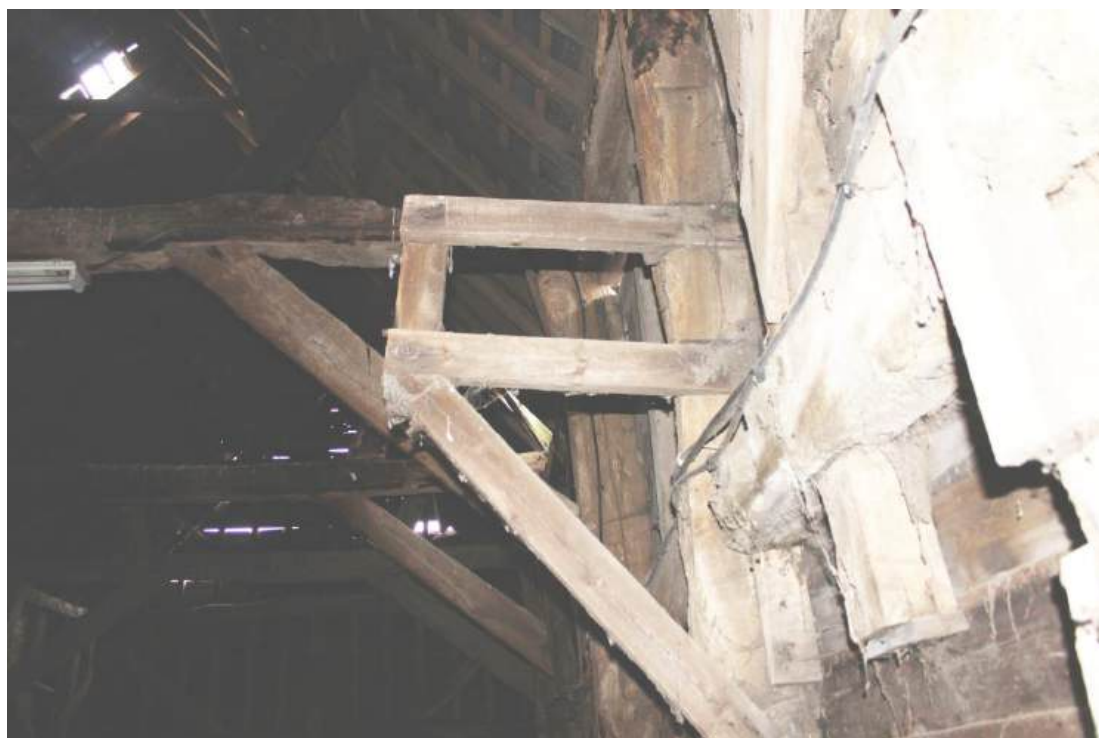
Above this doorway, a loading bay hatch with intact wooden shutters is visible, which appears to have been associated with a wooden hoist visible above and to the right of the doorway (*Plates 20-22*). The edges of a possible stone cobbled 'threshing floor' were noted at the N end of this bay, in front of the winnowing door, suggesting the remainder may have been removed at a later date (*Plate 23*).

*Plate 22: Internal view Barn 1 – View looking W showing detail of hoist above doorway in N wall*

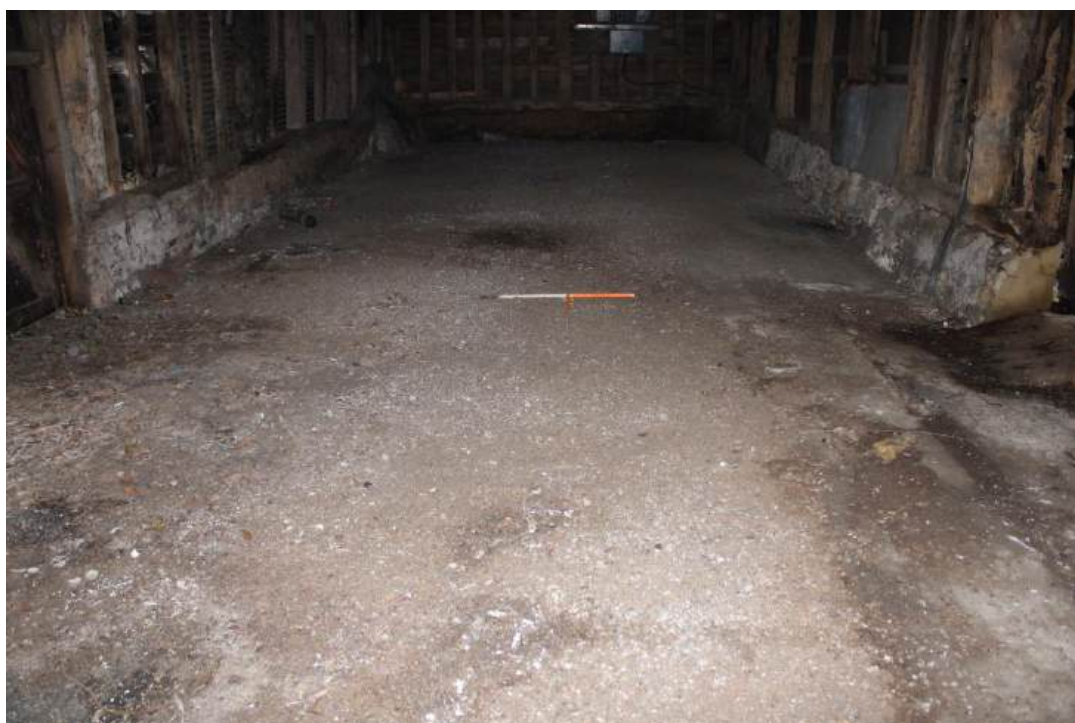
*Plate 23: Internal view Barn 1 – View looking E showing detail of floor at N end of barn with possible remains of threshing floor to right of picture*

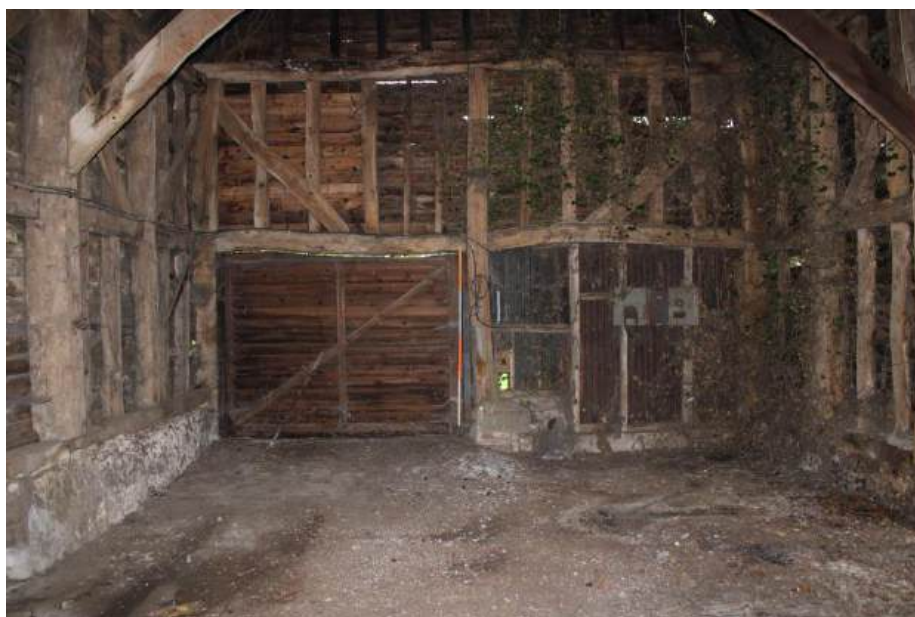
*Plate 24: Internal view Barn 1 – view looking E showing eastern end of Barn 1 with modern car port door*

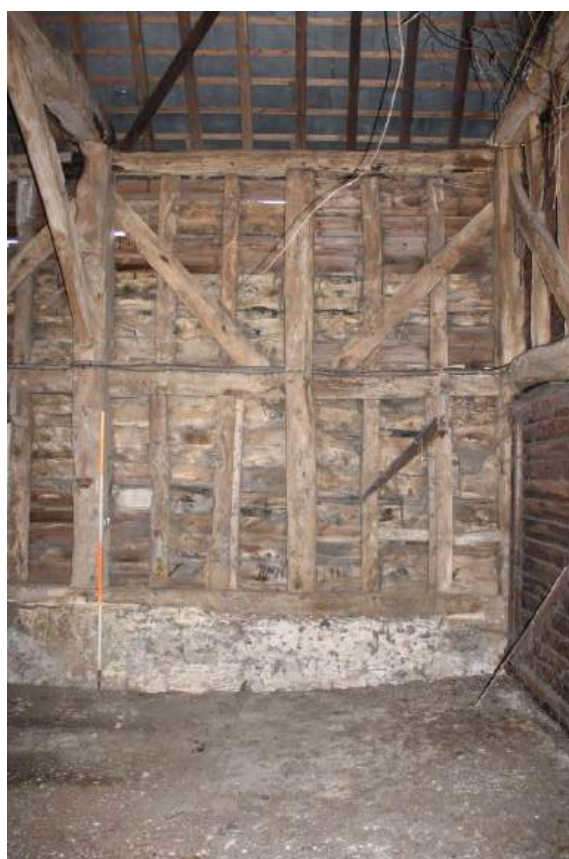
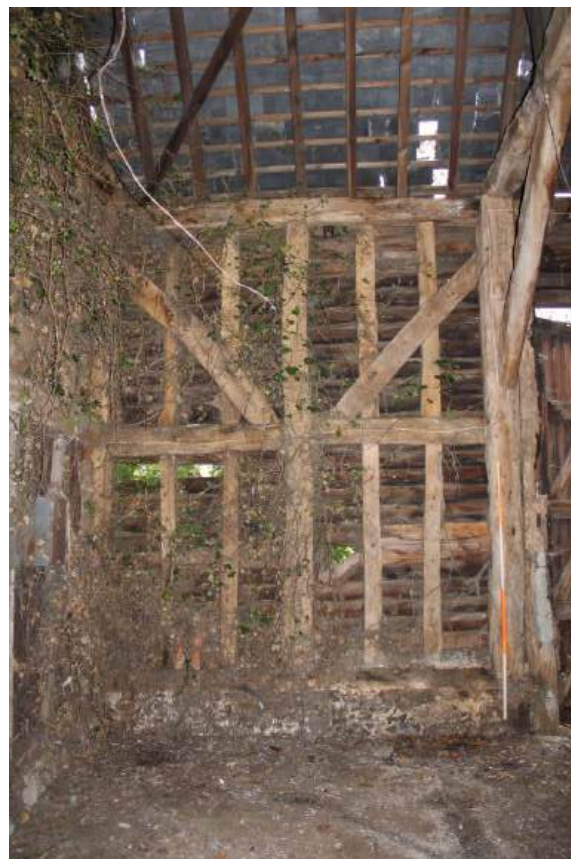
*Plates 25 and 26: Internal view Barn 1 View looking N and S showing timber framing in easternmost bay of Barn*

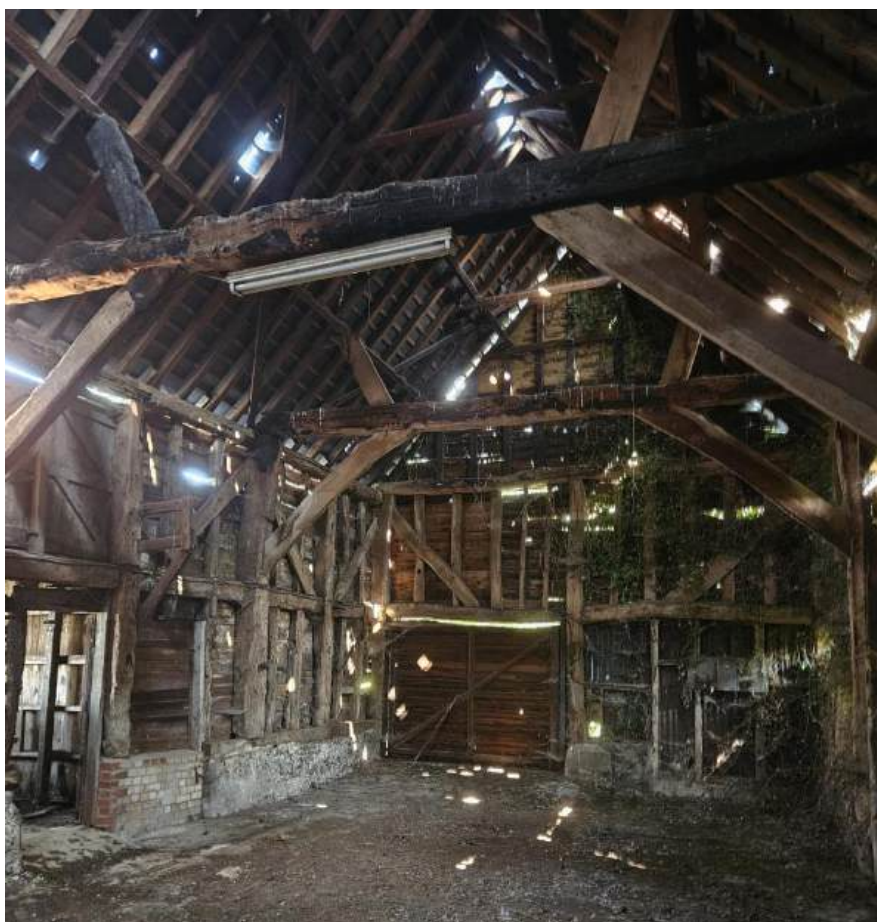
*Plate 27: General view looking towards eastern end of Barn 1 showing blackened roof trusses*

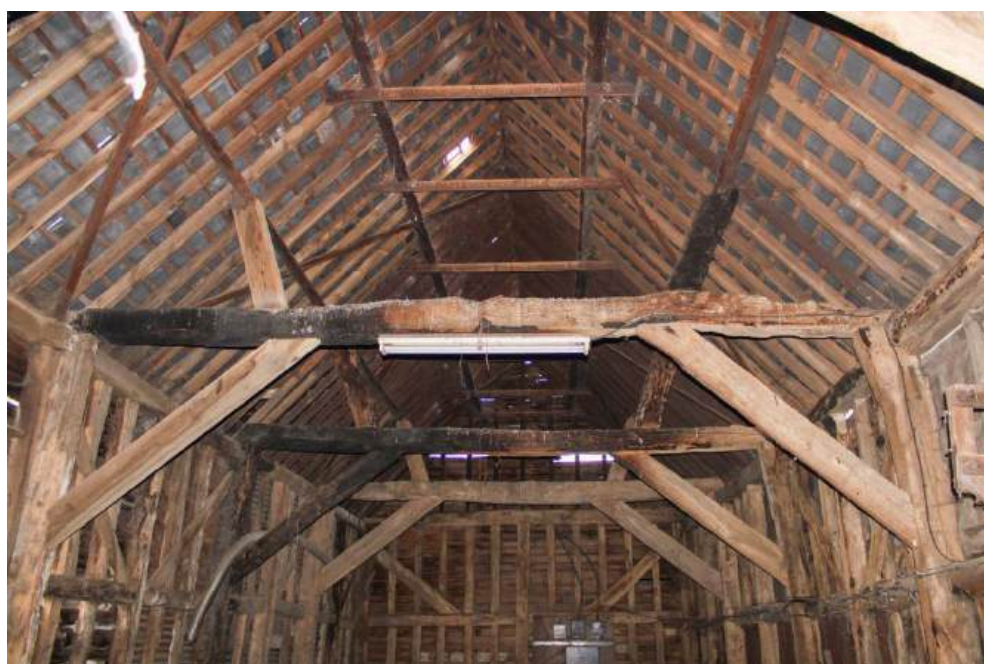
*Plate 28: Internal view Barn 1 – view looking W showing queenpost roof trusses in central and western bays*

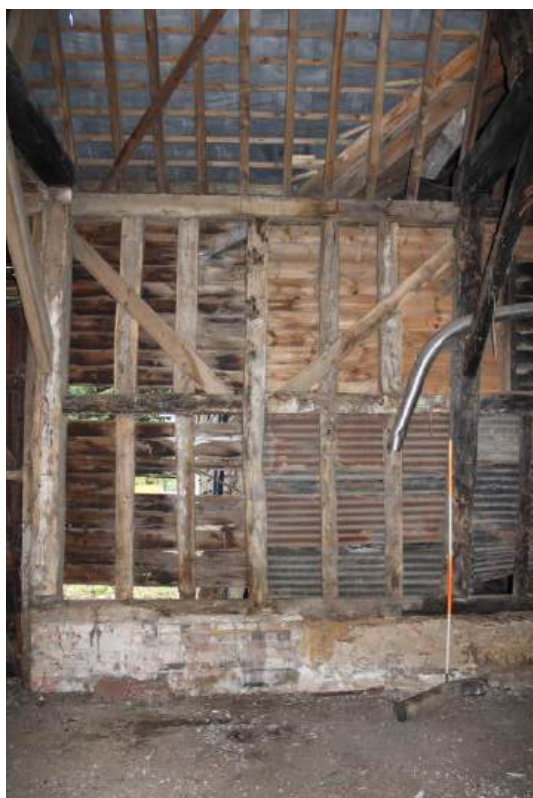
*Plate 29: Internal view Barn 1 – view looking S showing detail of timber framing to right of double doors in Bay C*  
*Plate 30: Internal view Barn 1 – view looking N showing detail of timber framing to left of winnowing door in Bay C*

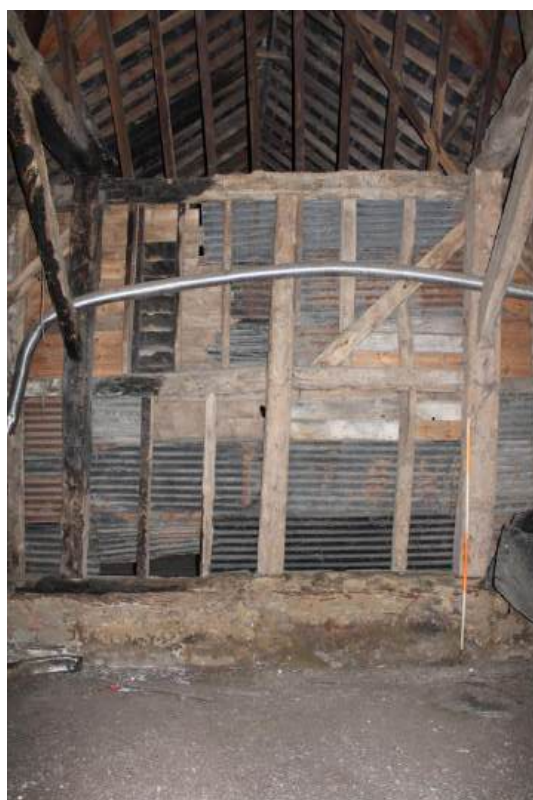
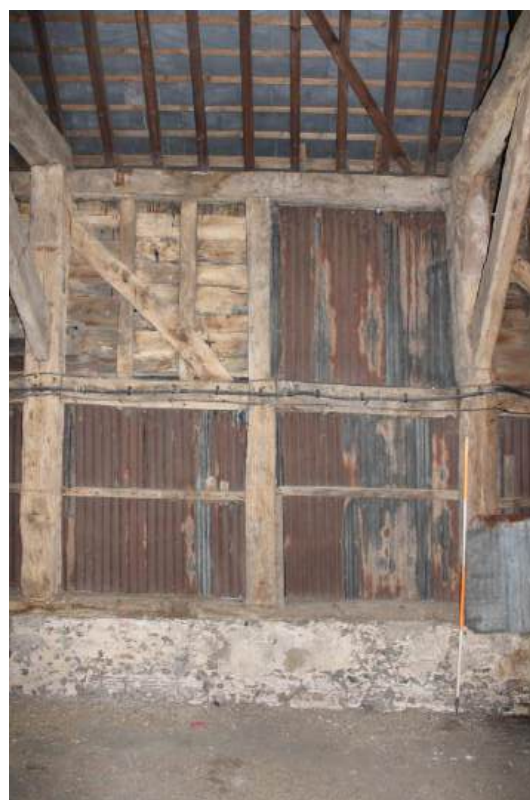
*Plates 31 & 32 : Internal View barn 1 - View looking N and S showing detail of timber framing in Bay D*

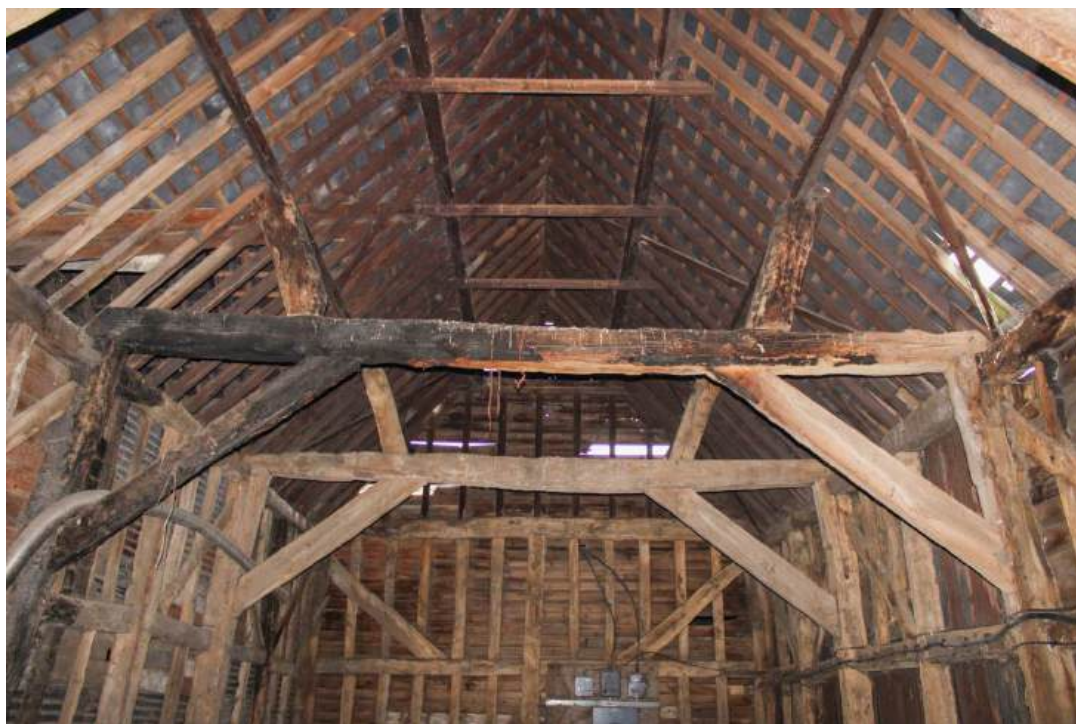
*Plate 33: Internal view Barn 1 – view looking W showing detail of queen post roof truss in western portion of barn (Bay D)*
