# Archaeological Standing Building Recording

On Behalf of  
**Netherdown**

Concerning  
**Lordship Farm Barns**  
**Pirton Road**  
**Holwell**  
**Hertfordshire**  
**SG5 3SS**

**November 2024**

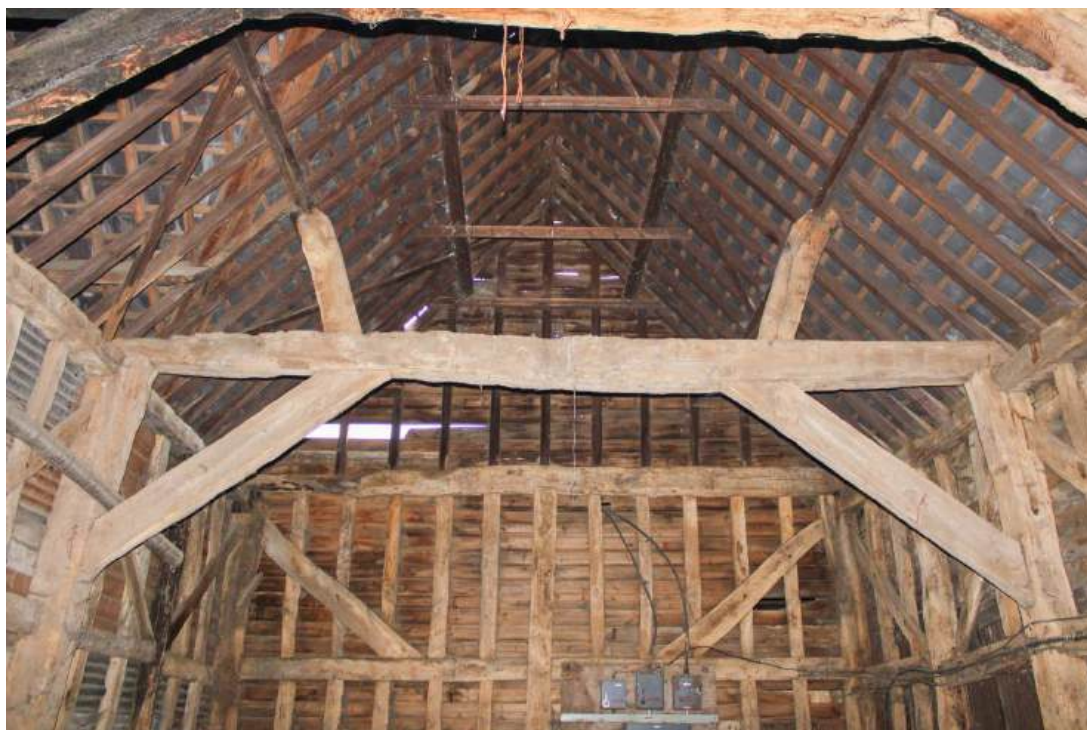
*Plate 34: Internal view Barn 1 – view looking W showing detail of queen post roof truss at westernmost end of barn (Bay E)*

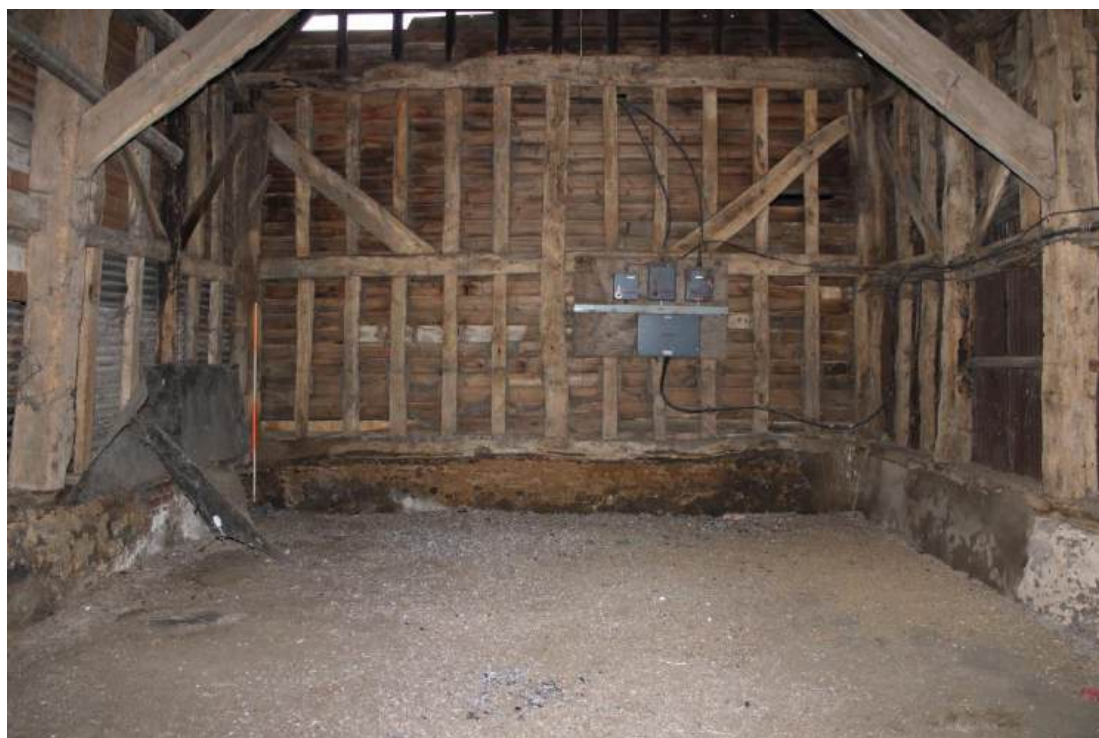
The roof structure of the barn consists of four queen-post roof trusses, each truss comprising slightly tapering tie-beams supported on heavy jowelled wall-posts, which, in turn, are connected to the posts by angled braces at either end. Each tie-beams is linked by two heavy inclined queen struts to a pair of clasped purlins running longitudinally along the roof slope which carry the principal rafters. Evidence of fire damage was noted to the roof trusses along the N side of the barn (*Plates 21, 29, 32, 35*)

*Plate 35: Internal view Barn 1 – view looking W showing close studded timber-framing at W end of barn*

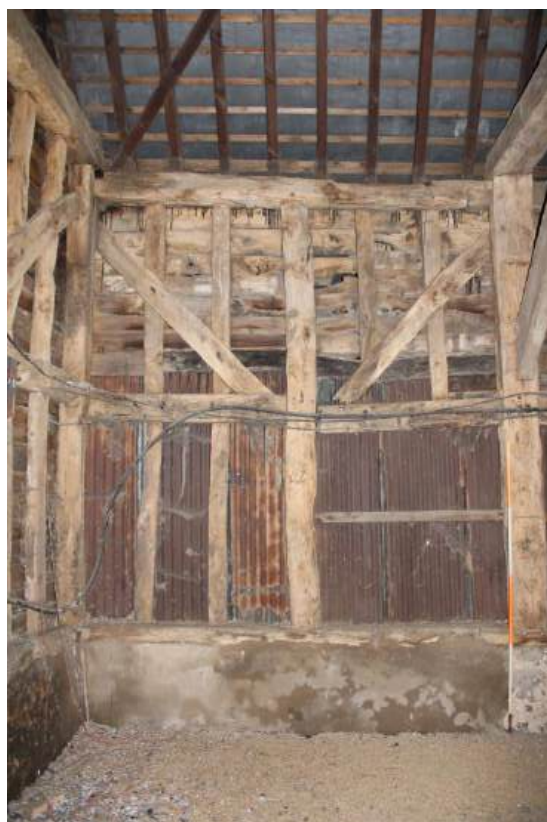
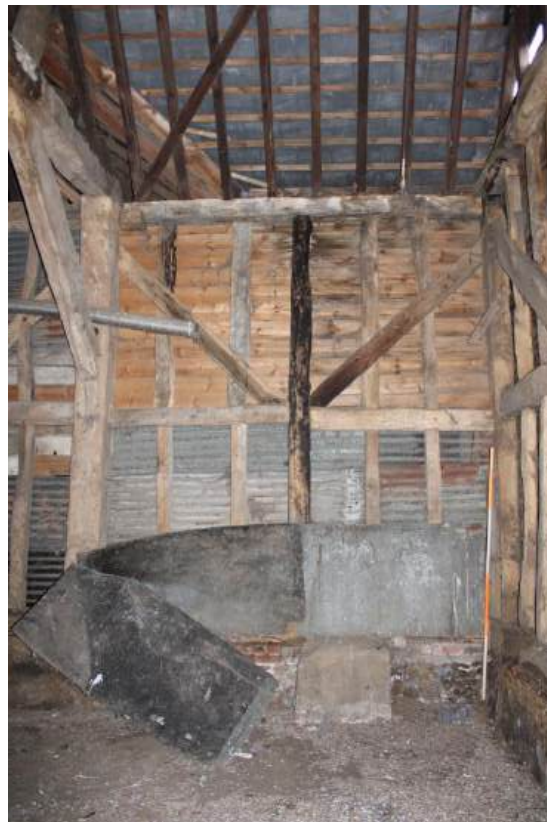
*Plates 36 & 37 Internal view Barn 1 – views looking N and S showing detail of timber framing in westernmost bay (Bay E)*

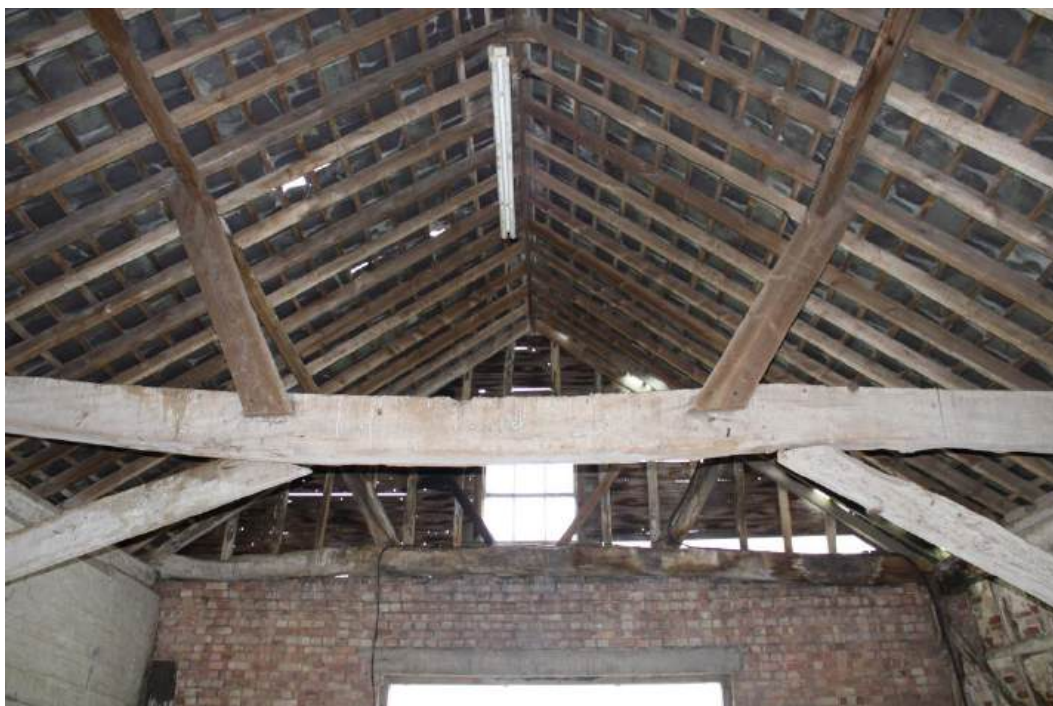
*Plate 38: Internal view Barn 2 – View S towards queen post truss at S end of Barn (Bay G)*

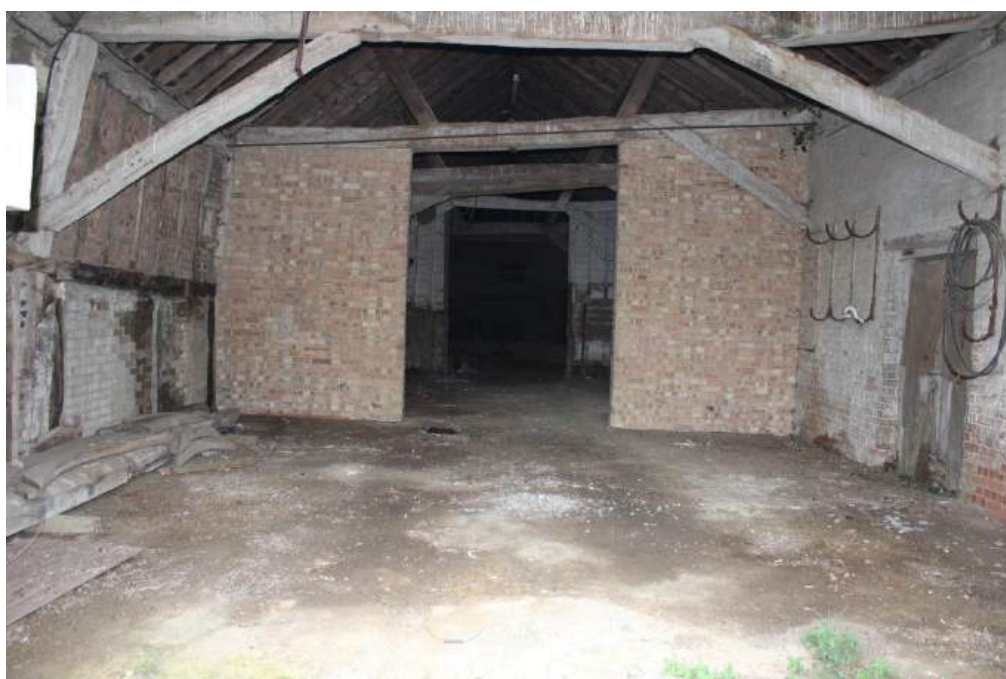
The roof trusses are again of queen-post type but appear to have been subject to a significant degree of repair and replacement. Each tie-beam rests upon a squared timber wall-post along the W side of the barn while on the E side it is supported by a brick wall-post or pier (reflecting the fact that this portion of the barn was heavily rebuilt in the late 19<sup>th</sup> century). Further support is provided by pairs of angled or curved braces connecting the tiebeam to the wall post with inclined queen struts linking the tie-beam to a pair of clasped purlins running longitudinally along the roofslope (*Plates 39, 40, 46, 51, 58*).

*Plate 39: Internal view Barn 2 – view looking N showing interior of S part of barn with modern brick partition*

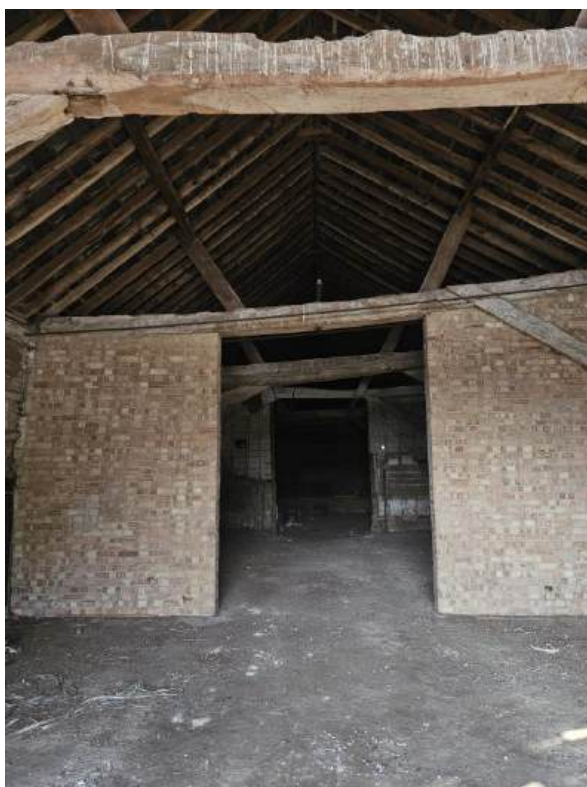
*Plate 40: Internal view Barn 2 – View looking N showing detail of modern brick partition wall in central bays of barn*

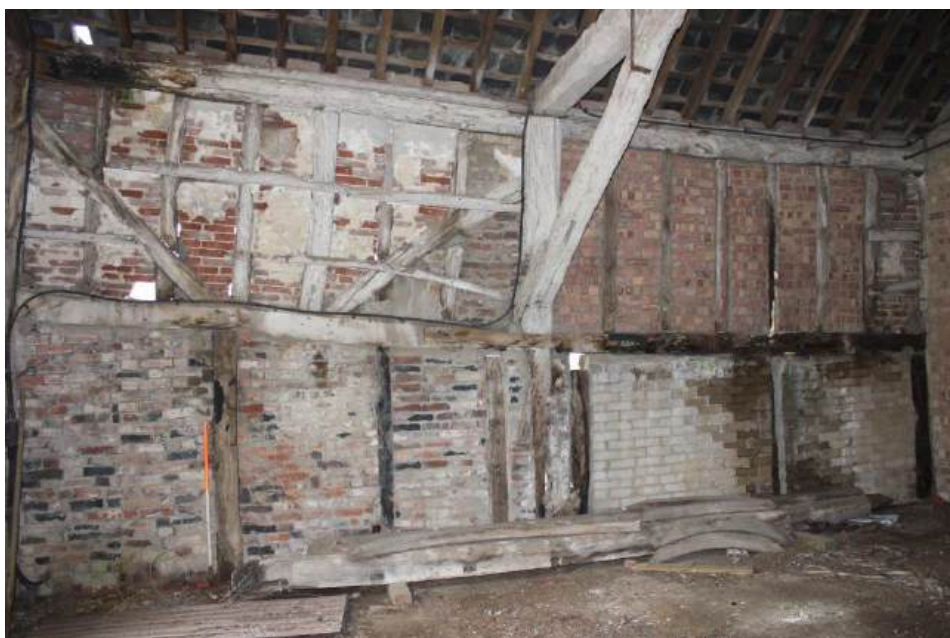
*Plate 41: View looking W showing detail of timber-framed panels in southernmost bay of Barn 2 (Bay F)*

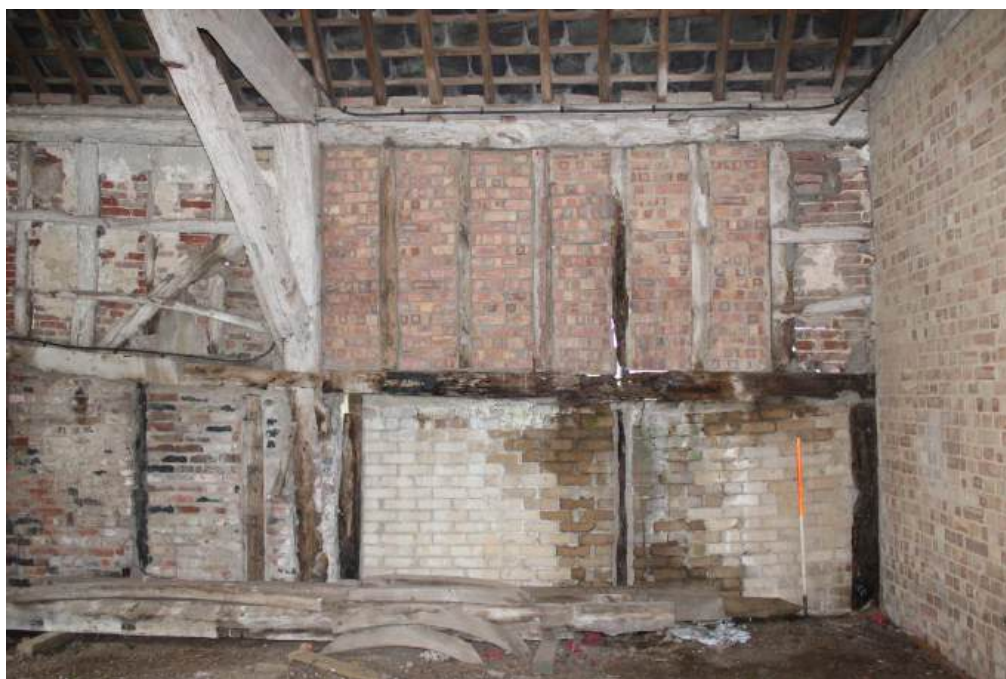
*Plate 42: View looking W showing detail of timber framed panels with modern brick infill in W elevation of Barn 2 (Bay G)*

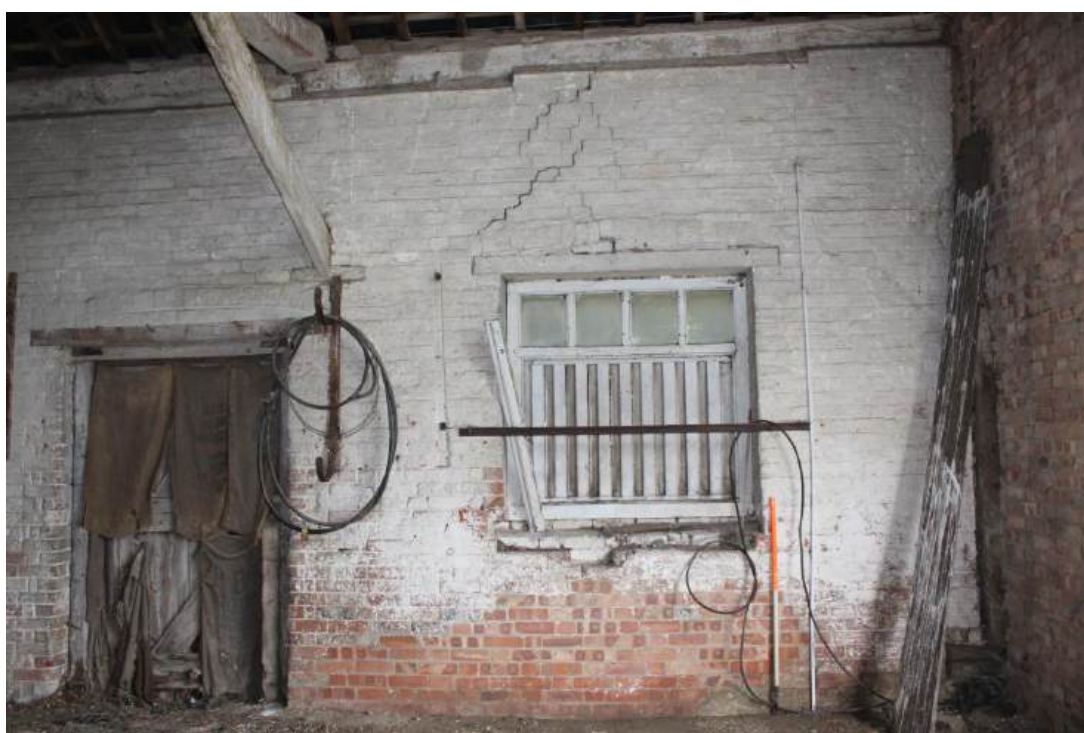
*Plate 43: Internal view Barn 2 - view looking E showing detail of E wall at S end of Barn (Bay F) with window with upper glazed lights and 'hit and miss vents' and harness hook to right of doorway*

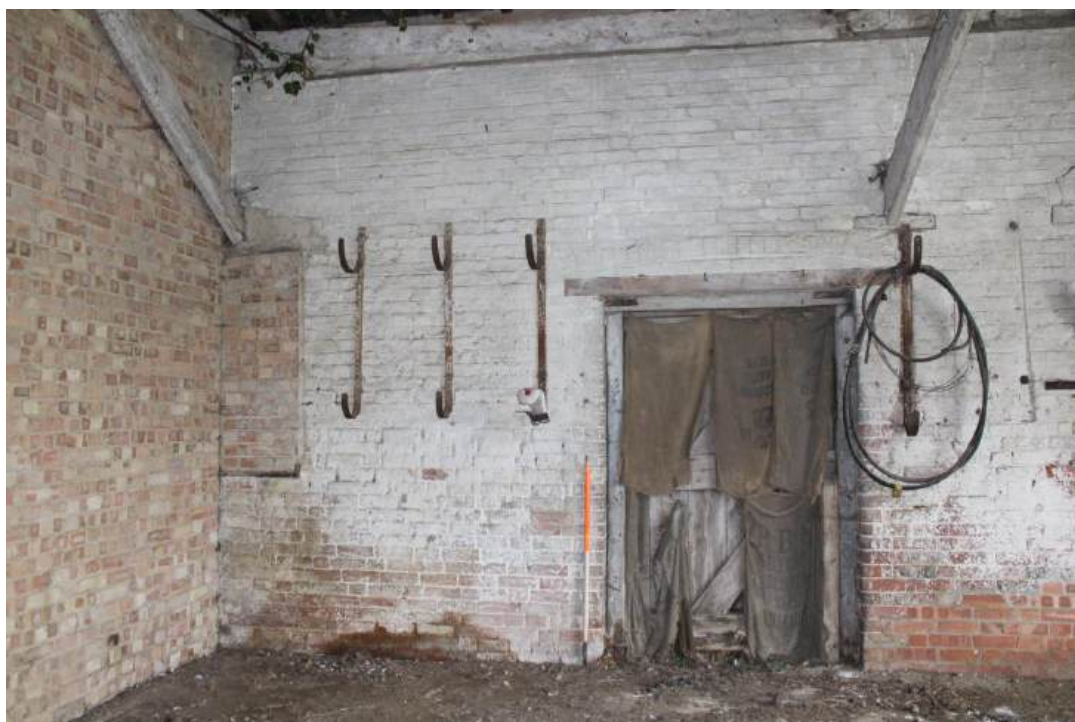
*Plate 44: Internal view Barn 2 – view looking E showing door in E wall with flanking harness hooks and blocked window to left, blocked as a result of the construction of the modern brick partition wall*

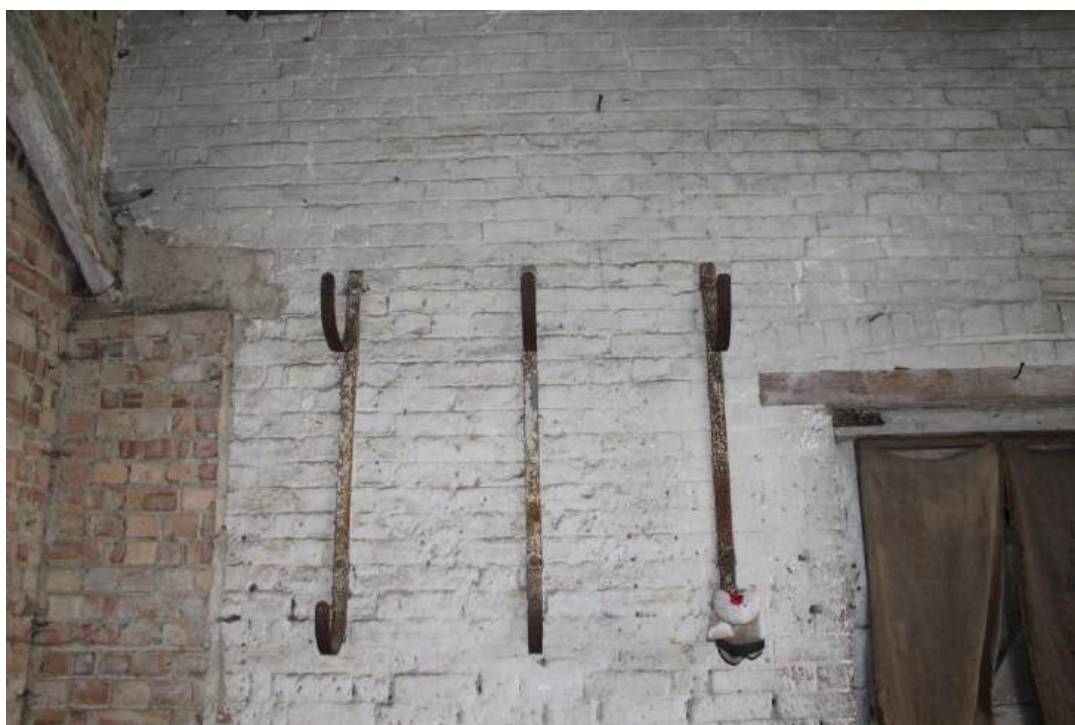
Another possibility is that these hooks were inserted at a later date and may reflect the usage of the building to house shire horses rather than cattle; up to 31 shire horses are known to have been accommodated at Lordship Farm in the early 1900s, according to local newspaper records. However, no evidence for stalls, mangers or hayracks was noted within the barn, although it is possible that these may have been removed when Barn 2 was remodelled in the late 20<sup>th</sup> century. It may be noted that the insertion of the new brick partition wall appears to have resulted in a slight reordering of Bay G and Bay H, as evidenced by the fact that one of the segmental-arched windows in the E wall was blocked (*Plate 45*).

*Plate 45 View looking E showing detail of wall hooks and blocked window in E wall of Barn 2 (Bay G)*

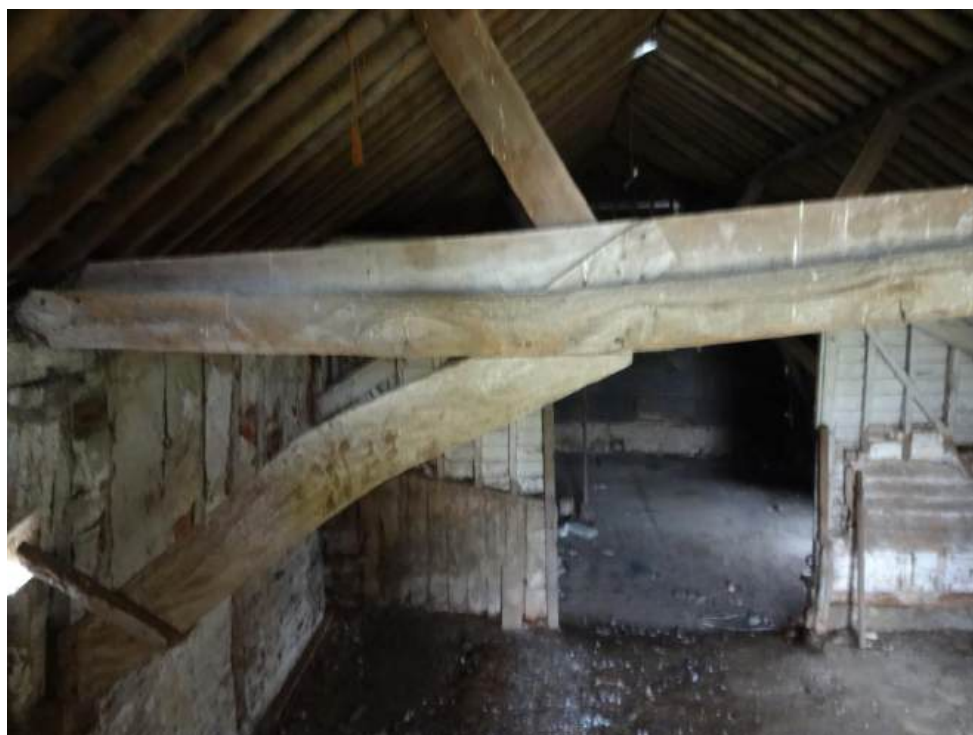
*Plate 46: Internal view Barn 2 – view looking N showing detail of queen post roof truss with curved struts between bays H and I*

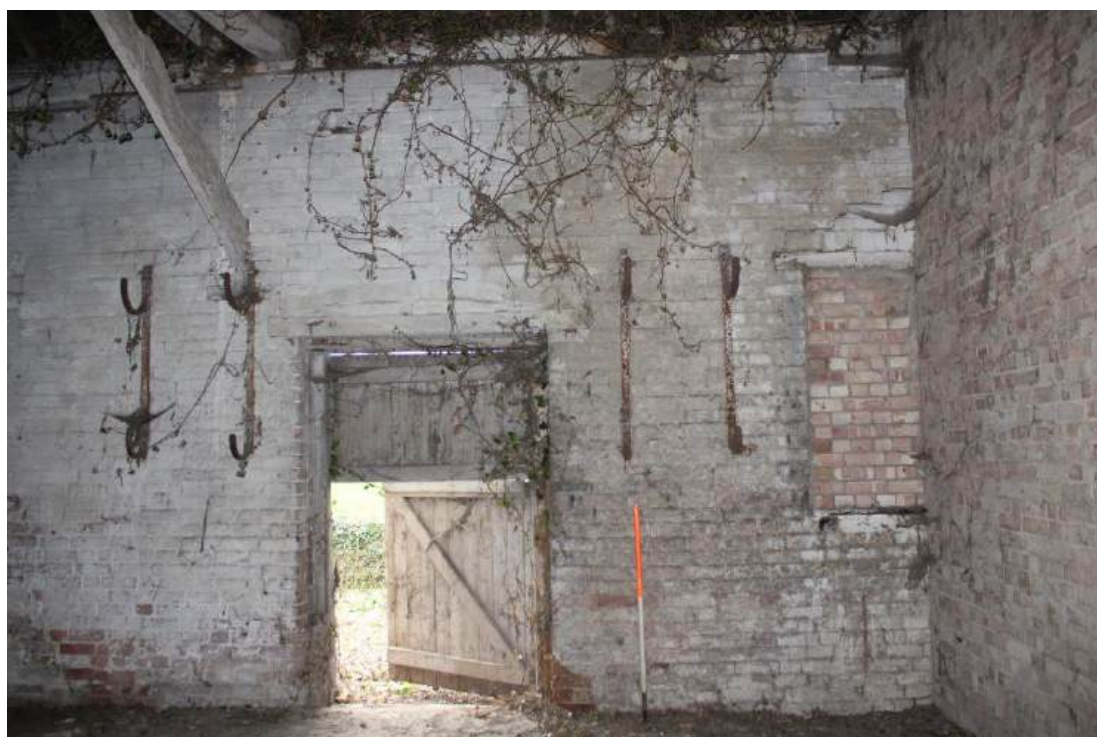
*Plate 47: View looking E showing doorway flanked by harness hooks on E wall of Barn 2 (Bay H) with blocked window visible to right of picture*

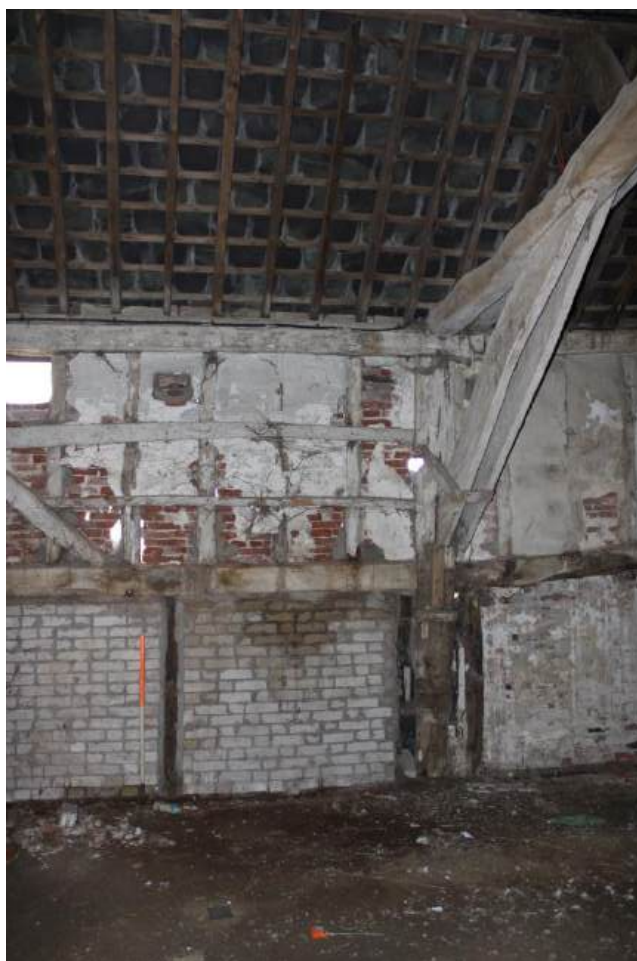
*Plate 48: View looking W showing detail of timber framing in W elevation of Barn 2 (Bay H)*

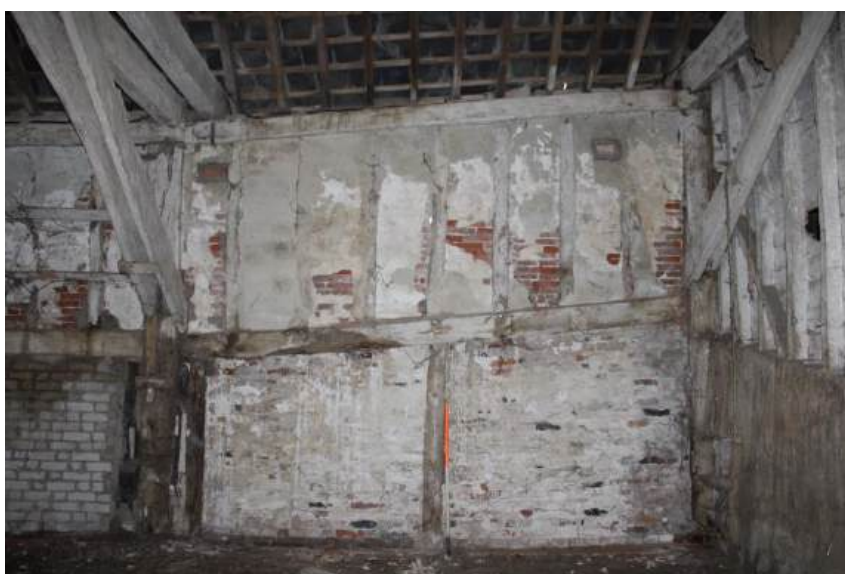
*Plate 49: View looking W showing detail of timber framing in W wall of Barn 2 (Bay I)*

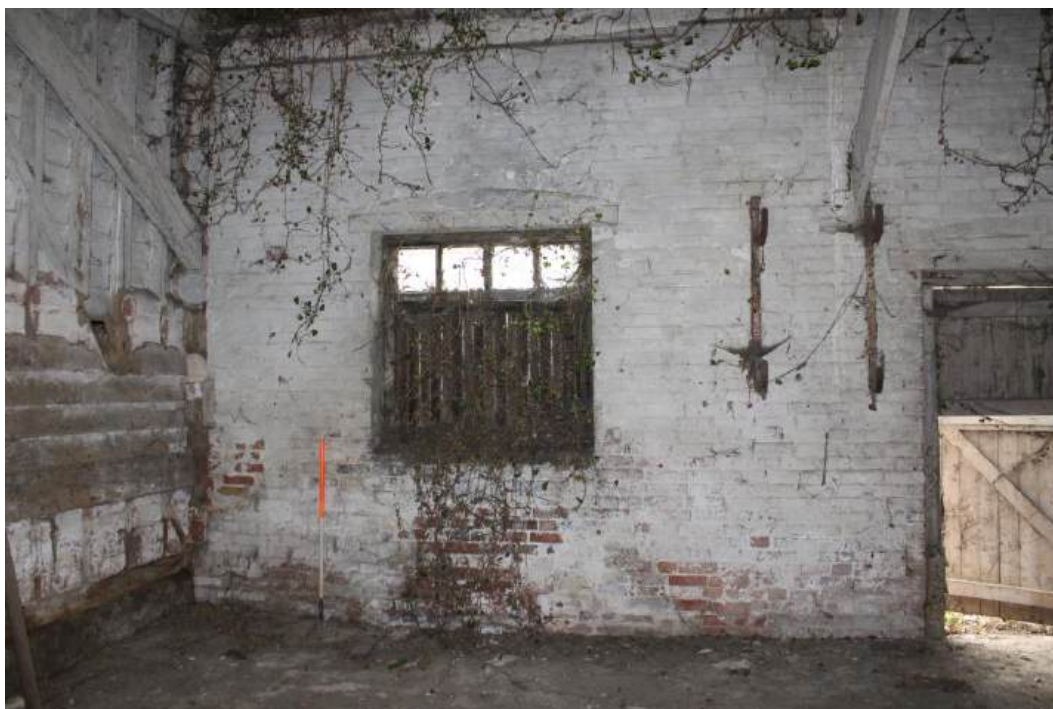
*Plate 50: View looking E showing detail of window in E wall of Barn 2 with doorway to right (Bay I)*

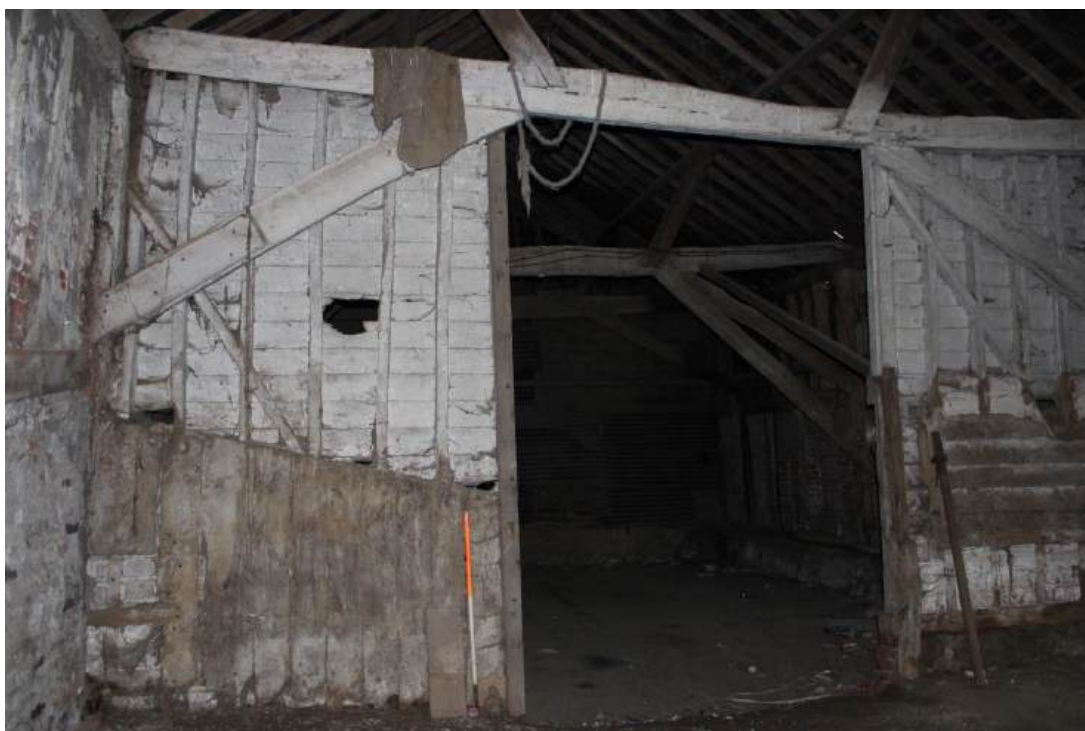
*Plate 51: View looking N showing partition wall with brick plinth in Barn 2 (Bay I)*

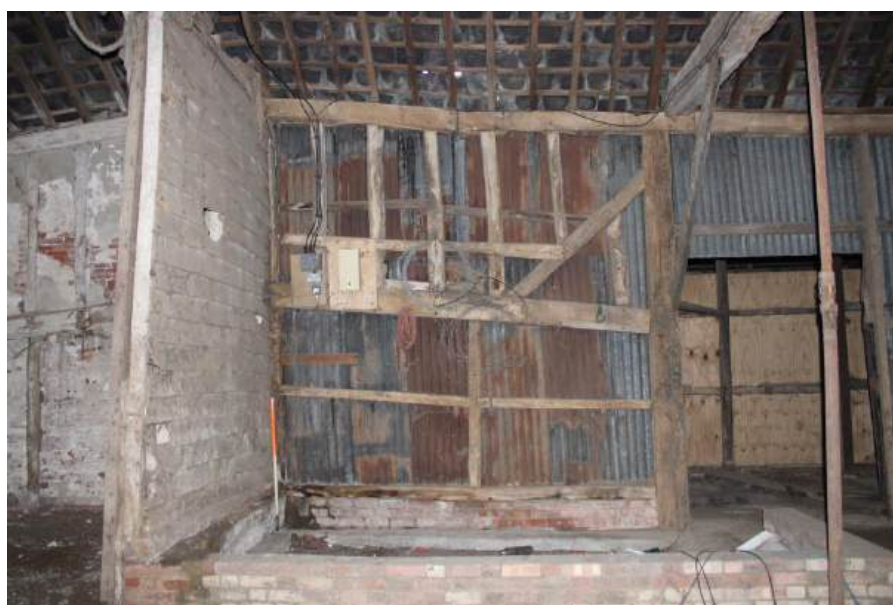
*Plate 54: View looking W in Barn 2 showing detail of brick engine base at N end of barn (Bay J) with timber framing of W wall in background and doorway to modern barns to right of picture*

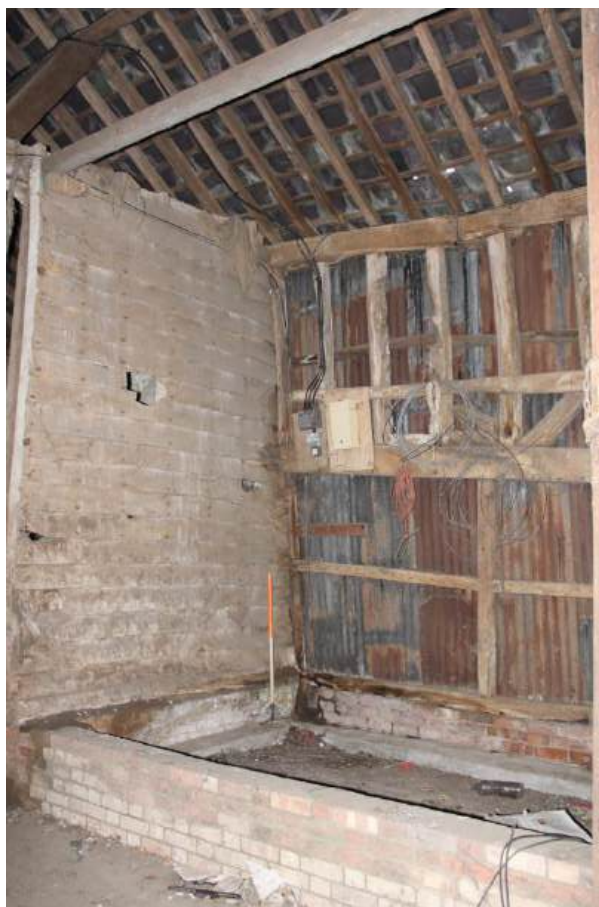
*Plate 55: View looking SW showing detail of engine base and partition wall in Barn 2 (Bay J)*

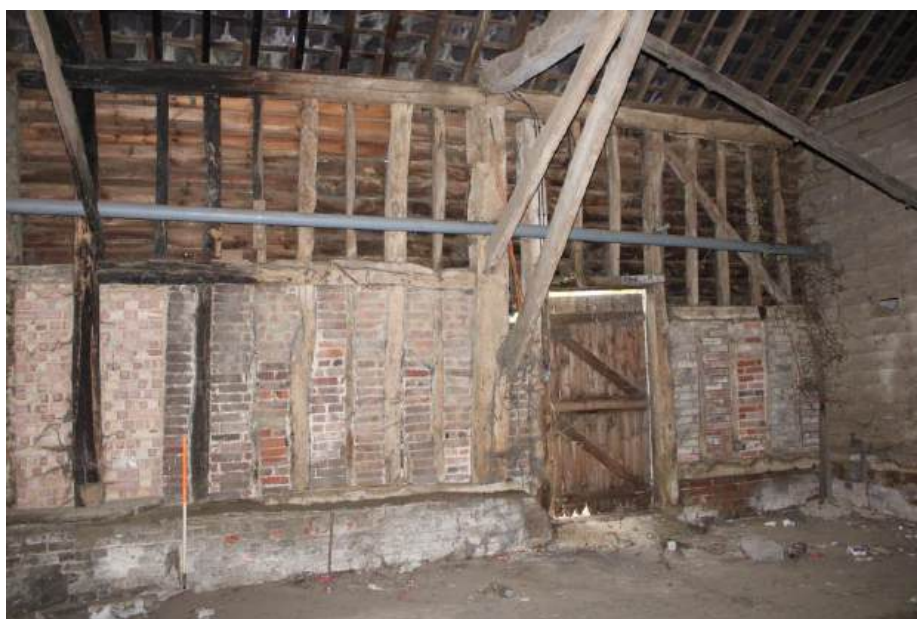
*Plate 56: View looking W showing timber framing in northernmost bays of Barn 2 (Bays J & K)*

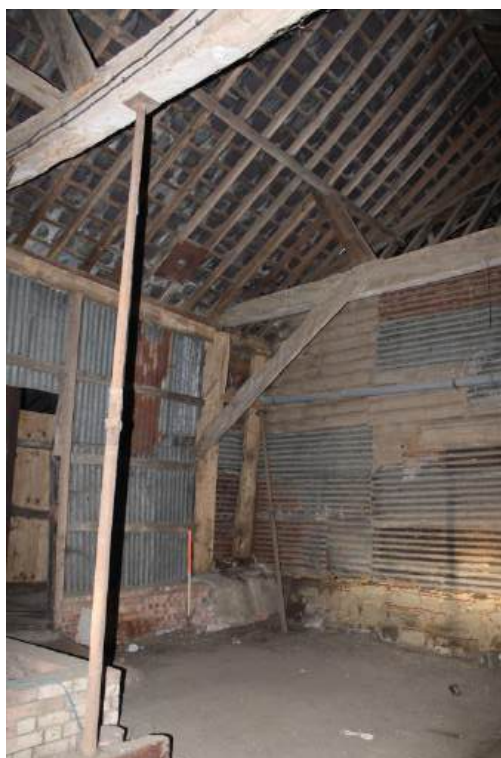
*Plate 57: View looking NW showing timber framing in W wall at northernmost end of Barn 2 (Bay K)*

A timber partition wall standing on a brick plinth separates the central and southernmost four bays of Barn 2 from the two northernmost bays (*Plates 51-52*). These two northern bays (Bay J & Bay K) do not appear to have been converted into a cowhouse in the late 19<sup>th</sup> century and retain their internal timber-framing partially intact (*Plates 53 & 56*), although on the W side, it appears to have been partially truncated by the construction of an engine, probably for the processing of animal feed, with a rectangular brick base (*Plates 54-55*) and by the insertion of a doorway linking Barn 2 to the modern barns to the W (*Plates 57-58*).

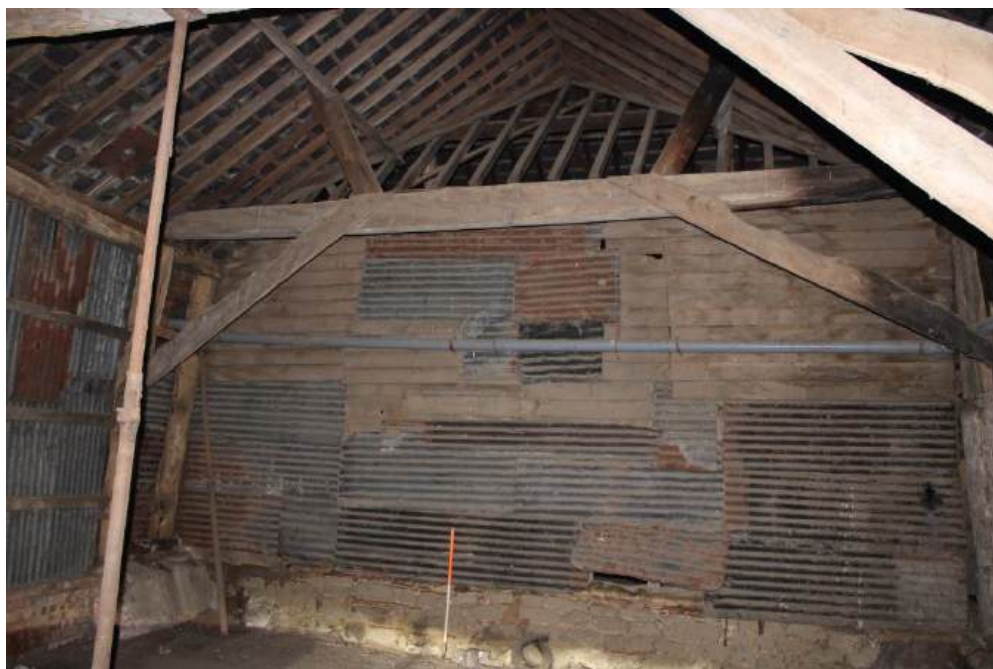
*Plate 58: View looking N showing northern end of Barn 2 with queen post roof truss*

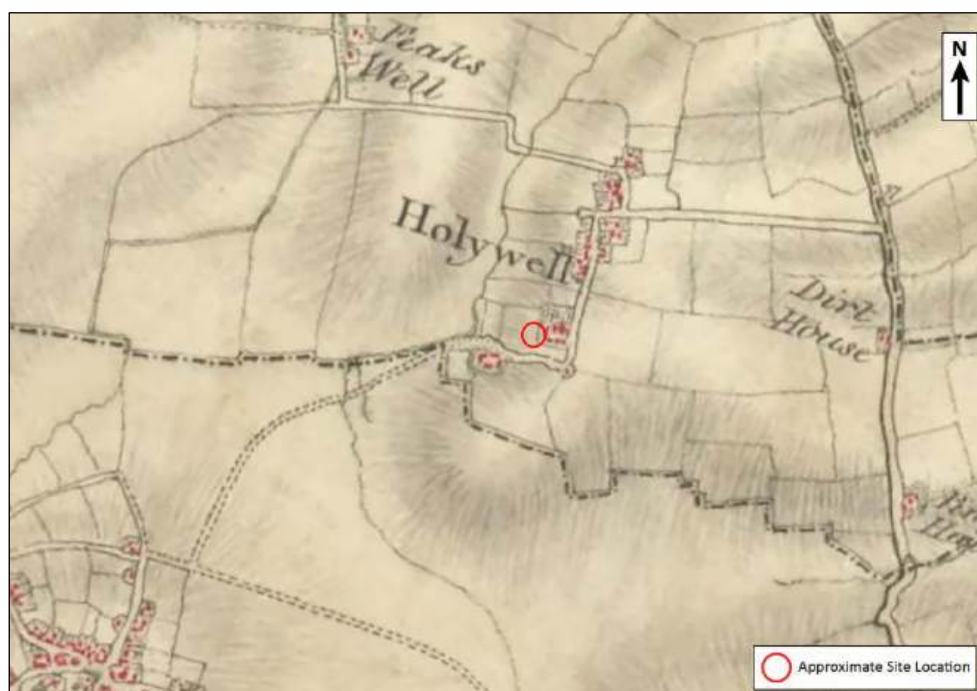
Fig. 13: Extract from the Ordnance Survey surveyor's drawing of 1804  
 (Reproduced by courtesy of the National Archives)

The earliest available historic map to show the site is the Ordnance Survey surveyor's drawing of Hitchin and district dated 1804 (*fig. 13*). Largely schematic in approach, the map lacks any significant detail and shows only the site as comprising two rectangular plots, the southernmost evidently representing the farmyard with structures indicated within, while the northern plot appears to represent a garden or orchard.

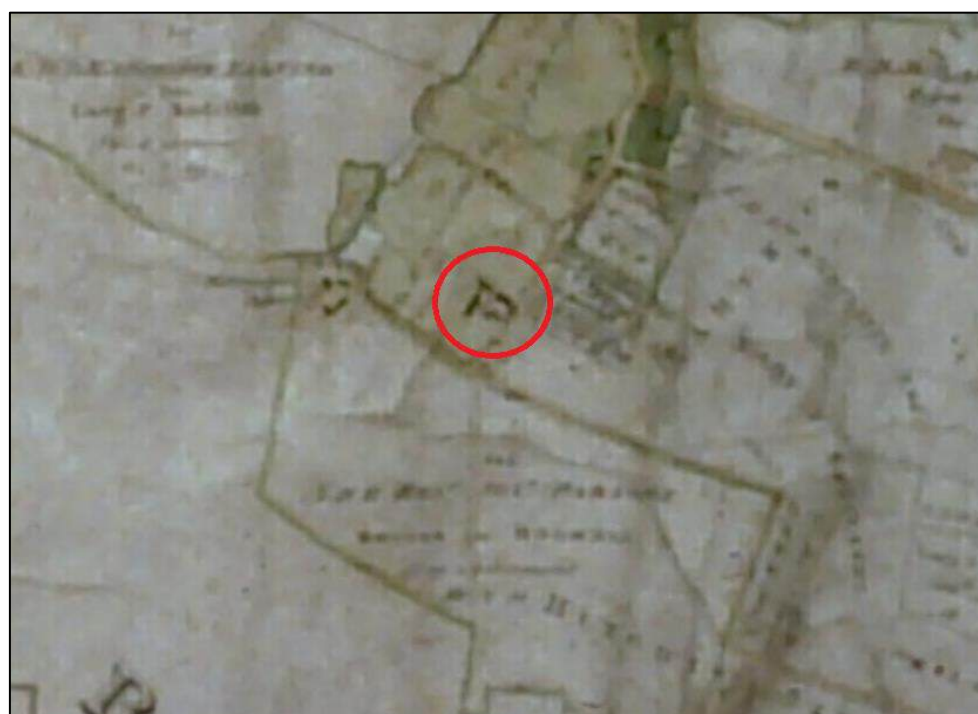
Fig. 14: Extract from the Shillington and Holwell Inclosure Award Map of 1817  
 (Reproduced by courtesy of the Hertfordshire Archives & Local Studies Library)

More useful detail is provided by the 1817 inclosure map for the parishes of Shillington and Holwell (*fig. 14*), which shows the farmstead at Lordship Farm with a building to the E adjoining the road to Pirton (presumably identifiable with the farmhouse) and two conjoined ranges of outbuildings to the W, aligned E-W and N-S, respectively, which appear to correspond to the listed barn and the curtilage listed barn, although admittedly the depiction is somewhat sketchy.
