**Walnut Tree Farmhouse  
Luffenhall  
Hertfordshire**

**Heritage Statement**

**July 2024**

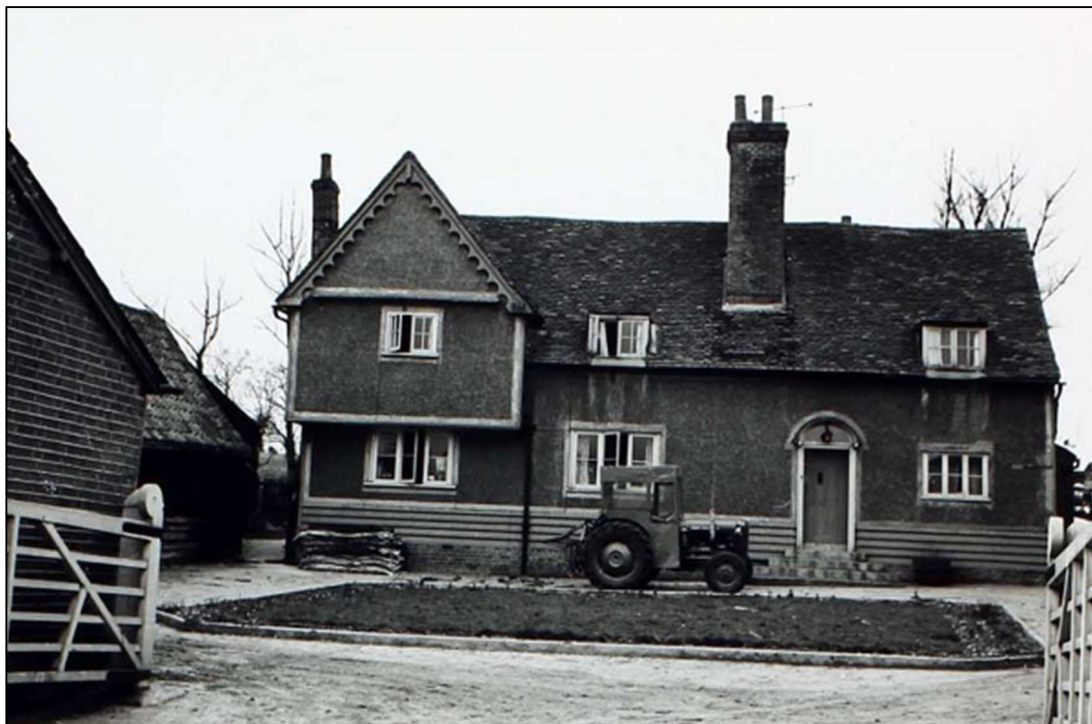
A photograph of Walnut Tree Farmhouse in 1959 (Fig. 6) shows it with roughcast render (un-painted) to the front elevation and various casement windows.

Figure 6. Walnut Tree Farm in c 1959 with roughcast render to the front elevation  
[https://historicengland.org.uk/images-books/photos/englands-places/card/202012?place=Luffenhall%2c+Hertfordshire+\(Place\)&terms=Luffenhall&searchtype=englandsplaces&i=-1&wm=1&bc=2%7c3&g=5683](https://historicengland.org.uk/images-books/photos/englands-places/card/202012?place=Luffenhall%2c+Hertfordshire+(Place)&terms=Luffenhall&searchtype=englandsplaces&i=-1&wm=1&bc=2%7c3&g=5683)

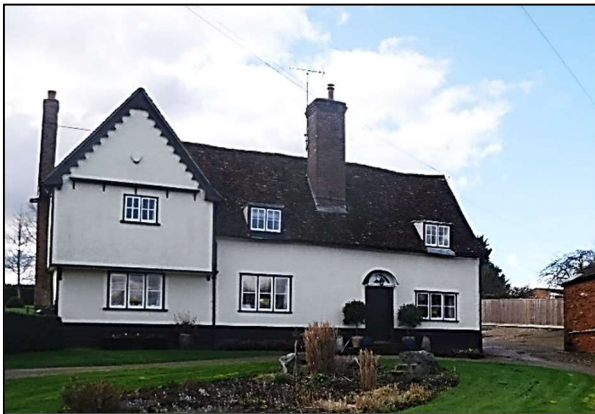
The farmhouse is a low two storey building set on a weatherboarded plinth given prominence by its position on the hill side. The elevations are painted rough cast for the late medieval range front range and jettied cross wing, with the exception of the north elevation which has an eighteenth-century chequered brick ground floor. The rear wing has a modern brick ground floor and rendered first floor where visible. On the south elevation the area from the stack to the late medieval range has a paler pink/yellow brick around the French windows.

The roofs are plain clay tiled pitched roofs with various chimney stacks, including a large stack within the front roof slope (rebuilt in the nineteenth century). All the windows are timber casements, the front elevation has larger split pane triple casements at ground floor level and smaller 4-pane casements at first floor. There are similar windows to the flank and rear elevations. The windows to the main front range look to be nineteenth or early twentieth century in date.

Figure 7. Walnut Tree Farmhouse, east (front) elevation

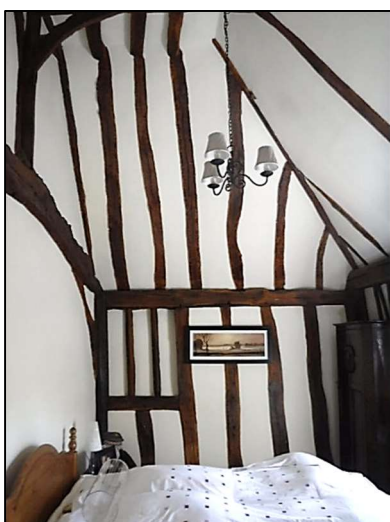
The heavy timber framing of the original fifteenth / sixteenth century front / east range is visible internally. Of note is a post in the RCHME text describing the surviving principal post supporting the open truss of the original hall. The roof has clasped purlins and the rafters are blackened. The first-floor room of the crosswing has been subdivided but is still open and has a cambered tie beam supporting the crown post roof with high collar-purlin and thin two-way brace. The stairs in the service wing are in their original position but are later and lead to the first-floor room with impressive framing, including curved wind bracing.

Figure 11. Timber frame to cross wing, first floor

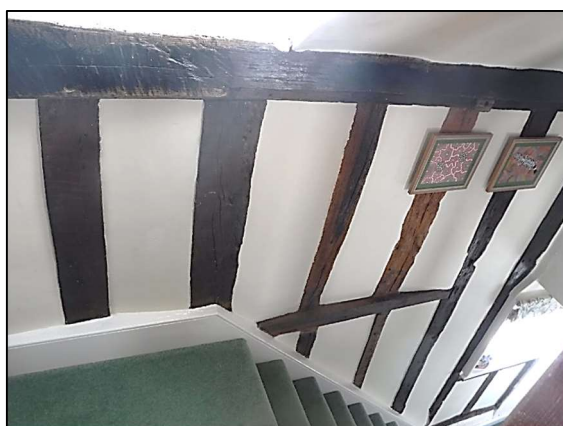
Figure 12. Timber frame to rear wall of front range

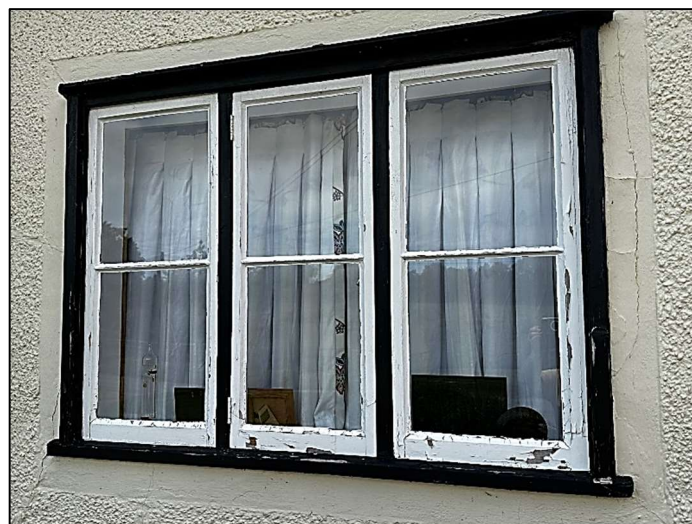
The windows are generally in poor condition, and the majority have rotted, particularly to the bottom parts of the windows which are most exposed and where moisture collects. Many of the window cills are also rotten and beyond repair. For a more detailed report on the condition of the windows see the plans accompanying the application. Figures 14 to 17 show examples of the poor condition of the windows. Figure 18 shows that water is penetrating the interior and collecting on the window ledge.

Figure 14. Window 2 (front elevation, ground floor centre).  
Peeling paint and rot to bottom part of window

The windows are all to be replaced on a like-for-like basis in hardwood versions, painted white and incorporating slim profile double glazed units (comprising two 4mm panes with a 4mm air gap between).

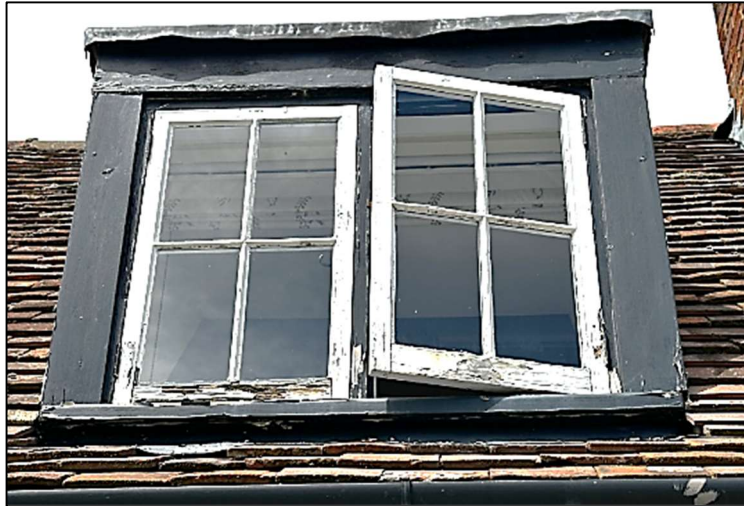
Figure 15. Rot to the base of window 12 (rear wing, south roof slope)

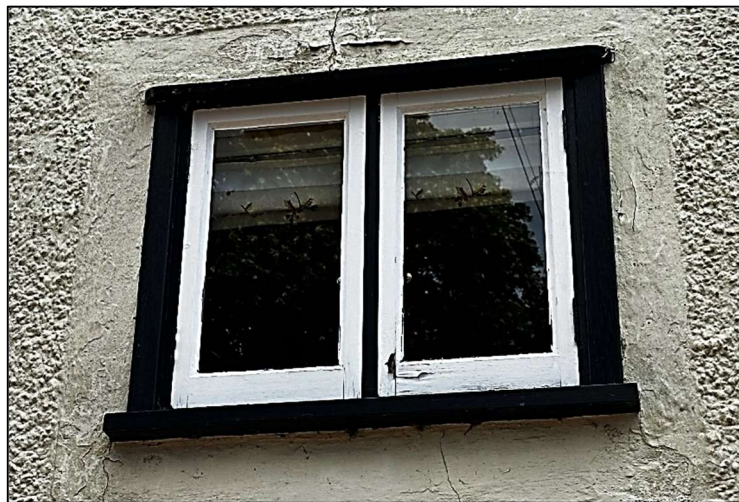
Figure 16. Window 20 (north gable end of main range, 1<sup>st</sup> floor).  
Rot to base of window next to joint.

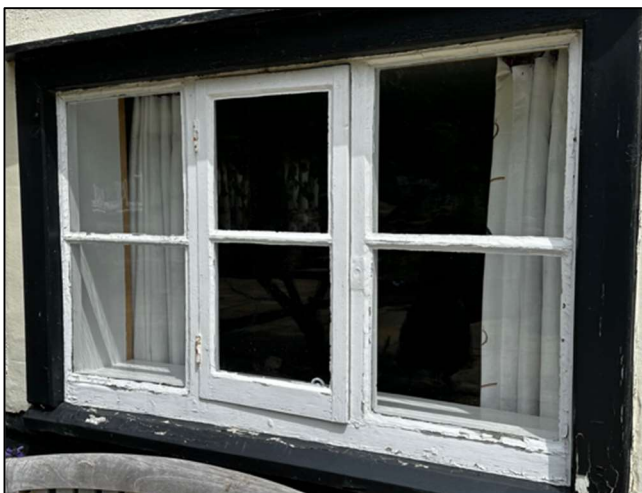
Figure 17. Window 5, south gable end of front range.  
Rot to base of window.

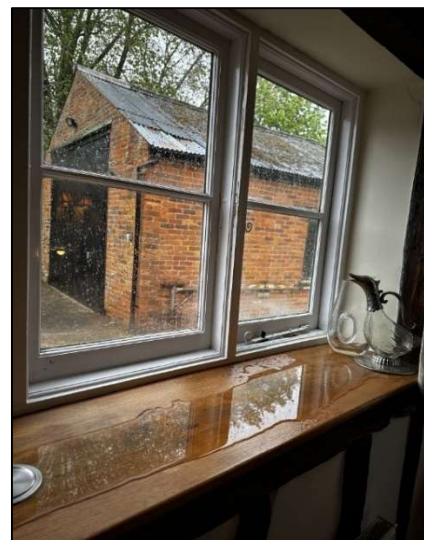
Figure 18. Window 4. Water ingress sitting on  
window ledge
