## Julians Park, Rushden, Buntingford, Herts. SG9 0TD.

Historic building recording and analysis of the House. Recorded 08 05 2024.

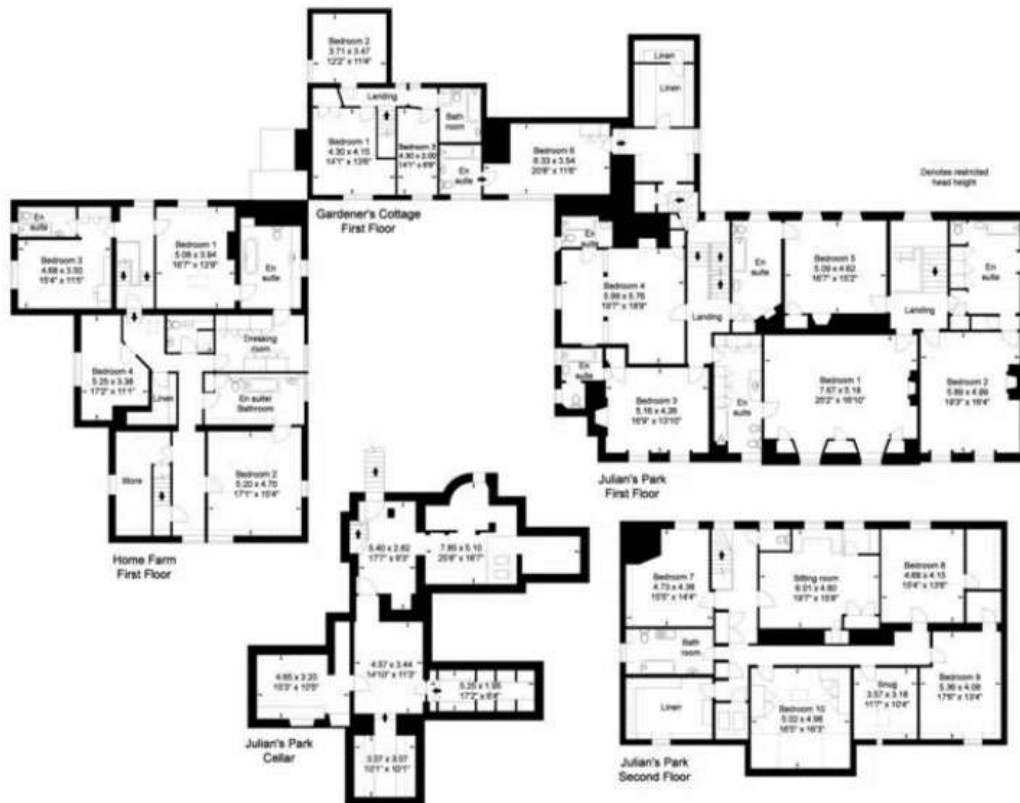
**2021 Sales Catalogue. Plans of the First and Second Floors with the Cellars.**

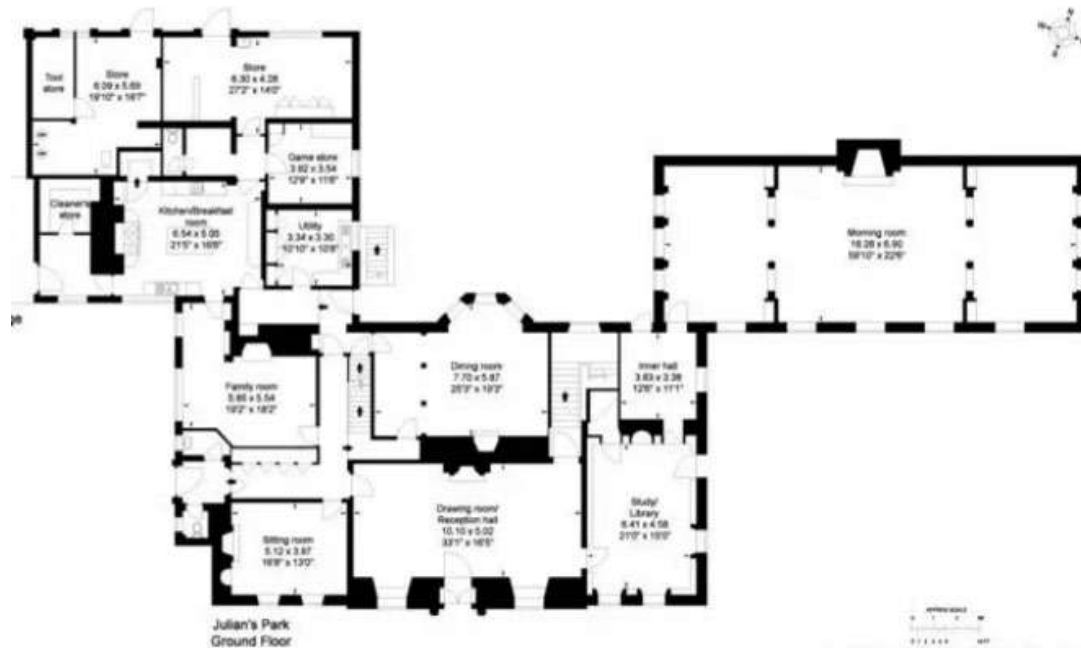
**2021 Sales Catalogue. Plans of the Ground Floor.**

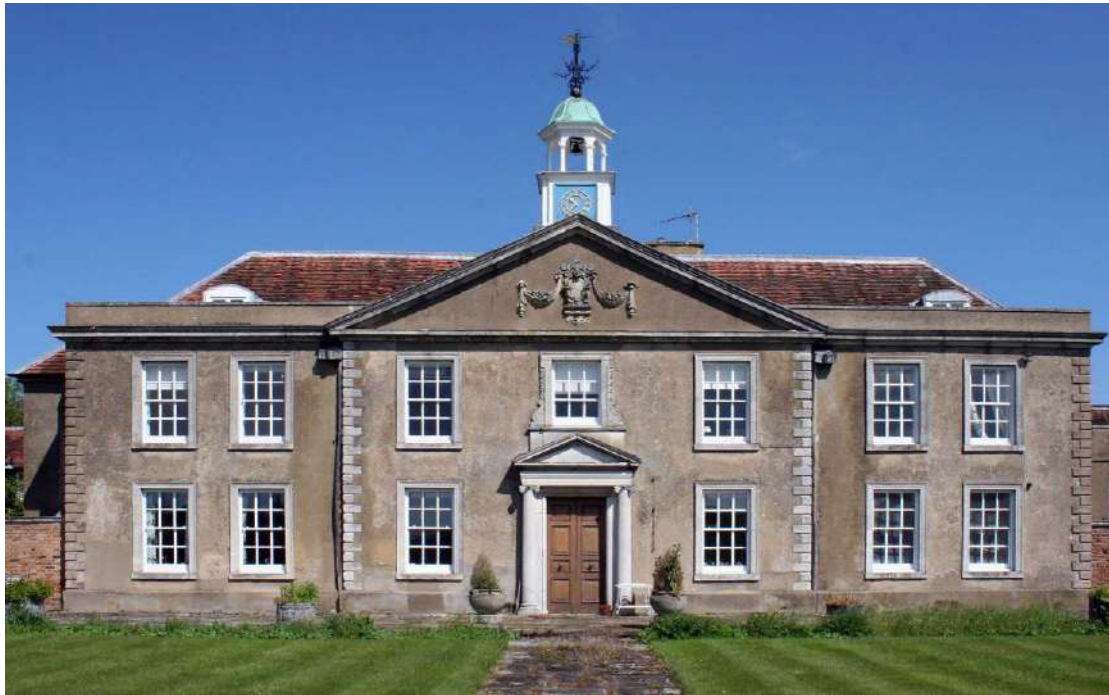
BJHC 26 05 2023. South elevation of the House.

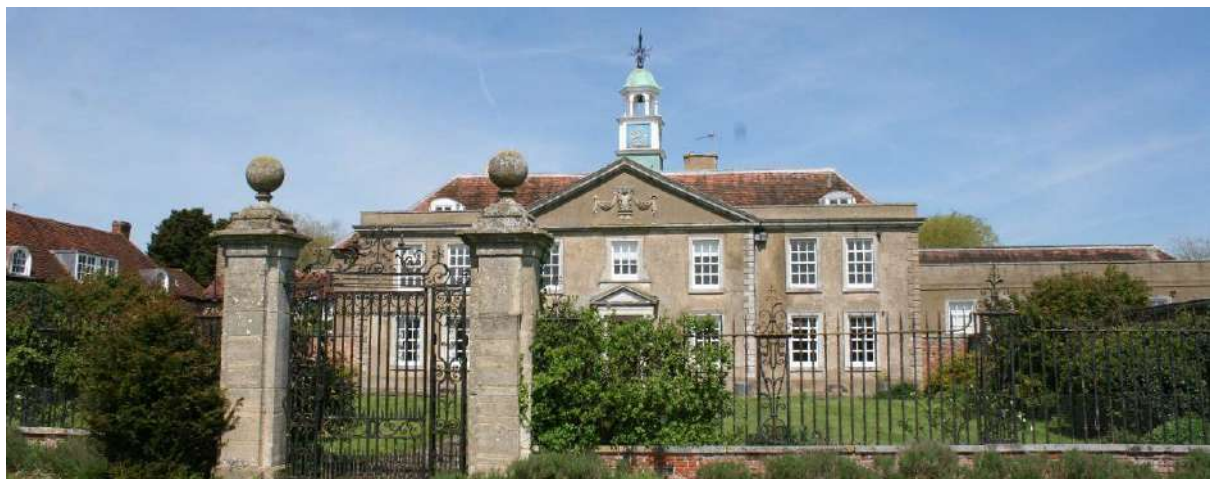
BJHC. 08 05 2024. Entrance gates and clair-voie

RUSHDEN JULIANS TL 33 SW 7/26 Forecourt Walls, Entrance Gates and Claire-Voie immediately S of Julians GV II Forecourt walls, entrance gates and clair-voie to Julians (q.v.). 1937-9 for Col. R. Cooper. Red brick walls about 2m in height with moulded Portland stone coping extend away from house with a low stone coped brick plinth to wrought iron clair-voie facing house. Quadrant spur walls away from far angles. Flanking side gates, entrance gate, at far angles and terminating spurs are ashlar piers, rebated corners except to side gate piers which are panelled, moulded caps and bases, ball finials to side and entrance gate piers, urn finials at ends. (Country Life, 20/6 and 4/7/47). Listing NGR: TL3079232503

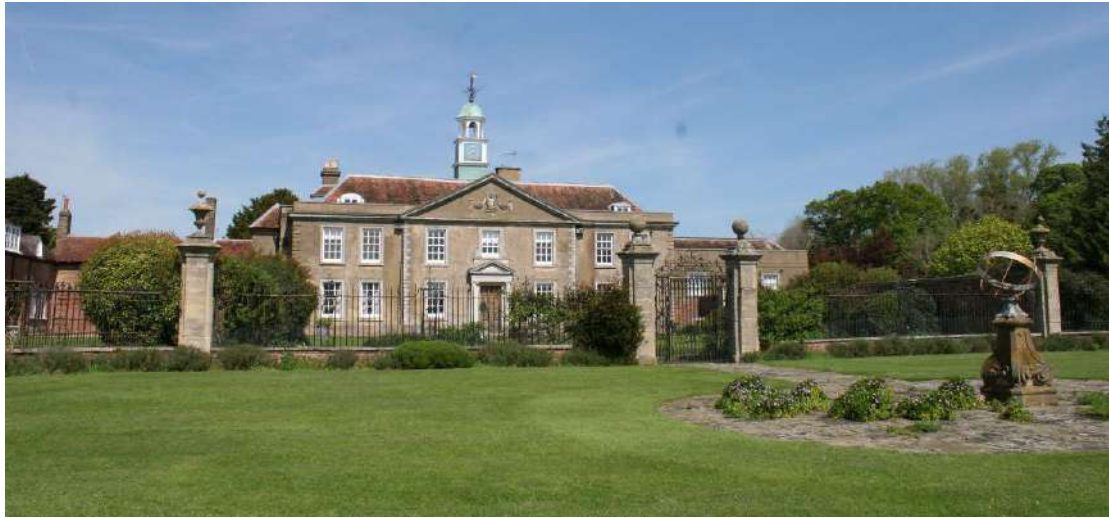
The south elevation from the terrace.

The south elevation has been rendered in a hard lime based cement and the Listed description notes that this was carried out in 1939. There are large sections of subsequent repair using a harder cement that is more deeply ruled to resemble stone blocks. There is a handsome central doorcase which is not shown on the 1826 (1699) engraving.

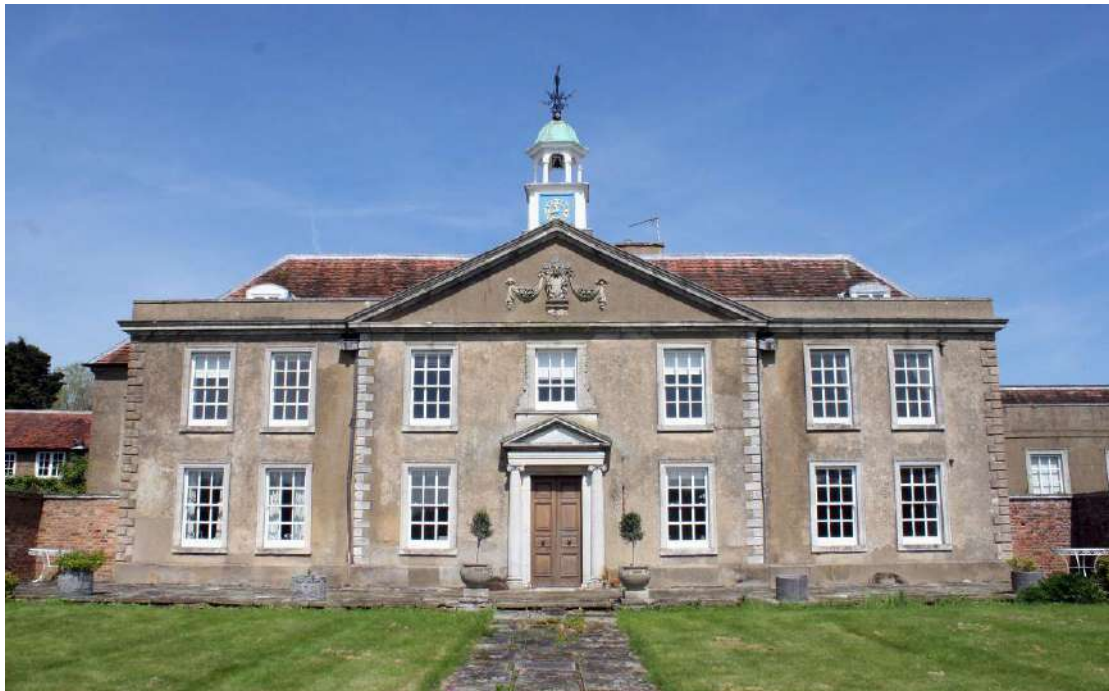
The south elevation from the gates.

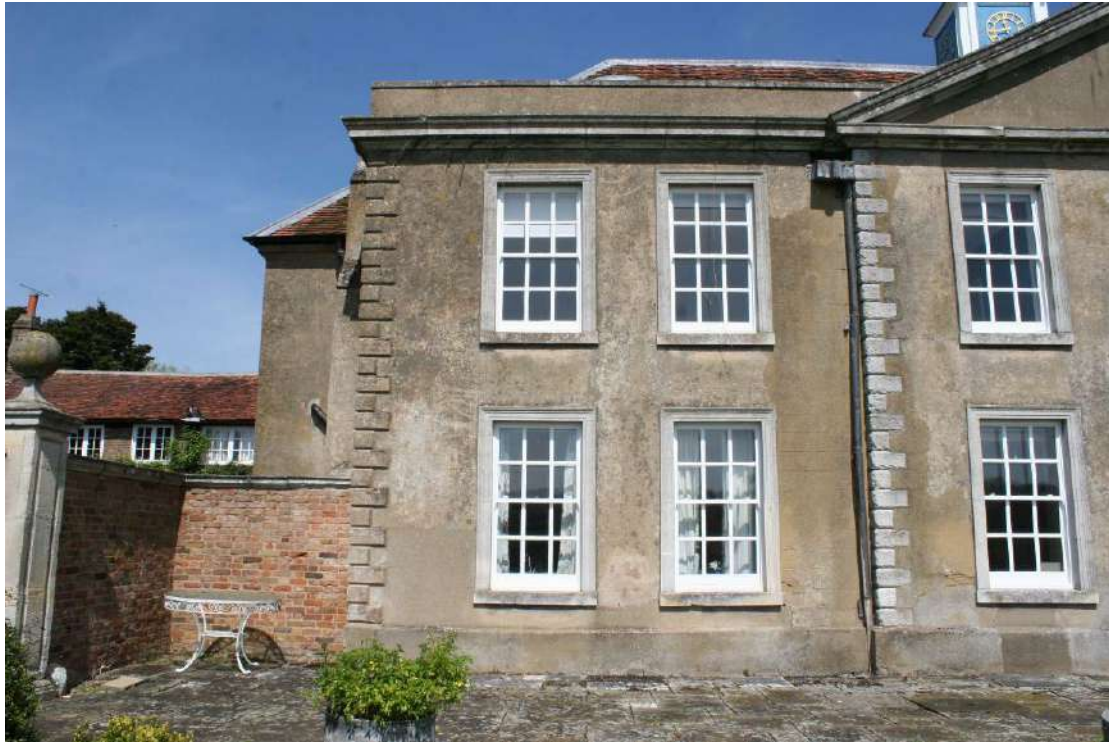
Detail of the west half for the south elevation.

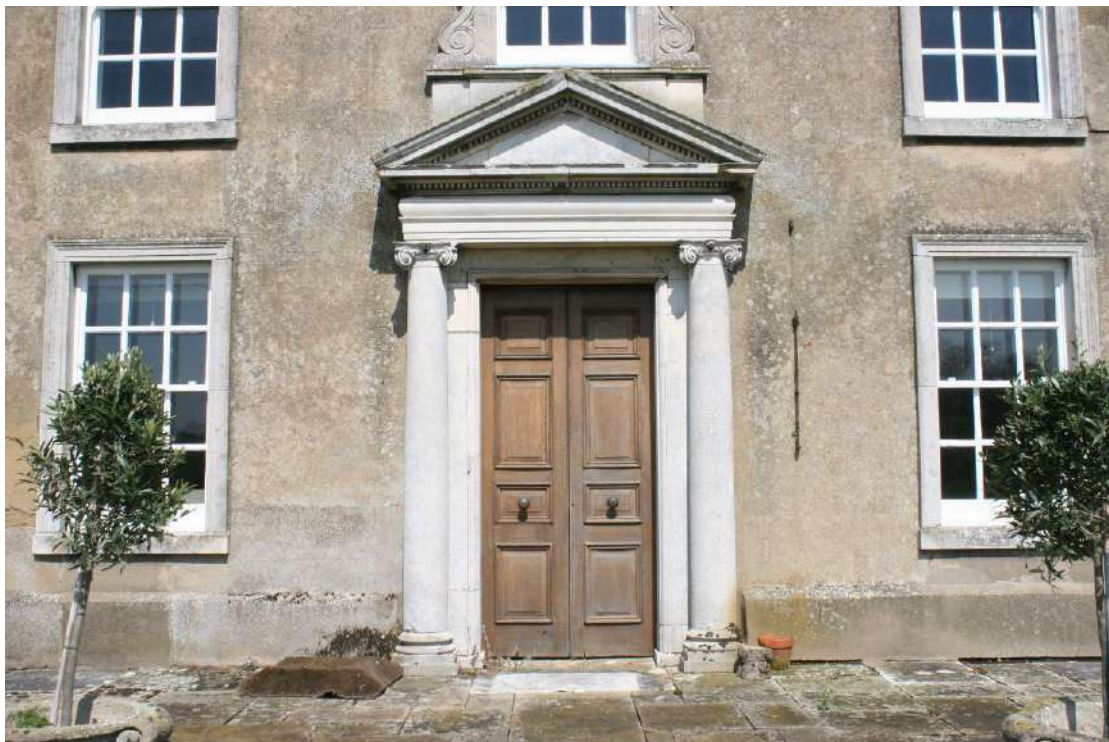
Detail of the entrance porch south elevation.

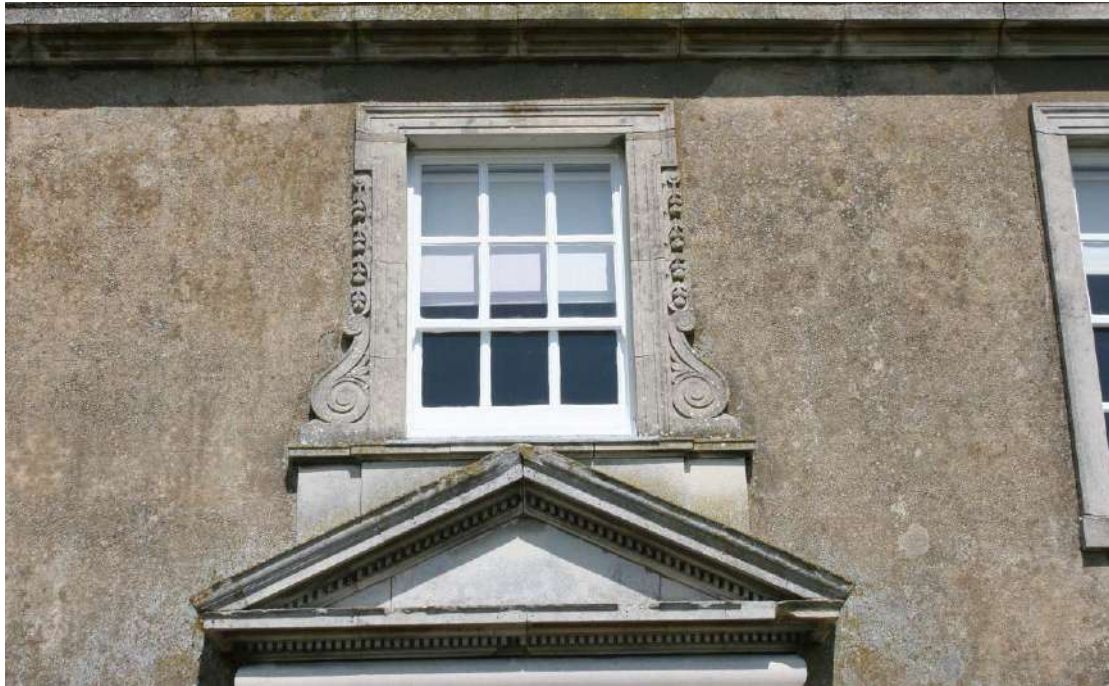
Detail of the horned sash window above the porch.

All the windows have simple horns (joggles) in Victorian style and clear window panes. Contrary to the Listing description, the crispness of the joinery and clarity of the glass show that all the windows were replaced as part of the 1939 works. The window surrounds and decorative quoins and other elements are also very crisp and were added by Cooper as stated in the 1947 Country Life article.

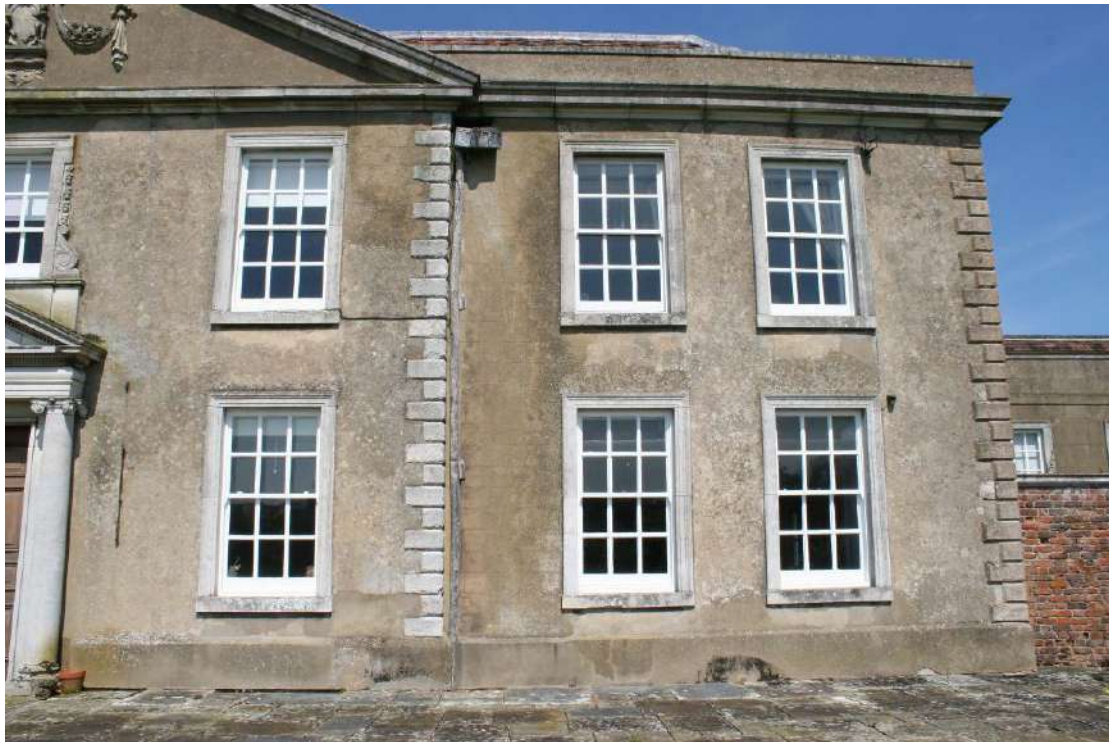
Detail of the eastern half of the south elevation.

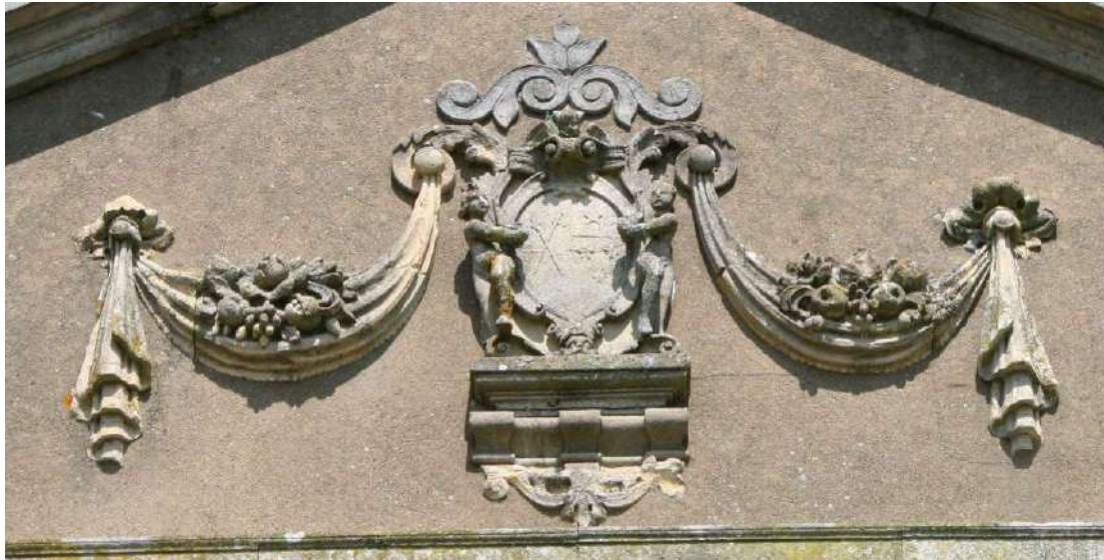
Detail of the Meetkerke coat of arms with crossed swords.

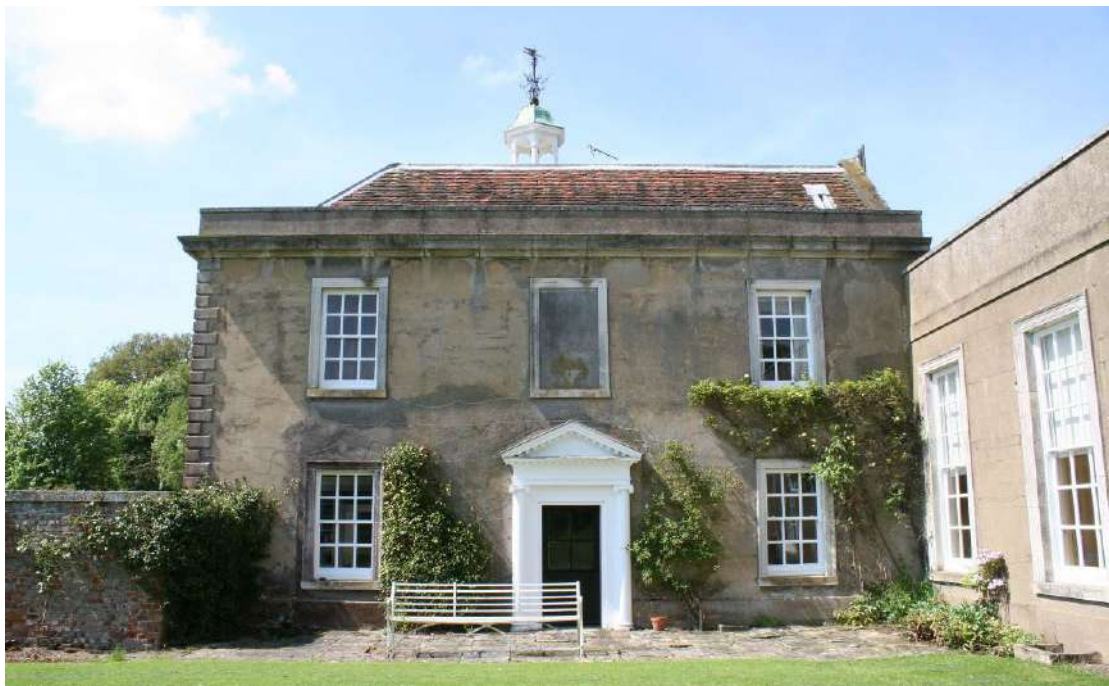
The east elevation of the House. To the RHS is the 1939 Music Room.

The east elevation is set out as a symmetrical facade about a timber doorcase with doric columns and an open tympanum decorated with modillions. Above is a blanked off window as part of the 1939 works to suit changes inside. The sash windows and half glazed door are all 1939 replacements. The render is patchy and in poor condition with large cracks under the cornice which also shows signs of opening joints.

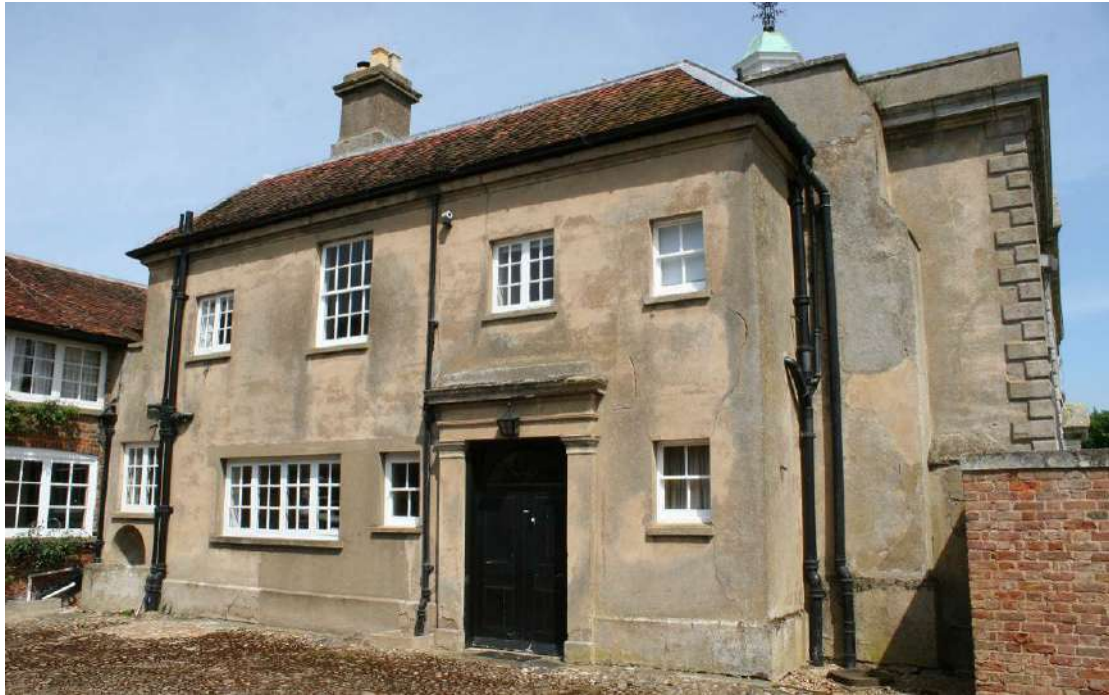
The west elevation.

The west elevation has the service wing and this is of a much lower hierarchy than the south and east elevation as the symmetry is loose and has somewhat random fenestration. There is a wide stucco doorcase with flat pilasters which is either remade or a new feature from 1939. The flat hood above is heavily eroded and clearly older. The hard render has deep cracks that have been caused by the insertion of the lower windows which serve the WC's.

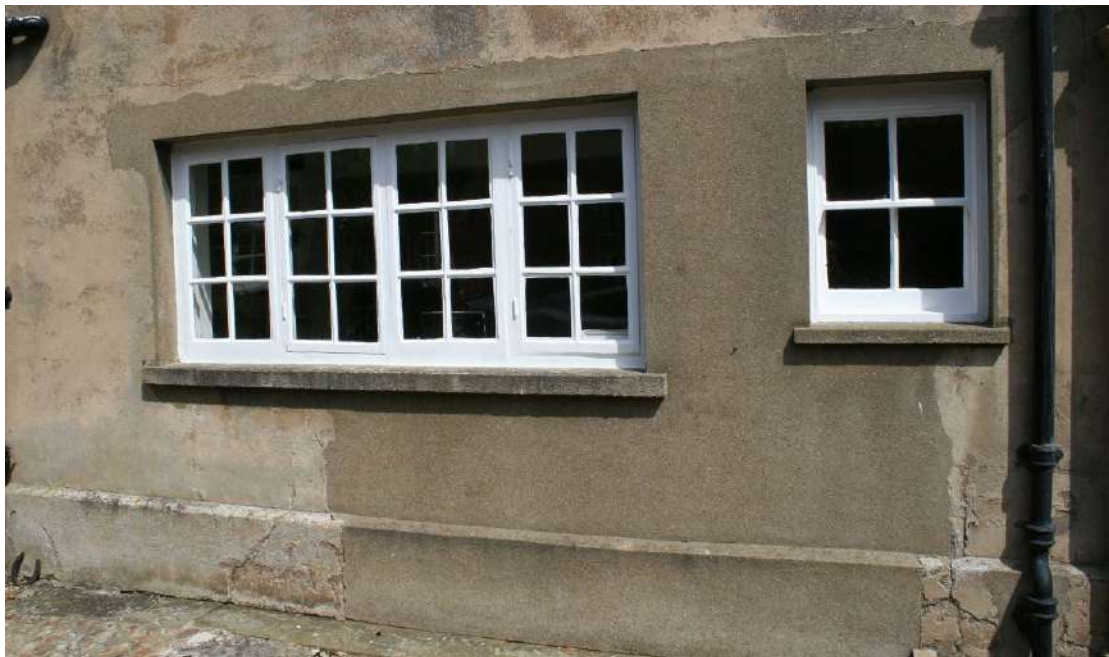
Modern repairs to the render on the ground floor.

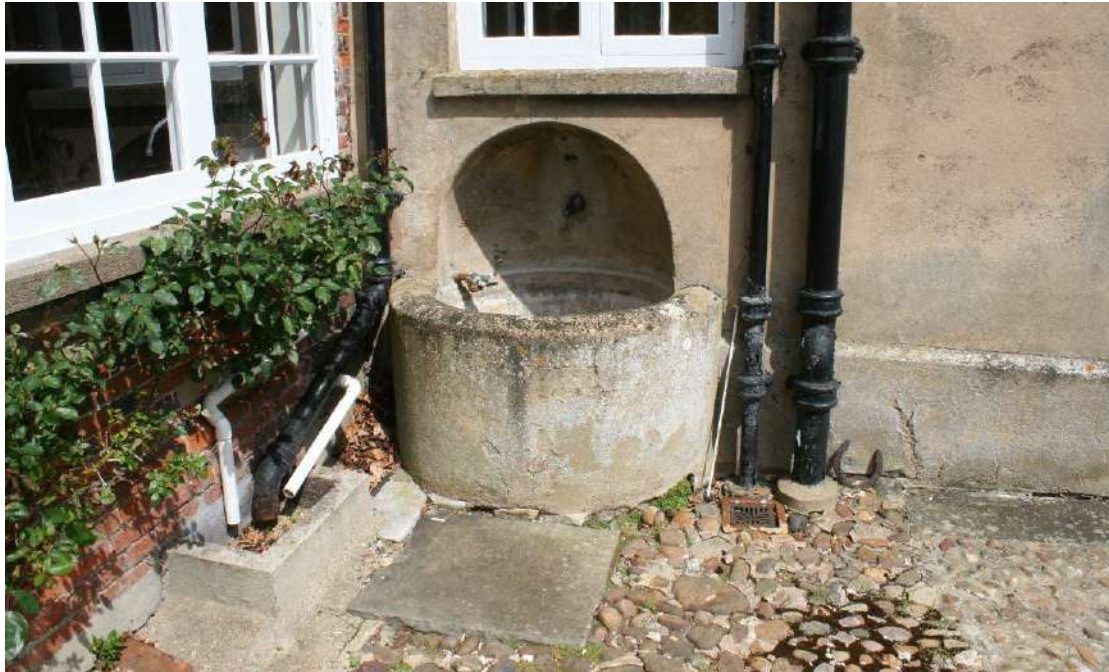
The water cistern on the west elevation.

An interesting feature is a water cistern set in the corner of the House with the Kitchen. It is fed by water pipes from the 1939 works and seen inside are the stopcocks connected to it. There is a modern style float valve but it has rotted away. As all the render is flush to the input pipes it can be inferred that this is a feature added in 1939. The yard is cobbled with several recent patch repairs and the service trenches for the drains and rainwater were cut through so it must predate the 1939 works and is probably Victorian.

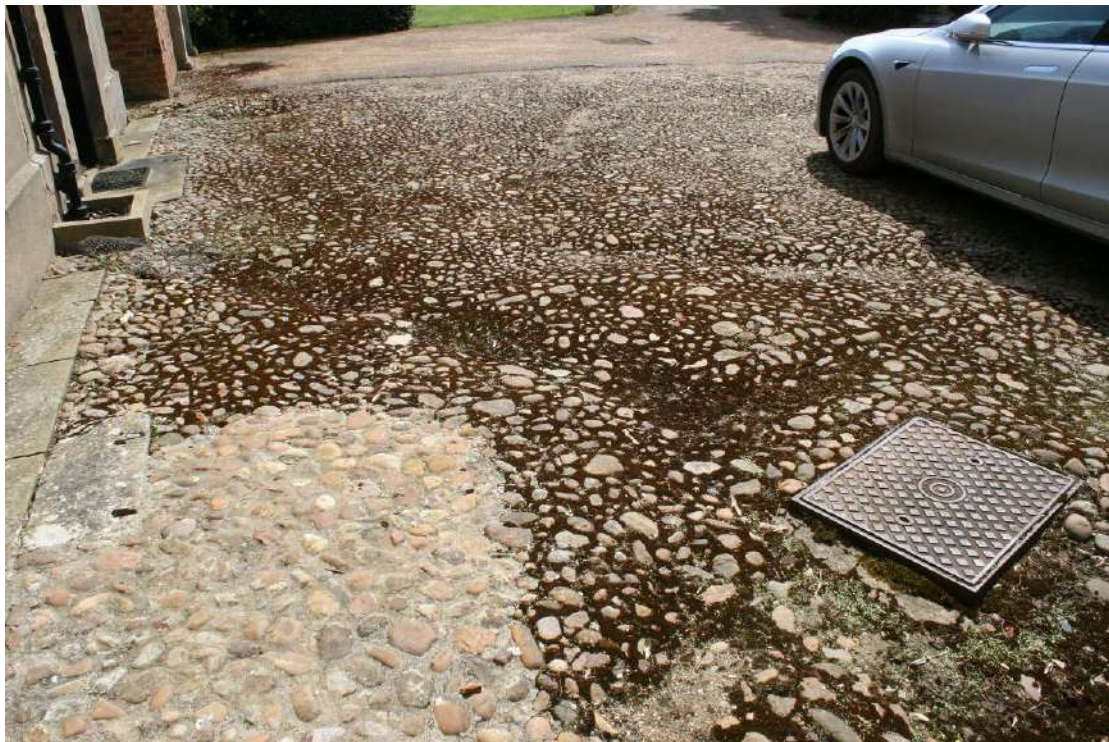
Cobbled surfaces with drainage trenches for MC20th drains.

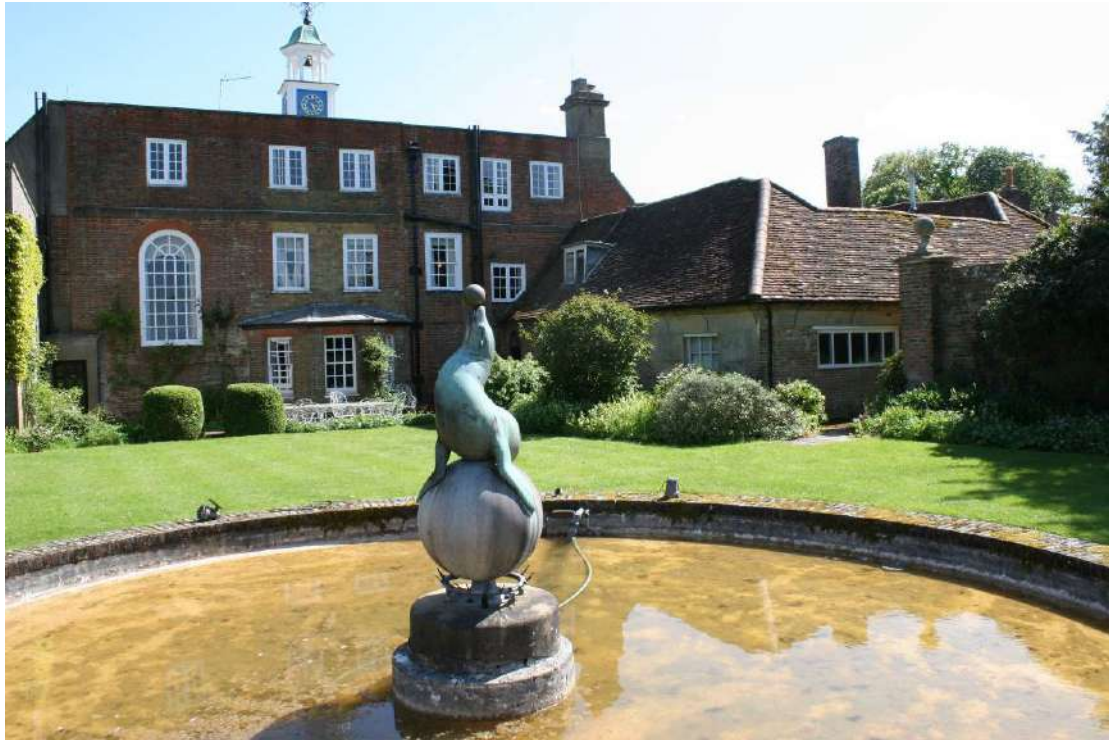
**The north elevation of the House.**

The north elevation has several phases of brickwork and altered fenestration. It can be seen that all the top floor windows have been replaced since the 1947 County Life photograph. Some of the discolouration of the brickwork can be attributed to the foliage now removed.

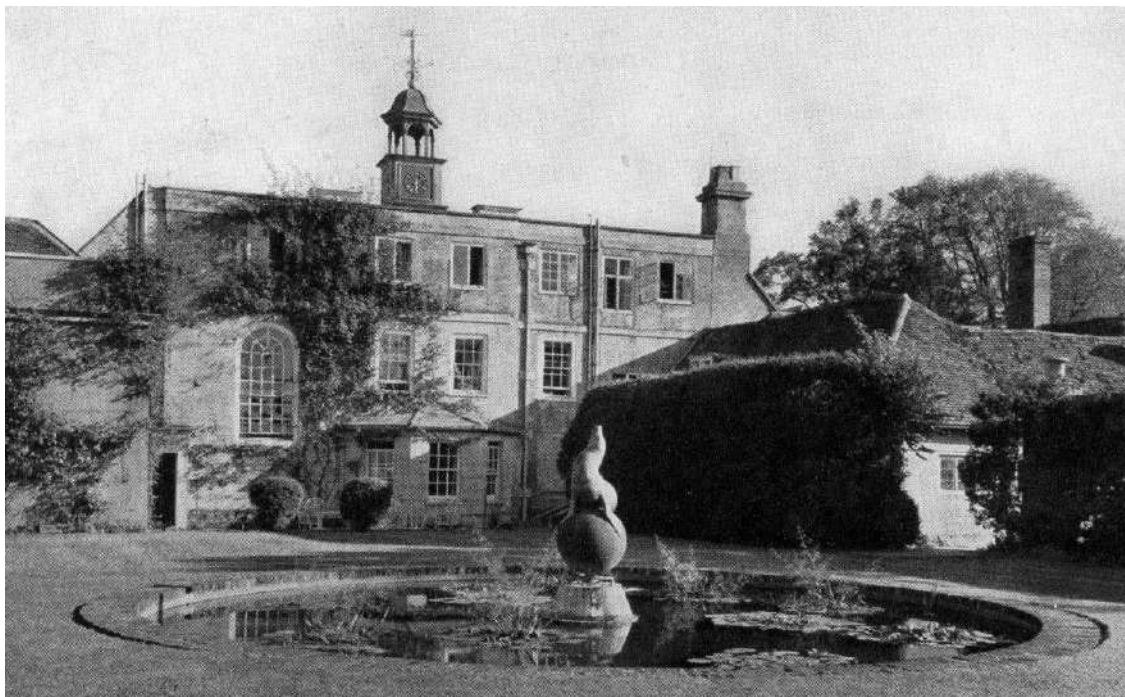
**1947 Country Life. North elevation.**

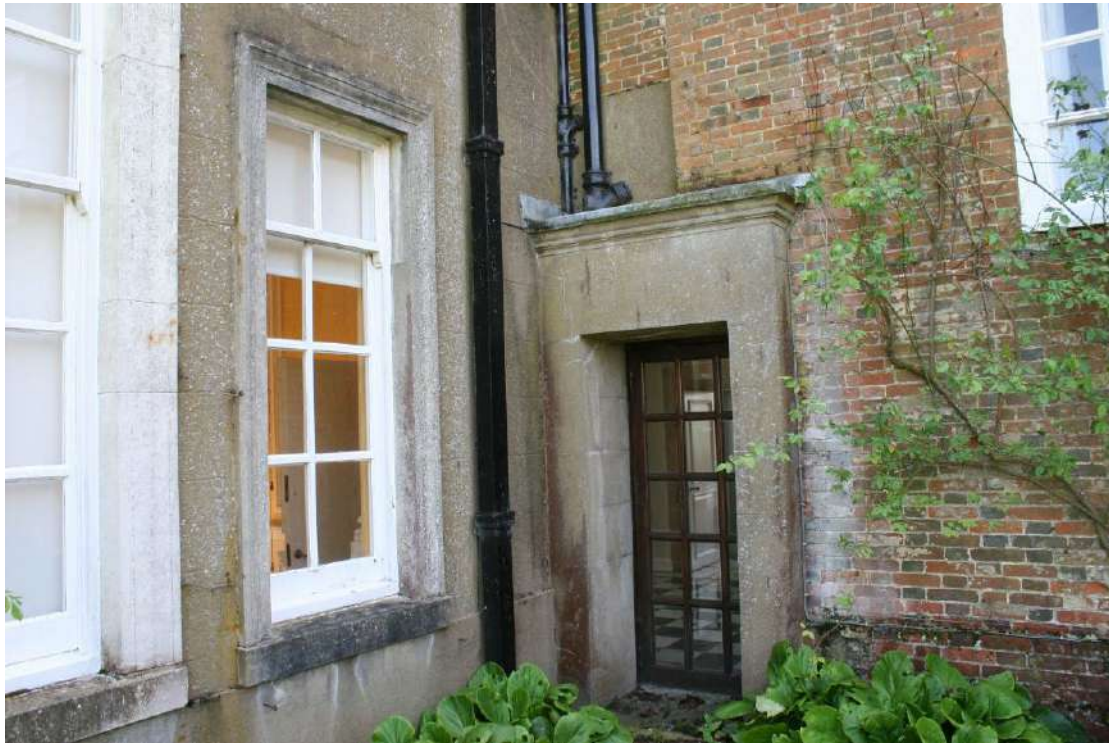
1939 inserted porch.

The large arch headed window lighting the main staircase matches the windows in the Music Room which was built by Col. R Cooper in 1939. The Country Life Magazine article notes that these windows were taken from Cothay Manor, Somerset where they were originally placed in an identical building erected in 1927. There is a small porch leading to an atrium that connects the house to the Music Room.

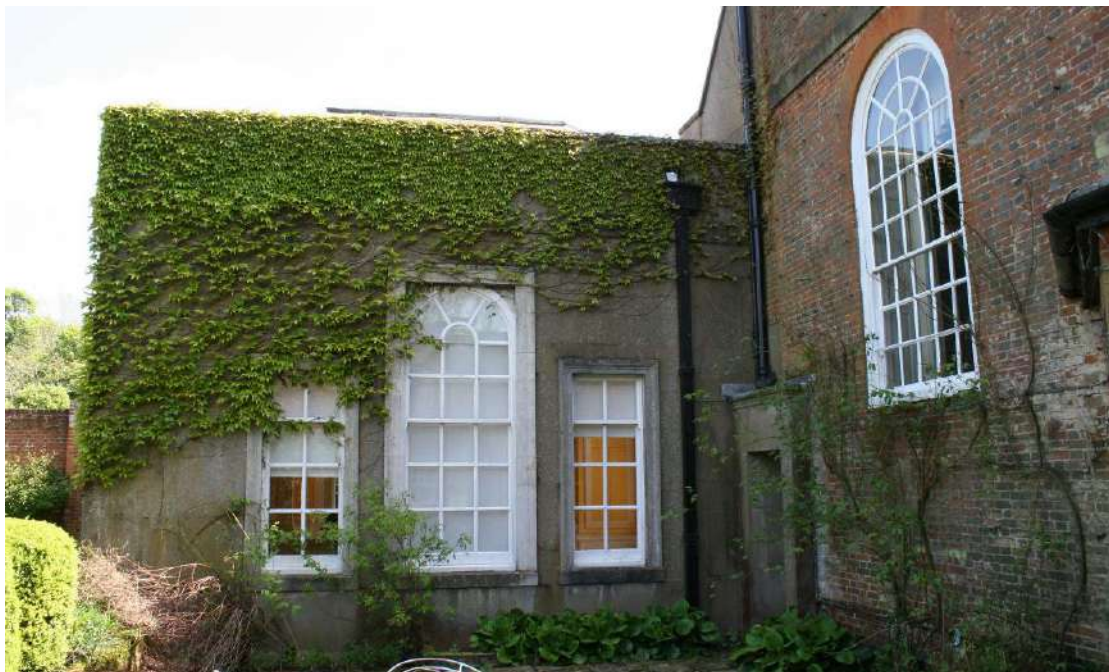
1939 inserted arch headed window is part of a suite used in the Music Room.

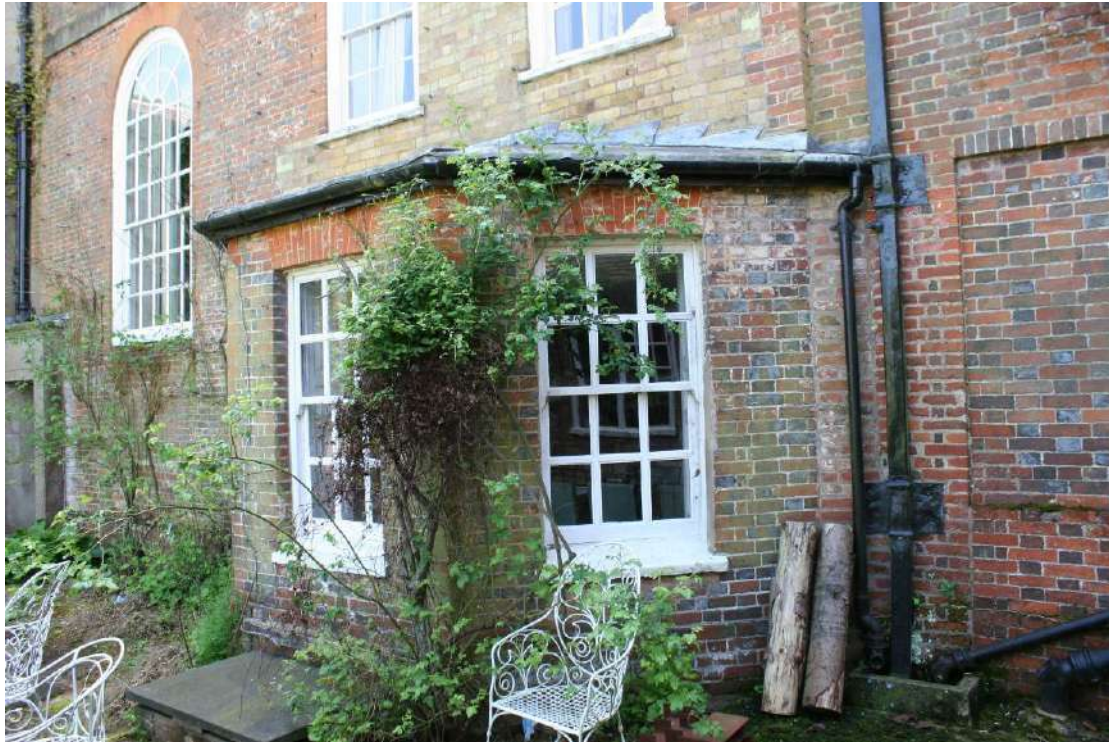
Victorian style canted bay window for the Dining Room. Note gault brickwork above.

There is a Victorian style canted bay window with C20th 6/6 horned sashes with modern float glass panes. Above is a large section of white gault brickwork which suggests there was a two storey structure here previously. Adjacent is a blocked doorway which was reduced to a window under a rowlock course lintel and then bricked up for the Dining Room wall.

Mapping shows the bay window in place by the time of the 1877 OS map. The 1838 Tithe Map shows a much larger footprint and the wall above the bay window has been clumsily remade with white gault bricks where a two storey tower has been removed. The interior panelling and shutters appear original to this period but the sash windows have been either very skilfully renovated or, more likely , replaced.

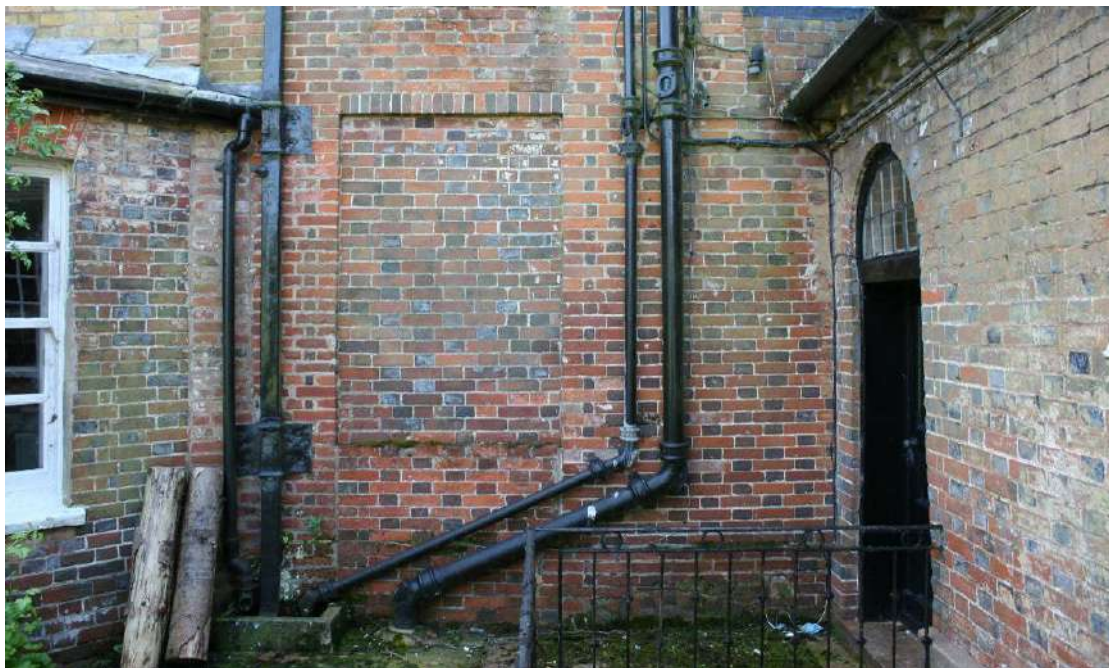
Doorway blanked off in two episodes, first to a window and now the Dining Room wall.

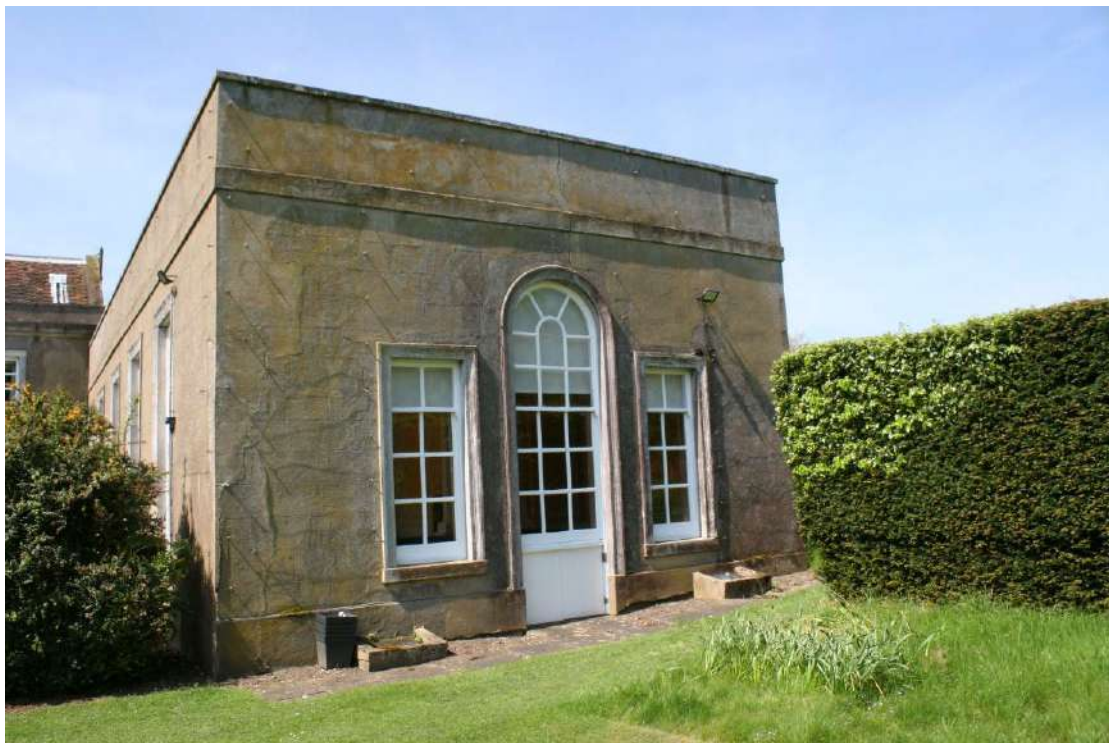
The east elevation.

The elevations are formed from Fletton brickwork coated with a thick cement based render which has suffered cracking and water ingress.

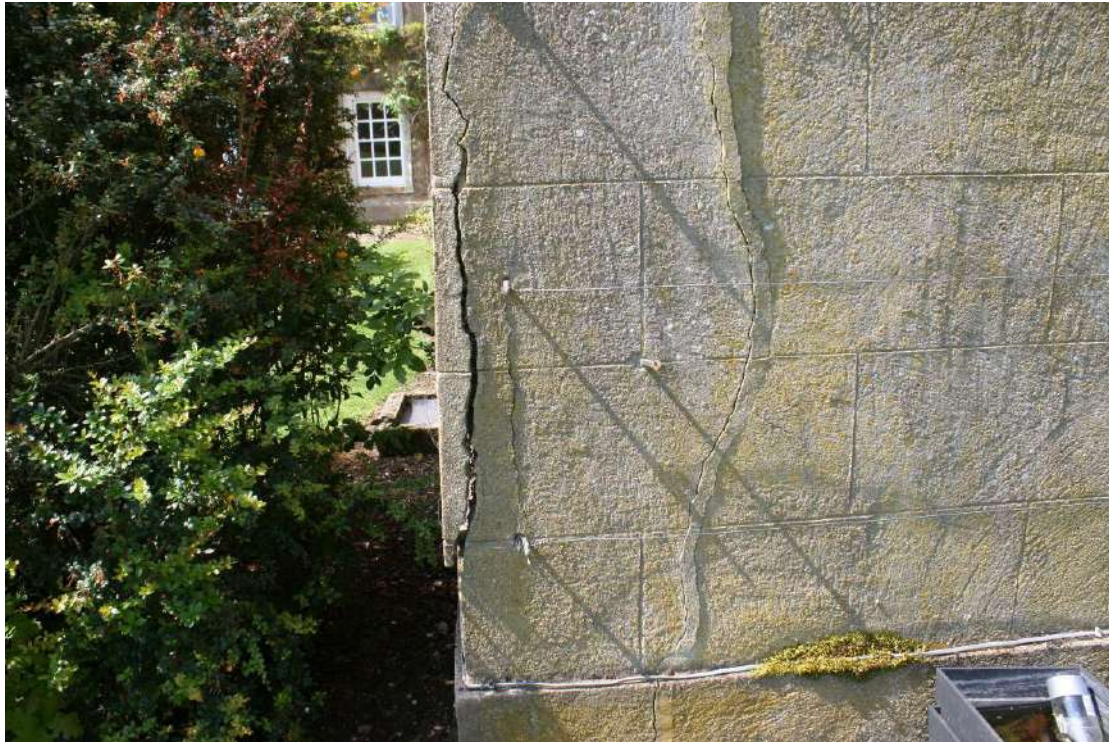
Detail of the render on the east elevation with serious cracks.

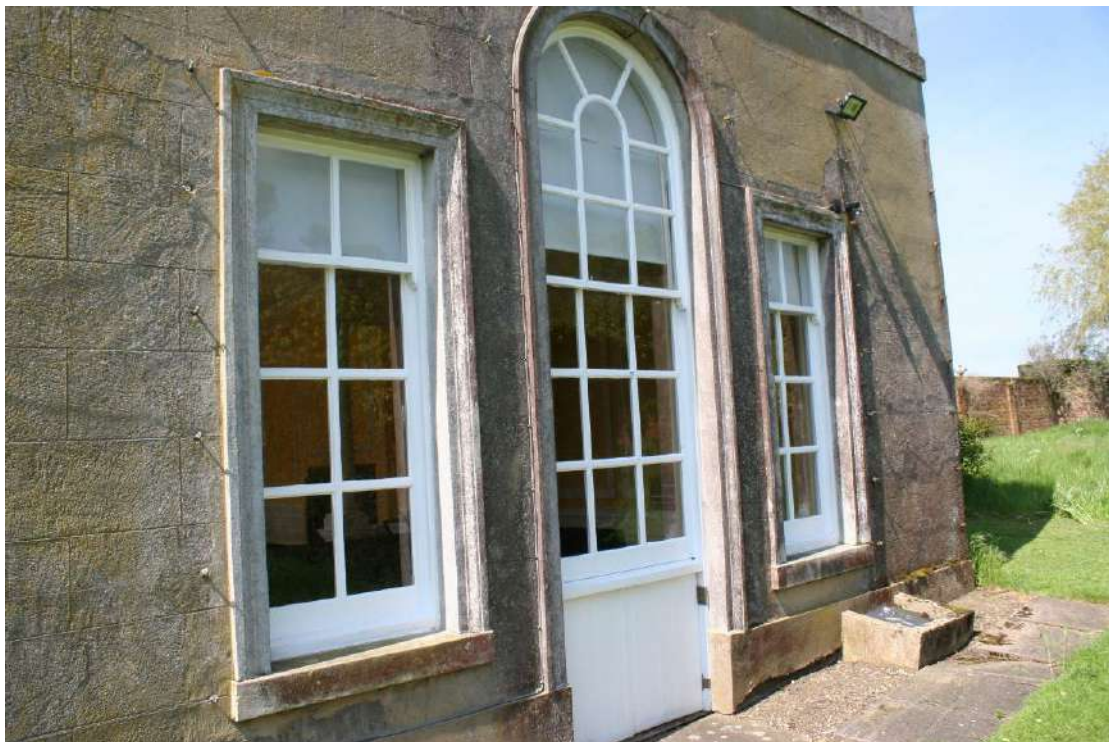
The windows and half door on the east elevation.

There is a long passage in the 1947 Country Life Magazine that details the history of the Music Room and its design and fabric. The windows and interior date from 1927 and were removed from the Music Room at Cothay Manor, Somerset when Col. R. Cooper sold it and the new owners converted it to bedrooms. See article following.

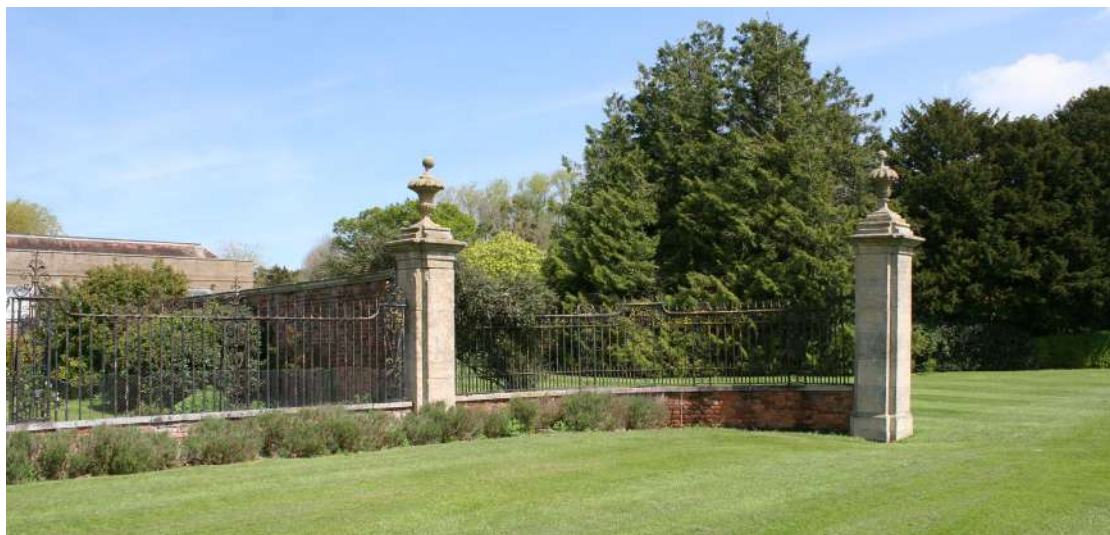
The added curved plinth, pillar and railings.

The forecourt railings have been extended to the east and west since 1947. The newer railings have extra horizontal bars and scrolls between each vertical railings.

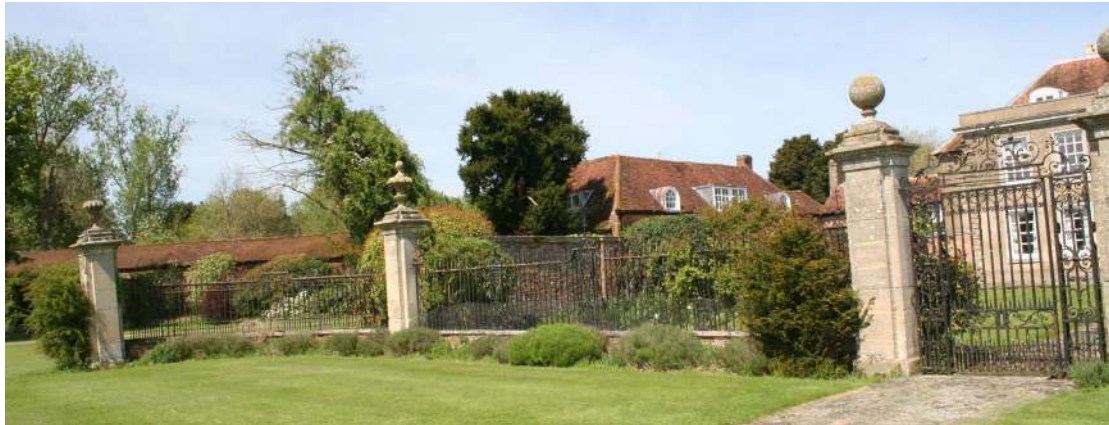
The west end of the railings with added curved section.

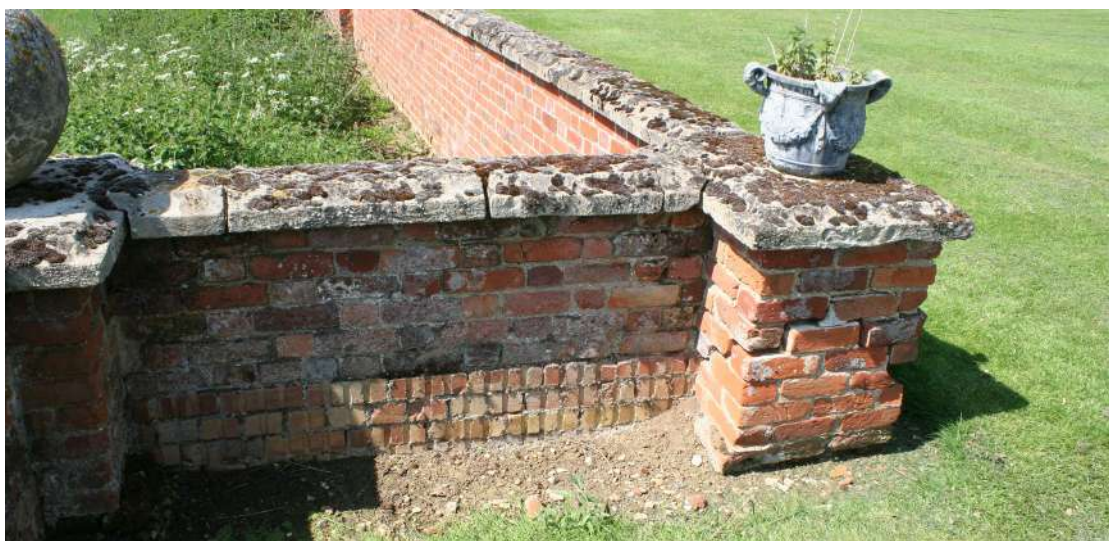
Detail of the Fletton brickwork.
