## Julians Park, Rushden, Buntingford, Herts. SG9 0TD.

Historic building recording and analysis of the House. Recorded 08 05 2024.

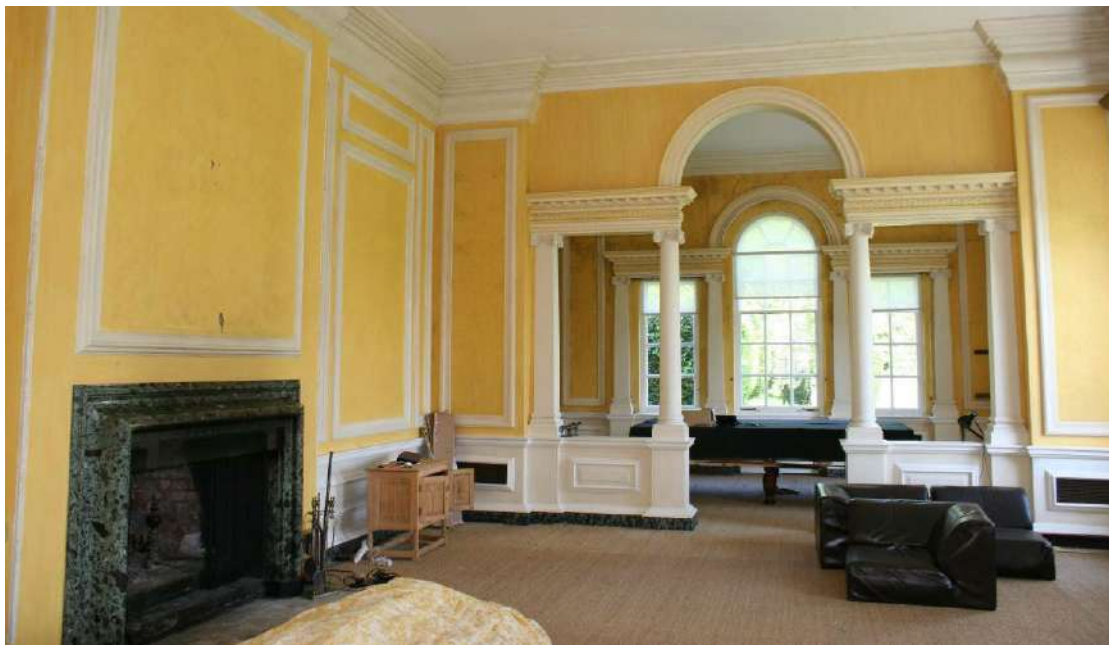
Looking E in the Music Room.

It is worth reviewing the Music Room because it sets the standard of décor and fabric for the rest of the House. As noted above the Music Room was built in 1939 using reclaimed materials from a building of 1927. All the panels are made from plywood and hardboard with machine made mouldings and the elegant columns are timber replicas of period styles with Ionic capitals with embellished volutes.

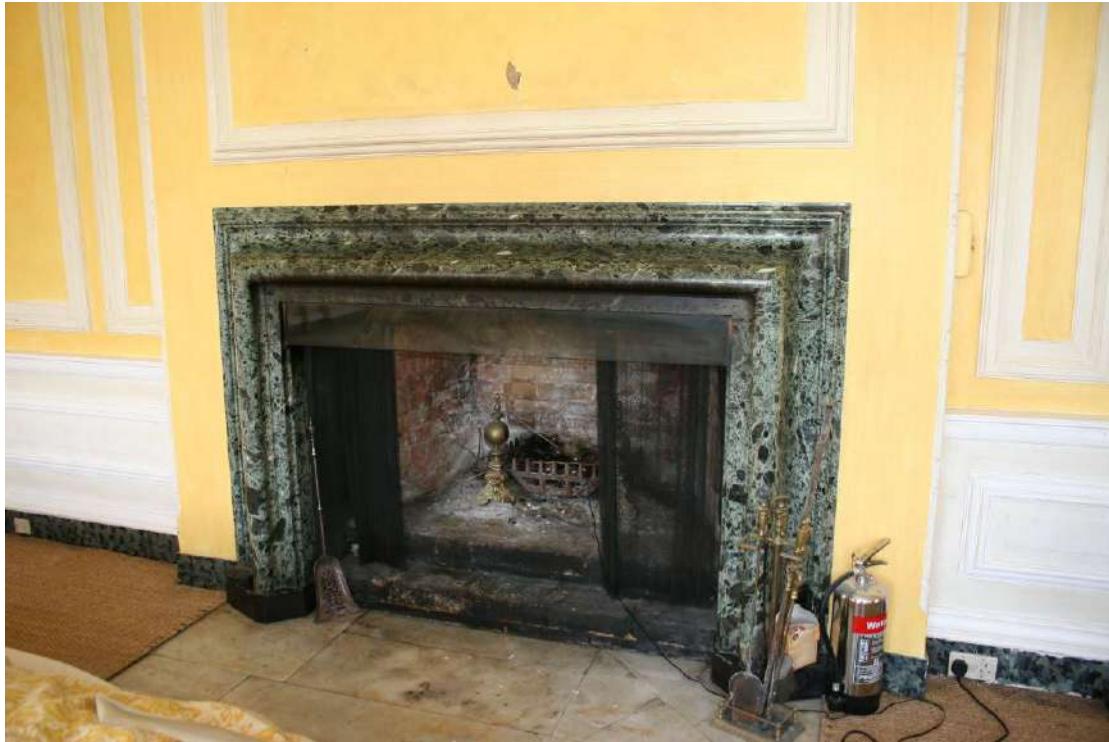
The green marble fire surround is a reclaimed piece.

The fireplace is noted in the 1947 Country Life Magazine article as having a carved overmantel with a full length Lely portrait which is now removed. Sir Peter Lely (1618 – 1680) was a Dutch painter famous for portraits. The room is outfitted with central heating which has outlet ducts built into the pedestals of the columns.

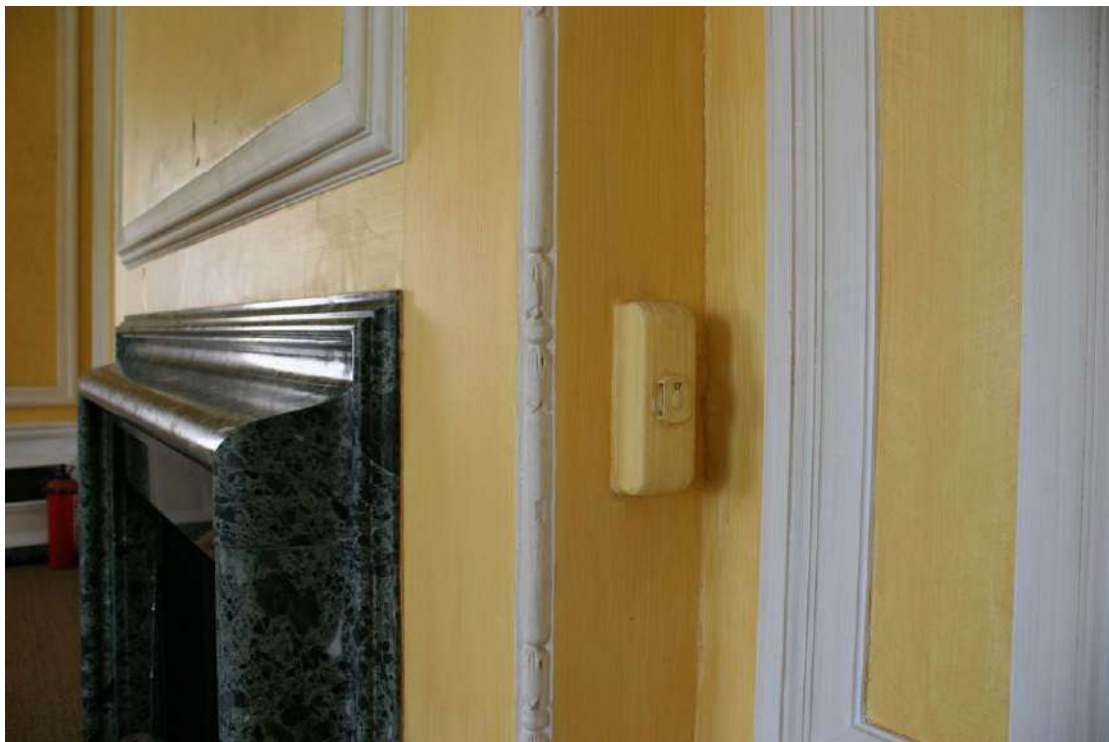
Detail of the fire surround, moulded beads and architraves. Central heating control.

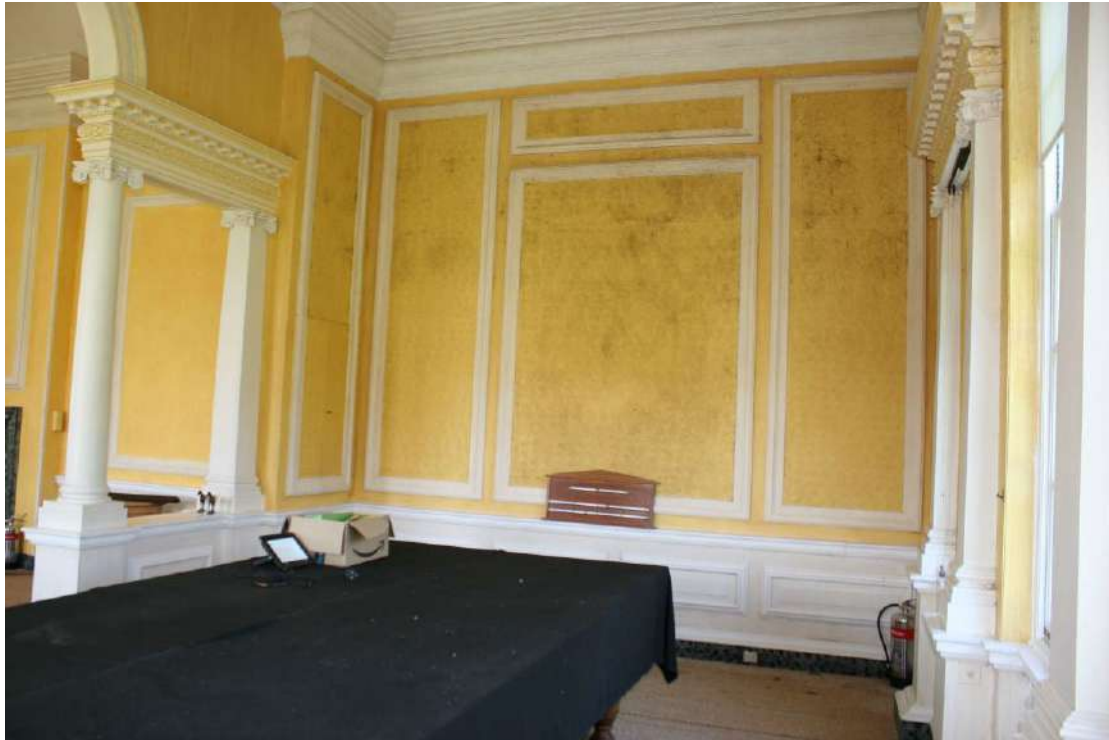
Looking NW in the Snooker Room.

The dividing partitions are hollow and are fitted with closets. At the east end the room is outfitted with a snooker table (rather than billiards) and the closets still contains the set of snooker balls. The score board and snooker cue rack are still on the walls. These are all LC20th fittings.

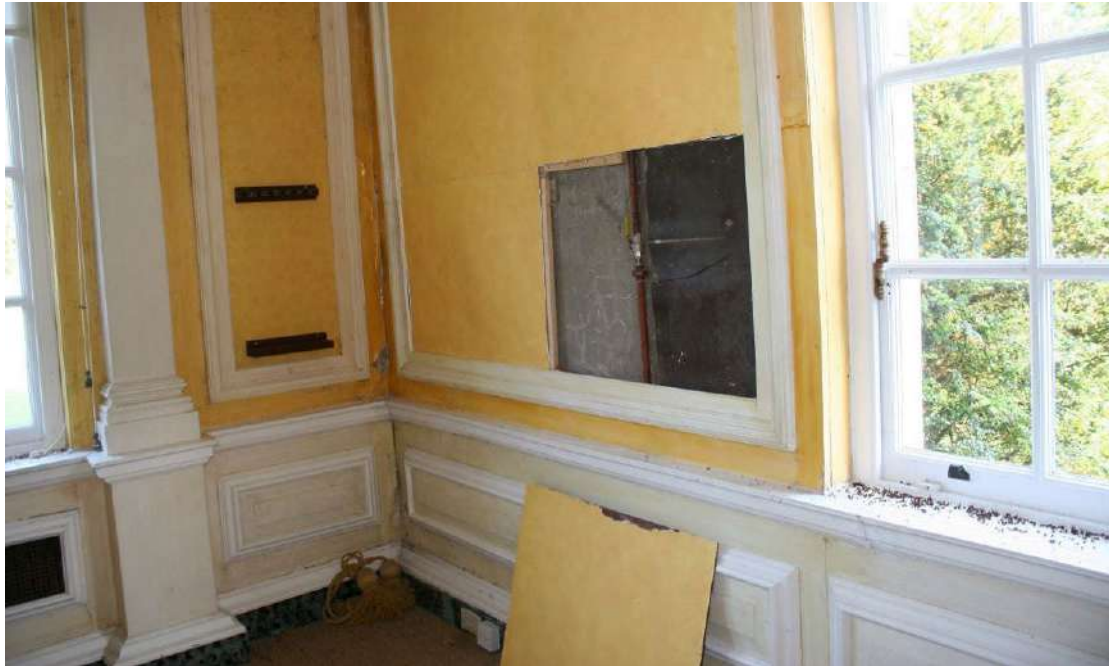
Removed panel in the SE corner.

The wall panels on the NW corner wall are loose due to the fixings failing from water ingress and a comprehensive renovation is require. There is a panel cut in the suspended pine floor for access to the services and the Fletton brick piers can be seen with typical vent holes along their length.

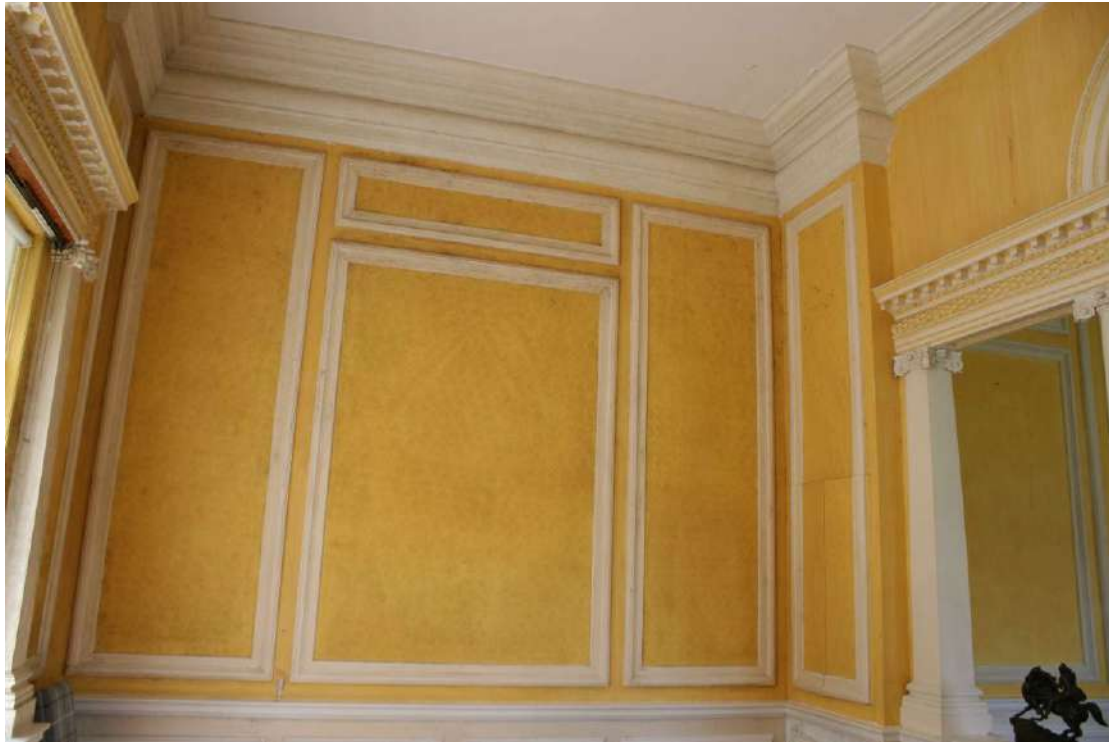
The wall panels on the NW corner wall looking N are loose.

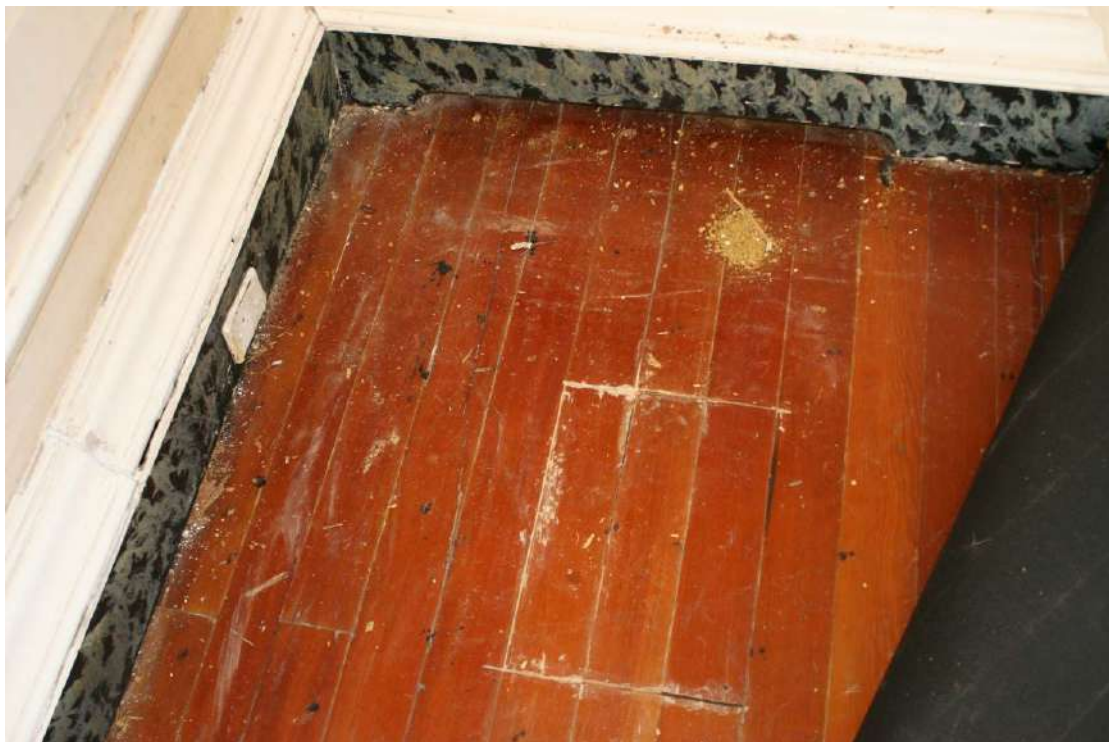
Detail of the suspended pine floor.

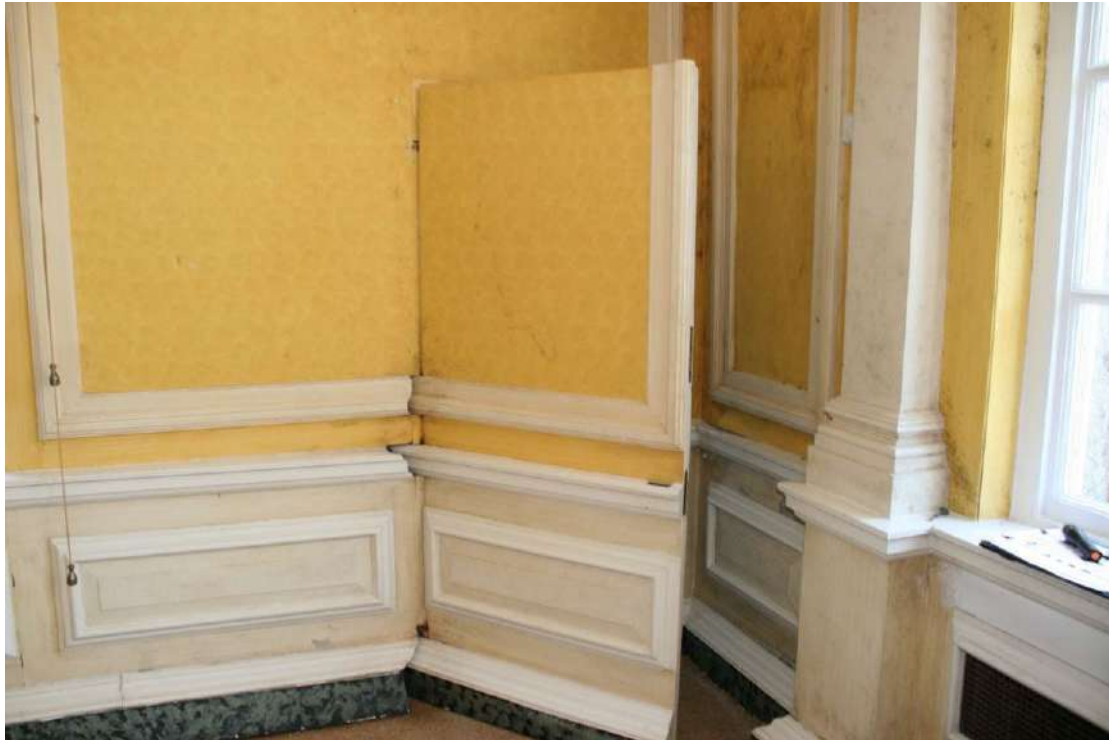
The entrance door is disguised as part of the panelling.

Features of interest are the corner door disguised as part of the panelling and water pipes concealed in the architraves, hollow walls and pelmets as part of the heating system. The House has an integrated water heating system with some interesting 1939 period radiators normally seen in industrial settings.

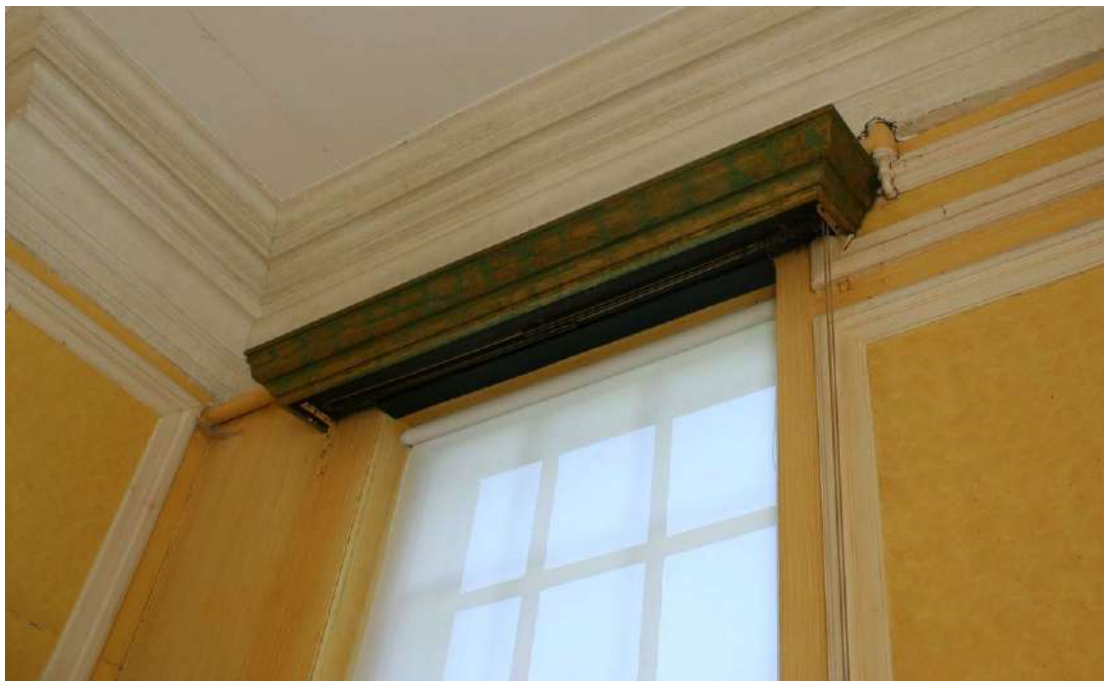
Water pipes concealed in the pelmet.

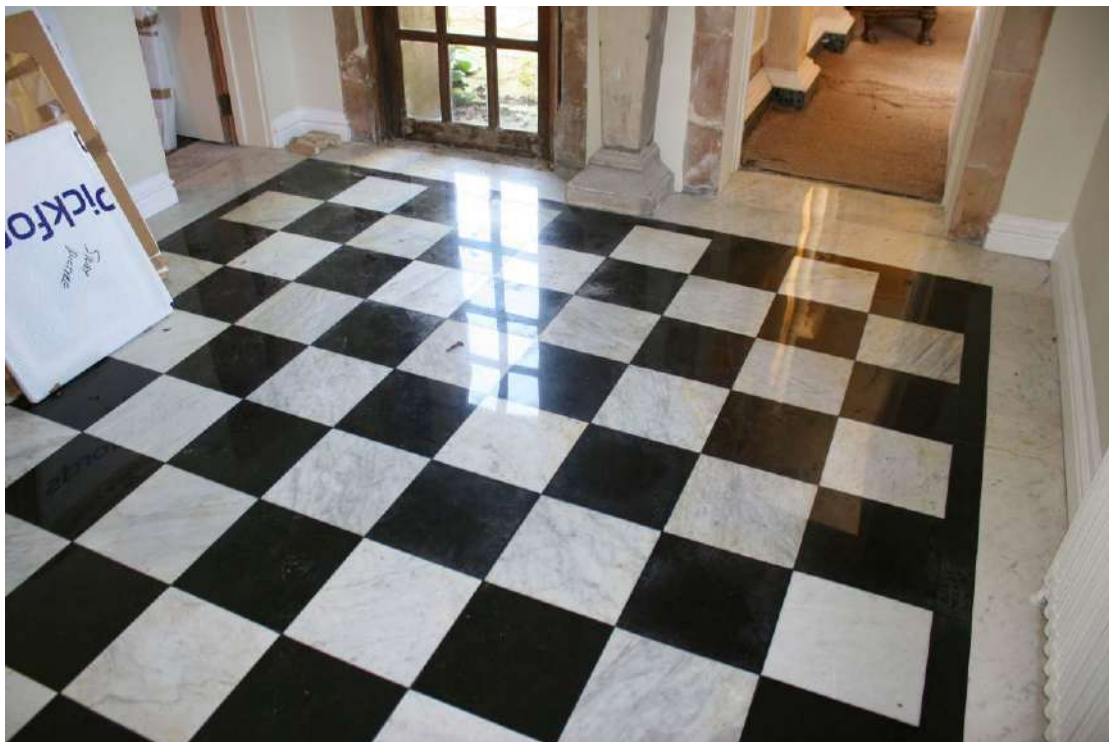
The marble tiled floor of the Atrium.

The Atrium was created in 1939 and has some reclaimed stone doorcases with open tympanum hoods. The beautiful marble floor has been recently restored.

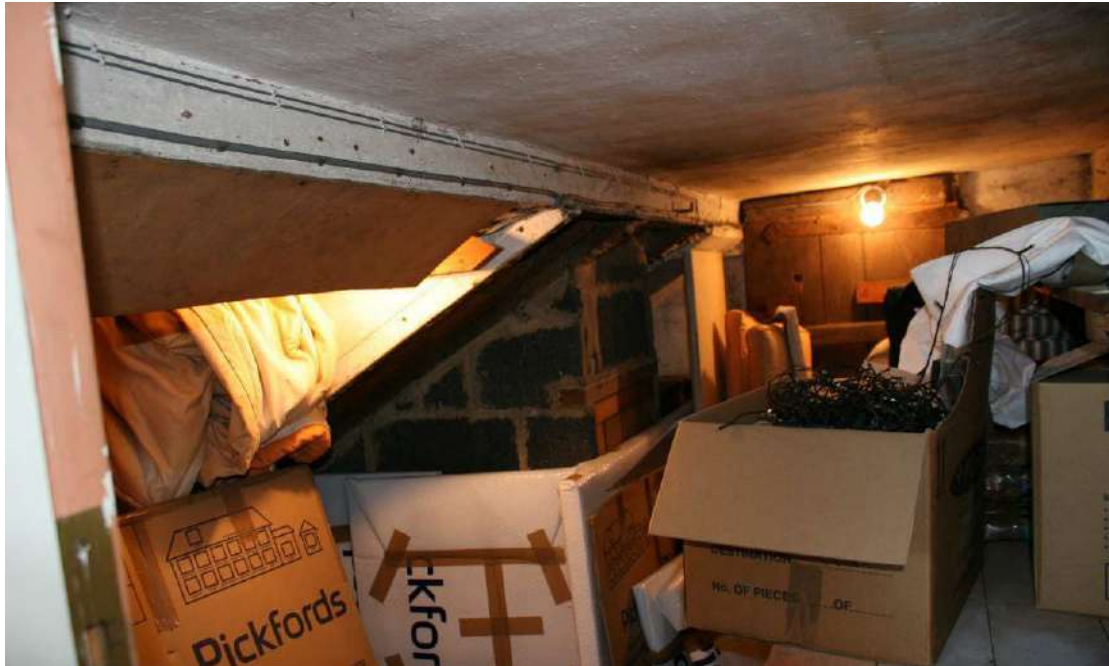
Looking W in the Store. Note the blockwork insertion and the very old door.

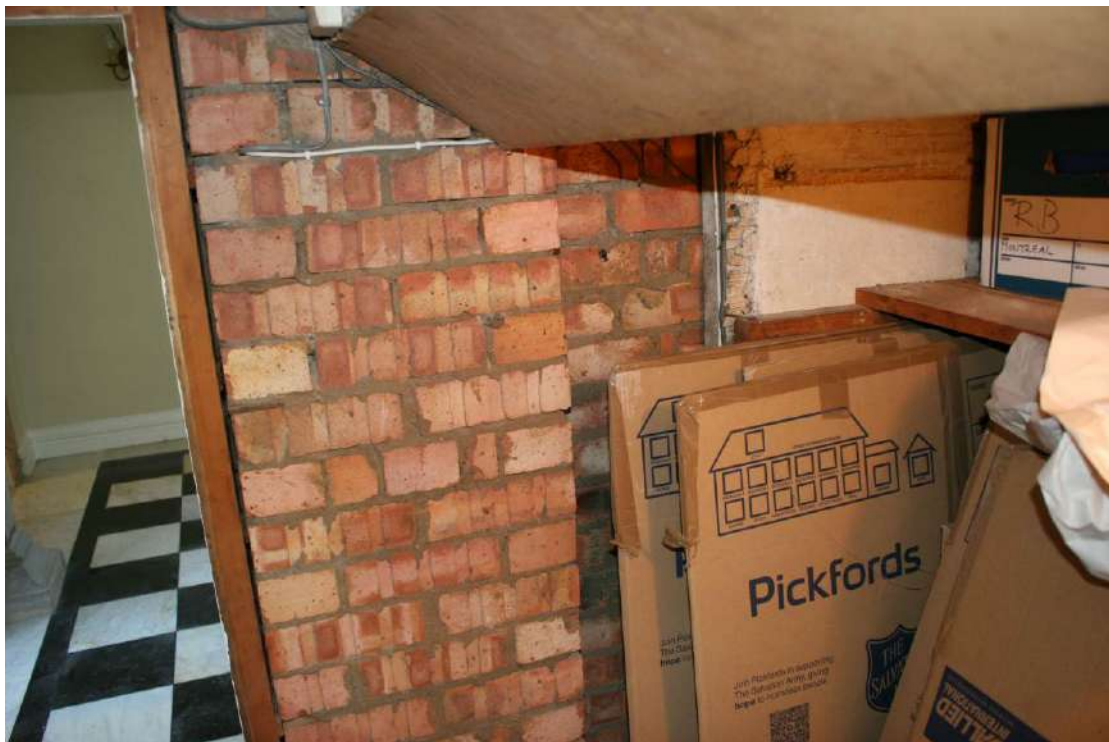
Looking E in the Store. The Atrium wall is made from Flettons set in cement.

The Store shows the MC20th construction materials with a Fletton wall forming the Atrium and a blockwork insertion to create a closet. A vertically boarded door is hung on pintles against the west wall.

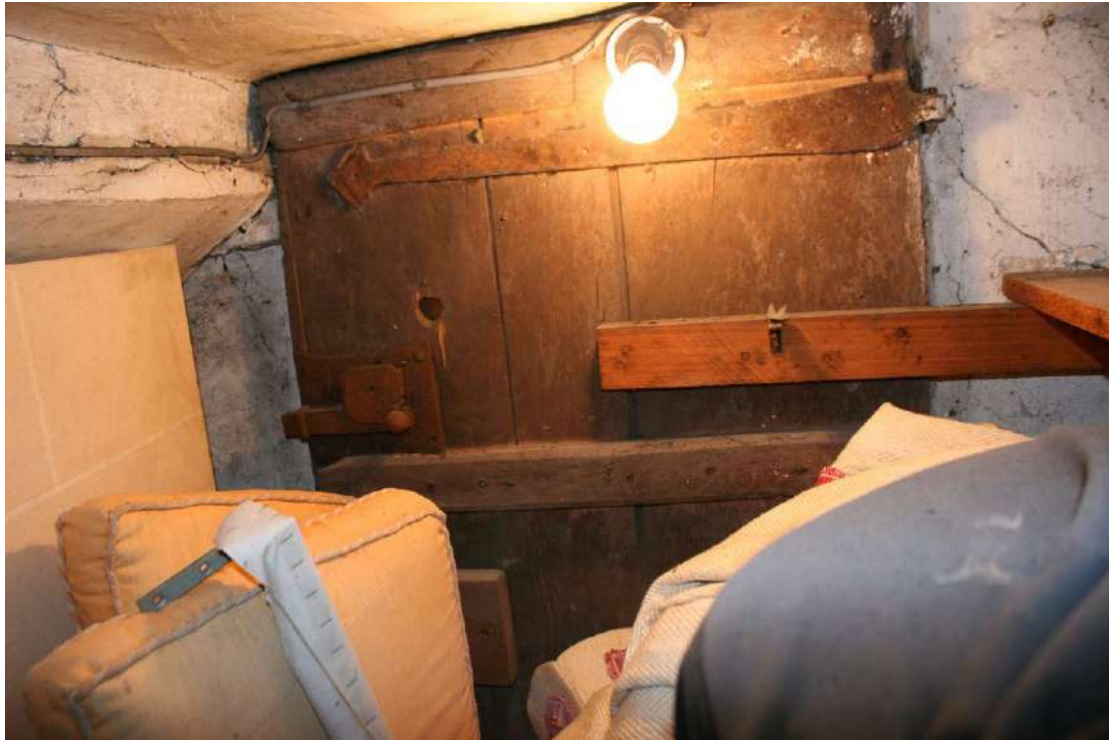
The upper part of the vertically boarded door in the Store.

The vertically boarded door is stiffened with nailed on ledgers and hung on pintles with broad, hand wrought pintle hinges with arrow headed terminals. There is an interesting lock plate fixed with wrought iron nails which can be operated by hand or with a key from the other side. The doorway is blocked and would lead into the Dining Room. The door has been battened across for shelving and has a light fitting screwed to it. The door is likely C17th and part of the original building dated to 1610. However, it is now a relic and out of place.

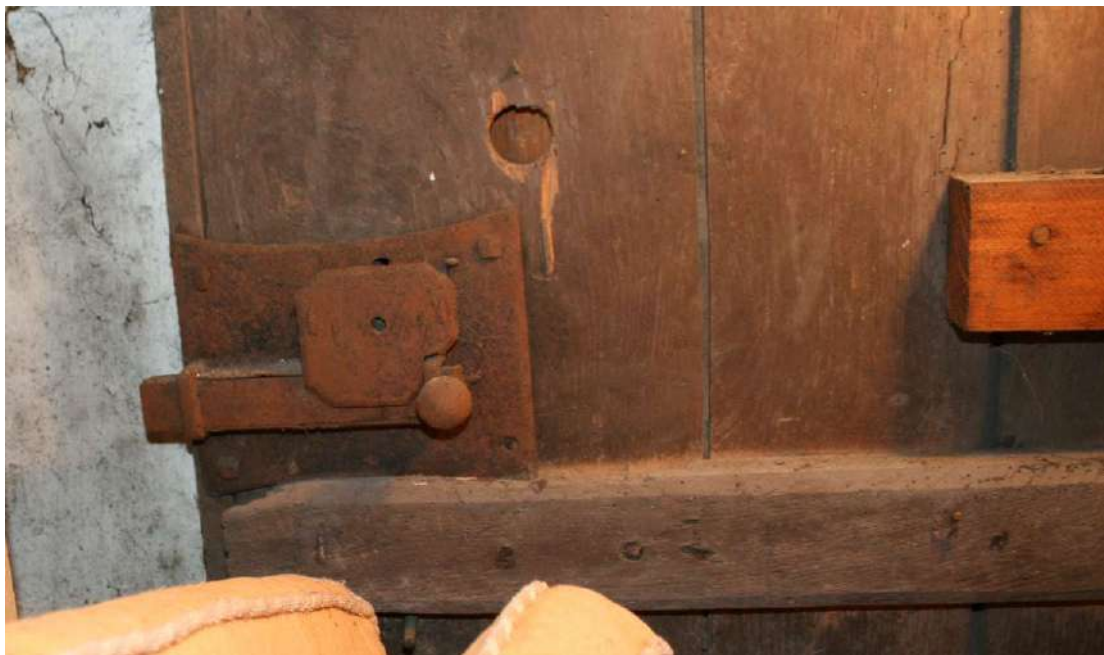
Detail of the bolt on the vertically boarded door.

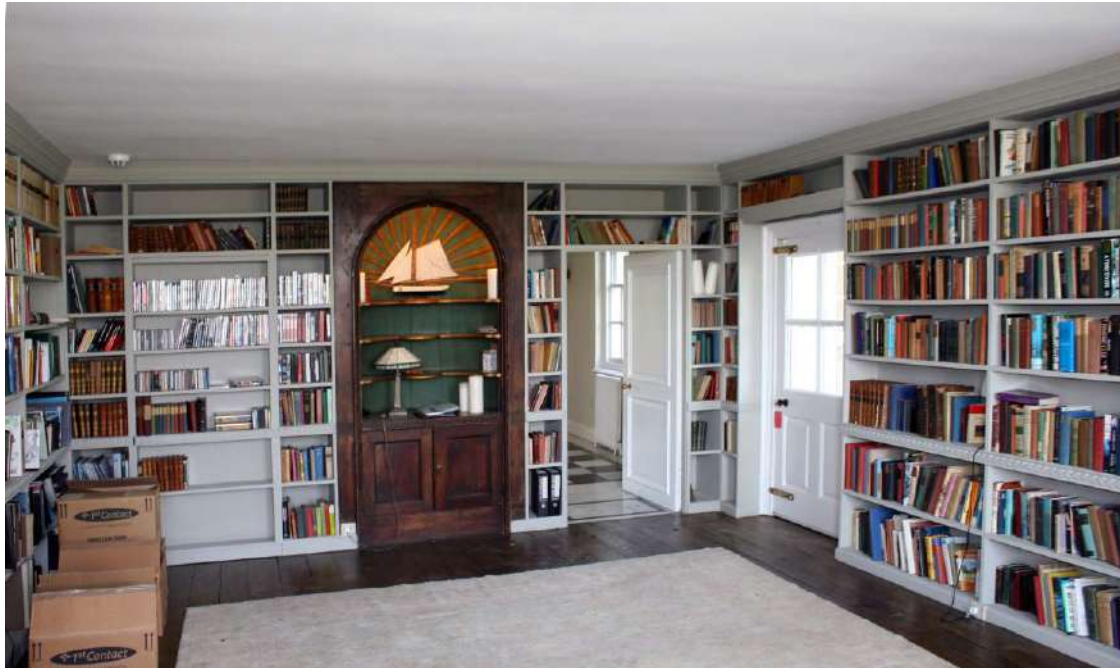
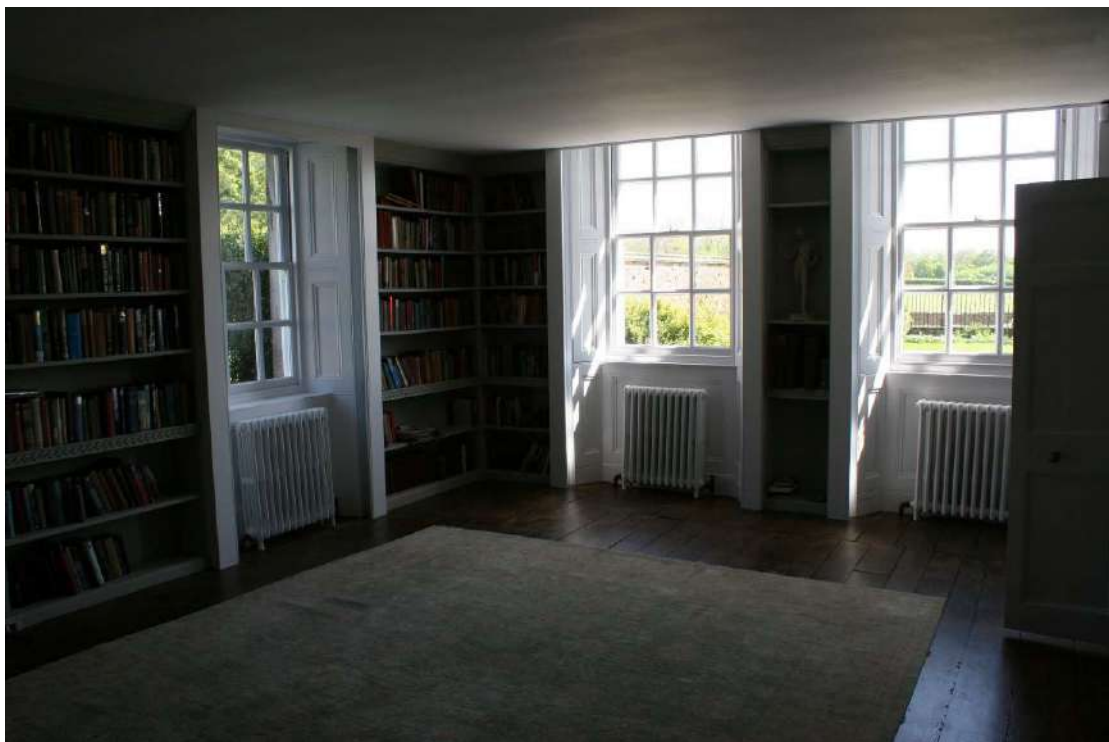
Looking N in the Library.

Looking S in the Library.

Created by Col. R Cooper in 1939 the walls are lined with contemporary shelves with variable height brackets set in brass strips. In the north wall is a barrel backed display cabinet that has lost its glass fronted doors. To the left of the cabinet is a secret door built into the shelving for a hidden closet.

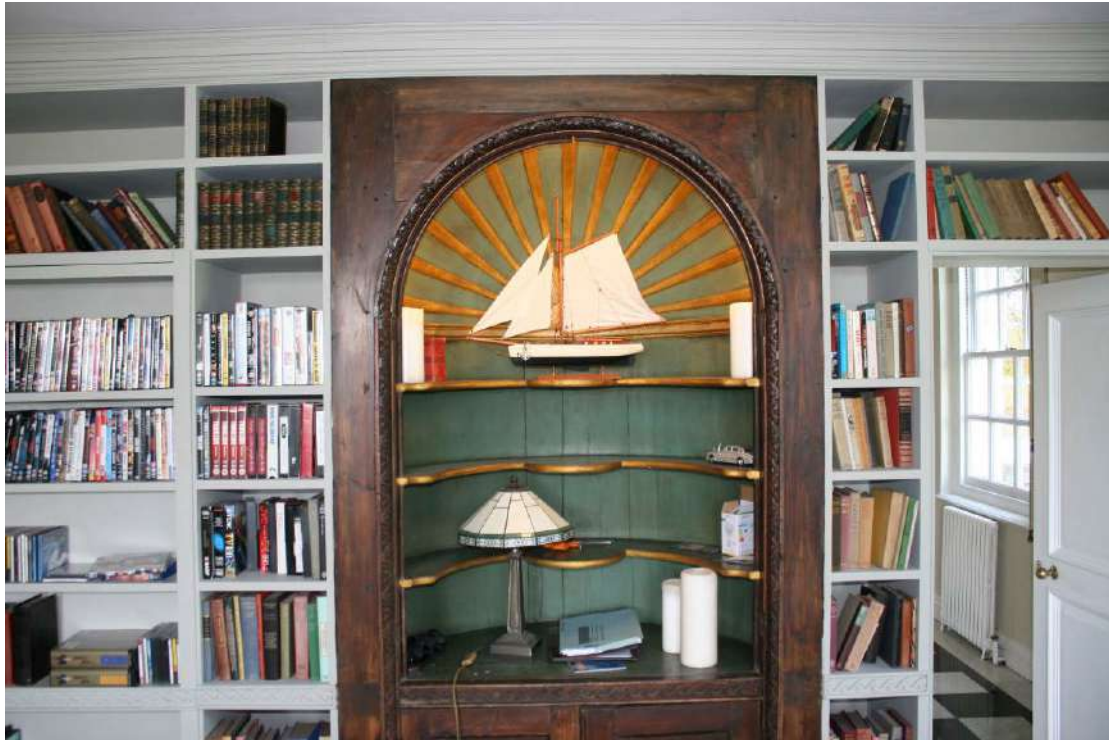
The upper part of the display cabinet.

The display cabinet is of a type popular in the C18th and EC19th and was used to display glassware and decanters behind glass doors which could be locked. Some variations had solid doors painted for display when opened. The upper barrel backed part is authentic to the C18th but the lower shelves and doors are from 1939. Probably installed by Cooper.

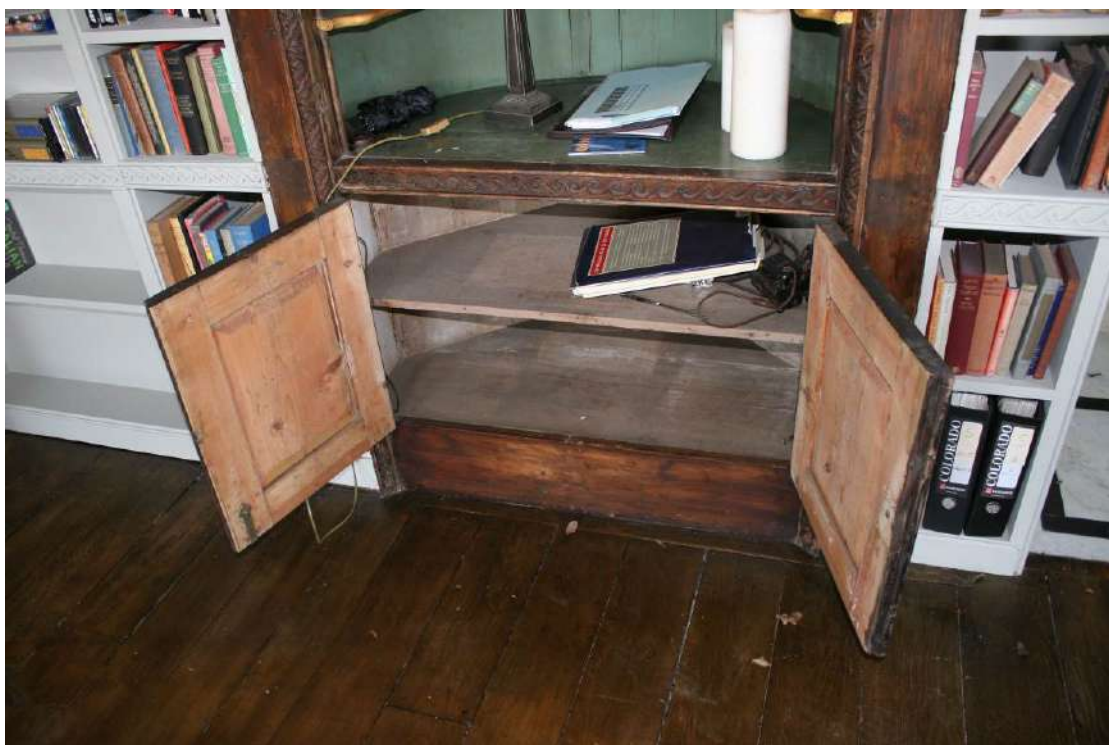
The lower shelves and doors are MC20th additions.

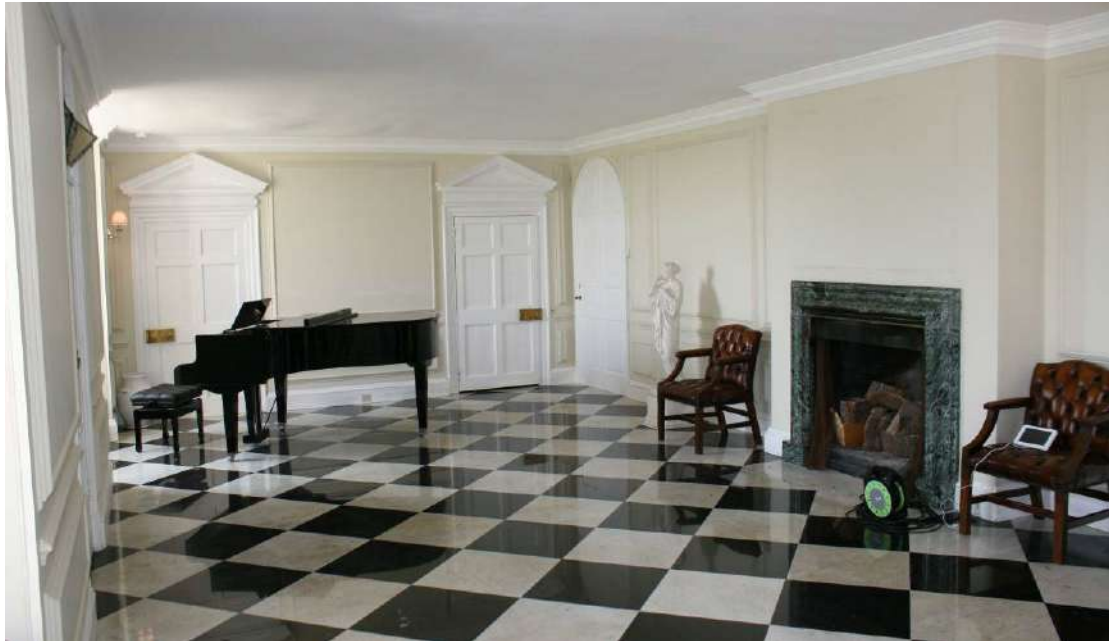
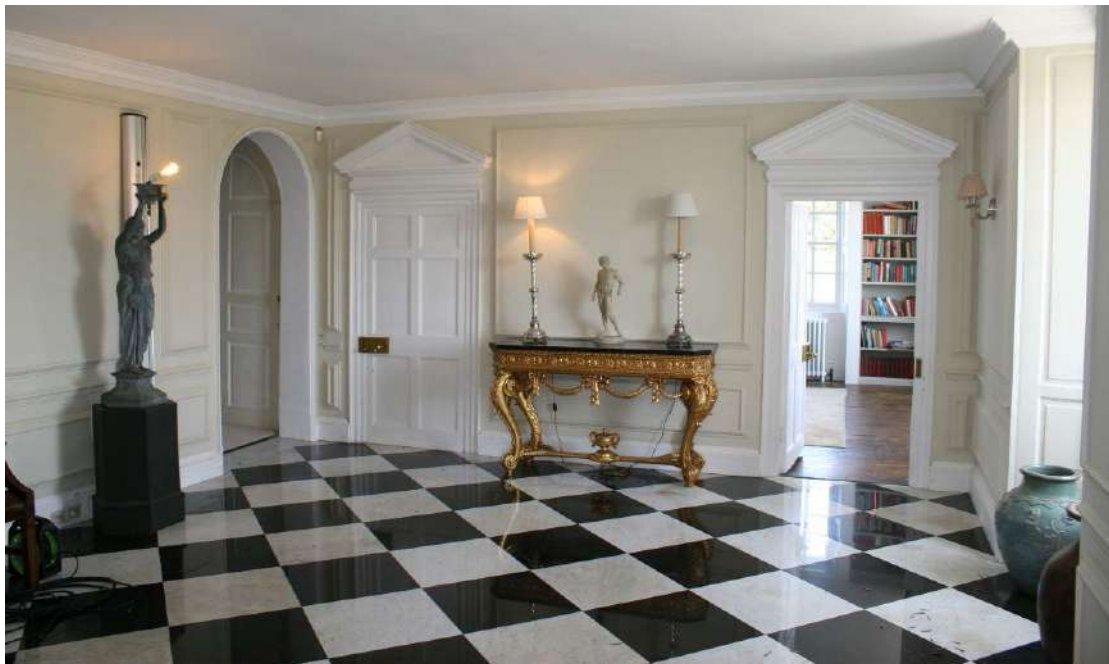
Looking W in the Grand Entrance Hall.

Looking E in the Grand Entrance Hall.

The Grand Entrance Hall is designed to the symmetrical tastes of the Georgian period with four matching doors in each corner, two of which have been blanked off. The six panel doors have open tympanum doorcases and wide moulded architraves. There are arched door heads and doors into the Dining Room (blocked) and East Staircase. The panelled walls are in pristine condition and have either been refinished or more likely are part of the 1939 works. The green marble fire surround also show no appreciable wear and the marble chequerwork floor has been recently restored. Underneath is a reinforced concrete floor from 1939.

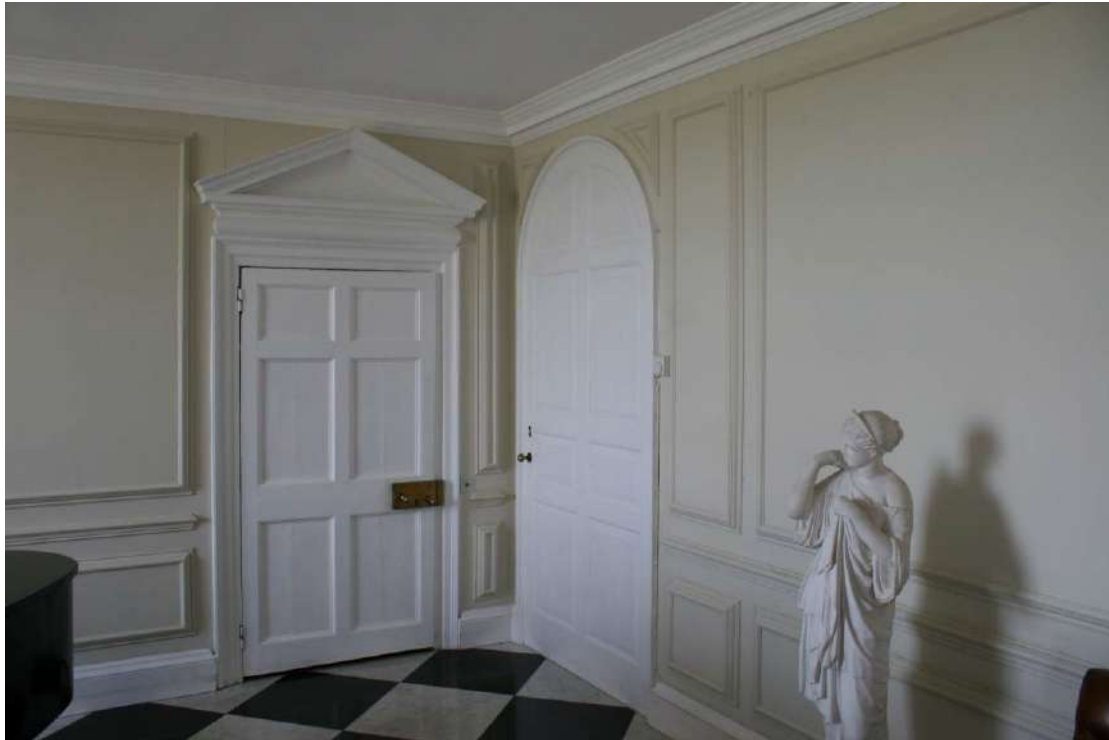
Detail of the doors to the West Entrance Hall and Dining Room (now blocked). Looking W.

Interestingly, the doors have Victorian brass lock boxes which are unusually set on the outside of the rooms. This would mean they could be locked from the Hall using the thumb slider without the need for a key, locking someone in the rooms. There are two arched doorways leading to the main East Staircase and to the Dining Room. The six panel door to the West Entrance Hall is undecorated on the west side and the design and fabric indicates it is a genuine C18th door.

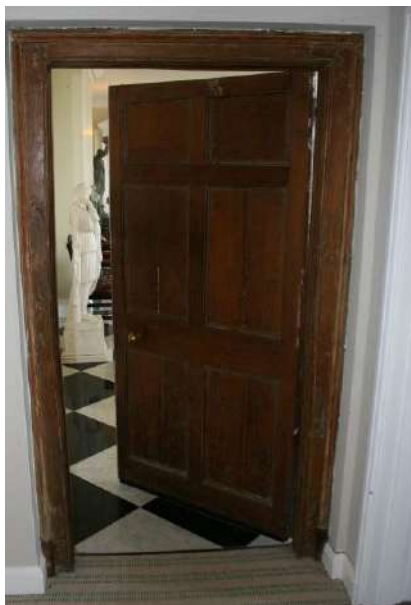
The west side of the Hall West Entrance Hall door.

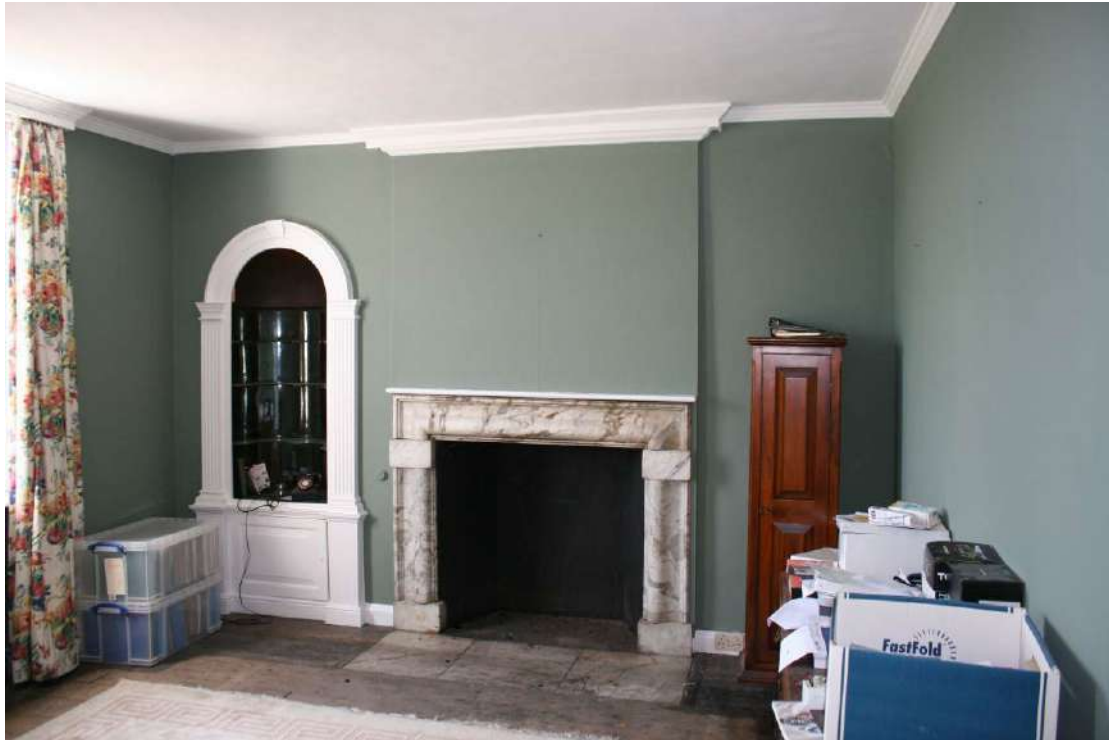
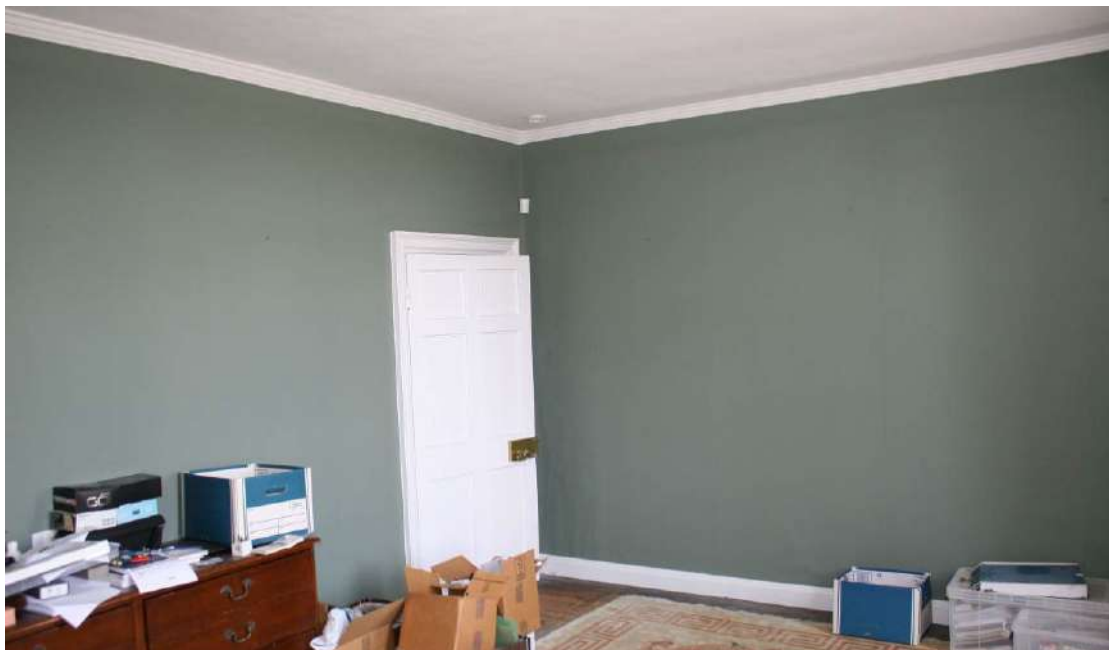
Looking W in the Morning Room.

Looking NE in the Morning Room.

Named on the 1939 Services Plan, the Morning Room lacks any real ostentation and has mean skirting and covings and no plaster features. There is an elegant grey veined bolection moulded marble fire surround but the fireback is made of large sheets of ribbed metal and must be from 1939. Adjacent is an Art Deco barrel backed cabinet.

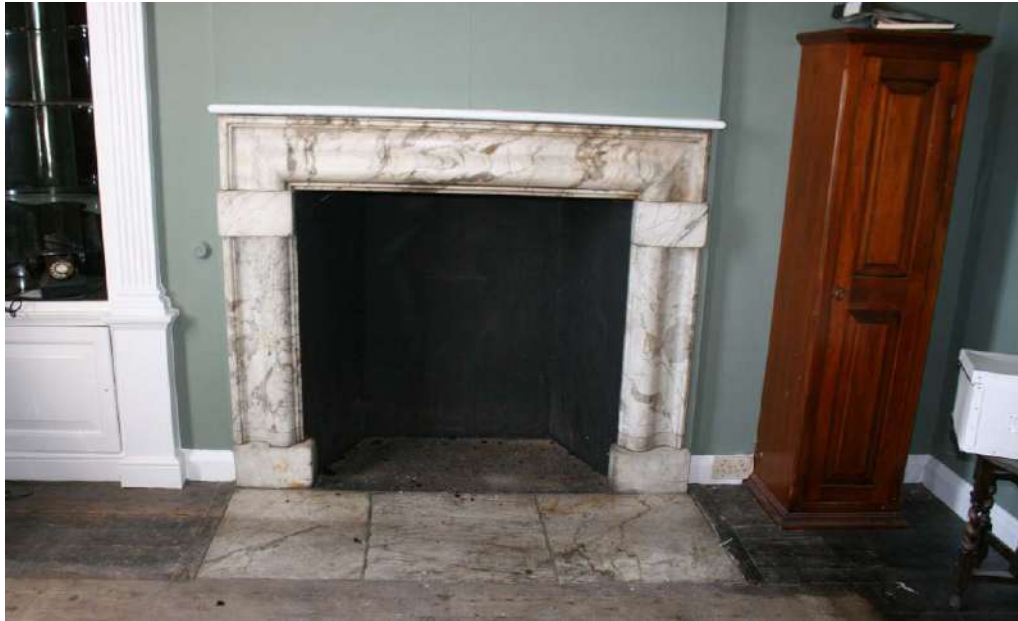
Detail of the marble fire surround. The cabinet is a secure gun cabinet.

The fire surround is very likely a reclaimed Georgian bolection moulded surround as it lacks a Victorian style mantel shelf (which has been added with a thin slip of timber). The display cabinet echoes the one in the Library but is made of glass and modern machined components and was not equipped with doors for security. Out of place in a Morning Room is a gun locker set in a wooden cabinet. In this room the matching brass lock box is on the inside of the door.

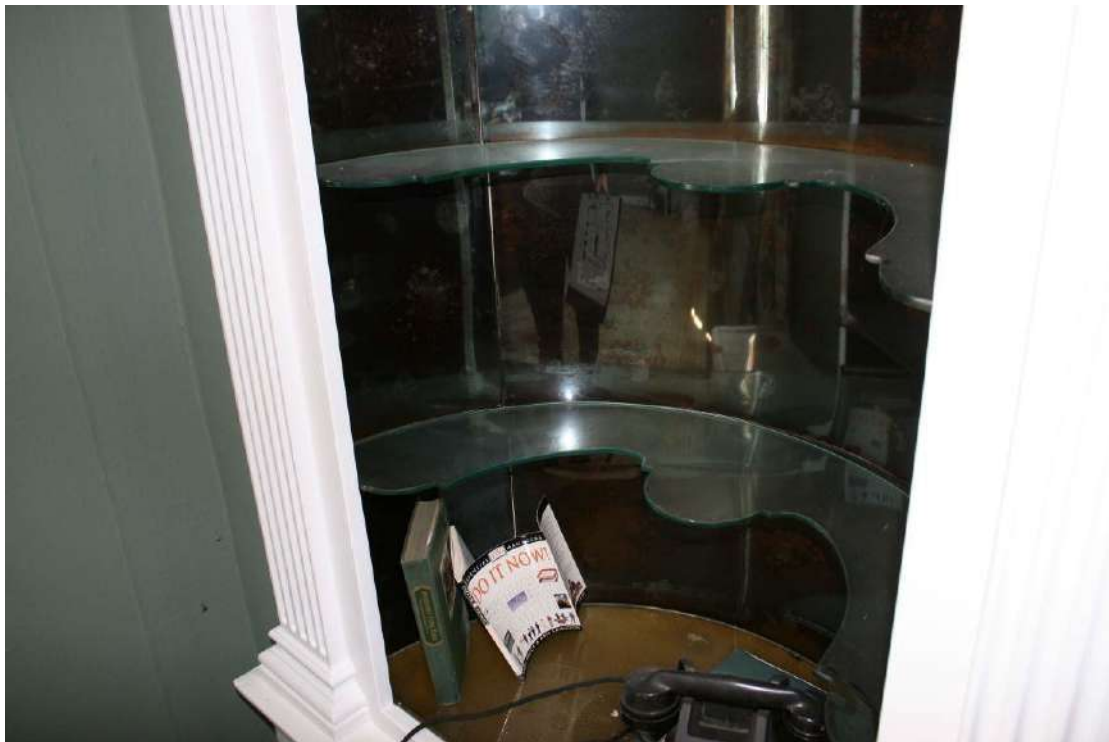
Detail of the glass barrel backed cabinet.

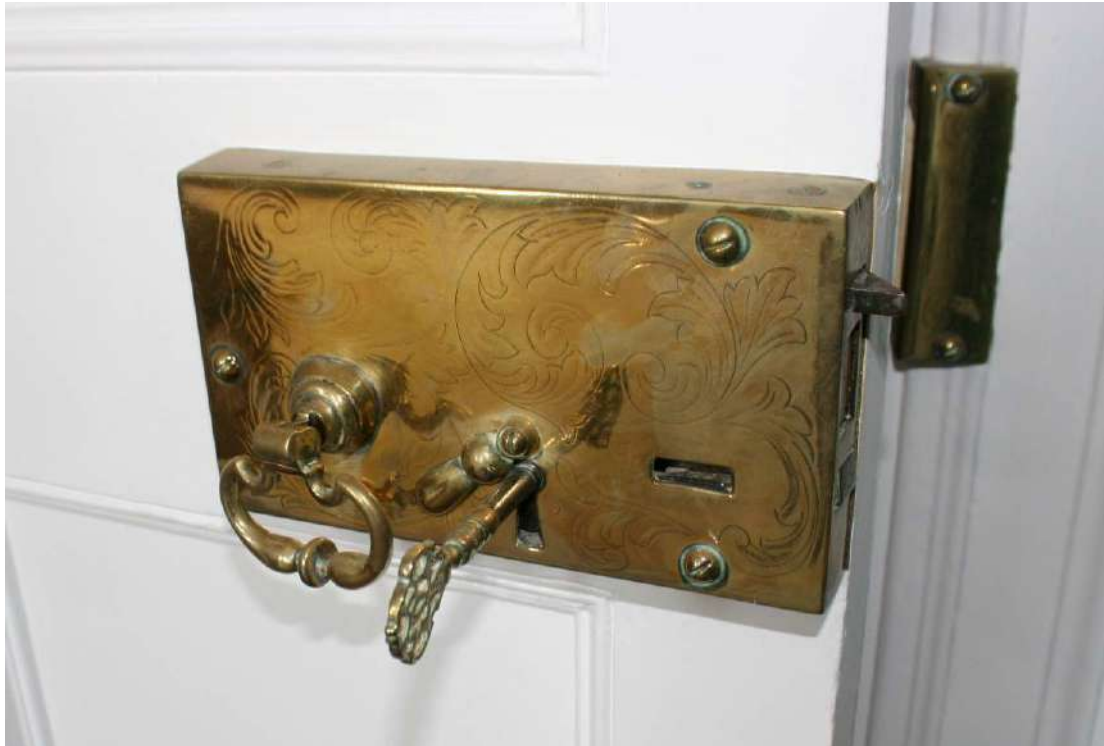
Detail of the lock box in the Morning Room.

The suite of locks on the ground floor have some intriguing features. The brass lock boxes are engraved with a variety of acanthus swirls and have thumb slides with smaller turned knobs (missing in the Morning Room). The Morning Room lock has an elegant drop handle which has an exact pair on the mortice lock in the Atrium door added by Cooper in 1939. It is likely they are all reclaimed or replica items.
