## Julians Park, Rushden, Buntingford, Herts. SG9 0TD.

Historic building recording and analysis of the House. Recorded 08 05 2024.

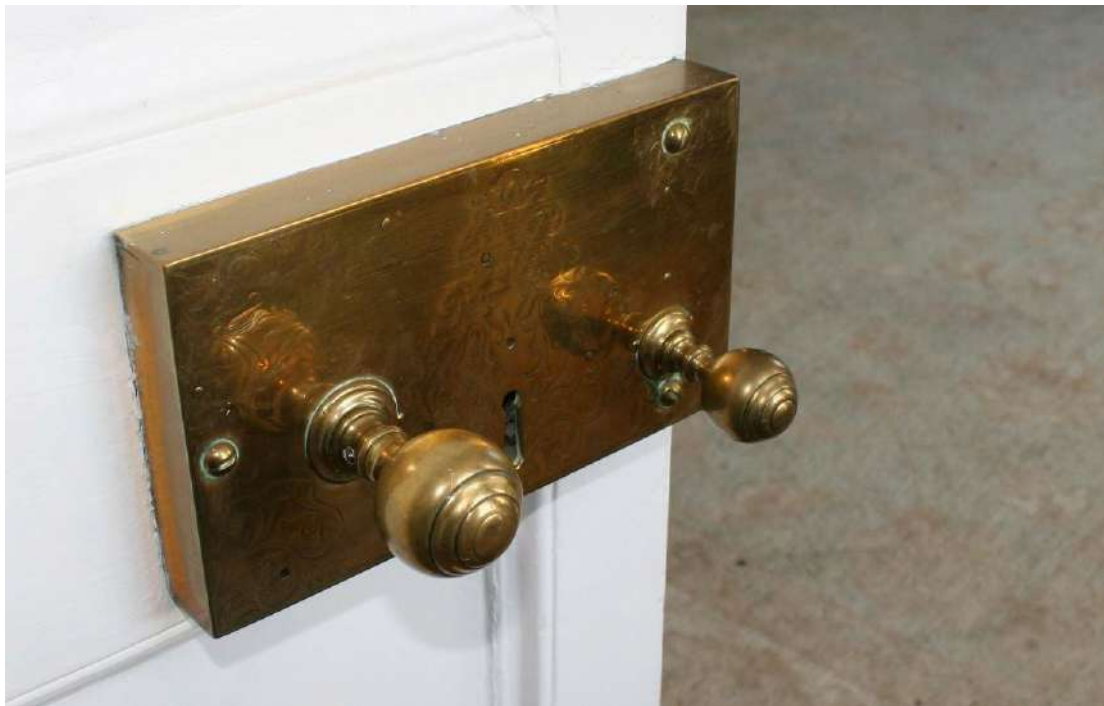
Detail of the lock box to the Library.

The suite of locks on the ground floor have some intriguing features. The brass lock boxes are engraved with a variety of acanthus swirls and have thumb slides with smaller turned knobs (missing in the Morning Room). The Morning Room lock has an elegant drop handle which has an exact pair on the mortice lock in the Atrium door added by Cooper in 1939. It is likely they are all reclaimed or replica items.

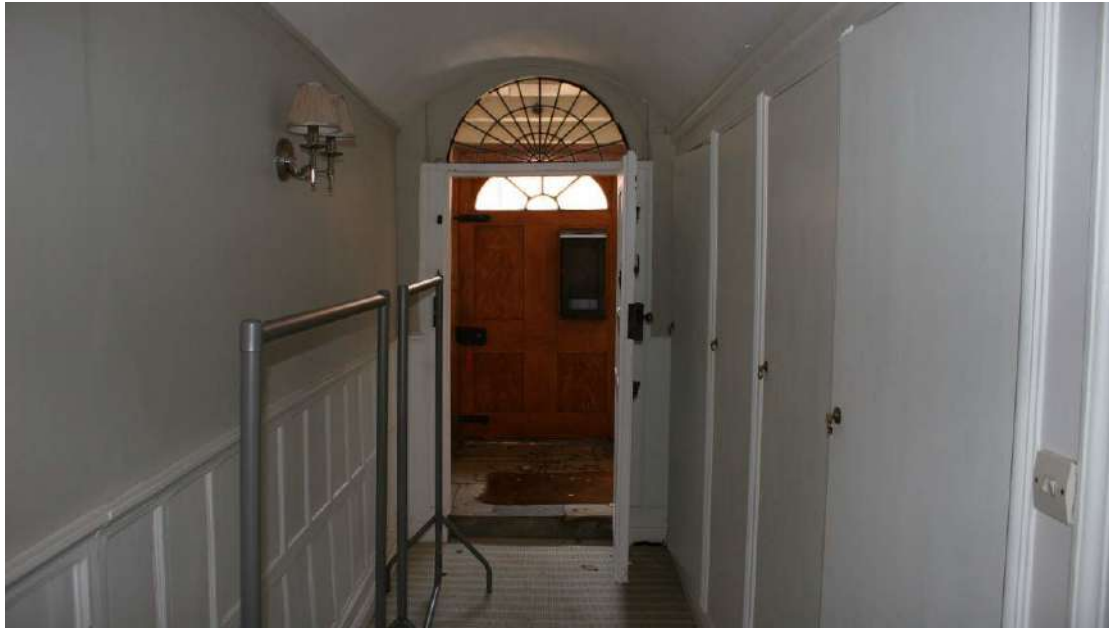
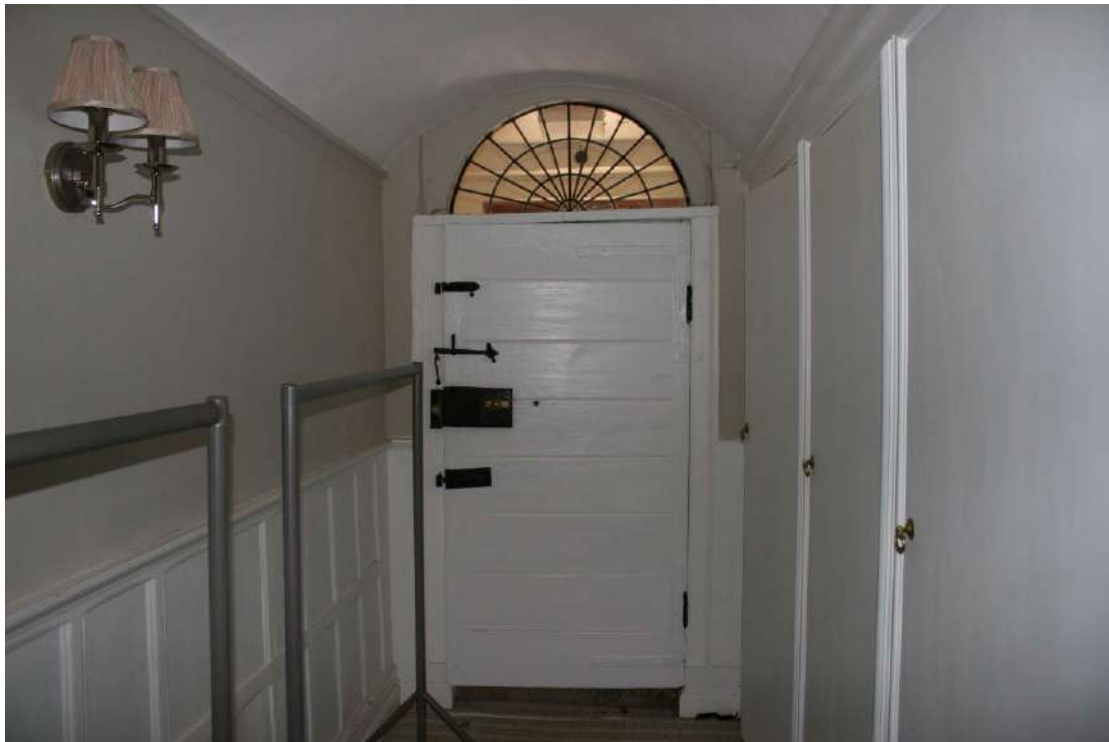
Looking W in the West Entrance Hall.

Looking W in the West Entrance Hall at the inner door.

The West Entrance Hall sits in the oldest part of the House, which extends north towards the Kitchen. One side is the wall common with the Morning Room but the north side is equipped with a series of coat closets put in place as part of the 1939 works. They have machined softwood battens and in places there are redundant terminals for electrical wiring. Of interest is the horizontally boarded inner door which appears C18th or earlier.

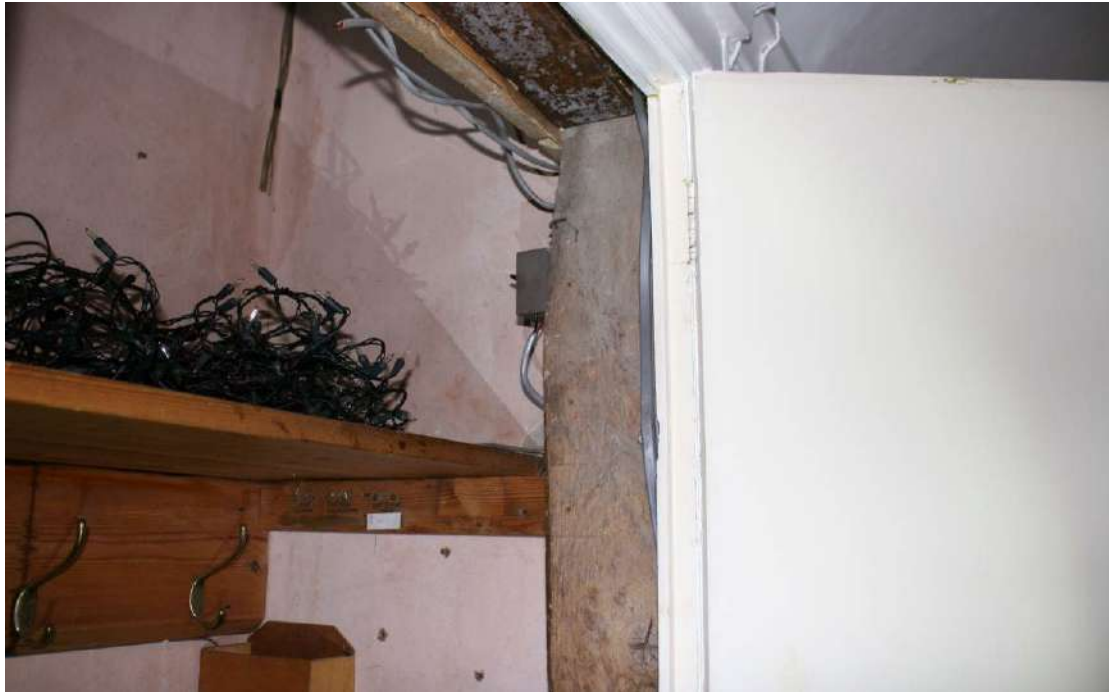
Older timber post inside the closets.

Inside the SE corner of the closets is a much older timber post that sits in line with the west range and is part of an early frame. Other parts of the frame are visible in the Servant's Hall. The electrical terminals are marked Main Bedroom, Stair Heads & Flower Room, GRD Floor only. A terminal box has been removed TR Blue, R Orange, T Green, Spare. A period grey metal power switch remains but the wiring has been cut.

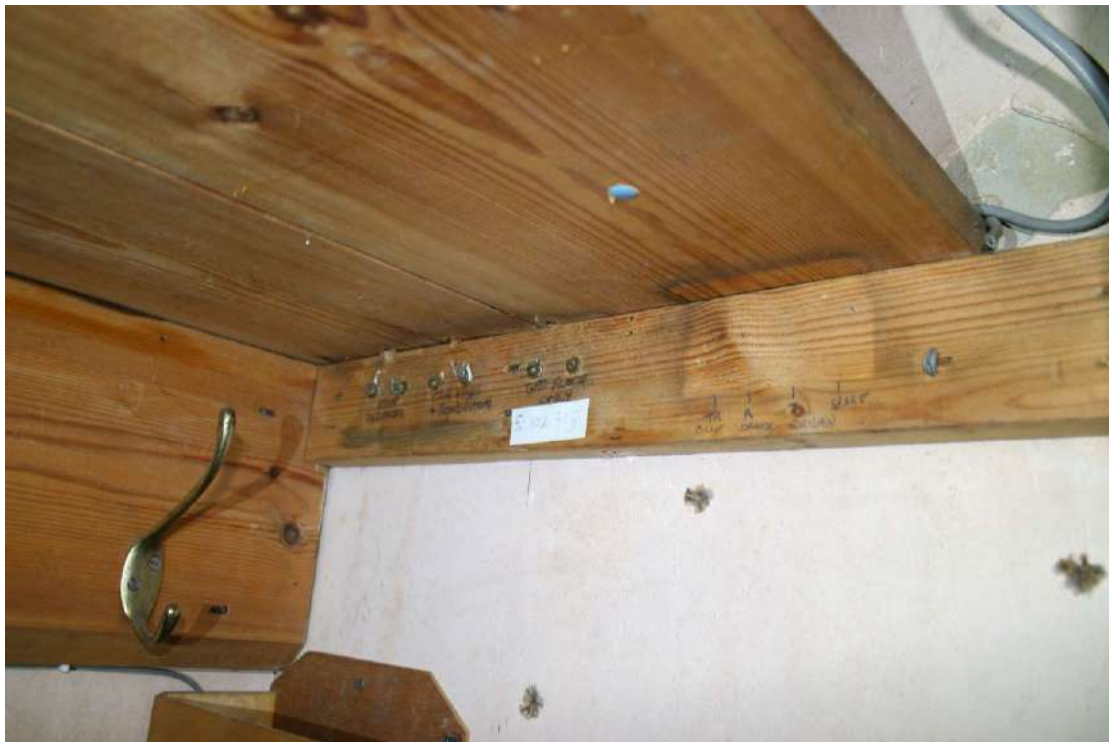
Detail of the construction of the closets with 1939 period electrical terminals.

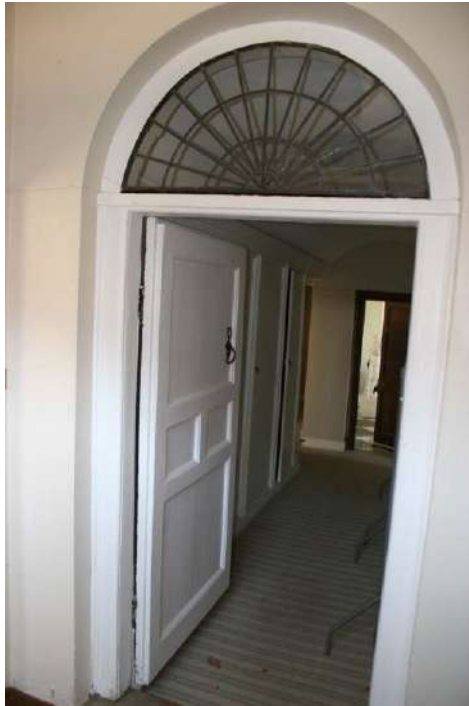
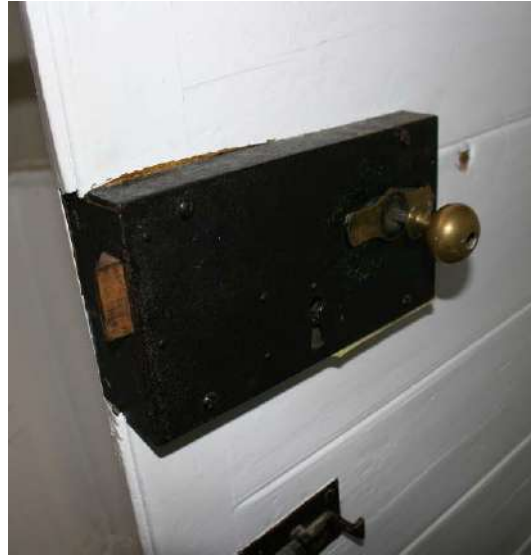
The inner door has been plated over to look Georgian. Detail of the cast iron lock box.

Of interest is the horizontally boarded inner door which appears C18th or earlier. The inner door is hung on IL hinges nailed to the frame with wrought iron rose headed nails dating it to before 1800 and probably before 1760 when screws were more easily available. There is a cast iron Georgian era lock box and a later slide bolt. The door also has a Suffolk latch to allow it to be opened from both sides. The threshold is made from worn and time polished stone slabs and indicate the West Entrance was long established before 1939 when a WC and Wash Room were put in either side.

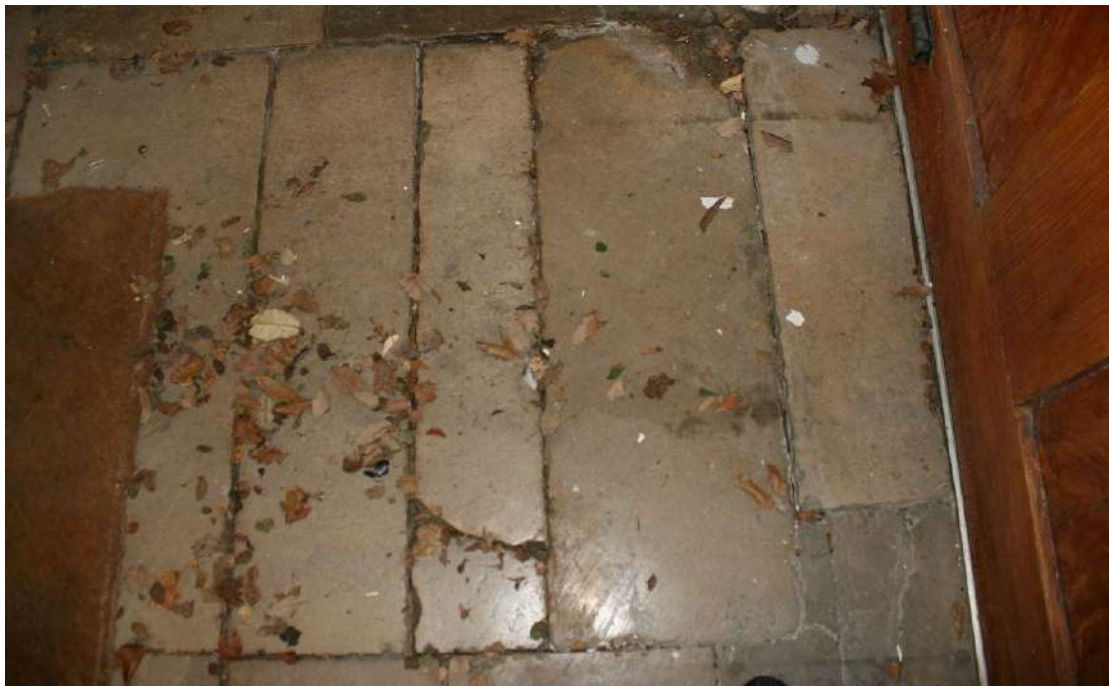
The worn stone threshold by the west door.

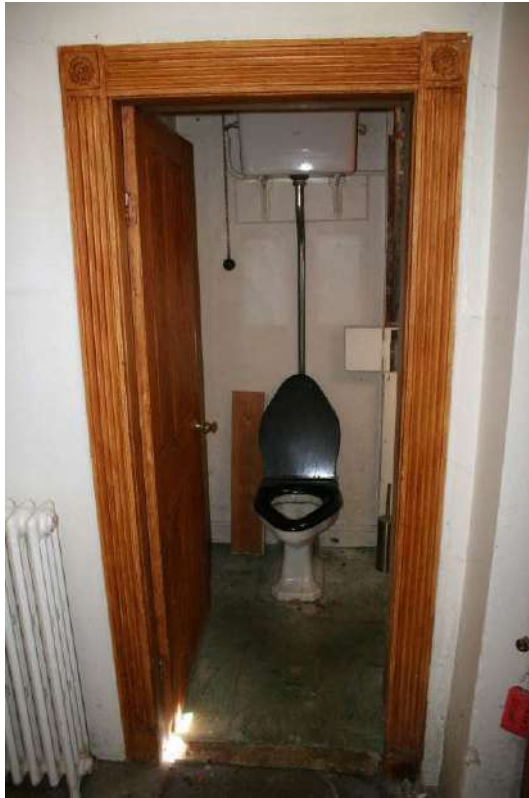
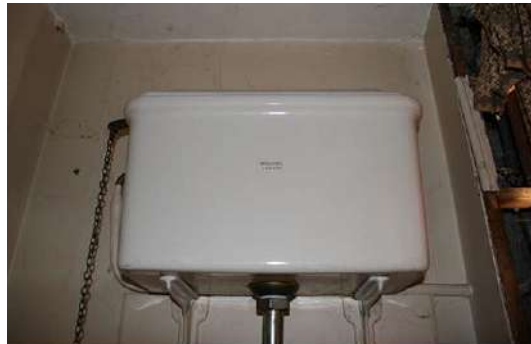
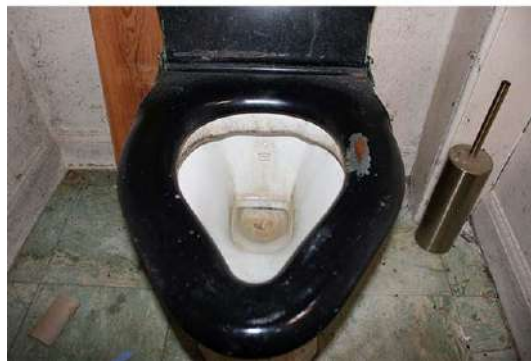
WC on the south side of the entrance lobby.

The WC and Wash Room contain 1939 period fittings with a Bolding pan and cistern and a typical square style wash basin. There is only one toilet facility on the ground floor.

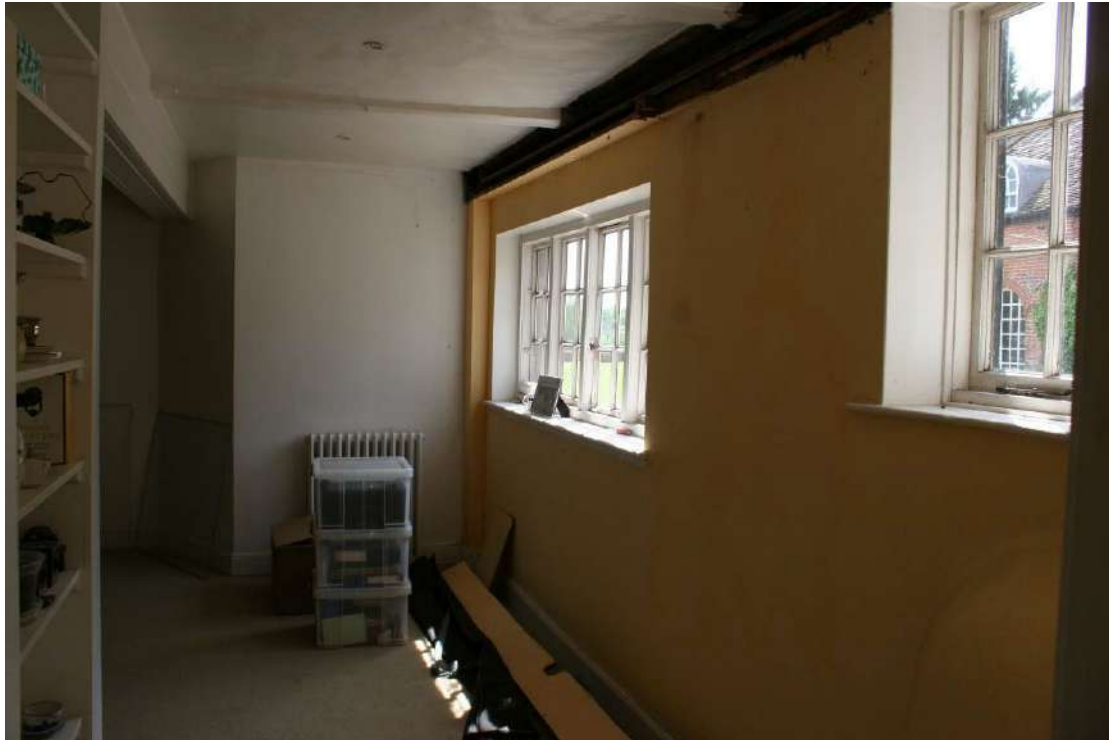
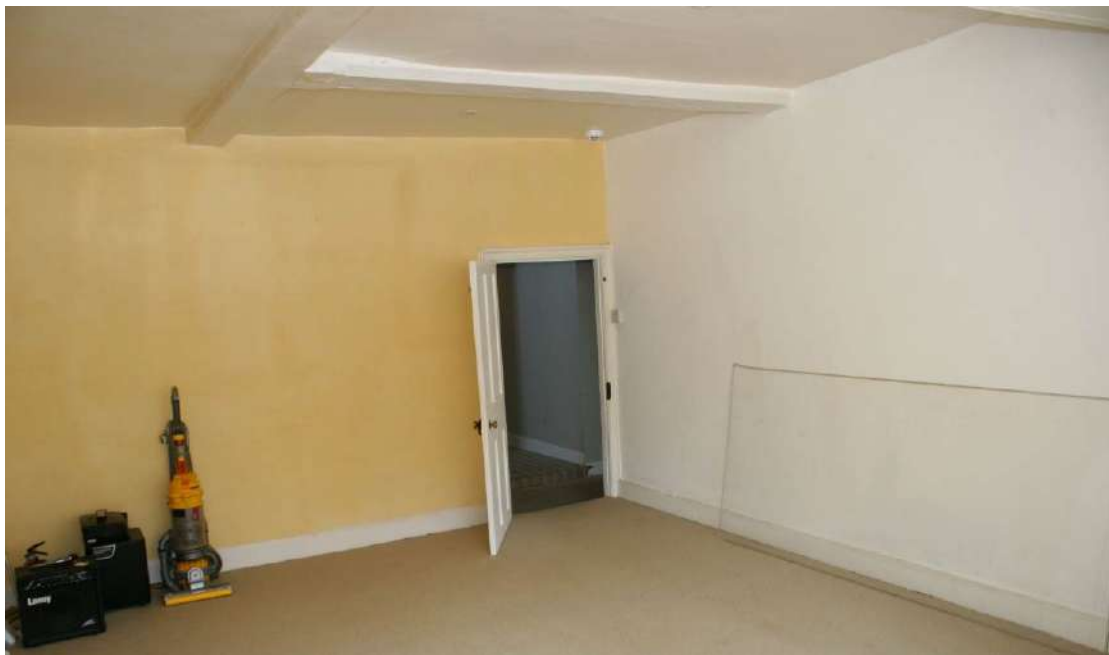
Looking S in the Servant's Hall from the Kitchen.

Looking SE in the Servant's Hall. Note the ceiling beams.

Noted on the 1939 heating system plan as the Servant's Hall, this room connects the Kitchen and Butler's Pantry to the rest of the House. There are exposed and boxed in beams in the ceiling that indicate an earlier timber-frame but the other features date to the 1939 refit. There is a four panel Victorian style door with a pressed steel lock box and brass knob.

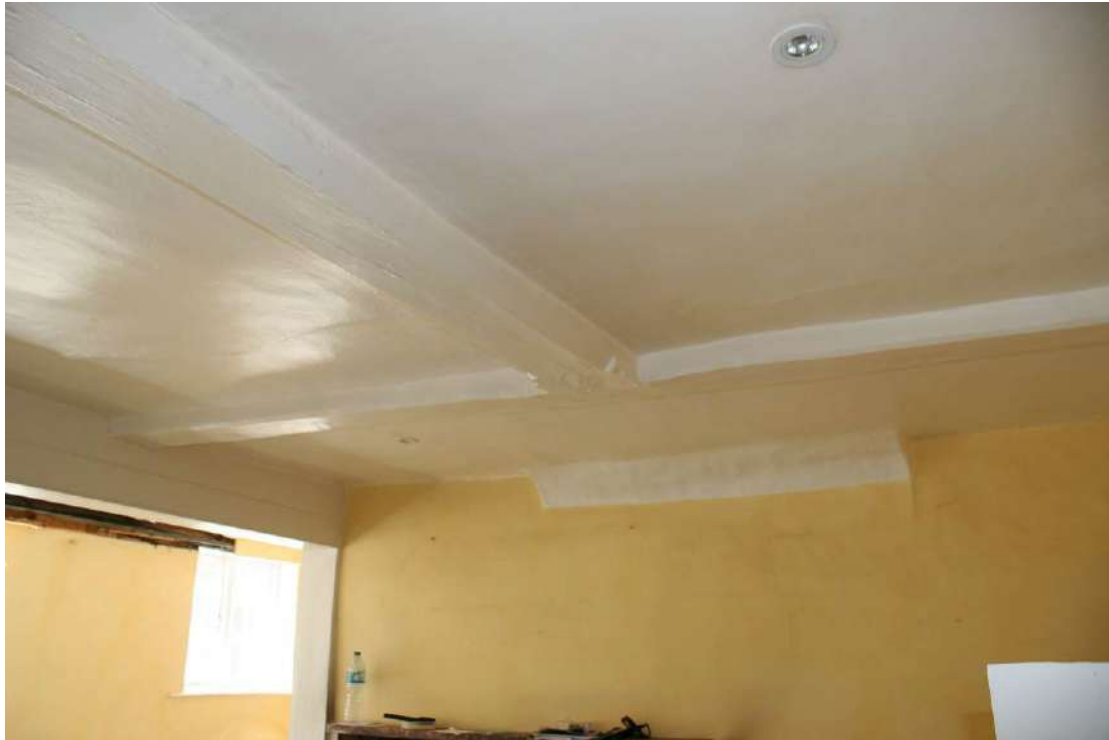
Looking NW at the axial main joist and bridging joist for the firestack bay.

The volume of the earlier frame can be seen in the ceiling where there is a main axial joist and a bridging joist for a smoke bay in which the very large firestack now sits. The small fireplace is one selected from a catalogue for the 1939 refit and was a popular type in the period. The other side of the firestack retains the original wide open fireplace with its original bressummer still in place. This is detailed in the report on the Kitchen and now is fitted with cupboards.

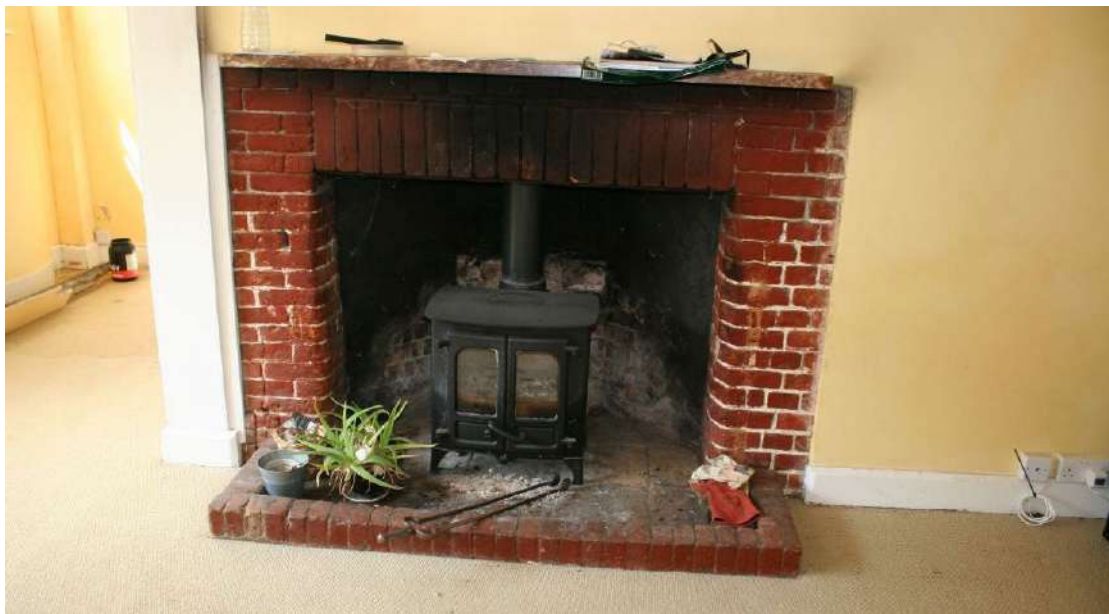
MC20th fireplace selected from a catalogue.

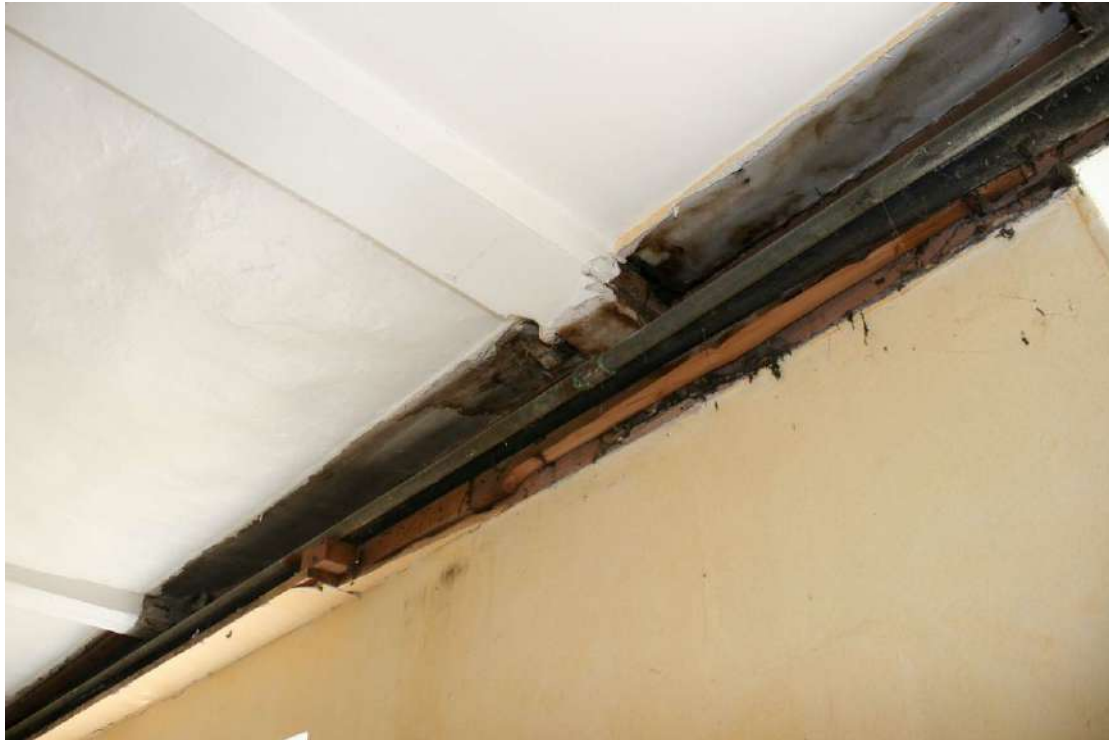
Detail of one of the boxes containing the 1939 plumbing.

The House has an extensive water and heating pipe system hidden in boxes and cabinets. Each stopcock (large tap) is numbered with a metal disc and there is a handwritten Services Plan for the Kitchen that shows those in the Servant's Hall as *No1 Cold water service from the well – shuts of whole cold supplies* and *No2 Controls supply to Cottages*.

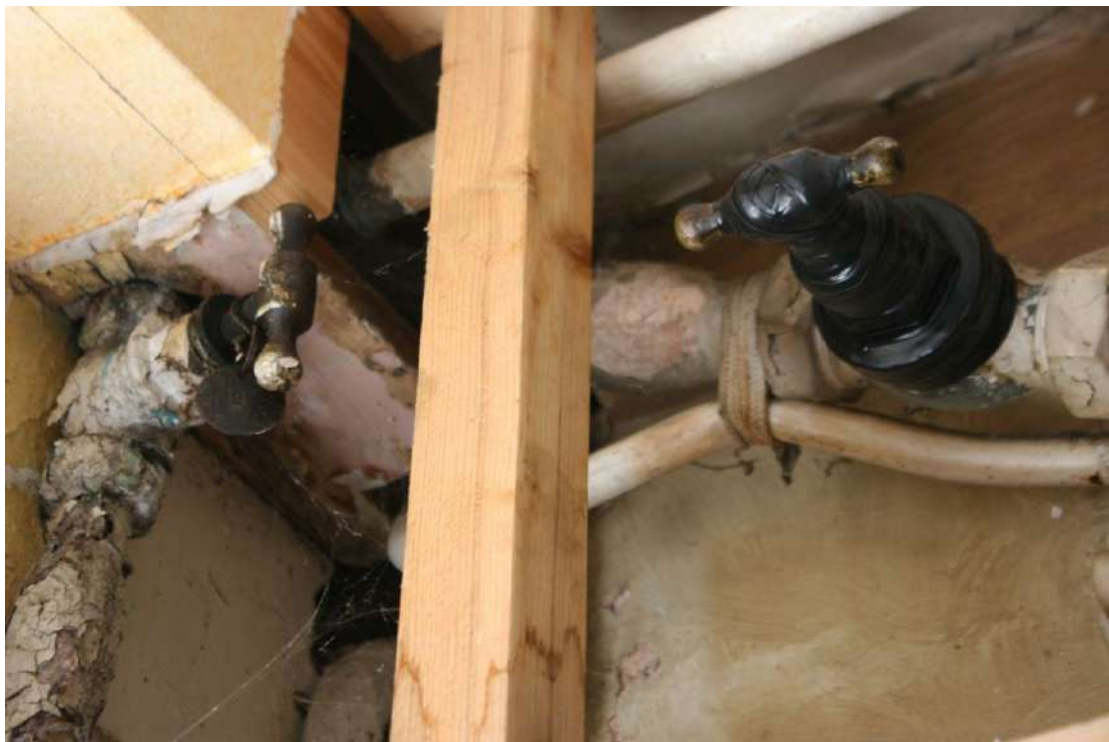
Detail of the 1939 stopcocks. One takes water from the well in the garden.

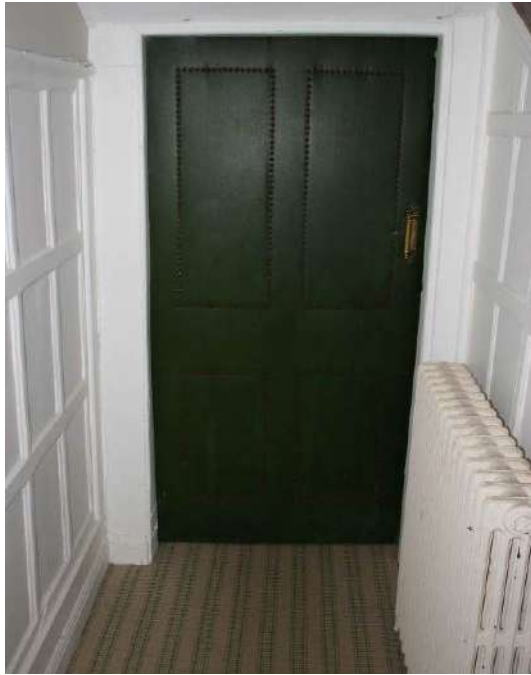
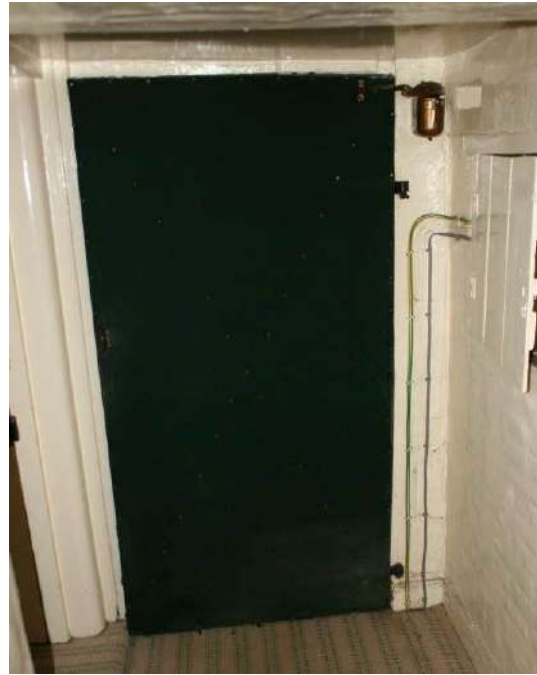
The front and rear of the Servant's door into the West Staircase Hall.

There is a traditional leather bound 'Green Door' in four panel Victorian style that connects the service rooms with the West Staircase Hall. The service side is covered with green baize. There is a 1939 period Yale closer complete with a slot cut into the wall to allow it to operate. Set into the side of the firestack is a cabinet to house the electrical controls for the heating system which are now modern digital units.

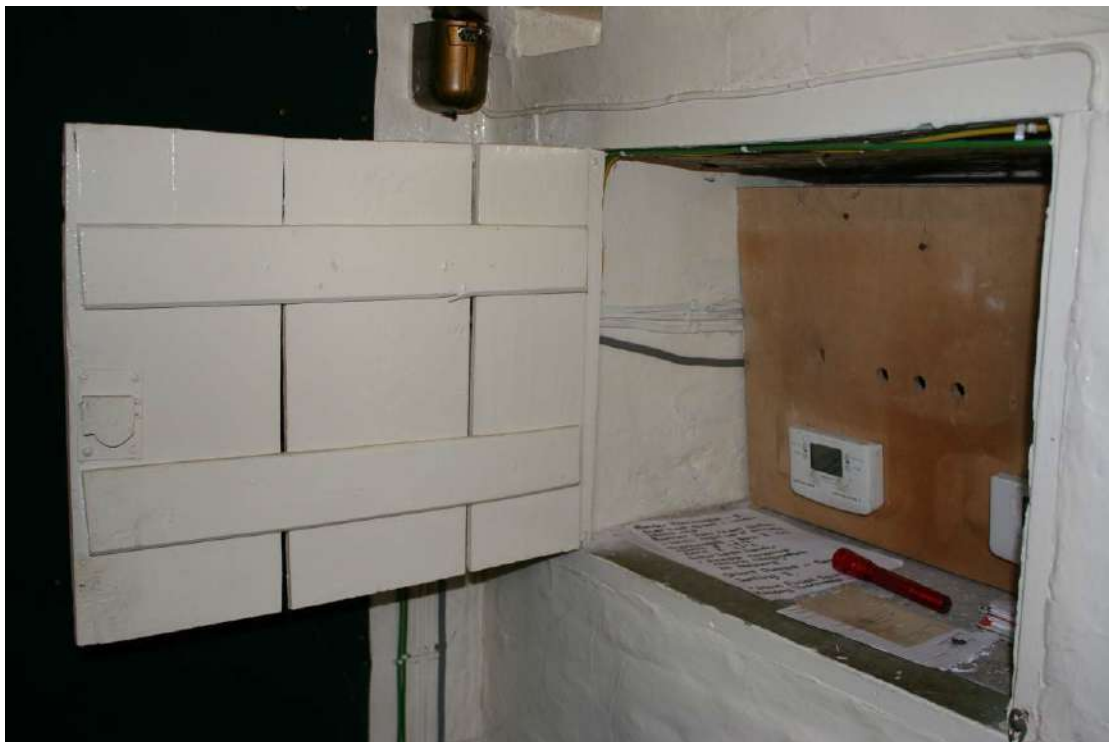
Electrical cabinet with modern heating controls.

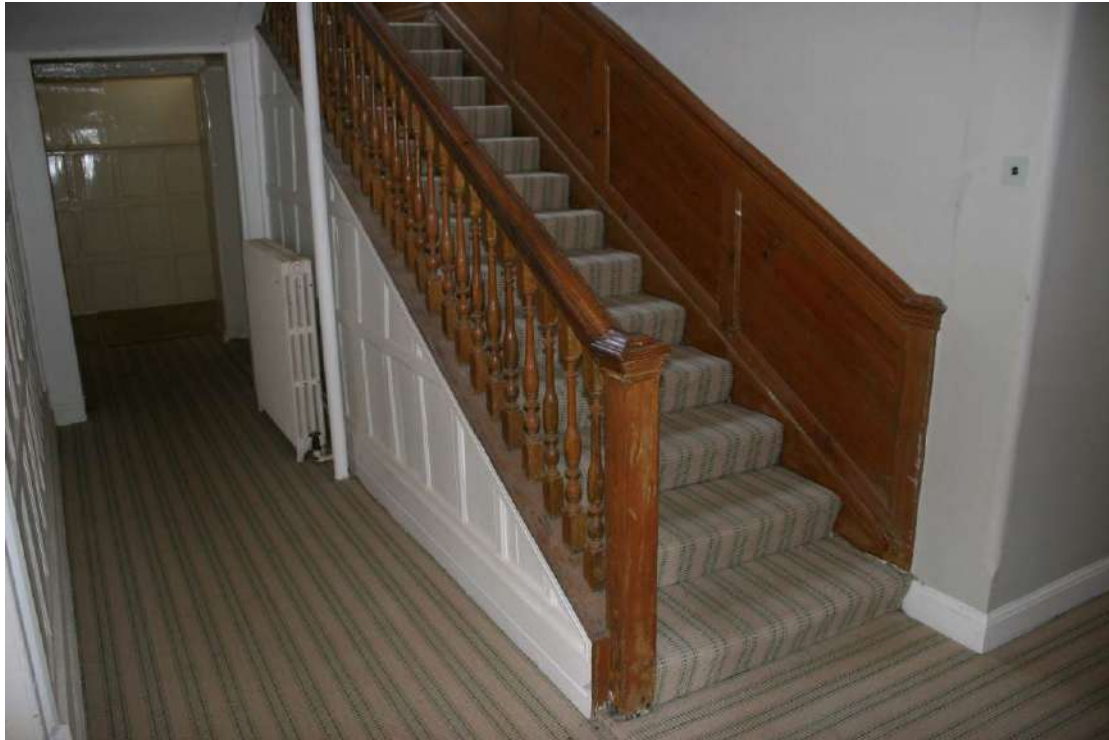
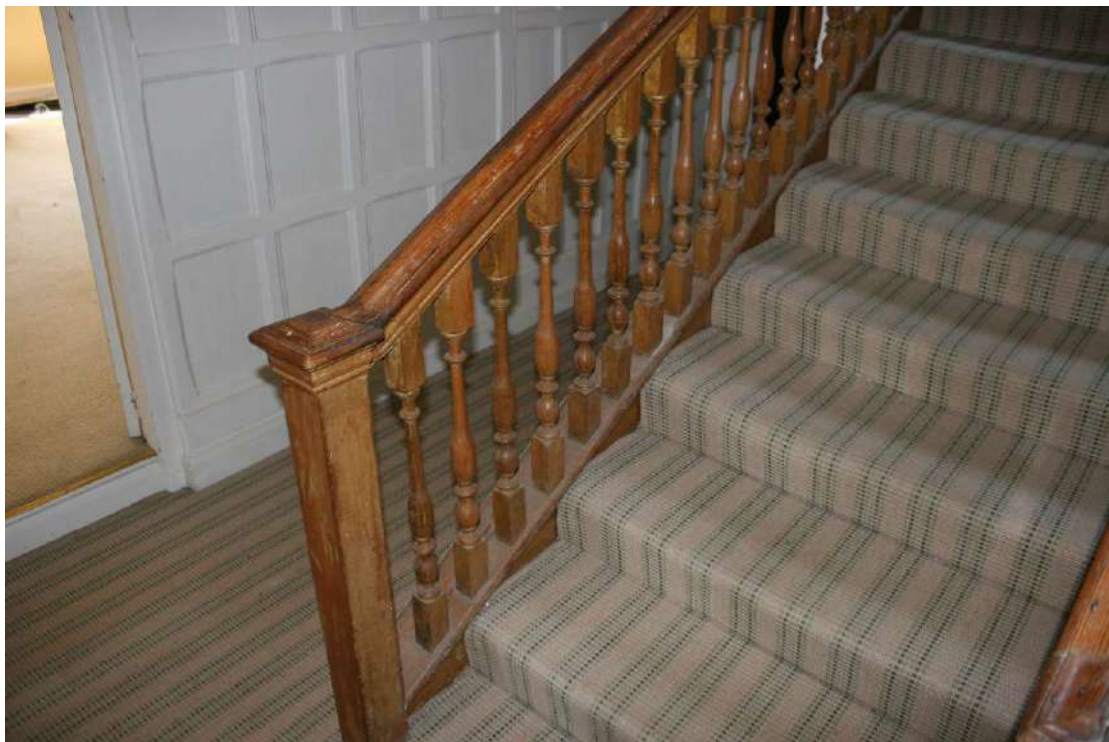
Looking N at the West Staircase.

Detail of the newel post and spindles.

Described in the 1952 Listing as *Early C18 dog-leg secondary staircase with slightly bulbous balusters, closed string, moulded handrail*. The staircase has a heavy square newel post and exposed pine wall panelling. The carcase and the passage wall are also panelled with C17th style panelling. The staircase ascends to the Attic rooms.

The West Staircase is complete and in original condition save for some supporting struts in the Cellar and cast iron pillars supporting the trimmer beams. It has very similar features to the East Staircase and is well described in the 1952 Listing: *Early C18 dog-leg secondary staircase with slightly bulbous balusters, closed string, moulded handrail*. What is not noted however is that the West Staircase ascends to the Attic floor which by deduction must have been established at the same time.

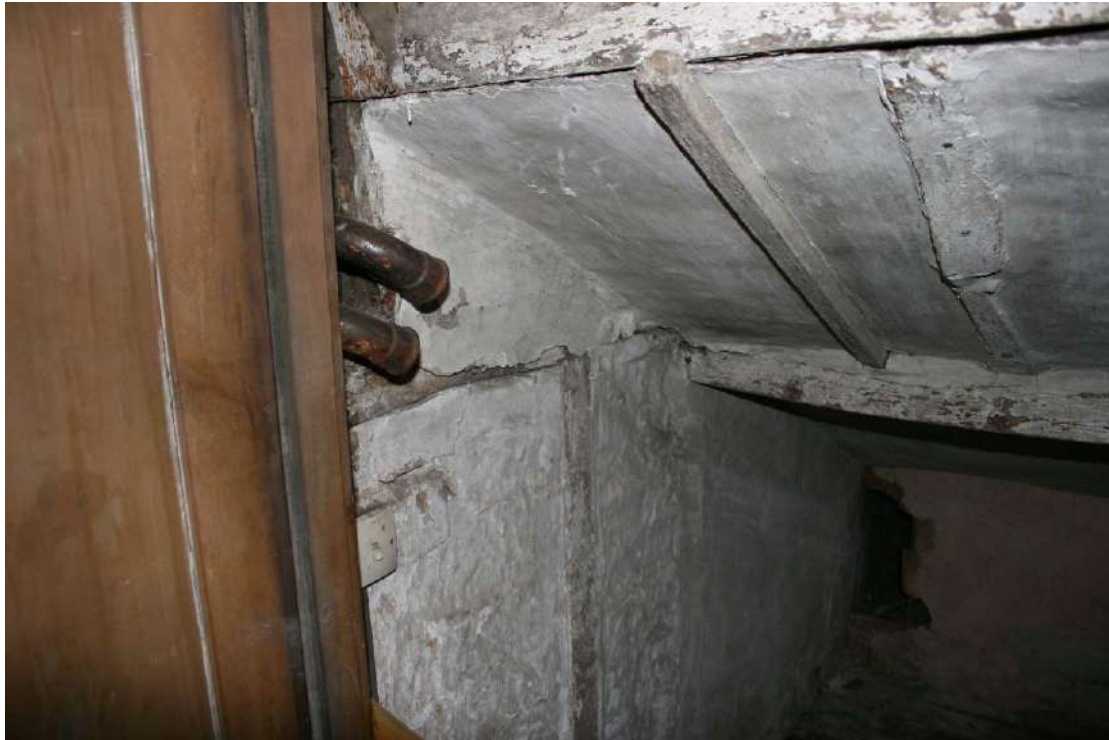
The soffit of the West Staircase. Looking SE.

The carcase panelling is made from oak and is likely also EC17th but it is clear that it has been resited, probably when the staircase was repaired and reinforced in the 1939 works. Bandsawn softwood supports have been added and the panels moved.

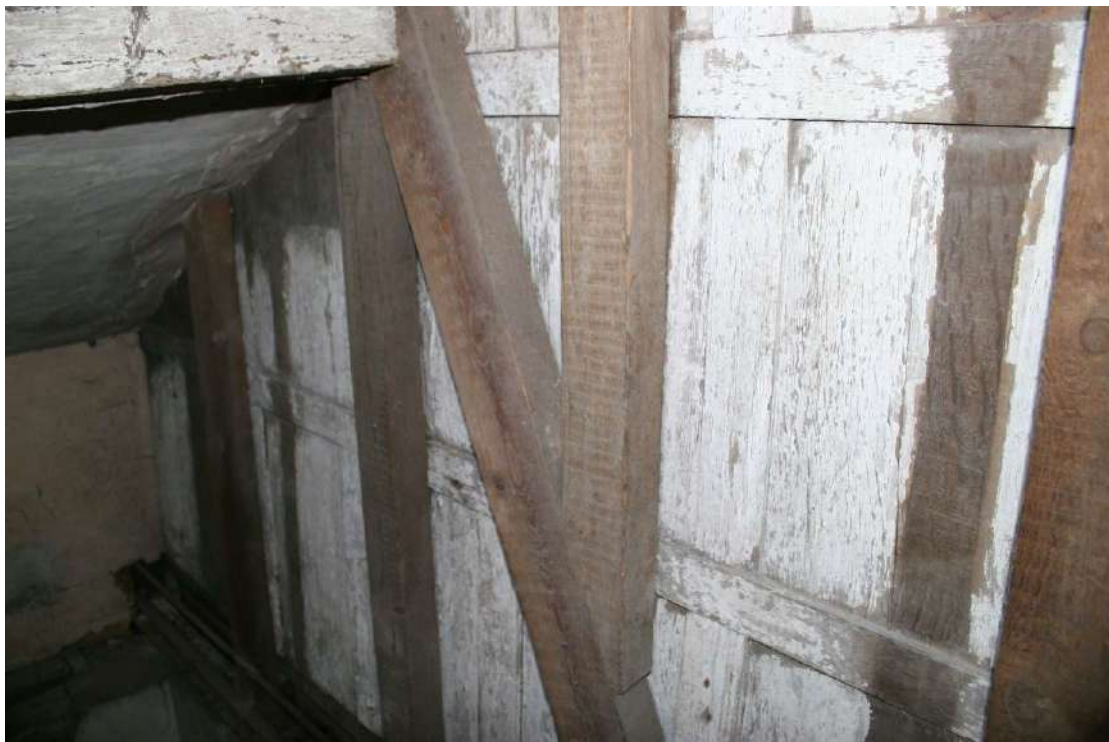
The back of the West Staircase panelling with C20th reinforcements to the staircase.

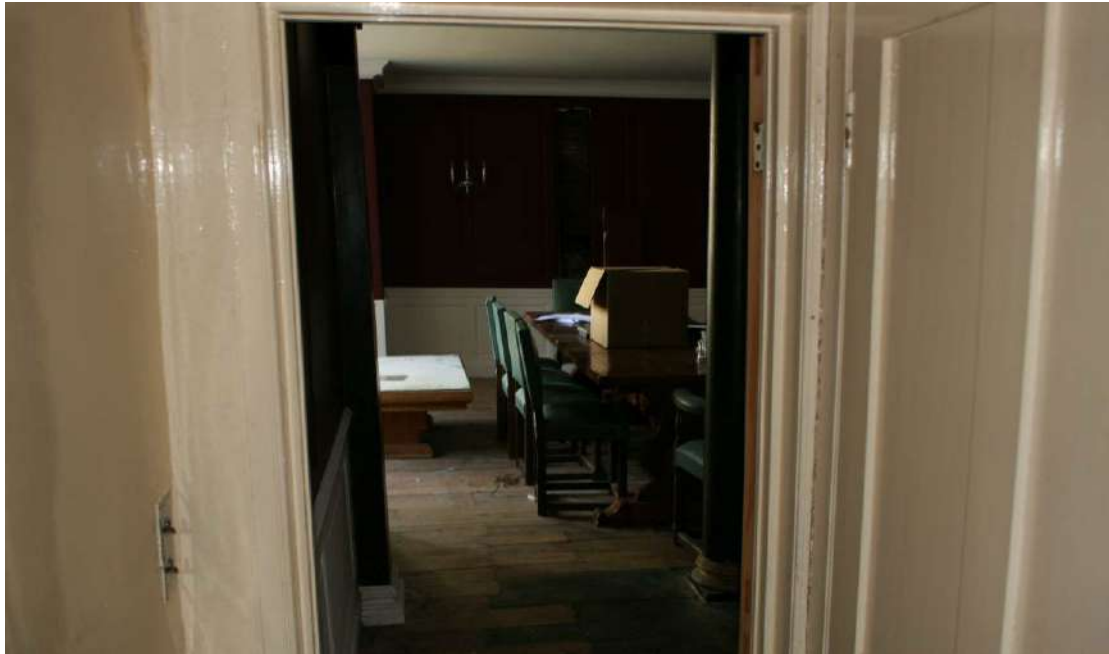
Looking W from under the West Staircase into the Dining Room.

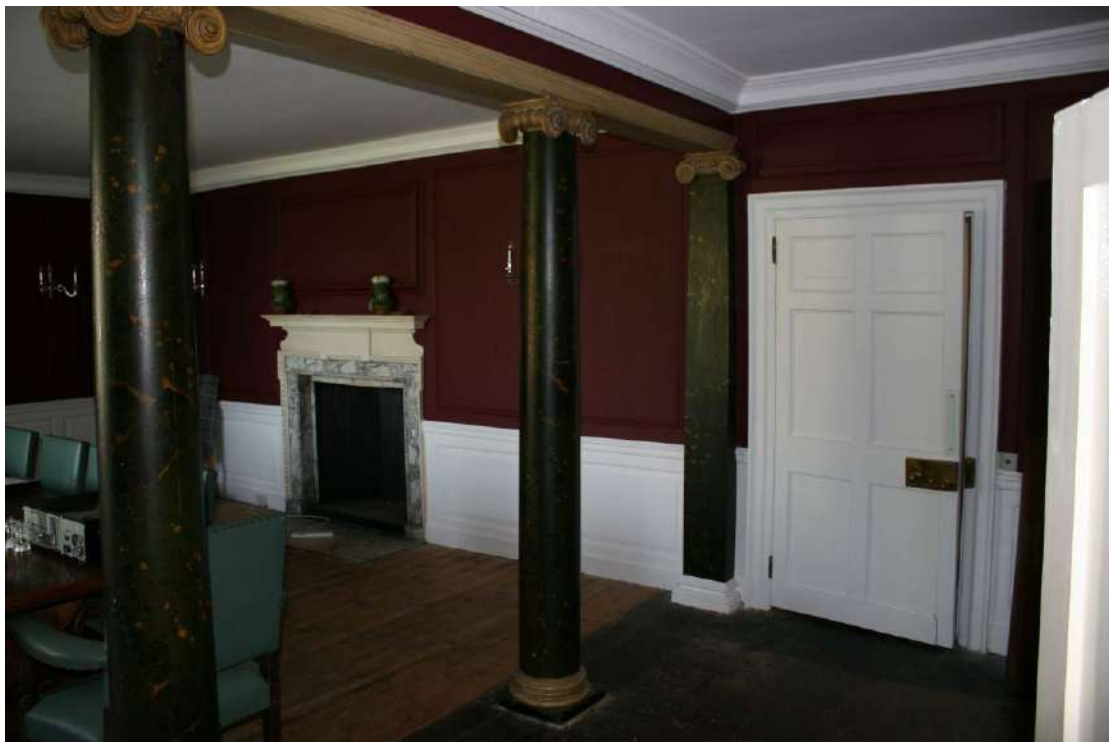
Looking SE in the Dining Room.

The Dining Room has some original C18th features with timber columns and flat pilasters against the walls painted to resemble marble supporting a heavy ceiling beam on Ionic capitals. The six panel Georgian style door leads into the Grand Entrance Hall and there is a more modest four panel Victorian door into the servant's passage.

The 1952 Listing notes . *Late C18 panelling and columnar screen in dining room*. While the columns may well be of LC18th style and genuine items, the panels appear to have been replaced in the 1939 works and their modern construction is shown in the east wall where one was removed for access. The brickwork blocking the Dining Room window is set under a rowlock course and matches much of that used in the remodelling of the Kitchen walls by Cooper in 1939.

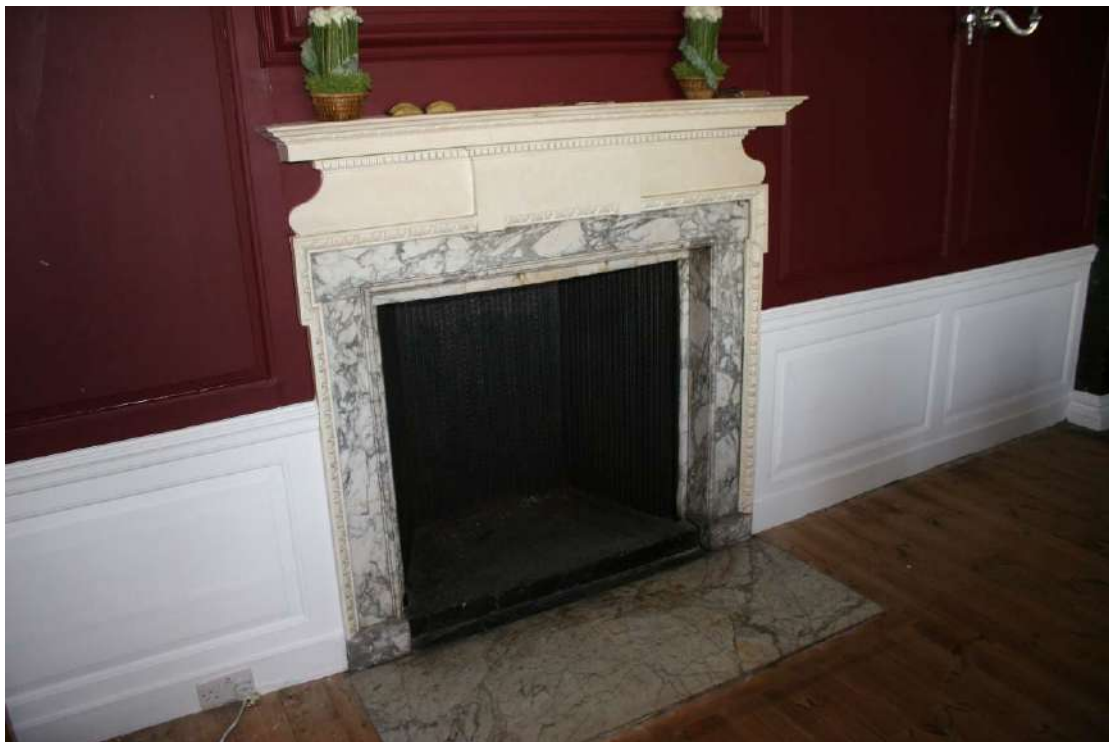
Detail of the marble fire surround and timber mantel shelf.

The room is panelled with large, fielded panels and wainscotting all of which fit correctly. There is a wide fireplace with an 'eared' grey marble fire surround and C18th style timber mantle with a central plaque and modillions to the mantel shelf. Like the other fireplaces the back has been sheathed with cast iron plates as part of the 1939 works and show little wear.

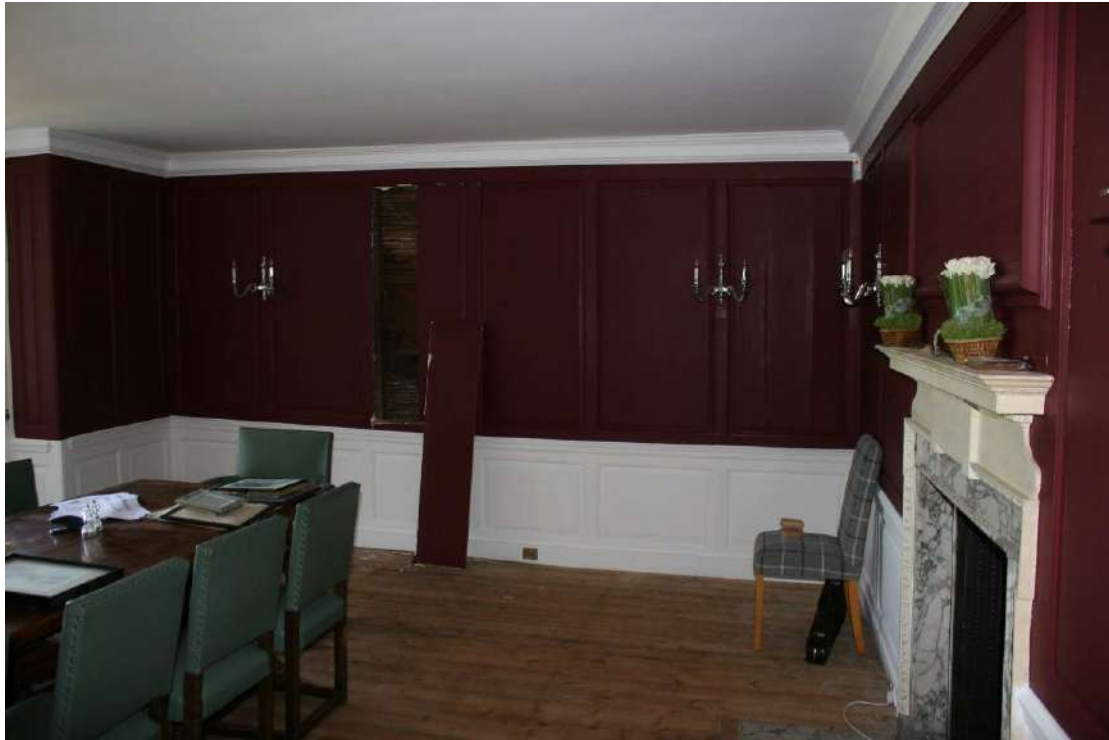
Looking E in the Dining Room. A panel has been removed.

One of the wall panels was removed to reveal the side of the East Staircase. This shows the string, risers and treads to be made of clean, fresh machined pine. The walls studs are also softwood but are greyed with age and bear saw marks from a powered reciprocating saw rather than being pitsawn.

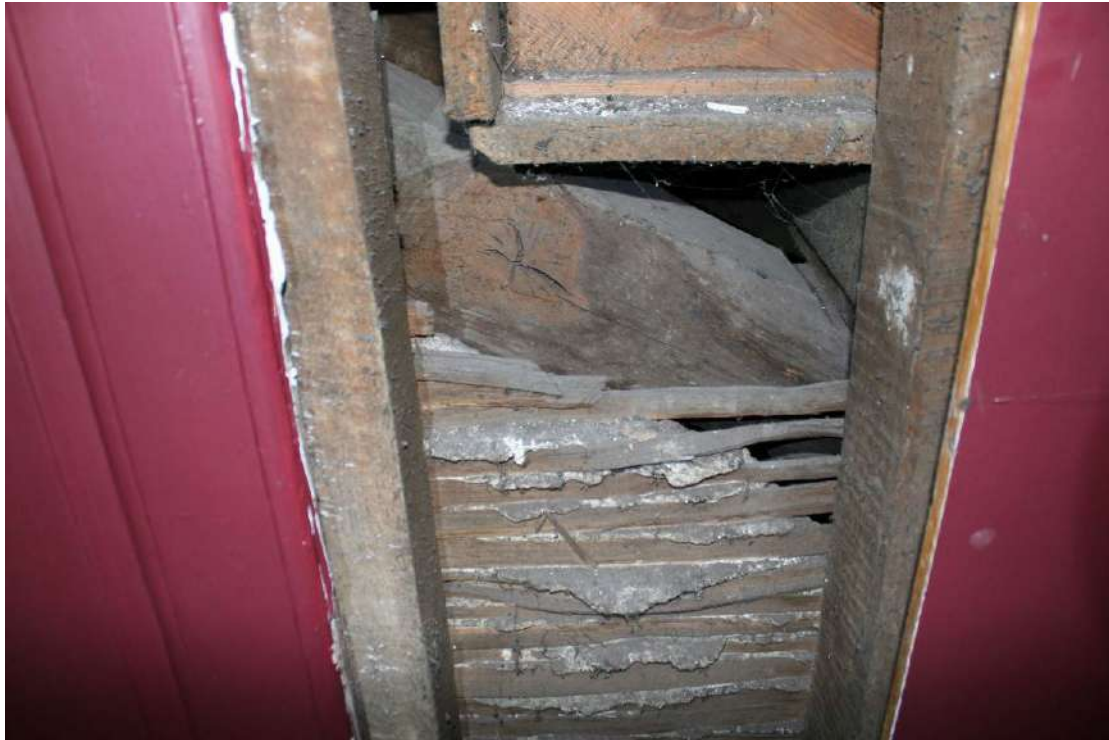
Detail of the bearer for the East Staircase and older riven laths.

There is an early bearer under the staircase of aged oak and section of older lath and plaster with grey lime plaster snots. Above the stair treads, the laths are made from riven cedar and have clean white snots where the wall has been thickly replastered. The panels are made from tongue and grooved clean pine, machine mouldings and plywood sheets.

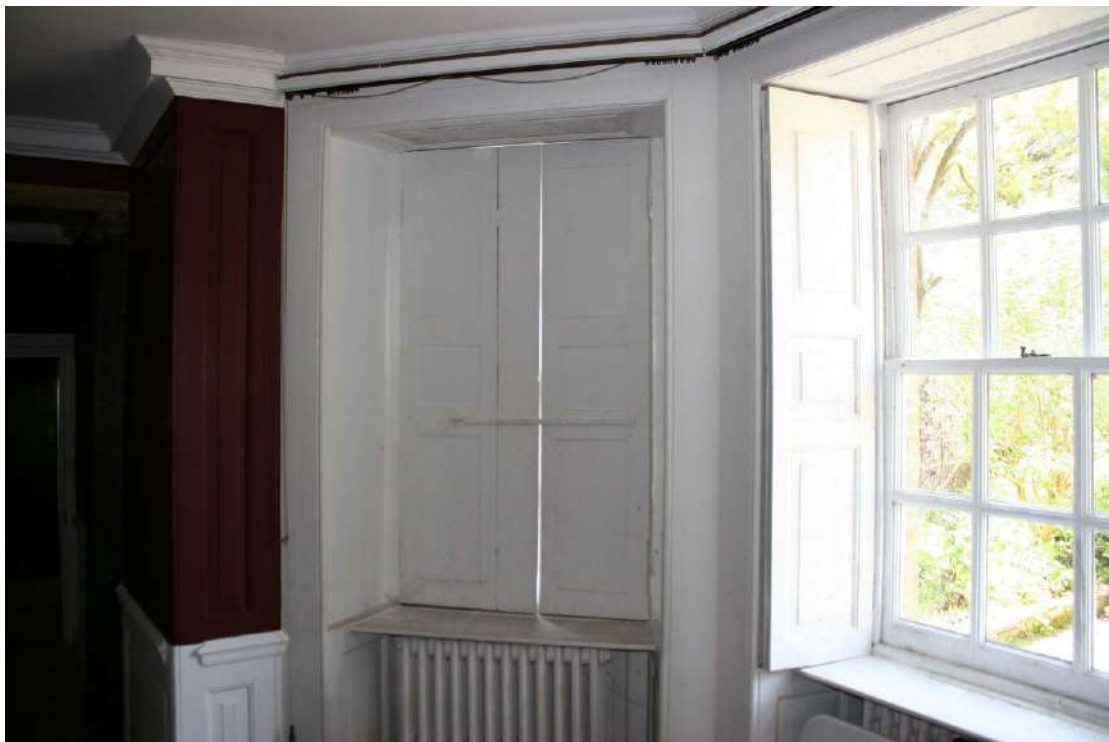
Detail of the shutter in the Dining Room Bay window.

The bay window is a LC19th addition and has well made shutters with iron shutter bars with turnbuckles and H hinges on the folding section. They are designed so that a narrow shutter can be opened to give light without the whole shutter being drawn back. The fielded panels match those on the walls and it can be concluded that the panels are either LC19th or from 1939. C20th cast iron radiators are set under each 6/6 sash window which are LC20th replacements.
