## Julians Park, Rushden, Buntingford, Herts. SG9 0TD.

Historic building recording and analysis of the House. Recorded 08 05 2024.

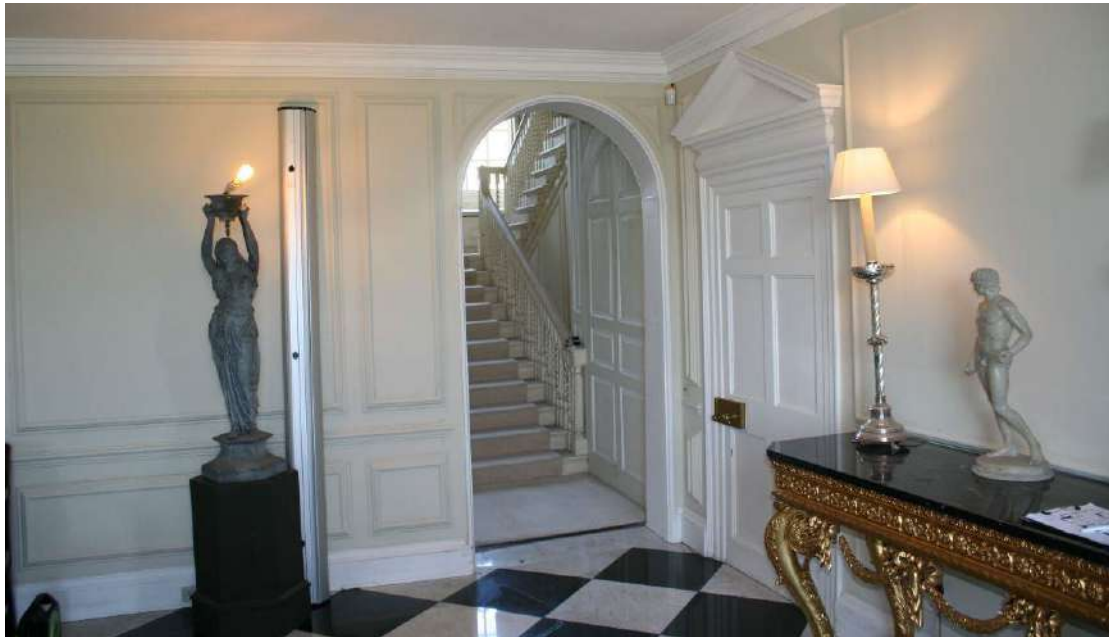
The East Staircase accessed from the Grand Entrance Hall. Looking NE.

This described in the 1952 Listing. *Interior: early C18 dog-leg staircase, barley twist and fluted colonnette balusters arranged 2 to 1, fluted colonnette newels, open string with cheek pieces, moulded ramped handrail, dado panelling.*

During the survey there was no evidence found of any structures earlier than the c.AD1710 walls and few features remain. The East Staircase is described as; *The staircase opens directly off the hall, and probably at one time formed a back projection, but considerable additions have been made to the house. The stair is a very good example of the Queen Anne period, with delicately twisted and fluted balusters and carved ends to the steps. The details are very similar to the stair at the Great House, Cheshunt, which belongs to the same period, though the arrangement of the returned ends of the steps is somewhat different. There are wide folding doors at the foot of the stair, to shut it off from the hall when desired.*

However, it can be seen that the treads and risers have been replaced in a later phase with machined softwood and only the balusters remain.

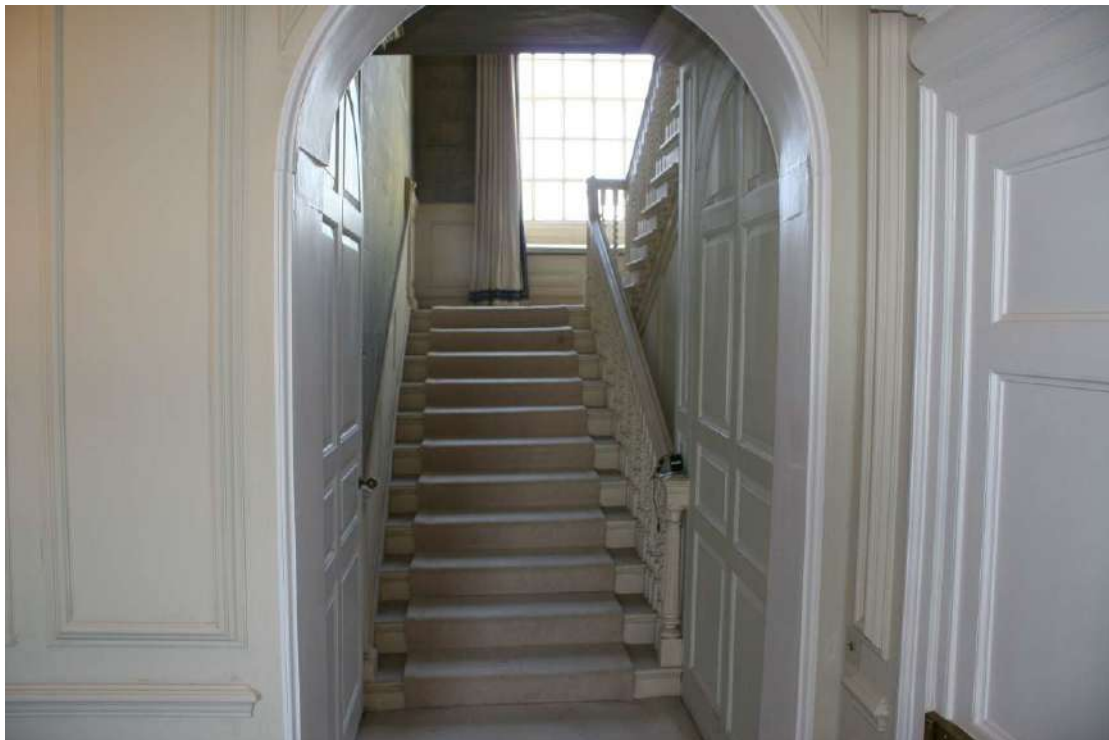
Looking N up the West Staircase.

The West Staircase is complete and in original condition save for some supporting struts in the Cellar and cast iron pillars supporting the trimmer beams. It has very similar features to the East Staircase and is well described in the 1952 Listing: *Early C18 dog-leg secondary staircase with slightly bulbous balusters, closed string, moulded handrail*. What is not noted however is that the West Staircase ascends to the Attic floor which by deduction must have been established at the same time.

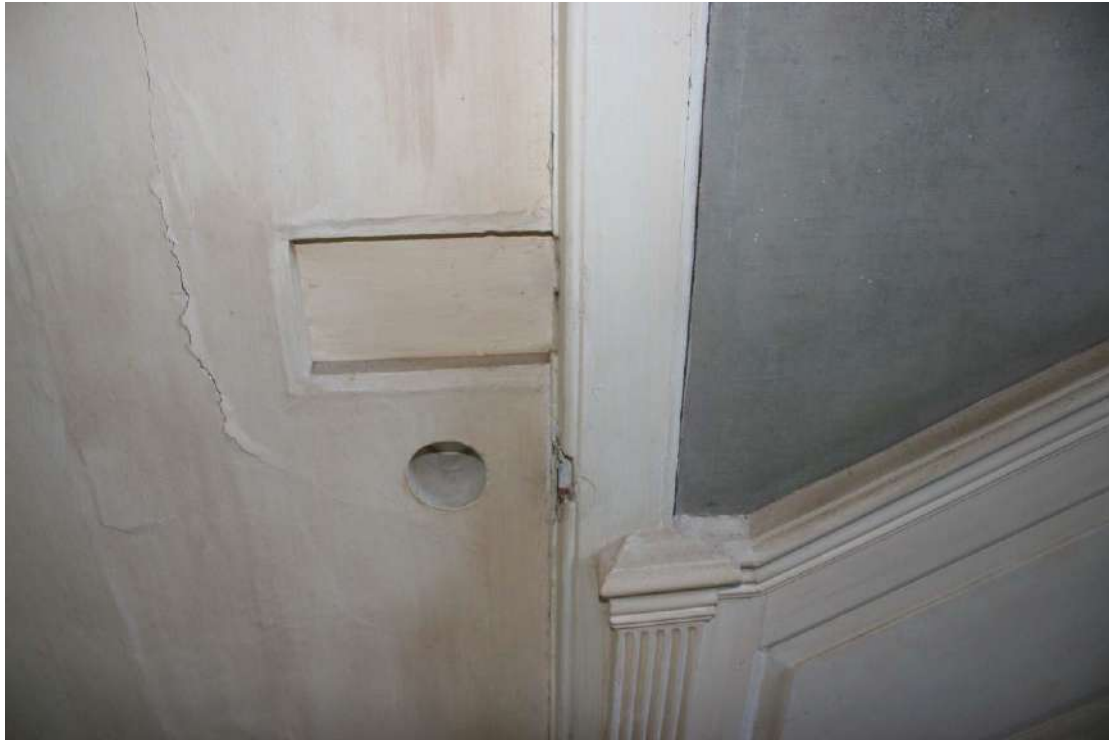
Recesses in the wall for the lock box and knob for the folding doors. (Now removed).

It was seen in the Dining Room that the string, treads and risers have been replaced with machined softwood. There is a hasp for a door bar and catch for a Suffolk latch and on the other side recesses in the wall for the lock box and knob for the folding doors described in VCH 1912 and probably removed by 1952. None of the records mention the wall paintings.

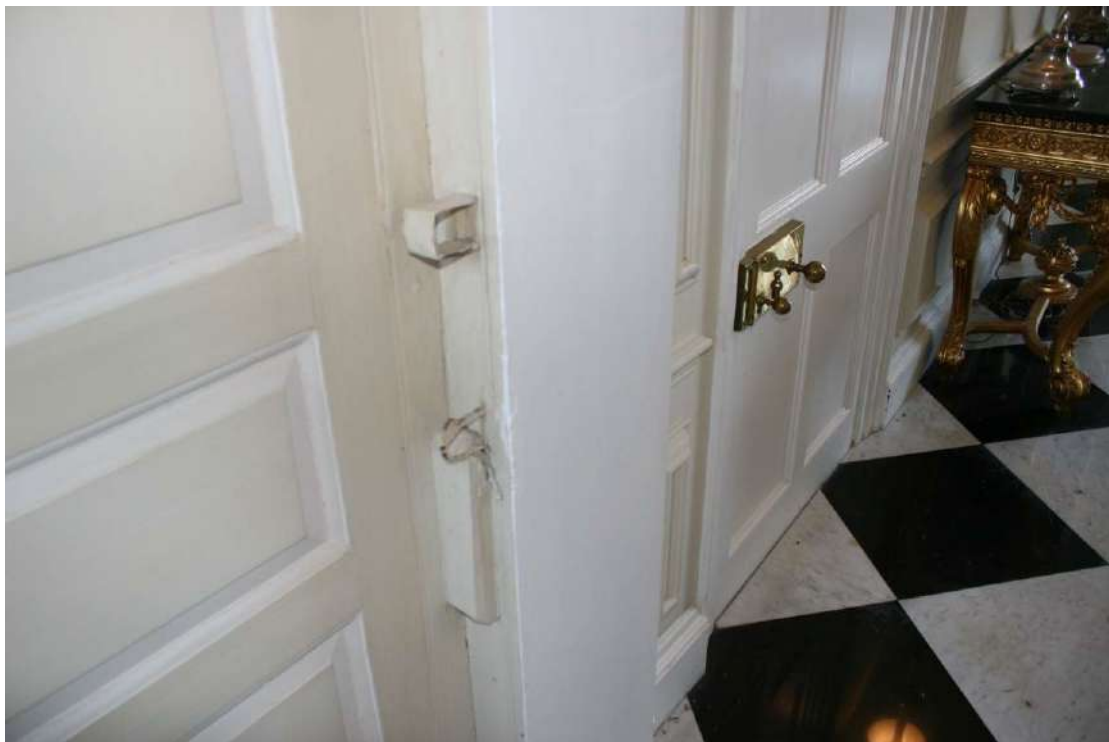
Hasp for a door bar and catch for a Suffolk latch.

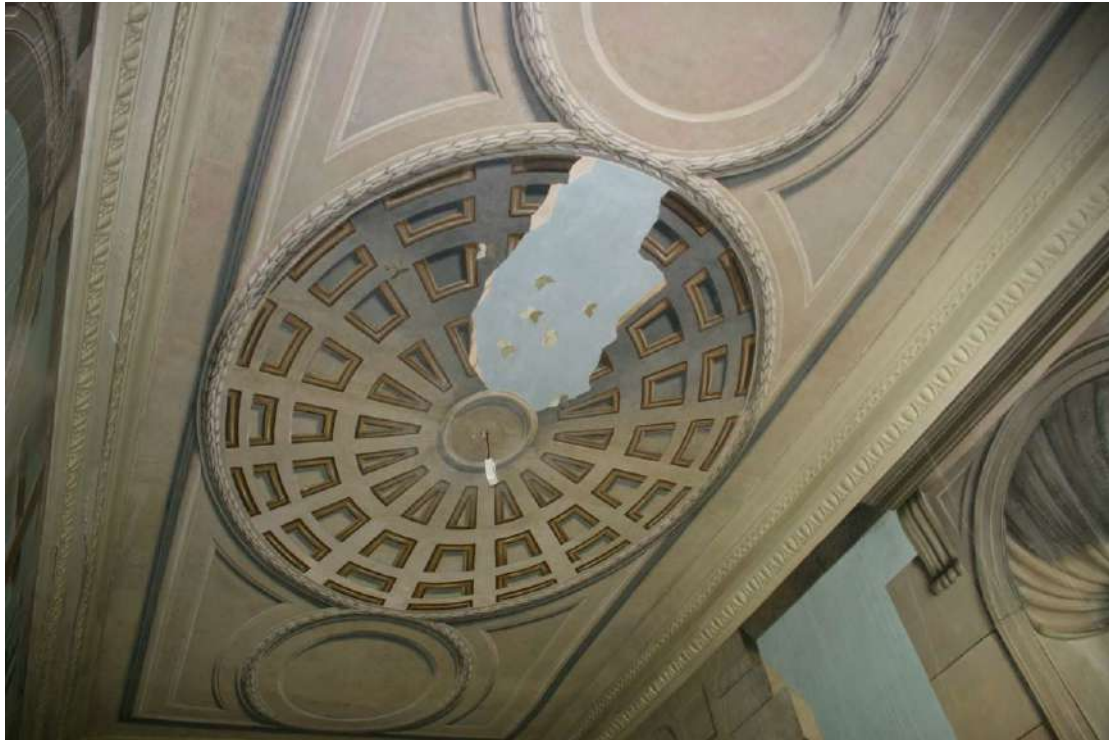
The ceiling has water damage.

From the fabric seen in the Dining Room it can be assessed that the render on the walls is either from 1939 or later, perhaps 1952 when the paintings were made. There are some deep and extended cracks in the render and the ceiling paper has peeled off due to water ingress from leaking bathroom fixtures above.

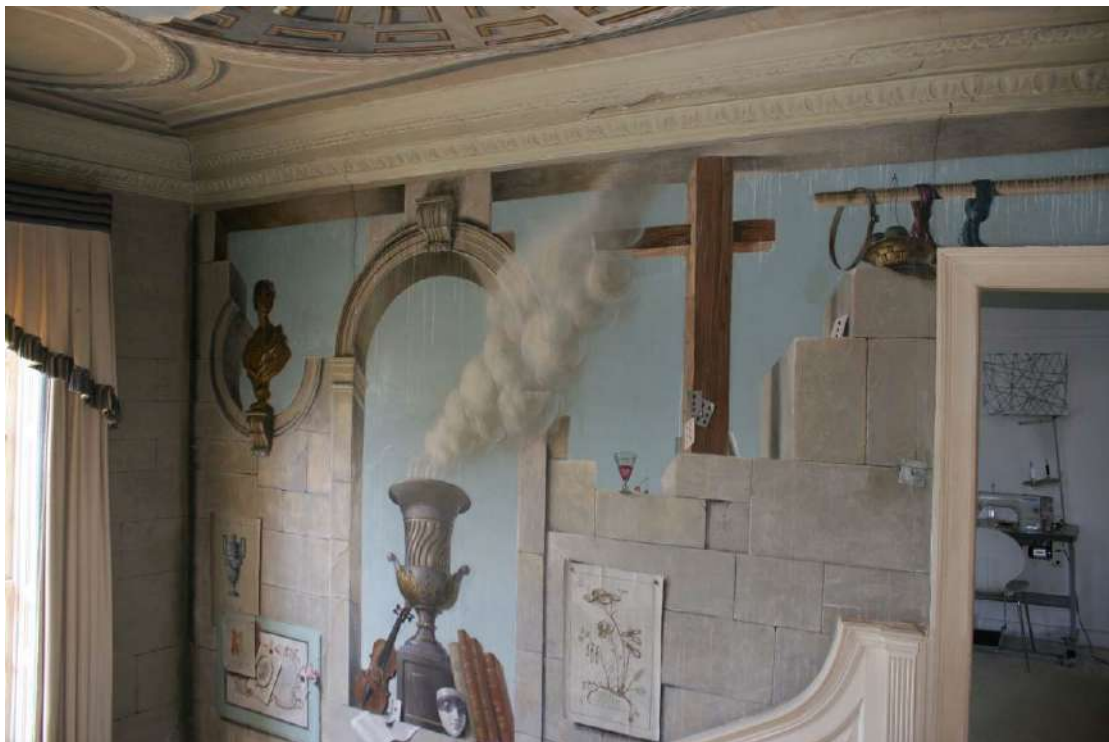
The east wall has serious cracking in the render.

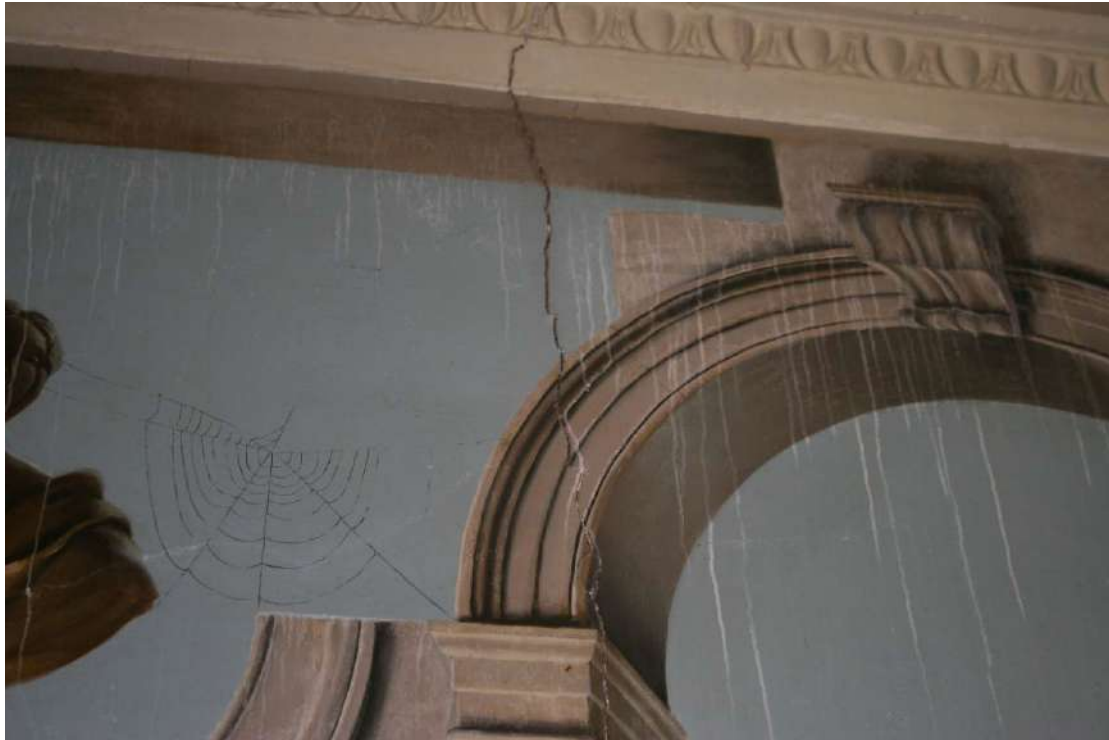
Deep visible crack in the east wall.

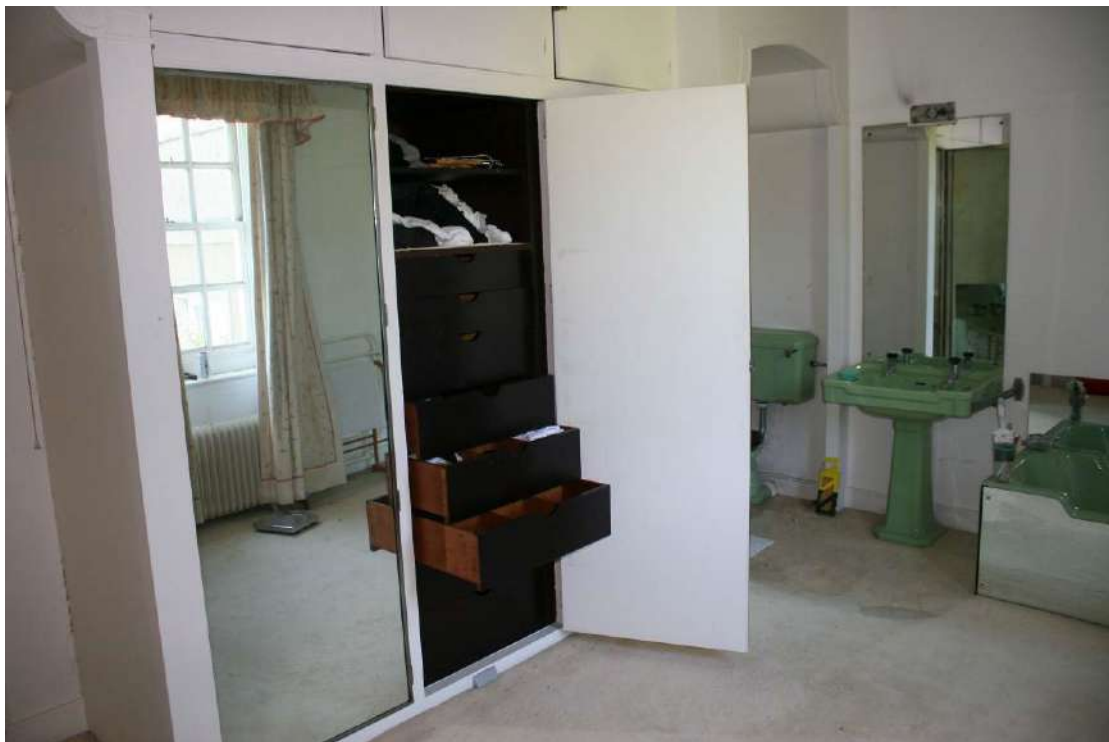
The glass fronted wardrobes conceal custom made valet drawers.

Bathroom 1 is decorated to 1939 standards and has Art Deco style avocado sanitary wares original to 1939. The wash basin matches that in the Wash Room by the West Entrance on the ground floor. There is a set of glass fronted wardrobes concealing custom made valet drawers and hanging rails. The walls are plainly finished as part of the 1939 refit.

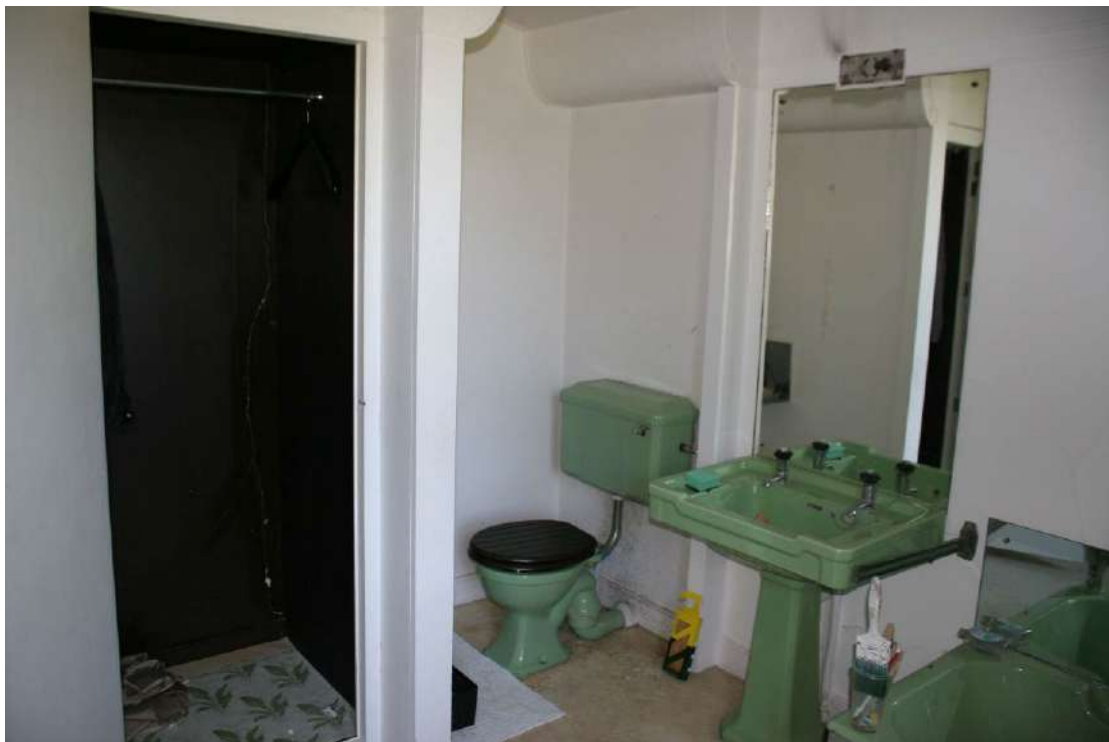
Original 1939 Art Deco style avocado sanitary wares.

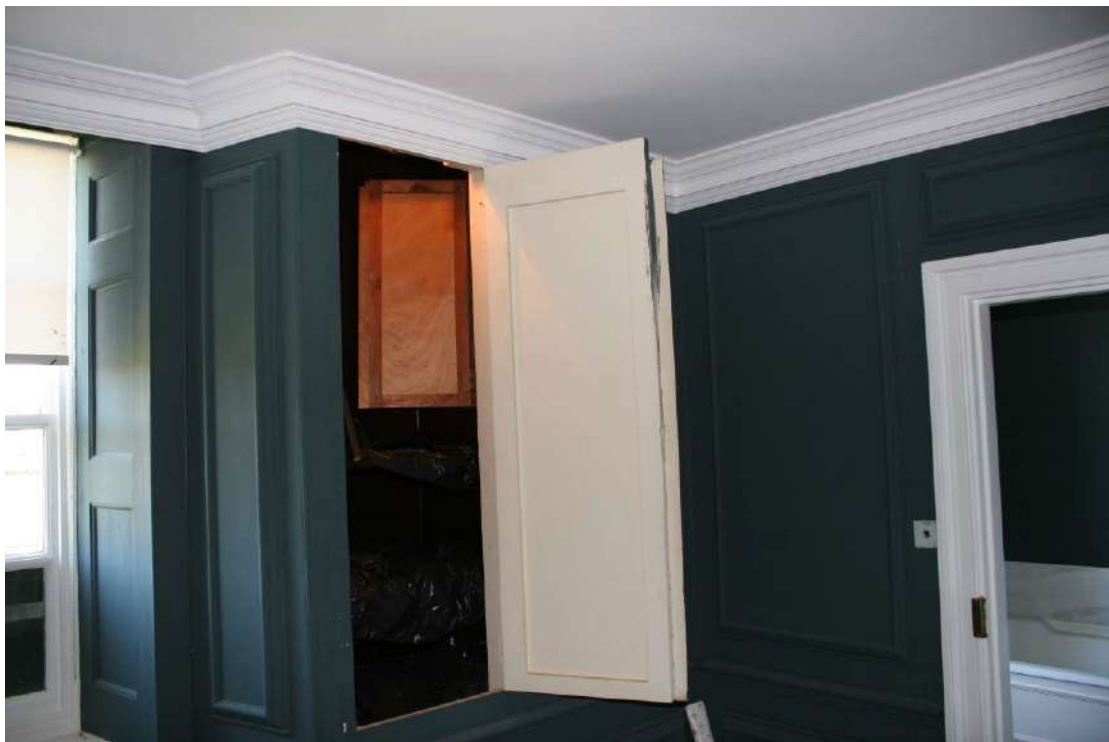
Closet containing the water cistern for the WC in Bathroom 2.

There a large number of features fitted into the walls that were put in during the 1939 works or later. There is a closet with fitted shelves, a hanging closet and a closet containing the cistern for the WC in Bathroom 2. In the hanging closet there is a vertical chain and spring with electrical connections for a front door bell.

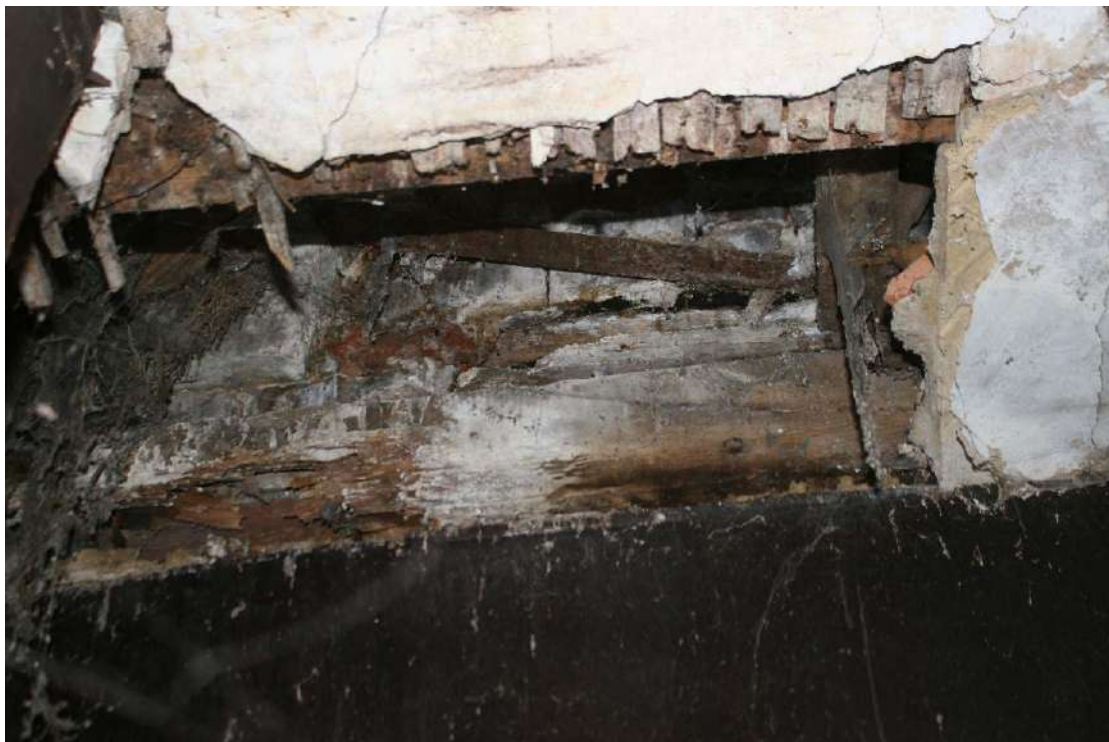
A fragment of the earlier lath and plaster panels above the shelves.

Looking up in the closets there are fragments of the earlier lath and plaster panels and where there are electrical sockets and light switches the panels are made of hardboard or Essex board.

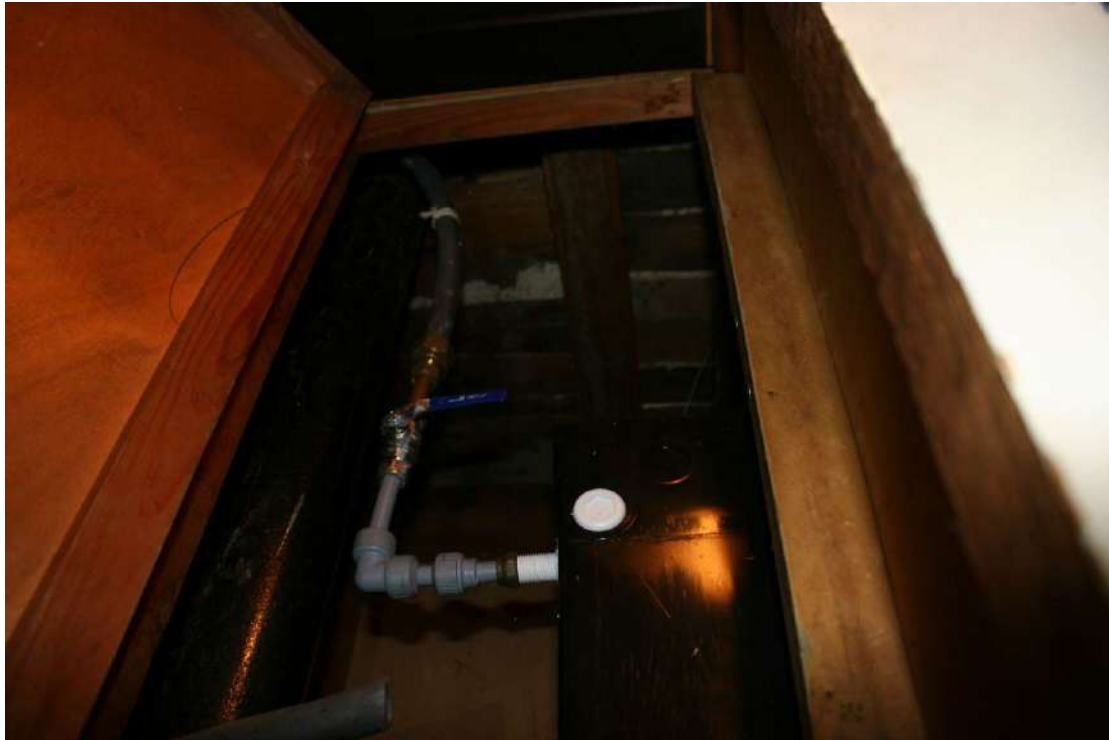
Plywood closet to conceal the cistern for Bathroom 2.

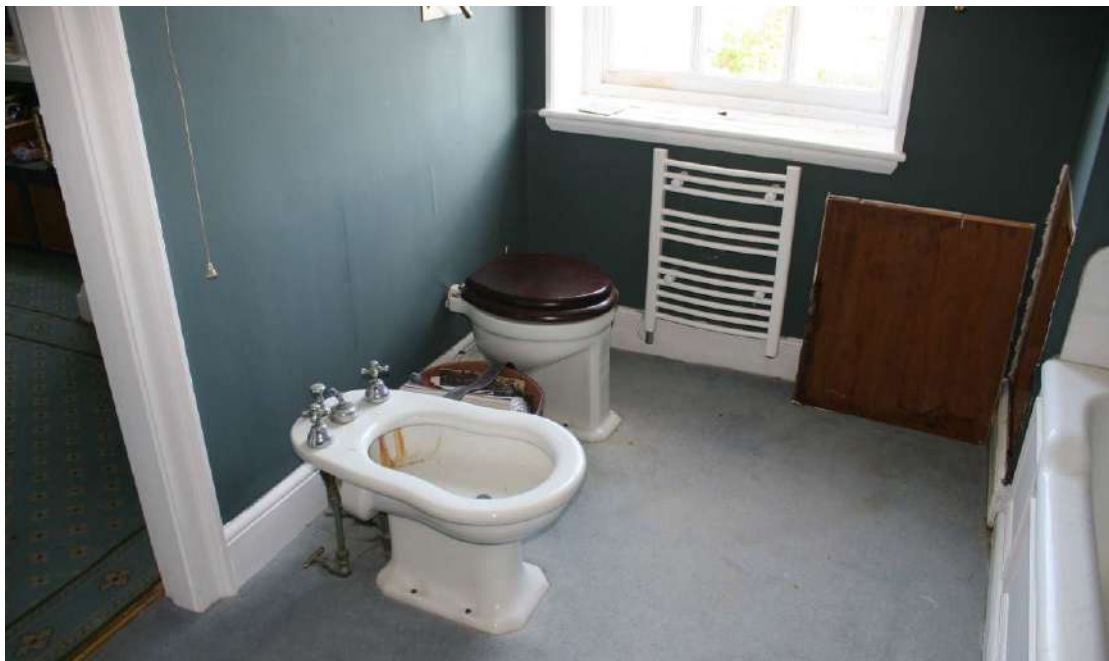
1939 original bidet and WC with original 1939 pipe work.

Bathroom 2 is a large well-appointed room with the luxury of a bidet, a feature not common in English homes as well as a WC with hidden cistern. The partition wall is inserted as part of the 1939 works as it is clumsily set against the window splay.

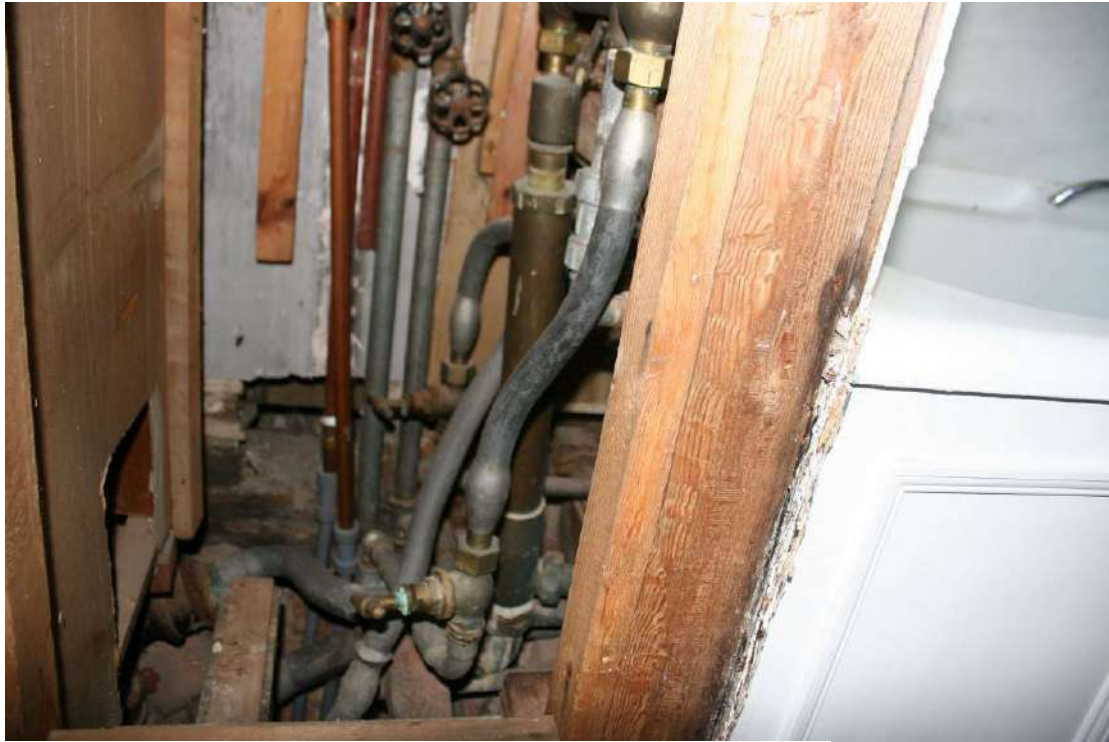
The plywood and softwood timber carcase hiding the 1939 plumbing.

All the plumbing is hidden in plywood and machined softwood carcasses and boxing. The floor joists are also machined softwood but are much older and discoloured with age. There is a large baulk of timber that has been hacked back for the plumbing that may be older still.

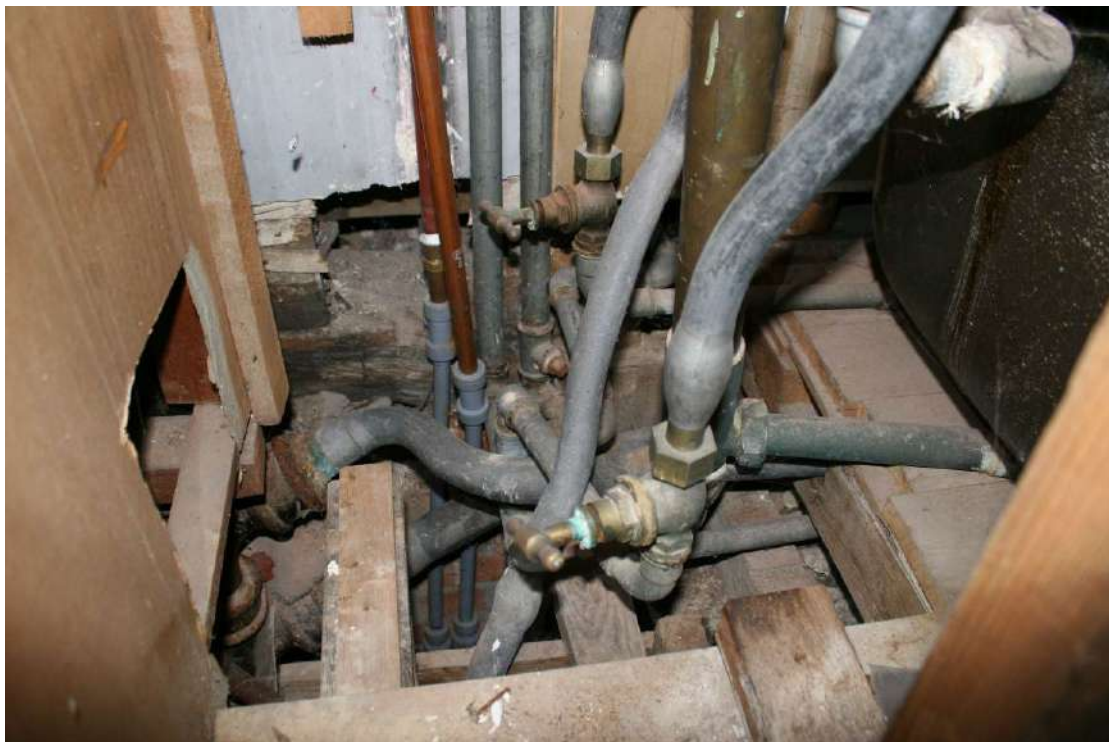
Detail of the leadwork pipes.

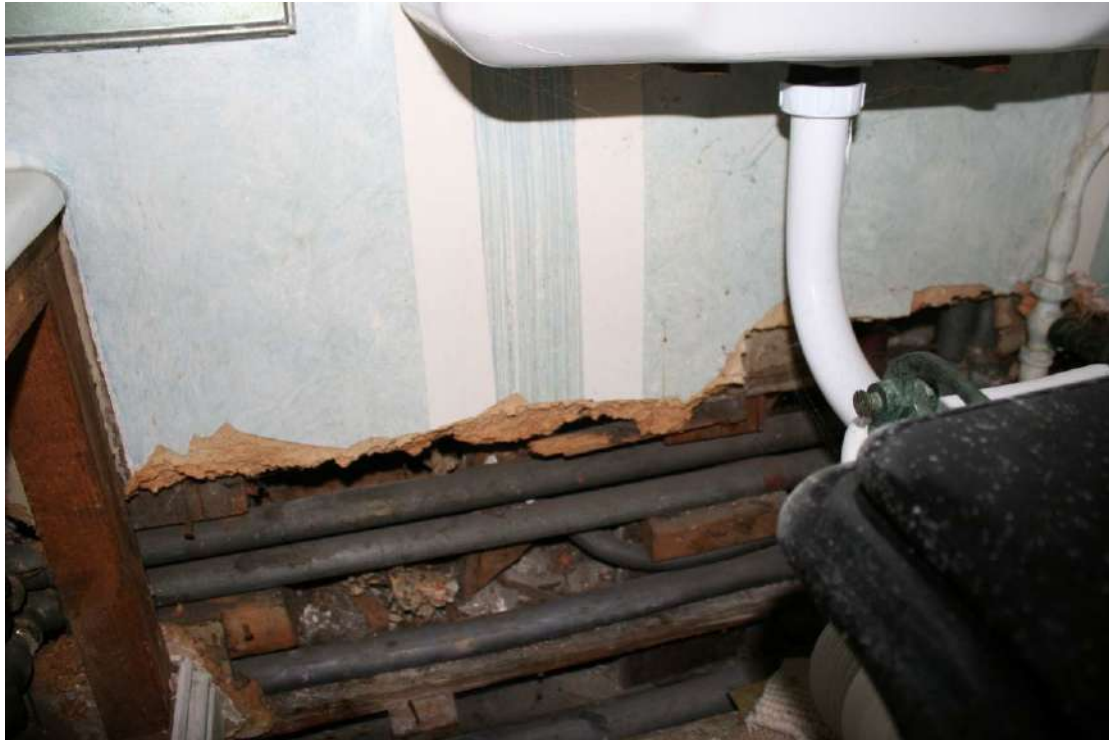
Outfitted as part of the 1939 works all the fabric is of that year except for the hob grate cast iron fireplace. The walls are clad with plywood and hardboard.

Water damaged hardboard panels concealing the lead water pipes.

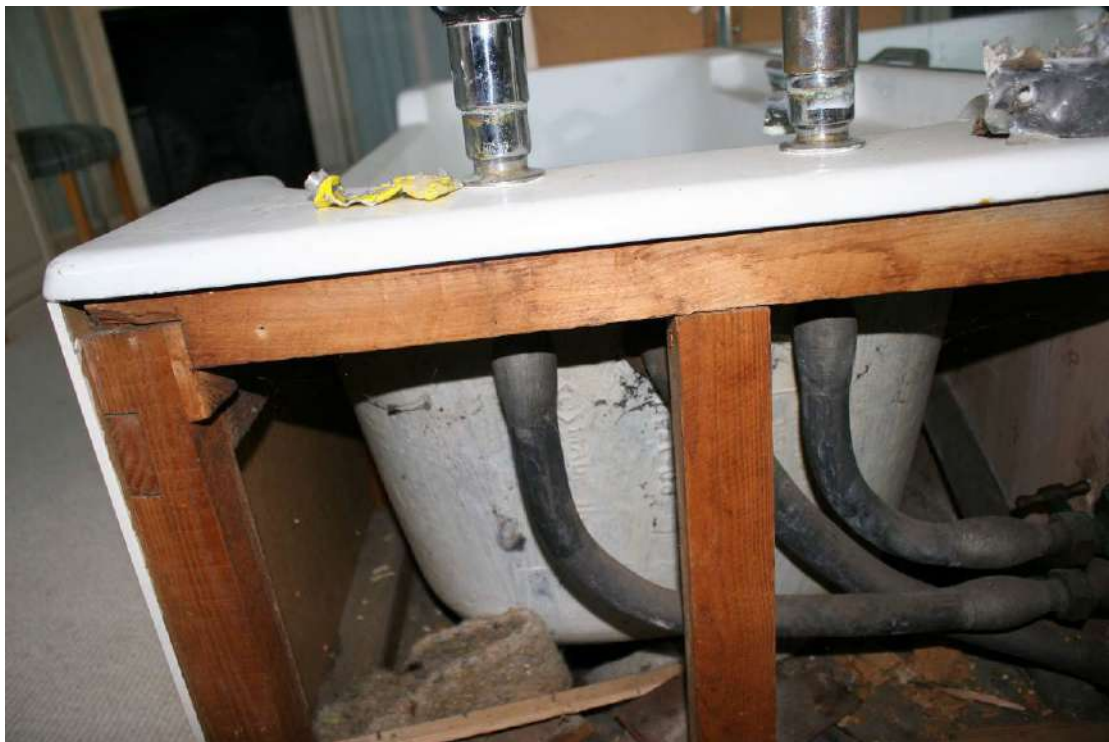
Machined softwood carcase for the cast iron bath.

All the bathroom fixtures are of the period 1939 and the cast iron bath is marked Made in Britain 27. The square Art Deco basin is branded Bolding 'Julia' London. John Bolding & Sons Grosvenor Works were situated at 56-58 Davies Street, London from 1891 to 1969. They were manufacturers of high end sanitary appliances, brass founders and metal merchants.

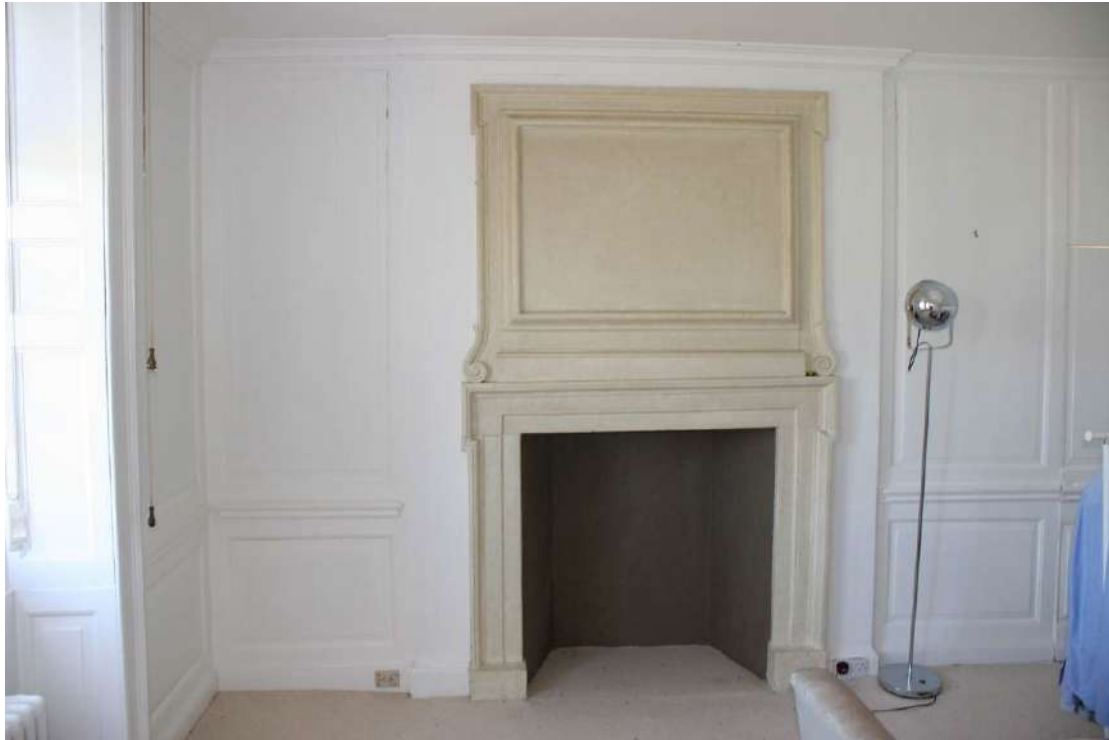
The fire surround and overmantel is resin fake.

There is a C18th style eared fire surround with a panelled overmantel also with ears and two small volutes. These are made of a resin compound which may be fibreglass. Again, the fireback has cast metal sheets. In the corner is a closet with a panelled door and a sponged paint effect inside. All these features are of 1939 or later.

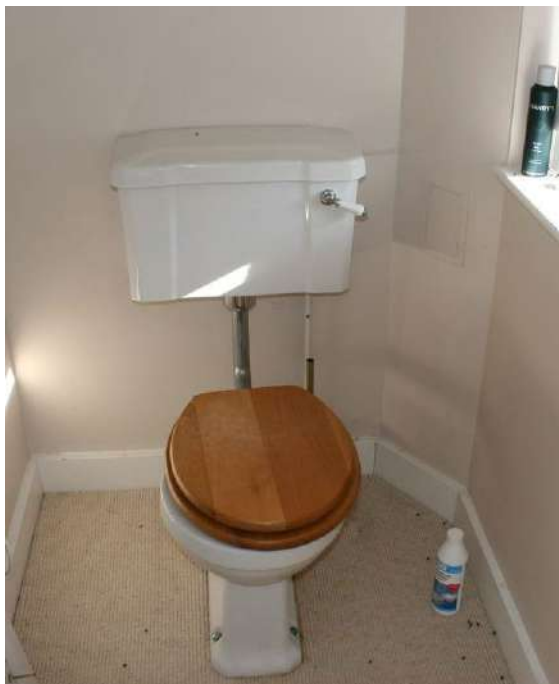
LC20th WC and cistern.

Bathroom 4 is concealed in the NW corner of Bedroom 4 but was originally accessed from Bedroom 5. The Georgian style panelled door is still in-situ in Bedroom 5. The bath and basin are from 1939 but the WC has been replaced in the LC20th.

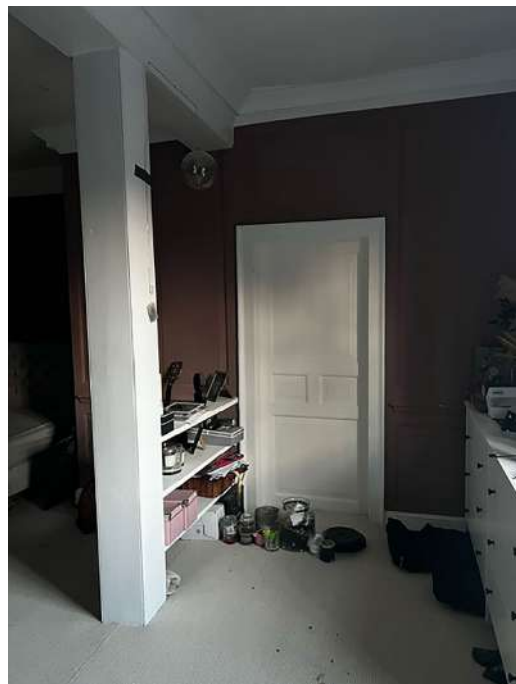
Blocked door from Bedroom 5 into Bathroom 4.

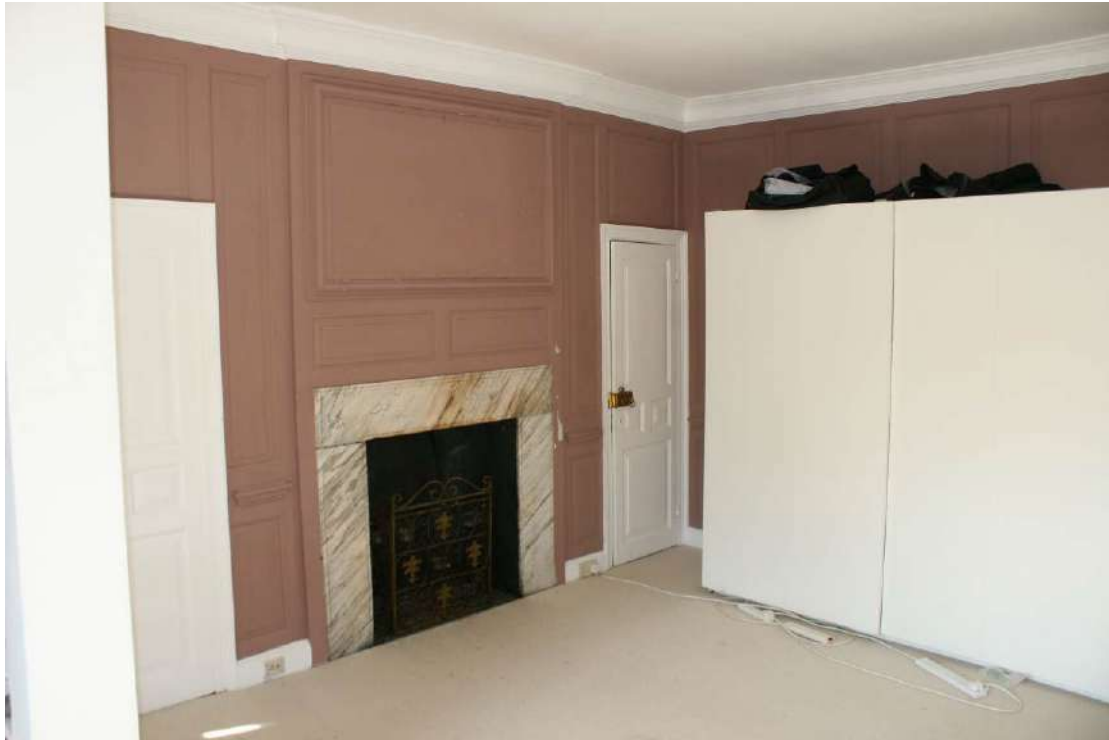
Looking NE in Bedroom 5 at the fireplace and closets.

The fireplace has a flat grey marble surround of Art Deco style and all the panelling is cut to respect it. Of interest are the narrow closet doors which are 1/2/1 panel doors with brass lock boxes. Inside there is a batten with C19th style hat and coat pegs as well as a MC20th clothes rail.

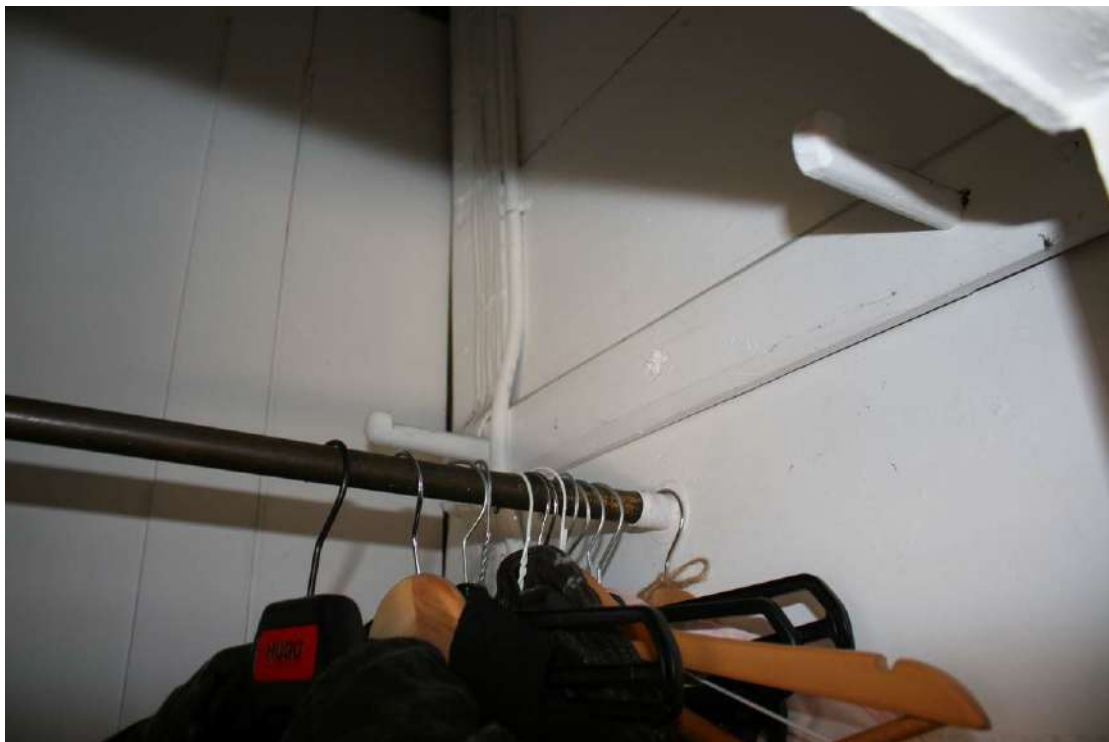
C19th hat and coat pegs in the closet.

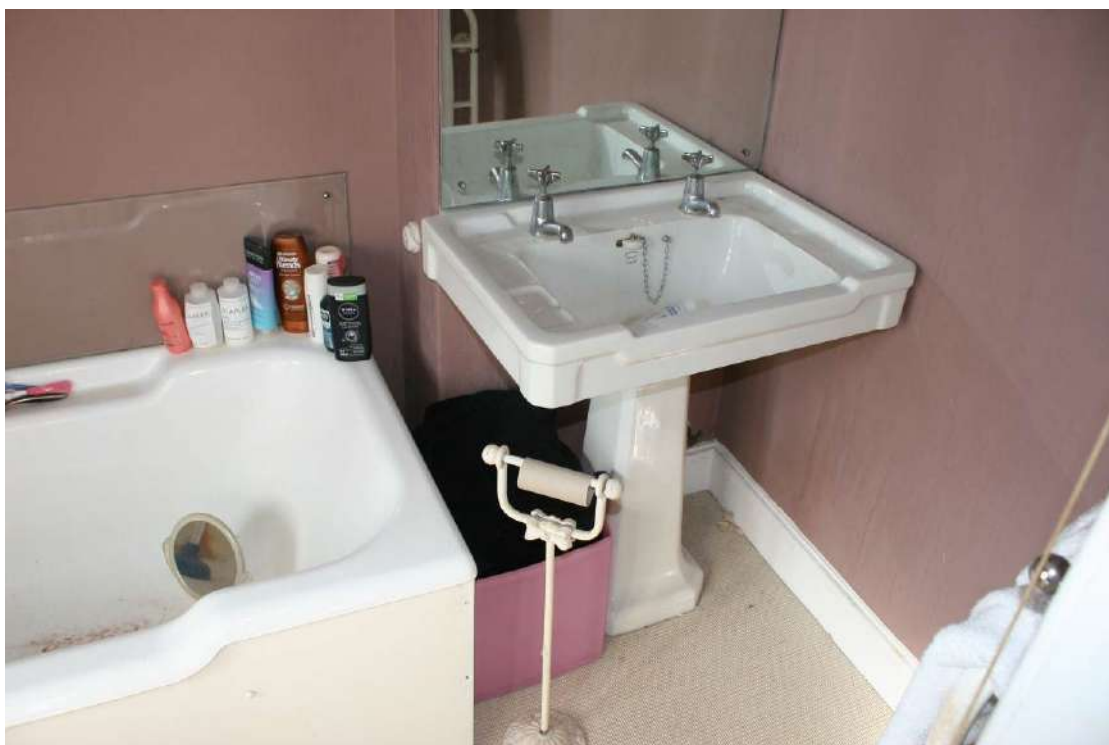
1930's style bath and basin in Bathroom 5.

Bathroom 5 is outfitted with 1930's Art Deco style white bath and Bolding 'Julia' London basin.

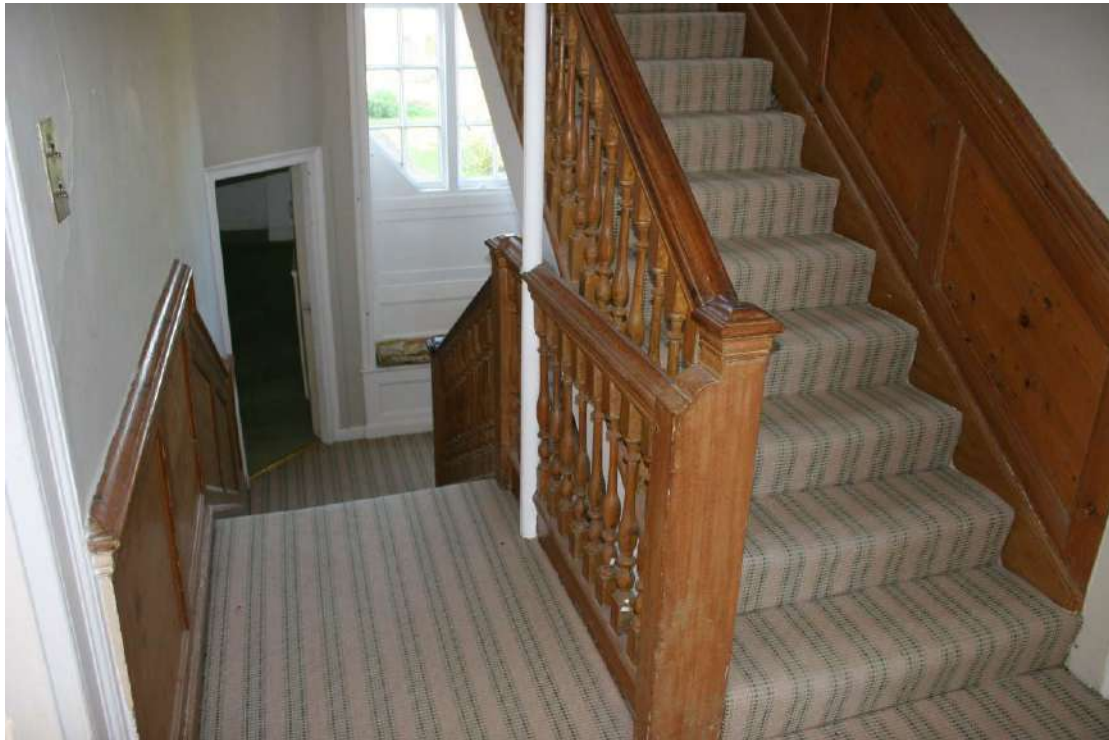
The West Staircase continues to the Attic floor reinforced with iron pillars.

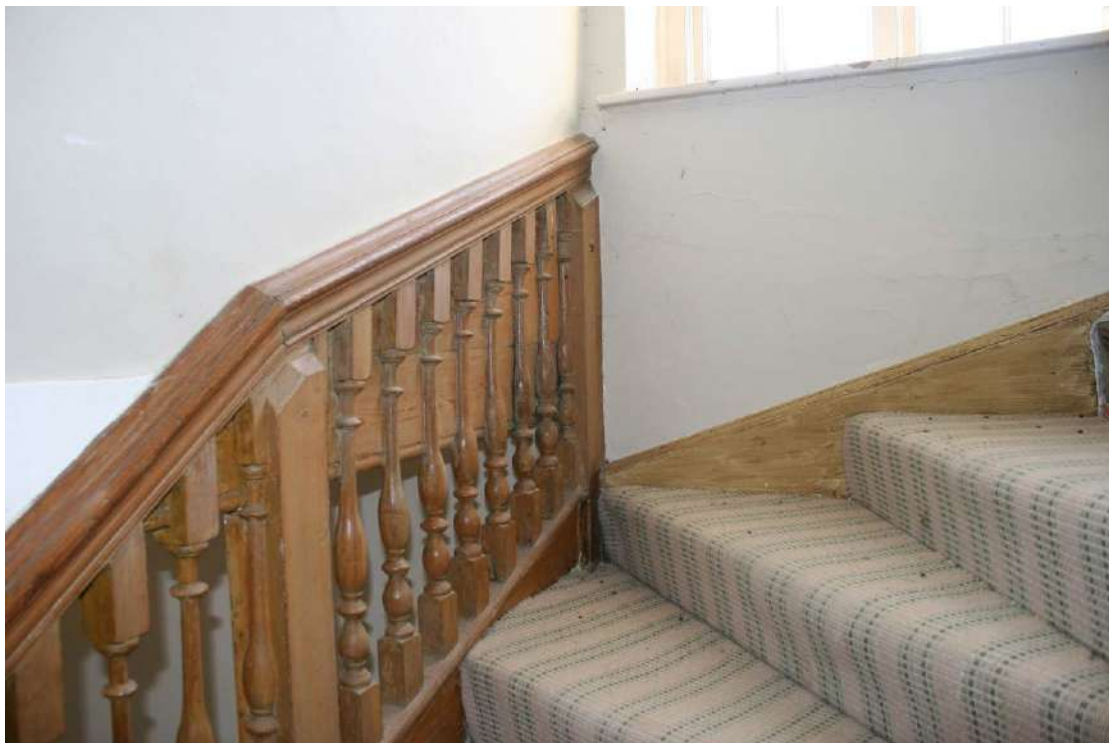
Detail of the balusters at the top of the stairs.

The West Staircase continues up to the Attic floor. An iron pillar has been added to support the upper floor but the balustrade was cut through to insert it.

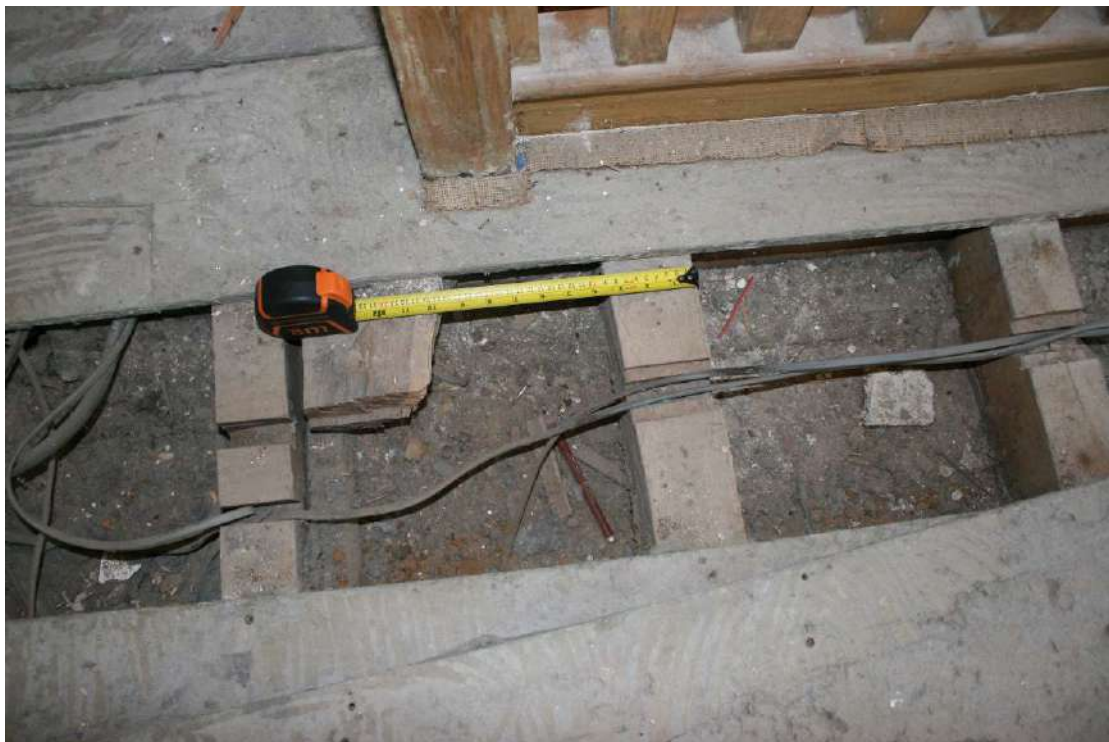
Detail of the floor joists on the Attic Landing.

The Attic floor is made from straight cut softwood and has 3.5x4.75in joists set at 16in centres and those on the Landing appear mechanically cut rather than from a pitsaw. The floorboards are 10in wide pine boards with some narrower inserts. The ceiling below is old laths over boarded with Essex or plasterboards.

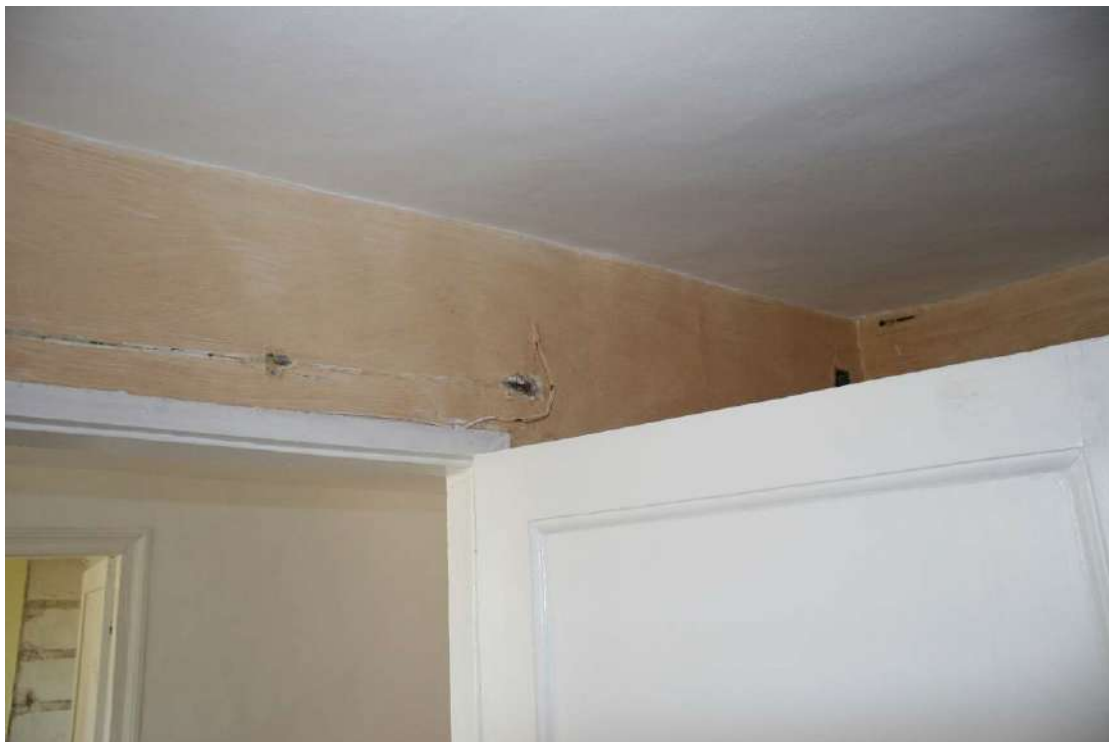
Looking at the SE corner where the old bell pull wires ran.

Room 1 has a typical Georgian style two panel servant's door with a Bakelite knob and is part of a suite of doors on this floor.. This room was used by servants in the C19th as there is a wire guide for a servant's bell in the corner. These were replaced by electric wires in the C20th which were then painted over before being pulled out.
