## Julians Park, Rushden, Buntingford, Herts. SG9 0TD.

Historic building recording and analysis of the House. Recorded 08 05 2024.

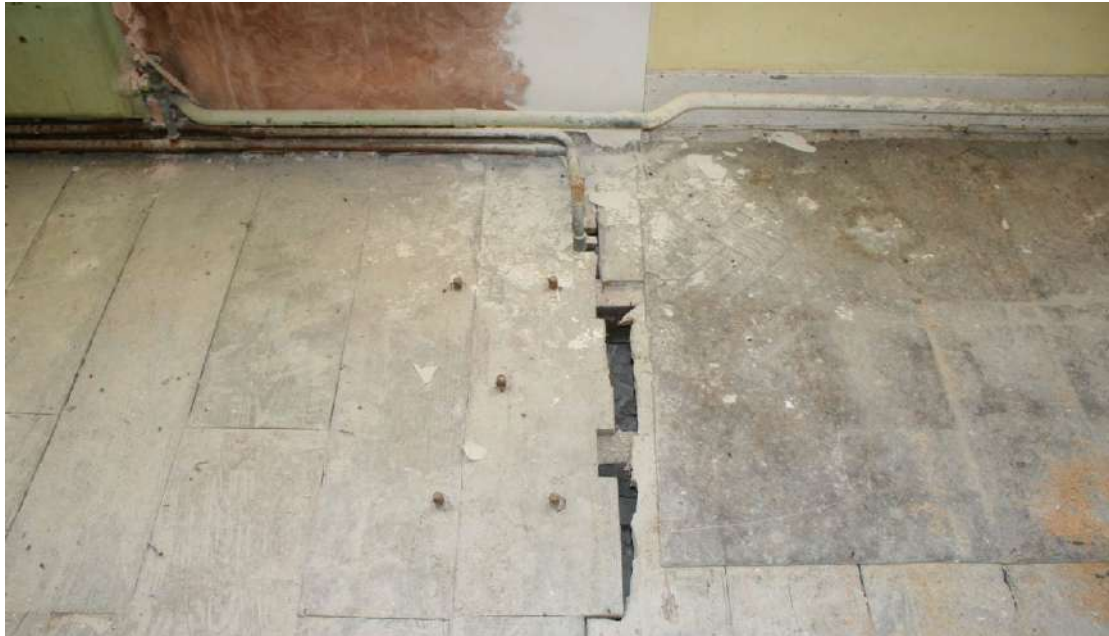
The floor has been water damaged where bath was fixed to the floor. Looking N.

Where the bathroom was situated, the bath has leaked and the floor is damaged. This may have contributed to the damage to the mural. The ceiling above is also damaged and there is a large repair section of recent plasterboard that replaces earlier plasterboard that may indicate an ongoing problem. The previous layer may well date to 1939. Period steel joists have been inserted to support the main timber joist.

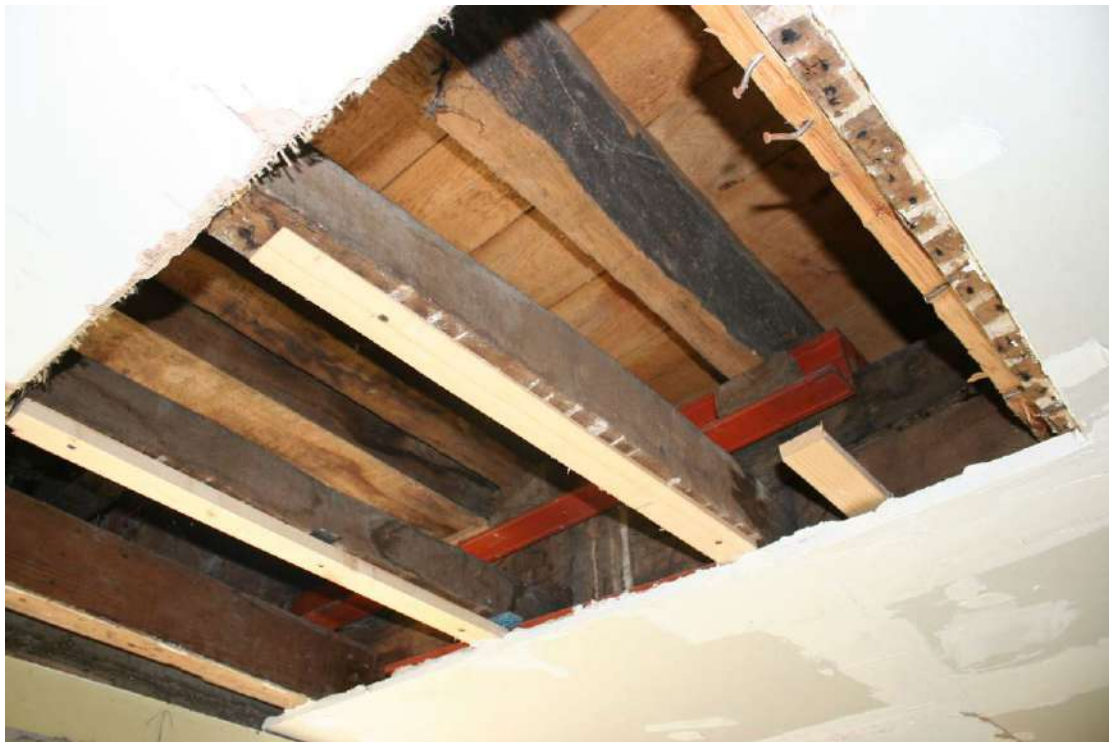
The ceiling has been repaired and has plasterboard sheets.

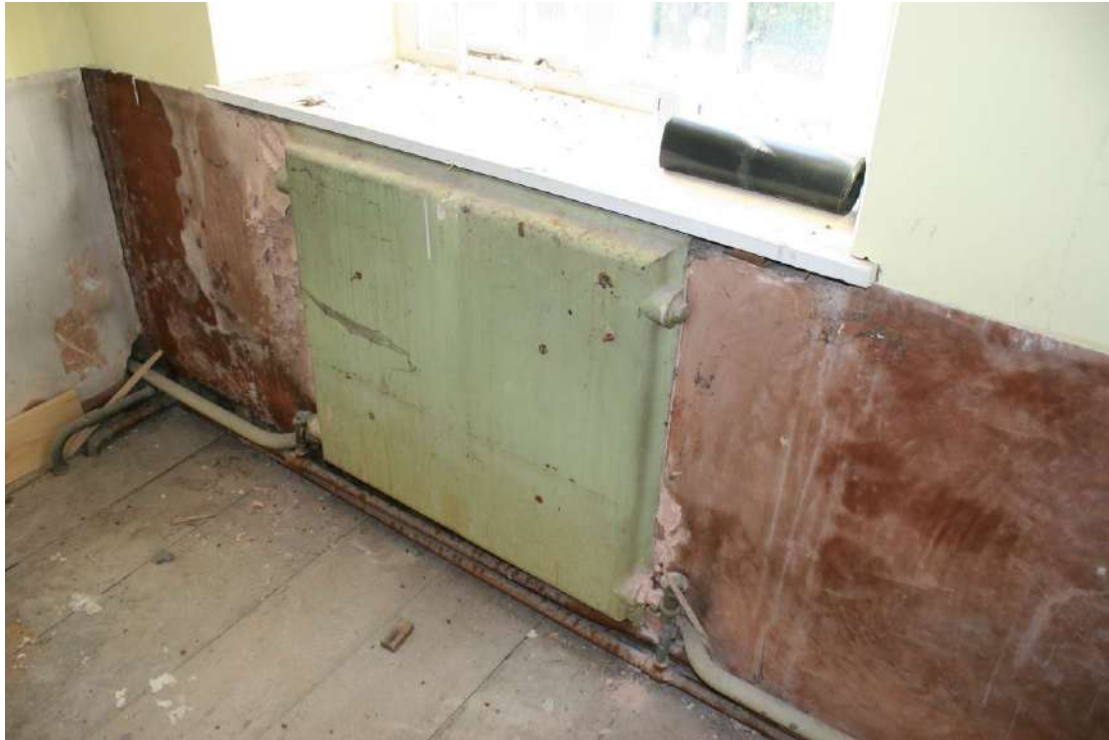
Unusual industrial radiators are used on the Attic floor.

The Attic is heated with unusual heavy duty industrial style slab radiators that may be military in origin. There is a small closet equipped with shelves covered with plastic patterned sheet and 20 cup hooks as well as coat or apron hooks. This looks like a small pantry for the staff.

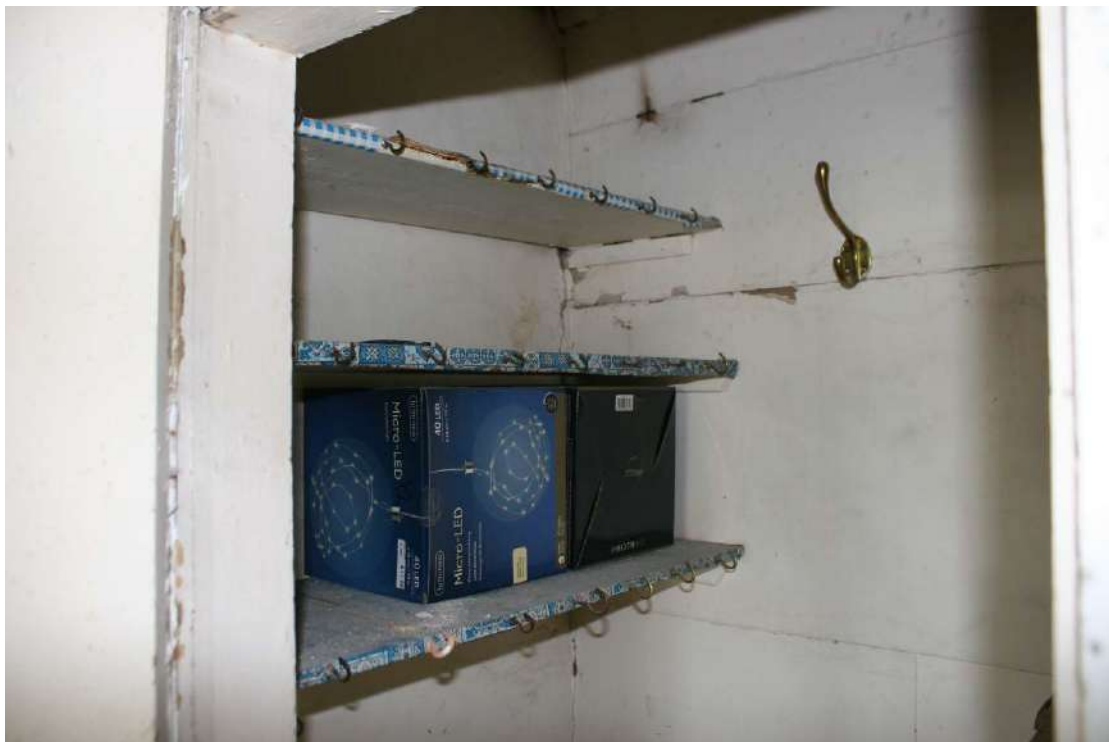
The small closet served as a pantry and coat cupboard.

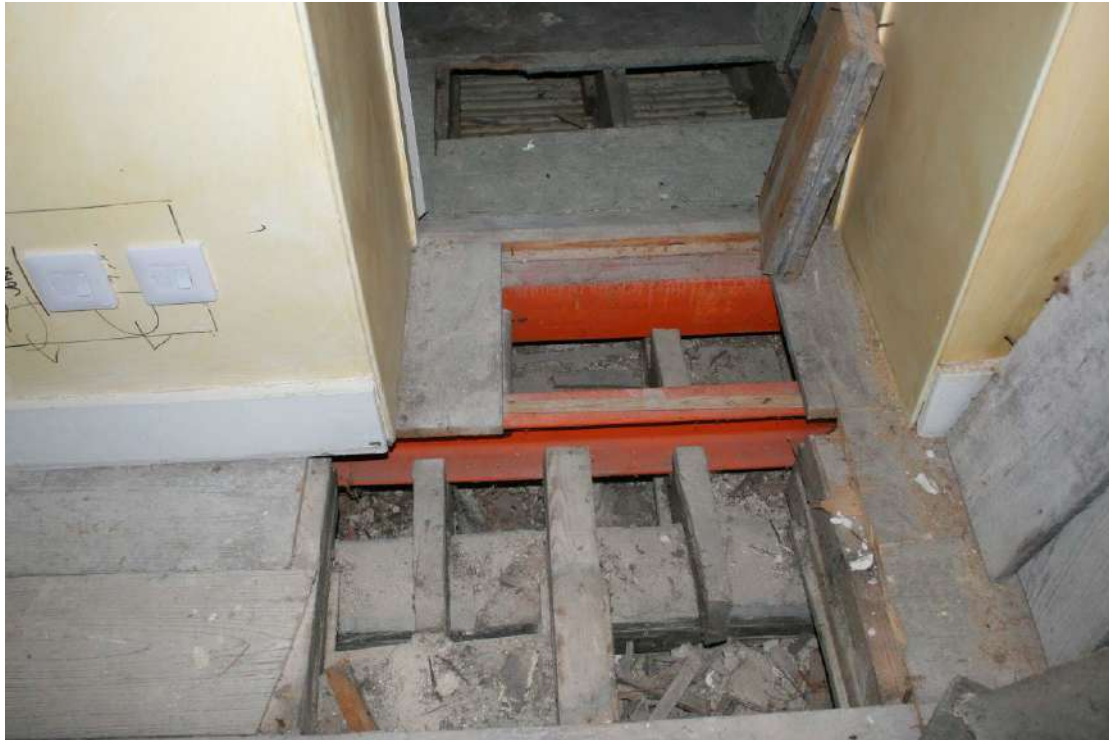
C20th steel joists parallel to a large oak joist.

There are C20th steel joists set in the floor that run under the partition wall with Room 3. In Room 4 the two panel door appears to be MC20th copy with a Victorian box lock branded with a small brass plate Wolfeson Rawlett Patentees – Dieu et Mon Droit.

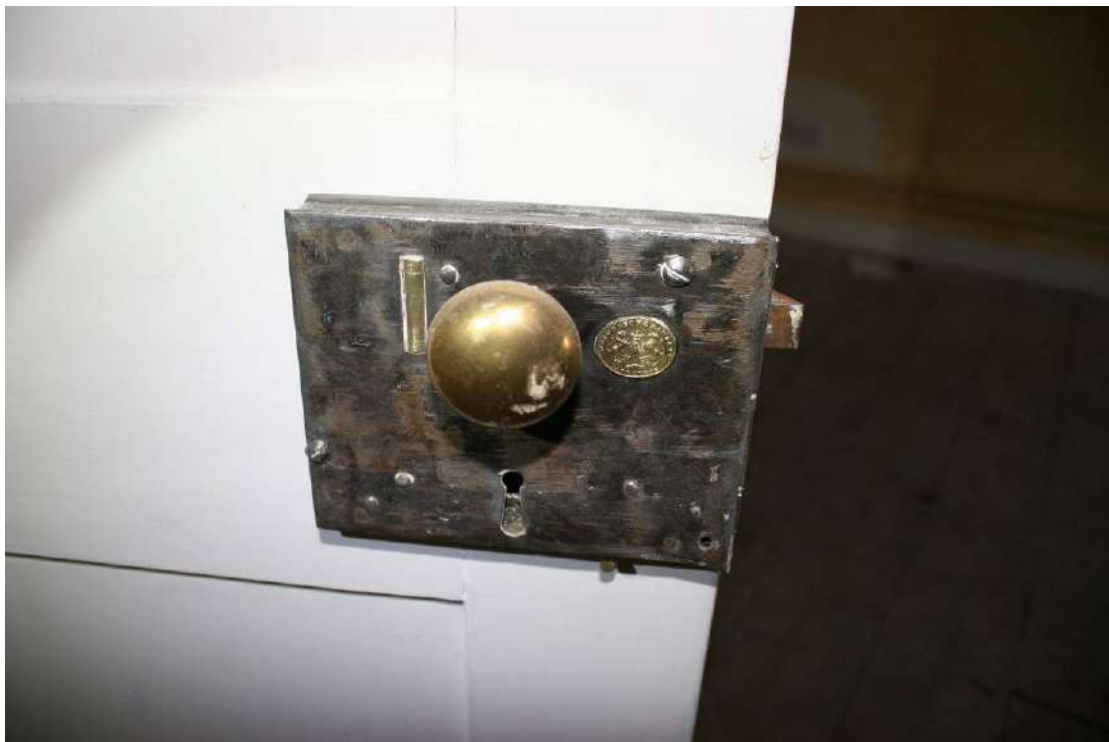
LC19th box lock.

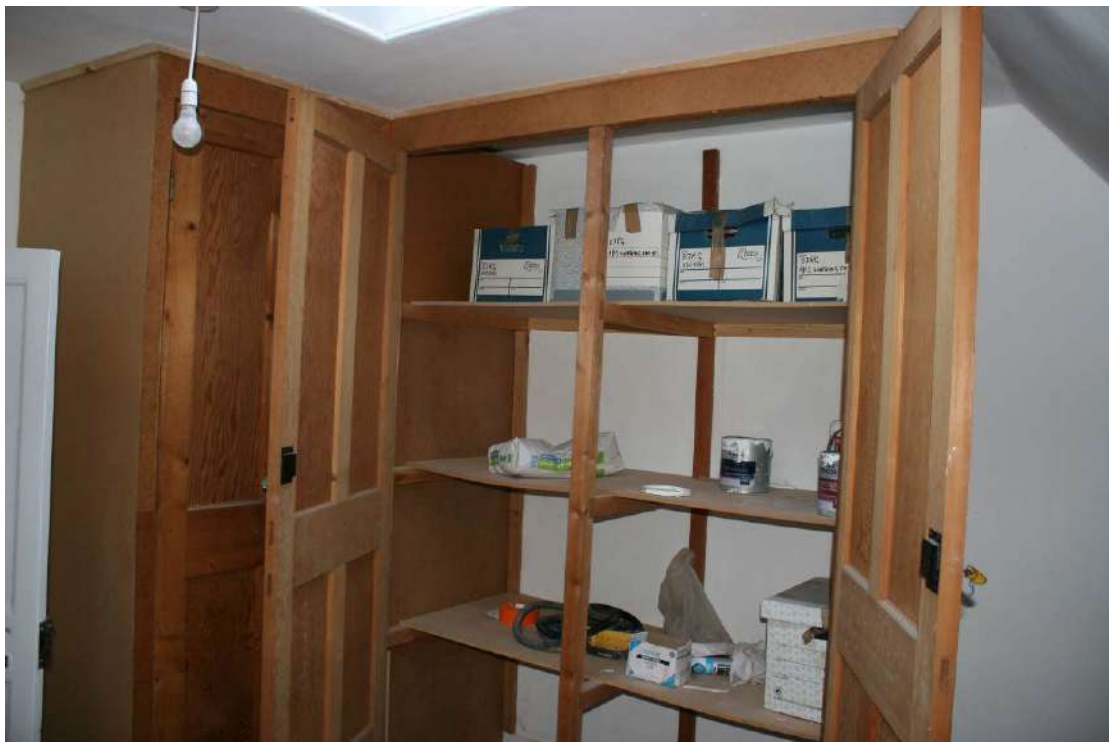
Wooden closet in Room 5.

Room 5 retains a 1939 set of wooden closets but the room is otherwise featureless. Two lights have been inserted.

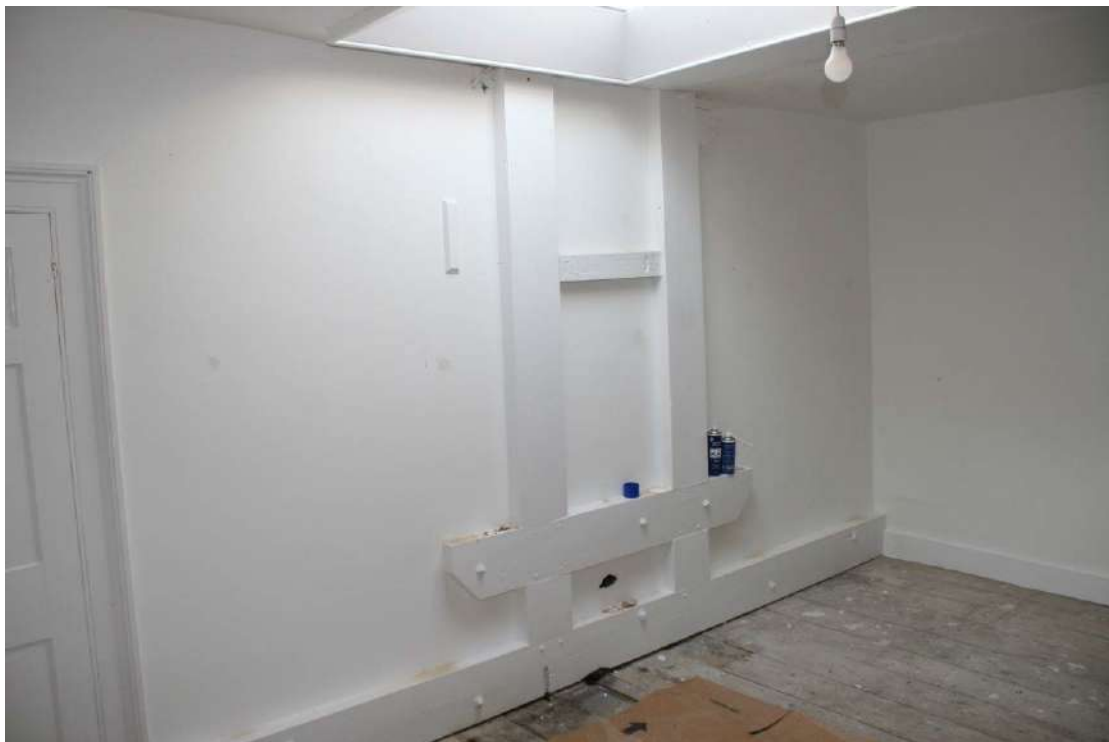
Looking NE in Room 6. The cradle supports the 1939 clock tower.

Room 6 is an unusual shape set under the tympanum part of the roof. In the north wall is a large timber cradle that supports the 1939 clock tower. There is a skylight directly above.

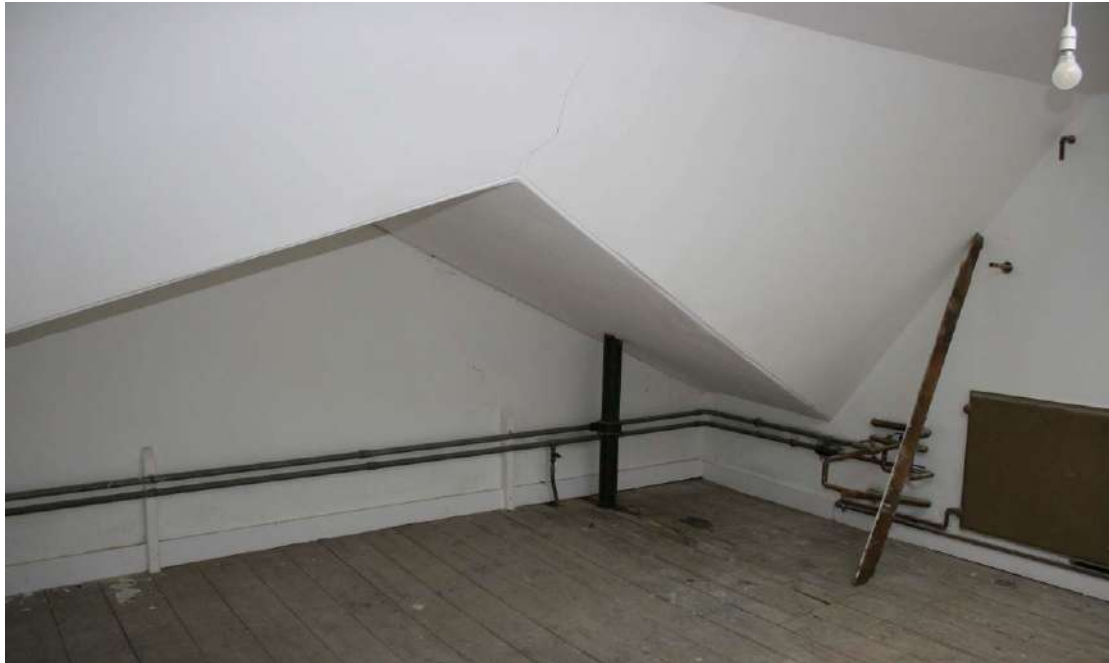
The industrial radiator in Room 7.

The room has one of the industrial radiators and exposed pipework and a downpipe which seems unlikely to have been visible when first installed as all the other services are boxed in. The room originally contained water tanks feeding the exposed pipes. The four panel door is a MC20th copy of a Victorian door and has both a Victorian lock box and MC20th pressed steel lock.

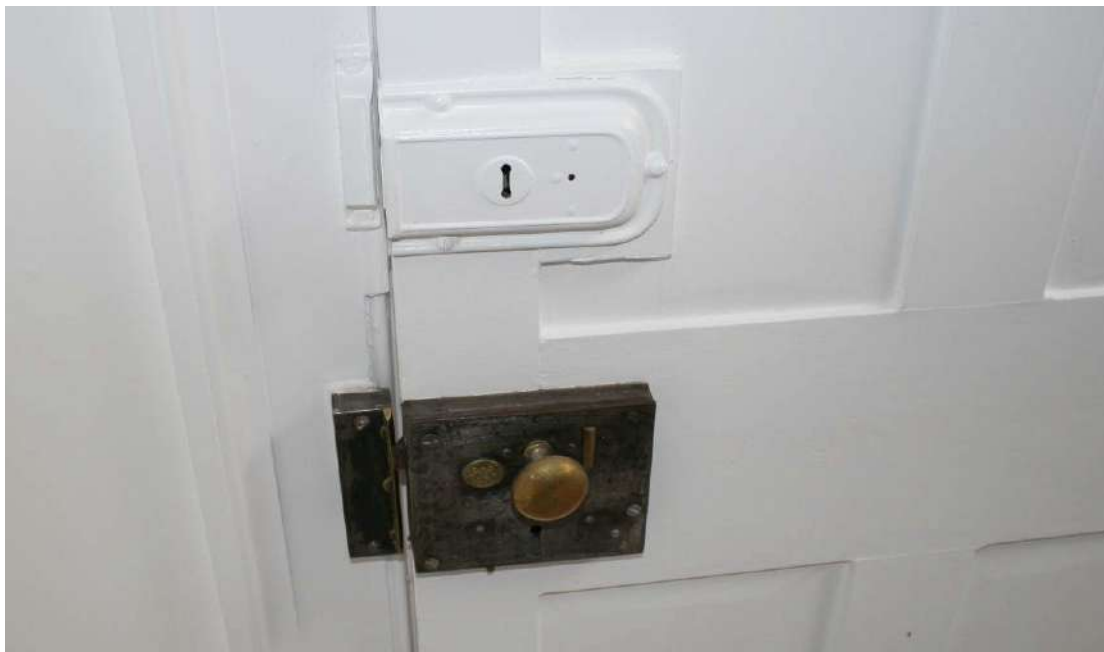
Two types of door lock.

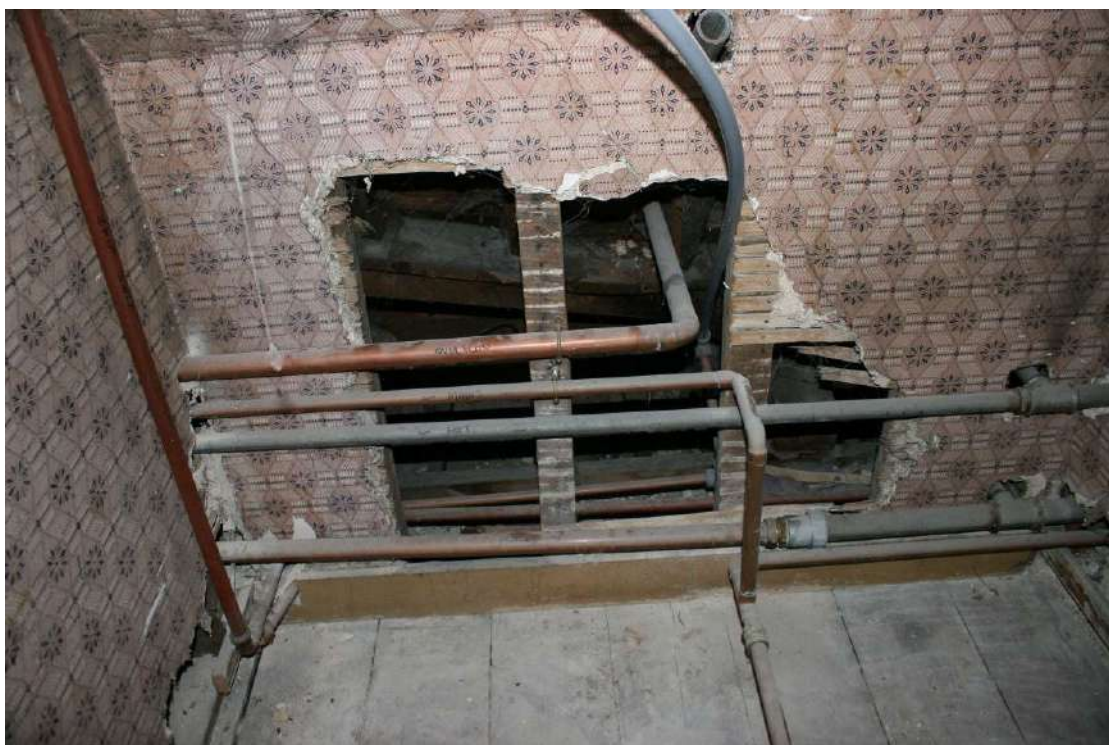
Detail of the LC20th and C21st pipework and MC20th studs and lath and plaster.

Room 7 was probably an airing cupboard for water cylinders as part of the heating and hot water supply.

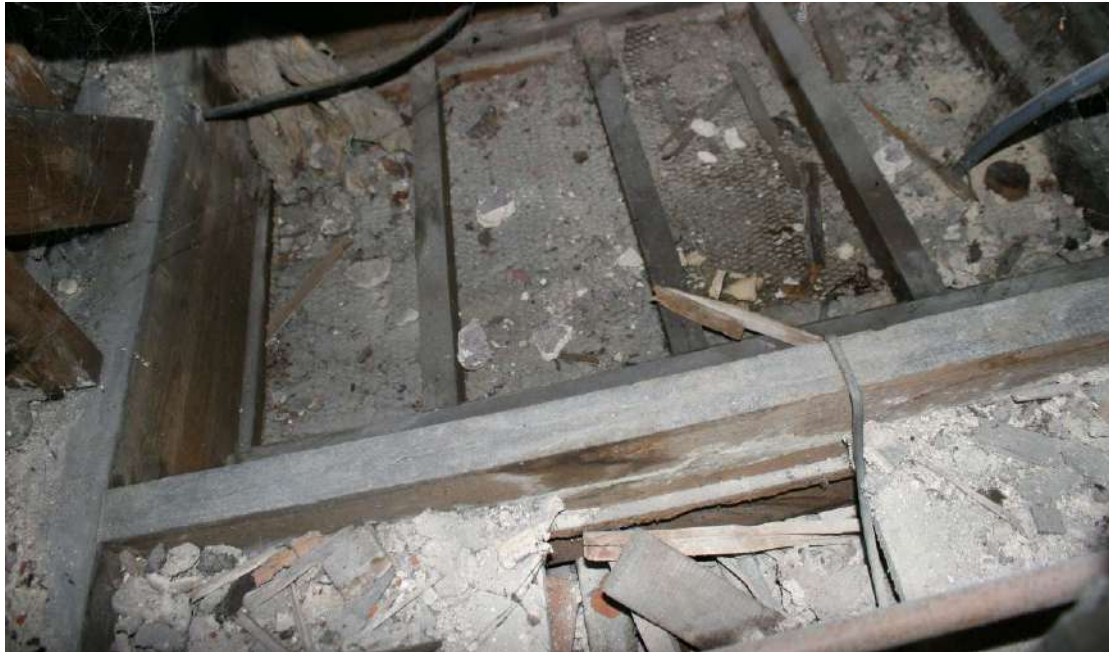
Detail of the machined softwood joists behind the studwork walls.

The walls are lined with machined softwood studs and lath and plaster covered with a geometrical brown wallpaper. The laths are very clean but fixed with wrought iron nails and with bright white haired plaster are probably Victorian. Behind the studs, the ceiling joists are also made from machined softwood. The structure of the roof dates from the 1939 works by Col. R. Cooper (Country Life 1947) and the machined pine boards have red paint bracking marks. There is also a cotton backed asphalt membrane that indicates a roofing repair between 1965 and 1985. The ceiling panels are made from grey cement on EML mesh. Hussey notes that 'He (Cooper) substituted the old red tiles for slates on the roof' but he must have meant the opposite as the roofs all have red tiles.

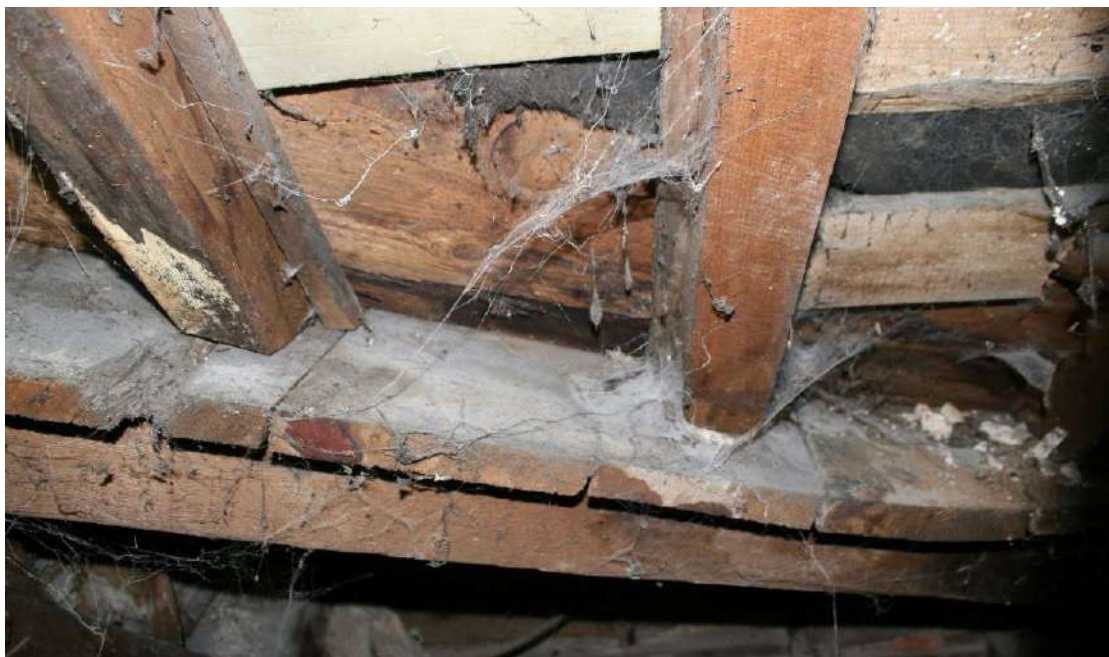
Detail of the roof structure with C20th red bracking marks.

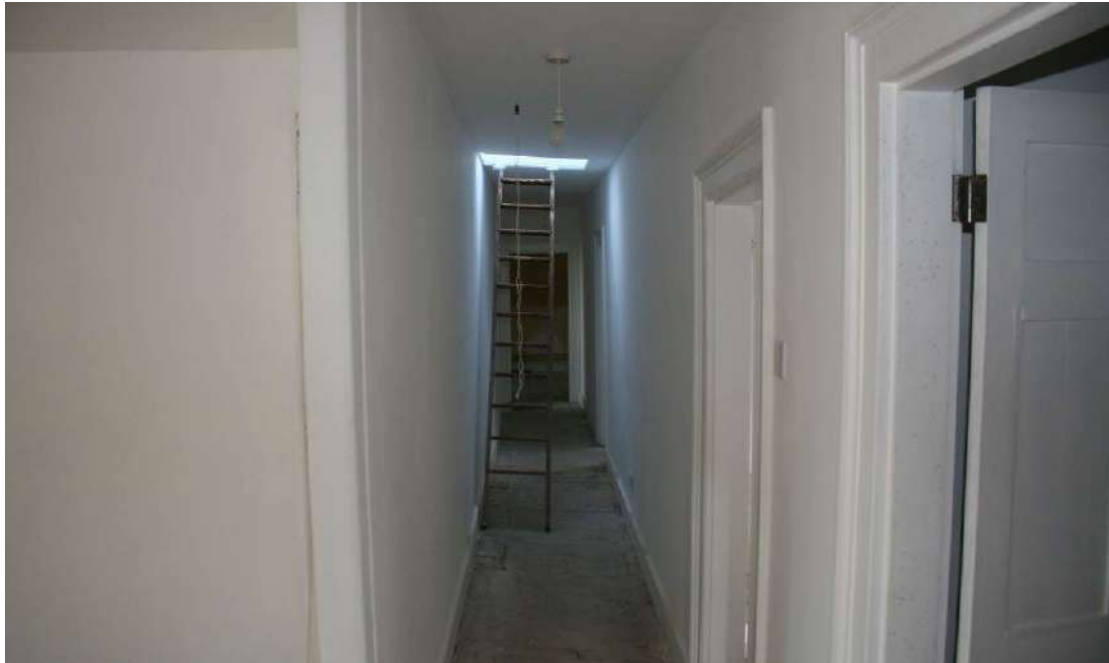
Looking E in the corridor.

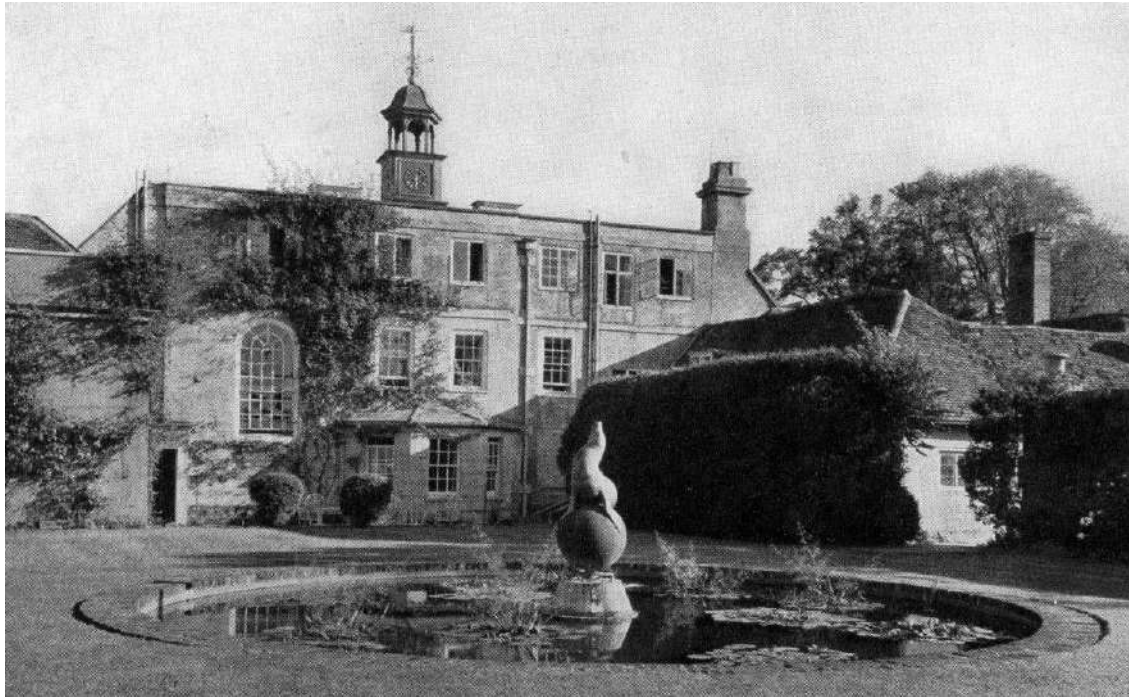
1947 Country Life. North elevation.

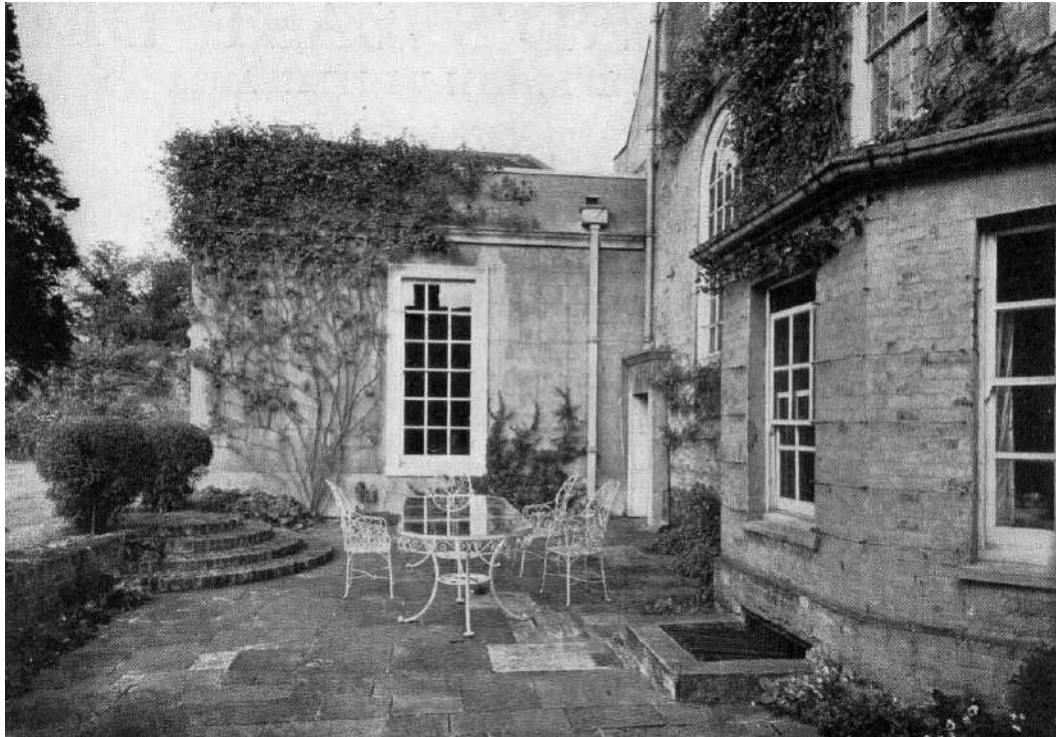
**1947 Country Life. West elevation of the Music Room.**

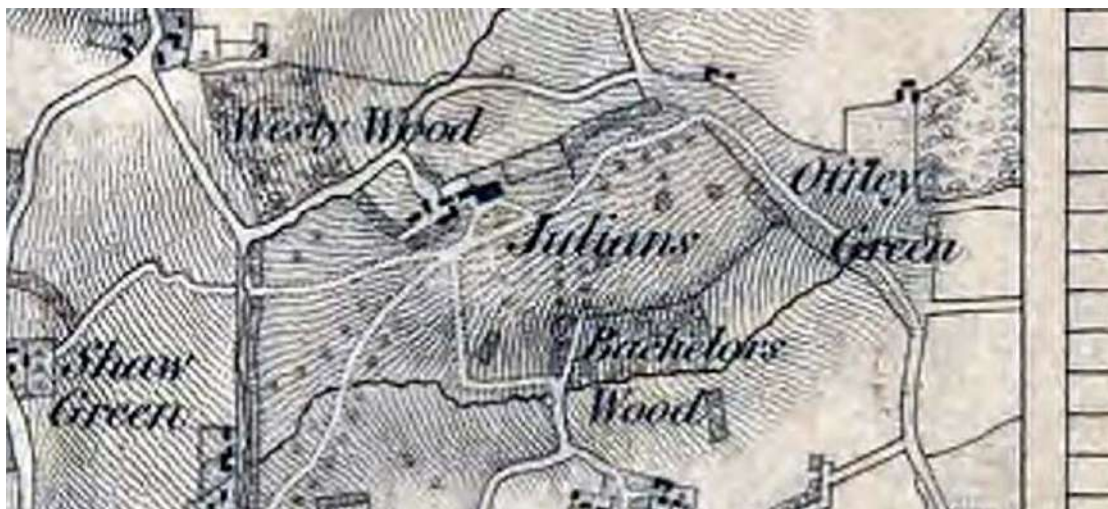
1805 Ordnance Survey.

The 1805 OS is known to more schematic than accurate but it does show the House in the correct disposition with the Kitchen wing and farm buildings.
