# **Julian's Park, Buntingford, Herts**

## **Ecology Report**

By Applied Ecology Ltd

September 2023

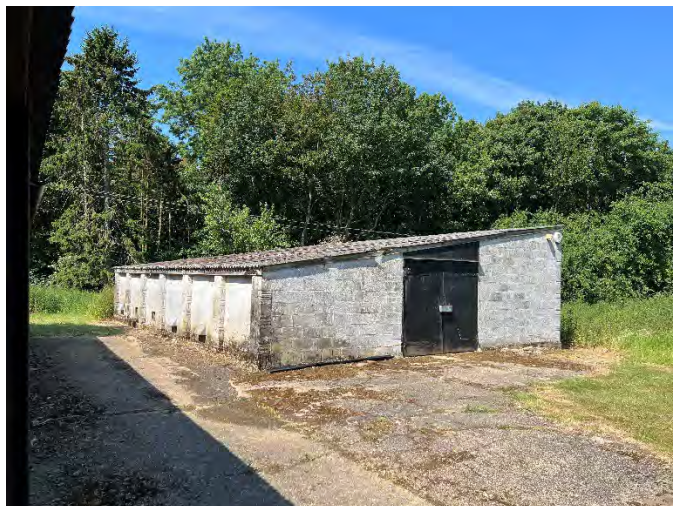
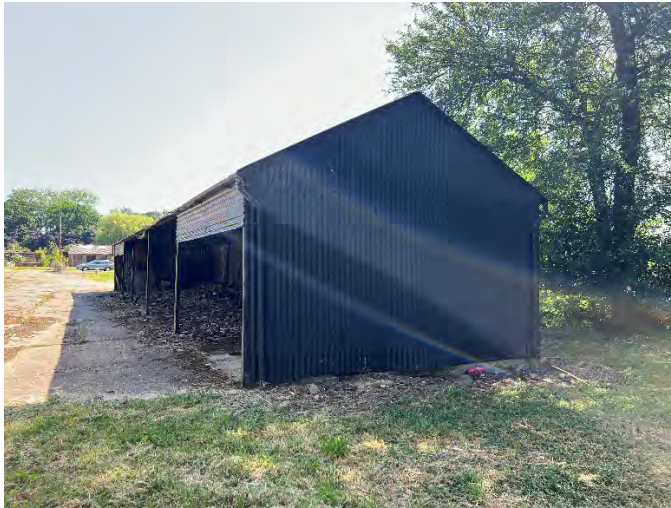
#### *Agricultural Barns 1*

- 3.5 Buildings with no bat roost features or evidence of bats.
- 3.6 Buildings of **negligible bat roost suitability** that could be removed/renovated without restriction in relation to bats.

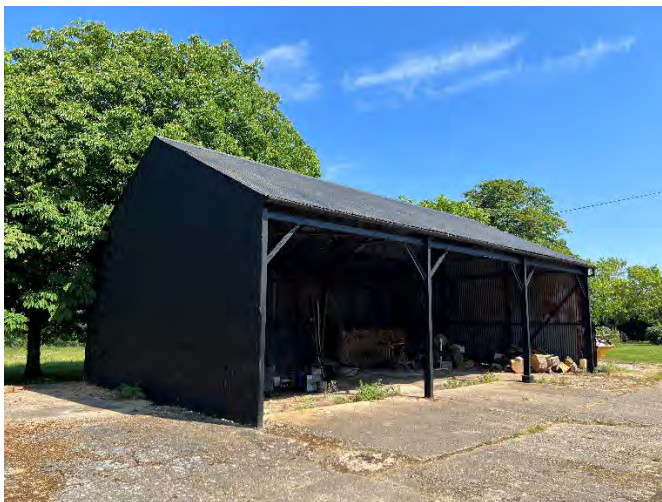
### *Agricultural Barn 2*

- 3.7 Building with no bat roost features or evidence of bats.
- 3.8 Building of **negligible bat roost suitability** that could be removed/renovated without restriction in relation to bats.

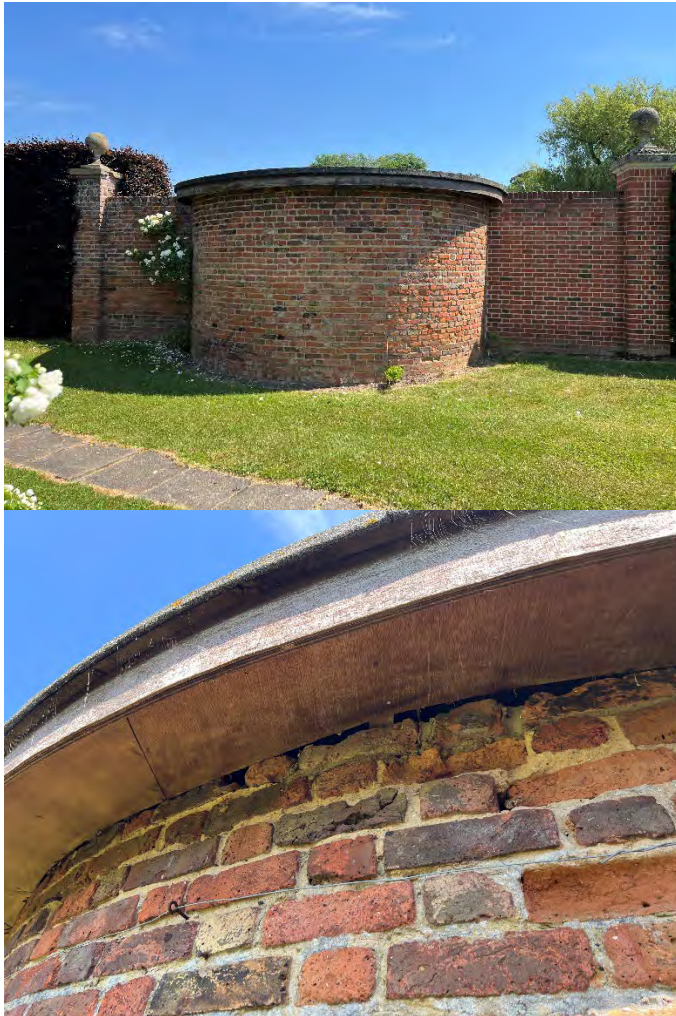
### *Pool Room*

- 3.9 Brick built semi-circular structure with flat roof and gaps between timber soffits and walls with one pipistrelle bat dropping stuck to brick work below soffit gap.
- 3.10 A building of **moderate bat roost suitability** requiring two separate bat activity surveys to assess bat roosting use.

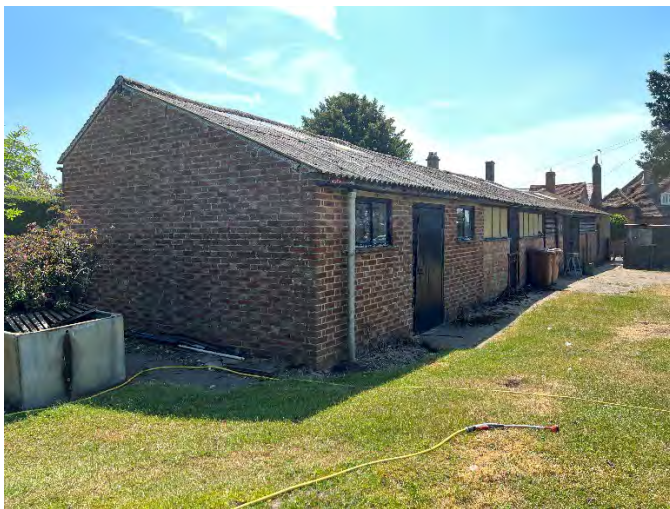
### *Workshop*

- 3.11 Building with no obvious bat roost features or evidence of bats
- 3.12 Building of **negligible bat roost suitability** that could be removed/renovated without restriction in relation to bats.

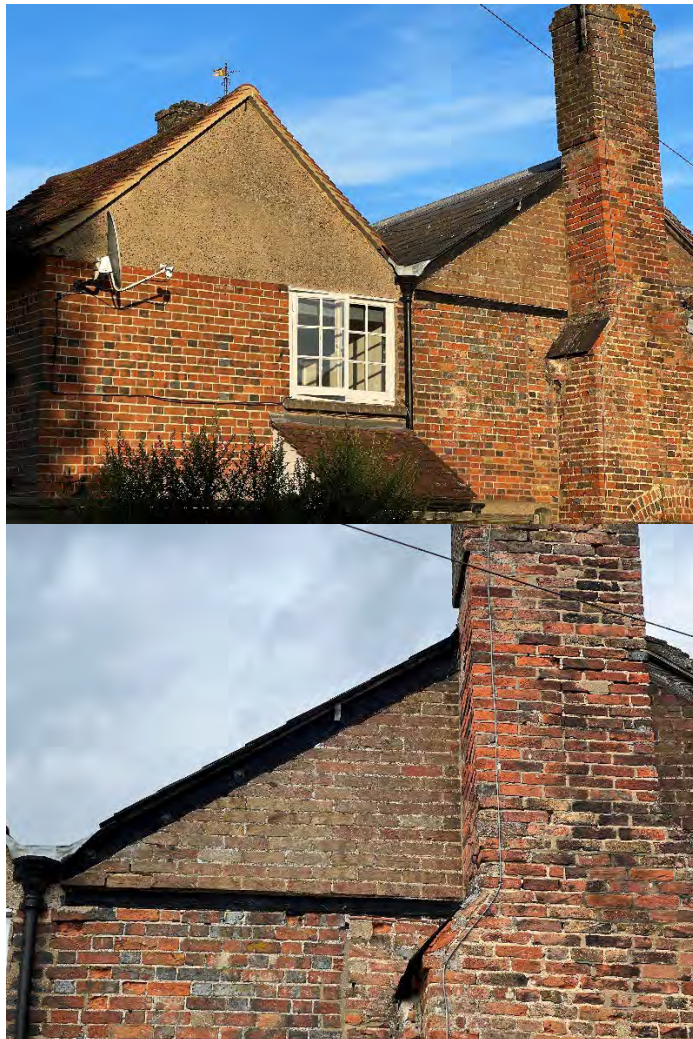
*Gardener's Cottage*

- 3.13 Building surveyed externally (internal access not possible). Brick building with two parallel pitched slate and clay tile covered pitched gable ended roofs. No evidence of bats on external surfaces but some mortar gaps in brickwork, lead flashing gaps, gaps between timber work in external walls and adjoining brickwork, and gaps under clay tiles.
- 3.14 Given the complete absence of external bat evidence the building was assessed as possessing **low bat roost suitability** requiring a single bat activity surveys to assess bat roosting use.

- 4.3 Construction work that could directly or indirectly disturb / damage the Gardener's Cottage maternity roost should be completed outside of the maternity period of May-September, and would need to be designed and planned to retain the roost in the same location, and for the use of a traditional 1F felt with respect to re-roofing.

- 4.5 Bat roosts in brickwork on the Coach House and Gardener's Cottage could also be adversely impacted by repointing / brick replacement, and provision of integrated brick faced bat boxes in locations where bats are roosting will need to be considered as part of the overall bat mitigation strategy.

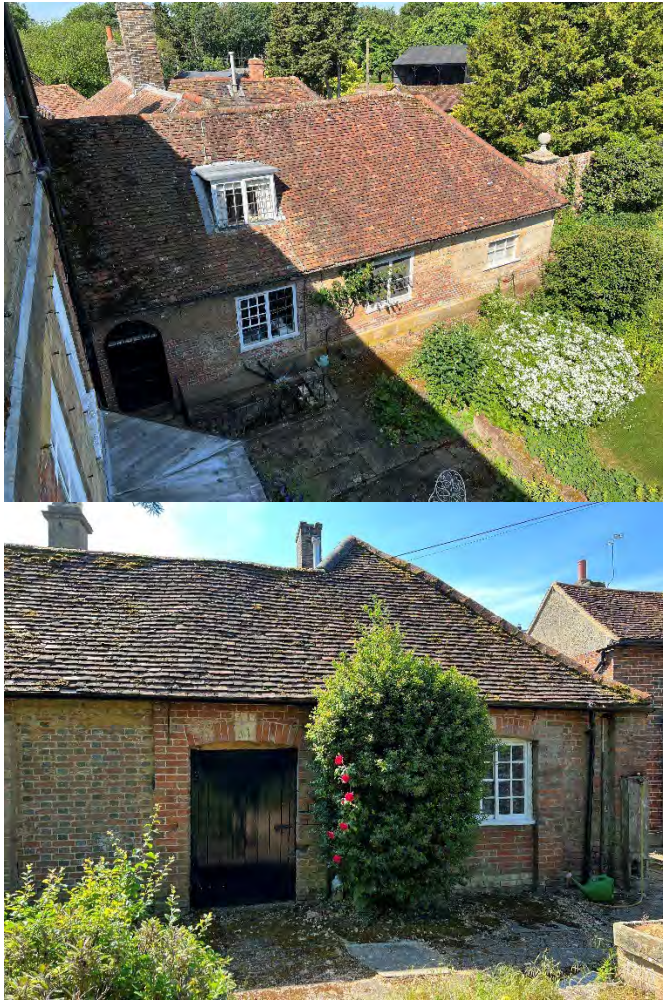
*Kitchen Wing*

- 3.15 Brick built clay tiled double hipped pitched roof. With a small number of butterfly and moth bat feeding remains in internal derelict rooms on north side of building. No evidence of bats on external surfaces. Gaps under lifted clay roof tiles.
- 3.16 A building of **low bat roost suitability** requiring a single bat activity surveys to assess bat roosting use.

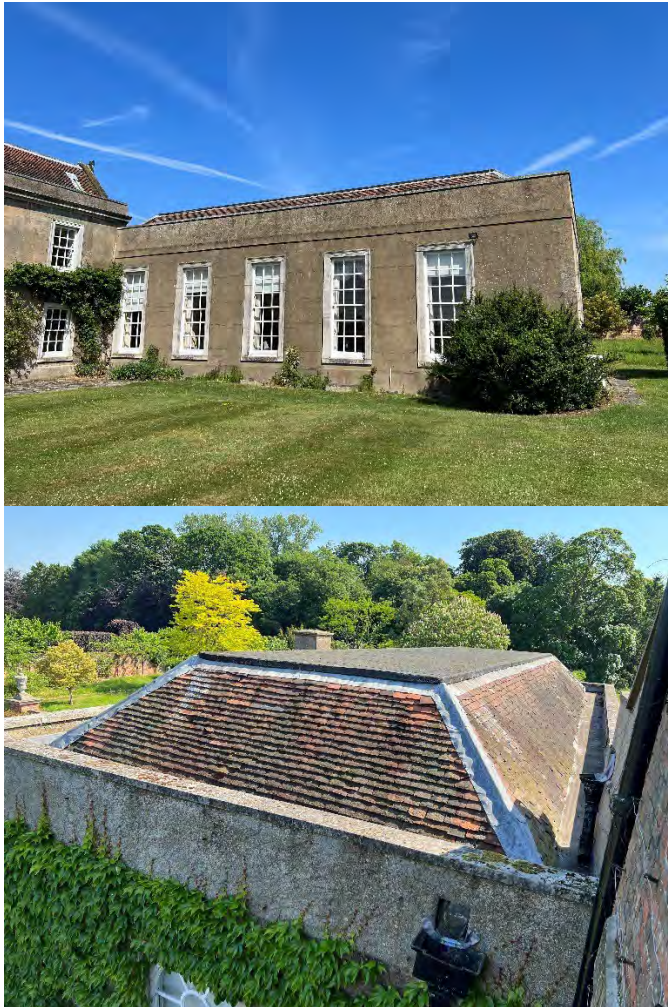
### *Drawing Room*

- 3.17 Stone building with half-pitched flat roof with pitches covered in clay tiles. No evidence of bats on or inside building. Roof pitches covered in clay tiles with few gaps and crevices between tiles and flashings.
- 3.18 Building of **low bat roost suitability** that would need to be subject to a single bat activity survey in the event that work to the roof is planned. It is understood that no work is proposed in the immediate future to the Drawing Room roof, and follow-up bat activity survey of this building has not been completed as part of the current survey.

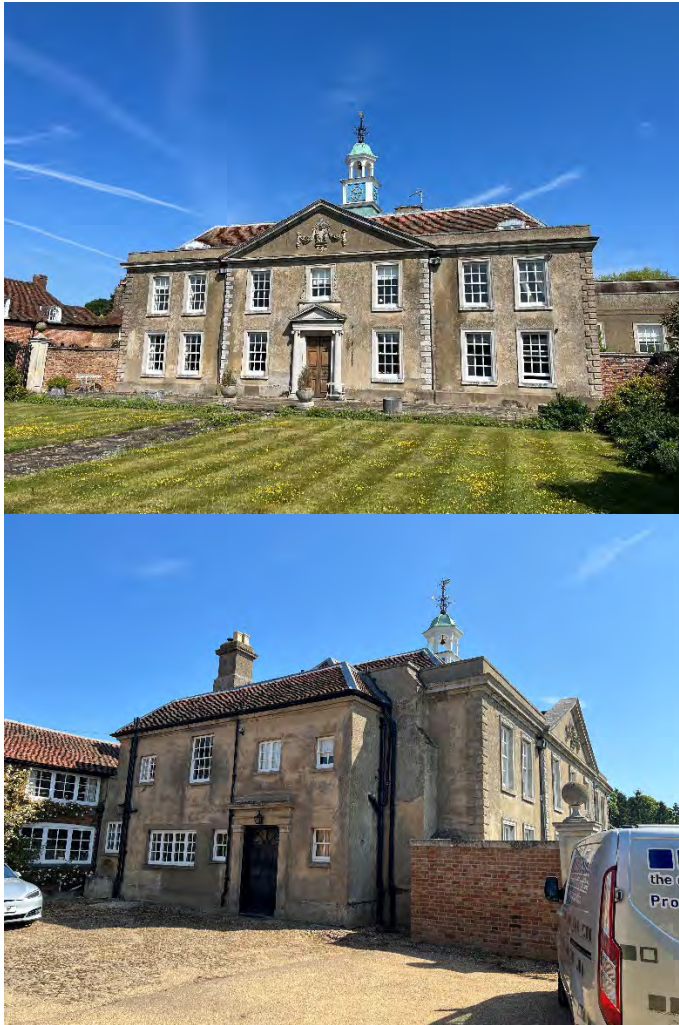
*Julian's Hall – Main Villa*

- 3.19 A large stone building with bell tower, and a half-pitched flat roof with clay tile faces. Hipped clay tiled roof extension on west side of the building
- 3.20 Gaps below clay tiles, gaps below flashings, gaps in stonework next to some window frames.
- 3.21 No large internal roof spaces.
- 3.22 No evidence of bats on the exterior of the building.
- 3.23 A building of **low bat roost suitability** requiring a single bat activity surveys to assess bat roosting use.

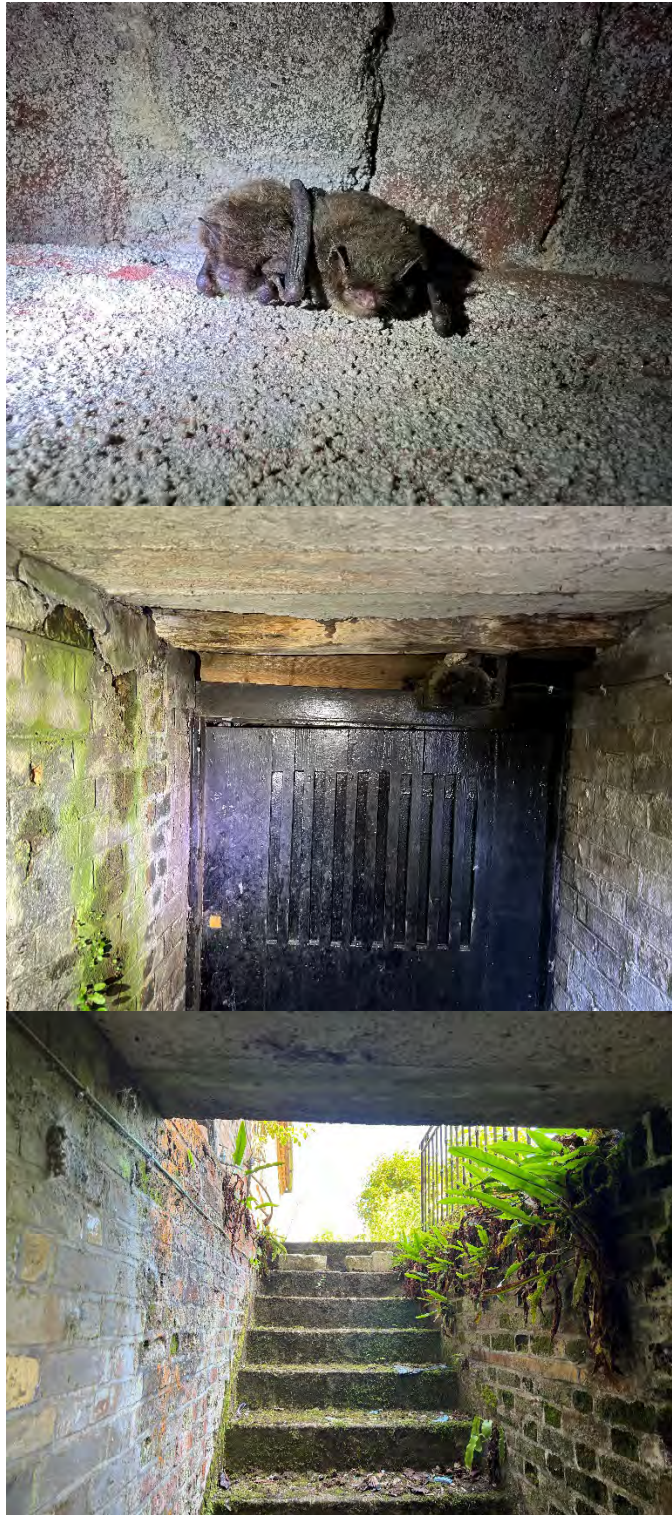
*Julian's Hall – Cellar*

- 3.24 Extensive cellar below the Main Villa with confirmed day roost of two Daubenton's bats *Myotis daubentonii* (one dead Daubenton's bat also present on the wall next to the two live bats). A few bat droppings on the floor of the cellar, but no evidence to suggest the presence of a large or important roost. Bat access in and out of the cellar appeared to be via a horizontal gap over the external cellar access door leading to steps up to ground garden level on north side of the building.
- 3.25 A confirmed bat roost of **moderate bat roost suitability**.
- 3.26 The cellar is also likely to be used by hibernating bats in the winter.
- 3.27 No works proposed to the cellar and therefore no follow-up bat activity survey work completed as part of this assessment.

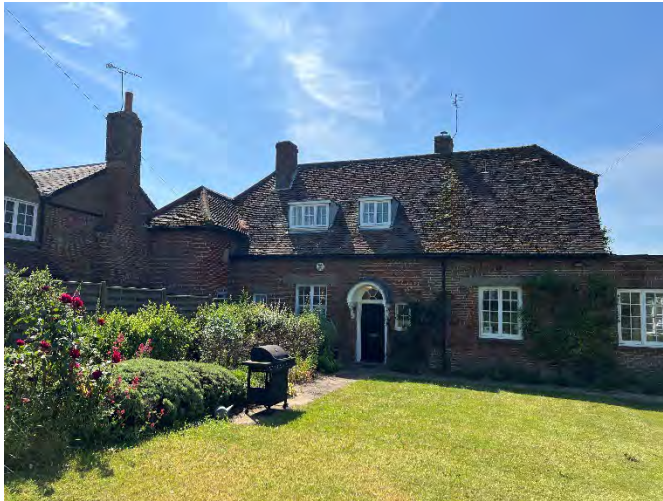
### *Cottage*

- 3.28 A brick built building with a half-hipped clay tiled roof with single storey flat roofed brick extensions. No internal survey access possible during survey.
- 3.29 Mortar gaps in external brickwork, gaps under clay roof tiles.
- 3.30 No evidence of bats on external surfaces.
- 3.31 A building of **low bat roost suitability** requiring a single bat activity surveys to assess bat roosting use.

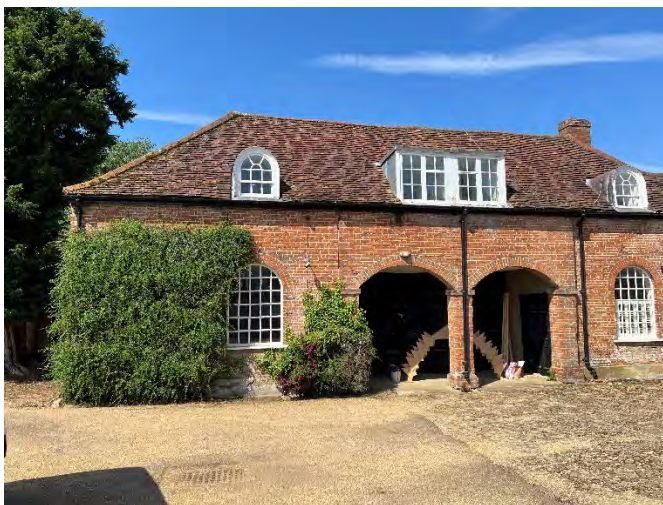
*Coach House*

- 3.32 Brick built hipped clay tiled roof with dormers.
- 3.33 Gaps under clay roof tiles, mortar gaps in brickwork, holes in brickwork.
- 3.34 No evidence of bats present on external surfaces.
- 3.35 A building of **low bat roost suitability** requiring a single bat activity surveys to assess bat roosting use.

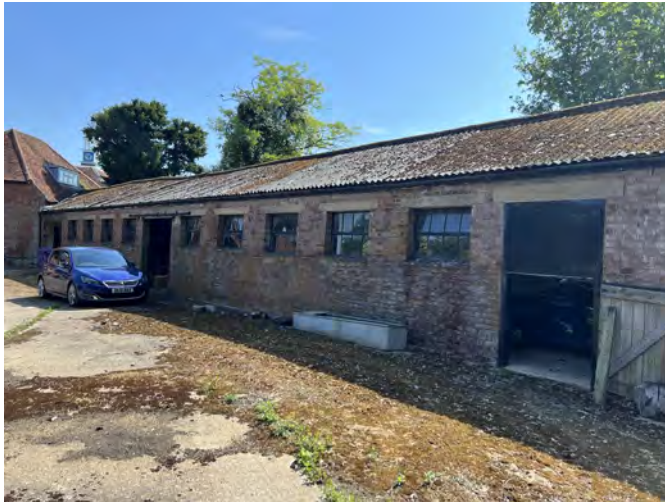
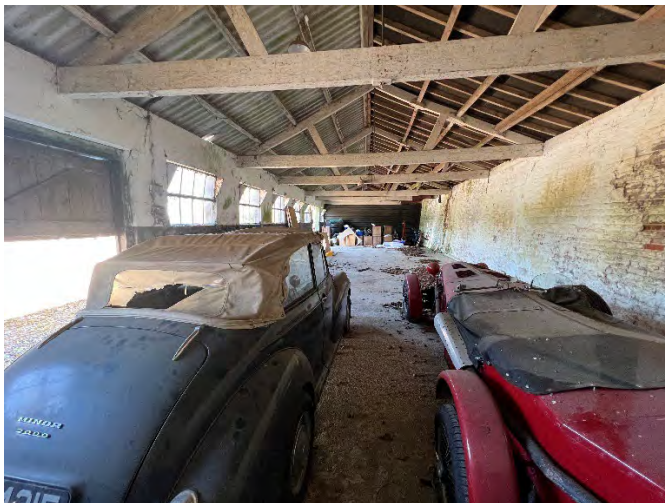
*Garage*

- 3.36 Brick built garage with timber roof trusses and a shallow pitched roof with west pitch covered in cement sheets, and east face covered by clay tiles. Northern end of the building attached to the east side of coach house with a walk through section.
- 3.37 Doors and window openings along west side open. West side of the garage completely obscured by shrubs and other vegetation.
- 3.38 One nesting barn swallow on roof trusses.
- 3.39 Scattered mixed age and size bat droppings on floor of garage below ridge – circa 50 in total indicating presence of bat roost inside roof structure, and probable bat foraging inside the garage.

- 3.40 A building of **moderate bat roost suitability** requiring two separate bat activity surveys to assess bat roosting use.

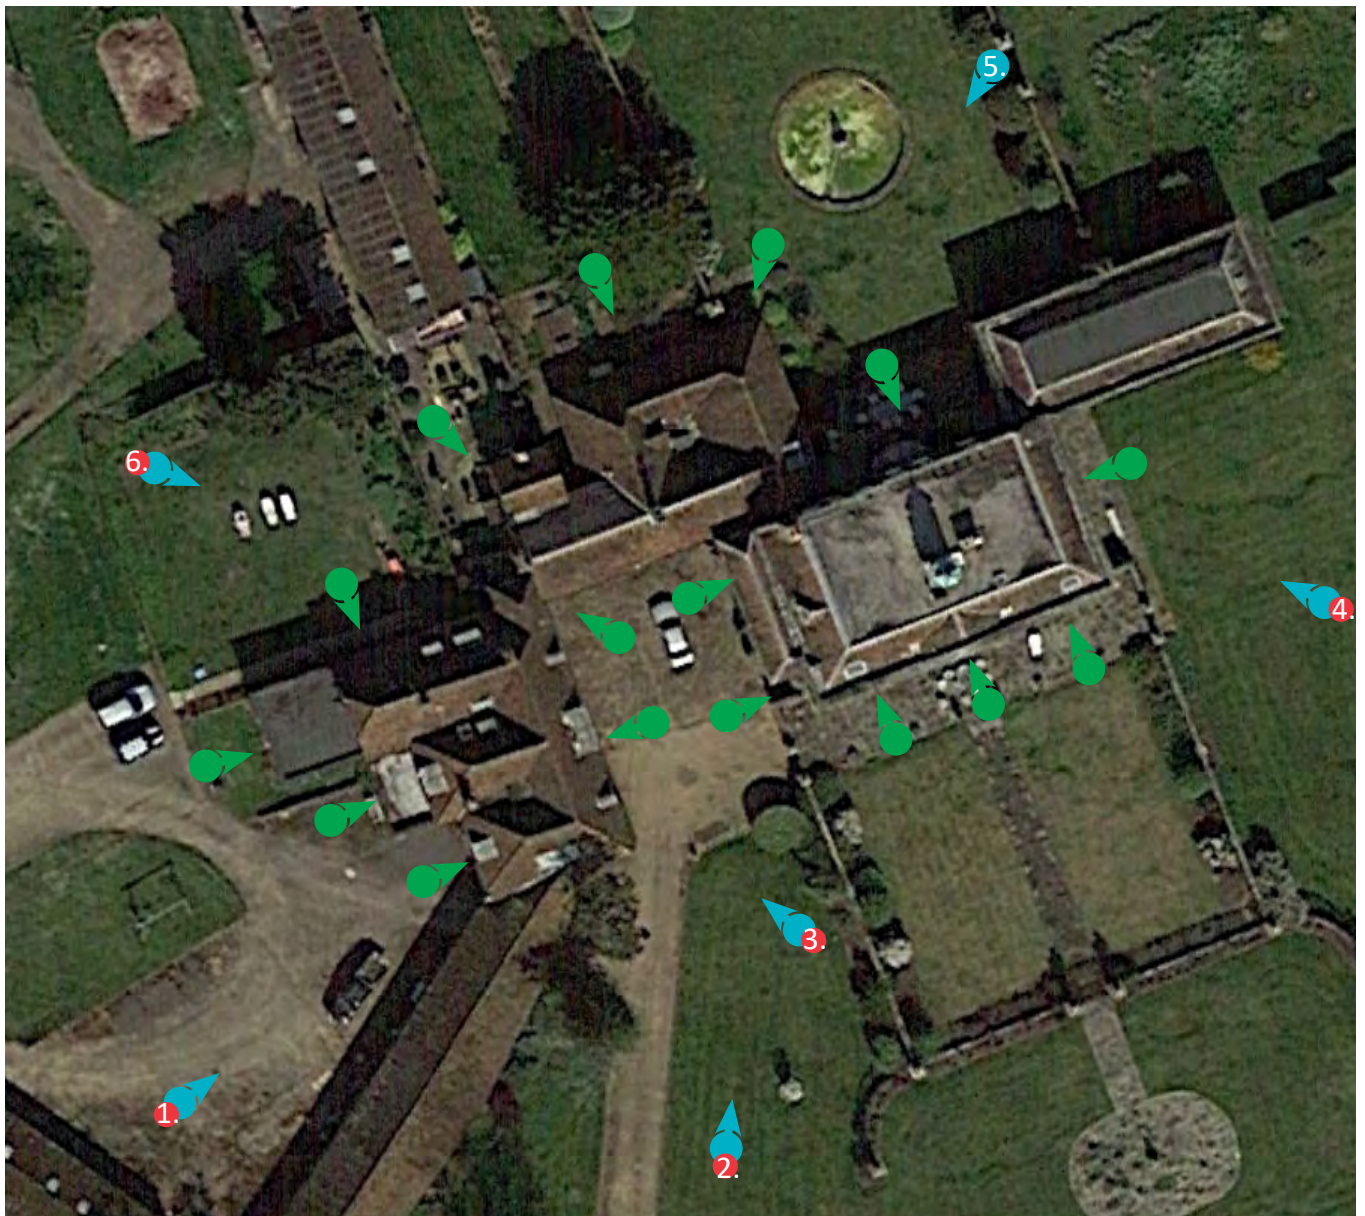
## Bat survey set-up

Bat roost emergence survey set up 24 August 2023

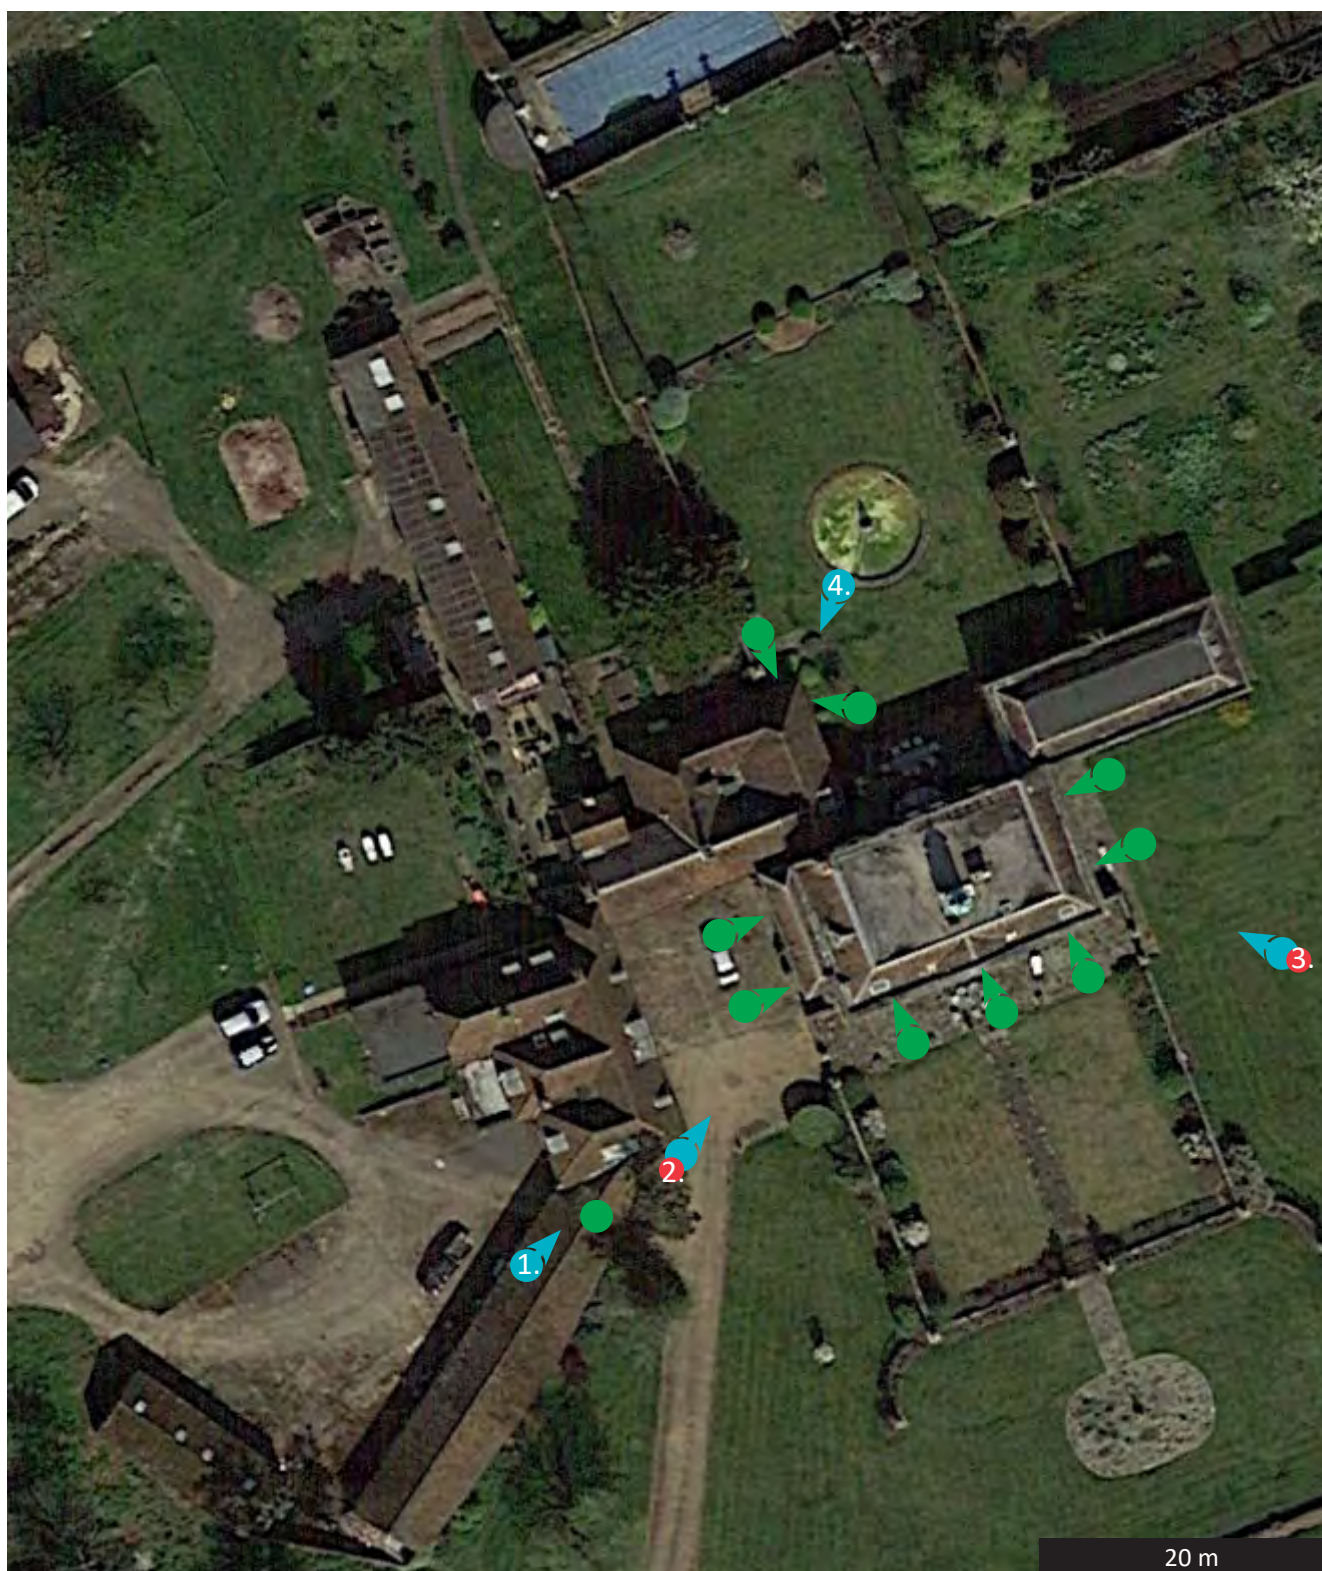
Bat roost emergence survey set up 24 August 2023

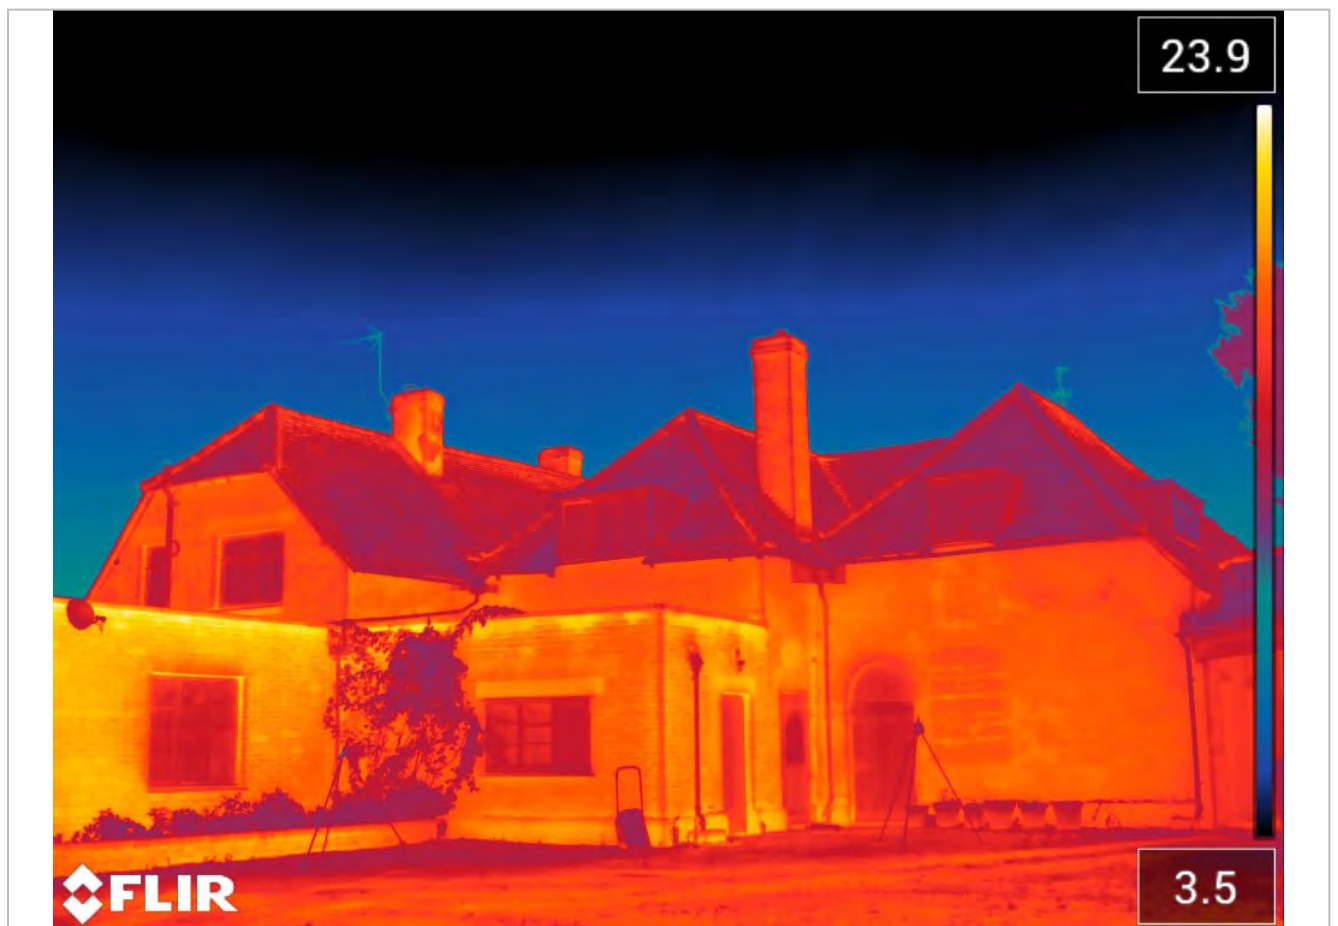
FLIR T1020 (1024 x 768 pixel resolution) with 45 degree lens = bat in flight detection distance of 104 m.  
Camera located 38 m from furthest point of building

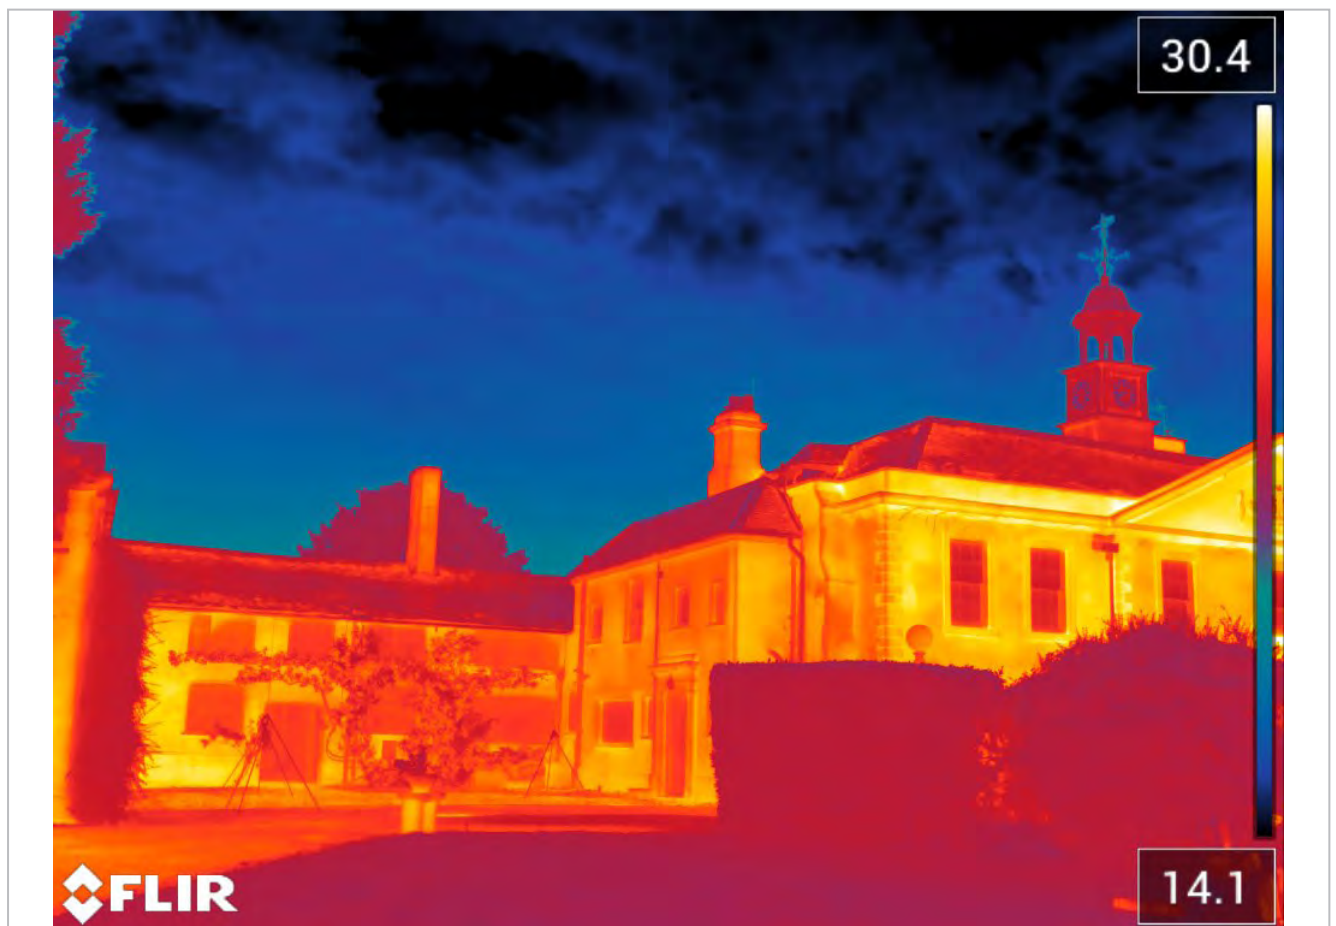
FLIR T1020 (1024 x 768 pixel resolution) with 45 degree lens = bat in flight detection distance of 104 m.  
Camera located 43 m from furthest point of building

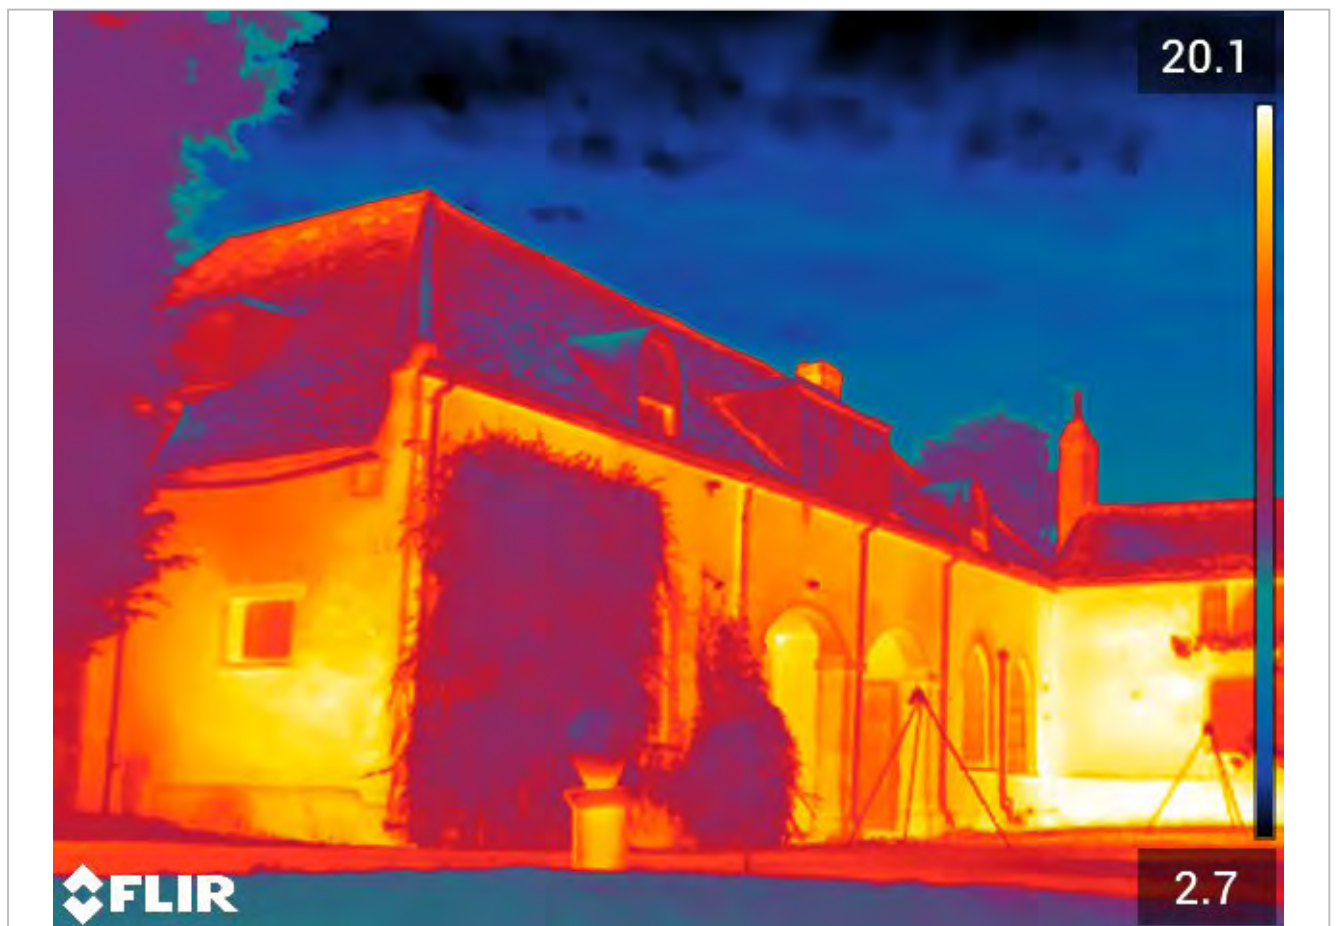
FLIR T540 (464 x 348 pixel resolution) with 42 degree lens = bat in flight detection distance of 51 m.  
Camera located 30 m from furthest point of building

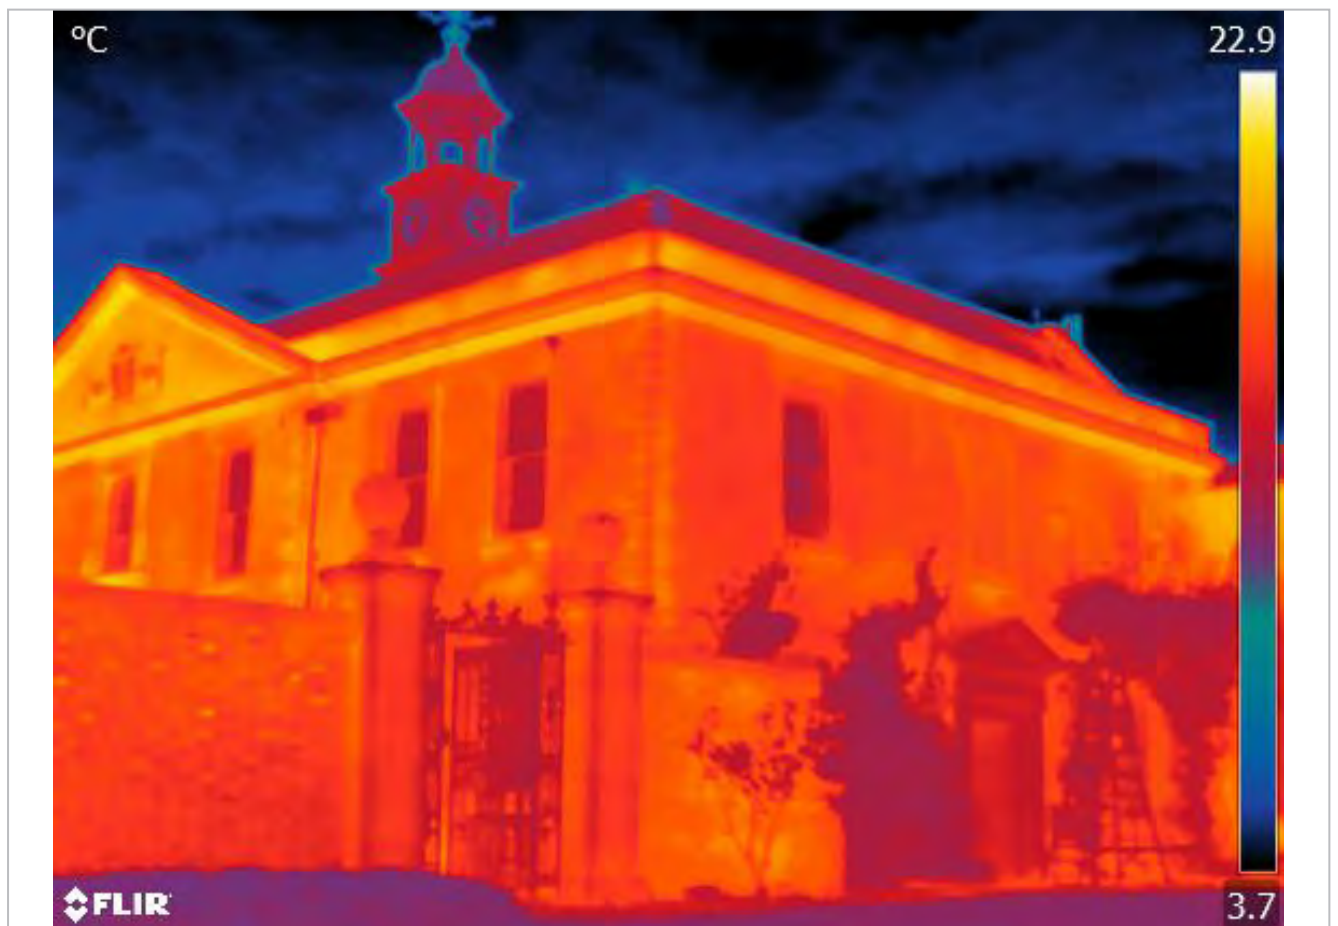
FLIR T860 (640 x 480 pixel resolution) with 42 degree lens = bat in flight detection distance of 66 m.  
Camera located 25 m from furthest point of building

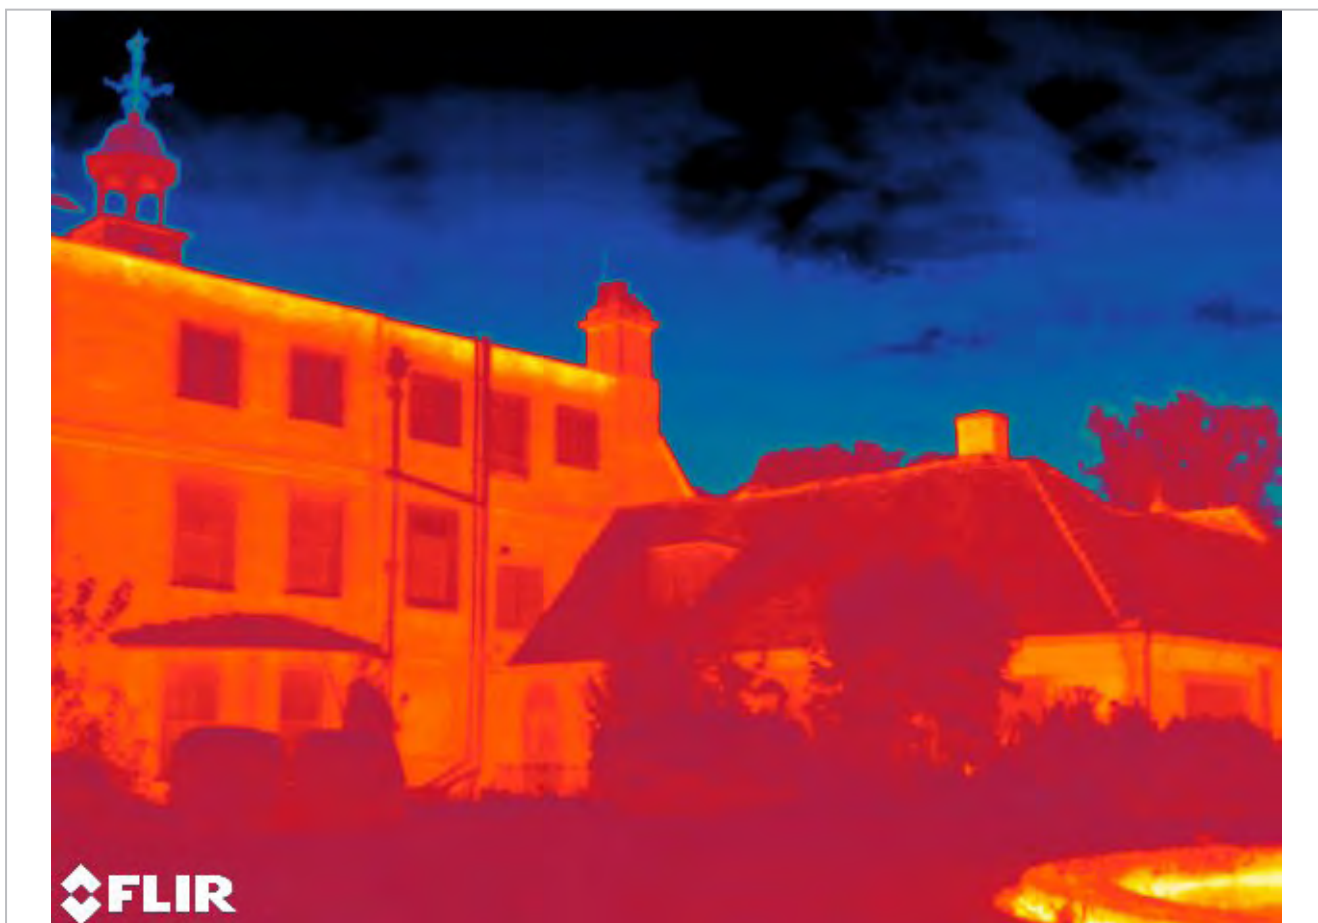
FLIR T540 (464 x 348 pixel resolution) with 42 degree lens = bat in flight detection distance of 51 m.  
Camera located 30 m from furthest point of building

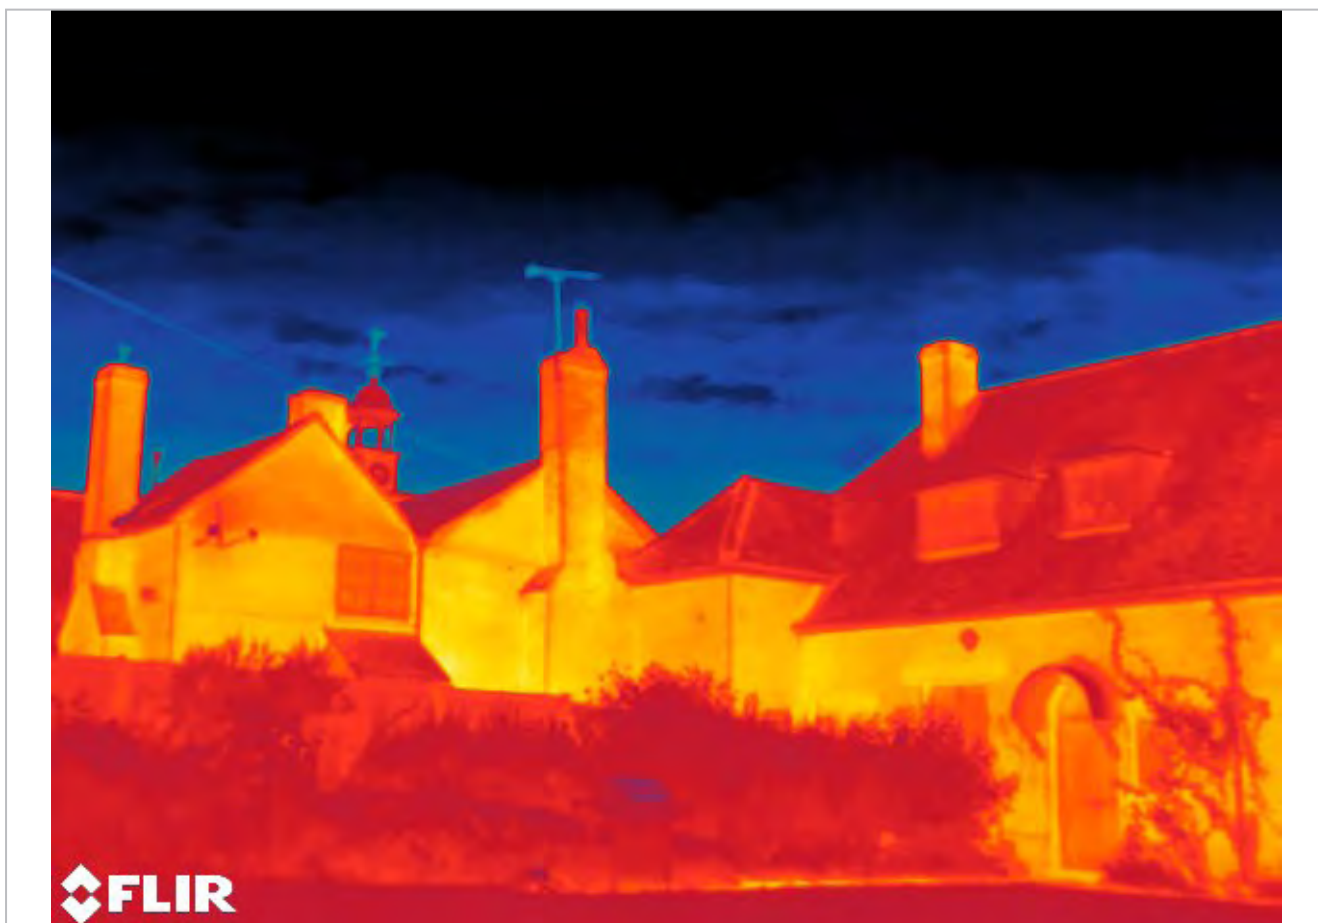
FLIR T540 (464 x 348 pixel resolution) with 42 degree lens = bat in flight detection distance of 51 m.  
Camera located 32 m from furthest point of building

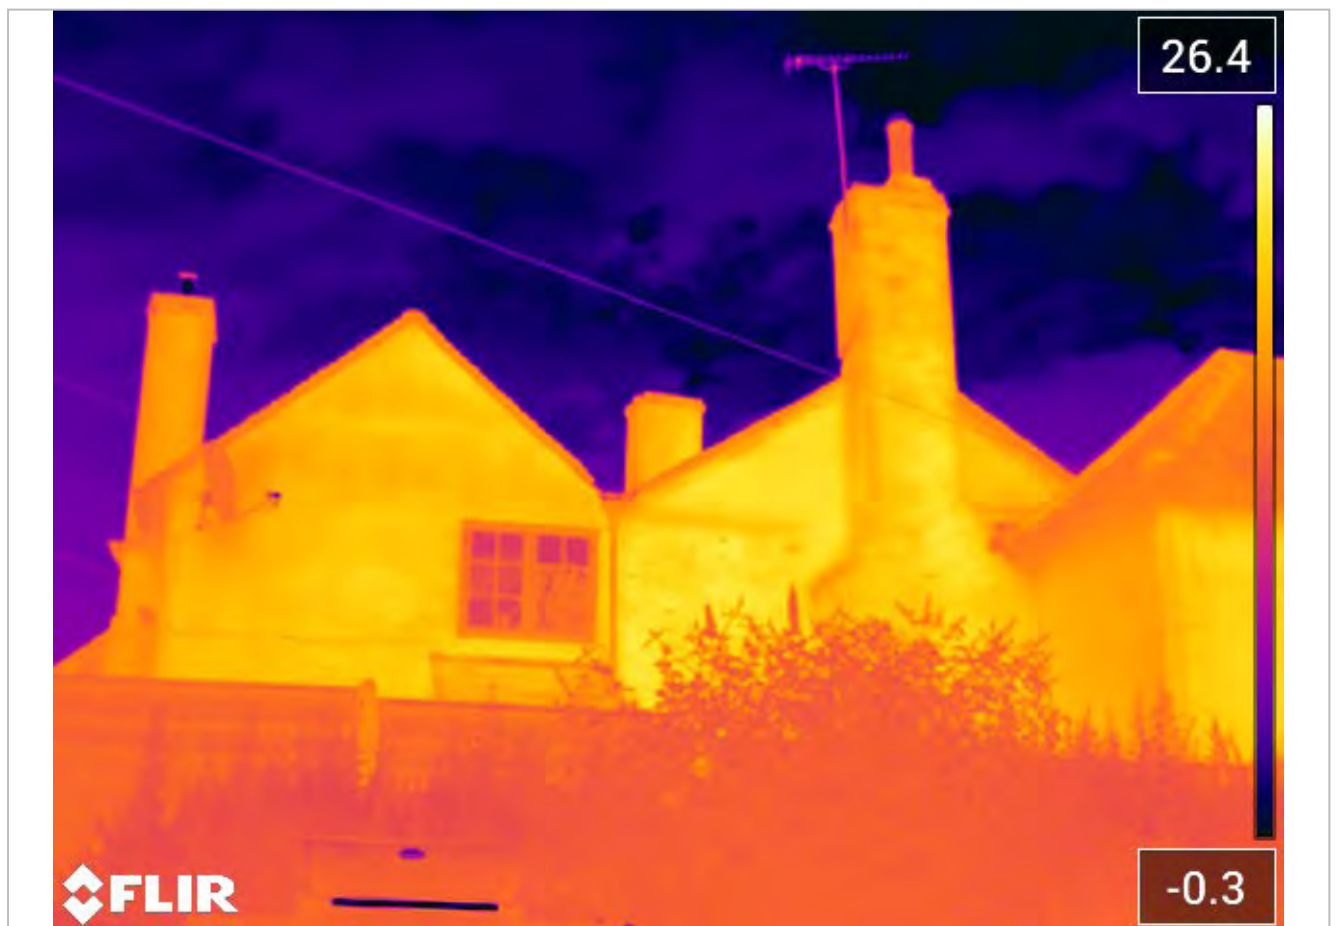
FLIR T860 (640 x 480 pixel resolution) with 42 degree lens = bat in flight detection distance of 66 m.  
Camera located 19 m from furthest point of building

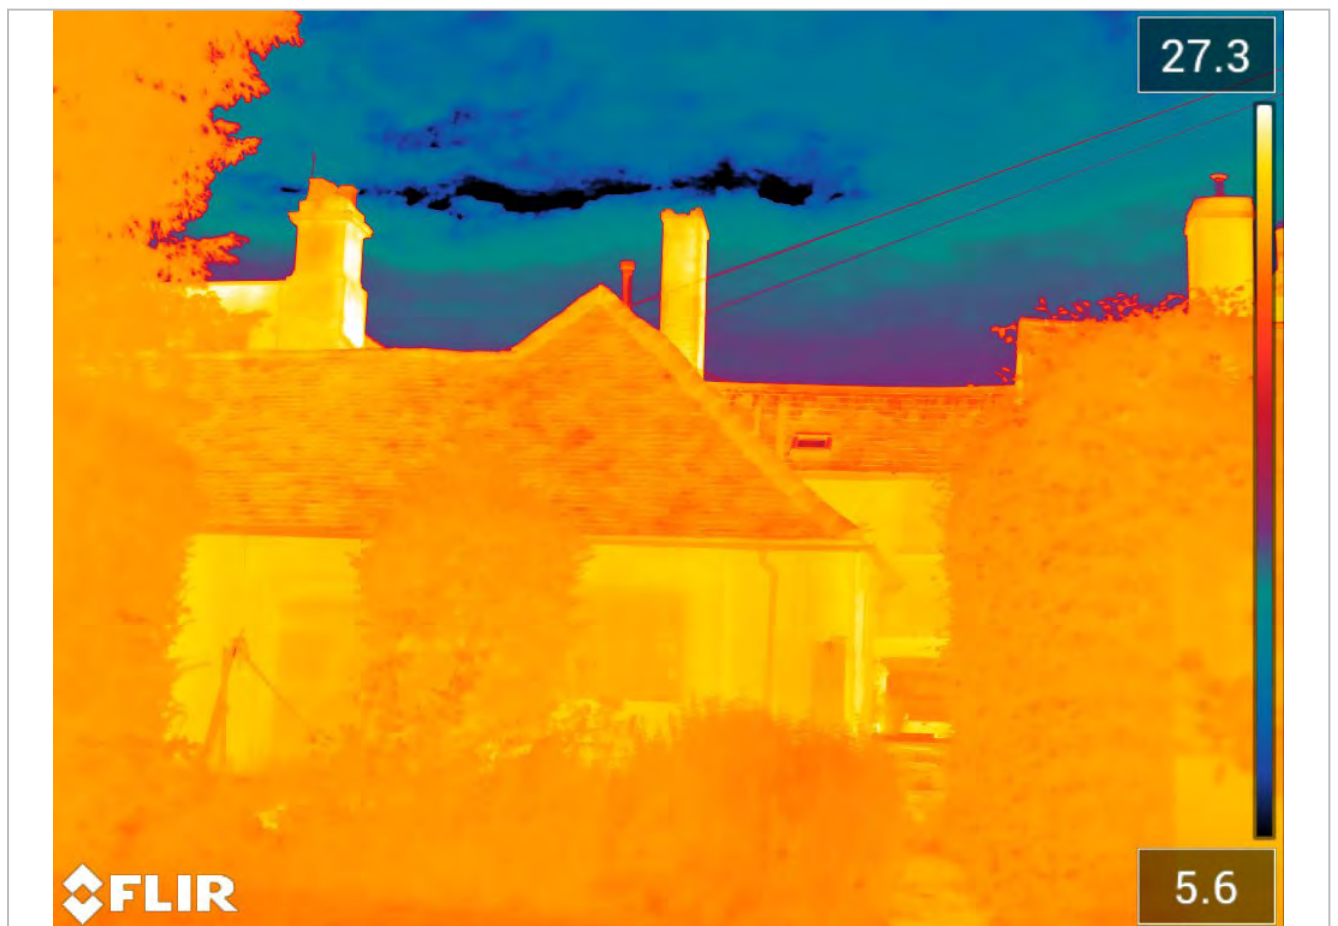
FLIR T1020 (1024 x 768 pixel resolution) with 45 degree lens = bat in flight detection distance of 104 m.  
Camera located 30 m from furthest point of building
