# **Julian's Park, Buntingford, Herts**

## **Ecology Report**

By Applied Ecology Ltd

September 2023

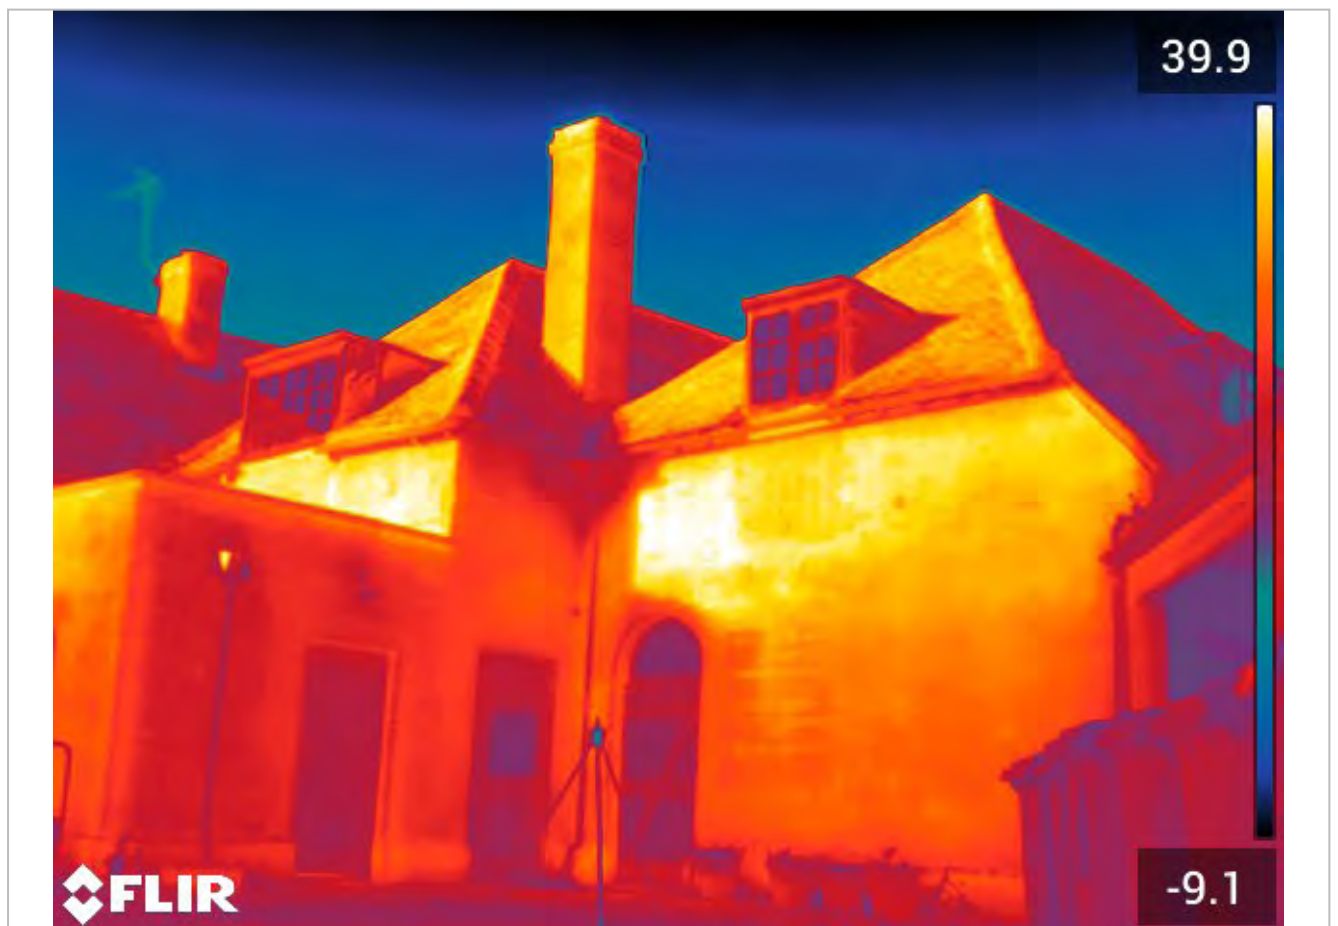
FLIR T540 (464 x 348 pixel resolution) with 42 degree lens = bat in flight detection distance of 51 m.  
Camera located 19 m from furthest point of building

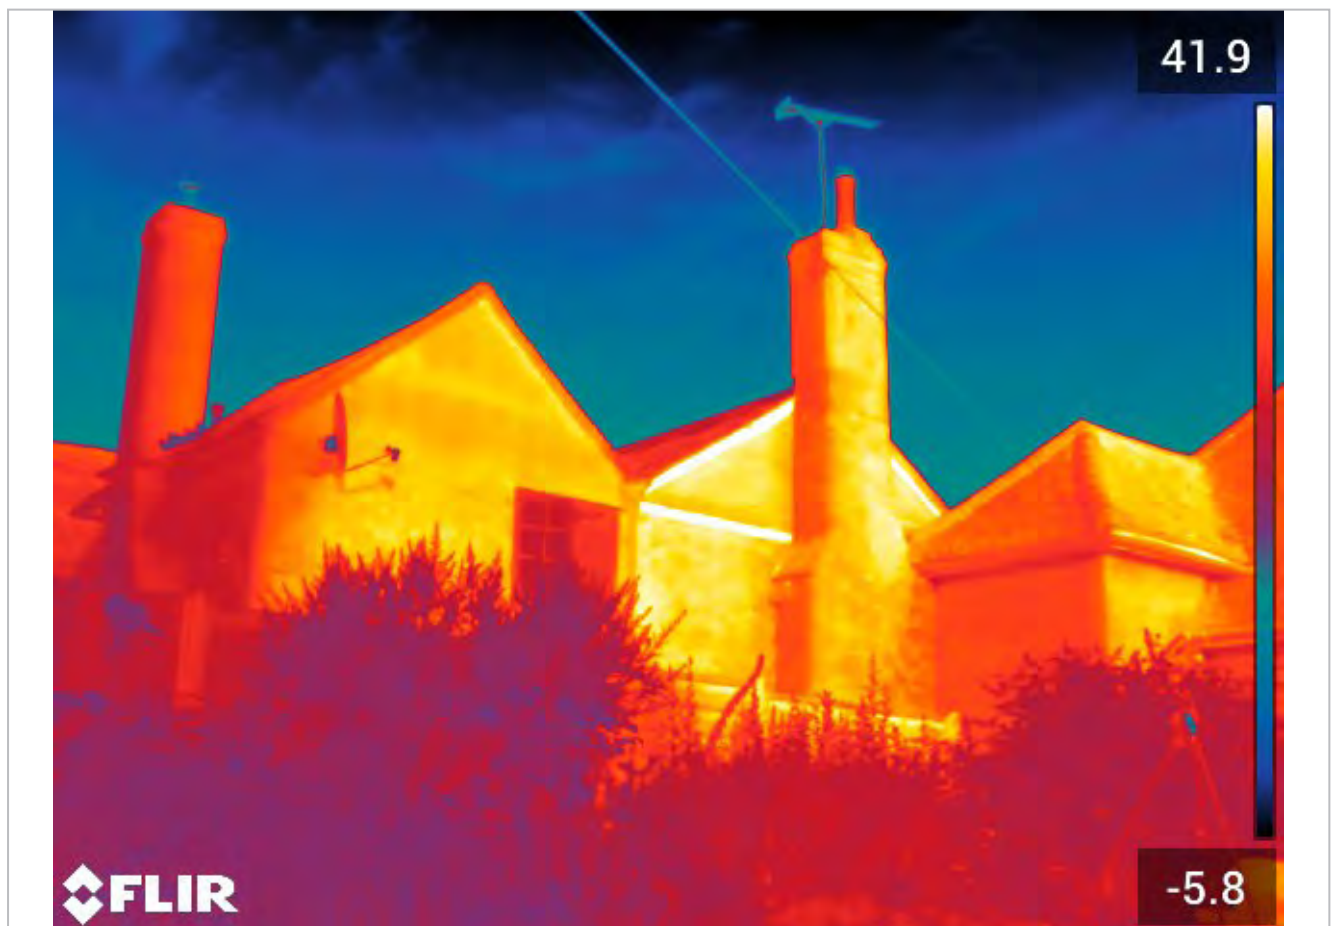
FLIR T860 (640 x 480 pixel resolution) with 42 degree lens = bat in flight detection distance of 66 m.  
Camera located 19 m from furthest point of building

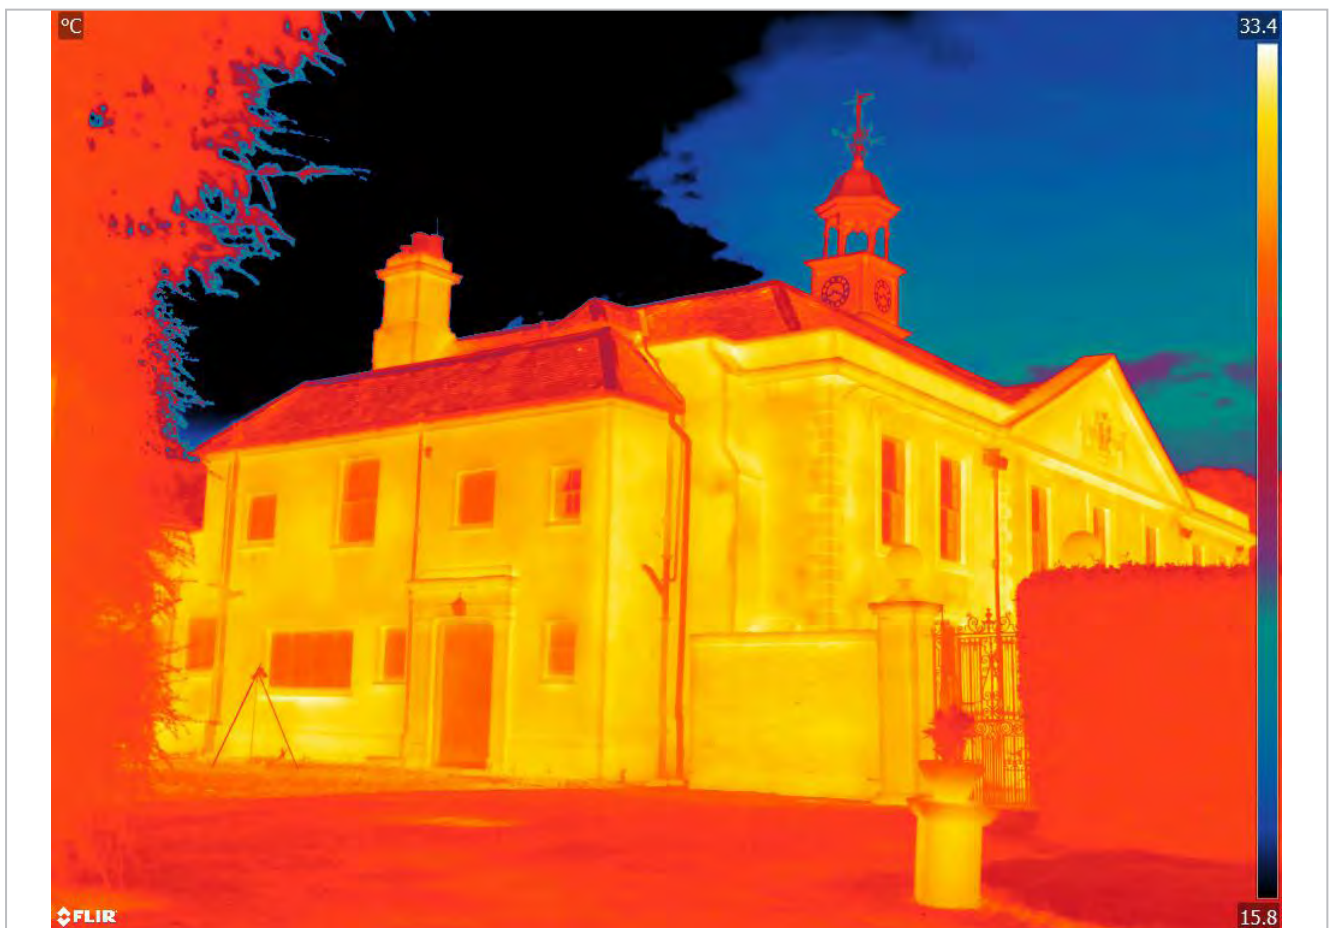
FLIR T1020 (1024 x 768 pixel resolution) with 45 degree lens = bat in flight detection distance of 104 m.  
Camera located 28 m from furthest point of building

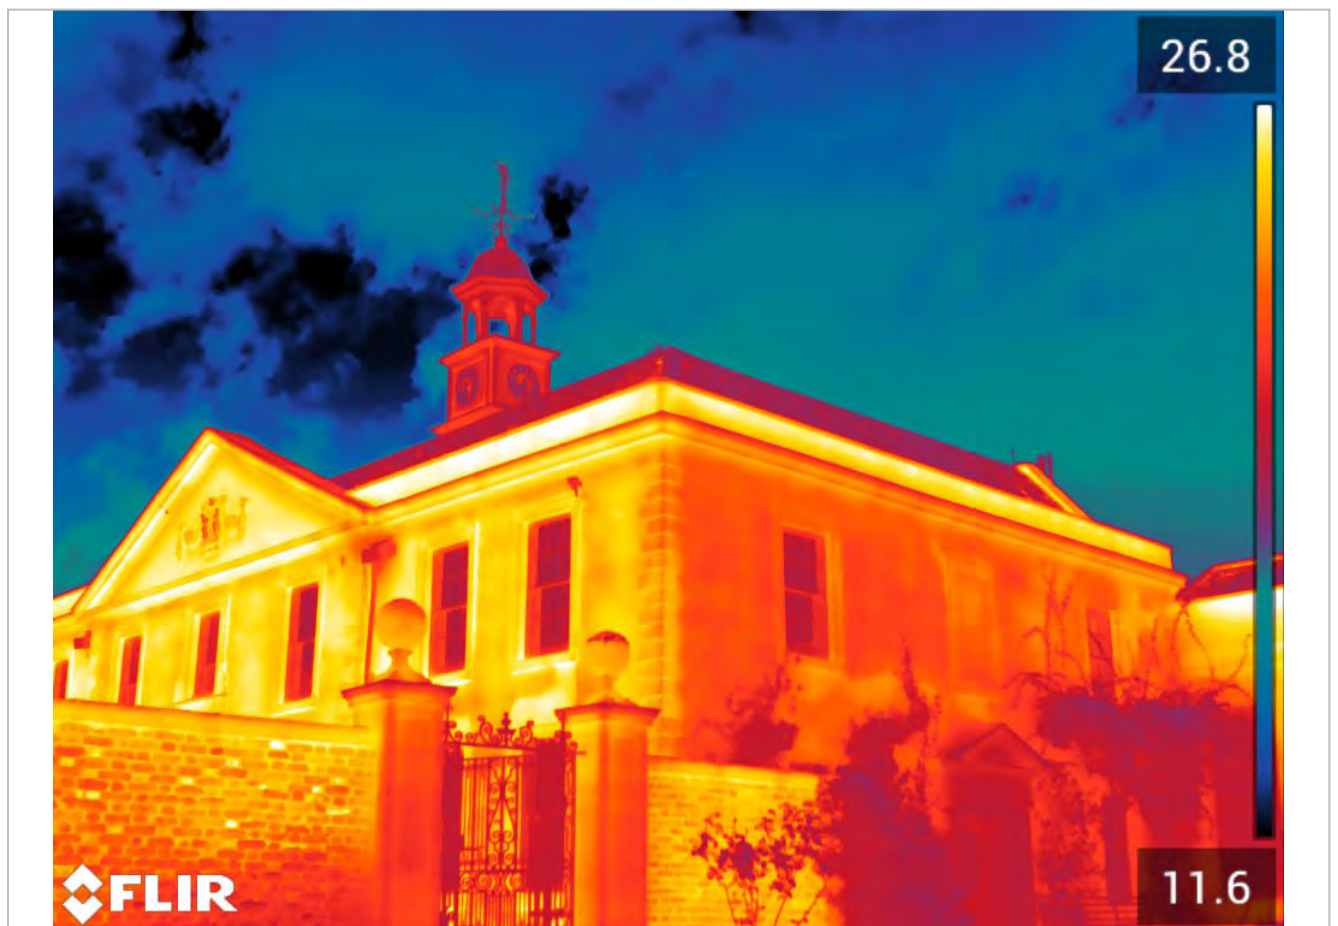
FLIR T1020 (1024 x 768 pixel resolution) with 45 degree lens = bat in flight detection distance of 104 m.  
Camera located 28 m from furthest point of building

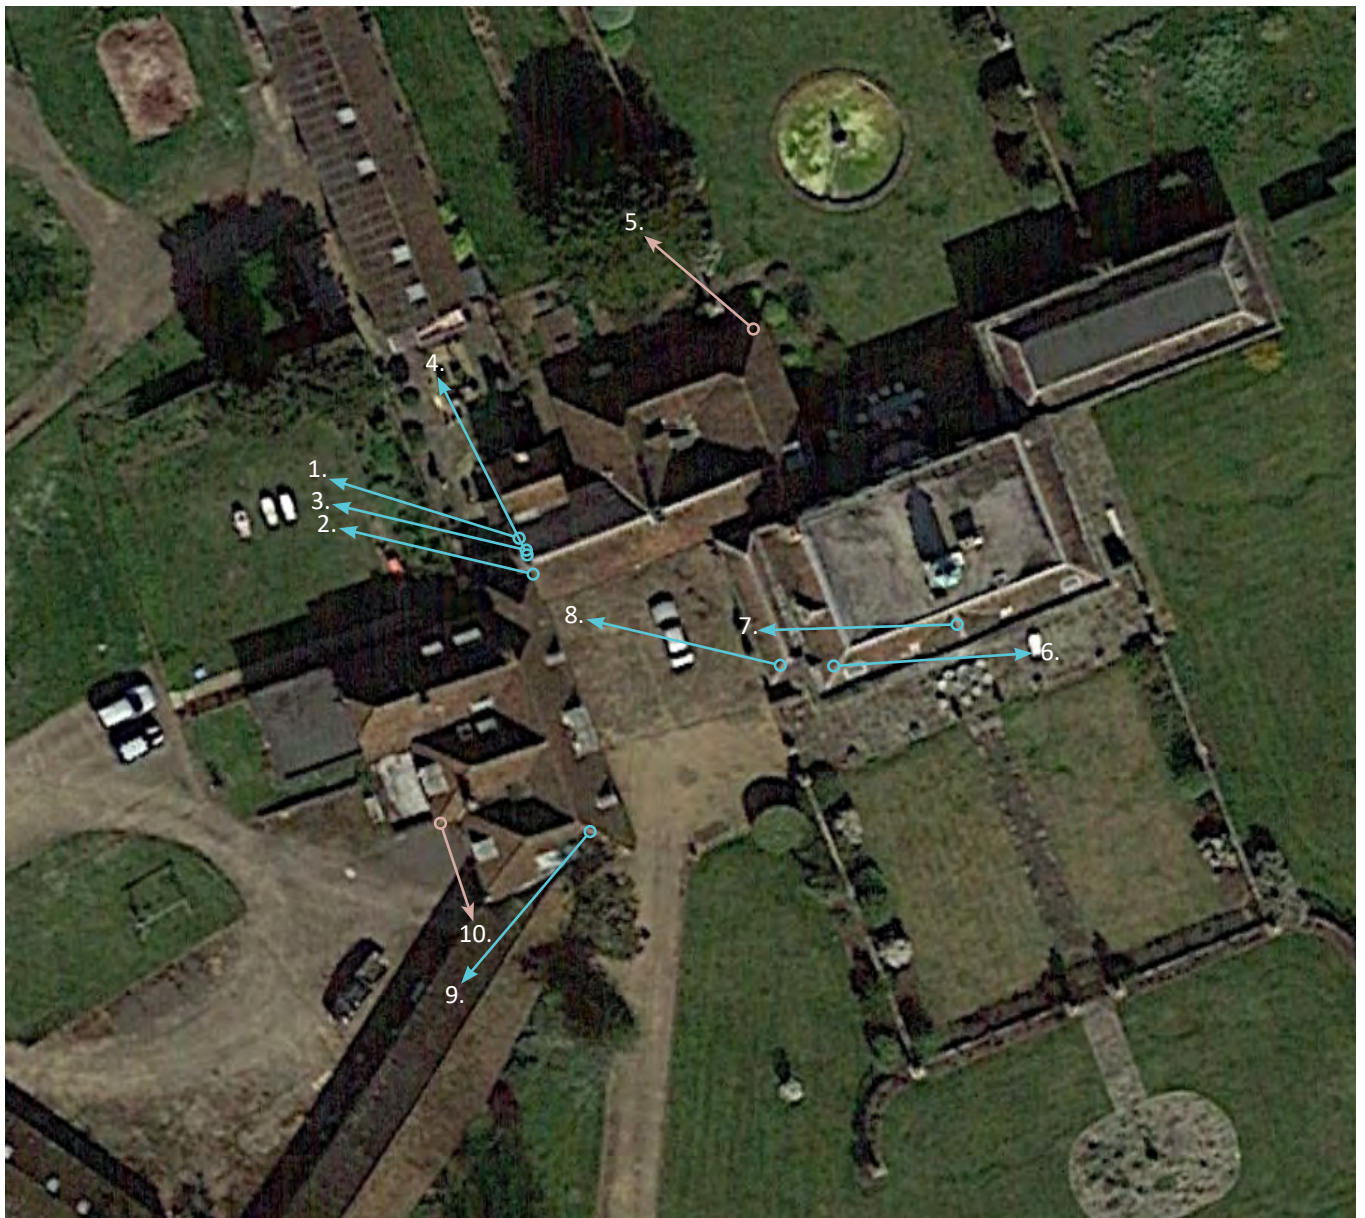
## Bat Survey Findings

1. Common pipistrelle bat (x41) emerged from verge between 21.17-21.59
2. Common pipistrelle bat (x1) emerged from verge @ 21.20
3. Common pipistrelle bat (x1) emerged from base of chimney @ 20.31
4. Common pipistrelle bat (x1) emerged from chimney brickwork @ 21.40
5. Brown long-eared bat (x3) emerged from ridge tile between 21.26-21.36
6. Common pipistrelle (x1) emerged from ridge tile @ 21.27
7. Common pipistrelle (x1) emerged from ridge tile @ 21.35
8. Common pipistrelle (x1) emerged from ridge tile @ 21.35
9. Common pipistrelle (x1) emerged from ridge tile @ 21.35
10. Brown long-eared bat (x1) emerged from wall @ 21.34

- 4.3 Construction work that could directly or indirectly disturb / damage the Gardener's Cottage maternity roost should be completed outside of the maternity period of May-September, and would need to be designed and planned to retain the roost in the same location, and for the use of a traditional 1F felt with respect to re-roofing.

- 4.5 Bat roosts in brickwork on the Coach House and Gardener's Cottage could also be adversely impacted by repointing / brick replacement, and provision of integrated brick faced bat boxes in locations where bats are roosting will need to be considered as part of the overall bat mitigation strategy.

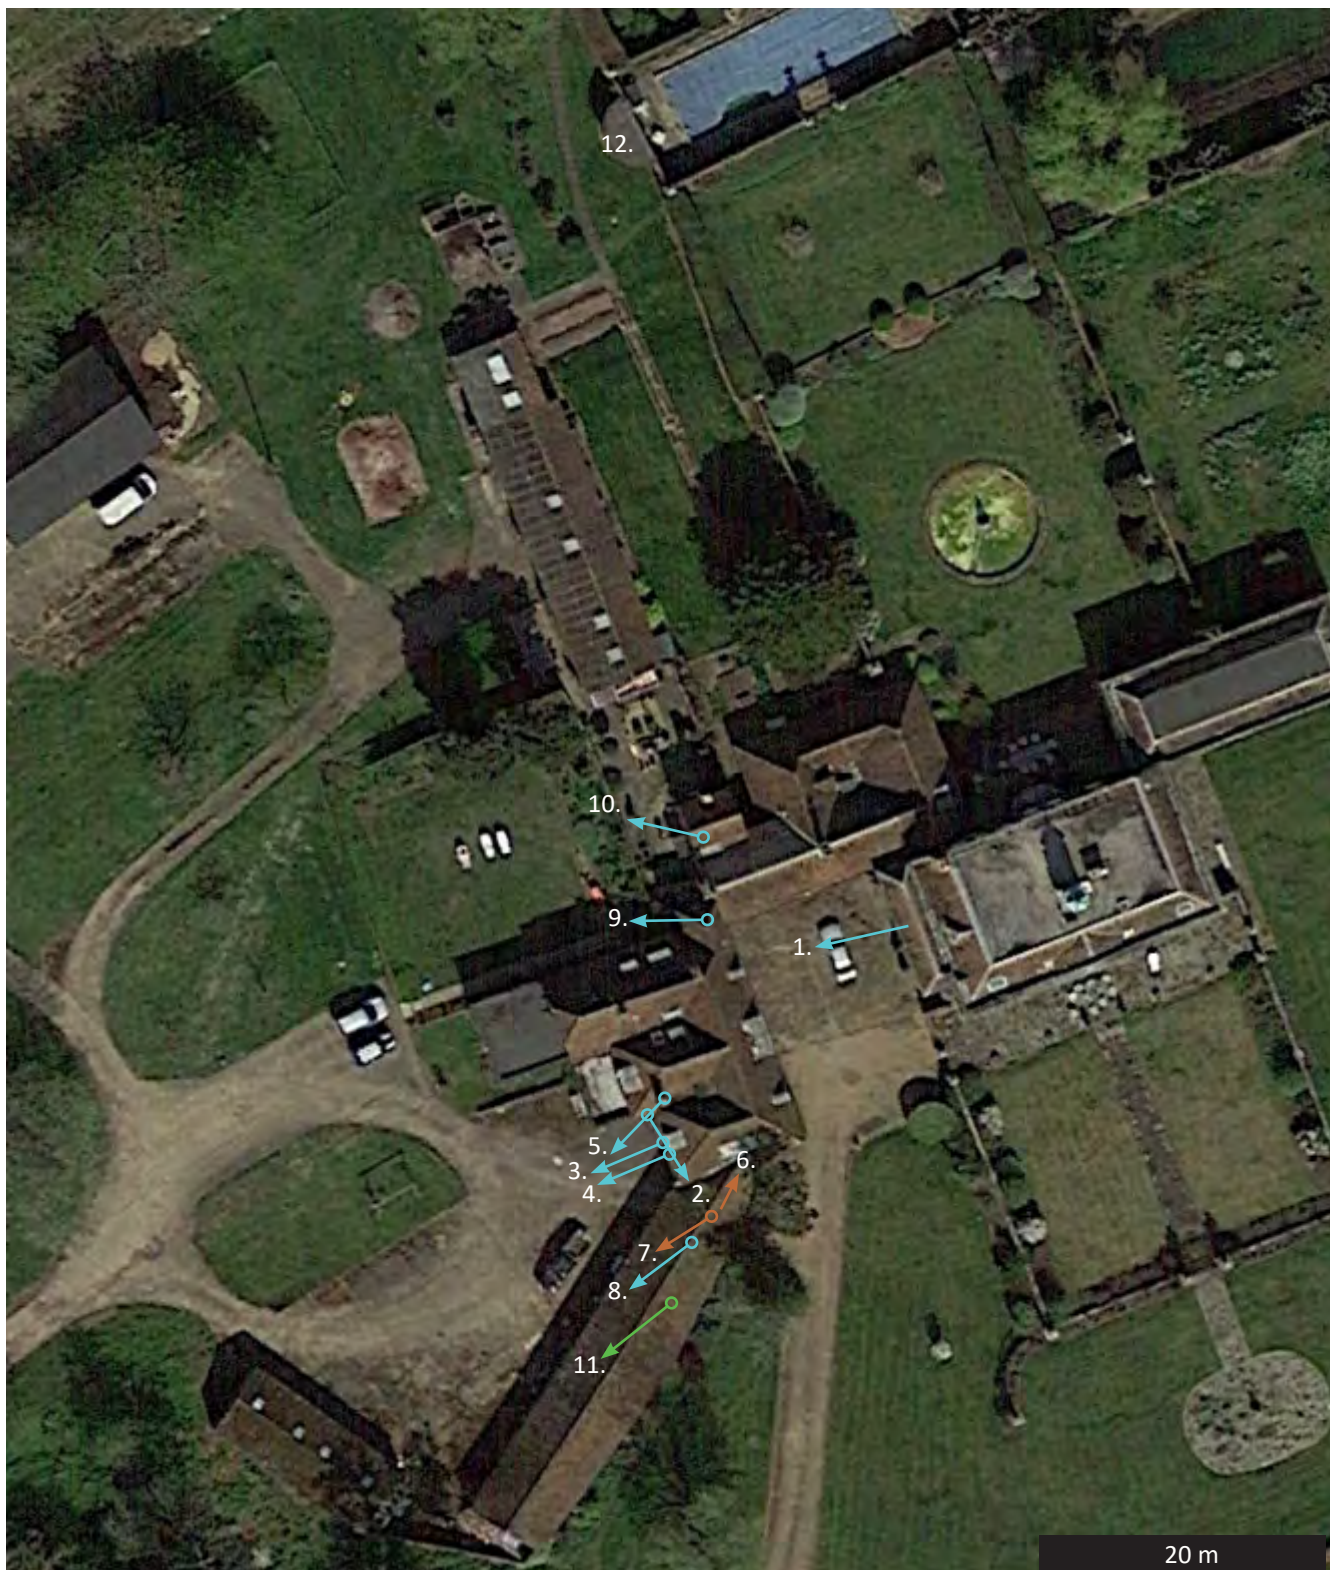
1. Common pipistrelle bats (x11) emerged from different locations on roof from below tiles between 20.05-20.26
2. Common pipistrelle (x3) emerged from mortar gap in wall brickwork between 20.16-20.24
3. Common pipistrelle (x1) emerged from hole in brick wall @20.16
4. Common pipistrelle(x1) emerged from mortar gap in brickwork @20.21
5. Common pipistrelle (x3) emerged from roof tile near eave @ 20.20
6. Brown long-eared (x2) emerged from ridge @ 20.28
7. Brown long-eared (x1) emerged from timber near ridge @20.29
8. Common pipistrelle (x1) off ridge @ 20.28
9. Common pipistrelle (x1) off ridge tile @ 20.21
10. Common pipistrelle (x1) off roof tile @ 20.26
11. Natterers bat off roof timber inside @ 20.53
12. No bats off pool building

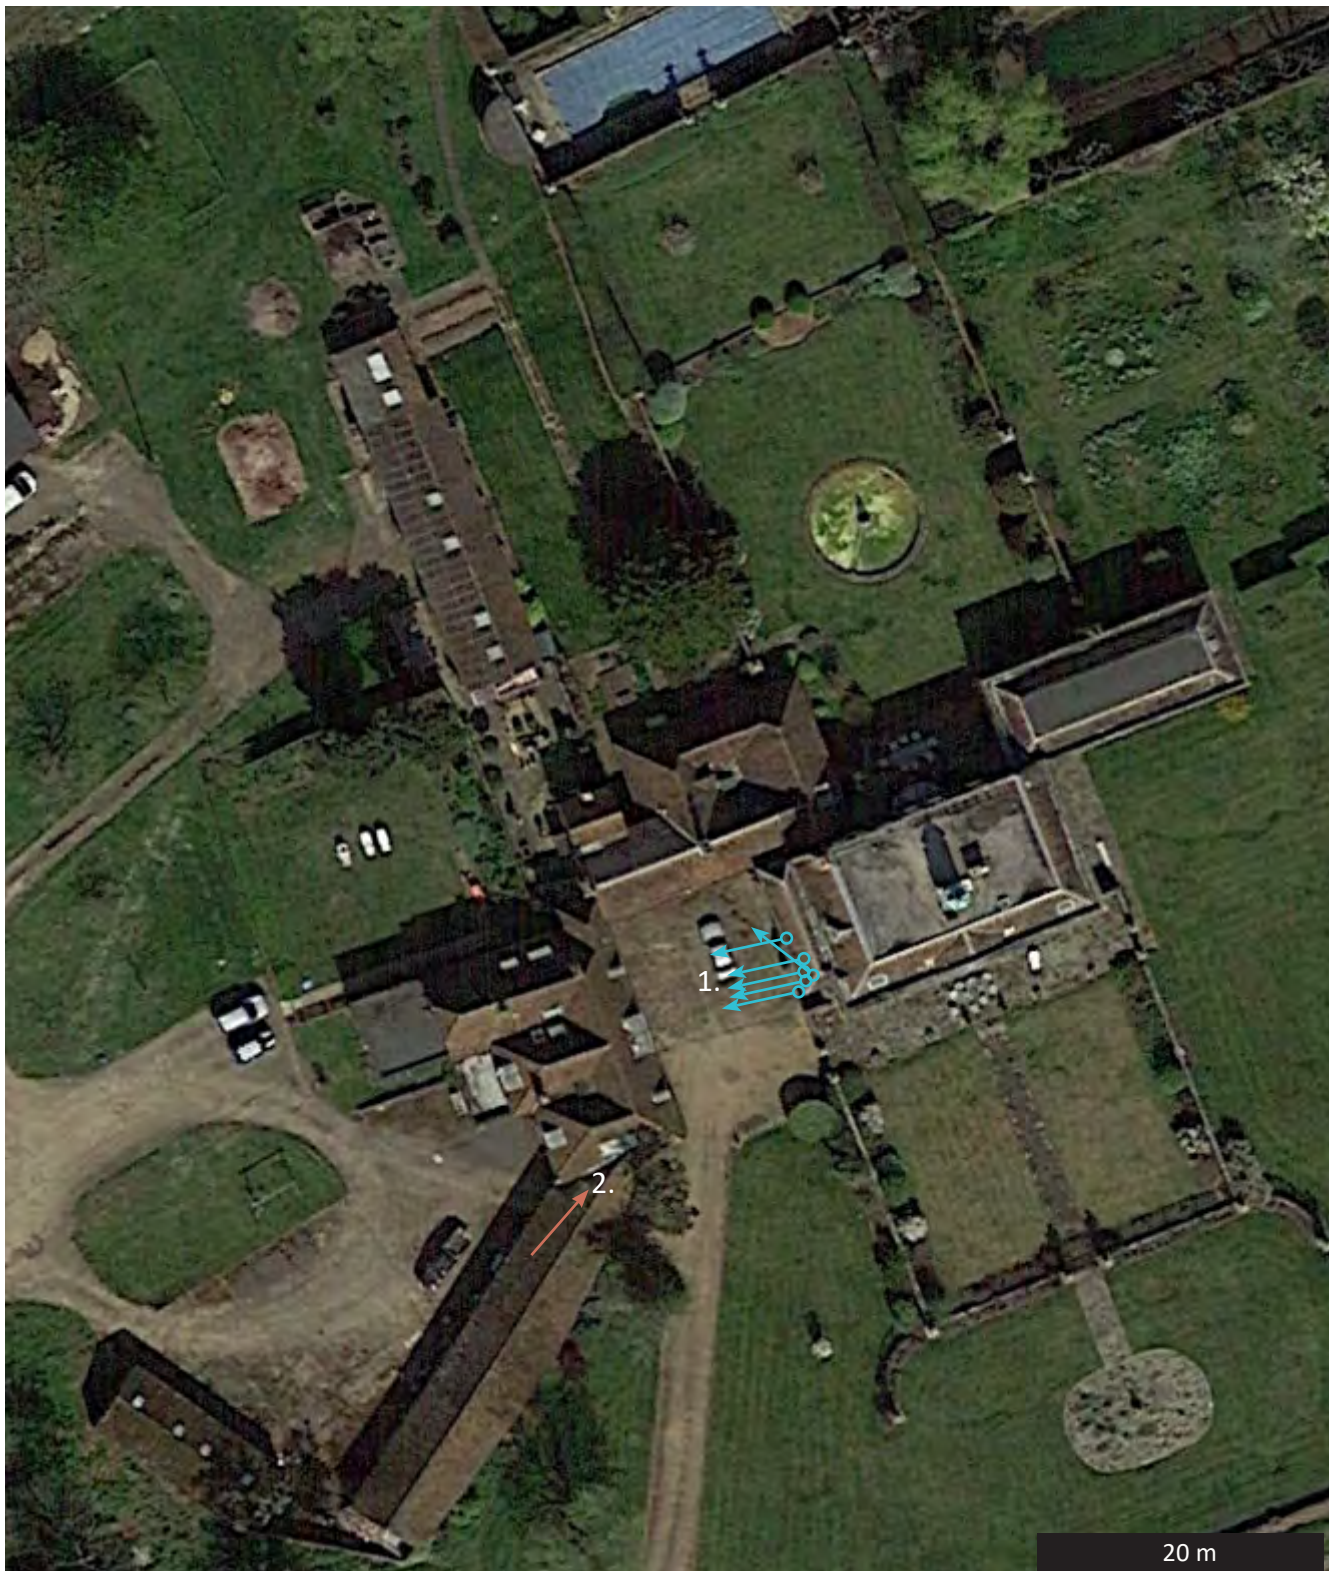
1. Common pipistrelle bats (x9) emerged from six different roof tile/ ridge gaps between 20.17-20.24.
2. Brown long-eared bat (x1) emerged from interior roof @ 20.41 and continued to fly / perch / preen in the garage roof area until 20.59

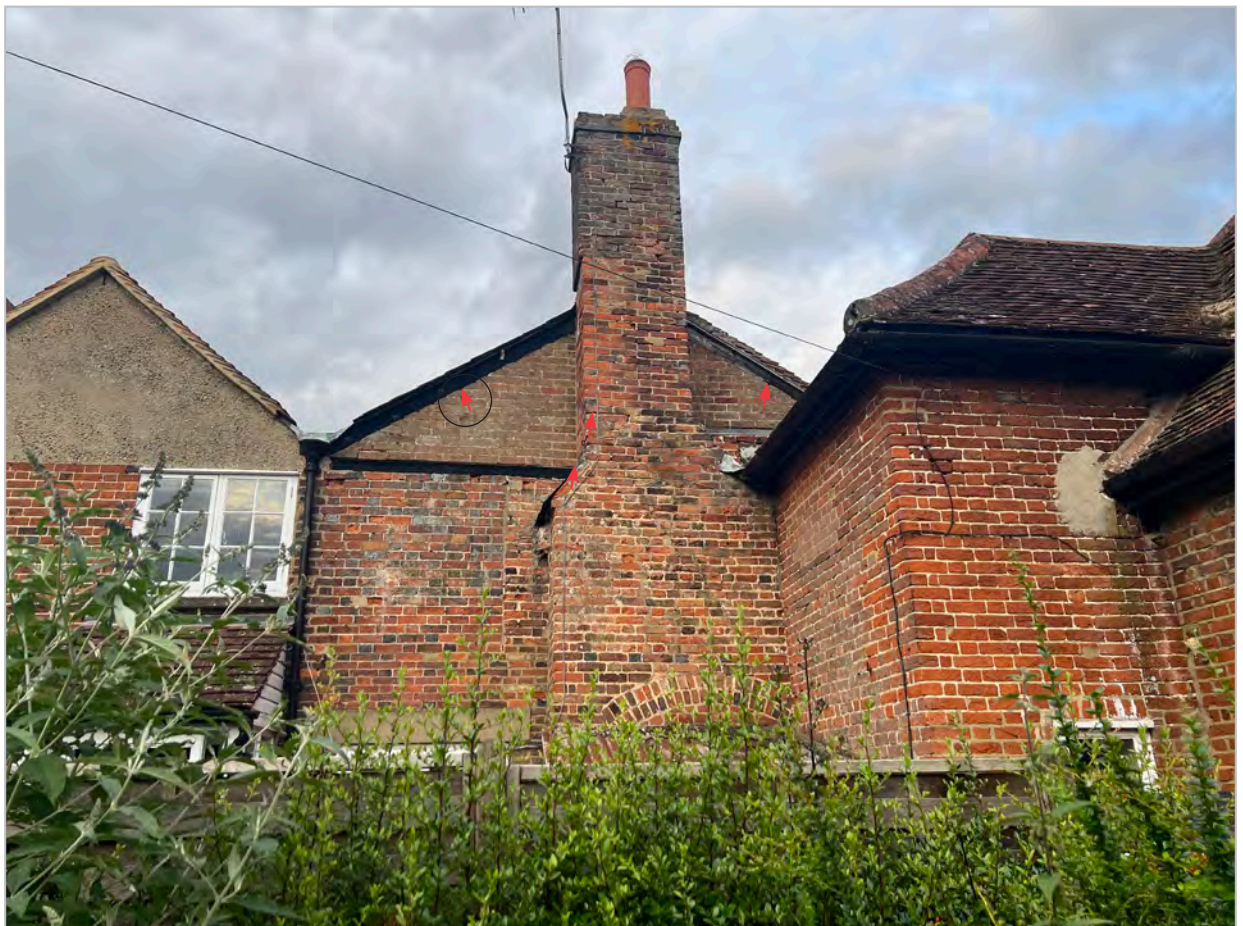
Gardener's Cottage common pipistrelle bat maternity roost exit points (red arrow) - 41 bats out of circled arrow

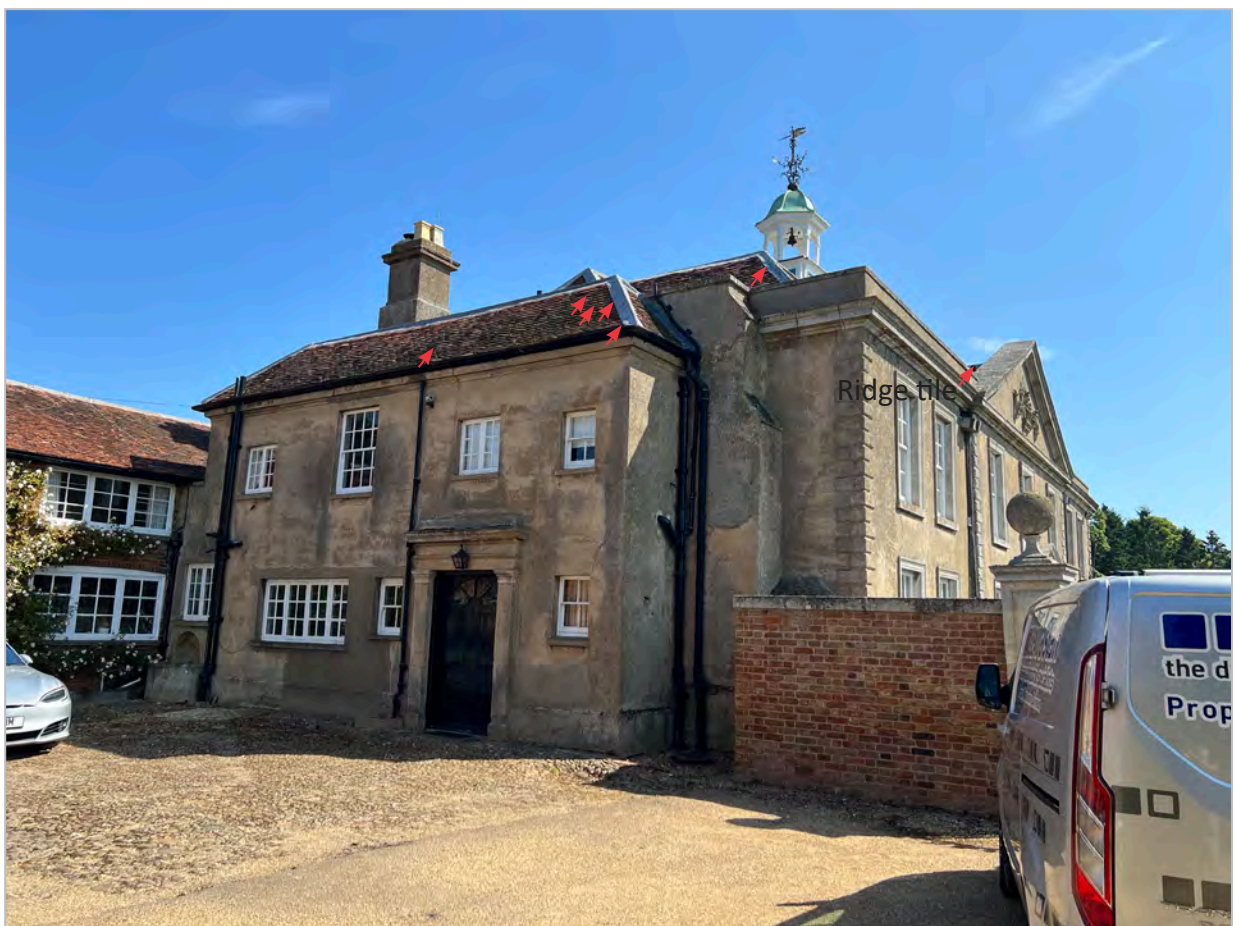
Main Villa common pipistrelle bat roost exit points

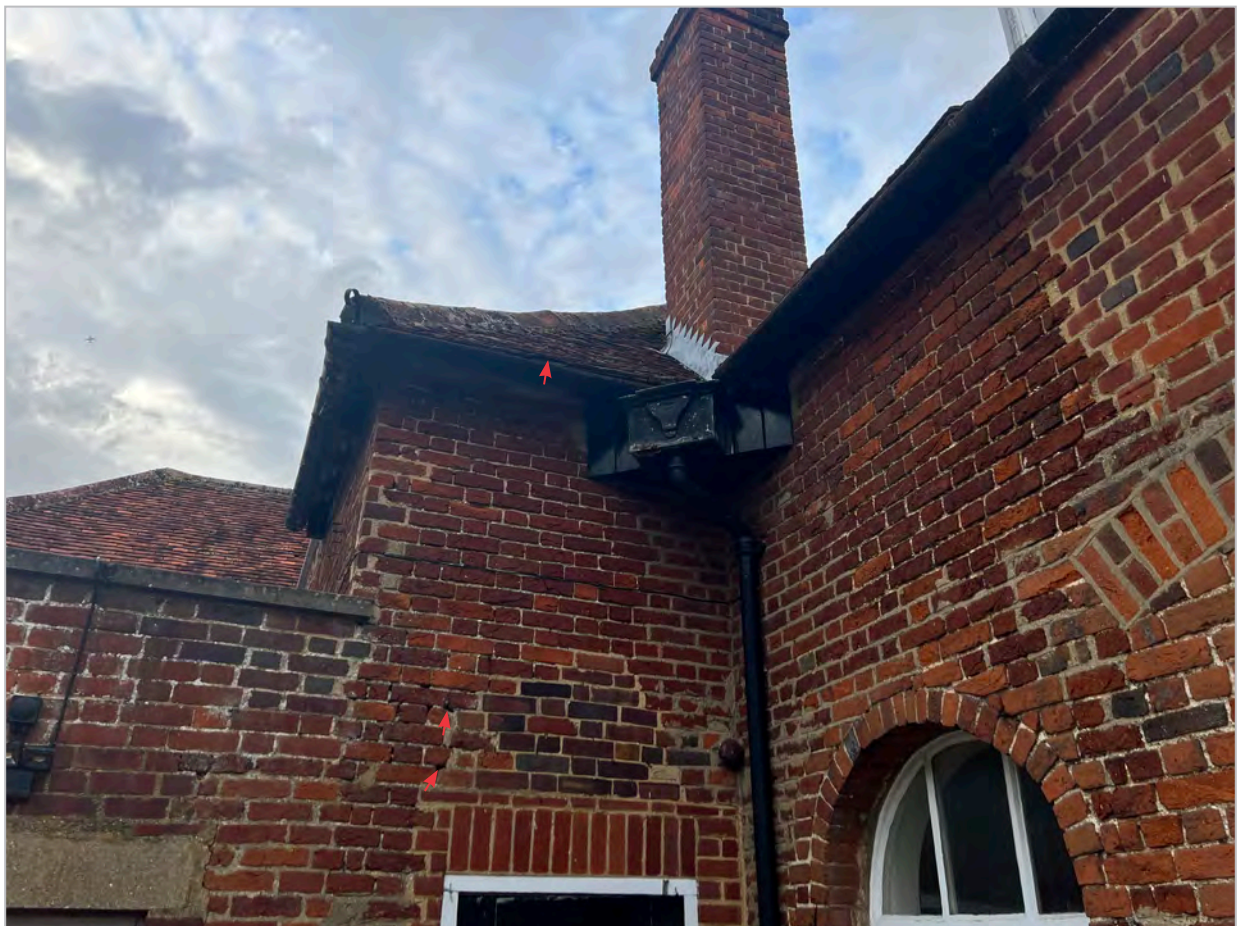
Coach House common pipistrelle and brown long-eared bat roost exit points (red arrows)

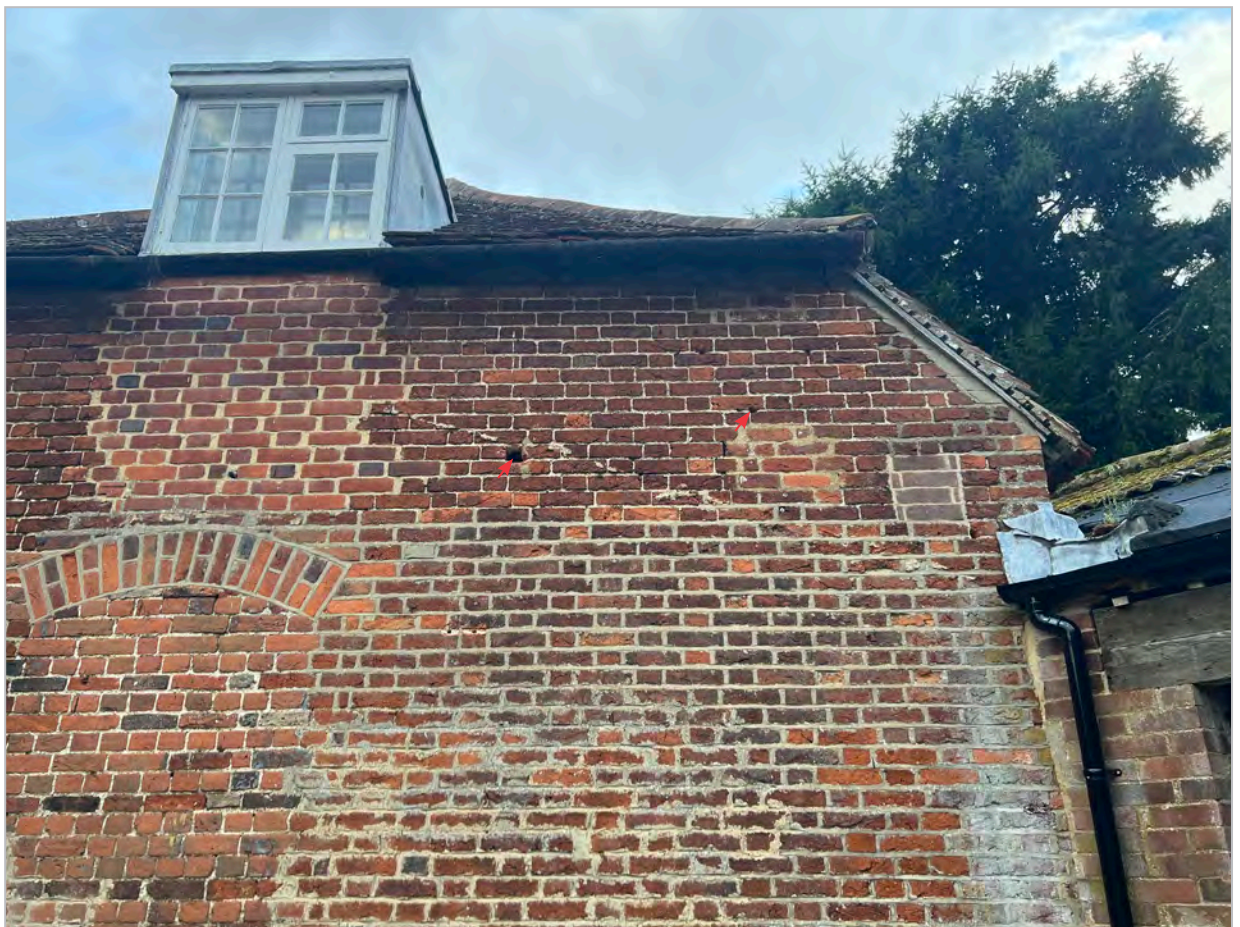
Coach House common pipistrelle roost locations

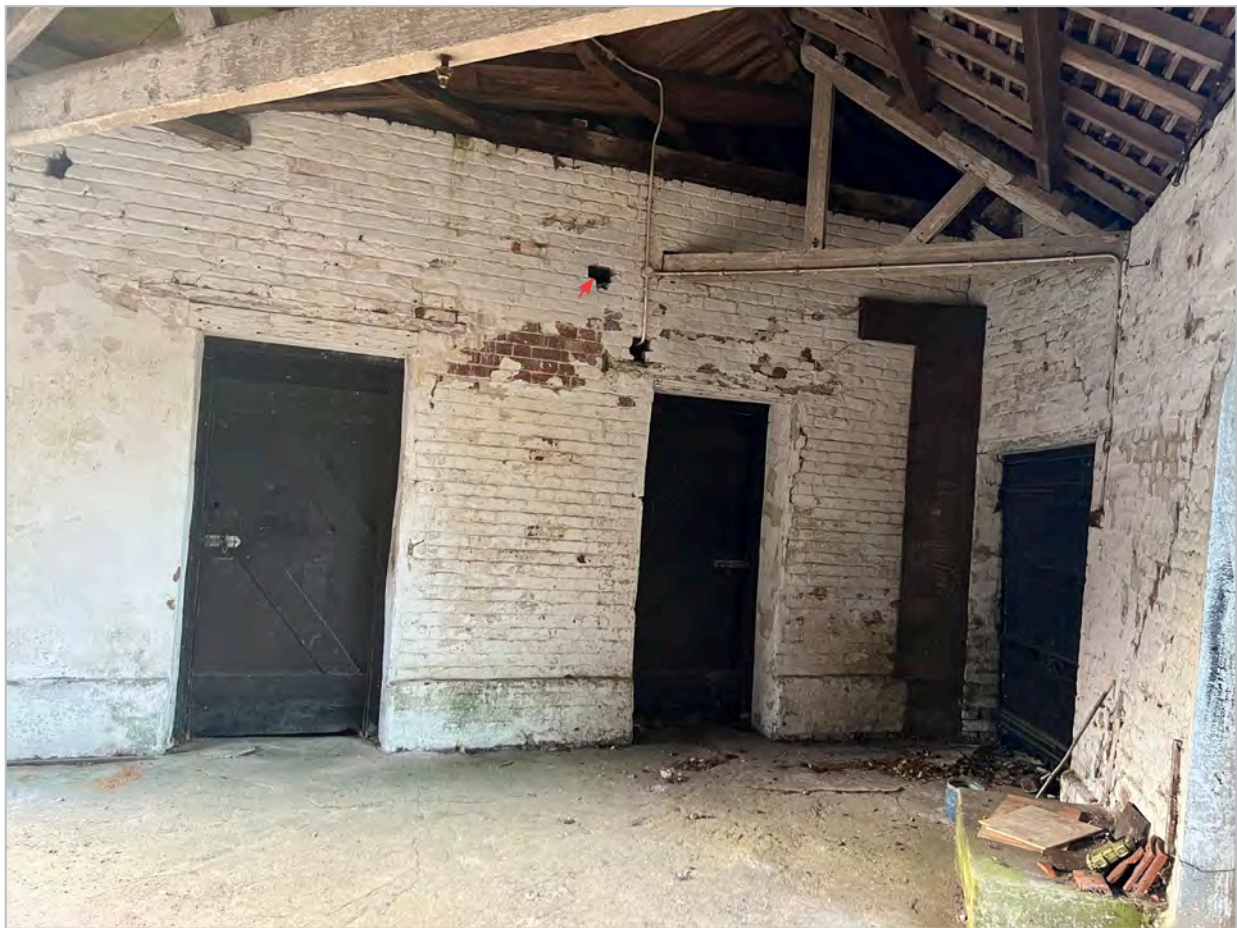
Coach House brown long-eared bat exit point

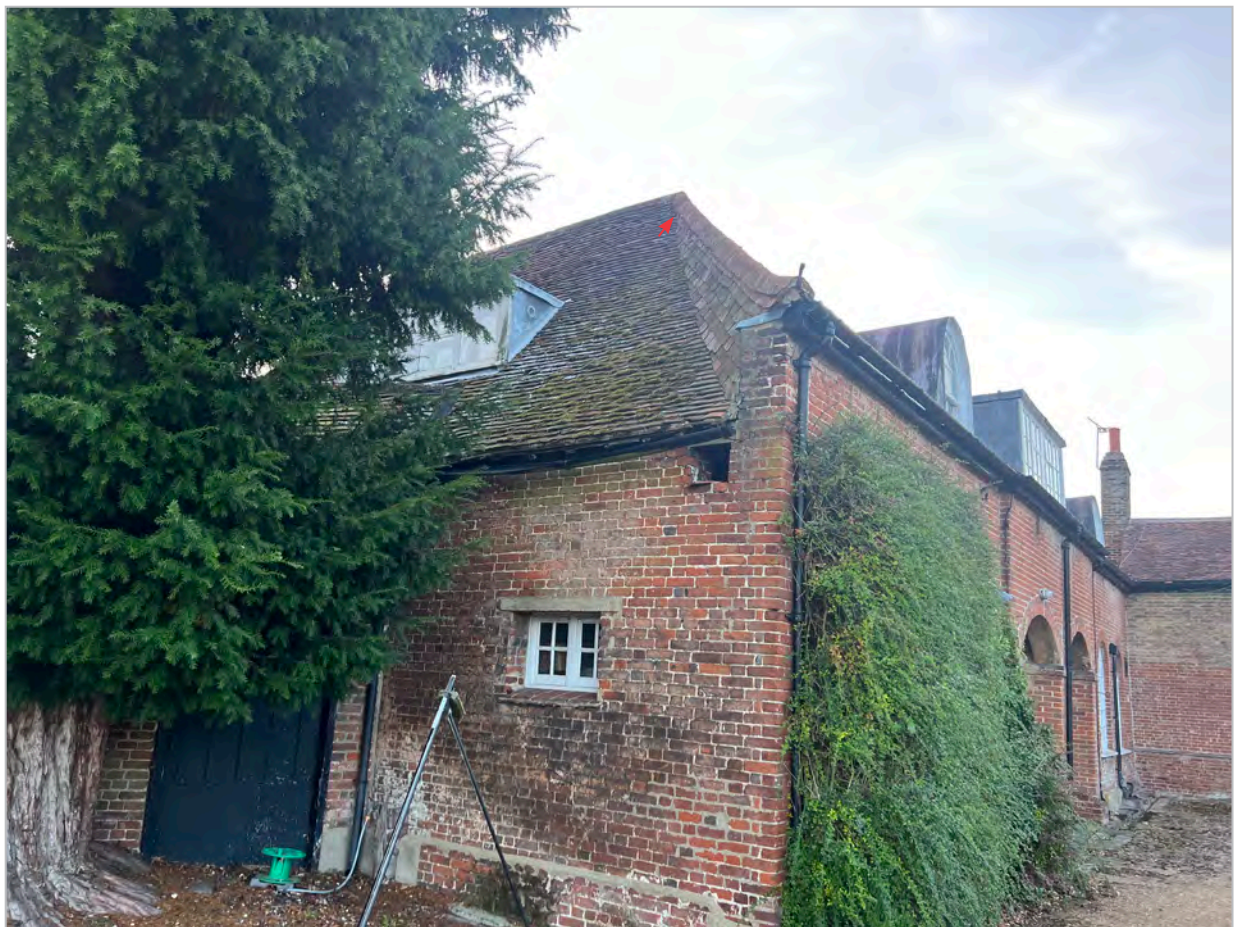
Common pipistrelle bat common pipistrelle roost exit point

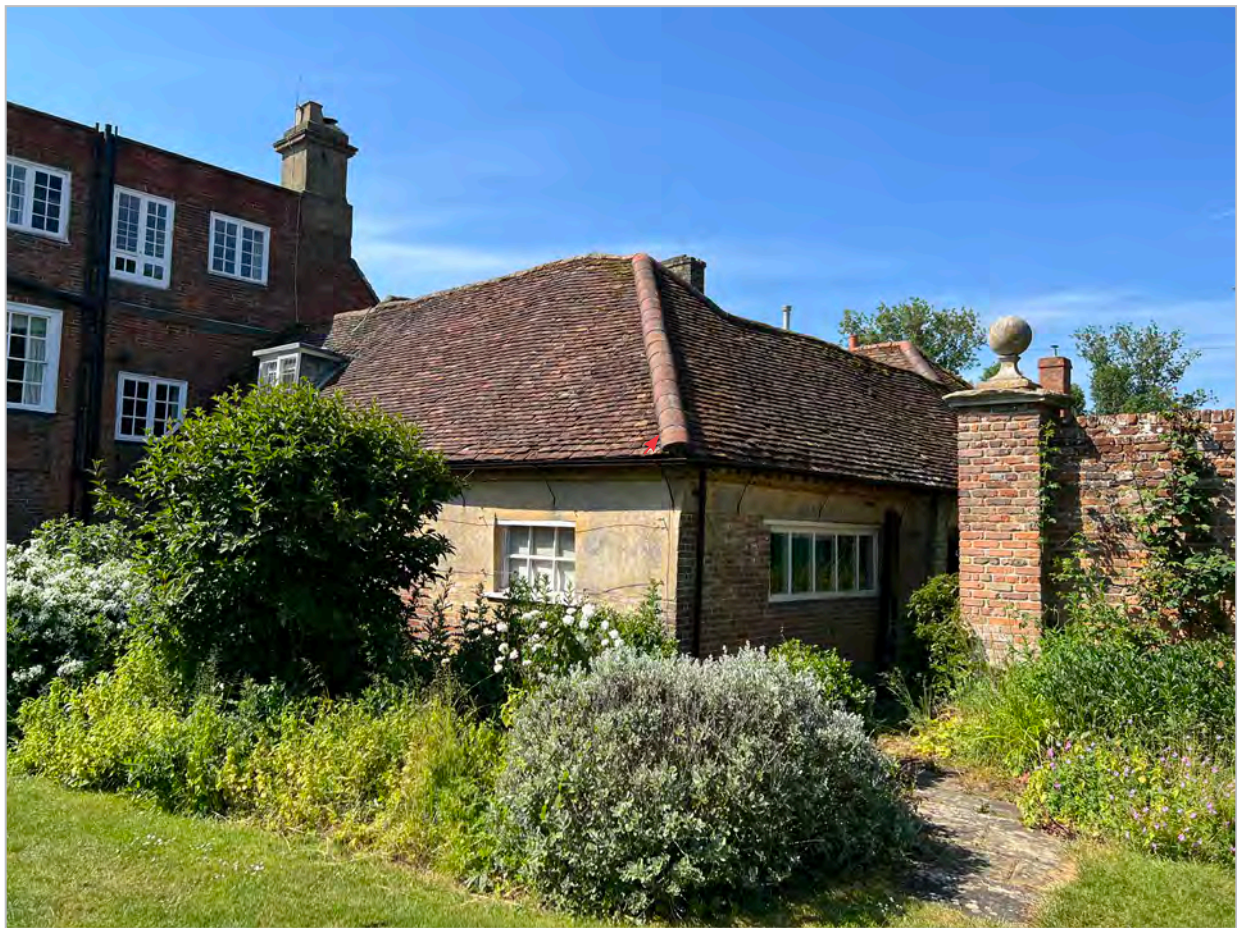
Kitchen Wing brown long-eared bat roost exit point

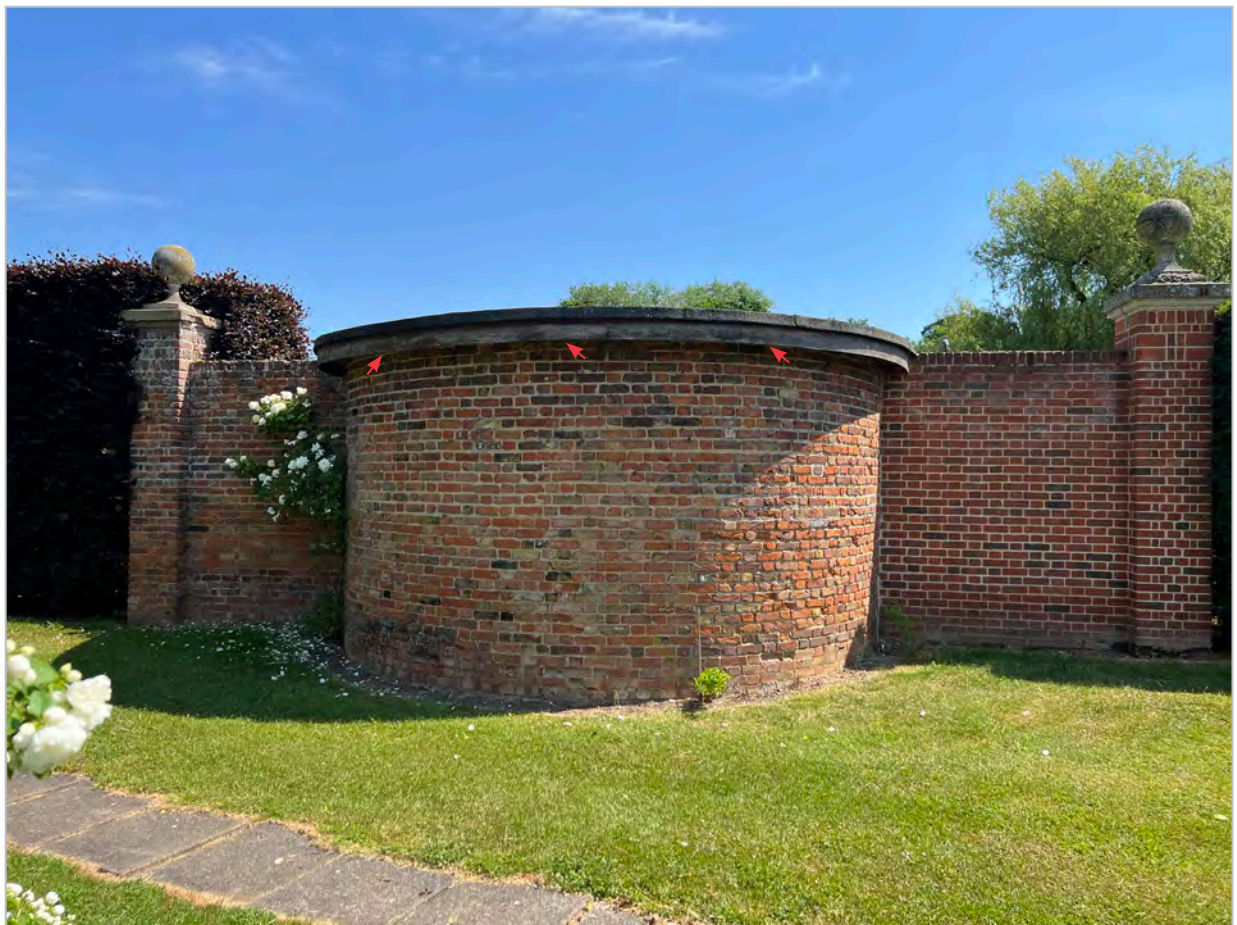
Pool Building common pipistrelle roost exit points

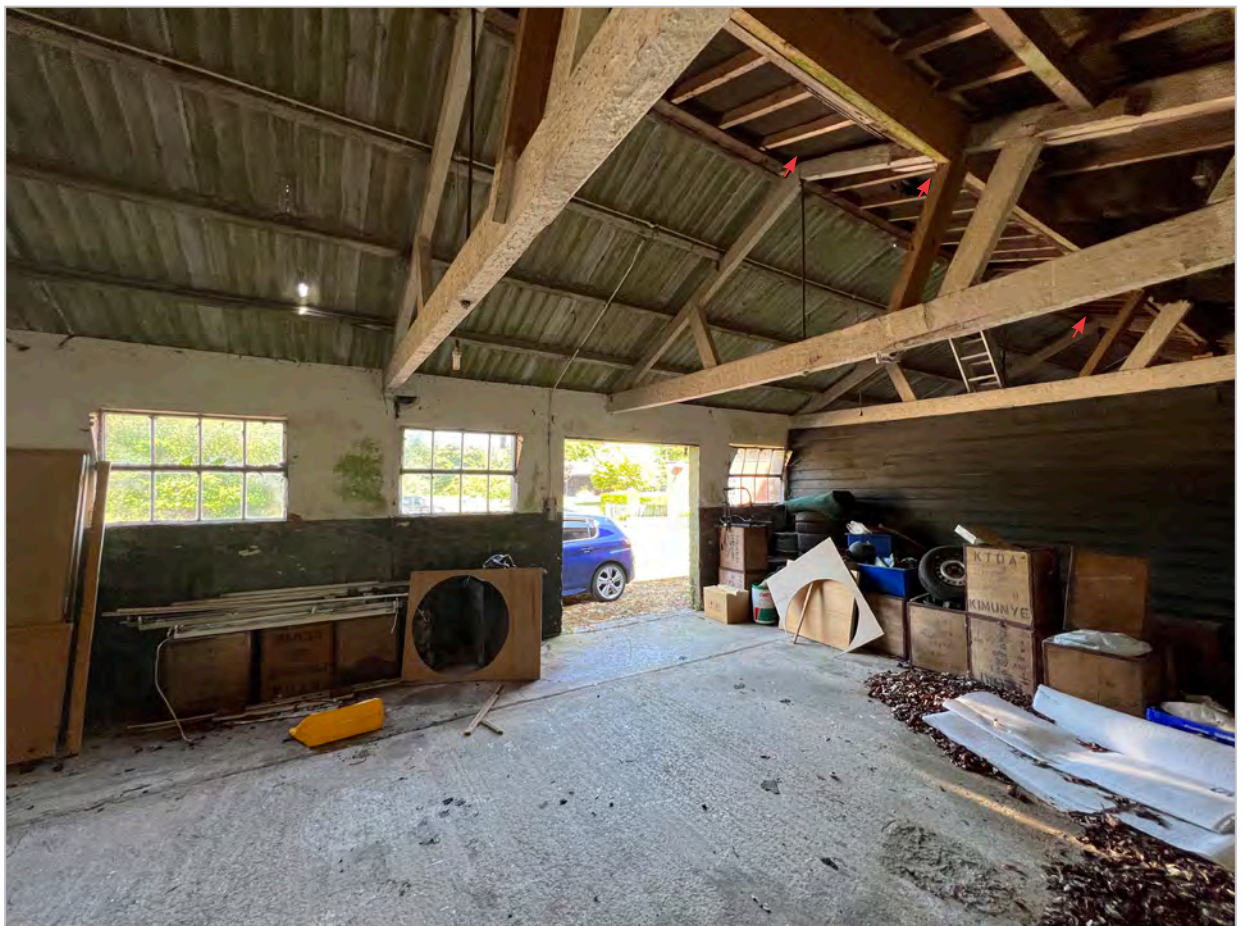
Garage - common pipistrelle, natterers bat, and brown long-eared bat roost locations

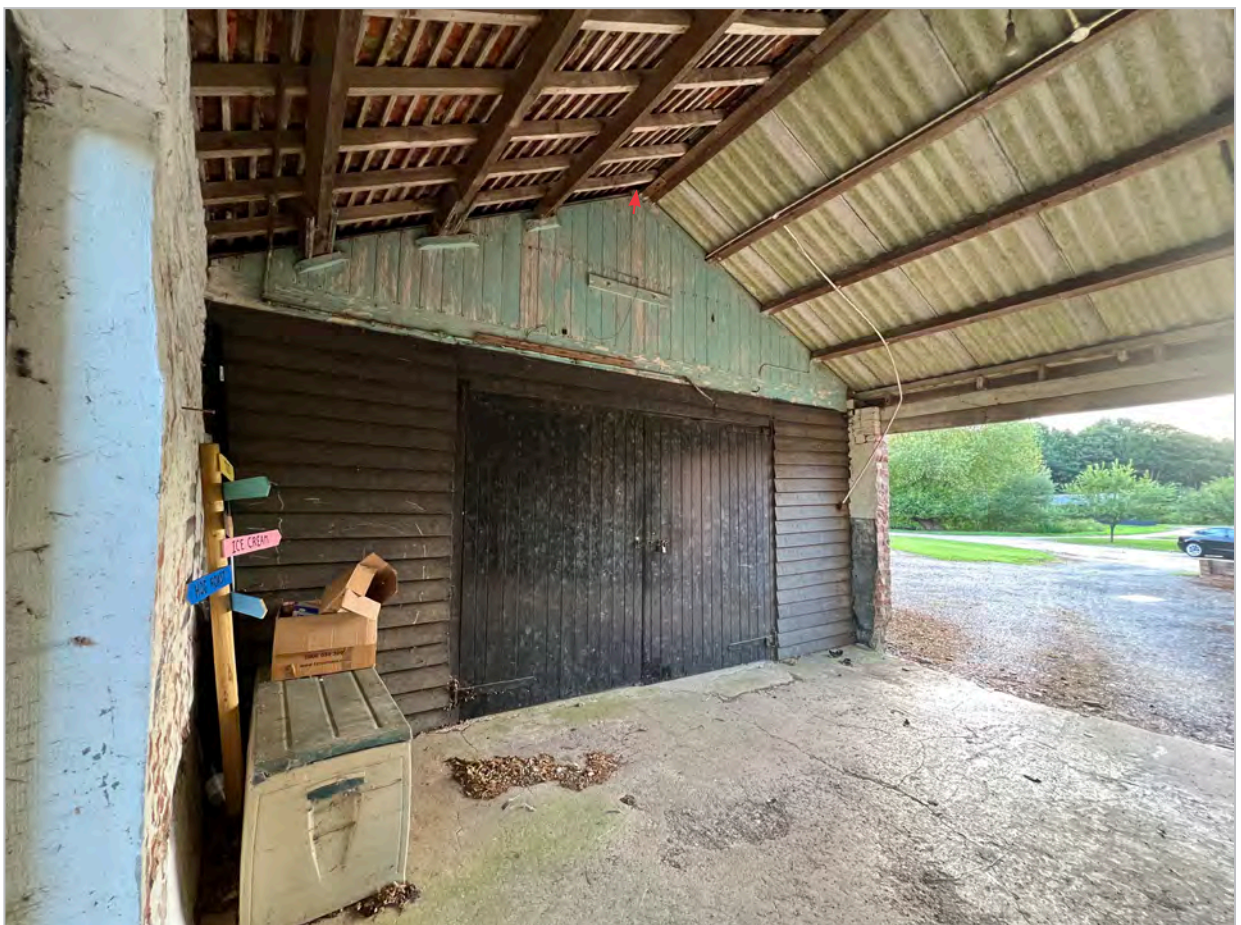
Gap above garage doors at east end of building used by brown long-eared bats to move between garage sections
