# **COYNE ENVIRONMENTAL LTD**

**44 High Street,  
Barkway,  
Royston,  
Hertfordshire  
SG8 8EE**

## **PRELIMINARY ROOST ASSESSMENT**

**JULY 2025**

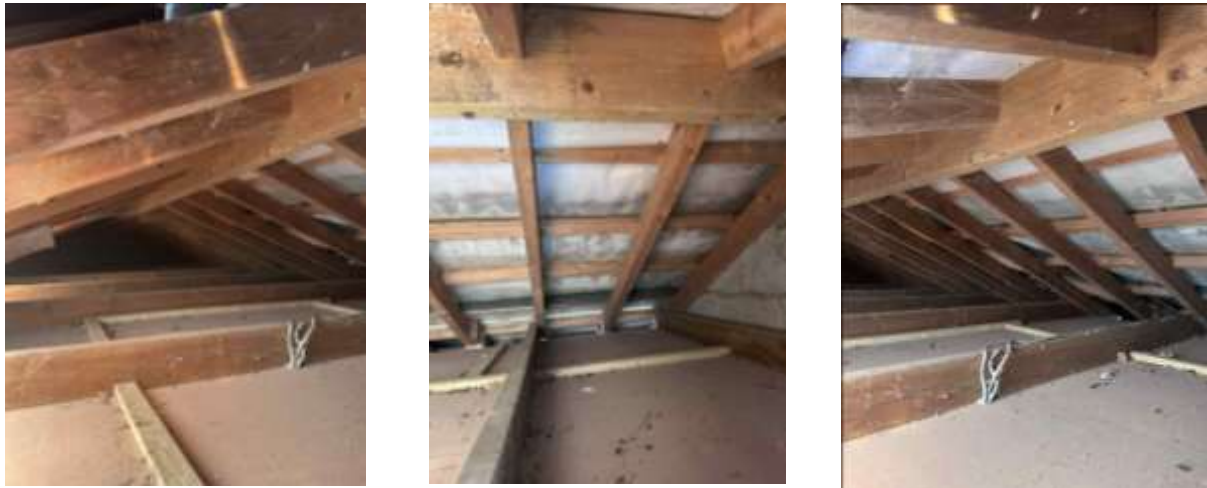
The south section of the outbuilding was able to have the loft accessed; this area had been plywood boarded to create a loft. The loft was bright from the skylight upon investigation many cobwebs were discovered and no signs of bats. Rat droppings were discovered in this loft area near the ladder hatch. Due to the bright light levels, cobwebs and the level of disturbance from the frequency of the usage of the building this section was determined **low suitability for bat roosts**.

**Figure 1** South section loft of the surveyed outbuilding

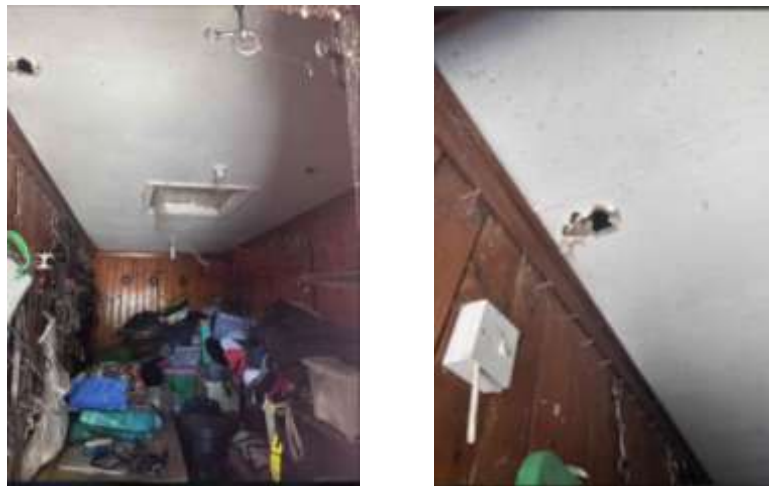
The centre section of the outbuilding could not have the loft accessed due to the storage space occupied below. However, no access points were seen from the front

of the outbuilding, but the rear side was inaccessible to determine access points. The area was investigated for bat droppings and insect meals, and none were found. The area had thick cobwebs present, and the loft area also consisted of another sky light seen from the investigation of the South section loft which impacts the suitability for it being a roosting site. A small hole is present within the plywood ceiling, but no bat droppings below or oil staining was visible; and no exit points are available from this main section as the main door remains closed.

**Figure 3** Centre section of outbuilding
