# **Phase 1 Land Contamination Risk Assessment**

**The Proposed Conversion of a  
Former Poultry Building into 3 No.  
Residential Dwellings with all  
Associated Building Works  
on the site of  
Woodcotes, Fears Green, Sandon,  
Buntingford, Hertfordshire SG9 0QZ**

**Date: October 2024**

3823D P1 Jani - Buntingford

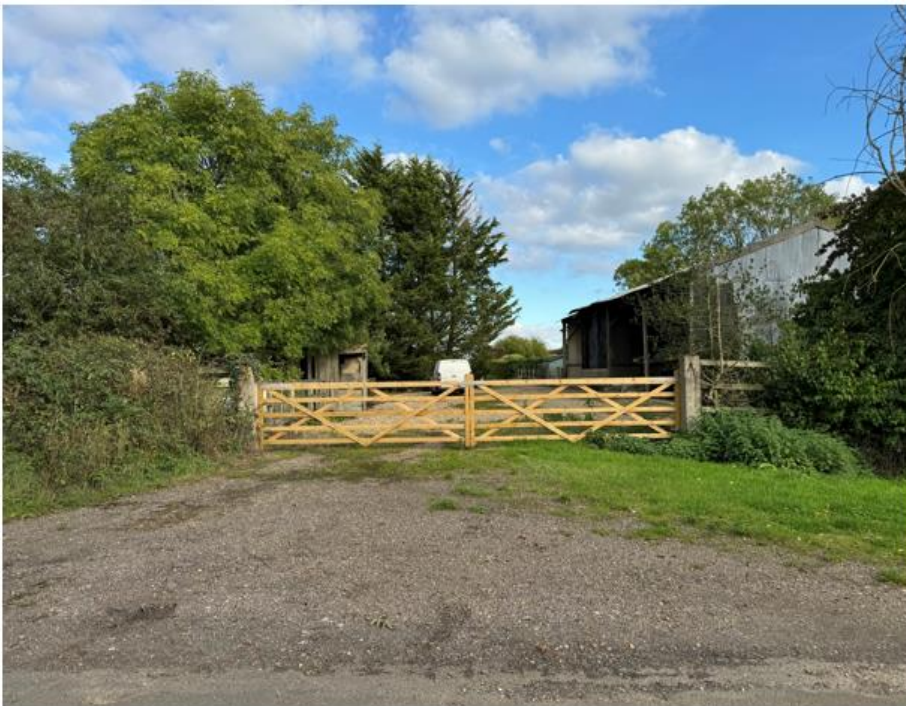
**Photo No.1: Facing east from the adjacent roadside showing the gated site access (outside red-line boundary)**

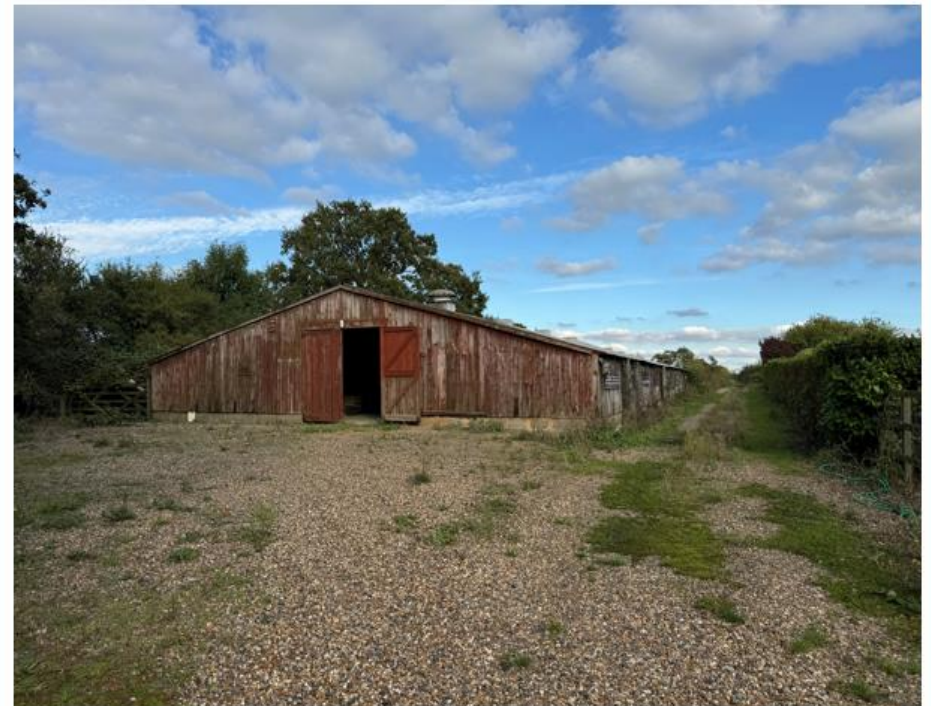
Access to site was provided via a gate to the west of site, before a gravelled access route leads to the site itself. The structure on site was seen to be constructed of timber structuring and cladding with concrete flooring through and corrugated metal roofing. Brackets formerly holding cement guttering were noted along the northern and southern faces, with some areas of fragmented, potentially asbestos containing cement guttering noted around these faces (including within dense overgrowth occupying the entirety of the exterior area outside the northern face of the shed). The interior of the shed was noted to be split into two halves, separated by a small room.

**Photo No.2: Facing slightly NE outside the SW corner of site showing the front (western) face of the former poultry shed**

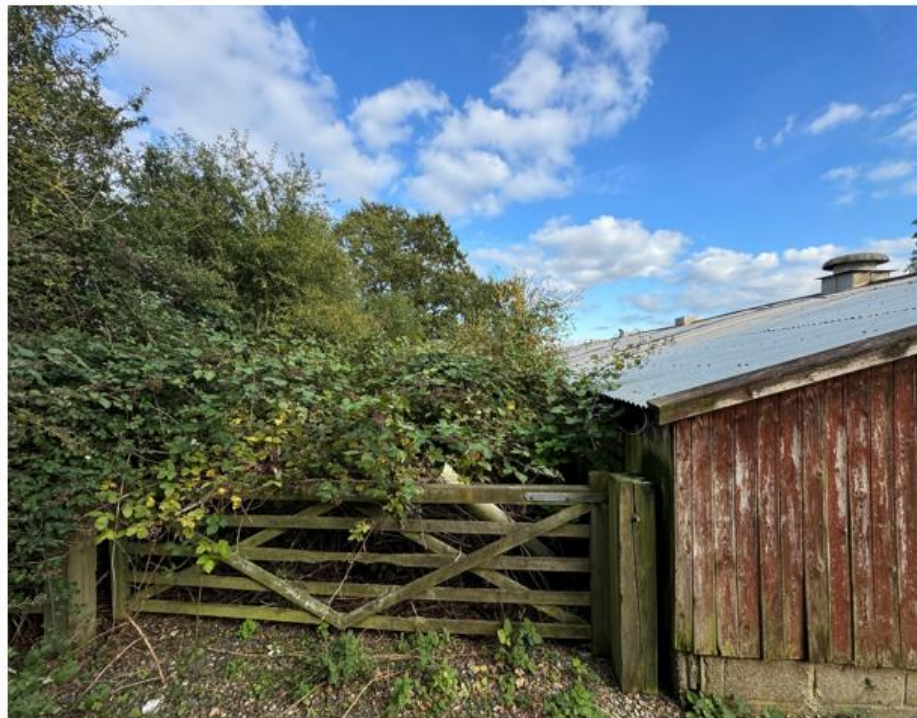
The exterior area on site, located directly north of and parallel with the barn, was largely inaccessible on the day of the walkover due to heavy overgrowth; however, some further fragments of concrete guttering were noted in this area.

**Photo No.3: Facing east showing the northern face of the poultry shed and overgrown exterior area (within red-line)**

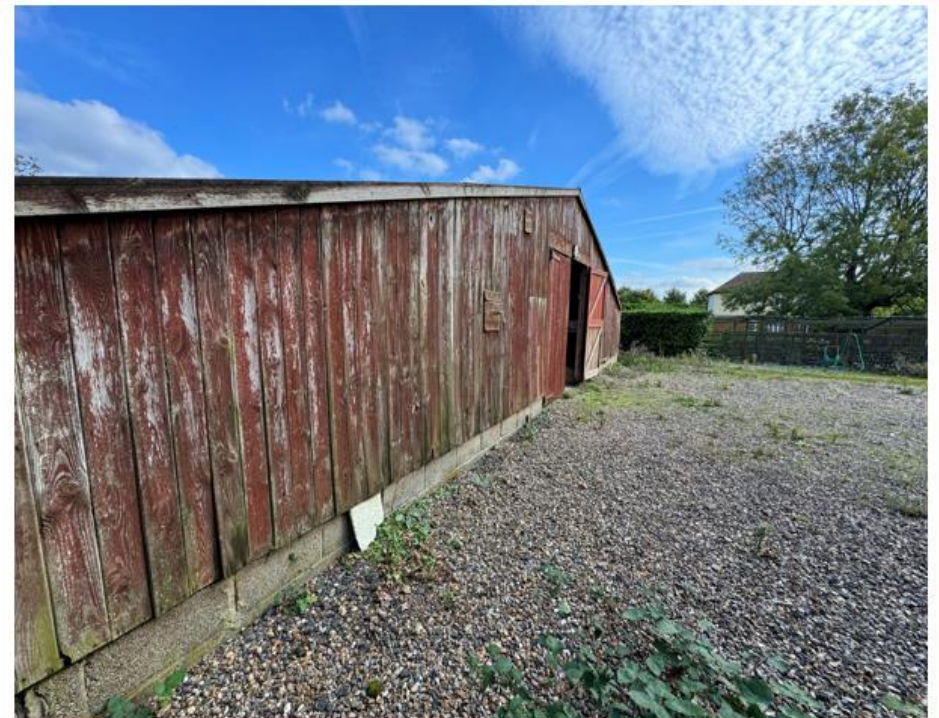
**Photo No.4: Facing SE outside the NW corner of shed**

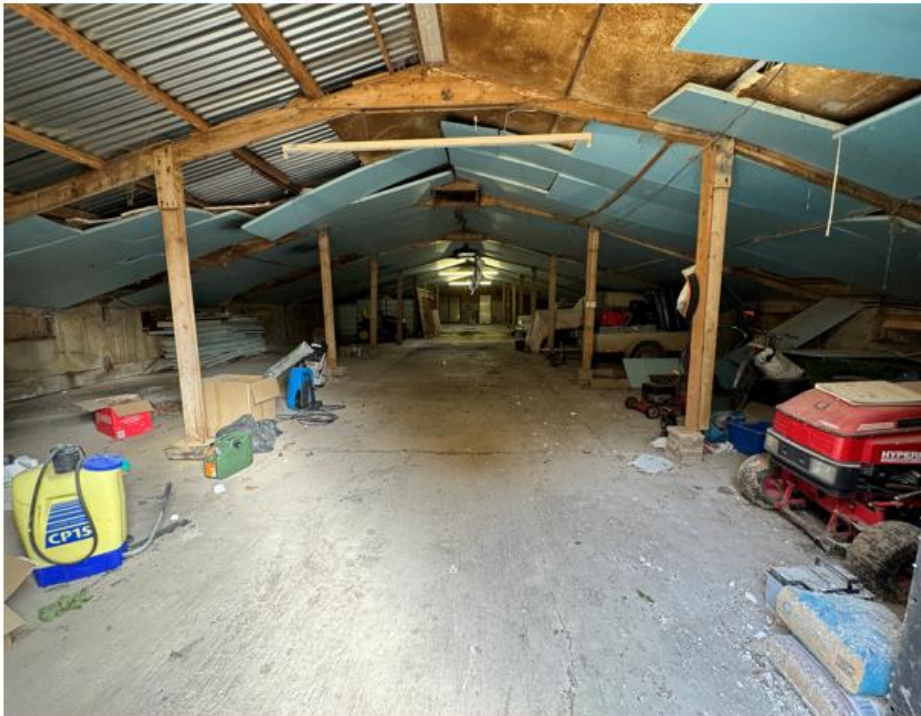
**Photo No.5: Facing east from within the western access to the poultry shed showing concrete flooring and misc. storages**

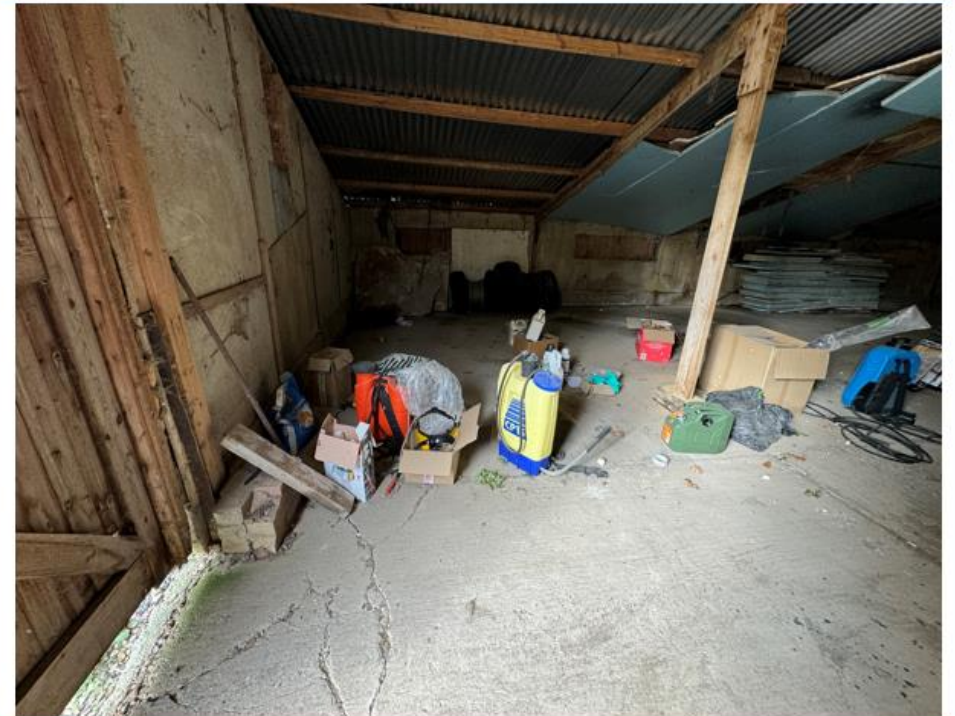
The agricultural usage of the site and noted storages within the shed (i.e. vehicles, fuel storage) are considered limited potential sources of hazardous vapours, which should be investigated further. TPH CWG samples and PID usage should be undertaken from beneath the present footprint of the barn / eastern and western wings.

**Photo No.6: Showing the storage arrayed inside the western extent of the poultry shed (i.e. construction materials, fuel)**

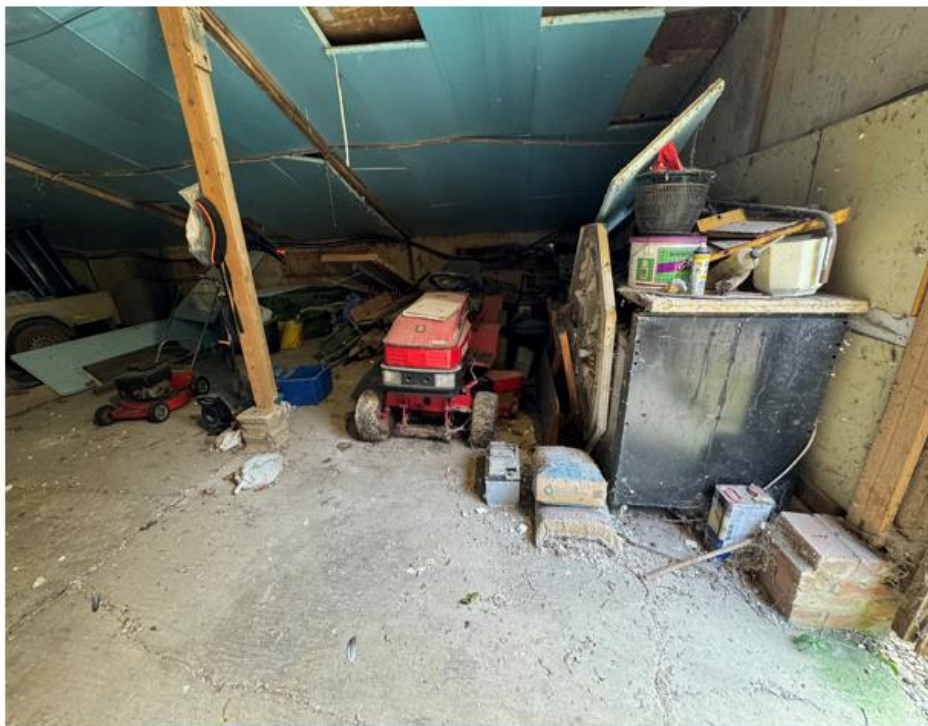
**Photo No.7: Showing the storage arrayed inside the western extent of the poultry shed (i.e. mower, workbench, tools)**

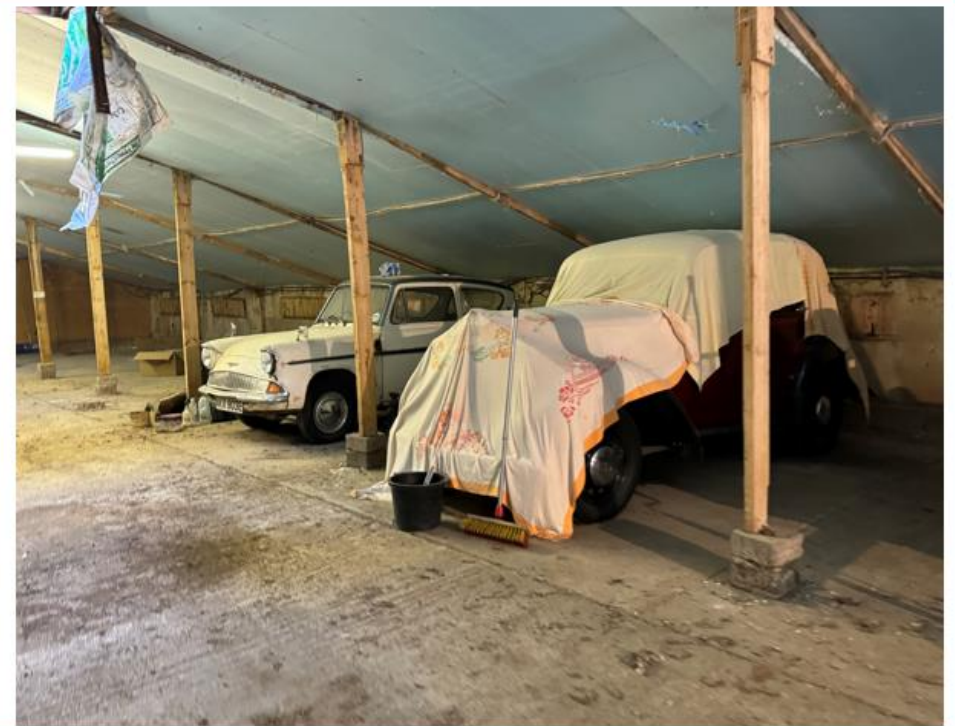
**Photo No.8: Showing classic vehicle storage within the central extent of the western half of the poultry shed**

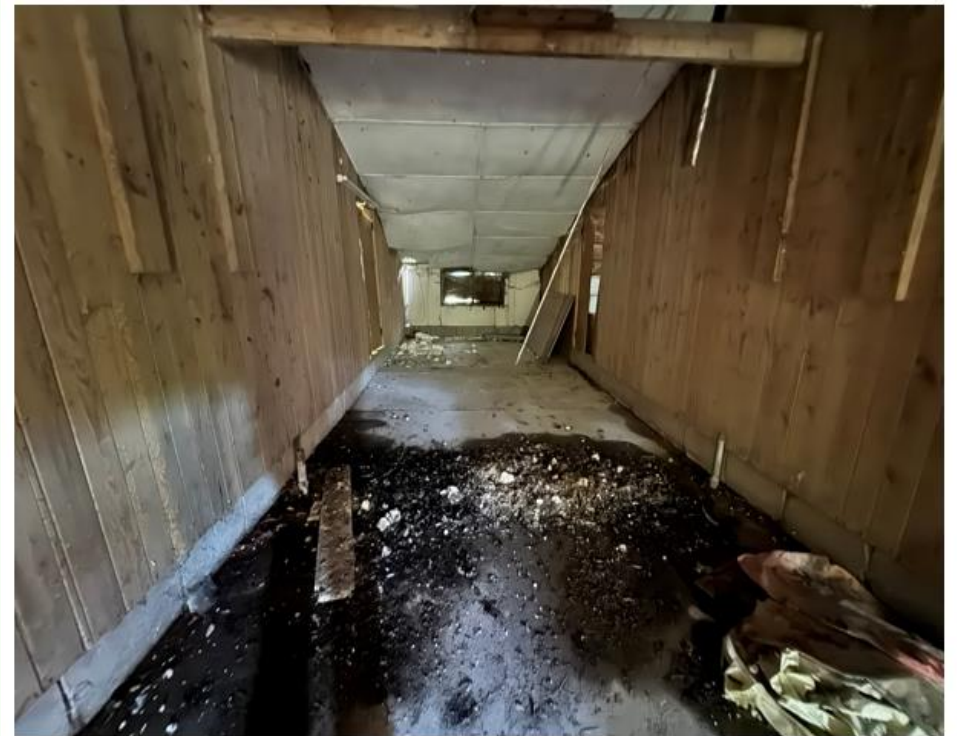
**Photo No.10: Small room separating the eastern and western wings of the poultry shed (roofing above allowing water ingress)**

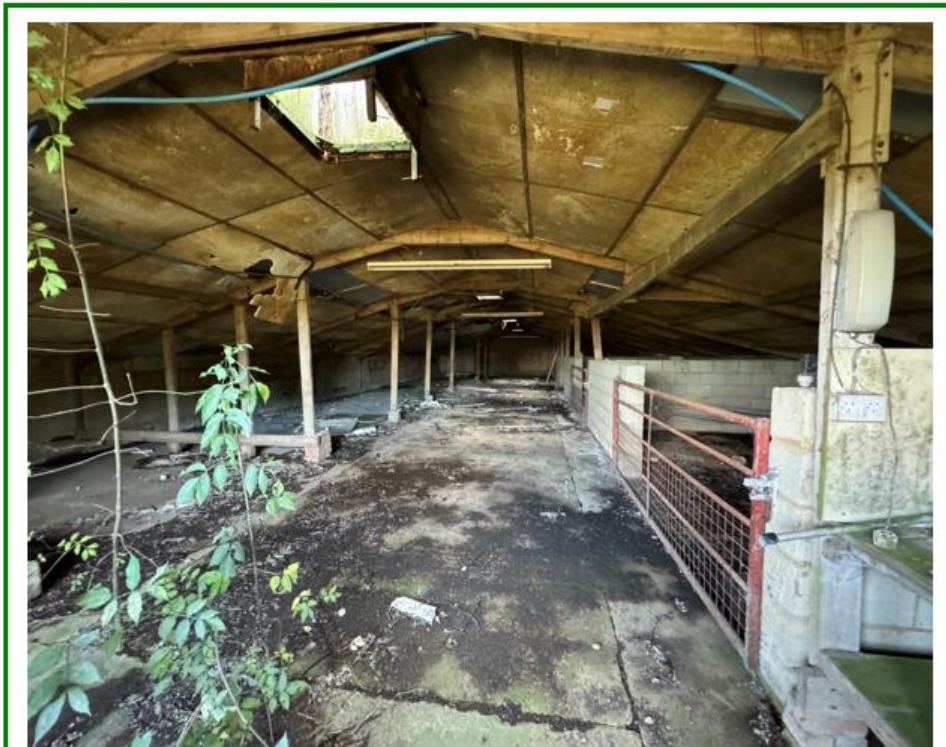
The remaining, eastern extent of the barn was seen to be of the same construction as the western, however the concrete flooring was noted to be in a poorer state of repair and water ingress and guano remained atop the concrete. A series of small animal pens were noted inside the northern face of this extent of the barn, which client information indicated had most recently been in use for the small-scale keeping of sheep.

**Photo No.12: Facing west inside the far eastern extent of the poultry shed and eastern section showing animal pens**

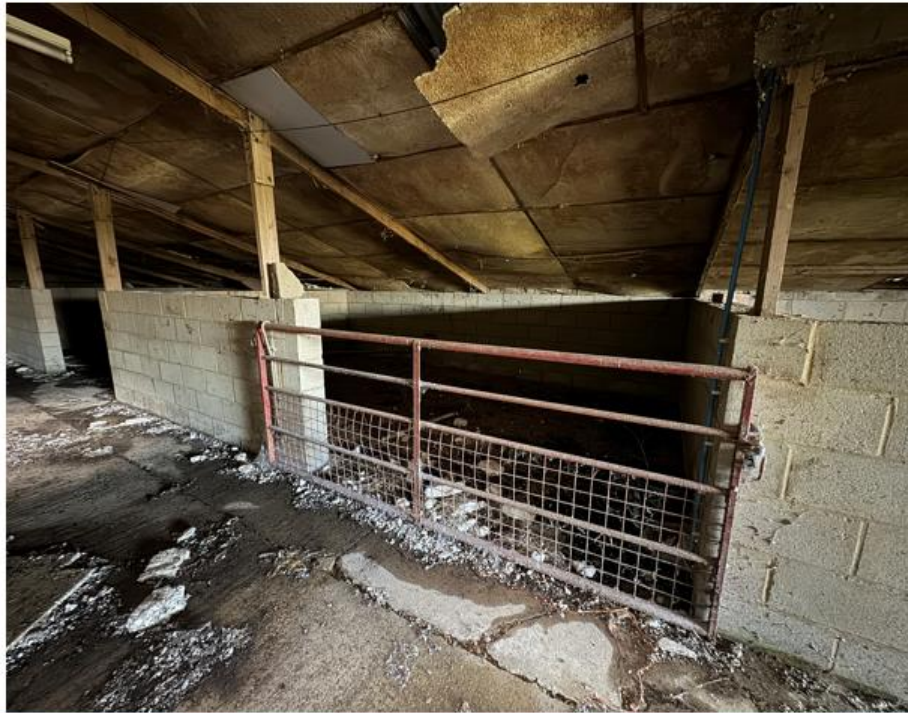
**Photo No.13: Further example shot of former animal pens (most recently in use for chickens and sheep)**

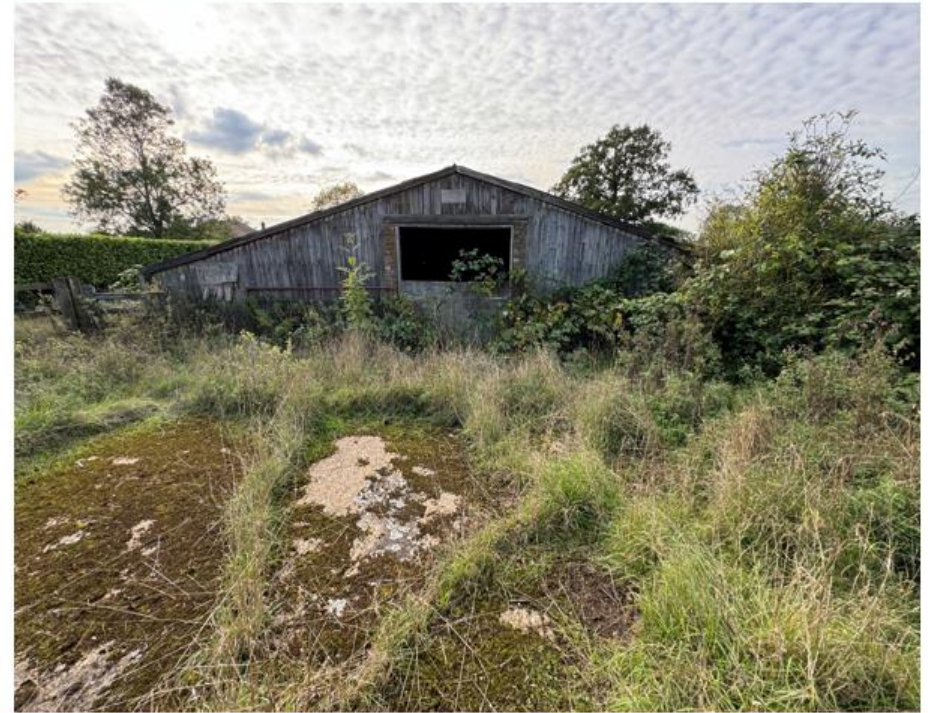
**Photo No.14: Facing west outside the rear (eastern) face of the poultry shed and beyond the eastern boundary of site**
