**Phase II Geoenvironmental  
Ground Investigation Report**

**Maydencroft Gardens**

**Report No: 25-02-12**

**APRIL 2025**

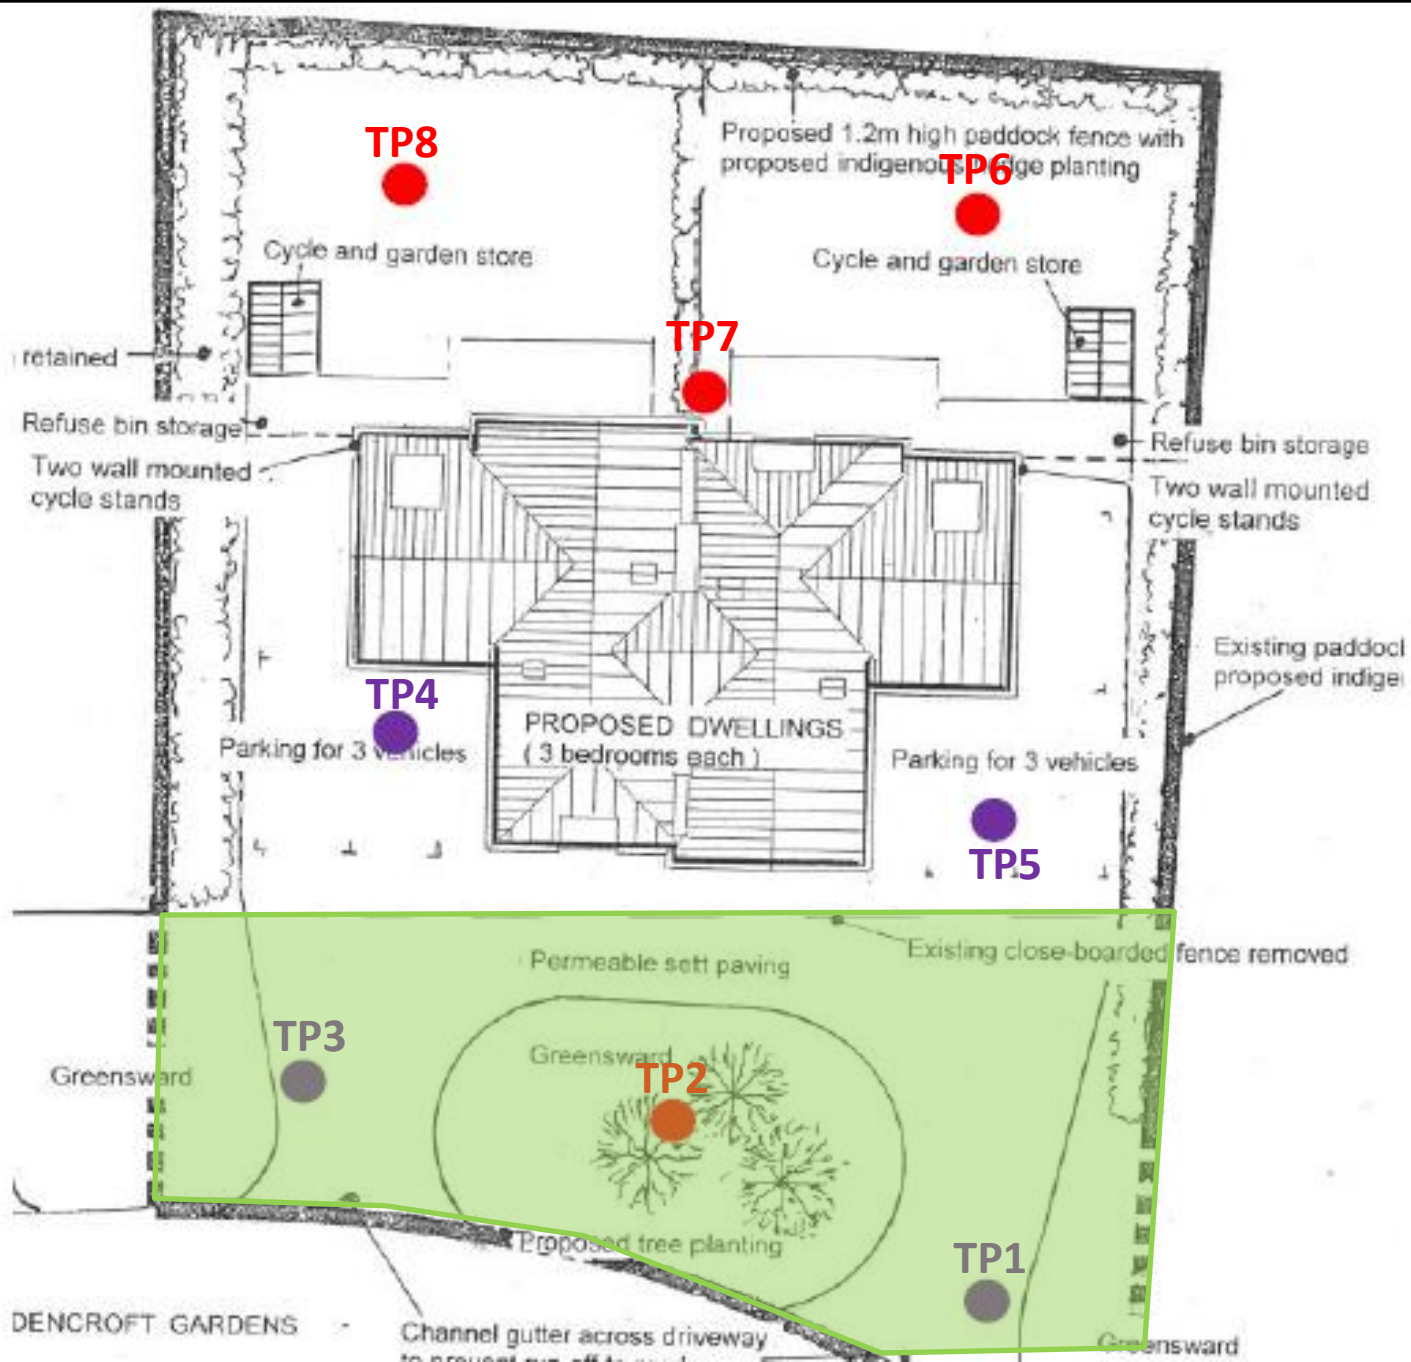
## Appendix A

- Asbestos Test Trial Pit
- Full Contamination Test Trial Pit
- Area Previously Remediated (Brown 2 Green Associates Ltd, Verification 2220/Rpt 5 v1, Report)

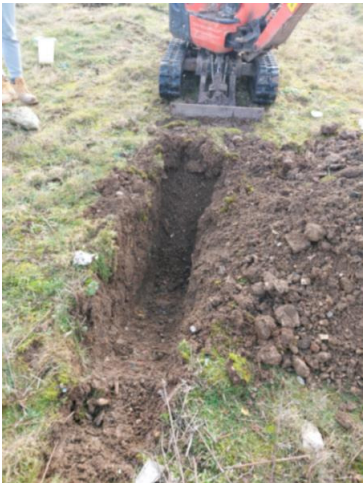
| <div> <a href="http://www.geo-integrity.co.uk">www.geo-integrity.co.uk</a><br/> <a href="mailto:info@geo-integrity.co.uk">info@geo-integrity.co.uk</a><br/> 01280 816409 </div> | | | | | <b>Site</b><br>Maydencroft Gardens, Gosmore, Hitchin, SG4 7EJ | | <b>Trial Pit Number</b><br><b>TP1</b> | | |
|---|---|---|---|---|---|---|---|---|---|
| 0.40 | D | | | | <div> <div></div> <div>(0.70)</div> <div></div> <div>0.70</div> <div></div> </div> | MADE GROUND - Soft brown slightly silty slightly sandy very gravelly CLAY. Gravel is fine to coarse, subangular to subrounded flint, brick and ceramic with one cement cobble | | | |
| | | | | | | Complete at 0.70m | | | |

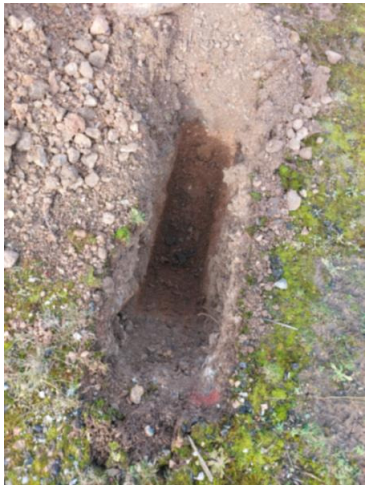
| <b>Scale (approx)</b><br>1:10 | <b>Logged By</b><br>HF | <b>Figure No.</b><br>25-02-12.TP2 |

| Depth (m) | Sample / Tests | Water Depth (m) | Field Records | Level (mOD) | Depth (m) (Thickness) | Description | Legend | Water |
|---|---|---|---|---|---|---|---|---|
| 0.20 | D | | | | (0.45) | MADE GROUND - Loose light brown slightly silty gravelly SAND. Gravel is fine to coarse concrete, brick, flint, quartzite, plastic and ash | | |
| | | | | | (0.55) | GLACIOFLUVIAL DEPOSITS - Loose to medium dense orangish-brown slightly sandy clayey GRAVEL. Gravel is fine to coarse flint and quartzite with occasional flint cobbles | | |

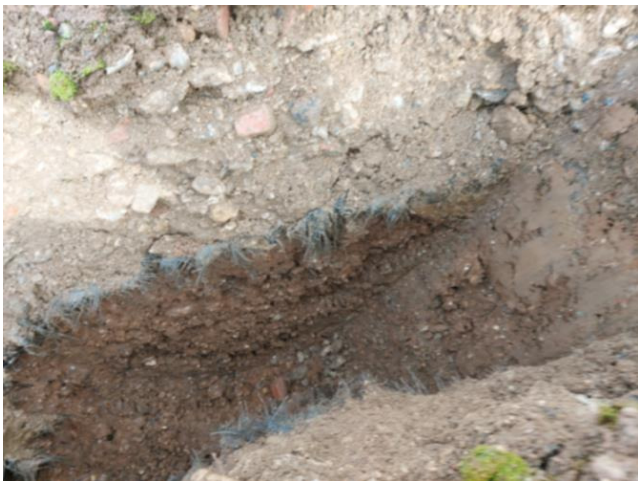
| <b>Scale (approx)</b><br>1:10 | <b>Logged By</b><br>HF | <b>Figure No.</b><br>25-02-12.TP3 |

| Depth (m) | Sample / Tests | Water Depth (m) | Field Records | Level (mOD) | Depth (m) (Thickness) | Description | Legend | Water |
|---|---|---|---|---|---|---|---|---|
| 0.30 | D | | | | (0.35) | MADE GROUND - Loose light brown slightly silty gravelly SAND. Gravel is fine to coarse concrete, brick, flint and quartzite | | |
| | | | | | (0.65) | GLACIOFLUVIAL DEPOSITS - Loose to medium dense orangish-brown slightly sandy clayey GRAVEL. Gravel is fine to coarse flint and quartzite with occasional flint cobbles | | |

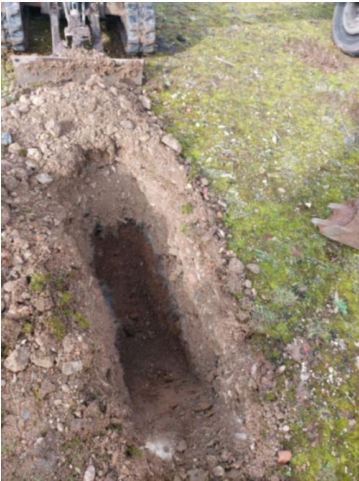
| <div> <a href="http://www.geo-integrity.co.uk">www.geo-integrity.co.uk</a><br/> <a href="mailto:info@geo-integrity.co.uk">info@geo-integrity.co.uk</a><br/> 01280 816409 </div> | | | | | <b>Site</b><br>Maydencroft Gardens, Gosmore, Hitchin, SG4 7EJ | | <b>Trial Pit Number</b><br><b>TP4</b> | | |
|---|---|---|---|---|---|---|---|---|--|
| 0.25 | D | | Slight Seepage(1) at 0.40m. | | (0.40) | MADE GROUND - Loose brown slightly silty gravelly SAND. Gravel is fine to coarse concrete, brick, flint and quartzite | | V1 | |
| | | | | (0.60) | GLACIOFLUVIAL DEPOSITS - Loose to medium dense orangish brown slightly sandy clayey GRAVEL. Gravel is fine to coarse flint and quartzite with occasional flint cobbles | | | | |
| 0.70 | D | | | | 1.00 | Complete at 1.00m | | | |

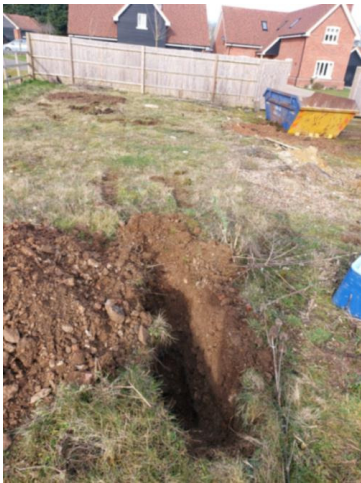
| <div> <a href="http://www.geo-integrity.co.uk">www.geo-integrity.co.uk</a><br/> <a href="mailto:info@geo-integrity.co.uk">info@geo-integrity.co.uk</a><br/> 01280 816409 </div> | | | | | <b>Site</b><br>Maydencroft Gardens, Gosmore, Hitchin, SG4 7EJ | | <b>Trial Pit Number</b><br><b>TP5</b> | | |
|---|---|---|---|---|---|---|---|---|---|
| 0.50 | D | | Slight Seepage(1) at 0.65m. | | 0.40<br>(0.30) | MADE GROUND - Loose light brown silty very sandy GRAVEL with occasional concrete cobbles. Gravel is fine to coarse flint, brick, ash and concrete | | V <sub>1</sub> | |
| | | | | (0.30) | GLACIOFLUVIAL DEPOSITS - Loose to medium dense orangish-brown slightly sandy clayey GRAVEL. Gravel is fine to coarse flint and quartzite with occasional flint cobbles | | | | |

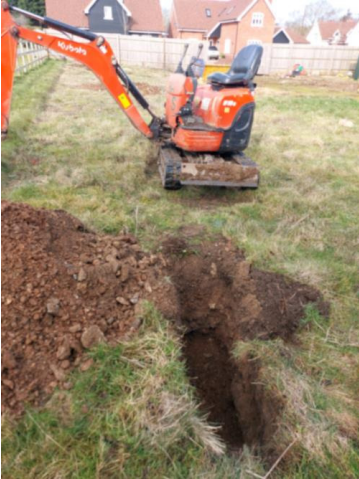
| | | | | | <a href="http://www.geo-integrity.co.uk">www.geo-integrity.co.uk</a><br><a href="mailto:info@geo-integrity.co.uk">info@geo-integrity.co.uk</a><br>01280 816409 | | | | | <b>Site</b><br>Maydencroft Gardens, Gosmore, Hitchin, SG4 7EJ | | | | | <b>Trial Pit Number</b><br><b>TP6</b> | |
|---|---|---|---|---|---|---|---|---|---|---|--|---|--|--|---|--|
| | | | | | 0.20 | MADE GROUND - (Loose) brown slightly silty sandy GRAVEL. Gravel is fine to coarse concrete, brick and flint with frequent brick cobbles | | | | | | | | | | |
| 0.50 | D | | | | 0.60 | GLACIOFLUVIAL DEPOSITS - Loose to medium dense orangish-brown slightly sandy clayey GRAVEL. Gravel is fine to coarse flint and quartzite with occasional flint cobbles | | | | | | | | | | |

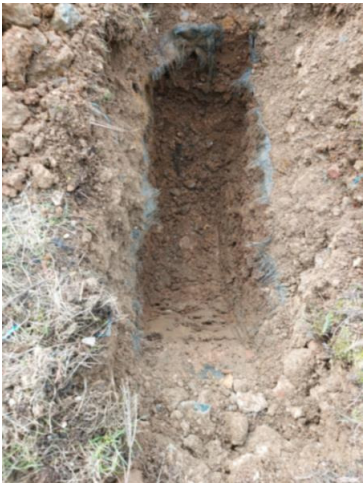
| <div> <a href="http://www.geo-integrity.co.uk">www.geo-integrity.co.uk</a><br/> <a href="mailto:info@geo-integrity.co.uk">info@geo-integrity.co.uk</a><br/> 01280 816409 </div> | | | | | <b>Site</b><br>Maydencroft Gardens, Gosmore, Hitchin, SG4 7EJ | | <b>Trial Pit Number</b><br><b>TP7</b> | | |
|---|---|---|---|---|---|---|---|---|--|
| | | | | | 0.20 | MADE GROUND - Loose brown and light brown slightly silty sandy GRAVEL. Gravel is fine to coarse brick, flint, concrete, ash and plastic | | | |
| | | | | | 0.55 | GLACIOFLUVIAL DEPOSITS - Loose to medium dense orangish-brown slightly sandy clayey GRAVEL. Gravel is fine to coarse flint and quartzite with occasional flint cobbles | | | |

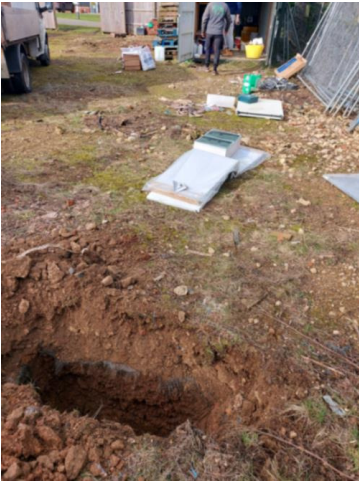
| 0.20 | D | | | | (0.35) | MADE GROUND - Loose brown slightly silty very sandy GRAVEL. Gravel is fine to coarse brick, metal, concrete and flint with occasional pockets of buff-orange sand | | | |
| 0.70 | D | | | | (0.65) | GLACIOFLUVIAL DEPOSITS - Loose to medium dense orangish-brown slightly sandy clayey GRAVEL. Gravel is fine to coarse flint and quartzite with occasional flint cobbles | | | |
