# **Preliminary Ecological Appraisal of Land at Charlton, Hitchin, Hertfordshire**

**July 2022**

**Philip Irving**

## **Land at Charlton, Hitchin Preliminary Ecological Appraisal**

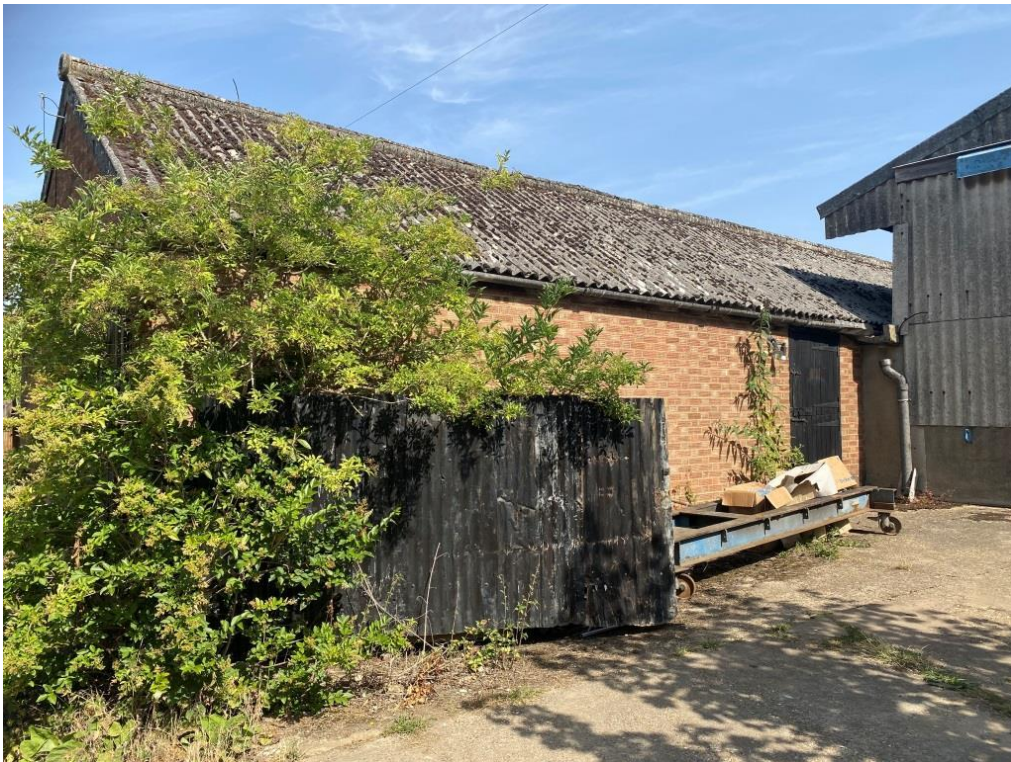
*East elevation of Building 1*

**Building 1** – A one storey brick barn with sliding wooden doors on the south elevation and a pitched corrugated sheeting roof, unlined and vaulted internally. The south end of the barn is divided internally by brick walls into two stores, with the centre of the barn divided into five enclosed grain stores that are fed by pipework that leads to extensive machinery in the north of the barn. There are walkways along the east and west sides of the grain stores, the eastern one within the main structure of the barn, though the one on the west side consists of a low-sided corrugated sheeting structure with a mono-pitched roof, with a concrete track along its northwest side. The barn is in good structural condition with no significant damage to the well-pointed brick walls or the roof, and is considered to have negligible potential to support roosting bats.

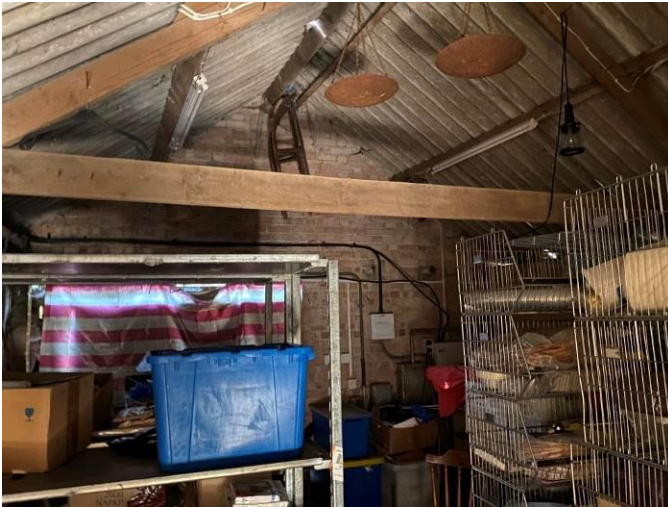
*Store at south end of Building 1*

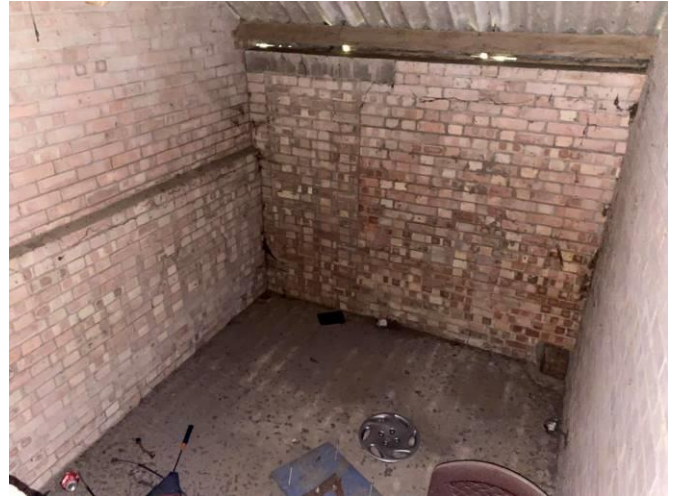
*Grain store in centre of Building 1*

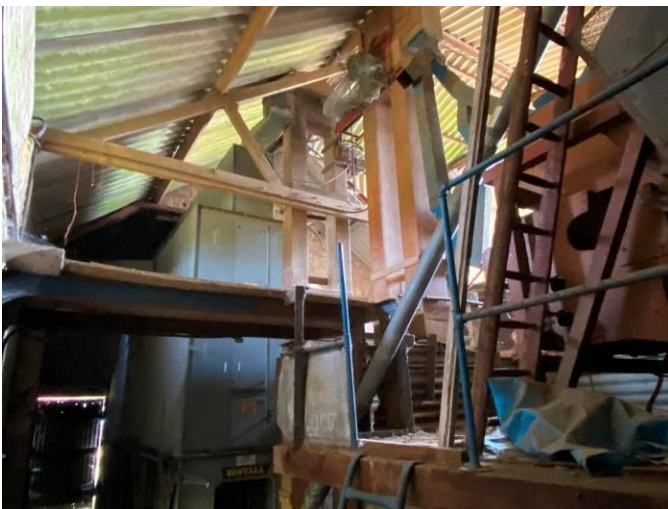
No evidence of barn owls was found in any of the buildings, and the only evidence of nesting birds was a large disused bird nest, probably jackdaw, on the machinery in the north end of Building 1.

*Machinery at north end of Building 1*

As nesting birds are protected by law under The Wildlife and Countryside Act 1981, initial building or demolition work, or any clearance of woody vegetation, should be timed to avoid the bird nesting season (which is generally from March to September). If this isn't possible, a check for nesting birds will be undertaken prior to works commencing by an ecologist. If an active nest is found, work must cease and an appropriate sized buffer established around the nest. The buffer must remain intact until it has been confirmed that the young have fledged and the nest is no longer in use.

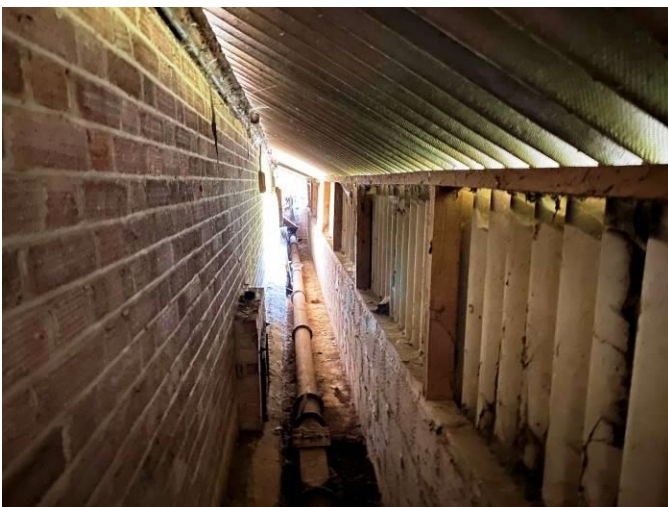
*Walkway on west side of grain stores in Building 1*

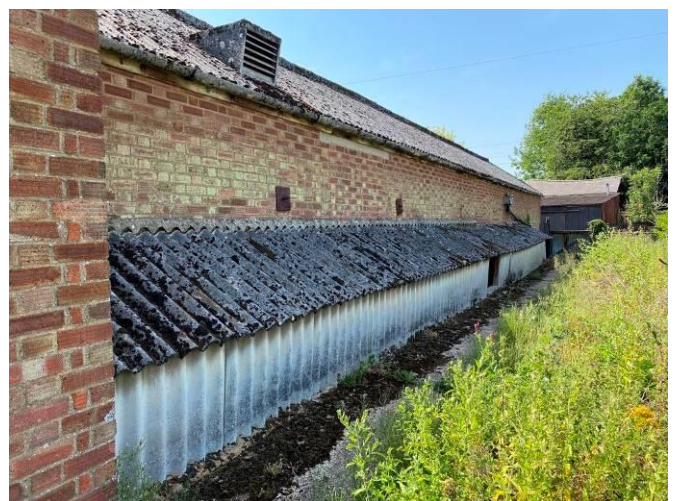
*Exterior of walkway on west side of Building 1*

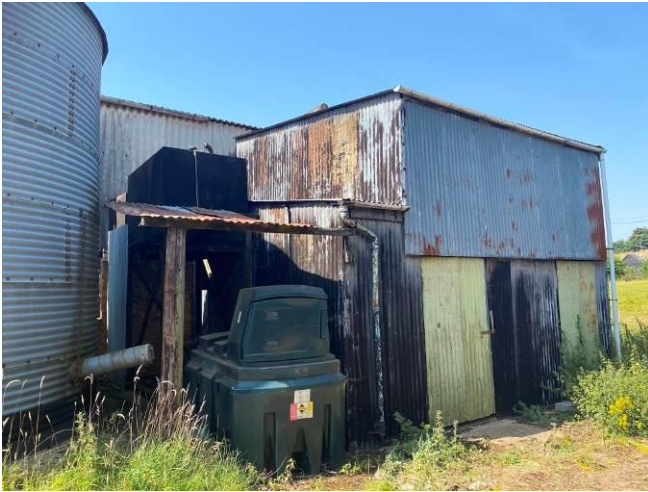
Attached to the north end of the barn and connected internally to it are a flat-roofed corrugated iron shed and a steel-framed and pitched roofed corrugated sheeting machinery store that is open-sided on the east elevation. Due to the materials used in their construction, the sheds are considered to have no potential to support roosting bats.

*Corrugated iron shed to north of Building 1*

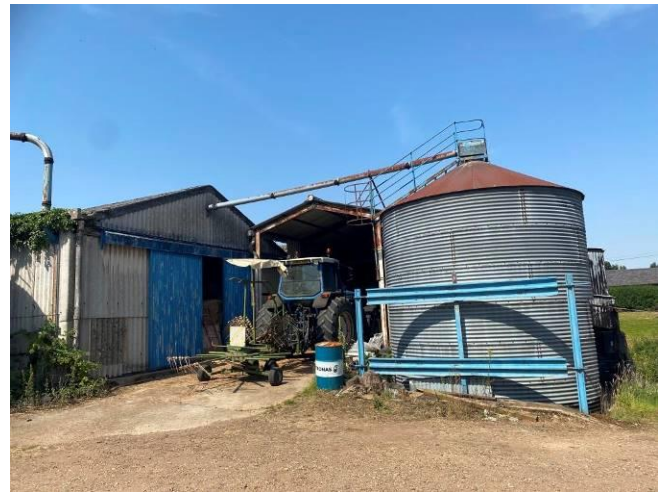
*Machinery store and silo to north of Building 1*

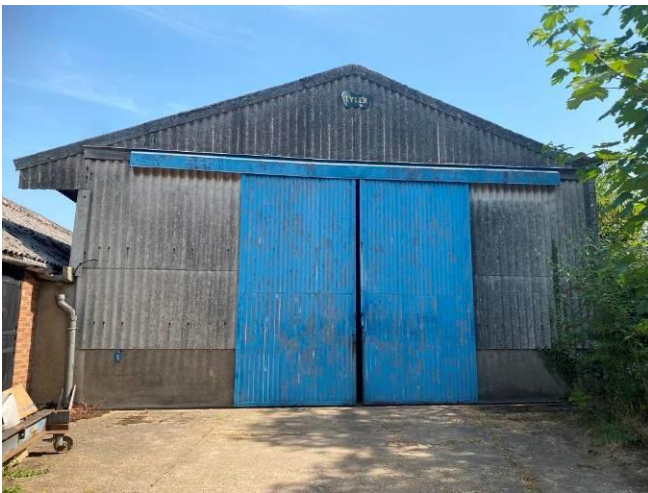
**Building 2** – A modern concrete-framed shed with corrugated sheeting on the walls and the low-pitched roof. Double sliding doors on the north and south elevations provide access to the undivided and vaulted interior, which is used as a workshop and vehicle and hay store. The shed is in good structural condition with no significant damage to the walls and roof, though there is ivy (*Hedera helix*) on part of the east elevation, and combined with the materials used in its construction and the high levels of disturbance from its use, it is considered to have negligible potential to support roosting bats.

*South elevation of Building 2*

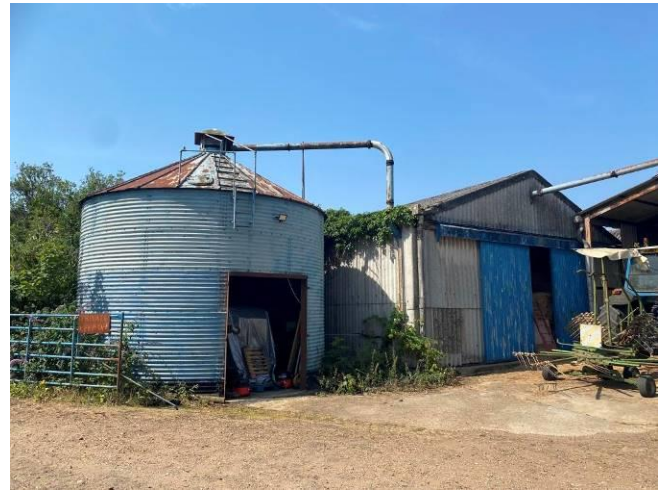
*North and east elevations of Building 2 and silo*

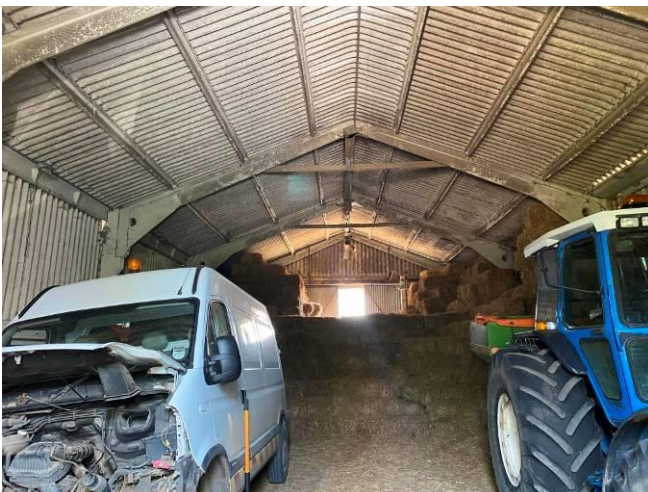
*Interior of Building 2*

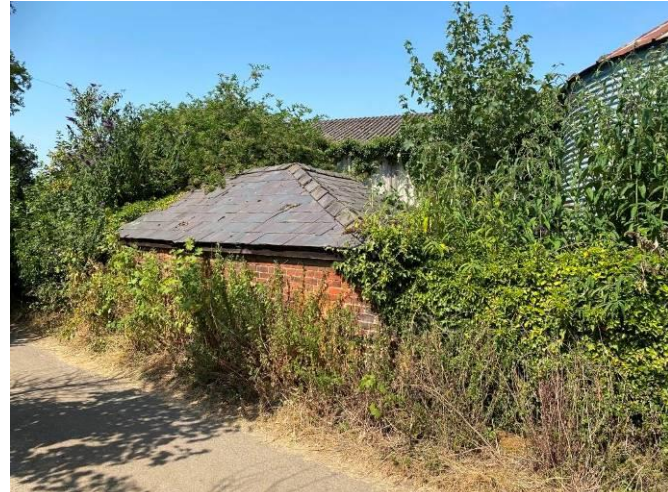
Attached to the east elevation of the shed is a low, one storey brick barn with a pitched and hipped slate roof, and is partly overgrown with ivy, sycamore (*Acer pseudoplatanus*) saplings, buddleia (*Buddleia davidii*) and elder (*Sambucus nigra*).

*Barn attached to east elevation of Building 2*

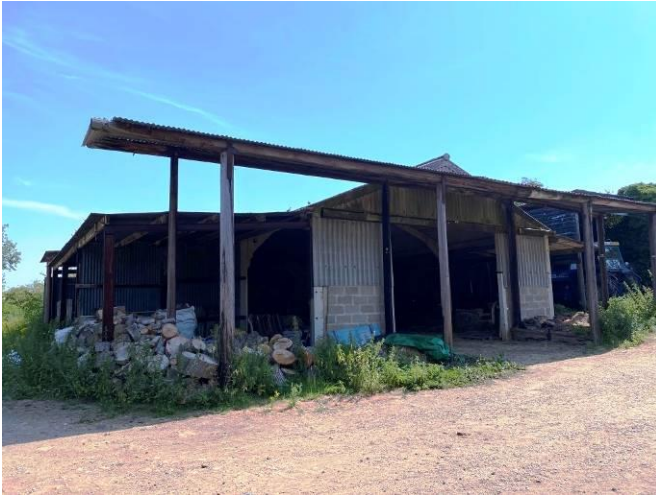
**Building 3** – A modern concrete-framed shed used for storing firewood and other materials, mostly open-sided with a low-pitched corrugated sheeting roof, and unlined internally with occasional skylights, making the interior very light and draughty. Part of the southwest elevation either side of the entrance is constructed of breeze block and corrugated sheeting, and there are timber-framed and open-sided sections with flat, corrugated iron roofs attached to the southwest, southeast and northwest sides of the shed.

*Southwest and northwest elevations of Building 3*

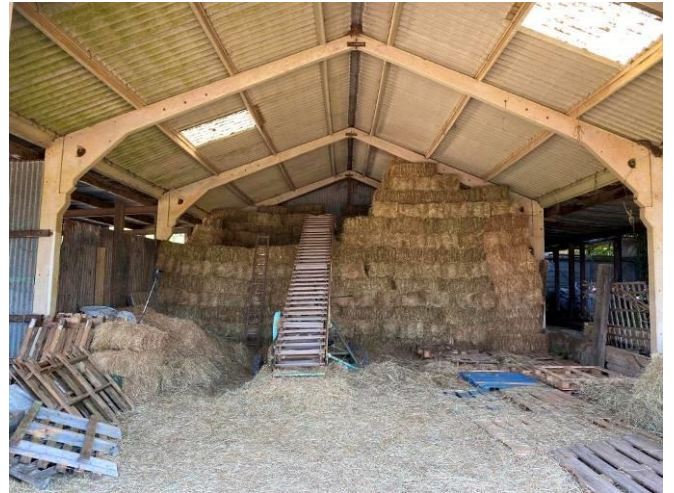
*Interior of Building 3*

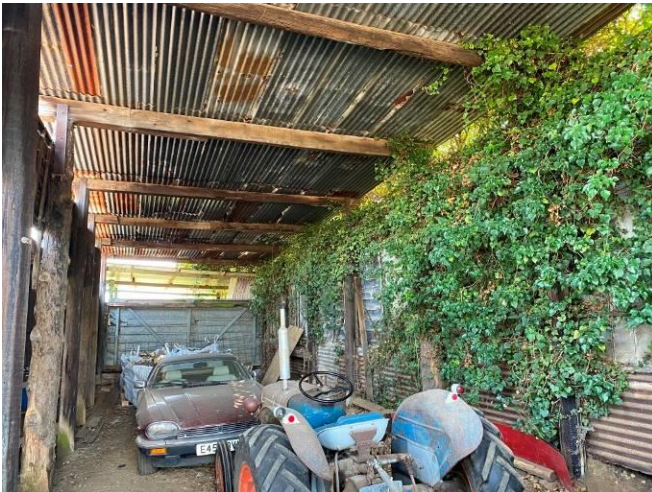
Directly to the southeast of the shed is a timber-framed shed with a flat, corrugated iron roof that is open-sided apart from corrugated iron on the southeast elevation, which is mostly covered in dense ivy. Directly to the northeast of the shed is another timber-framed and open-sided shed with a flat profiled steel sheeting roof. To the northwest of this shed is a corrugated iron and timber panel shed with a curved corrugated iron roof that is divided from the main shed by a stand of buddleia and elder.

*Shed to southeast of Building 3*

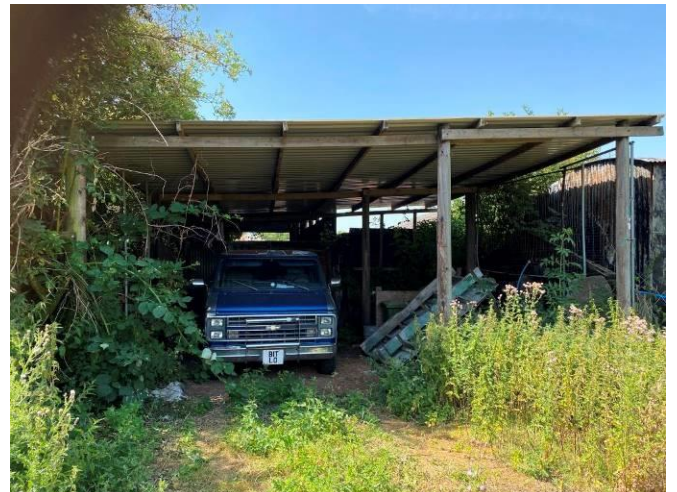
Due to the materials used in their construction and most being open-sided, all the sheds are considered to have no potential to support roosting bats.

*Shed to northeast of Building 3*

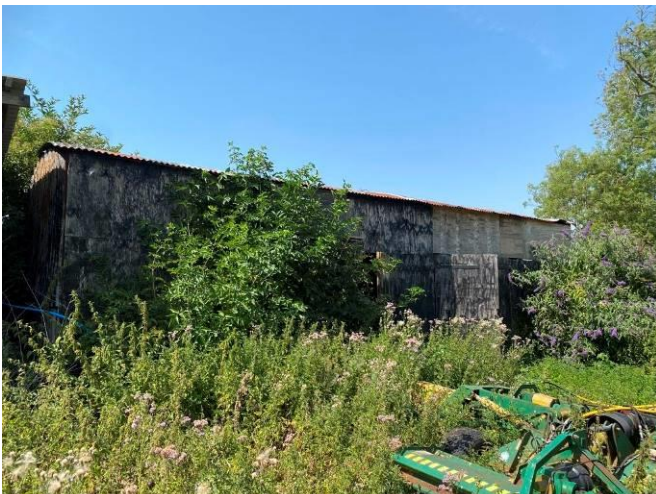
*Curved roofed shed to northeast of Building 3*

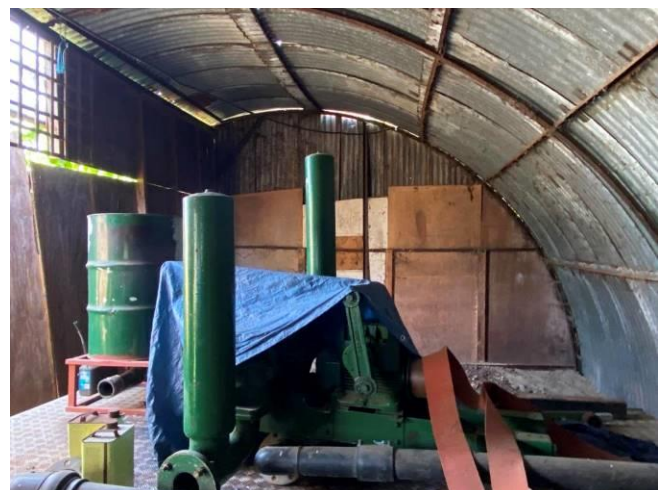
*Interior of curved roofed shed*

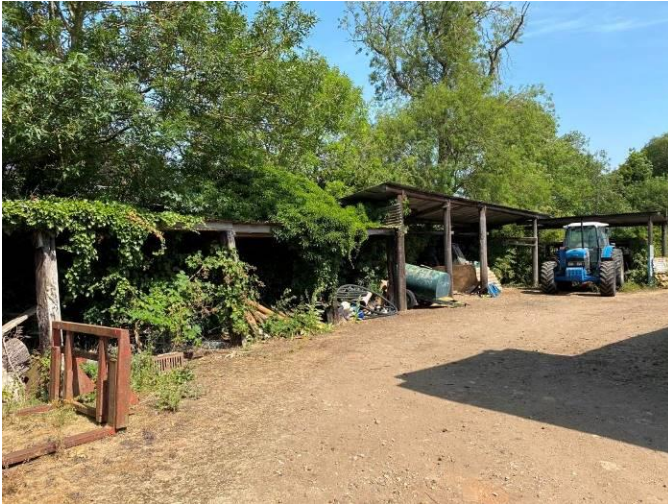
Building 4 – Open-sided timber framed barns with flat, corrugated iron roofs, partly covered in dense ivy. Due to their open-sided construction they are considered to have no potential to support roosting bats.

*Building 4*

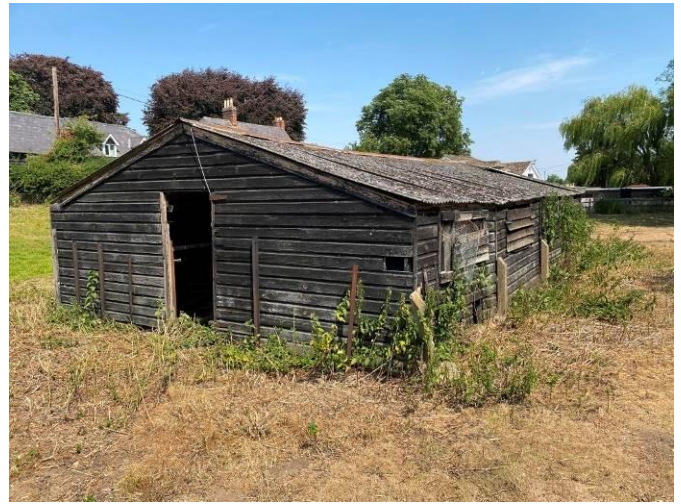
Building 5 – Located in the field to the northwest of the farmyard is a low one storey wooden shed with a pitched timber-framed corrugated sheeting roof, unlined internally with part of the roof missing at the north end. The disused shed is divided internally into meshed and panelled cages and has numerous unglazed and meshed windows that make the interior very light and draughty. Due to this and the materials used in its construction the building is considered to have no potential to support roosting bats.

*South and east elevations of Building 5*

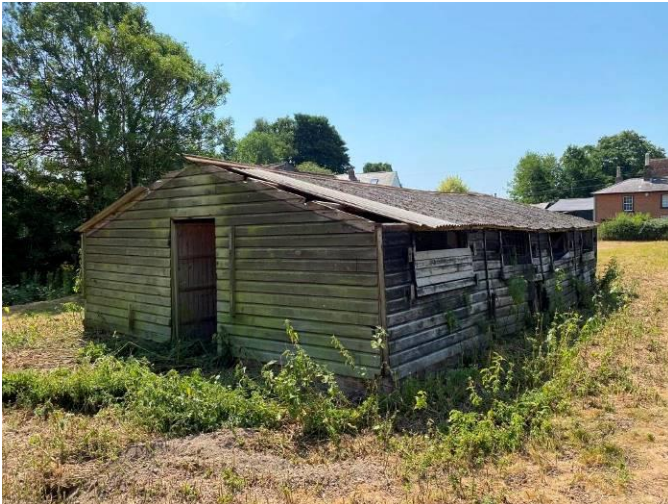
*North and west elevations of Building 5*

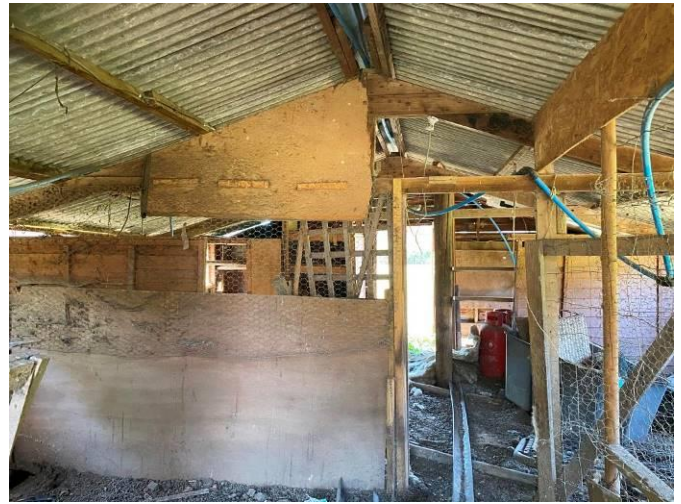
*Interior of Building 5*

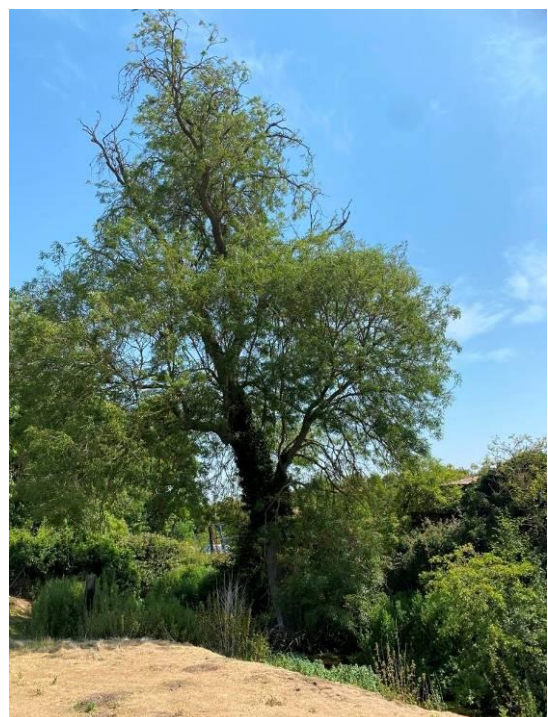
The only tree that contained deadwood features that could support roosting bats was the mature ash at the north end of the River Hiz which contained dead branches and woodpecker holes in the trunk.

The only tree at the site that contains any deadwood features that could have potential to support roosting bats is a mature ash along the River Hiz. The tree would be retained, though a check for bats would need to be made if any tree surgery work is carried out on it.

*Mature ash along River Hiz*

Any tree surgery work required on the mature ash tree along the River Hiz should be carried out with care and a check for evidence of bats made prior to work commencing, with any holes or cavities exposed for evidence of bats, using an endoscope if necessary.

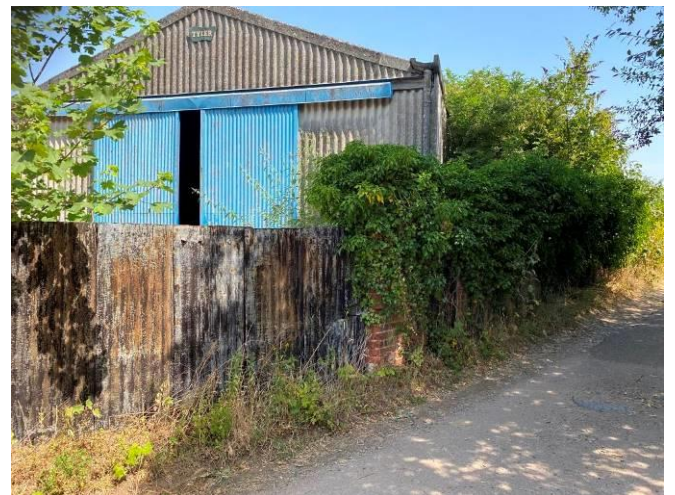
An ivy-covered brick wall and corrugated iron fencing is present on the boundaries of the farmyard in the southeast corner of the site, with a low wooden fence along the north boundary of the northwest field.

*Corrugated iron fence and wall in southeast corner*
