# DESKTOP STUDY REPORT

| Site Address: | Rear of Maple House, St James Court, Therfield, Hertfordshire.<br>SG8 9FN |
| Project No.: | 18964 |

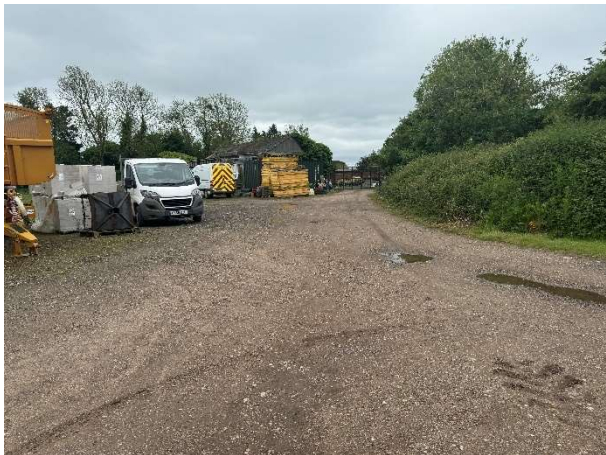
**Print 1** View of the yard area within the north of the site.

Within the north of the site area there is a gravel / roadstone yard area, towards the boundary of this area vegetation has started to grow. Towards the southeast there are two storage containers with building materials and equipment in place,

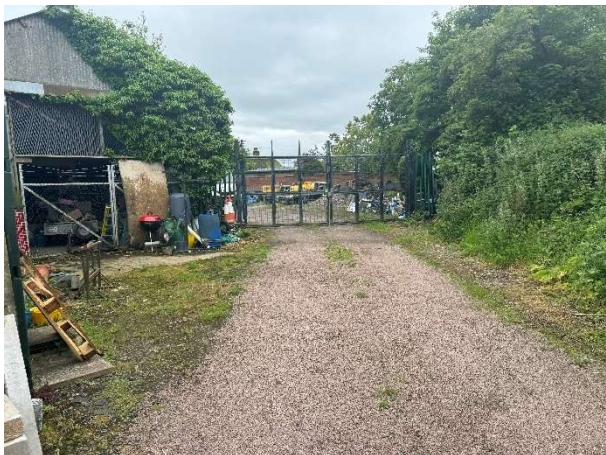
**Print 3** View of the access to the yard to the west of the barn.

From this area there is access into the barn and also to a yard area to the west of the barn.

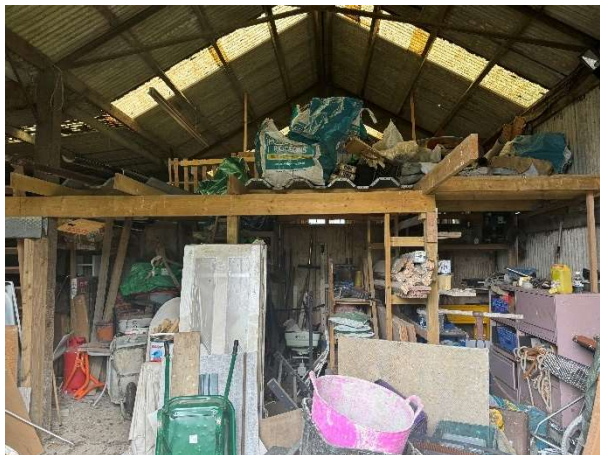
**Print 4** View within the barn.

The barn can be accessed to the north and west, at the time of the walk over there was storage across the building so only pedestrian access was possible.

Possible Asbestos containing materials were reviewed on the roof and cladding of the barn, the sheeting looked to be intact and in a good state of repair, suggesting that there is limited risk of this forming a risk of fragment being in place within the soils. From the walk over no obvious fragments were seen in place. We recommend that an asbestos survey of the building be carried out, if not done so already, prior to any further demolition or works on site. A full assessment for asbestos within the fill in site will be required to fully consider risk from Asbestos.
