**LAND AT GREENLEAS, BYGRAVE  
ROAD, BALDOCK**

**AN ARCHAEOLOGICAL  
EVALUATION**

**PCA REPORT NO: 17961 V1**

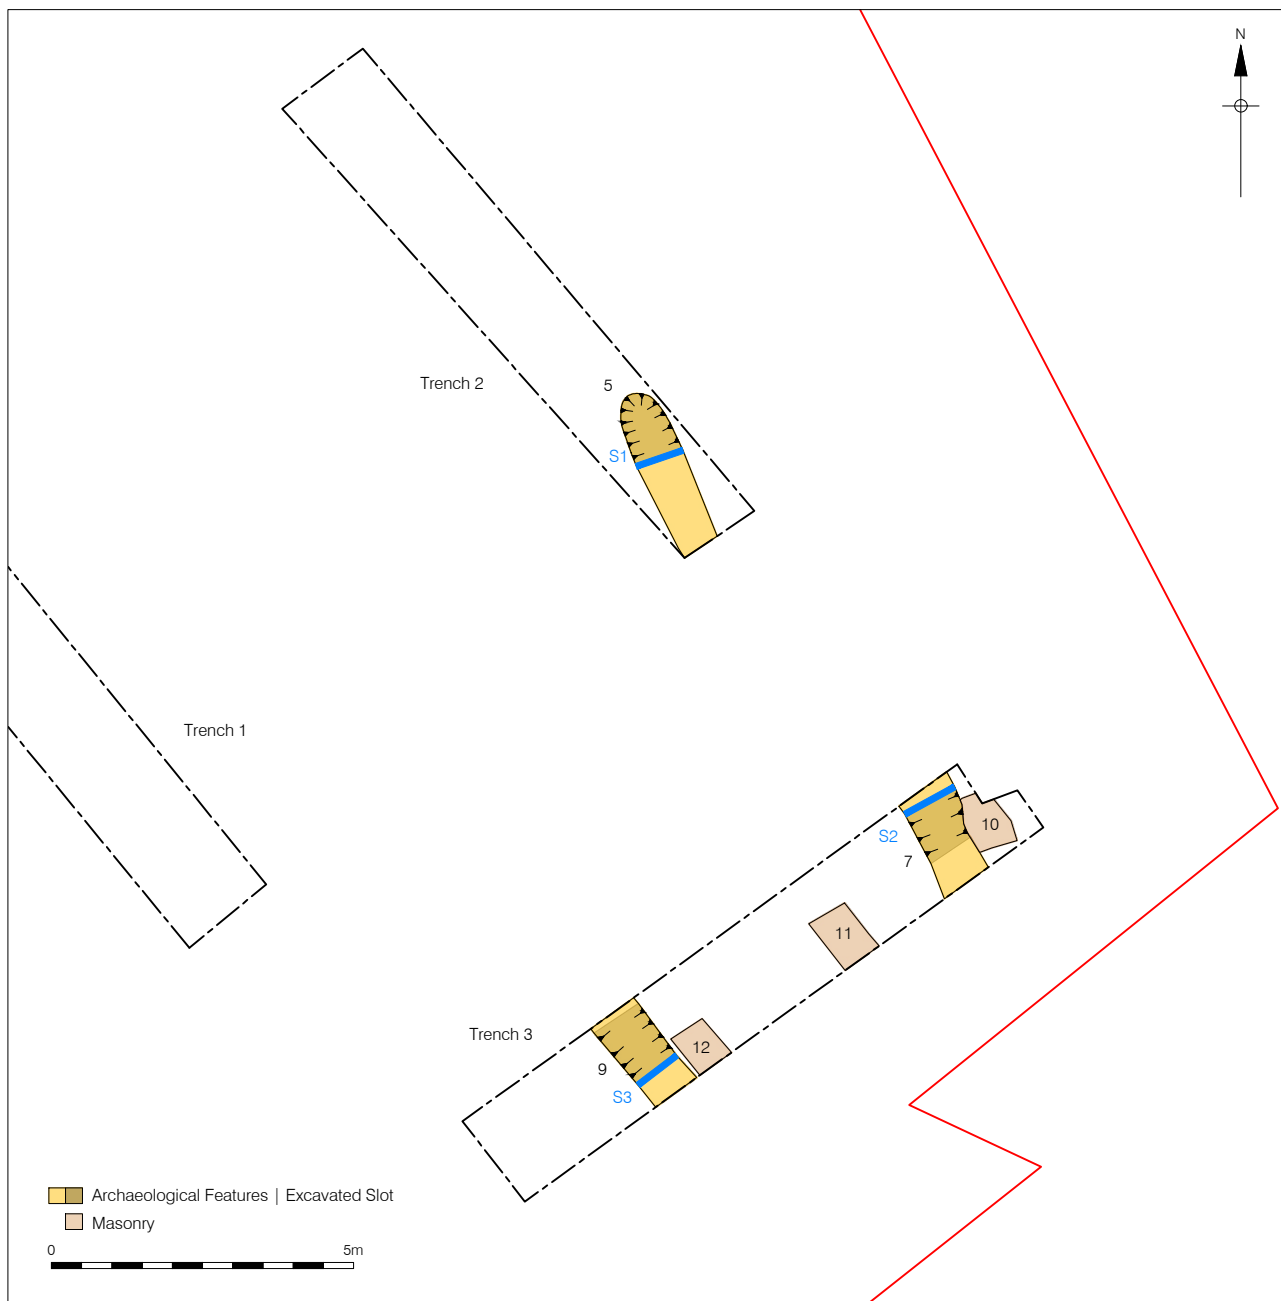
Figure 3  
Trench 2 and 3, Plan and Sections  
Plan 1:125, Section 1:40 at A4

- 6.4.1 Trench 2 contained Ditch [5]. Ditch [5] was linear in plan and was aligned north-south. It had moderate sloping sides and a concave base. It measured 2.7m long, 0.78m wide, and 0.18m deep. Its single fill (4) consisted of friable sandy silt which was light brown in colour and contained no datable evidence.

- 6.5.2 Ditch [7] was linear in plan and was aligned north-south. It had moderate sloping sides and a concave base. It measured the full width of the trench, 0.96m wide, and 0.12m deep. Its single fill (6) consisted of friable sandy silt which was light brown in colour and contained no datable evidence.

- 6.5.3 Furrow [9] was linear in plan and was aligned north-south. It had gradual sloping sides and a concave base. It measured the full width of the trench, 0.85m wide, and 0.05m deep. Its single fill (8) consisted of friable sandy silt which was light brown in colour and contained no datable evidence.

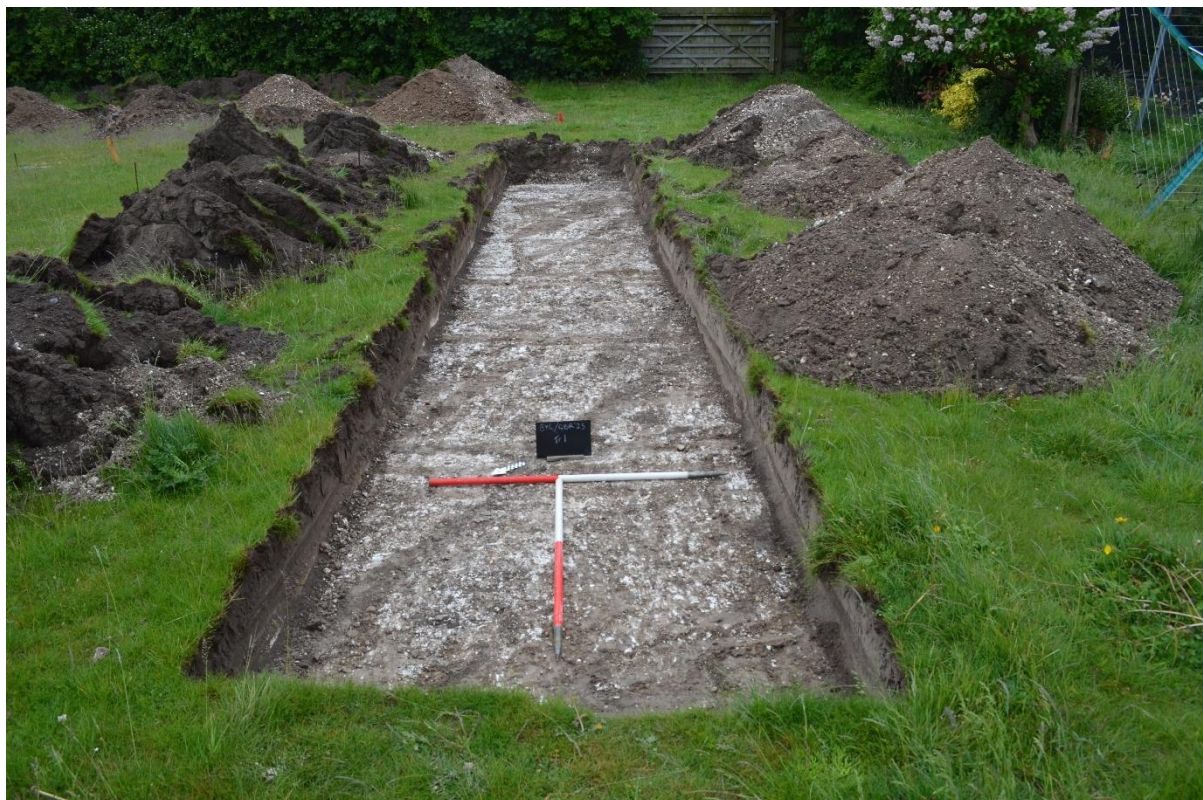
Plate 2: Trench 1, view south-east.

- 6.3.1 Trench 1 contained no archaeological finds, features or deposits. The presence of plough scars was noted.

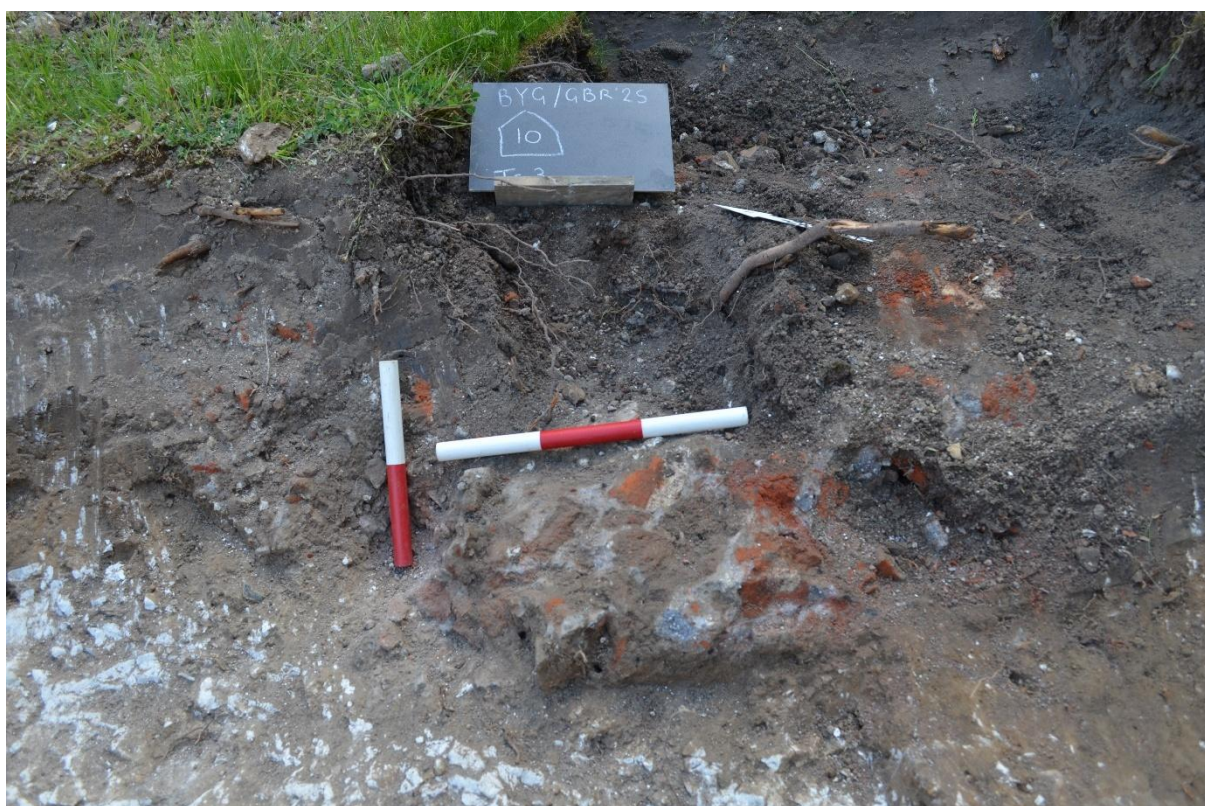
Plate 8: Post-pad 10 (trench 3), view north-east.

- 6.5.4 Post-pads (10), (11) and (12) were a combination of red brick and cement mortared structural foundations. They were roughly rectangular in shape measuring between 0.65-0.9m in width and 0.6-0.9m in length but were not fully exposed in the trench. Due to the materials used in the concrete base, they date to the post-medieval or modern period.

- 7.3.1 The three post-pads were formed by a mix of rubble material, largely red brick mixed with cement and were not visible prior to the opening of the trench. The material within the post-pads is indicative of a late post-medieval or even early modern date. The structure the post-pads form has not been recorded on any modern mapping (Abrams 2025, Appendix 4: Modern Mapping), and is therefore believed to have been an auxiliary structure, such as a shed or storage room.
