## HERITAGE STATEMENT

ALTERATIONS AND CHANGE OF USE AT

TEMPLE DINSLEY

JULY 2024 REVISION 4

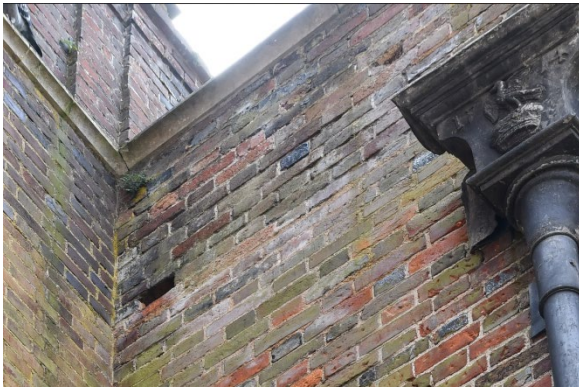
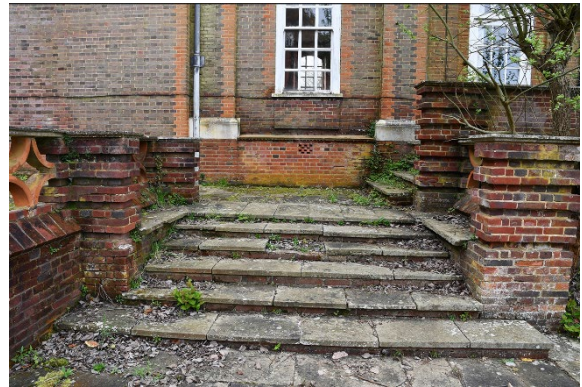
Water damage to parapet and brickwork

Damage to paving and external brickwork

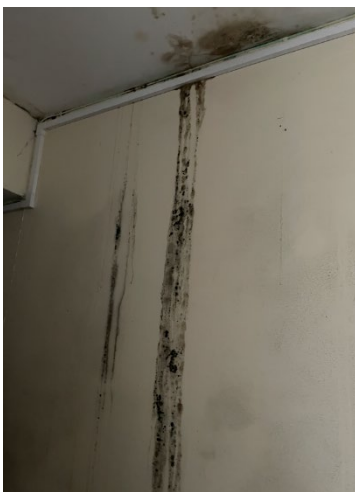
Damp and mould

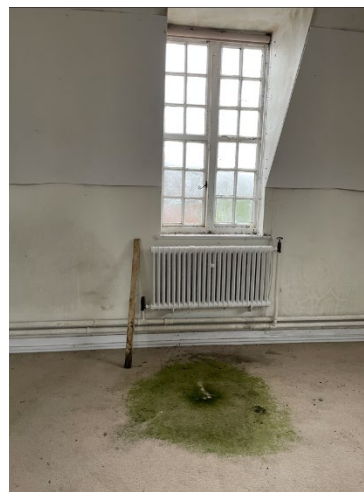
Leaks, damp and mould

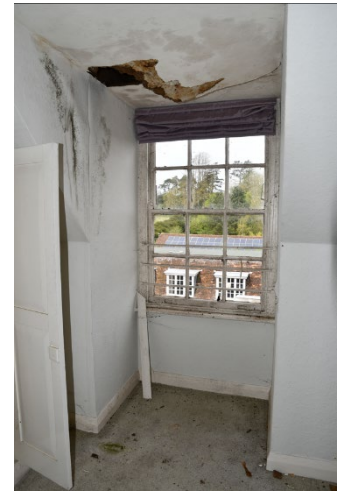
Failure of dormer

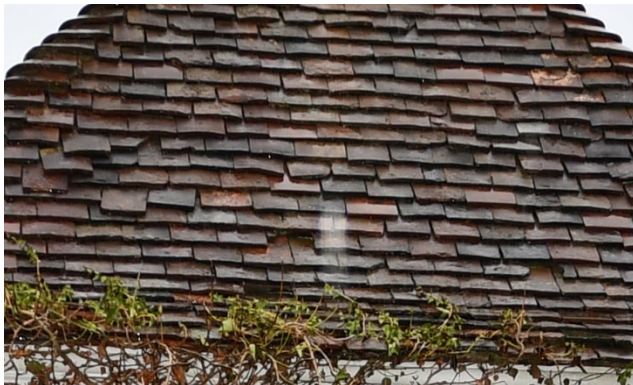
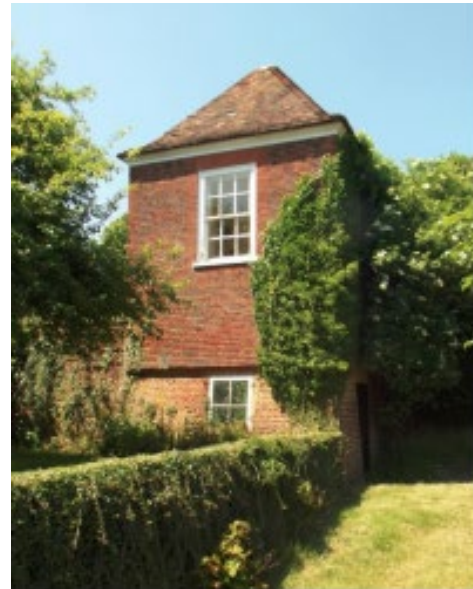
(Above left) Growth, damp, slipped and poor condition roof tiles.

(Above right) East Elevation.

(Right) Detail of damp and deteriorated Flemish bond brickwork and pointing especially at low level.

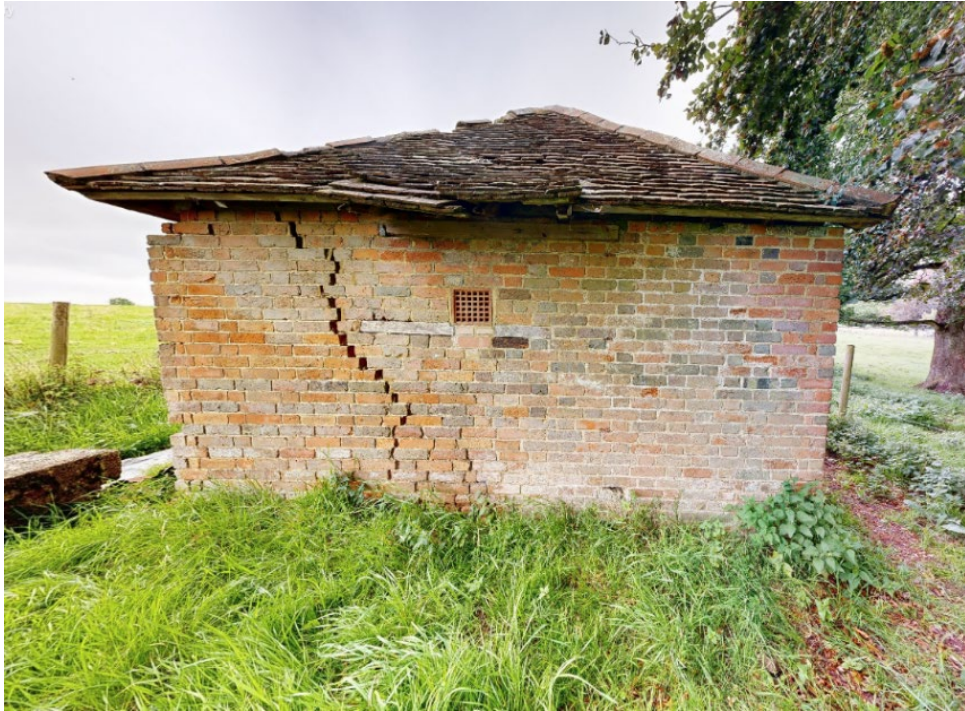
Side elevation showing typical structural movement and poor condition of the roof and eaves. The central section of the roof has deformed and dropped.

- The roof tiles have come to the end of their useful life and reroofing will be necessary. There is no evidence of guttering, which may have been intentional so needs further investigation, in which case the condition of the eaves overhang is critical. The internal timbers are water stained, especially at eaves level.

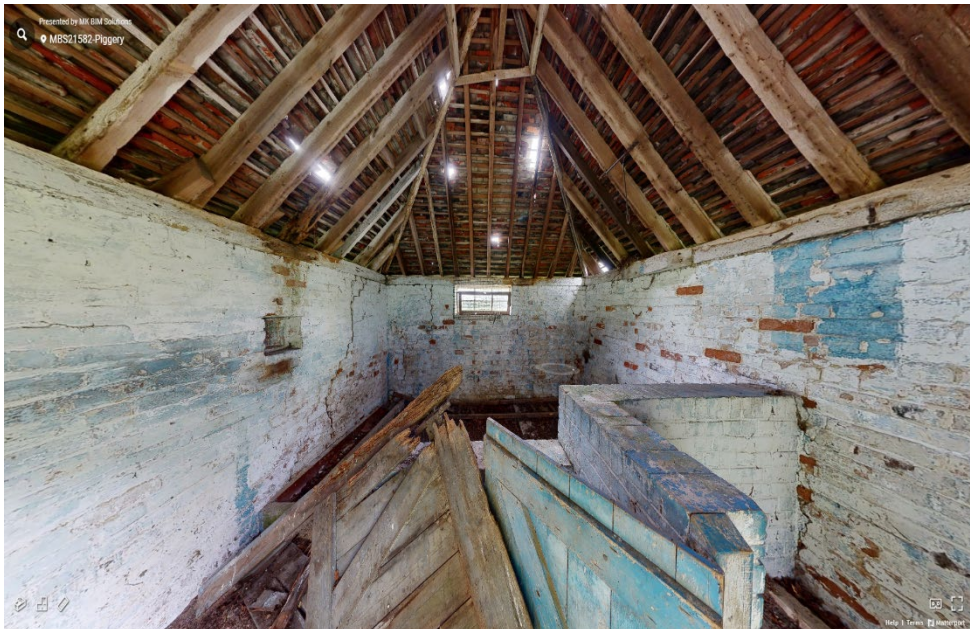
Interior showing the debris including the original boarded door and the poor condition of the brickwork. The enclosure and door on the right is later C20.

- The original vertically boarded timber door is incomplete and detached, lying loose on the floor.
- The interior is filled with debris, some of which may provide further information about the building and its former use. Further investigation is necessary to consider whether its past as a well house has contributed to its structural issues, and whether further functional historic fixtures survive.

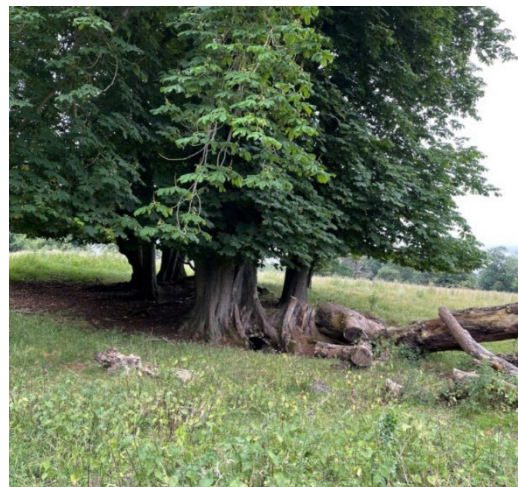
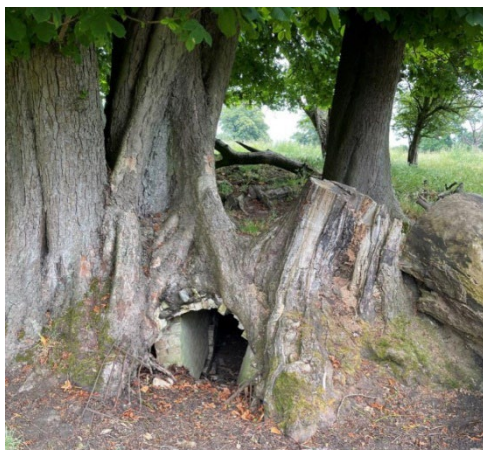
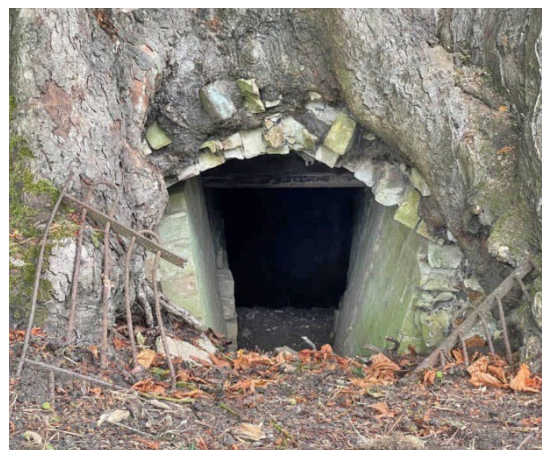
The immediate setting of the building is limited and contained by the roots of a chestnut tree.

The crushed condition of the entrance passage is visible. Two associated sections of wrought iron hooped estate fencing are partly buried at the entrance to the Ice House.

The structure is in poor condition, due to longstanding tree root damage. The trees are protected and therefore a 'holding' approach as a ruin to limit further damage is appropriate.

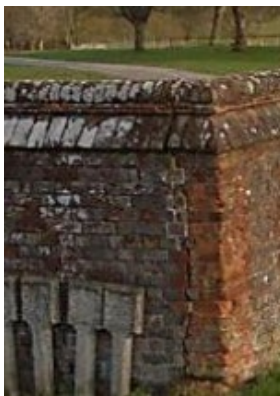
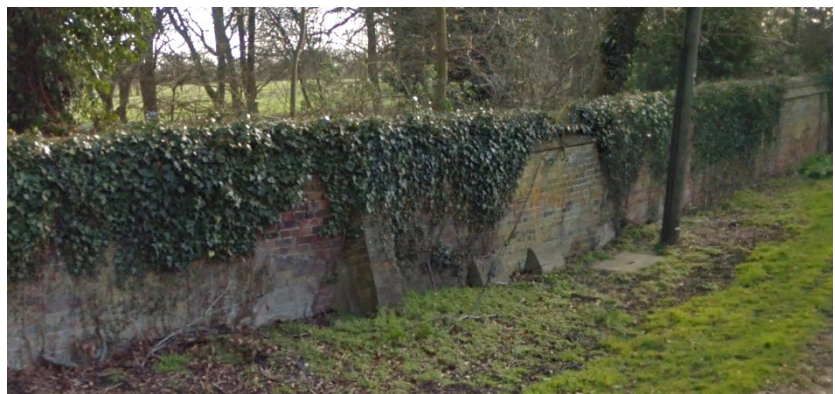
Typical defects © Google 2019. (Left) vertical crack. (Right) Leaning section of wall with ivy.

The two corners at the junction of curved and straight sections of wall have vertical cracks. There is moss and ivy growth and some bricks and joints have deteriorated and failed, particularly on the northern and southern ends and at low level.

There is damage due to the proximity of trees and subsequent piers have been added to a leaning section of wall in the northern half.

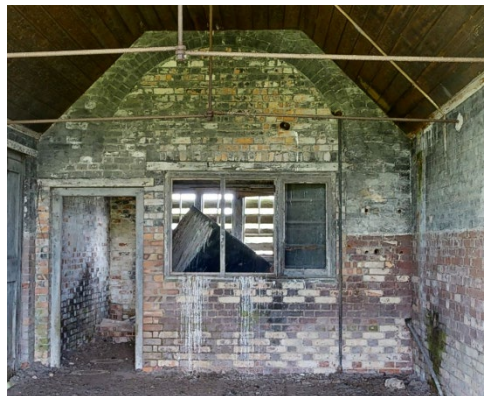
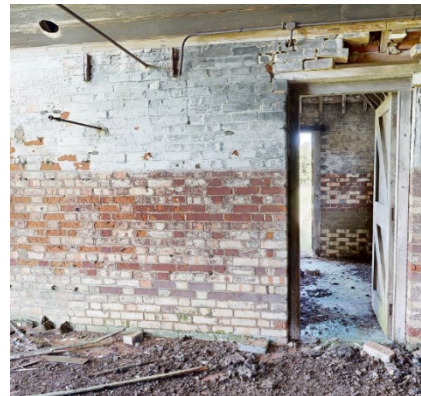
*Internal and external typical views and condition*

The structure has been poorly maintained over recent years. Some tiles are missing or slipped, some weatherboards are missing and it no longer has guttering. Internal and external windows and doors are in need of repair or missing. Some brickwork is unsupported or missing and the majority of flooring is unmade earth. Repairs are necessary for the building to have a use.
