For the Site of: Hexton Manor, Hexton, Hitchin, Hertfordshire SG5 3JH

# Emergence and Activity Bat Survey (EBS)

The following report details the findings and recommendations for the site of Hexton Manor, Hexton, Hitchin, Hertfordshire SG5 3JH (Kennels).

The client commissioned Cherryfield Ecology to undertake an EBS as the proposals include for conversion of The Kennels (B1) to a detached dwelling with associated features.

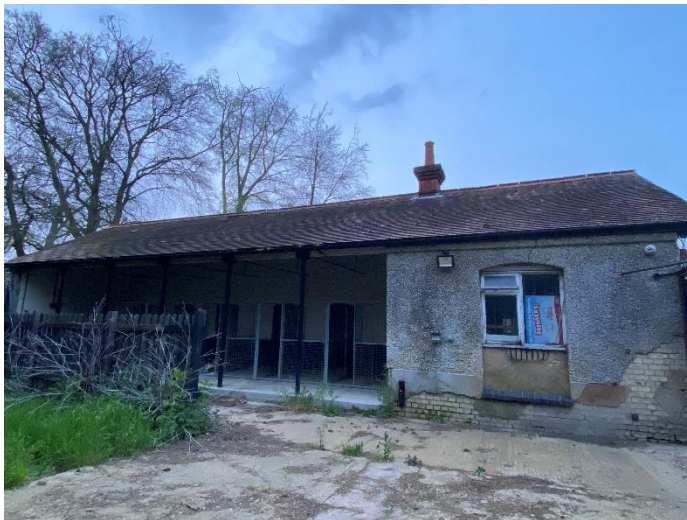
| | B1 | 22/05/2024<br>20:45 to 22:30<br>SS: 21:00 | Figure 2: Still from southern elevation.<br>A CP was heard but not seen at 21:37. CPs were then observed foraging at 21:43 and 21:48 over the building. Continuous foraging was heard but not seen from 21:49 |

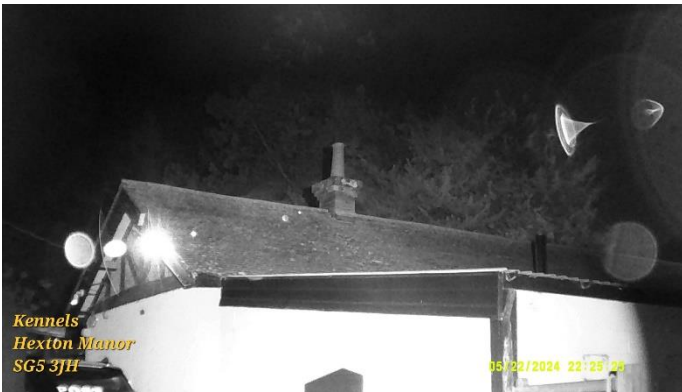
| | | | <p>to 21:55. A SP was seen foraging south-east to east at 22:06.</p> <p>Kennels<br/>Hexton Manor<br/>SG5 3JH</p> <p>05/02/2024 22:25:25</p> <p>Figure 3: IR still from north-eastern elevation.</p> |

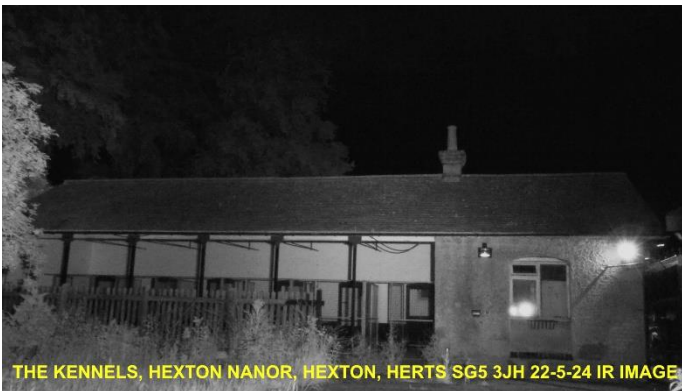
| PH | B1 | As Above | <p>A CP was first observed foraging in front of the kennel at 21:11 until 21:31. A CP passed over the roof heading west at 21:43. Foraging CP was recorded at 21:54 and 22:08. A Brown long eared bat <i>Plecotus auritus</i> (BLEB) was seen but not heard passing north over the kennel roof at 22:13.</p> <p>THE KENNELS, HEXTON MANOR, HEXTON, HERTS SG5 3JH 22-5-24 IR IMAGE</p> <p>Figure 4: IR still from southern elevation.</p> |

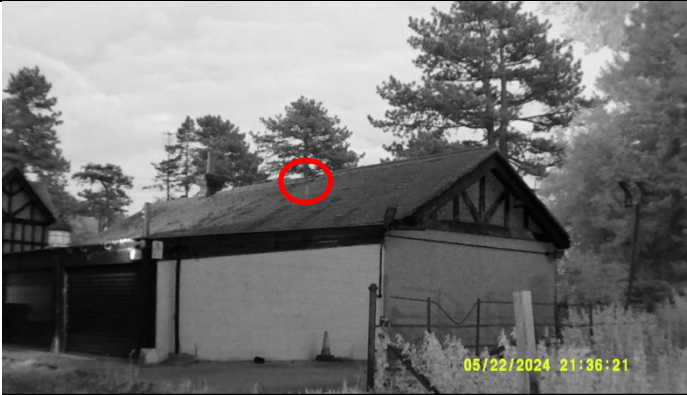
| ZH | B1 | As Above | <p>A CP distant pass was heard but not seen at 21:31. <b>A CP emergence was observed emerging from, the north-western elevation at 21:36.</b> CP was then observed foraging west to east around the trees from 21:38 until 21:40 and 21:47. A BLEB was heard but not seen at 22:08.</p> |

| | | | <p>05/22/2024 21:36:21</p> <p>Figure 5: CP emergence at 21:36.</p> <p>05/22/2024 22:20:00</p> <p>Figure 6: IR still from north-western elevation.</p> |

A bat roost (day) for Common Pipistrelle (*Pipistrellus pipistrellus*) will be lost when works are carried out.

Alternate roosts will need to be provided before development on B1 commences. **A bat licence (Bat Mitigation Class) will be required** post-grant of planning in order to allow the conversion to proceed lawfully. (Please refer to **Section 4.3** of this report for further details).

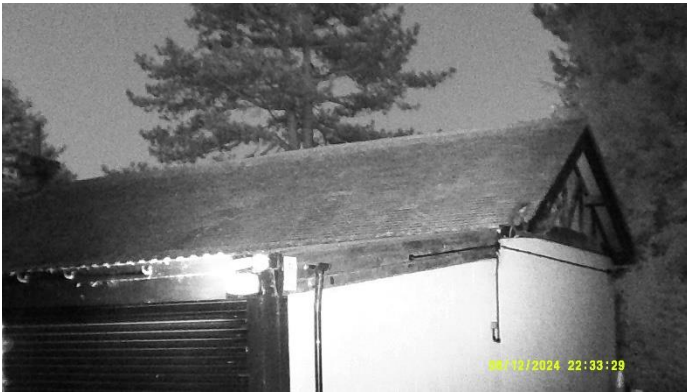
| JW | B1 | <p>12/06/2024</p> <p>21:06 to 22:55</p> <p>SS: 21:21</p> | <p>A CP was heard but not seen at 21:39 and 21:45. A CP was then observed foraging around trees at 21:47 and 21:58 and 22:14. A BLEB passed at 22:23. No further activity was recorded.</p> <p>06/12/2024 22:33:29</p> <p>Figure 7: IR still from north-western.</p> |

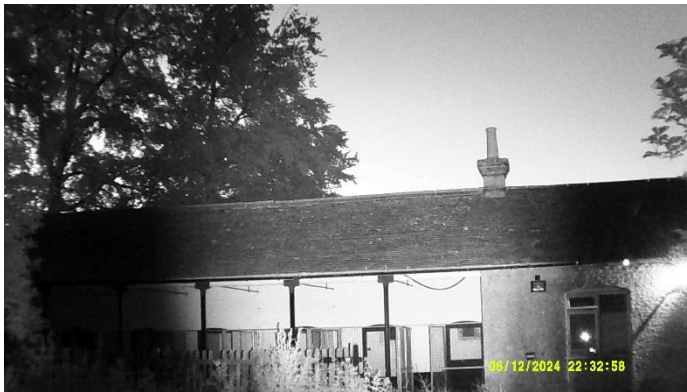
| | | | <p>from 21:39 until 21:45. A BLEB was observed passing at 21:59. A SP pass was recorded at 22:03. A CP was observed flying south over the building at 22:08.</p> <p>Figure 8 : IR still from southern elevation.</p> |

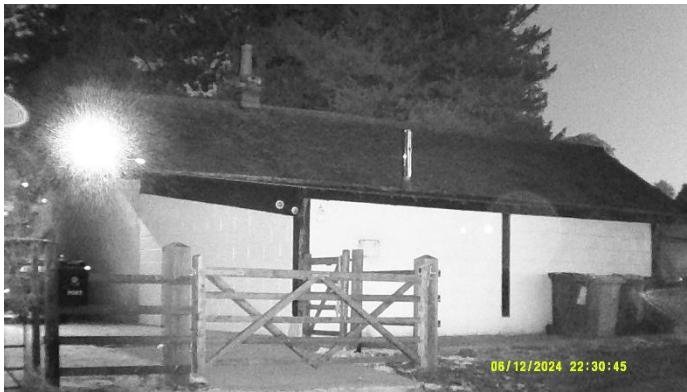
| ES | B1 | As Above | <p>A CP was observed passing from behind the kennels towards the driveway at 21:40. A myotis species was recorded passing at 22:21. No further activity was recorded.</p> <p>Figure 9: IR still from north-eastern elevation.</p> |

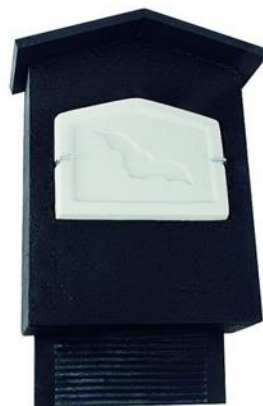
Figure 11: Chillon Woodstone Bat Box (British-made)

A minimum of one Chillon Woodstone bat boxes will be hung on the building at a minimum of 3m from ground level and face south/southwesterly. These boxes are known to be used by Brown Long-Eared bats (BLEB) and crevice-dwelling species.
