Report prepared for: Ermal Kuci

For the Site of: 211 Icknield Way, Letchworth Garden City, Hertfordshire, SG6 4TT

# Preliminary Roost Assessment (PRA)

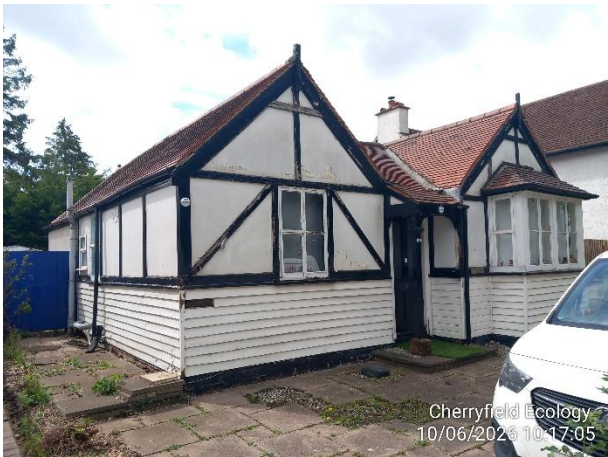
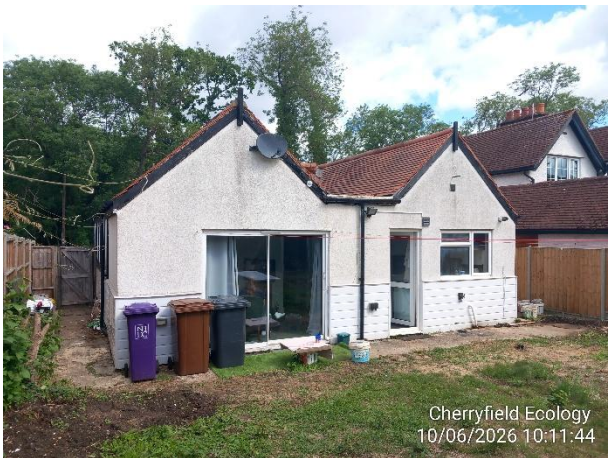
| Building/Tree/Structure Number | Description |
|---|---|
| B1 | <p><b>External</b></p> <p>B1 is a brick-built single-storey residential dwelling. The roof is made up of two gable ends, connected by a cross ridge, and covered in clay roofing tiles. A timber soffit box surrounds the eaves of the building as does some plastic guttering. The doors and windows are UPVC framed. Some of the mortar has been chipped away at the gable ends, however, mortar is still present under the tiles, not leading into any cavities.</p> <p>Figure 2: Example of B1's front exterior</p> <p>Figure 3: Example of B1's rear exterior</p> <p><b>Internal</b></p> <p>Internally, there is one loft void, this is timber clad, insulated and the roofing tiles are lined with bitumen felt.</p> |

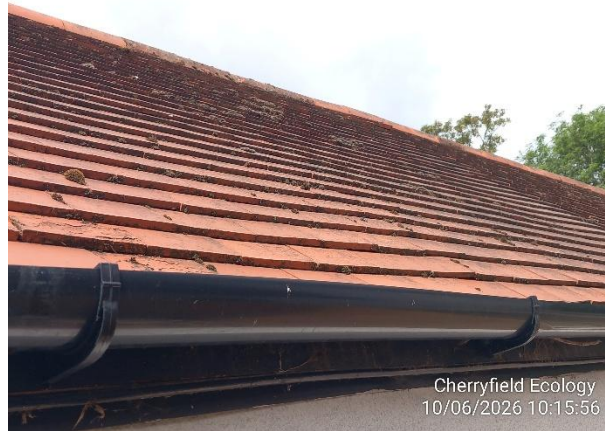
Figure 6: Example of the roofing tiles

| Potential for bat use | Buildings:<br>Level of likelihood of roosting presence -<br>B1 - Negligible<br>The building provides negligible potential for roosting bats due to the small number of potential roosting opportunities. A small section of ridge tiles are missing from the building which have been covered by felt. Some |

tiles have insulation foam sprayed into, to deter rats. Most of the mortar is present, and while some has been chipped off, it is still present just under the tiles, creating no cavities.

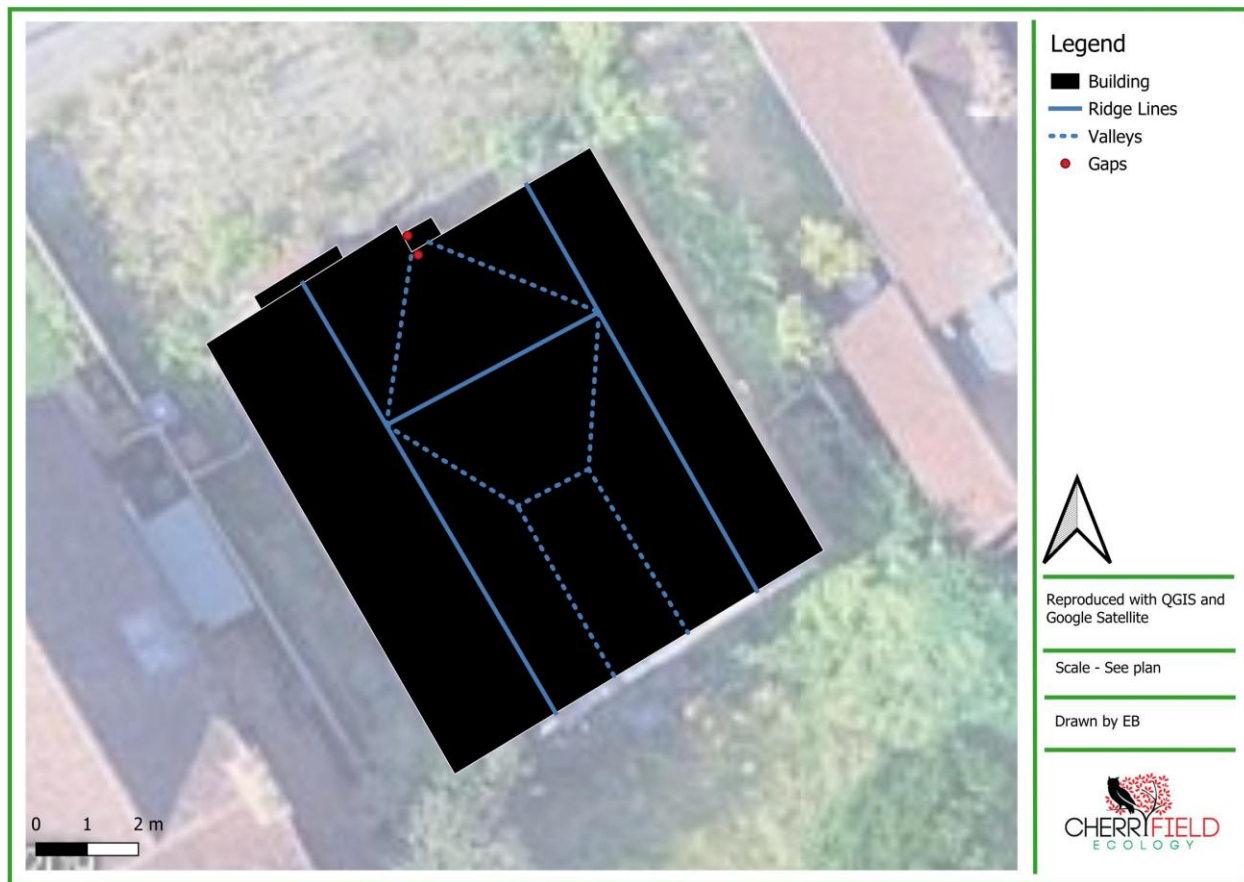
Figure 9: Site Plan

This section details the structures reference and description (see Figure 9 for Site Plan).
