| 0.00014 | 0.00014 | 0.00014 | 0.00014 | 0.00014 | 0.00014 | 0.00000 | 0.00000 | 0.00000 |

| <b>Client name:</b><br>Martin Grant Homes | <b>Site Location:</b><br>London Road, Hitchin | <b>Date:</b><br>03.12.2018 |

Report No: 1920378 L01 (00)

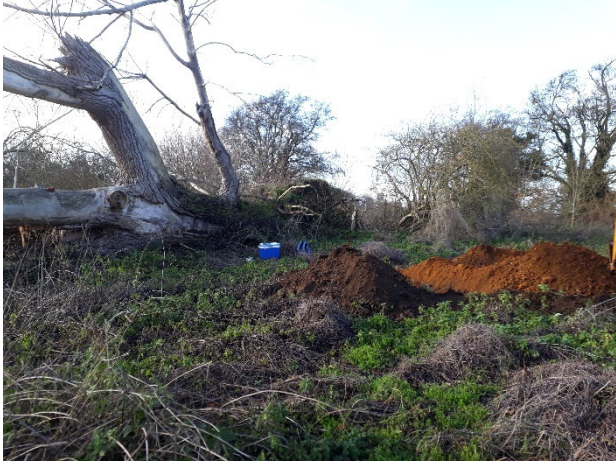
| No. 2 | Direction/Description<br>South/A fallen tree identified along the suspected infilled former sand pit |

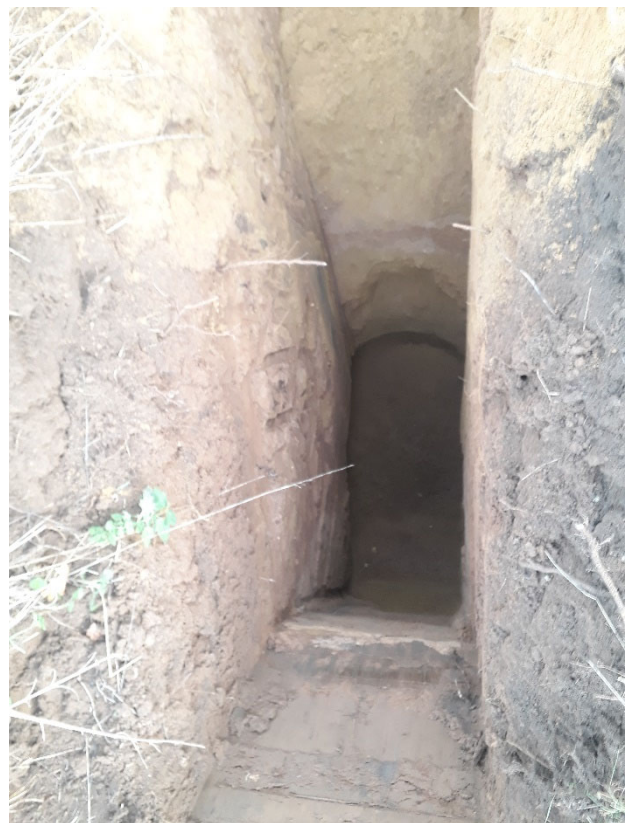
No. 5

Description:  
TP1

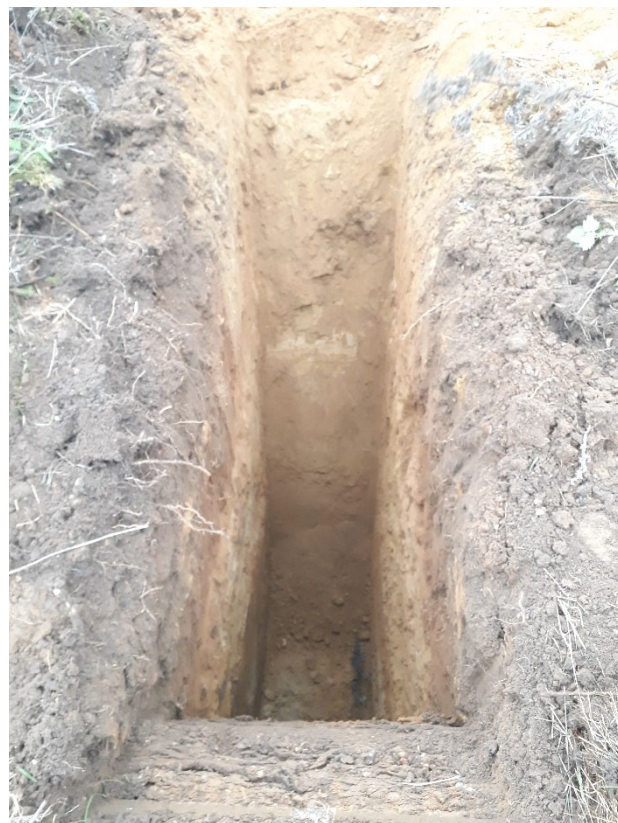
No. 6

Description  
TP2

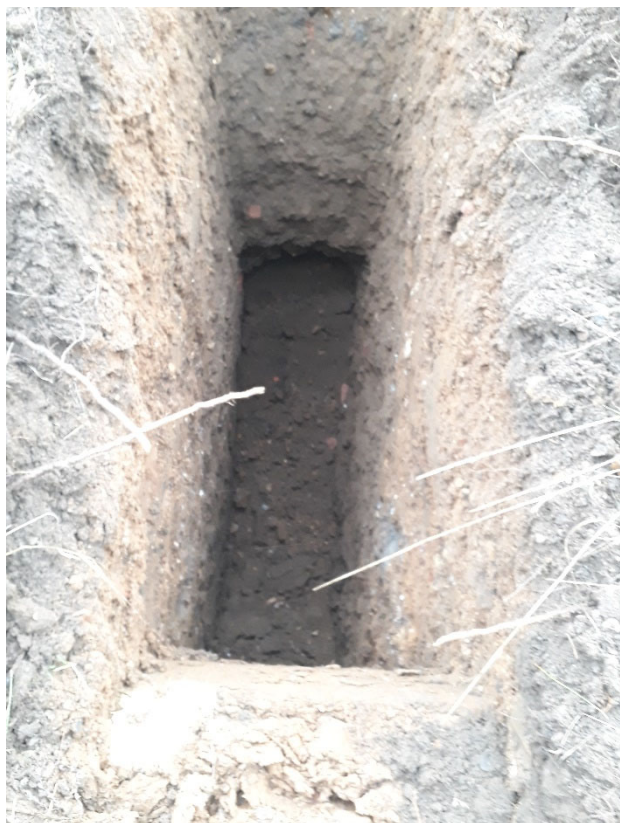
No. 7

Description:  
TP3

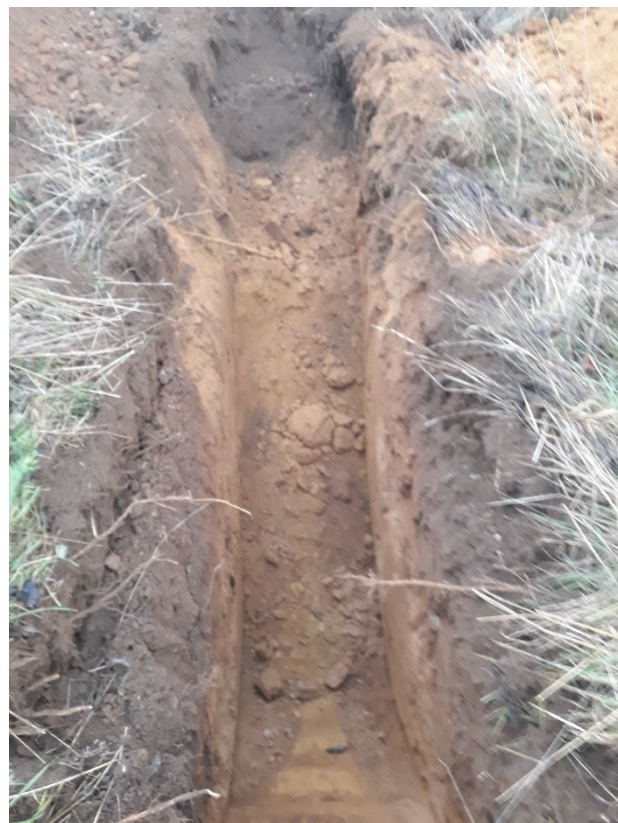
No. 8

Description  
TP4

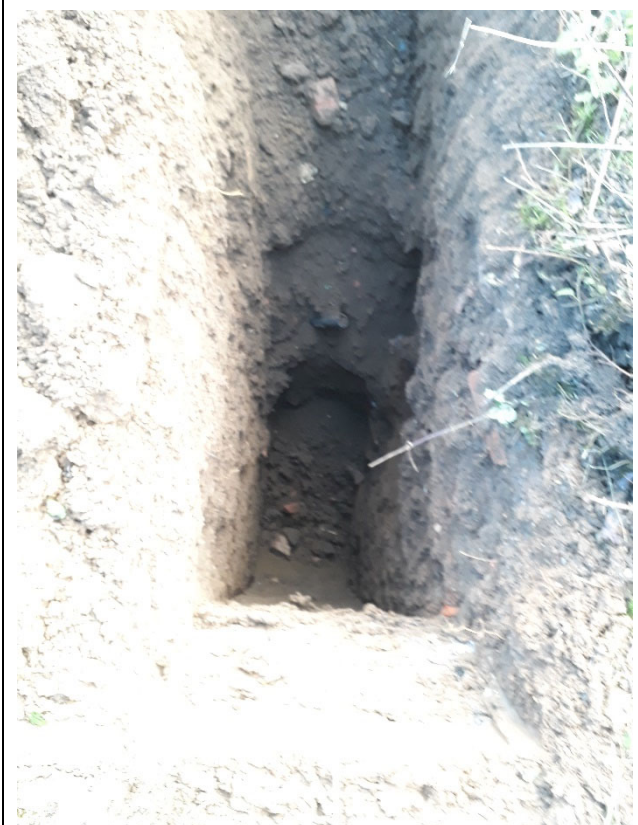
No. 9

Description:  
TP5

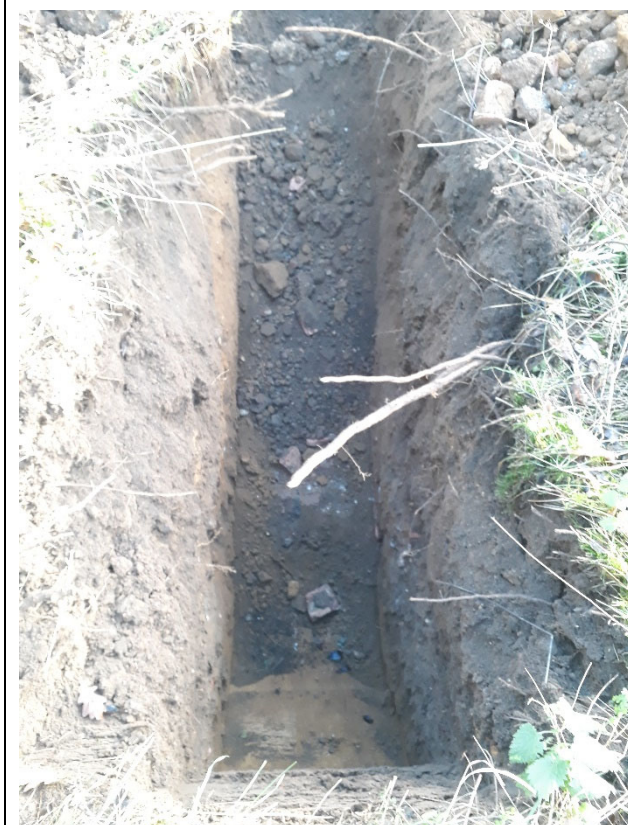
No. 10

Description  
TP6
