Our ref: 1920378-L01 (00)

**RE: LAND AT MILL LANE / LONDON ROAD, ST IPPOLYTS, HITCHIN, HERTFORDSHIRE  
SITE INVESTIGATION**

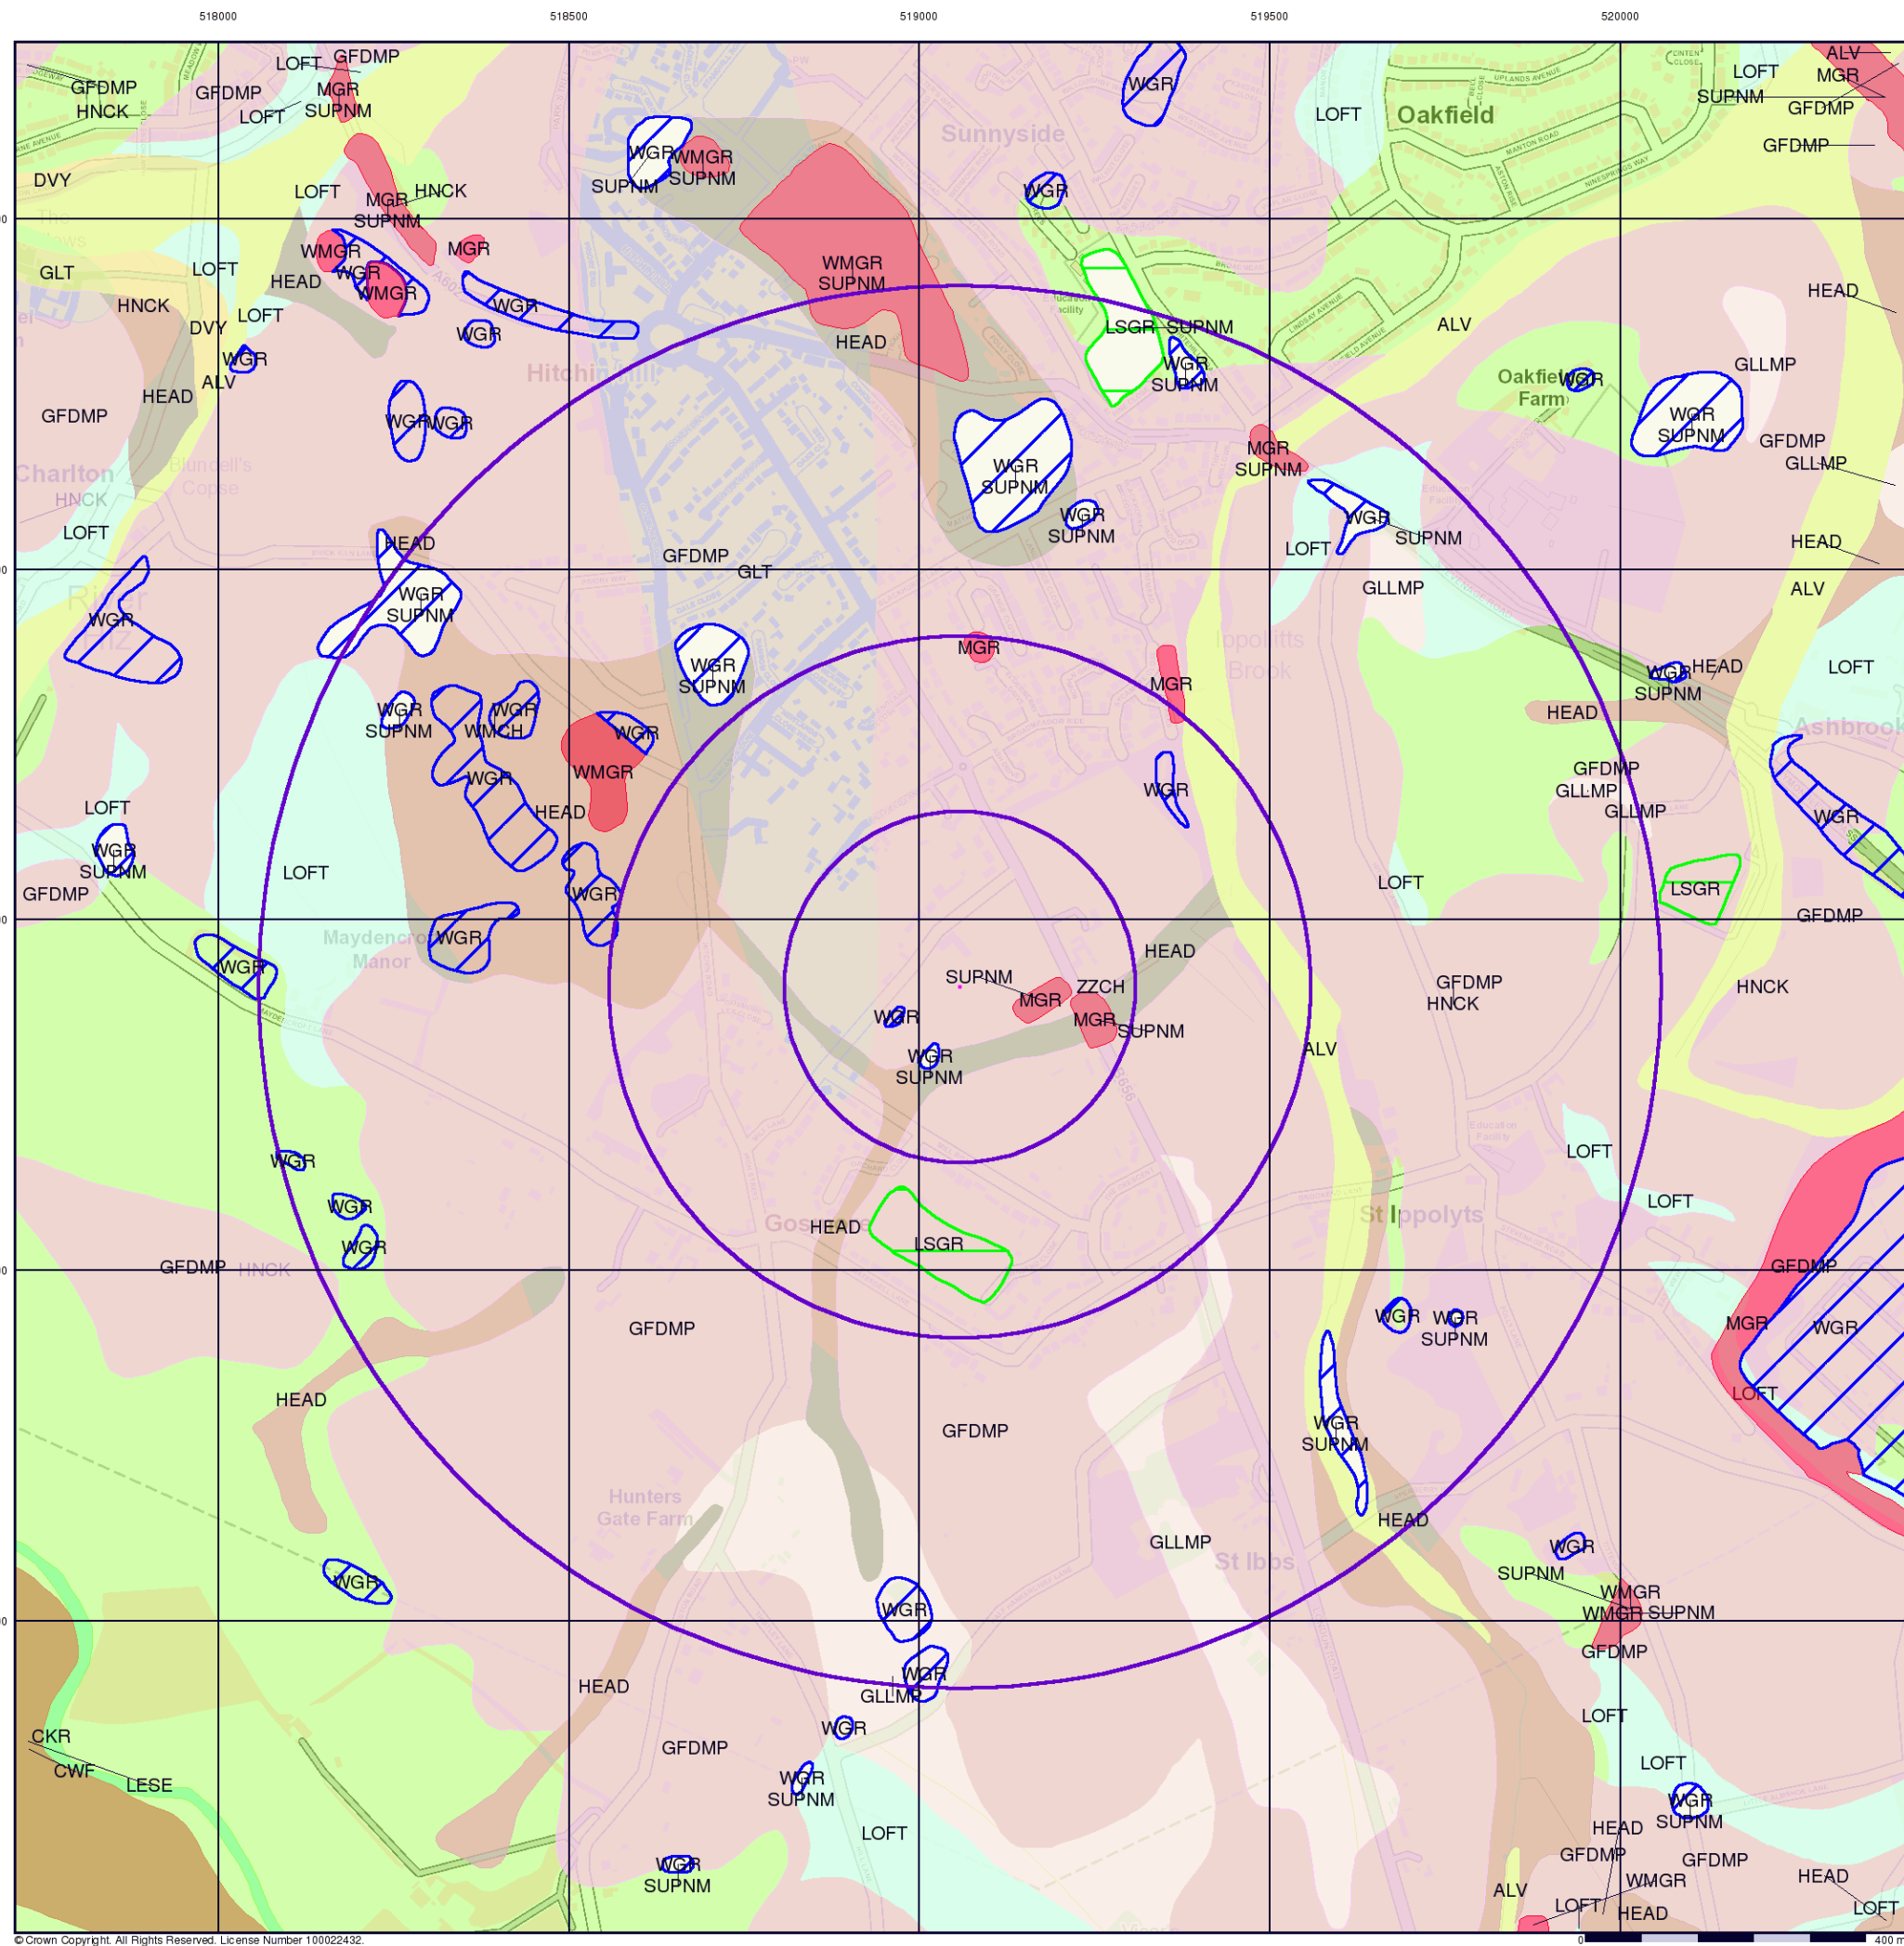
## Combined Surface Geology

The Combined Surface Geology map combines all the previous maps into one combined geological overview of your site.
