AGR Solar 4 Limited

## **Priory Farm Solar Array Grid Connection**

### **Arboricultural Method Statement**

February 2026

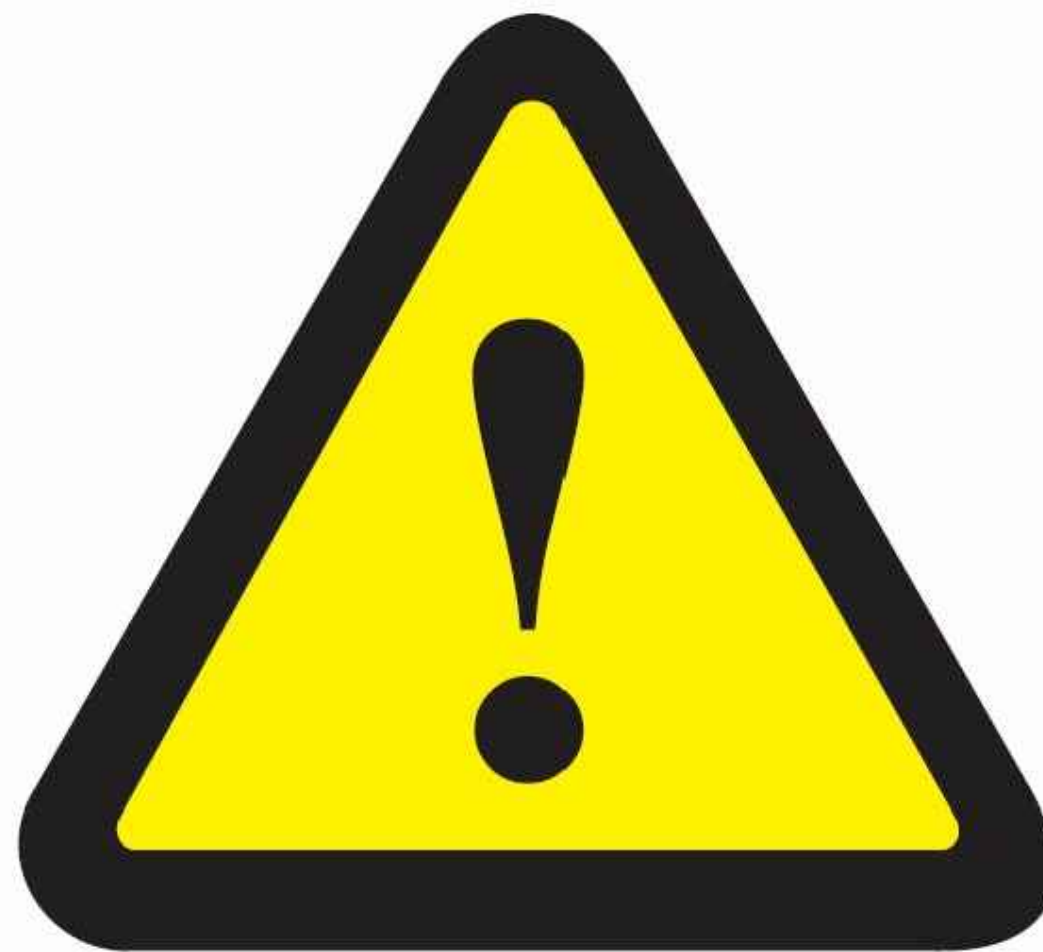
**PROTECTIVE FENCING. THIS  
FENCING MUST BE  
MAINTAINED IN ACCORDANCE  
WITH THE APPROVED PLANS  
AND DRAWINGS FOR THIS  
DEVELOPMENT.**

**TREE PROTECTION AREA  
KEEP OUT !**

**(TOWN & COUNTRY PLANNING ACT 1990)  
TREES ENCLOSED BY THIS FENCE ARE PROTECTED BY  
PLANNING CONDITIONS AND/OR ARE THE SUBJECTS OF A  
TREE PRESERVATION ORDER.  
CONTRAVENTION OF A TREE PRESERVATION ORDER MAY  
LEAD TO CRIMINAL PROSECUTION**
