## Ground Investigation Report

Proposed Residential Development

Greenside, London Road, Langley

Document no.: STX6902-R01-Rev\_B

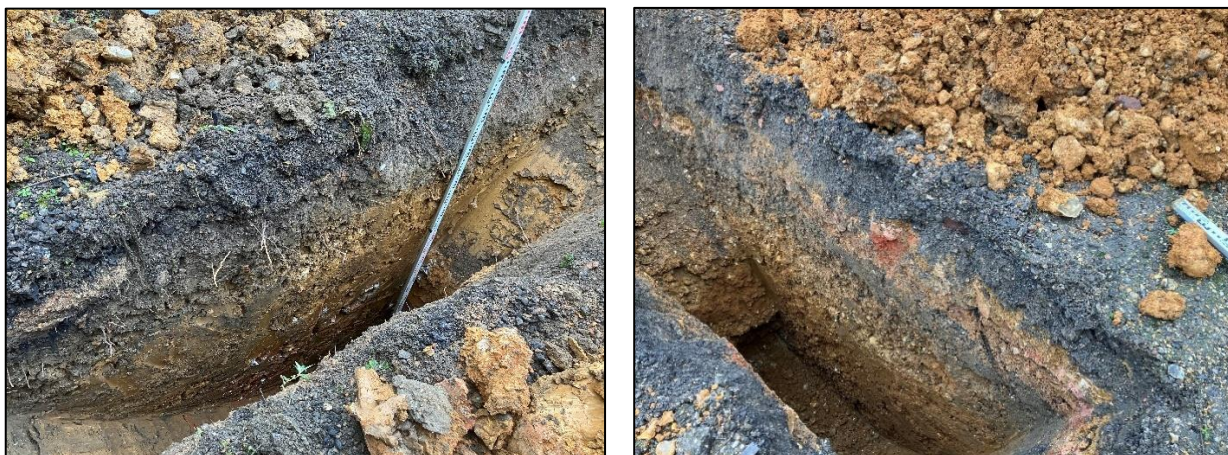
Figure 6-A: TP01 (left) and TP05 (right) showing gravels over clay Made Ground over Clay-with-flints Formation.

- 6.1.5 Photographs of typical ground conditions are presented below.

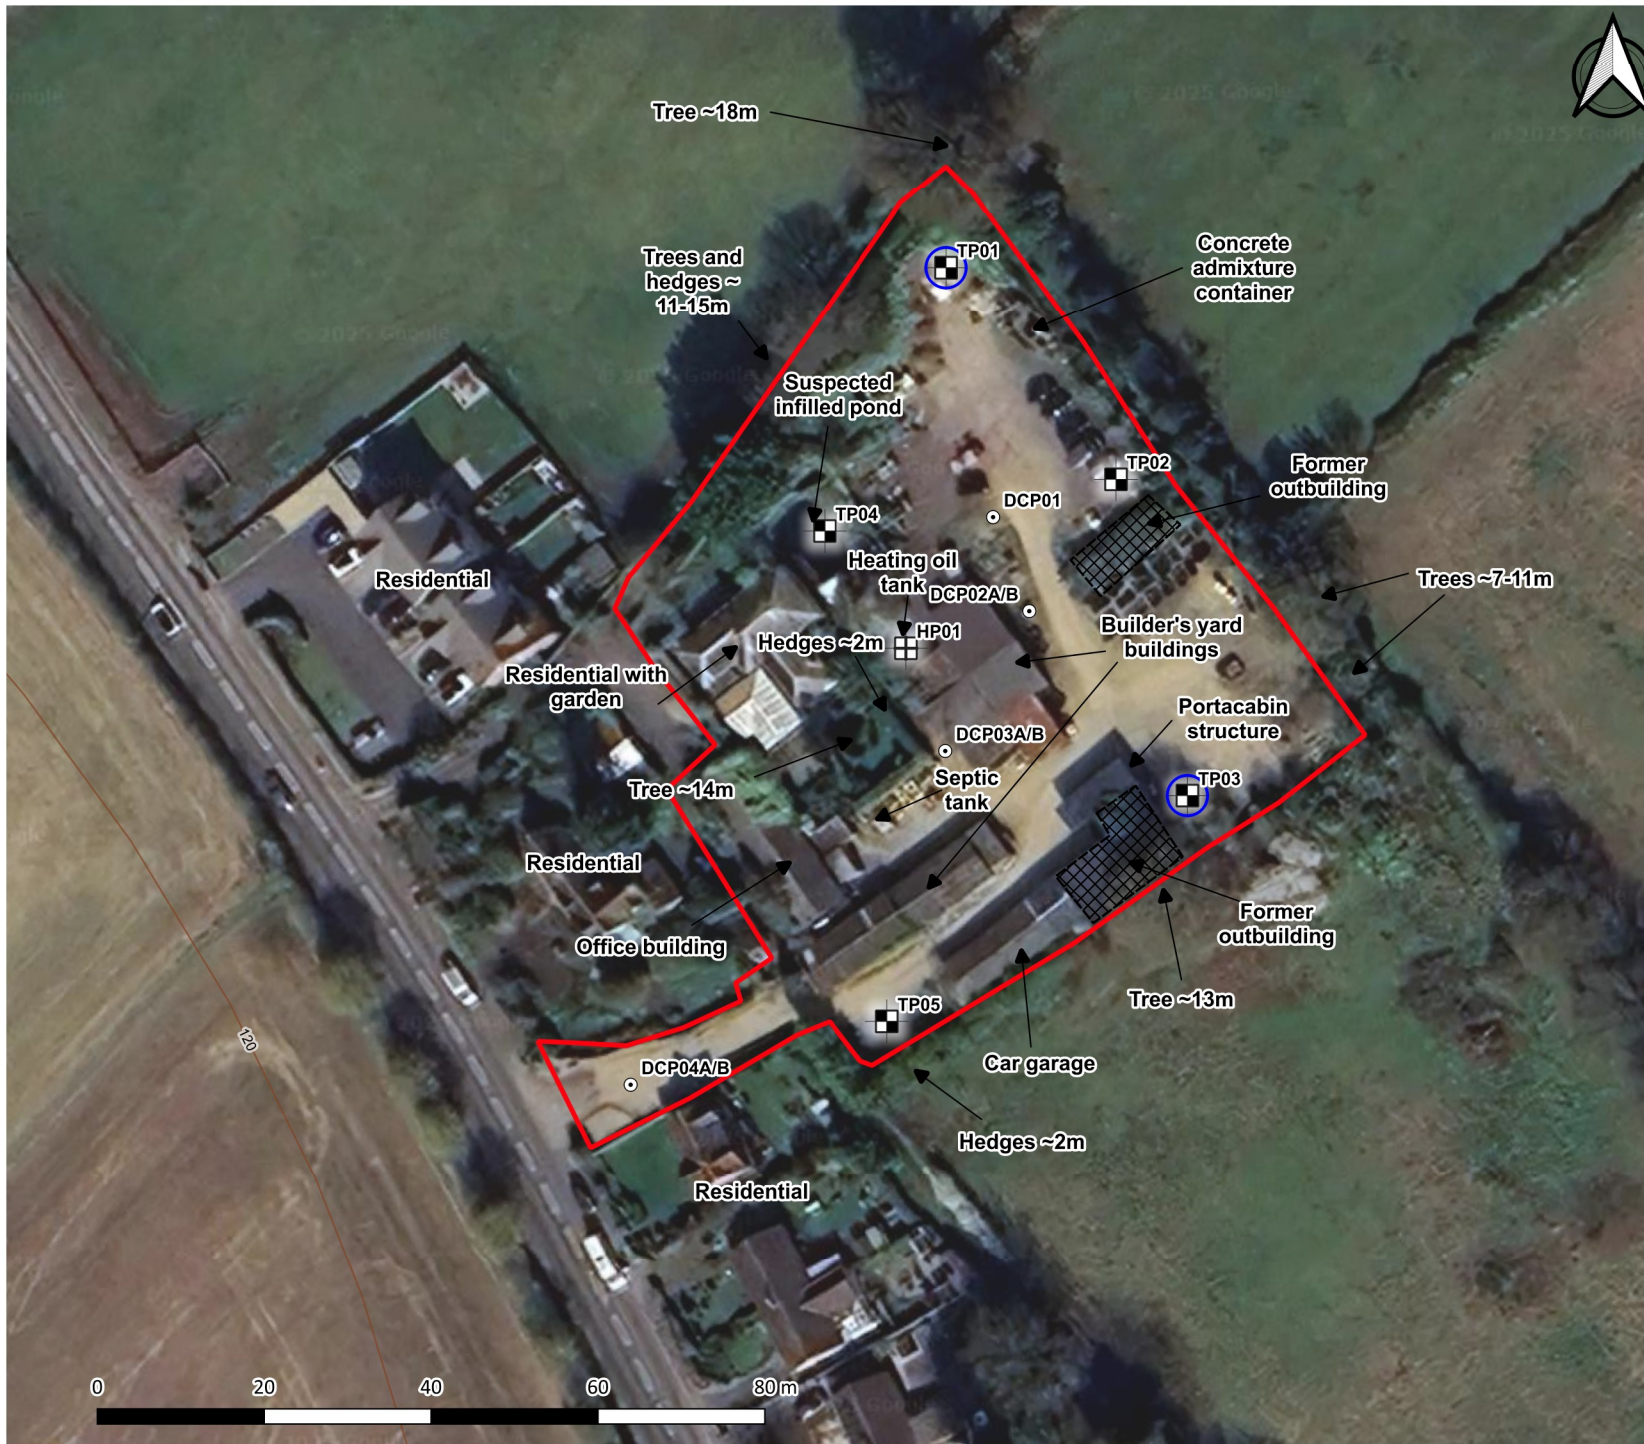
DRAWING No.  
STX6902-D01-A

- Site Boundary
- Trial Pit
- Dynamic Cone Penetrometer Test
- Soakaway Test
- Hand Pit

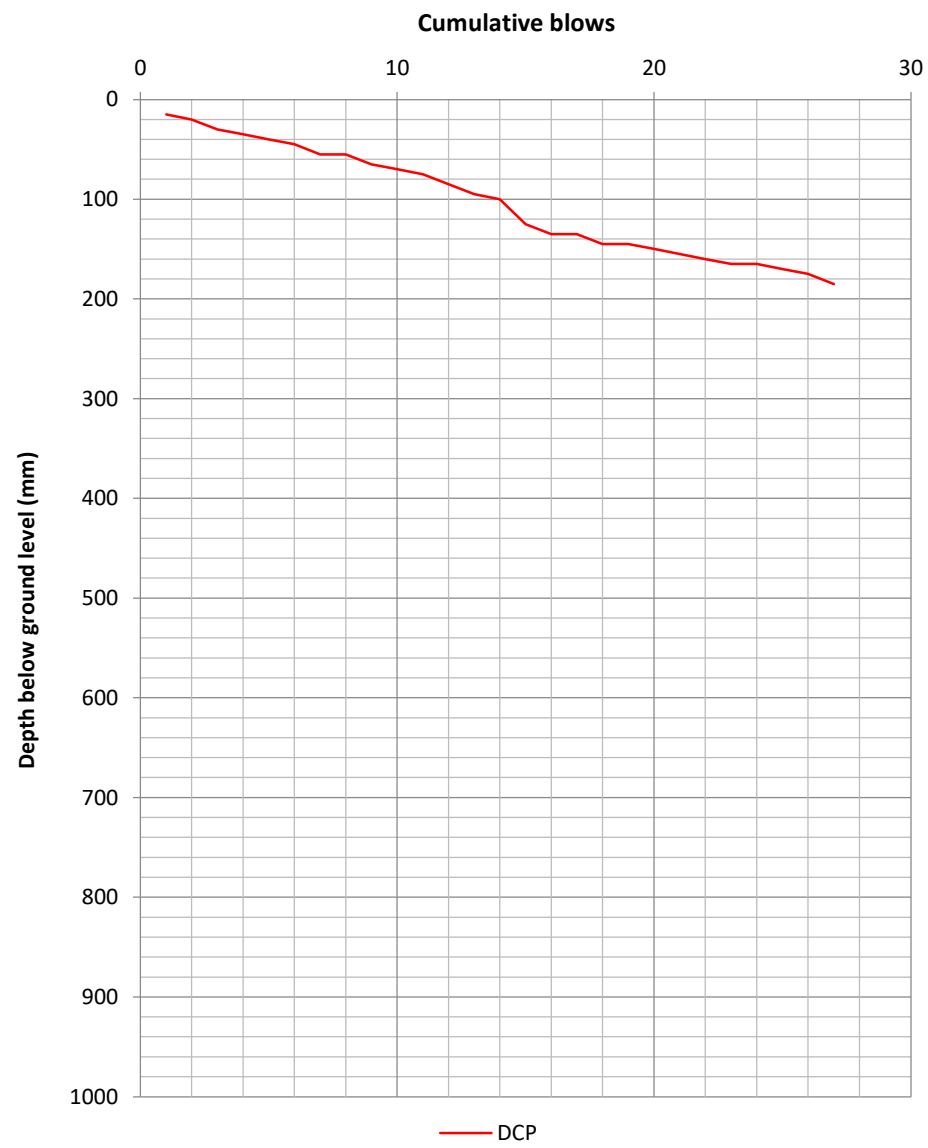
Plot showing number of blows against depth

1. Test procedure following Highways England Document CS229 Data for Pavement Assessment.
