## Tier 1 and Tier 2 Contamination Assessment

Proposed Residential Development

Carden Gardens, Welwyn

Document no.: STX7068-R01-Rev\_B

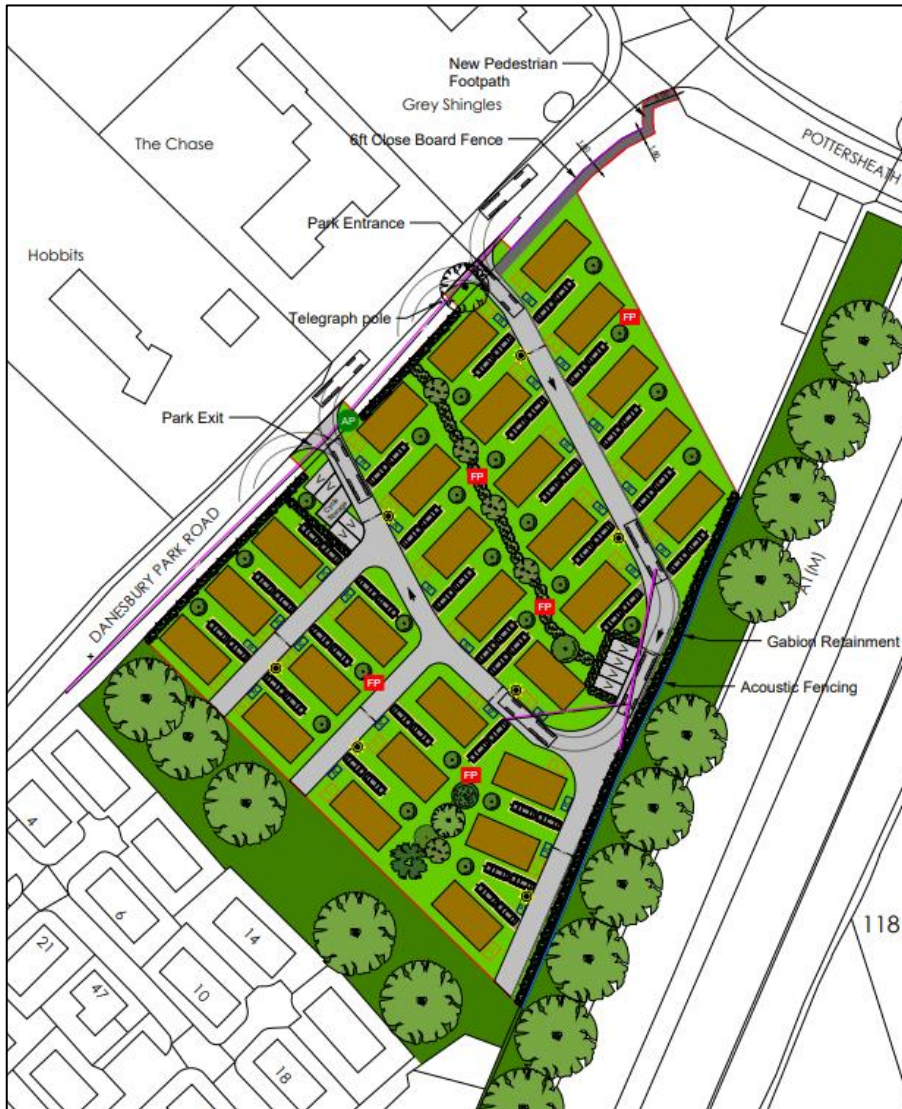
Figure 1-A: Proposed layout

- 1.1.1 The scheme at Carden Gardens consists of the development of land to provide 27 residential park homes as shown on the layout presented below.

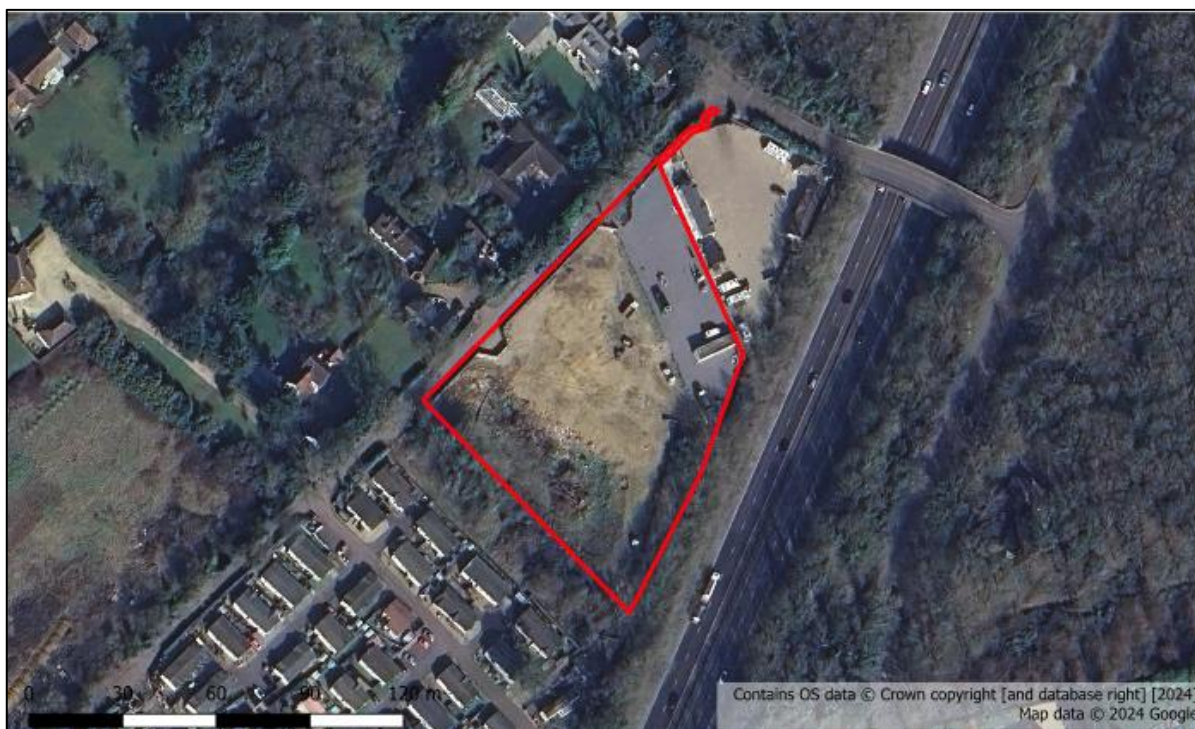
Figure 2-A: Aerial photograph and approximate site boundary

2.2.2 An aerial image showing the approximate site boundary is presented below, followed by a table summarising the key site features. A site plan is provided within Appendix A and photographic records are presented in Appendix C.

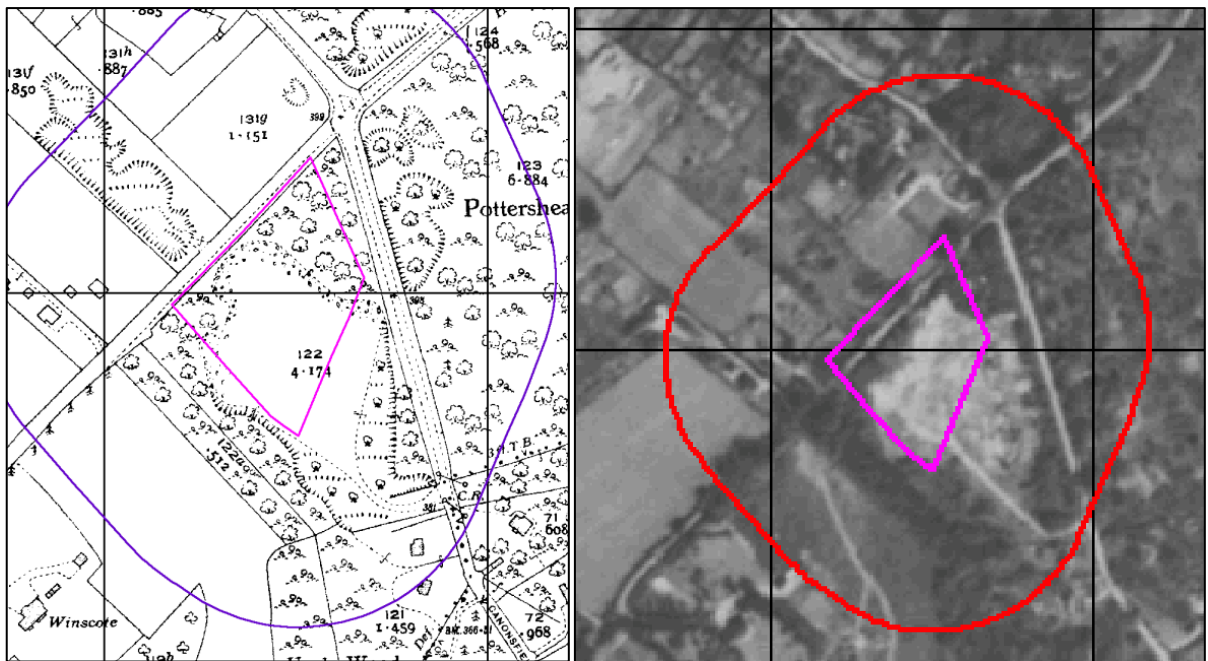
Figure 2-B: Historical Gravel Pit partially occupying site shown on historical map dated 1937(L) and 1949(R)

- 2.6.1 Based on historical maps, the site comprised woodland until the site was quarried in the 1930s. Aerial photographs from early 2000s onward and site reconnaissance indicate the site has been partially infilled although the date of infilling is unknown. The extent of the historical gravel pit in relation to the site is shown in the map extracts in Figure 2-B.
- 2.6.2 Based on information obtained from the planning portal, and anecdotal evidence from the previous report the site was formerly occupied by a landscape gardening business (Carden Gardens) and subsequently a poultry farm (Corner Wood Poultry). The site has also been used for unpermitted waste dumping in the past.
- 2.6.3 Surrounding land has typically comprised woodland, later with some residential development. Localised quarrying has occurred in the area.

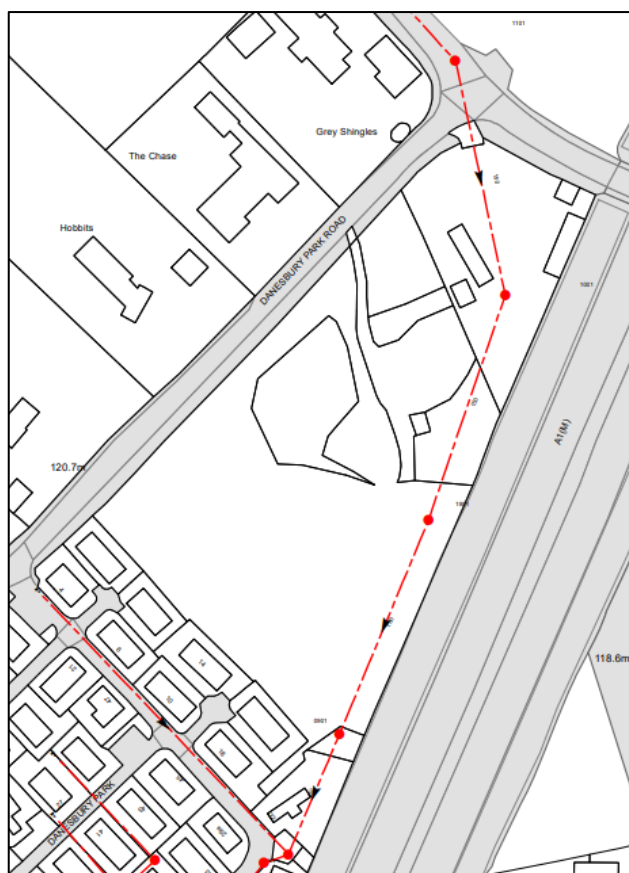
Figure 2-C: Foul Sewage Drain located within the site area.

- 2.17.1 Copies of all utility plans obtained are presented as Appendix H. The plans are provided for information only and should not be relied upon to be accurate. In addition, it is worth noting that the public utility plans provided by the asset owners typically exclude private service runs.
- 2.17.2 A review of the plans indicates a foul sewer drain runs parallel with the eastern boundary beneath site, with an extract presented as Figure 2-C. The asset holder should be consulted at the earliest opportunity to identify any construction constraints that may apply.

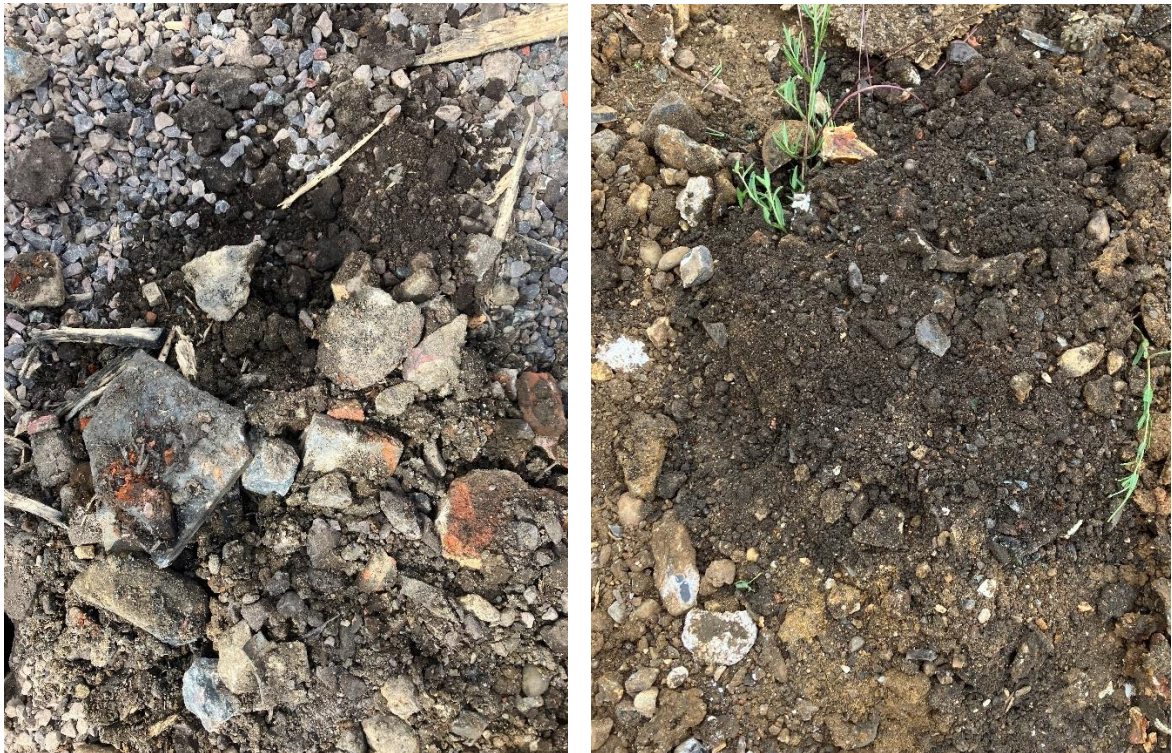
Figure 6-A: Coarse-grained Made Ground encountered in WLS05 (left) and WLS07 (right)

- 6.2.1 Made Ground was encountered in all exploratory locations and generally varied in thickness between 3.4m and >5.45m. However, within the far northern corner, Made Ground was more limited and extended to a depth of 1.1m. Based on historical maps, this area is likely to be outside of the former quarry.
- 6.2.2 Made Ground comprised both coarse-grained and fine-grained deposits. Generally, the coarse-grained soils were found within the top 1m of Made Ground and typically comprised a brown, grey or dark brown clayey gravel of concrete, flint, brick, clinker, glass, asphalt and metal, wood and plastic fragments. Fine-grained Made Ground typically comprised brown sandy, gravelly clay with occasional fragments of plastic and wood. Gravels consisted of brick, chalk, flint and rare concrete.
- 6.2.3 Photographs of the typical Made Ground are presented below.

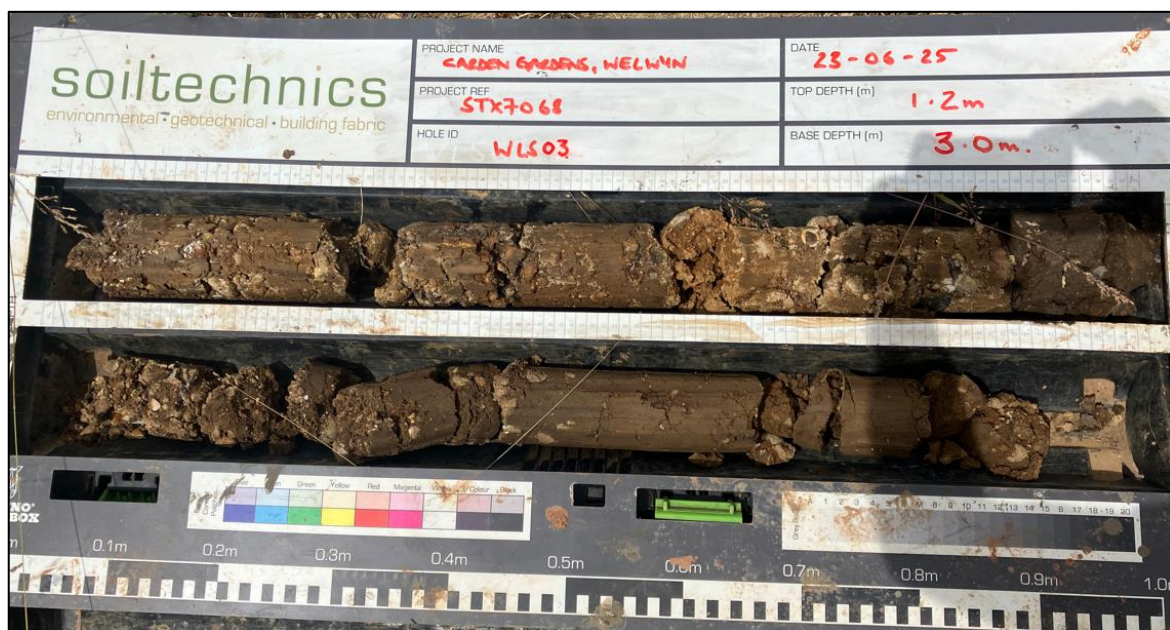
Figure 6-B: Fine-grained Made Ground encountered in WLS03 from 1.2m to 3m bgl.

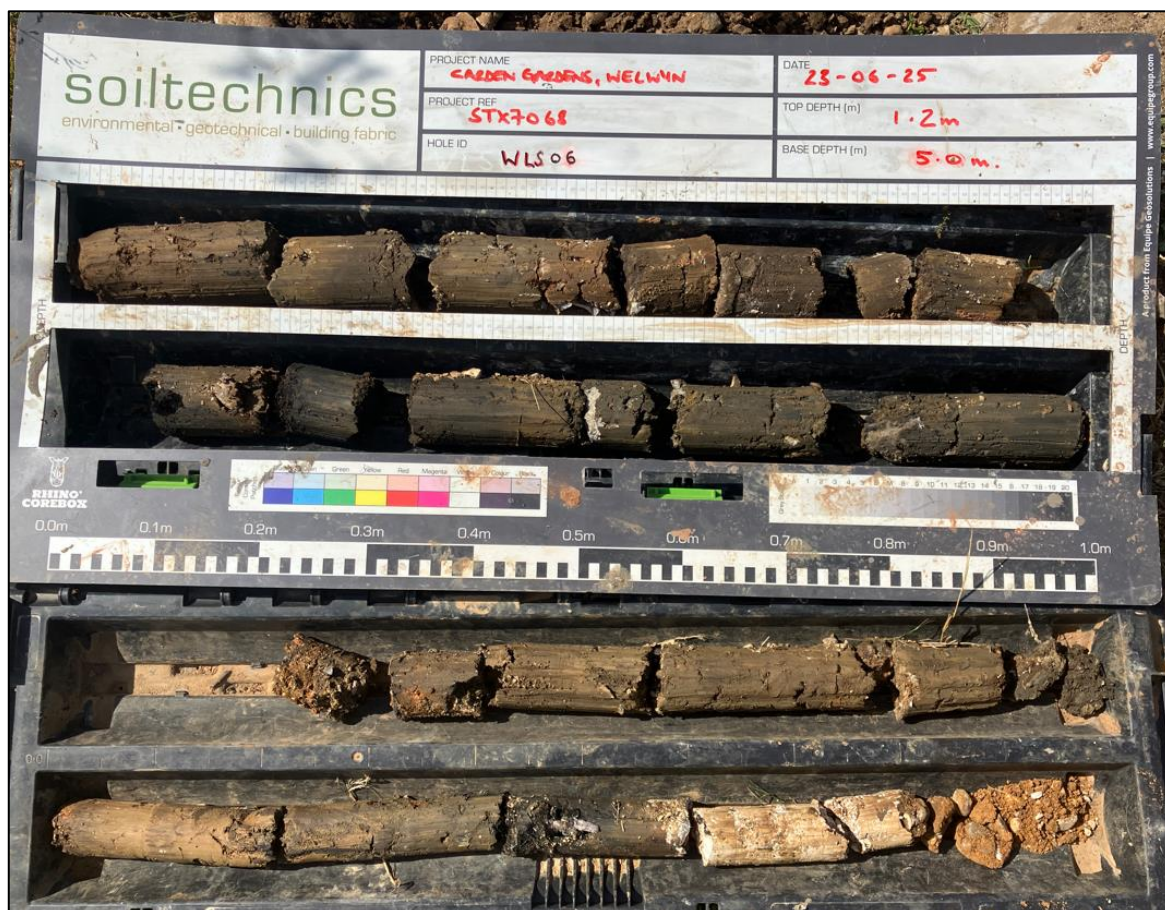
Figure 6-C: Fine-grained Made Ground encountered in WLS06 from 1.2m to 4.85m bgl.

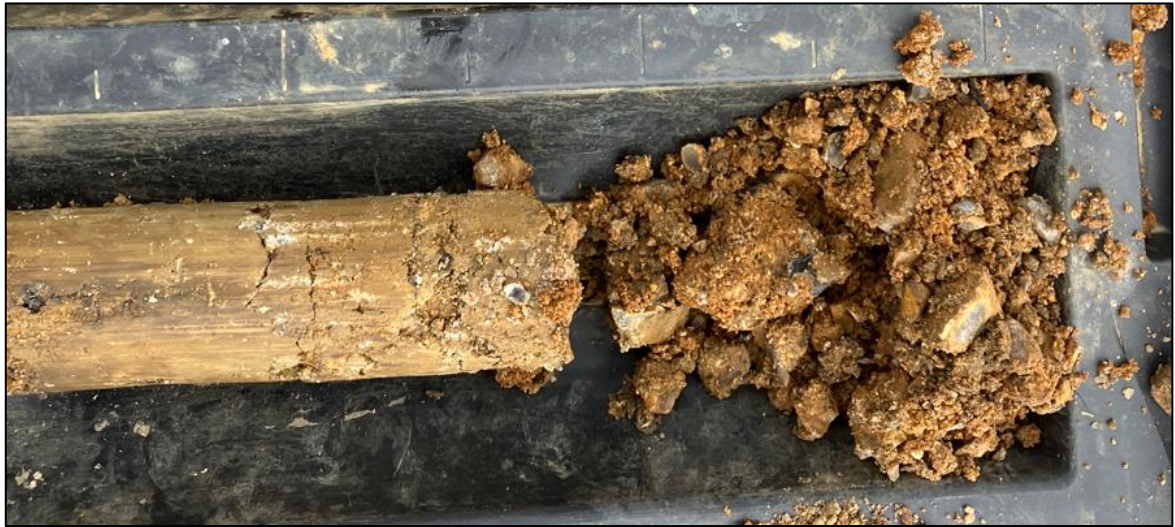
Figure 6-D: Glaciofluvial Deposits excavated from WLS01

6.3.1 Glaciofluvial Deposits were encountered below the Made Ground, where the base was determined, and extended beyond the termination depth of the boreholes. The Glaciofluvial Deposits were generally encountered as firm to stiff, orangish brown clay with varying proportions of sand and gravel of flint, and medium dense to dense orangish brown, slightly clayey, sandy, fine to coarse gravel of flint.

6.3.2 A photograph of the typical Glaciofluvial Deposits encountered is presented below.

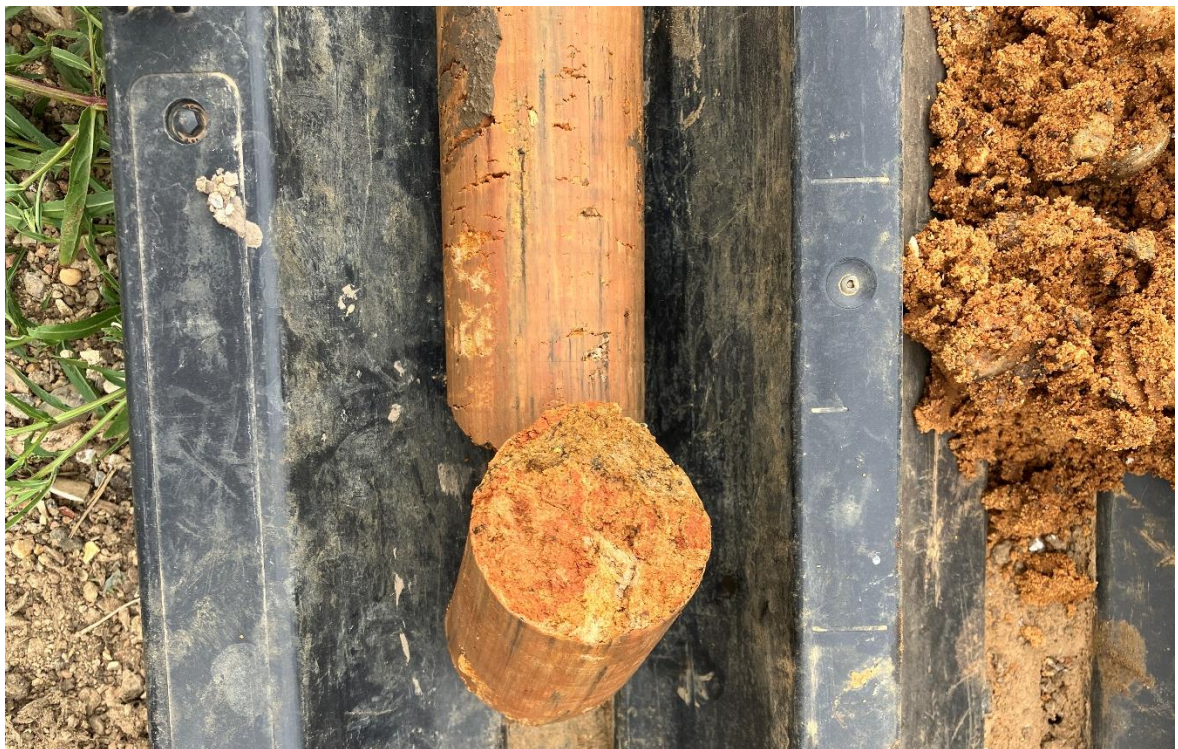
Figure 6-E: Glaciofluvial Deposits excavated from WLS02

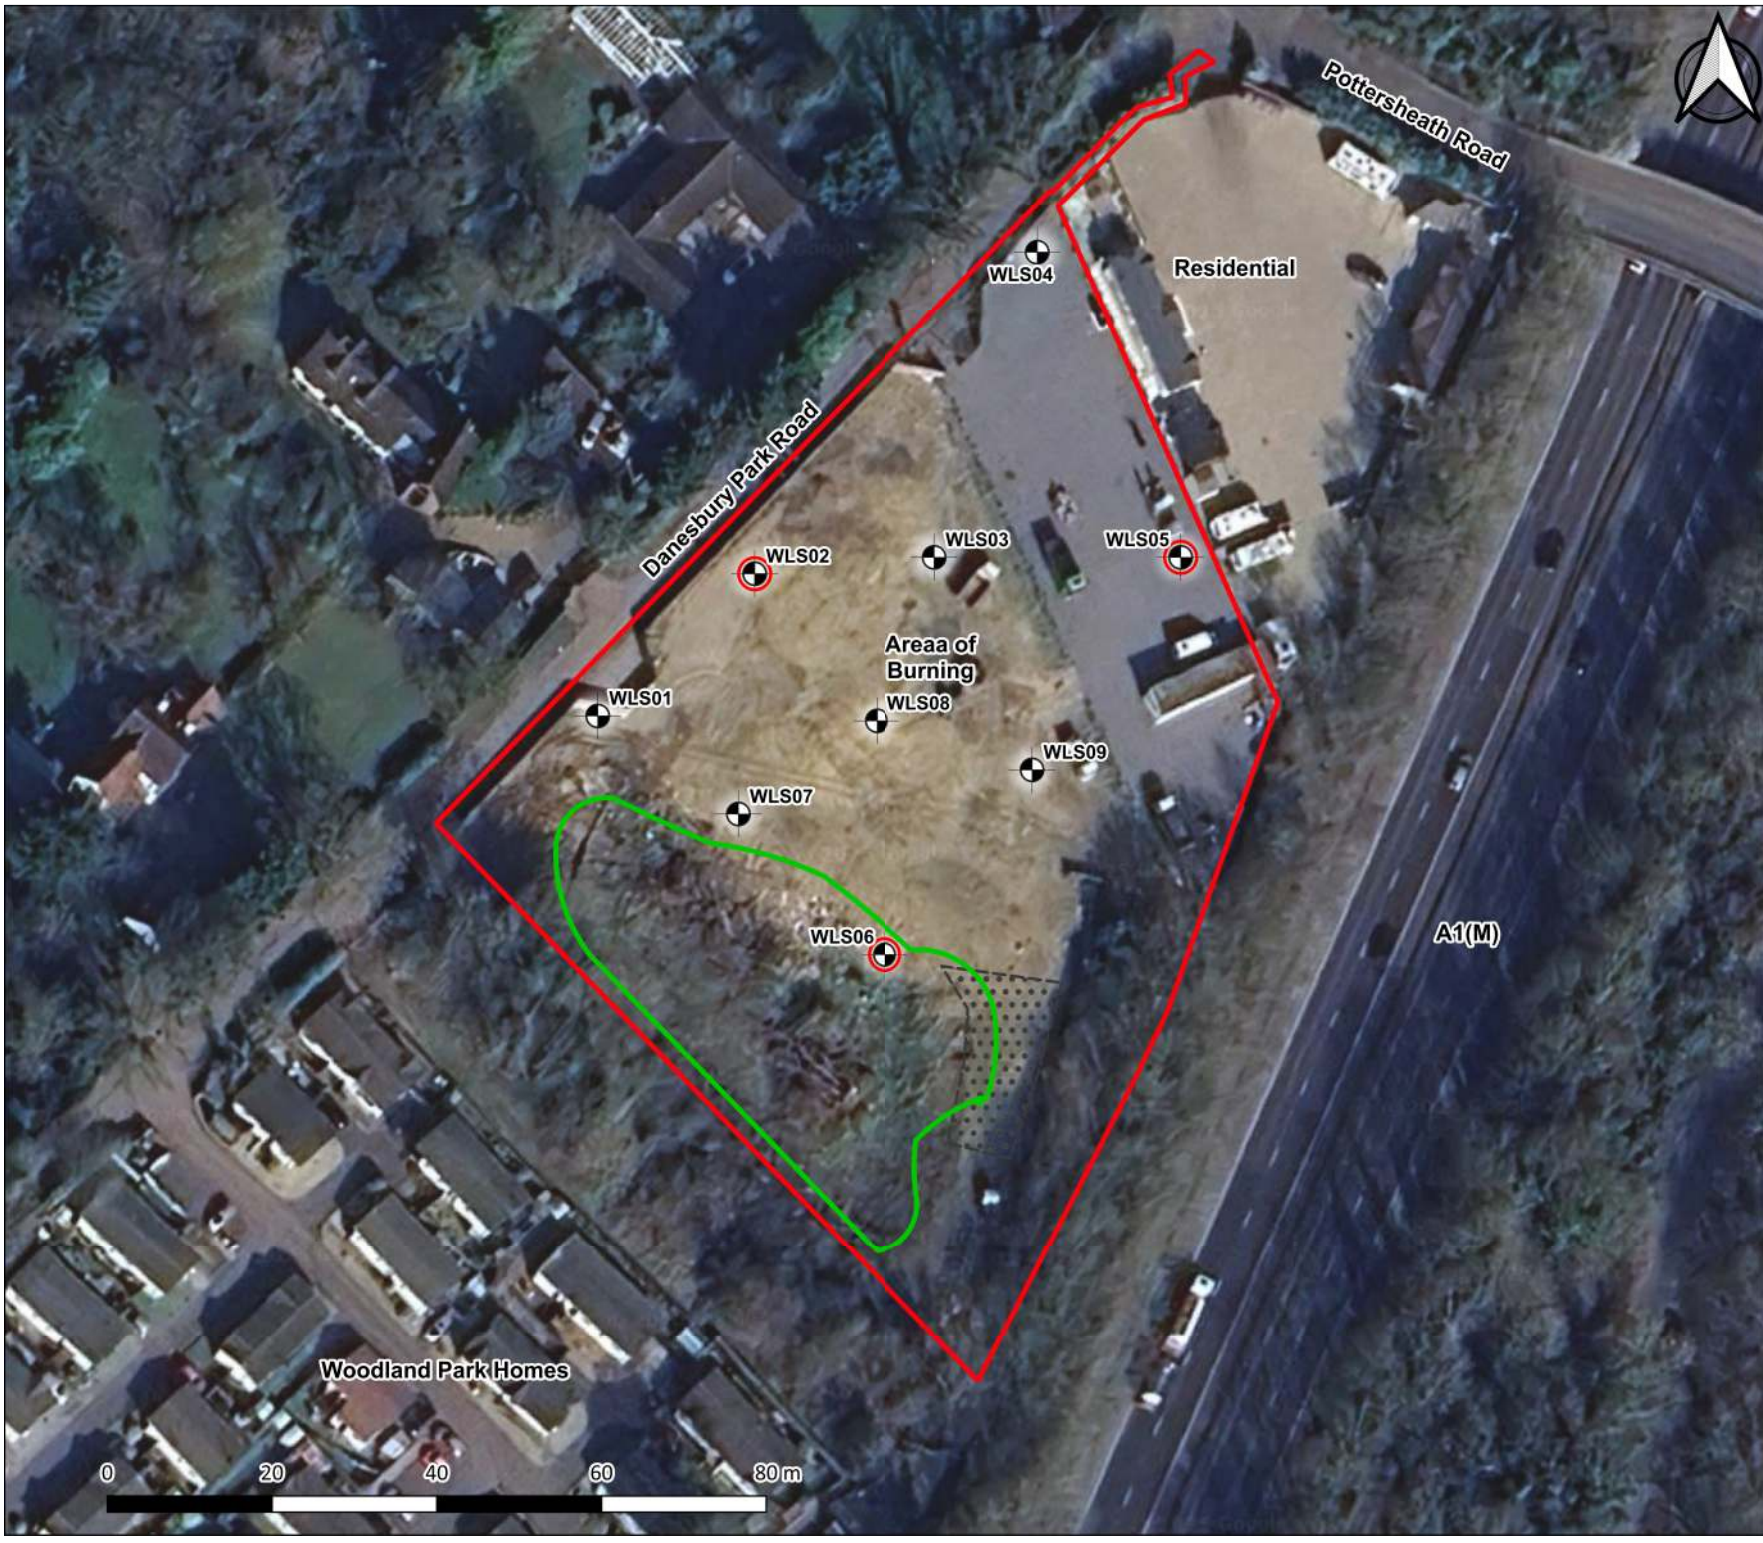
TITLE  
Exploratory Hole Location Plan

- Site Boundary
- Approximate Area/Zone of Quarry Pit, not backfilled, ~4m deep
- Building Rubble

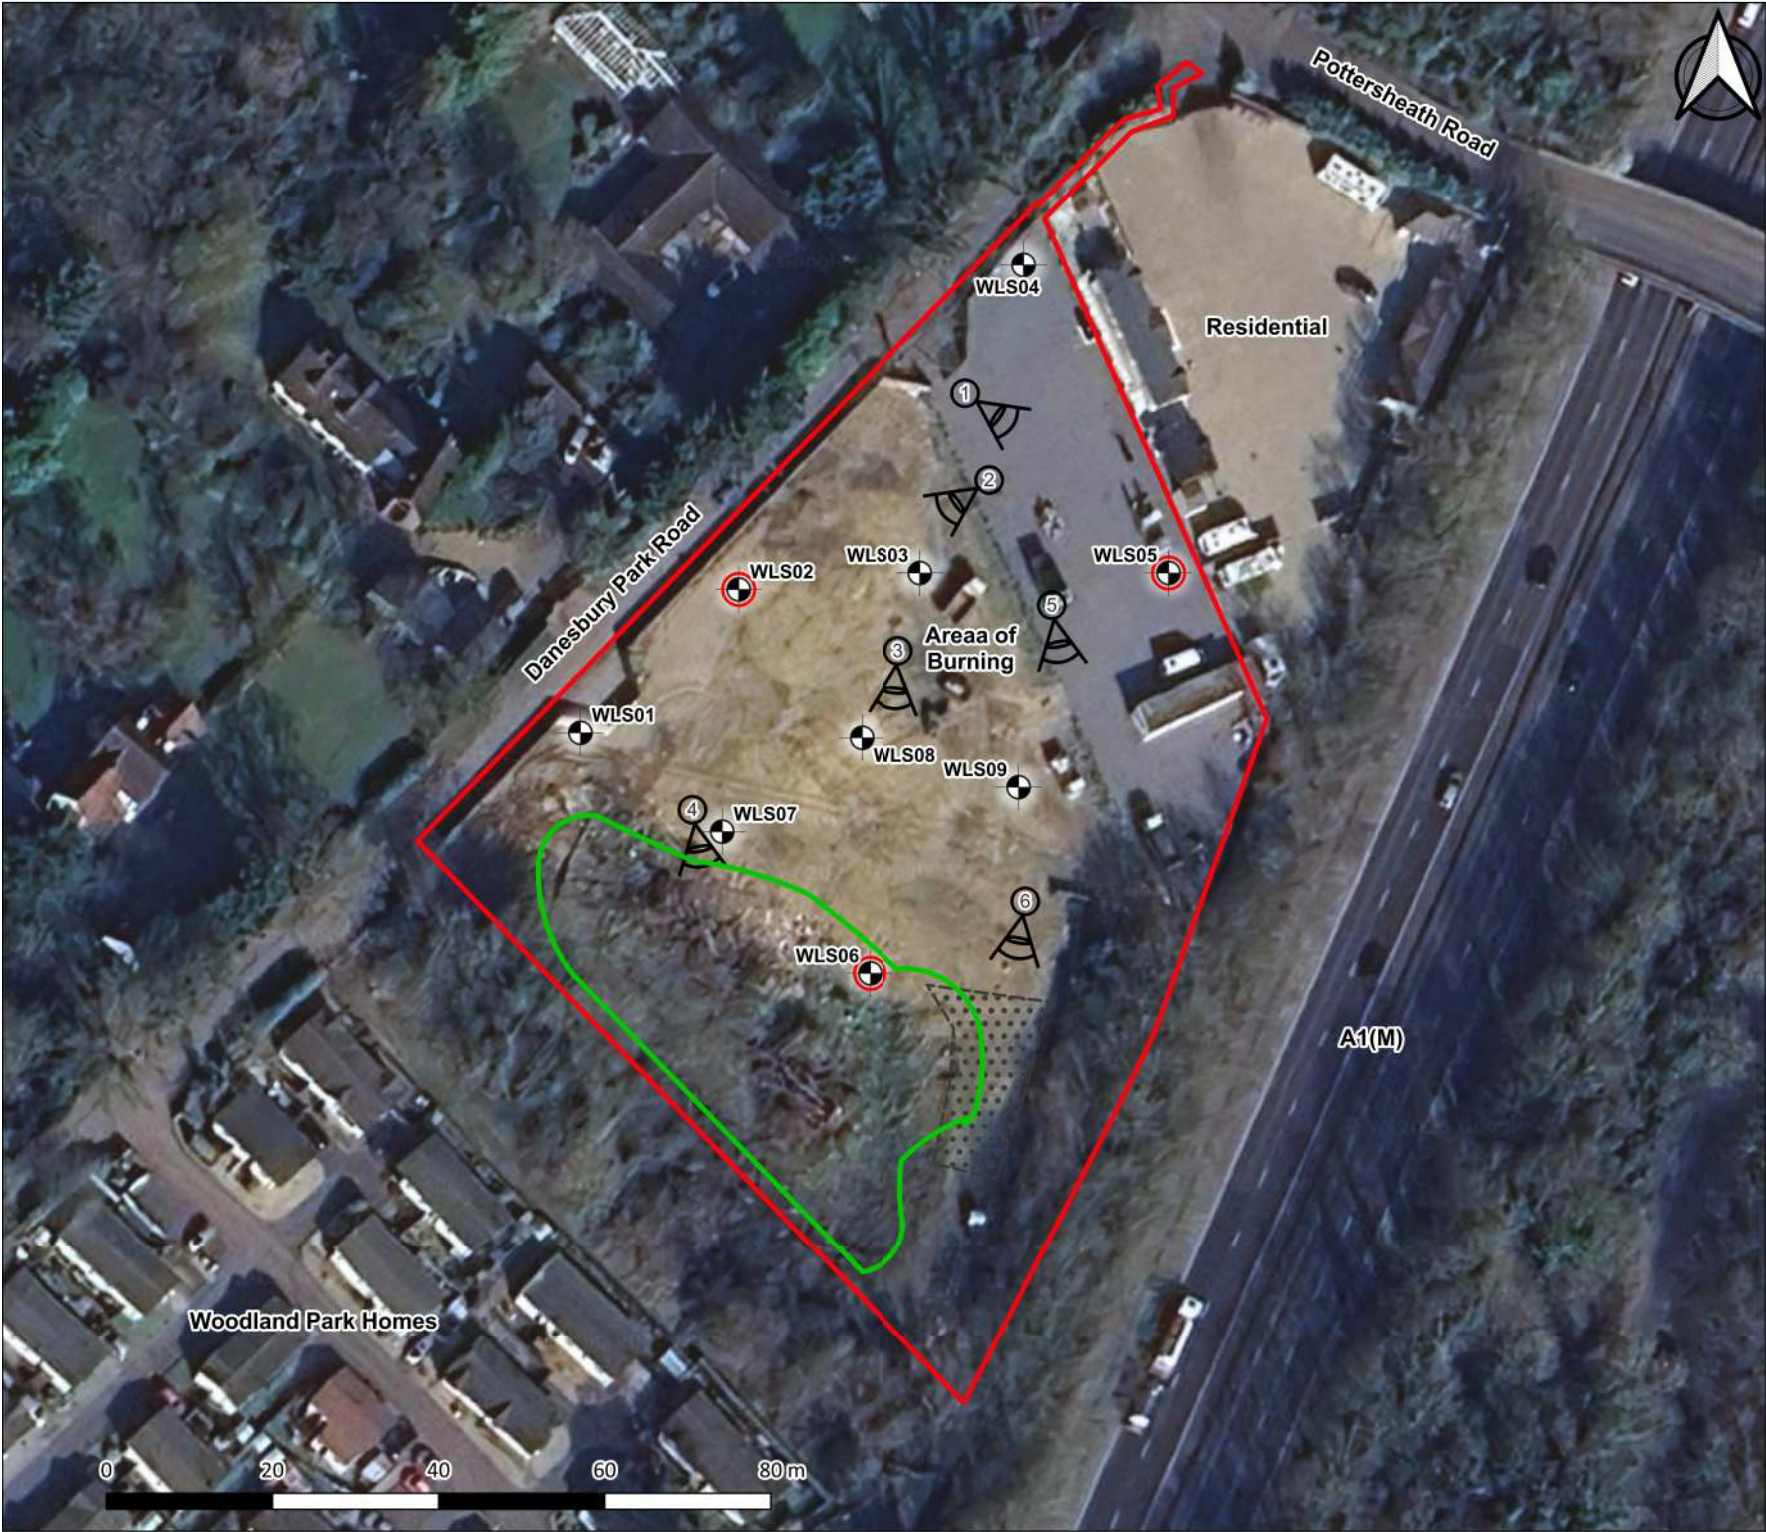
TITLE  
Photograph Location Plan

- Site Boundary
- Approximate Area/Zone of Quarry Pit, not backfilled, ~4m deep
- Site Photos
- Building Rubble
