**Re:** Slip End Farm, Slip End, Ashwell, SG7 6SL

On the instructions of James Northern, D Northern & Sons (client), MS Ecology (formerly Morgan & Stuckey Ecological Consultants) undertook a site walkover on 10 January 2025 to update the EcIA report J3172-1423 dated 12/08/2023.

**Site walkover results- 10/01/2025**

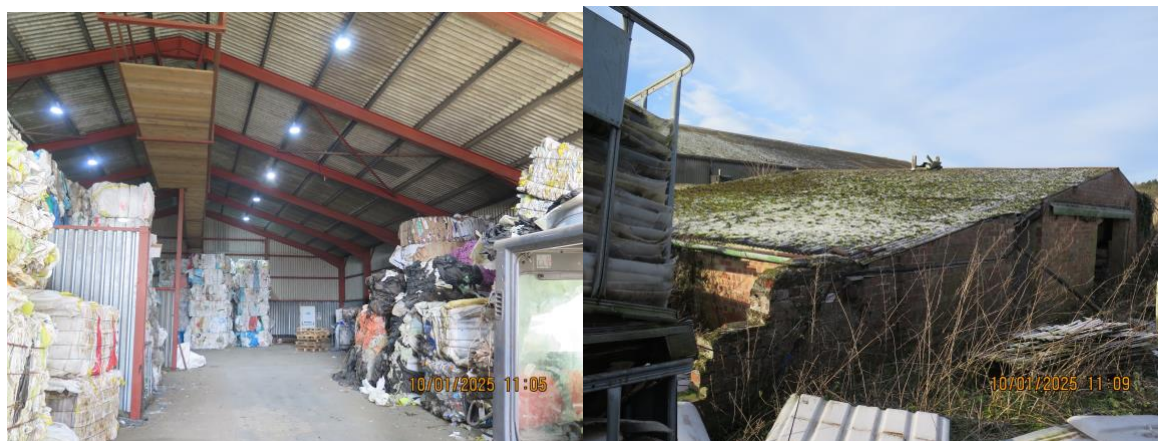
The first barn (B1) is a large modern barn with a pitched roof, built from a mixture of corrugated metal and asbestos type sheets and a large mechanically operated shutter which is closed at night. Inside, the barn is unlined and has large metal roof beams and is constantly in use with industrial activity (waste compaction).

B2 is a collection of old pigsties that have fallen into disrepair, built from brick with a pitched roof comprised of asbestos type sheets. Inside the lining was in poor condition.

Figure 1 Interior B1 and old pigsties B2

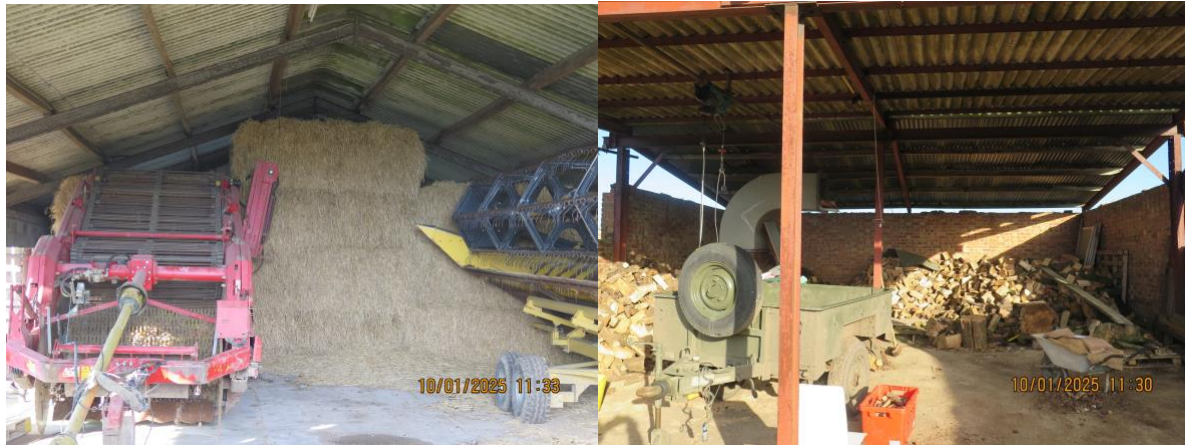
B3 is disused cattle shed with a large open front and partially open rear and side elevations. It is built from breeze block walls with a pitched roof comprised of asbestos type roofing sheets and it is unlined inside.

Lastly, B4 is an open pole barn, with partial brick walls and a shallow pitched roof comprised of asbestos type sheets

Figure 2 area at front of cattle shed and open sided pole barn

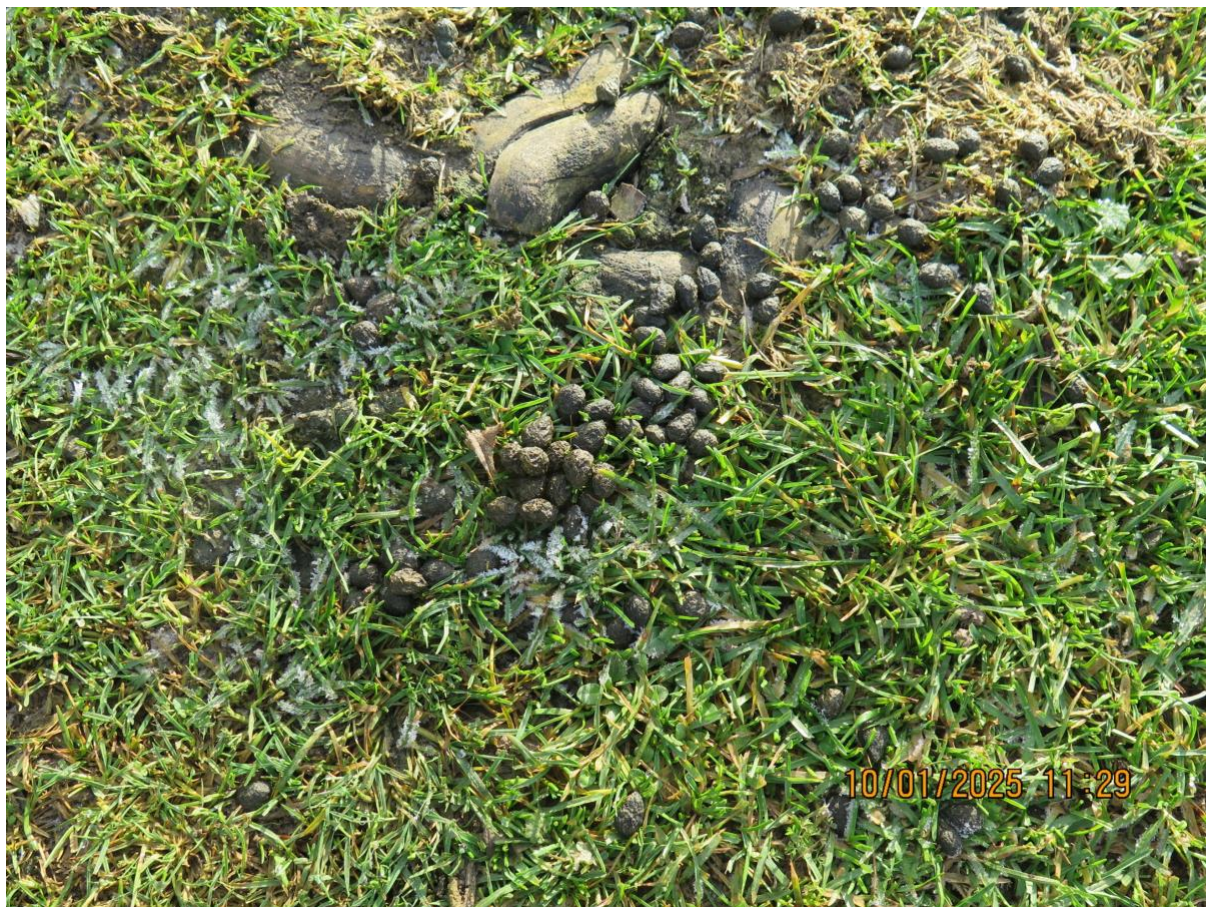
The north and north-eastern areas of the site are comprised of regularly mown grassland, part of which is currently used as a parking and storage area resulting in patches of bare ground, now also grazed by rabbits.

Figure 3 Grassland grazed by rabbits
