**Report prepared at**  
Land at Stevenage Road  
Hitchin  
SG4 7JY

**On behalf of**  
Bugler Homes Limited

**Report reference**  
25-268.01  
Version 2

| Report Quality Management | | | |
|---|---|---|---|
| <b>Project Title</b> | Preliminary Risk Assessment | | |

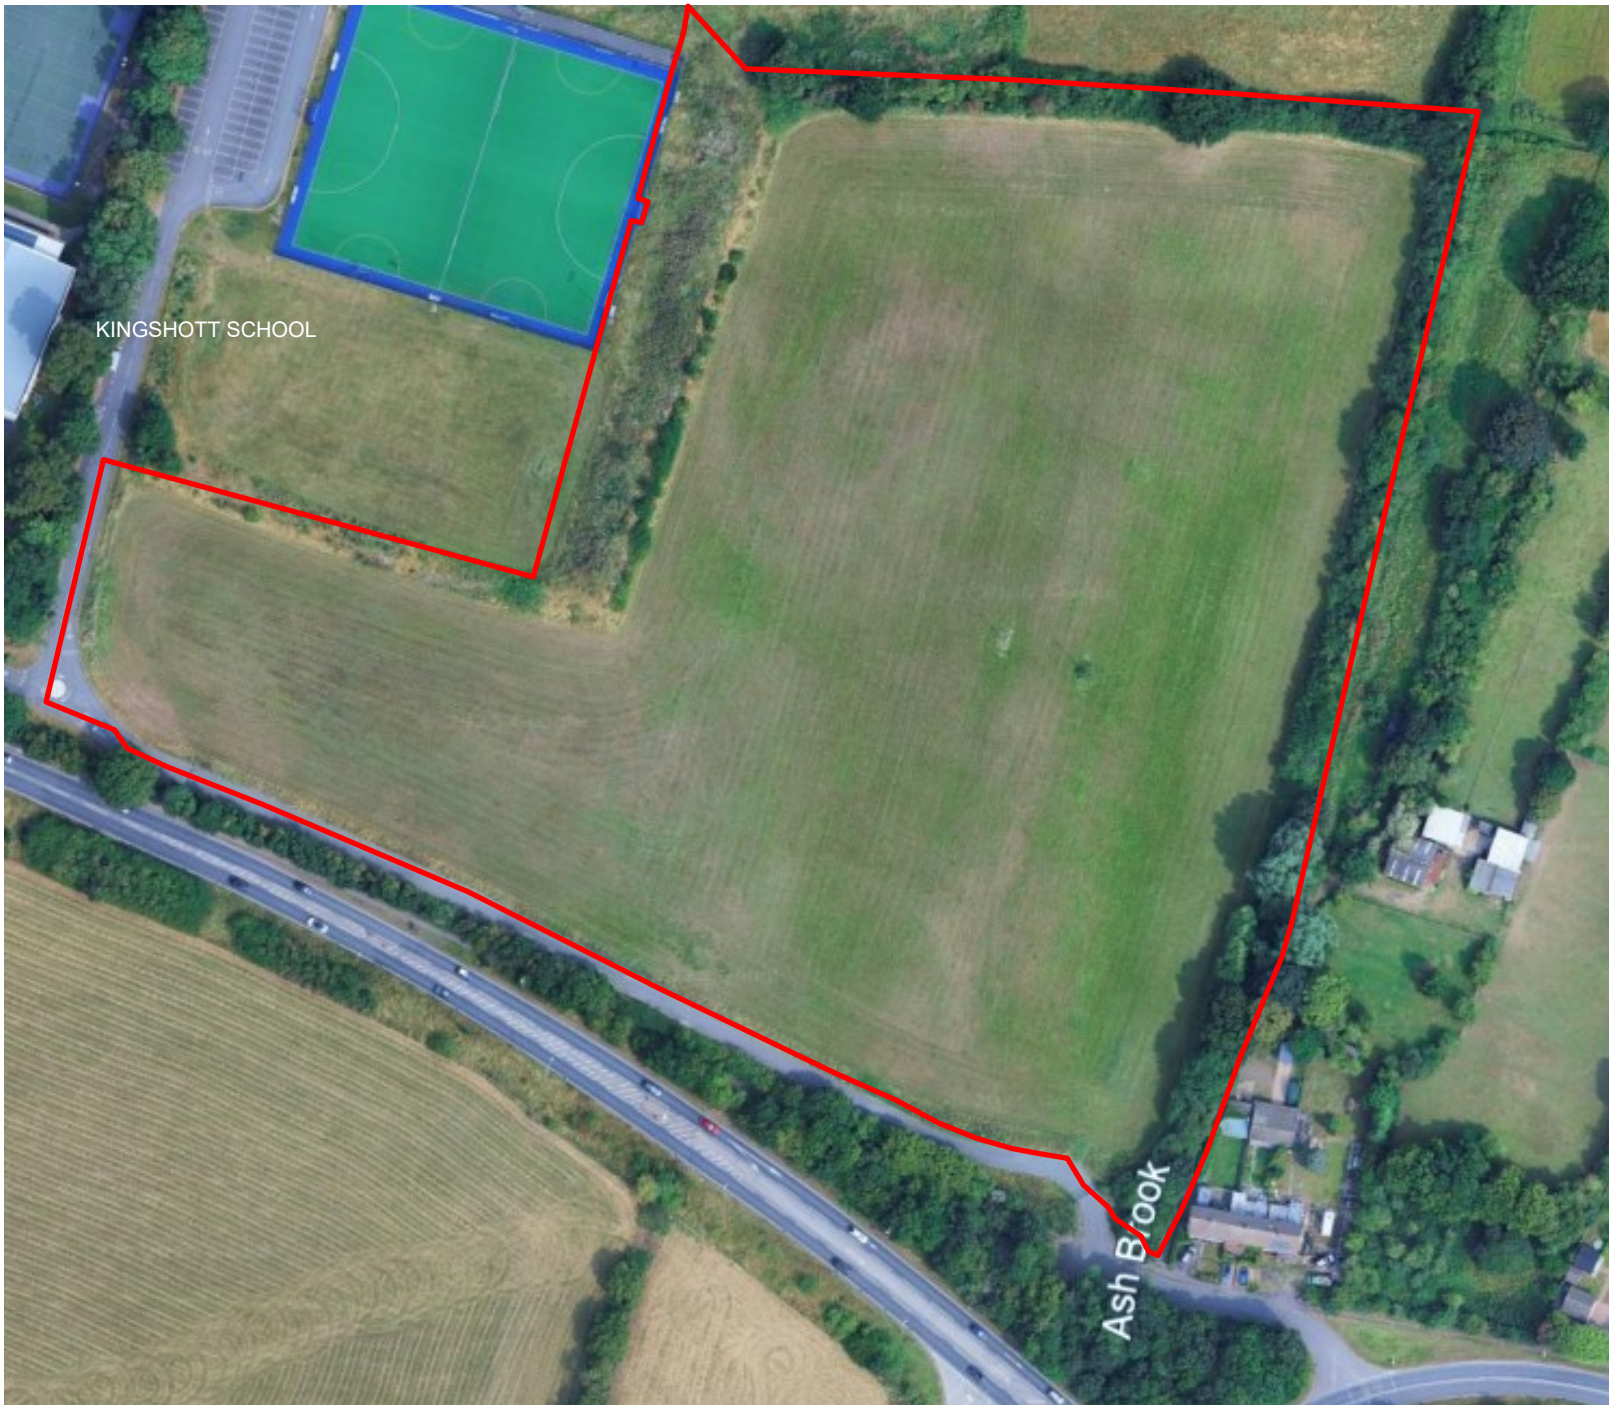
| Table 1.2: Site Details | |
|---|---|
| <b>Current Land Use</b> | The site currently comprises a large, grassed field.<br><br><b>Figures 2 and 3</b> are presented as the Existing Site Layout Plans, using an aerial view and topographical survey, showing the positions of the walkover photographs.<br><br><b>Figure 4</b> is presented as the Site Photographs. |

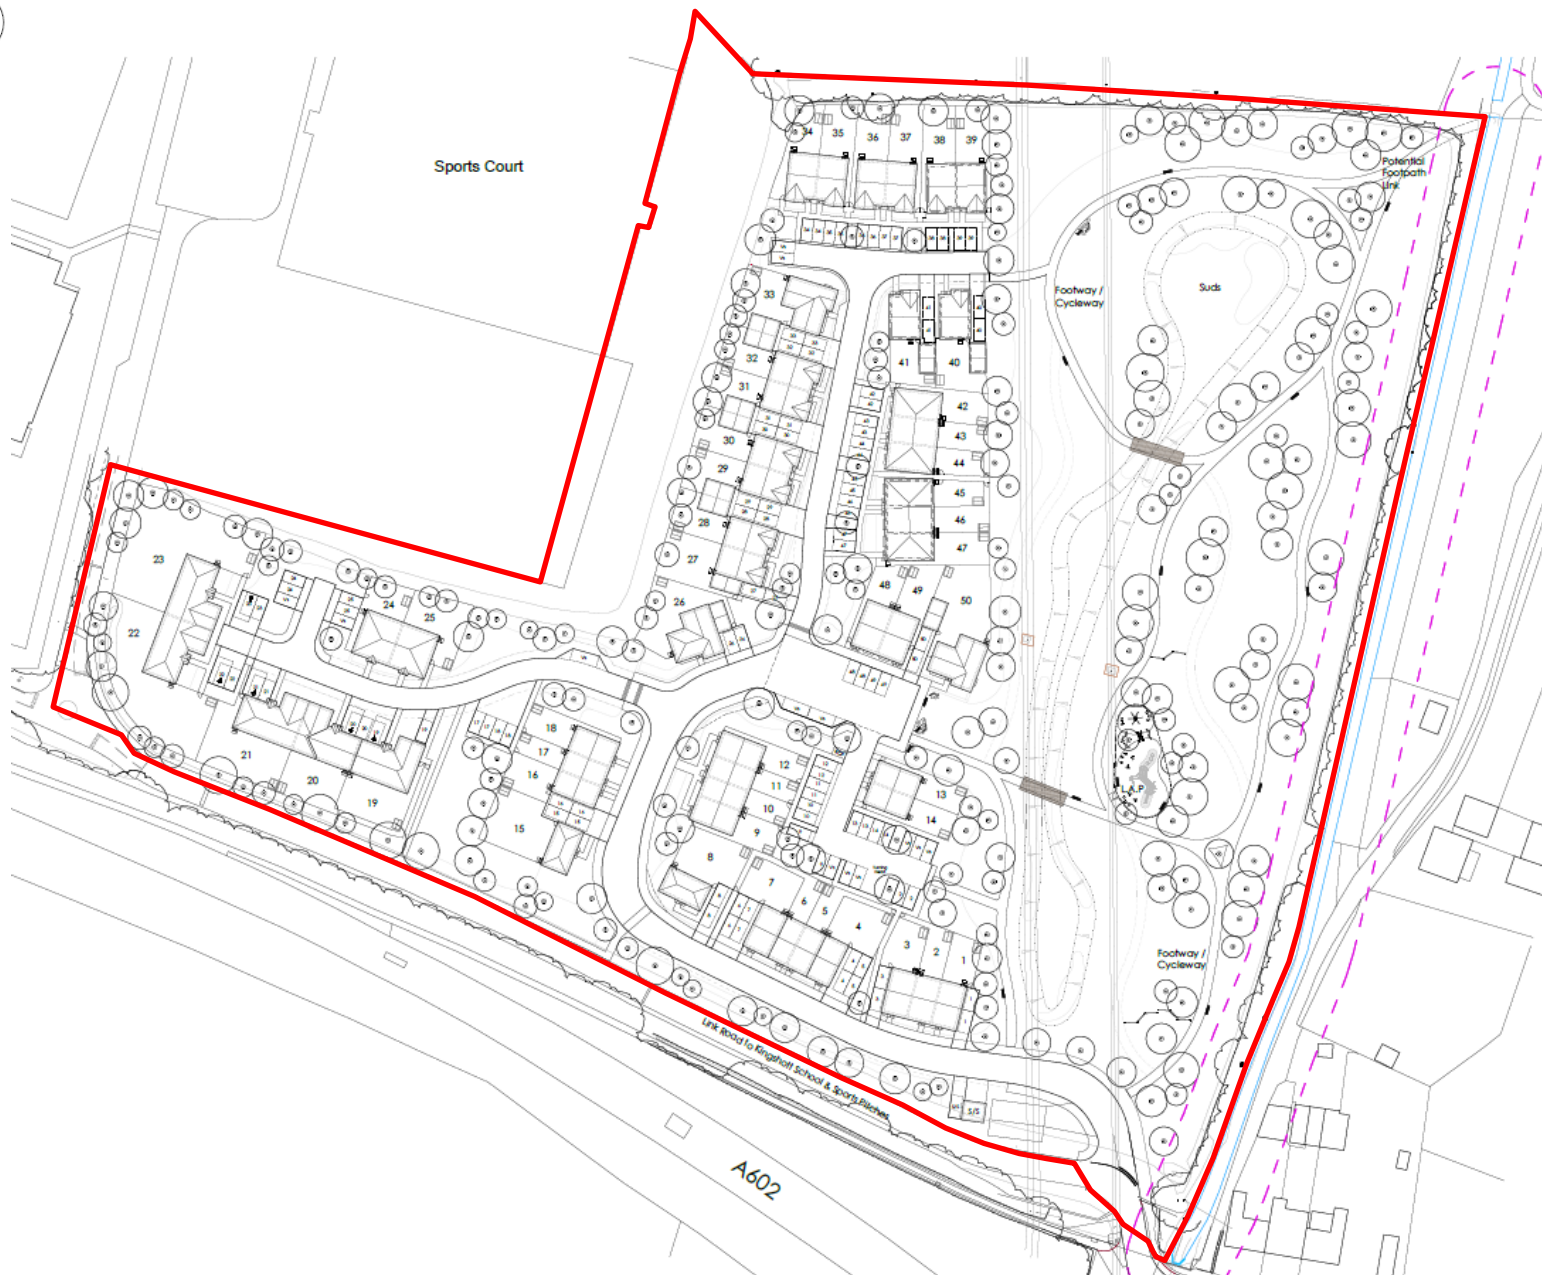
| Table 1.2: Site Details | |
|---|---|
| <b>Proposed Land Use</b> | The proposed scheme comprises the erection of 50no. residential dwellings (including affordable housing), new public open space, associated parking, landscaping and access.<br><br><b>Figure 5</b> is presented as the Proposed Development Plan. |
