**Barns at  
Porter's End Farm,  
Porter's End Lane,  
Kimpton,  
Hertfordshire.**

**Preliminary Roost Assessment**

August 2025

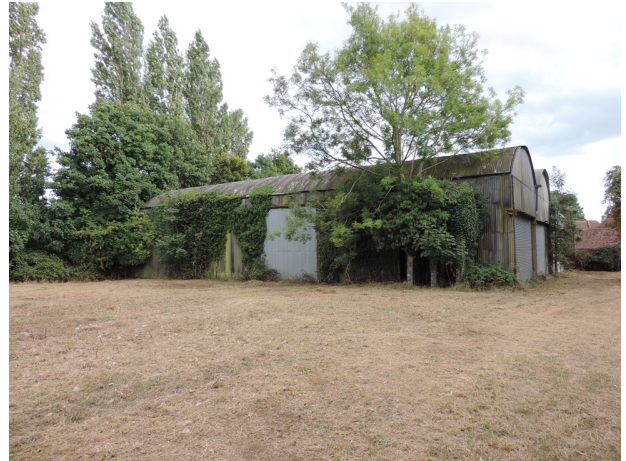
The larger of the two barns, this former agricultural building is of a simple metal framed construction, clad and roofed with unlined corrugated sheeting with two large shutter doors at its west end (see Photos 3 & 4.).

**Photo 3.** View of northern barn looking southeast.

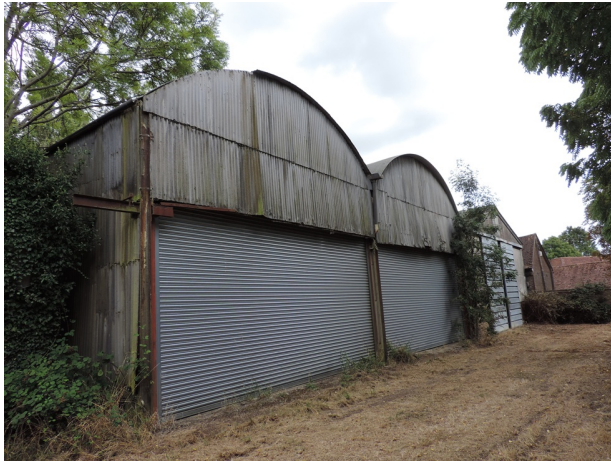
**Photo 4.** West end (front) of northern barn.

Gaps at the top of two shutter doors at the front.

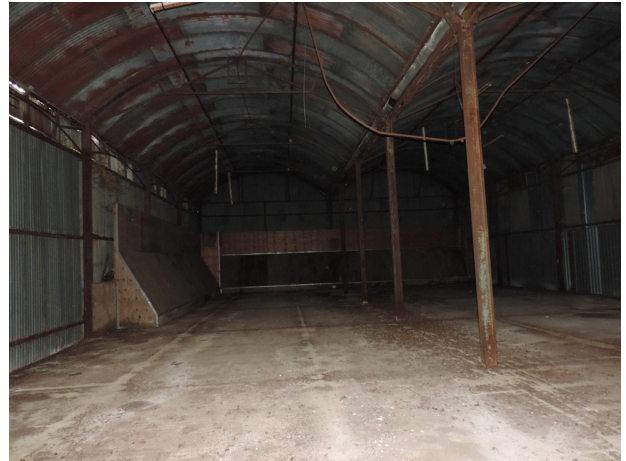
The building, which was empty at the time of the survey, encloses a single internal space, open to the roof on the inside with no enclosed spaces (see Photo 5.).

**Photo 5.** Interior of northern barn looking east.

During a thorough inspection inside the barn, no bats were found, and no evidence of bats or their roosting sites was identified.

No likely potential bat roosting sites were identified – the building was largely open and lacked suitable sheltered cavities in which bats may roost.

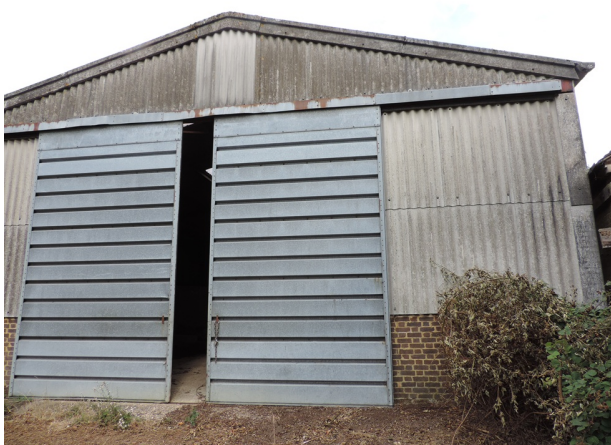
This barn is also of metal framed construction, clad and roofed with unlined corrugated sheeting. The building has large metal doors at its west end.

**Photo 6.** West end (front) of southern barn.

With the metal doors at the west end closed, no obvious potential bat access points were noted although it was considered likely that any gaps at the top of the west gable end would allow bats access.

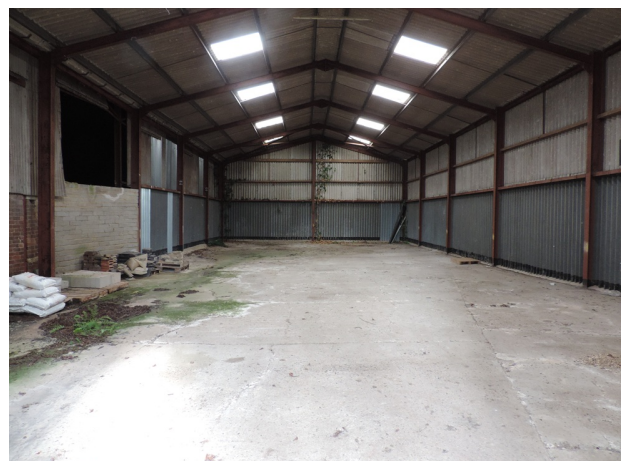
The roof of the building has a number of rooflights providing daylight illumination to the interior, which consists of a single internal space, open to the roof on the inside with no enclosed spaces.

Apart from a few stored items / materials the building was empty at the time of the survey (see Photos 6 & 7.).

**Photo 7.** Interior of southern barn looking east.

On the inside of the barn a large opening in the north wall of the building was noted (seen on the left in Photo 7.) – this leads directly into the adjacent northern barn and provides bats easy access directly from the interior of the northern barn.
