## Bat Emergence and Re-Entry Surveys (BERS)

Old Manor, Shaftenhoe End, Barley, Royston, Hertfordshire, SG8 8LE

This report is prepared to inform a planning application for the proposal described as: “Extension to the lodge, and internal renovations of the main house, to include skylights and reglazing of the western extension”

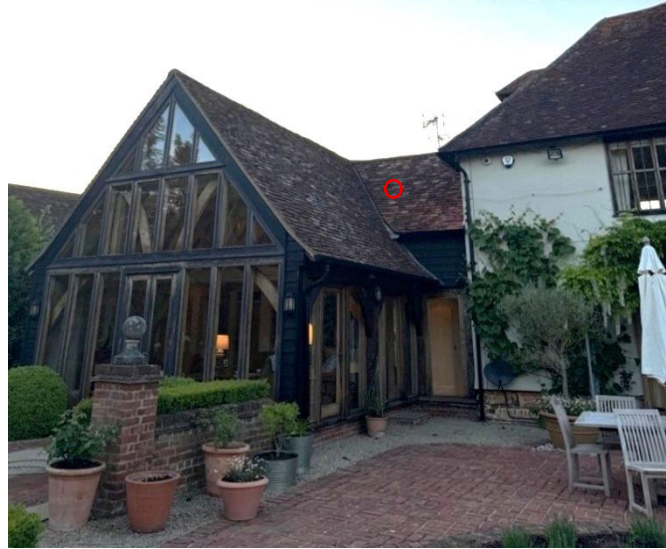
| Surveyor observations | | |
|---|---|---|
| Surveyor 1 | <p><b>Emergences observed - Yes</b></p> <p><b><u>Roost 1:</u></b></p> <p><b>Number:</b> 1</p> <p><b>Time:</b> emerged at 21:21</p> <p><b>Location of access point:</b> Tiles at join of extension to main property.</p> <p><b>Direction of travel on emergence:</b> Emerged and flew in a westerly direction</p> <p>Species ID confirmed on site as common pipistrelle.</p> <p>The first bat was a soprano pipistrelle, heard, at 21:09. Soprano and common pipistrelles were then heard passing continuously from 21:16 to 21:21.</p> <p>A pass east to west was observed from common pipistrelle at 21:22 and at 21:36.</p> <p>From 21:24 till 21:38, constant activity was observed from common pipistrelle, soprano pipistrelle and serotine, where they were foraging from the hedge line to the northeast. Constant activity from common pipistrelle occurred till the end of the survey at 22:17.</p> | <p>Emergence point of single Common pipistrelle (Red)</p> |

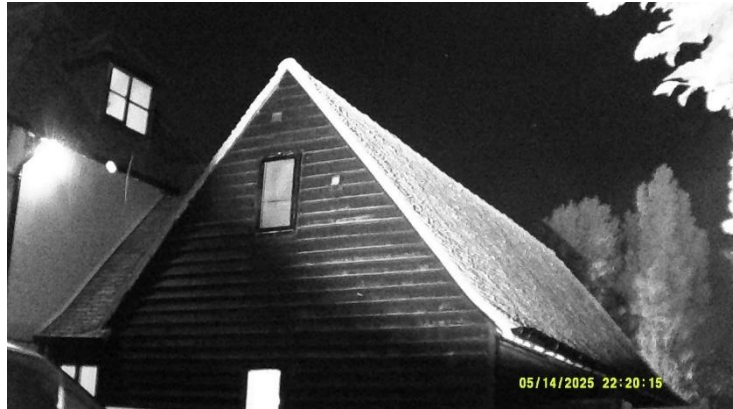
| <p><i>IR position 2</i><br/><i>IR nightfox whisker</i><br/><i>and XB5 Pro torch</i></p> | <p><b>Camera position:</b> Observing northwest elevation of the western extension of B1.</p> <p>A full review of the IR footage did not reveal any additional bat activity.</p> | |

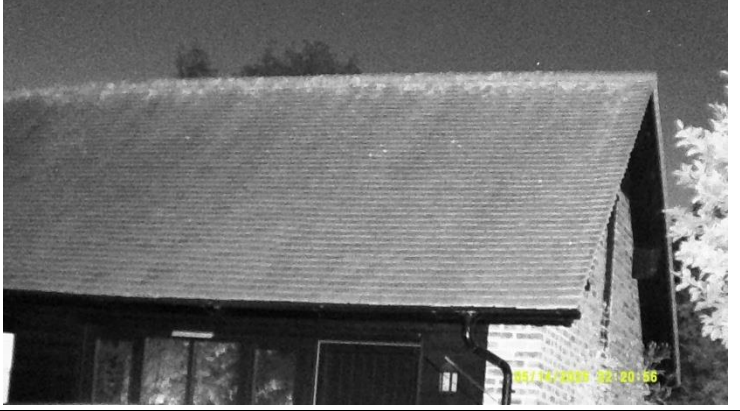
| <p><i>IR position 3</i><br/> <i>IR nightfox whisker</i><br/> <i>and XB5 Pro torch</i></p> | <p><b>Camera position:</b> Observing southeast elevation of B2.</p> <p>A full review of the IR footage did not reveal any additional bat activity.</p> | |

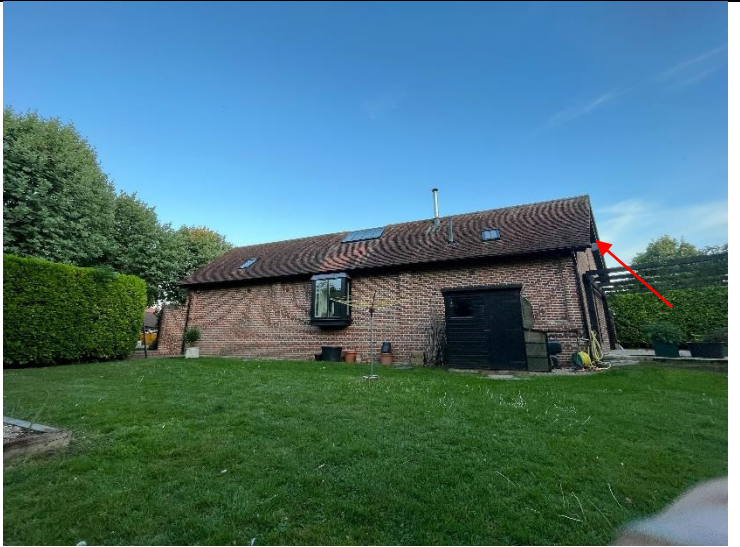
| <p><i>Surveyor 4</i></p> | <p><b>Emergences observed - Yes</b><br/> <b><u>Roost 2: Soprano pipistrelle day roost</u></b><br/> <b>Number:</b> 3<br/> <b>Times:</b> 3 consecutive emergences at 21:08.<br/> <b>Location of access point:</b> Under the wooden cladding on the western elevation of B2.<br/> <b>Directions of travel on emergence:</b> All individuals emerged and flew in a northerly direction.<br/> Species ID confirmed on site as Soprano pipistrelle</p> <p>A soprano pipistrelle passed from east to west alongside the building at 21:10. Foraging activity of soprano pipistrelles was then observed in the garden adjacent to B2 between 21:12 and 21:16, and 21:40 (2 individuals). Common pipistrelle foraging activity was seen continuously between 21:19 and 21:43, and between 21:56 and 22:01.<br/> A noctule passed from south to west at 22:12.</p> | <p>Soprano pipistrelle emergence point (Red arrow)</p> |

| | 2 | The roost will be disturbed when the extension is created on the northern extension of B2. According to current proposed plans, access to the roost would be maintained. |

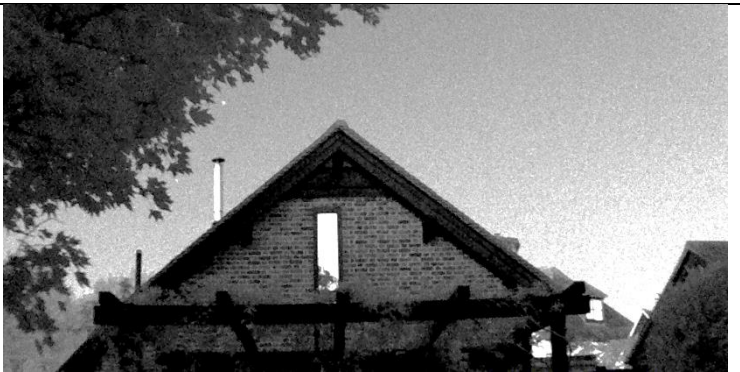
| <p><i>IR position 5</i><br/> <i>IR nightfox whisker</i><br/> <i>and XB5 Pro torch</i></p> | <p><b>Camera position:</b> Observing west elevation of B2.</p> <p><b>Emergences observed: Yes</b></p> <p><b><u>Roost 2:</u></b></p> <p><b>Number:</b> 3</p> <p><b>Times:</b> Three consecutive emergences at 21:08.</p> <p><b>Location of access points:</b> From under the wooden cladding on the western elevation of B2.</p> <p><b>Directions of travel on emergence:</b> All individuals emerged and flew in a northerly direction.</p> <p>Species ID confirmed on site as soprano pipistrelle. Surveyor 4 observed the emergence.</p> <p>No additional bat activity was observed.</p> | |

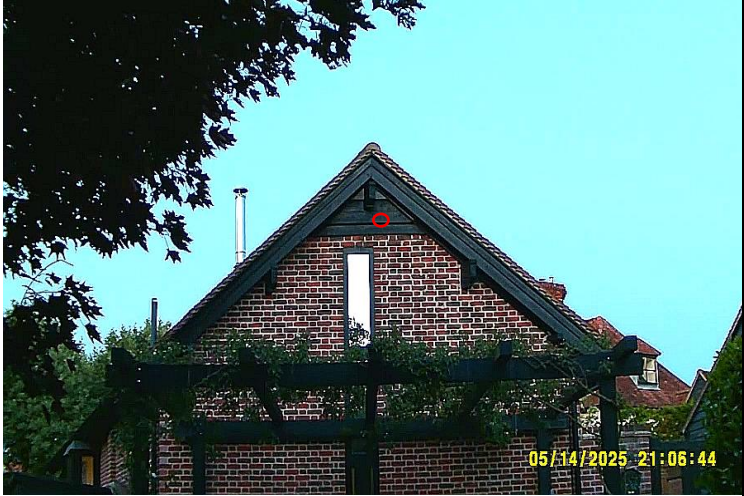
| | | <p data-bbox="1308 667 2049 703">Soprano pipistrelle emergence point (Red)</p> |

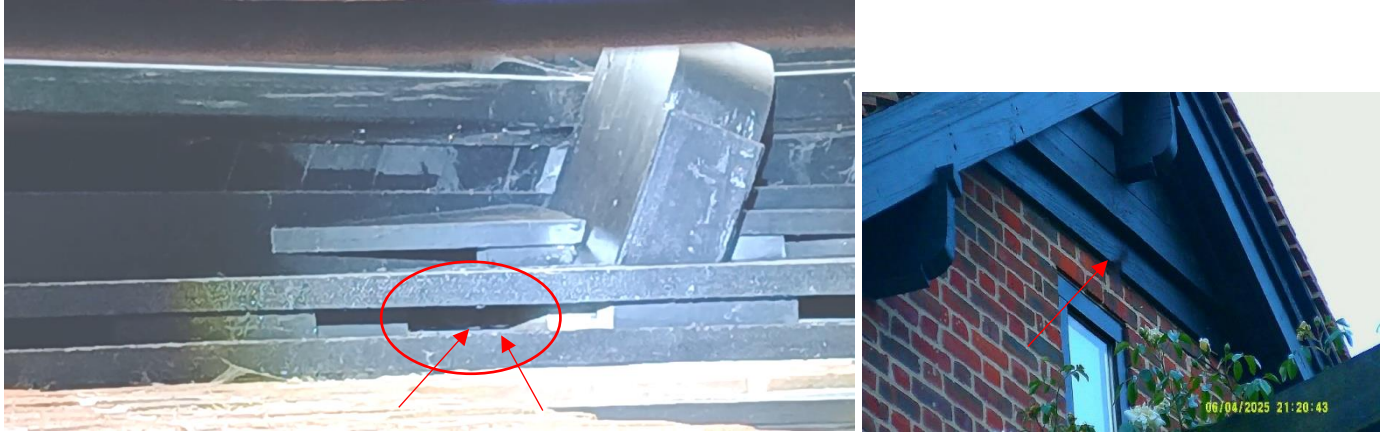
| Field Survey | | | | | |
|---|---|---|---|---|---|
| Building inspection prior to survey | <p>Carly Preen, Bat License 2024-12326-CL17-BAT carried out a torch inspection under the wooden cladding on the western gable end of B2. Two bats were seen in-situ under the second panel from the ground, confirming previous roost observations.</p> | | | | |
| | <p>Bats in-situ, under the wooden cladding</p> | | | | |

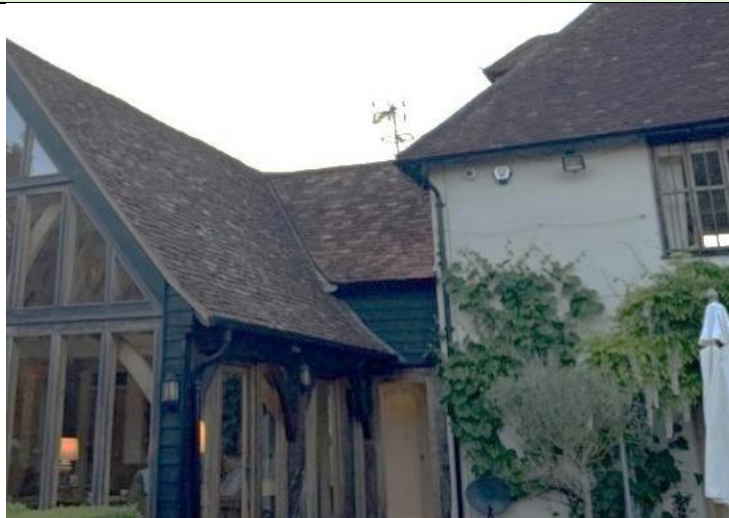
| Results | | | | | | |
|---|---|---|---|---|---|---|
| Surveyor 1 | | <b>No emergencies observed.</b><br><br>The first recorded activity was a common pipistrelle at 21:37. It travelled south over the ridge of B1 and into the garden to the south. This flight path was observed again at 21:38 and 21:42 by 2 common pipistrelles<br>Other bats during the survey were heard passing, including a noctule at 21:45, a barbastelle at 22:17, brown long eared bat at 22:19 and 22:22 and a myotis identified as Daubenton's at 22:37. The final bat was heard at 22:42.<br><br>No further activity. | | | | |

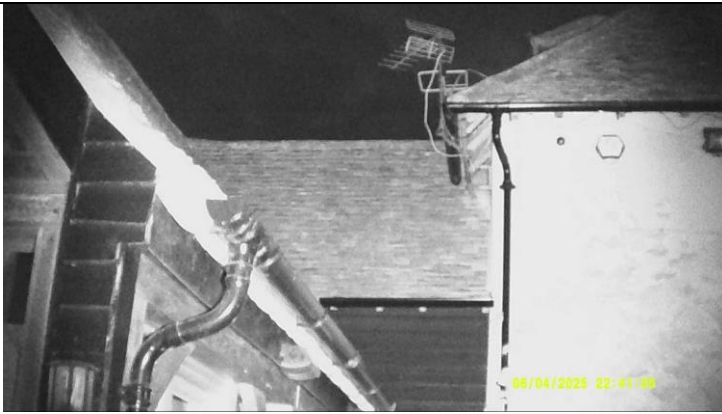
| <p><i>IR position 1</i><br/> <i>IR nightfox whisker</i><br/> <i>and XB5 Pro torch</i></p> | <p><b>Camera position:</b> Observing southeast elevation of B1</p> <p>A full review of the IR footage did not reveal any additional bat activity.</p> | |

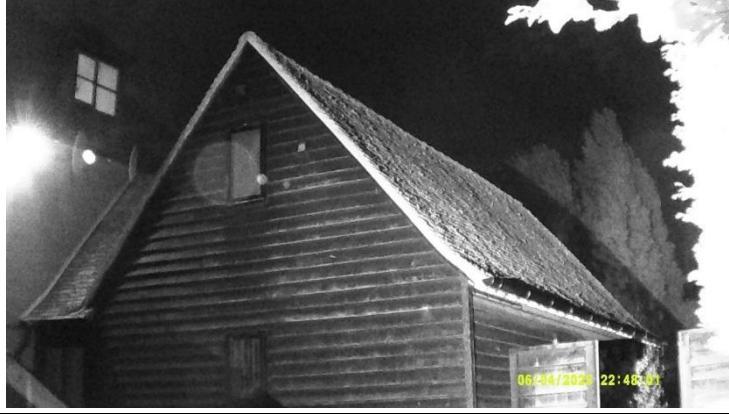
| <p><i>IR position 2</i><br/><i>IR nightfox whisker</i><br/><i>and XB5 Pro torch</i></p> | <p><b>Camera position:</b> Observing northwest elevation of B1 extension.</p> <p>A full review of the IR footage did not reveal any additional bat activity.</p> | |

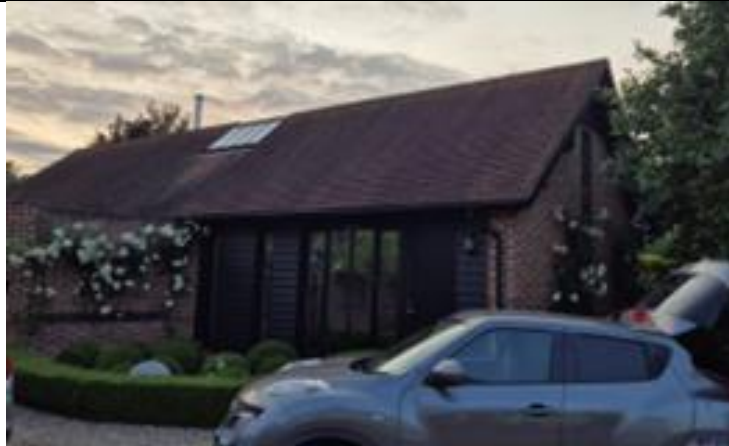
| <p><i>Surveyor 3</i></p> | <p><b>No emergencies observed.</b></p> <p>The first activity was a common pipistrelle, heard at 21:35. A further 15 common pipistrelle passes, were heard between 21:38 and 22:47.</p> <p>The first sighting was a common pipistrelle observed at 21:45, flying along a clockwise route to the south of B2. Another sighting followed at 21:46 of a common pipistrelle passing south to east, to the south of B2. Common pipistrelles were observed foraging on a north-south corridor to the south of B2 between 22:02 and 22:29.</p> <p>There were two <i>Myotis</i> sp, identified as Daubenton's bats, heard passing at 22:33 and another at 22:37. The latter was much fainter.</p> <p>No further activity.</p> | |

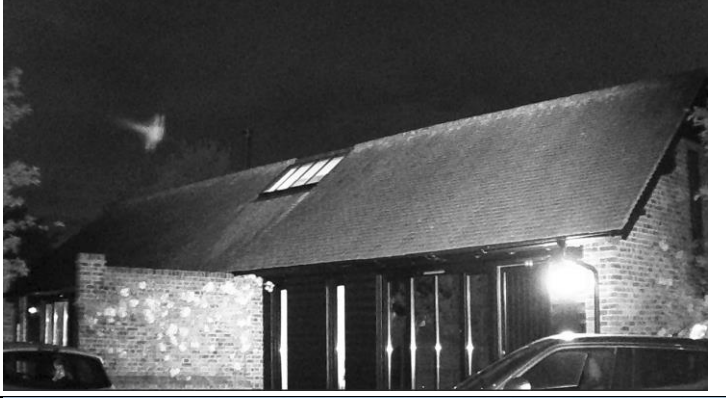
| <p><i>IR position 3</i><br/> <i>IR nightfox whisker</i><br/> <i>and XB5 Pro torch</i></p> | <p><b>Camera position:</b> Observing southeast elevation of B2.</p> <p>A full review of the IR footage did not reveal any additional bat activity.</p> | |

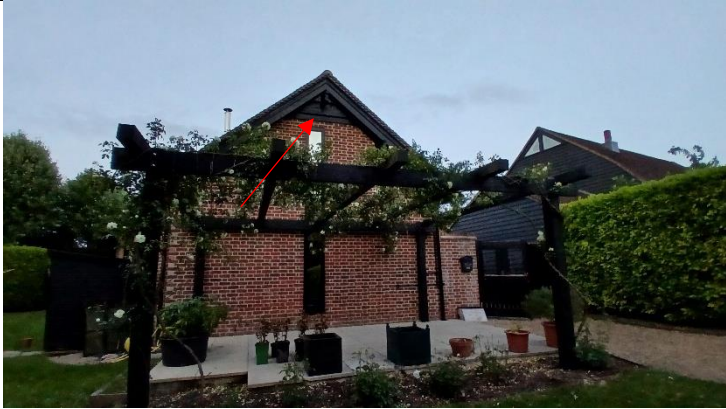
| <p><i>Surveyor 4</i></p> | <p><b>Emergences observed - Yes</b></p> <p><b><u>Roost 2:</u></b></p> <p><b>Number:</b> 3</p> <p><b>Times:</b> Two consecutive emergences at 21:20, and a third at 21:36.</p> <p><b>Location of access points:</b> Under the wooden cladding on the western elevation of B2.</p> <p><b>Directions of travel on emergence:</b> All individuals emerged and flew in a northerly direction.</p> <p>Species ID confirmed on site as soprano pipistrelle.</p> | <p>Soprano pipistrelle emergence point</p> |

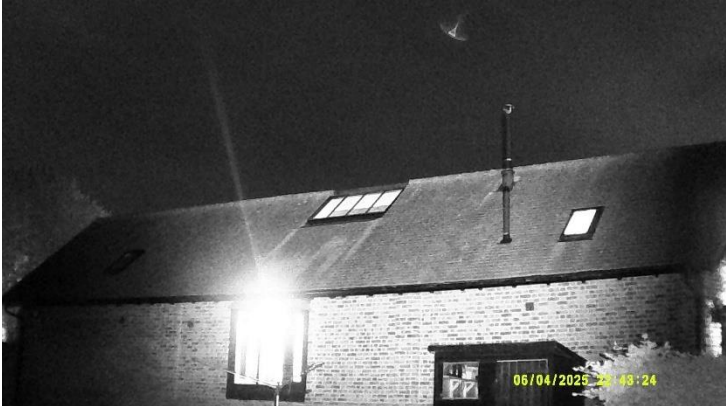
| <p><i>IR position 4</i><br/> <i>IR nightfox whisker</i><br/> <i>and XB5 Pro torch</i></p> | <p><b>Camera position:</b> Observing north elevation of B2.</p> <p>A full review of the IR footage did not reveal any additional bat activity.</p> | |

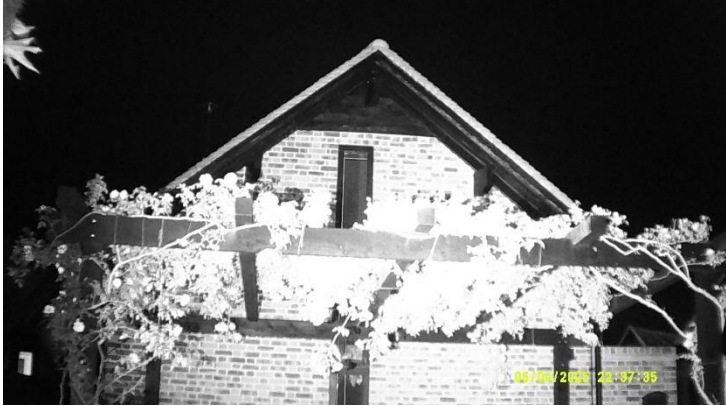
| <p><i>IR position 5</i><br/> <i>IR nightfox whisker</i><br/> <i>and XB5 Pro torch</i></p> | <p>Camera position: Observing west elevation of B2.</p> <p><b>Emergences observed:</b><br/> <b><u>Roost 2:</u></b><br/> <b>Times:</b> Two consecutive emergences at 21:20, and a third at 21:36.<br/> <b>Location of access points:</b> From under the wooden cladding at the western elevation of B2.<br/> <b>Directions of travel on emergence:</b> All individuals emerged and flew in a northerly direction.<br/> Species ID confirmed on site as soprano pipistrelle.<br/> Surveyor 4 observed the emergence.</p> <p>Foraging activity was observed in front of and above the elevation intermittently from 21:24 to 22:22.</p> | |

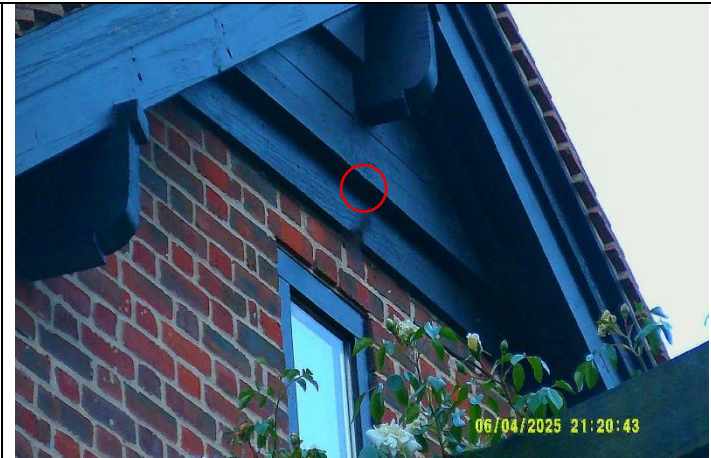
Emergence point 2 soprano pipistrelles from roost 2.

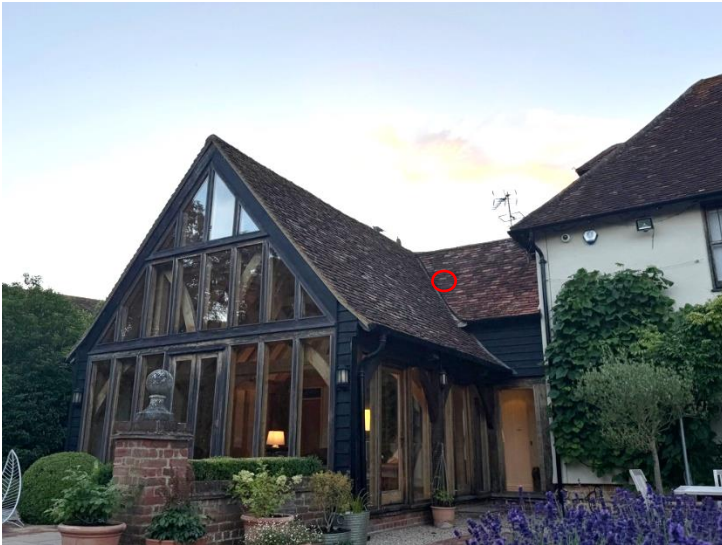
| Results | | | | | | |
|---|---|---|---|---|---|---|
| Surveyor 1 | | <p><b>Emergences observed -</b></p> <p><b><u>Roost 1:</u></b></p> <p><b>Number:</b> 1</p> <p><b>Time:</b> emerged at 21:57</p> <p><b>Location of access point:</b> Tiles at join of western extension to main building B1.</p> <p><b>Direction of travel on emergence:</b> Emerged and flew in a westerly direction.</p> <p>Species ID confirmed on site as common pipistrelle.</p> <p>The first activity was a common pipistrelle commuting northeast to southwest at 21:52. Common and soprano pipistrelles were observed commuting along this route throughout the night.</p> <p>At 22:34 a brown long-eared bat was observed flying from the garden over the building.</p> | | | <p>Emergence point of Common pipistrelle (Red)</p> | |

| | At 22:47 a bat thought to be a Nathusius's' pipistrelle passed from the garden, south to north, to the west of B1. Activity concluded with a final pass by a common pipistrelle at 23:02. | |

| | 1 | The roost will be damaged by the proposed skylight installation on the B1 western extension. |

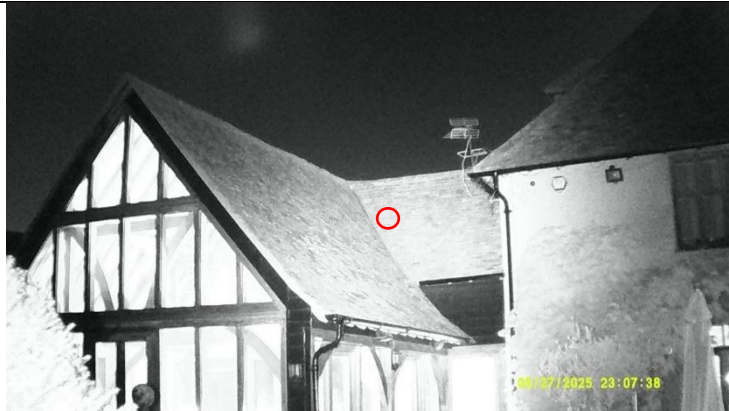
| <i>IR position 1</i><br><i>IR nightfox whisker</i><br><i>and XB5 Pro torch</i> | <p><b>Camera position:</b> observing southeast elevation of B1</p> <p><b>Emergences observed- Yes</b></p> <p><b><u>Roost 1:</u></b></p> <p><b>Number:</b> 1</p> <p><b>Time:</b> emerged at 21:57</p> <p><b>Location of access point:</b> Tiles at join of western extension to main building B1.</p> <p><b>Direction(s) of travel on emergence:</b> A single Common pipistrelle emerged and flew in a westerly direction. Species ID confirmed on site as common pipistrelle. Surveyor 1 observed the emergences.</p> <p>No additional observations were made.</p> | <p>Emergence point of Common pipistrelle (red) from roost 1.</p> |

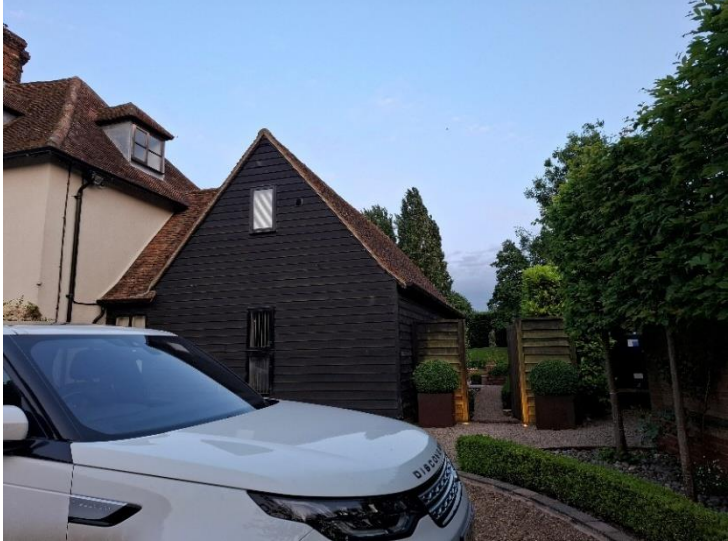
| <p><i>Surveyor 2</i></p> | <p><b>No emergencies observed.</b></p> <p>The first recorded activity was a common pipistrelle seen commuting from north to south over the B1 ridgeline at 21:54. Common pipistrelles were then seen on 11 occasions continuously commuting on an east-west corridor alongside B1 between 21:55 and 22:54. A further 9 common pipistrelle passes, were heard between 22:40 and 23:04.</p> <p>Two soprano pipistrelles passed, one observed at 21:57 commuting on an east-west corridor along B1. The second was heard passing.</p> <p>Two brown long eared bats were recorded passing east to west alongside the building at 22:39.</p> <p>No further activity.</p> | |

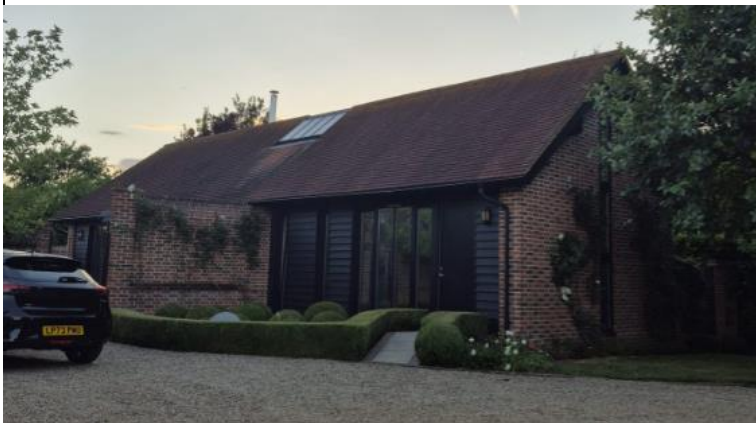
| B2 | | |
|---|---|---|
| Surveyor 3 | <p><b>No emergencies observed.</b></p> <p>The first recorded activity occurred at 21:54, in which a common pipistrelle was seen passing east to west behind Position 3.</p> <p>This was followed by two common pipistrelles seen travelling north to south between a gap between the tree and B2 at 22:55. Common pipistrelles were then seen foraging consistently along this route between 22:01 and 22:12. Common pipistrelles were observed foraging north-east to south-west in front of the elevation at 22:14.</p> <p>A common pipistrelle was observed foraging in front of the southern elevation of B2 between 22:24 and 22:26. Common pipistrelles were heard social calling between 22:21 and 23:05, with 2 individuals heard.</p> <p>A brown long-eared bat was heard passing at 22:38.</p> <p>No further activity.</p> | |

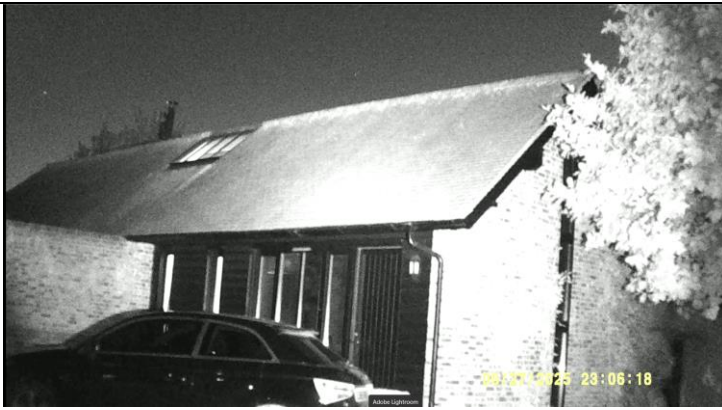
| <p><i>IR position 3</i><br/> <i>IR nightfox whisker</i><br/> <i>and XB5 Pro torch</i></p> | <p><b>Camera position:</b> Observing southeast elevation of B2.</p> <p>A full review of the IR footage did not reveal any additional bat activity.</p> | |

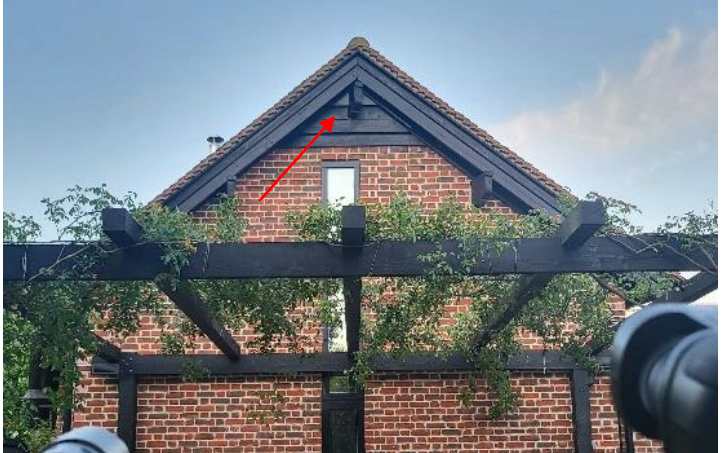
| <p><i>Surveyor 4</i></p> | <p><b>Emergences observed - Yes</b></p> <p><b><u>Roost 3:</u></b><br/> <b>Number:</b> 10<br/> <b>Times:</b> Emergences occurred between 21:32 and 21:41.<br/> <b>Location of access points:</b> Underneath wooden cladding on the western elevation of B2.<br/> <b>Directions of travel on emergence:</b> All individuals emerged and flew in a northerly direction.<br/> Species ID confirmed on site as common pipistrelles.</p> <p>Continual emergence and re-entry of common pipistrelles was observed between 21:32 and 22:12 under the top and second panels of the wooden cladding on the western elevation of B2. Due to a return behaviour beginning at 21:42, emergence numbers became more difficult to record after this point. Upon emergence, the pipistrelles continued to forage around B2 and B1 during this time.</p> | <p>Emergence point of Common pipistrelle</p> |

| | <p>Return behaviour was then noted again between 22:46 to 23:01.</p> <p>A Nathusius's' pipistrelle was heard passing at 22:16, followed by a leisler's noctule at 22:19.</p> <p>A brown long-eared bat pass, was heard at 22:33.</p> <p>A barbastelle pass was heard at 22:53 and 22:57.</p> <p>No further activity.</p> | |

| | 3 | The roost will be disturbed when the extension is created on the northern extension of B2. According to current proposed plans, access to the roost would be maintained. |

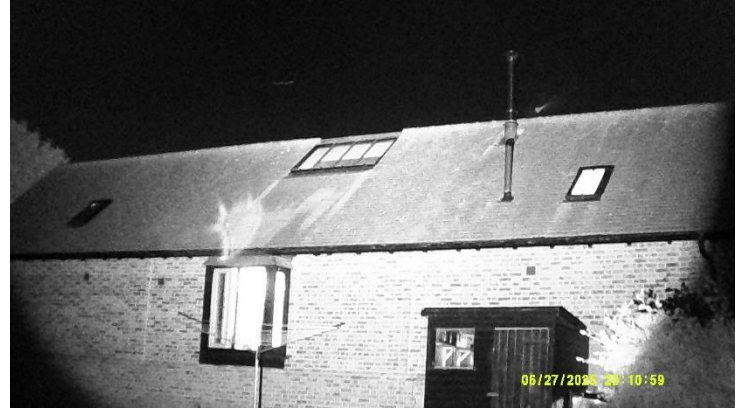
| <p><i>IR position 4</i><br/> <i>IR nightfox whisker</i><br/> <i>and XB5 Pro torch with</i><br/> <i>Magenta Bat4 detector</i></p> | <p><b>Camera position:</b> Observing north elevation of B2.</p> <p><b>No emergencies observed.</b></p> <p>Common pipistrelles (confirmed by magenta Bat4 detector audio during IR review) were observed passing on a south-north corridor and foraging above and north of B2 between 21:38 and 23:00, with a maximum of 5 individuals seen together at one time.</p> | |

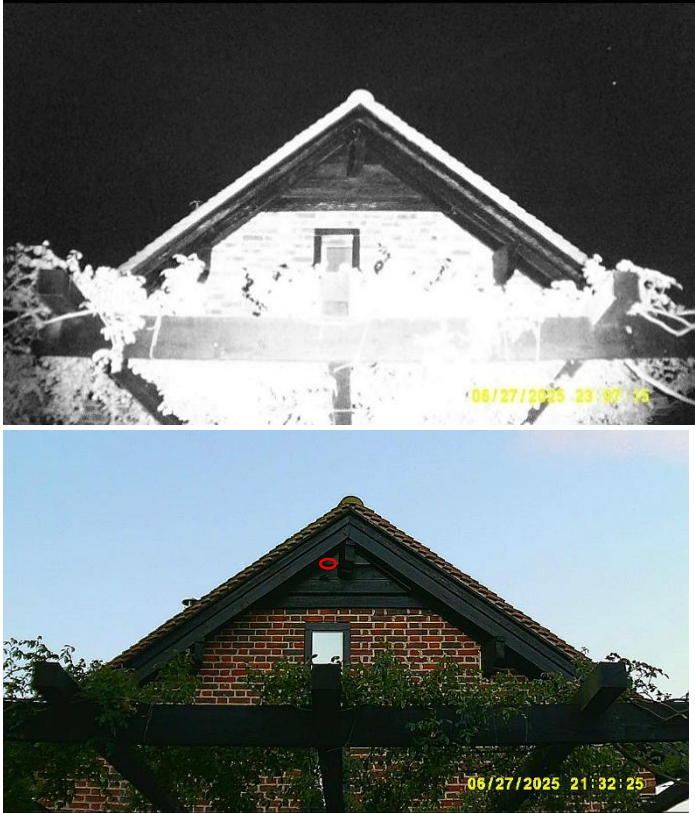
| <p><i>IR position 5</i><br/><i>IR nightfox whisker</i><br/><i>and XB5 Pro torch</i></p> | <p><b>Camera position:</b> Observing west elevation of B2.</p> <p><b>Emergences observed:</b></p> <p><b><u>Roost 3:</u></b></p> <p><b>Number:</b> 10</p> <p><b>Times:</b> emerged between 21:32 and 21:41.</p> <p><b>Location of access points:</b> Underneath wooden cladding on the western elevation of B2.</p> <p><b>Directions of travel on emergence:</b> All individuals emerged and flew in a northerly direction.</p> <p>Species ID confirmed on site as common pipistrelle.</p> <p>Surveyor 5 observed the emergences.</p> <p>A full review of the IR footage did not reveal any additional bat activity.</p> | <p>Emergence point of Common pipistrelle (red) from roost 3.</p> |
