Old Manor Farm House, Shaftenhoe End,  
Hertfordshire, SG8 8LD

Heritage Statement

Local Planning Authority: North Hertfordshire District Authority

September 2025

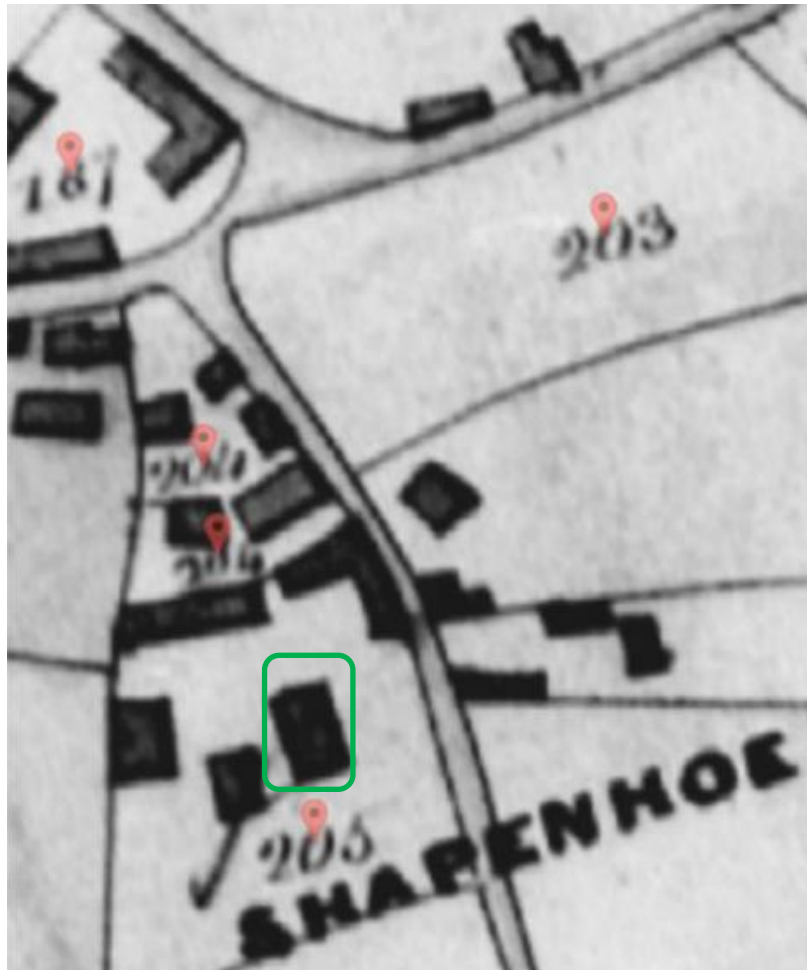
**Figure 3.1:** Tithe Map for Barley parish from 1839 showing Old Manor Farm within plot 205 with the approximate location of the Site marked in green. This map appears to be at a low level of detail, as it does not show the kitchen cross wing, which we know is 16th century.

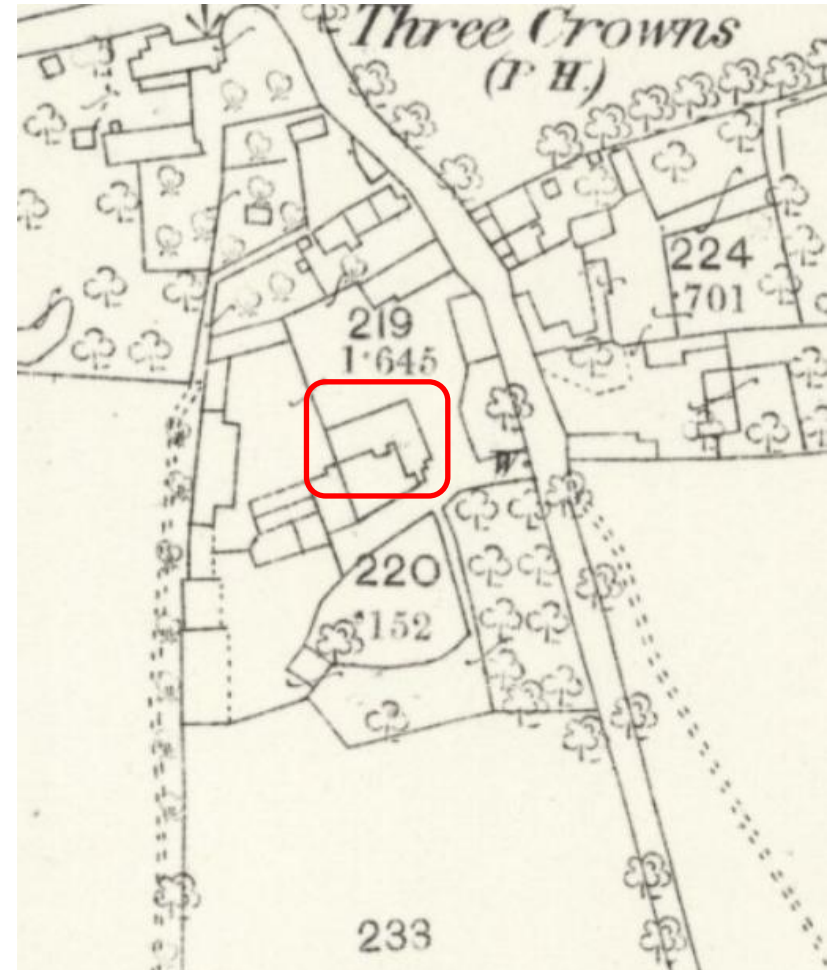
**Figure 3.2:** 1876 OS map with the approximate location of the Site marked in red (Source: NLS). The Old Manor Farm House is shown with the kitchen cross wing in the south-eastern corner and the southern stair wing in the centre of the main range's rear elevation. We can also potentially decipher a small projection from the external stack on the kitchen cross wing's southern elevation.

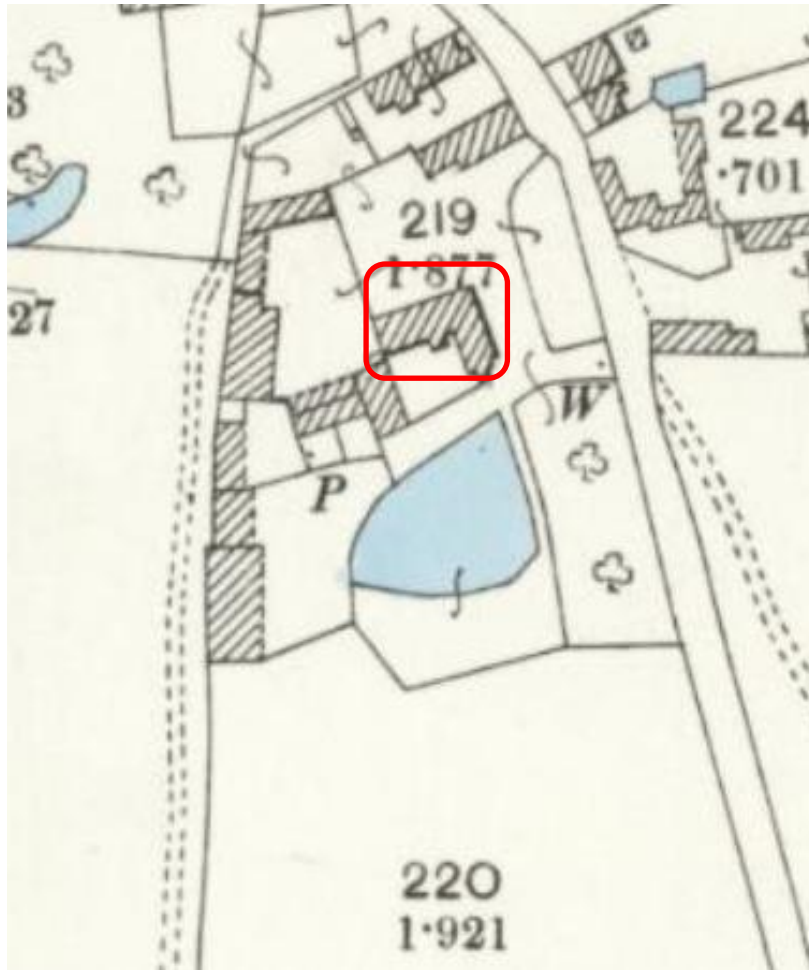
**Figure 3.3:** 1896 OS map with the approximate location of the Site marked in red (Source: NLS). There is no relevant change on-site since Figure 3.2.

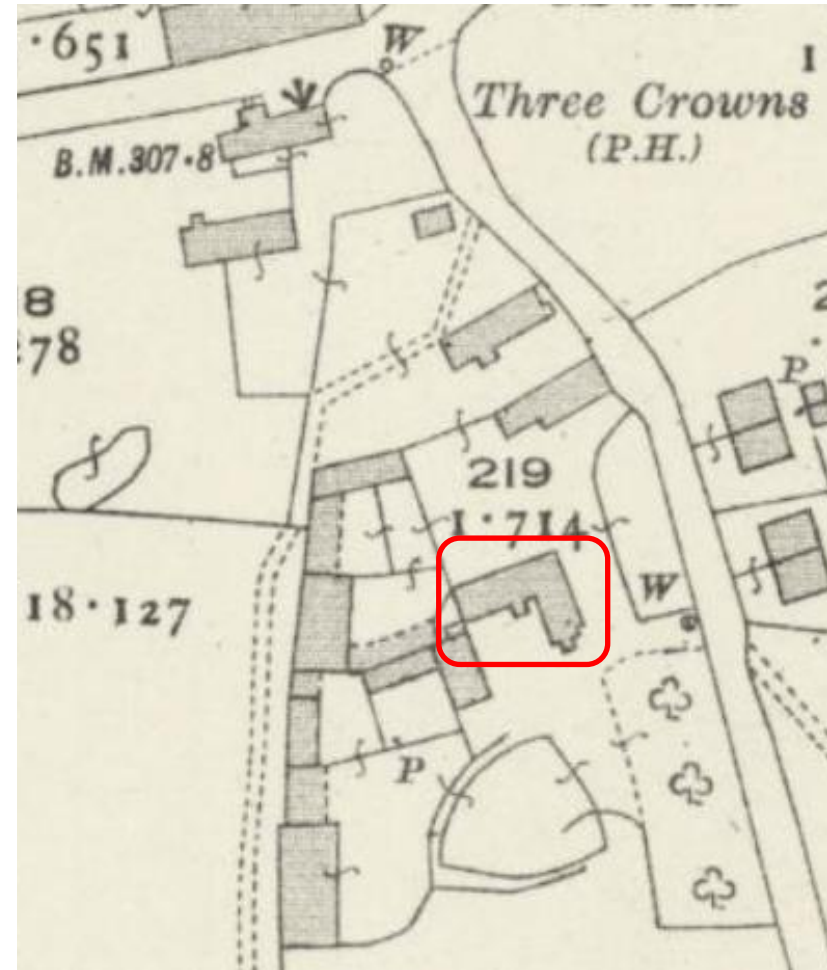
**Figure 3.4:** 1919 OS map with the approximate location of the Site marked in red (Source: NLS). There is no relevant change on-site since Figure 3.2.

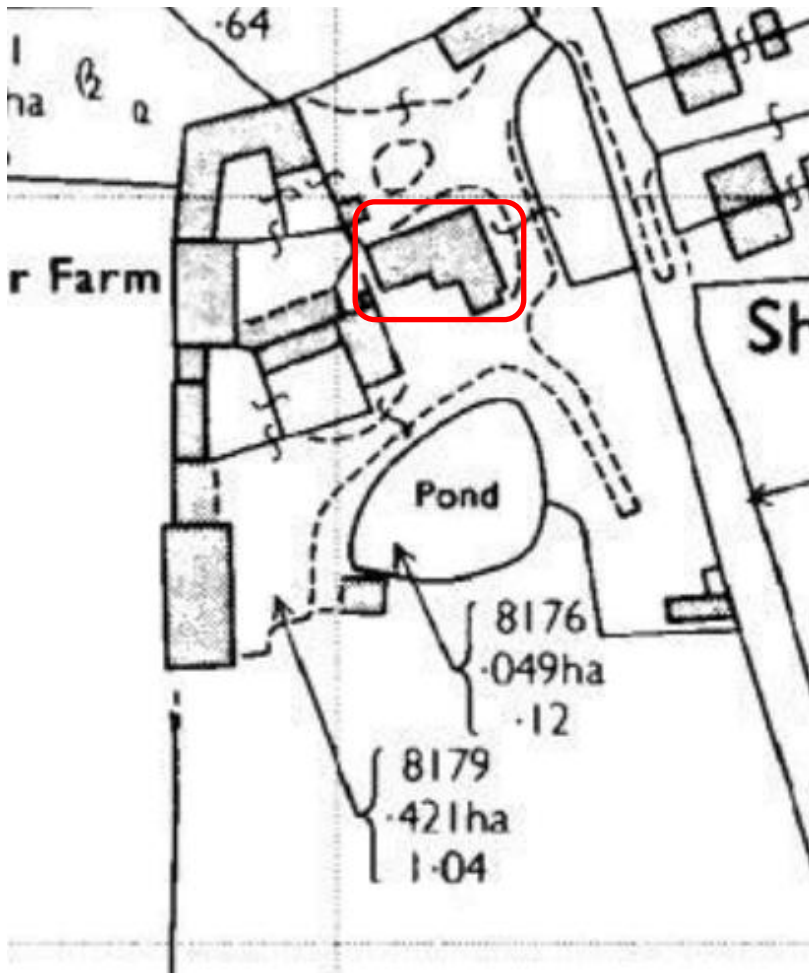
**Figure 3.5:** 1981 OS map with the approximate location of the Site marked in red (Source: Promap). This map appears to show the infilling between the stair wing and the kitchen cross wing since Figure 3.4.

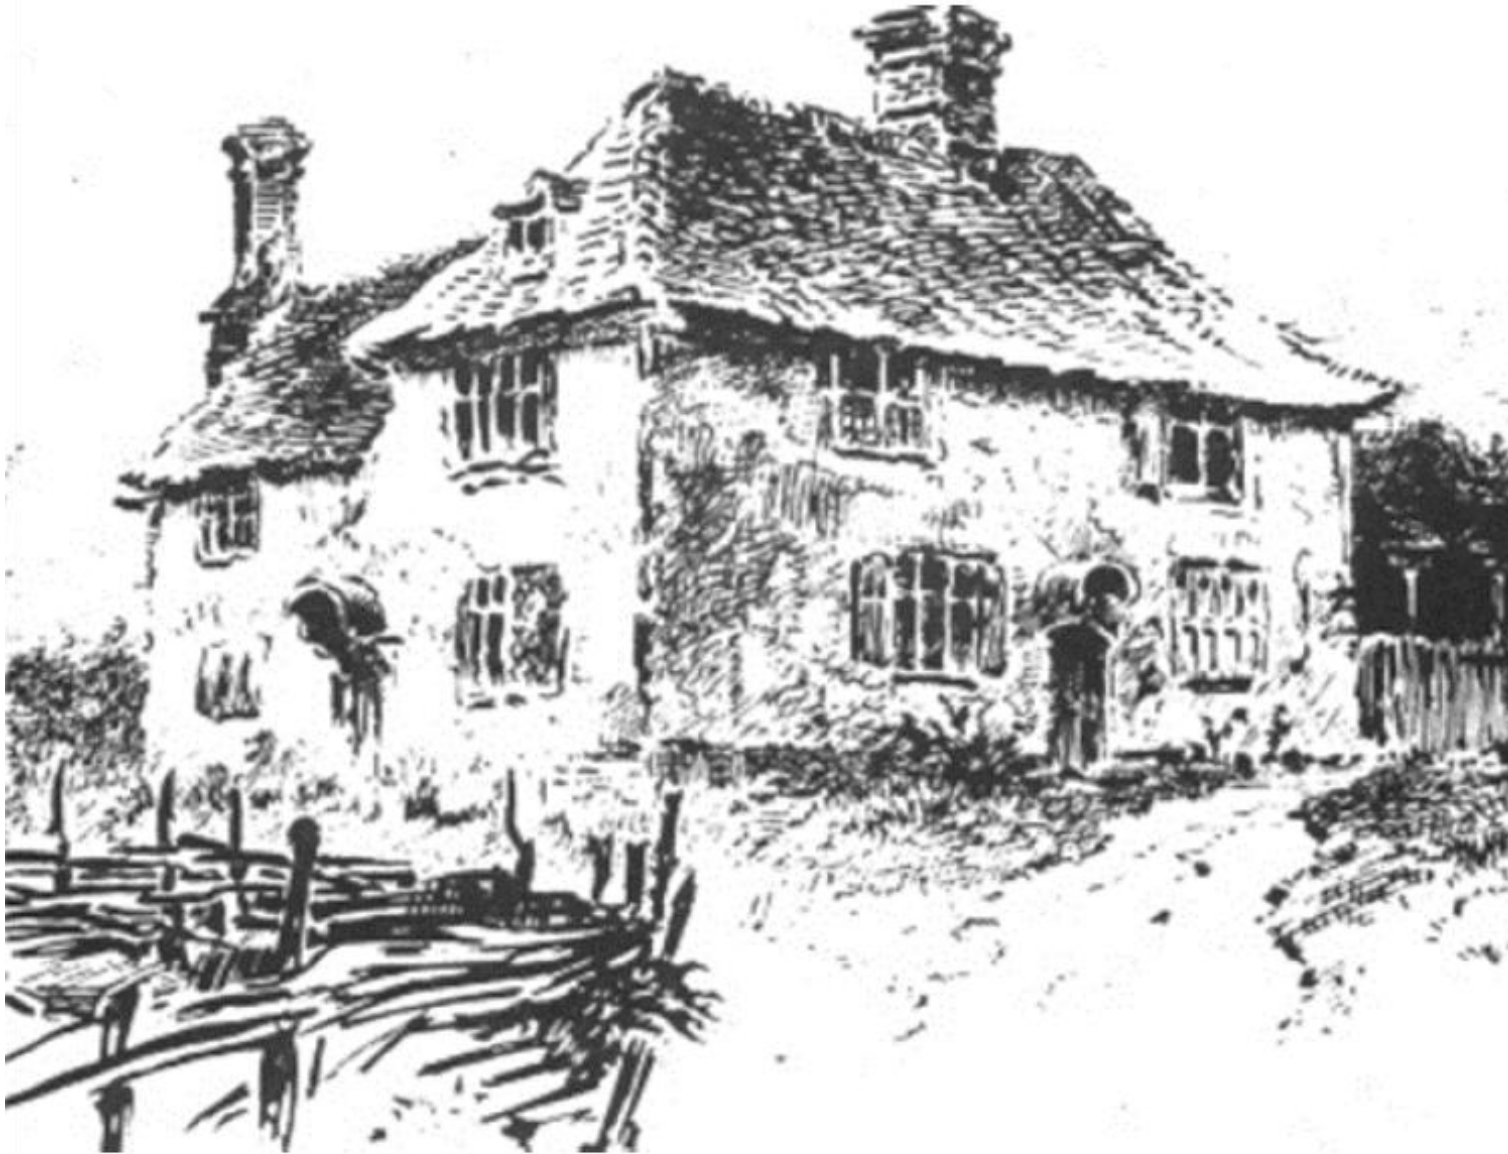
**Figure 4.1:** The Old Manor, Shaftenhoe End, c. 1890 (Source: Hertfordshire Genealogy).

A hipped dormer is shown on the 1890 drawing at Figure 4.1. A new 2-light casement window was installed in the 1990s to match those installed on the northern elevation.

Again the elevation above the plinth is rendered and painted (cream). The elevation is visually dominated by a large chimneystack, which tapers as it rises. The latter is an external red brick stack, tapering with crowsteps to the right hand side to conjoined diagonal shafts with a moulded base and oversailing cap, characteristic of 17th century stacks and appears to date to that period. This turned stack is evident in the 1890 drawing at Figure 4.1.

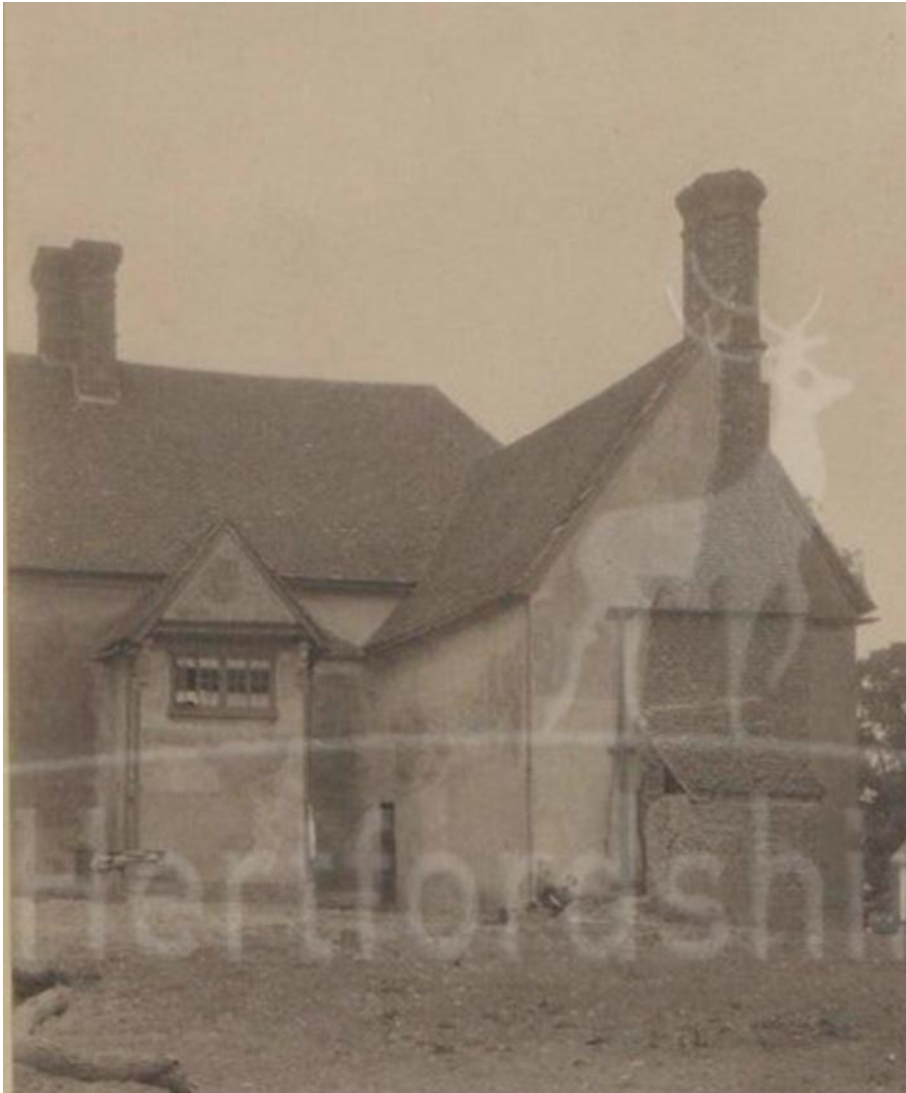
**Figure 4.2:** 1911 Image of the rear elevation showing the two wings and the door at the northern end of the kitchen cross wing's western elevation (Source: Hertfordshire Archives).

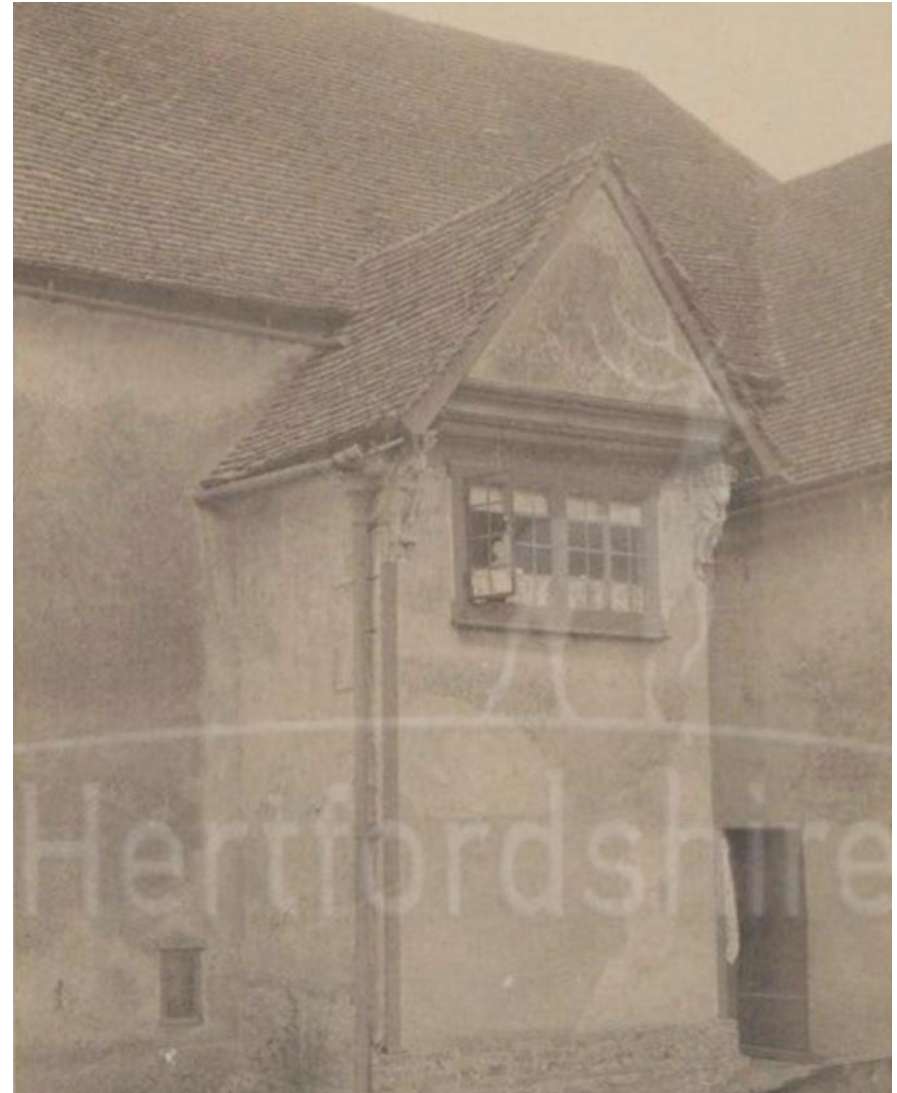
**Figure 4.3:** 1911 Image of the stair wing (Source: Hertfordshire Archives).

An external west doorway into the western elevation of the kitchen cross wing is visible on an historic photograph from 1911 (see Figure 4.3), at which point there was no infill between the kitchen cross wing and the stair wing. The RCHM report of 1994 comments that this doorway may have been the historic access point to the kitchen cross wing. Furthermore, along with a corresponding external doorway on the eastern elevation of the kitchen cross wing, it may indicate an original open passage between the detached kitchen cross wing and the main range (i.e. that the kitchen cross wing was detached from the main range). Such instances were not uncommon in the Tudor period due to the threat of fire. As such, this east-west movement route, and the external access into the kitchen cross wing from the west, are of some considerable historical significance. The present door on the western elevation is a good quality modern ledged boarded door.

West of the stair wing is a modern timber casement window installed as part of the 1990s phase of works. This is larger than the window shown at Figure 4.3 dating from 1911. The window serves the cellar staircase and has a lead lipped detail above to shed rainwater.

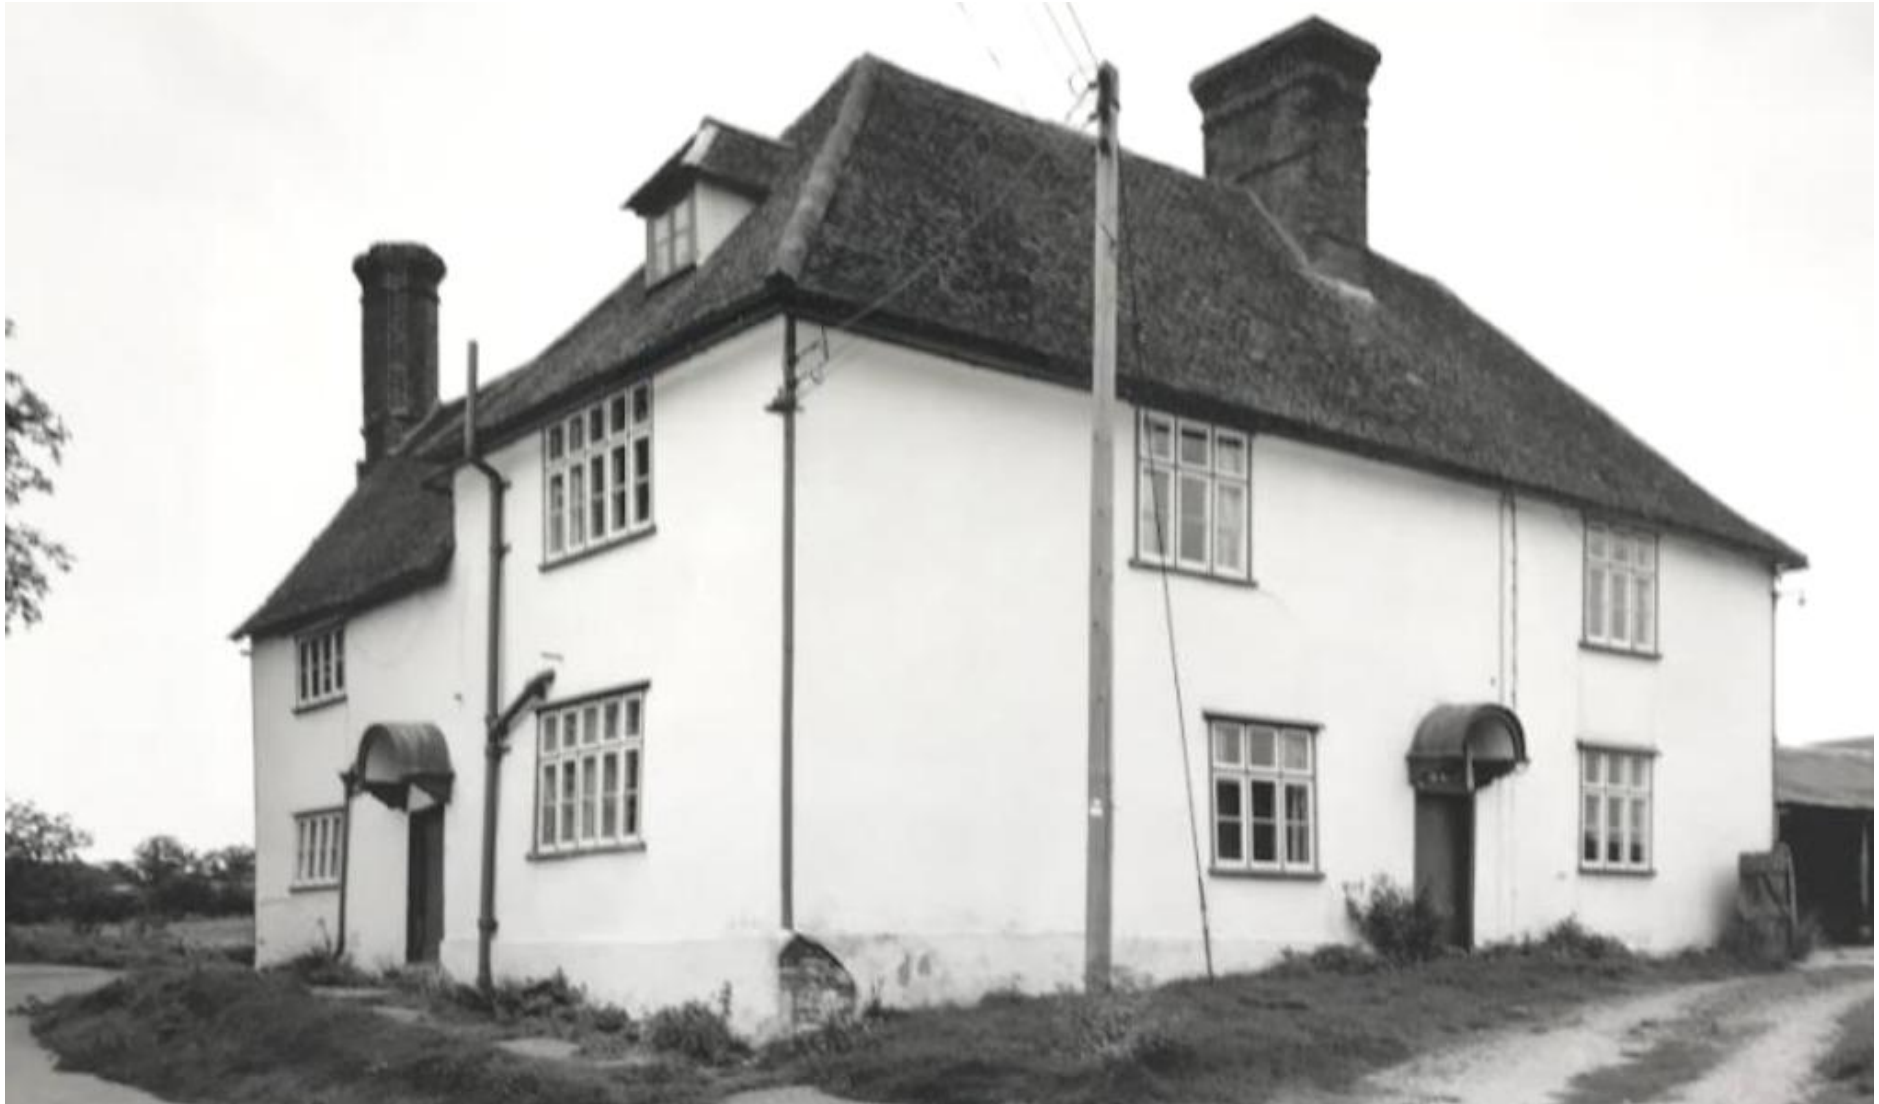
**Figure 4.4:** 1992-94 photograph (Source: Historic England Archives). Showing the northern and eastern elevations.

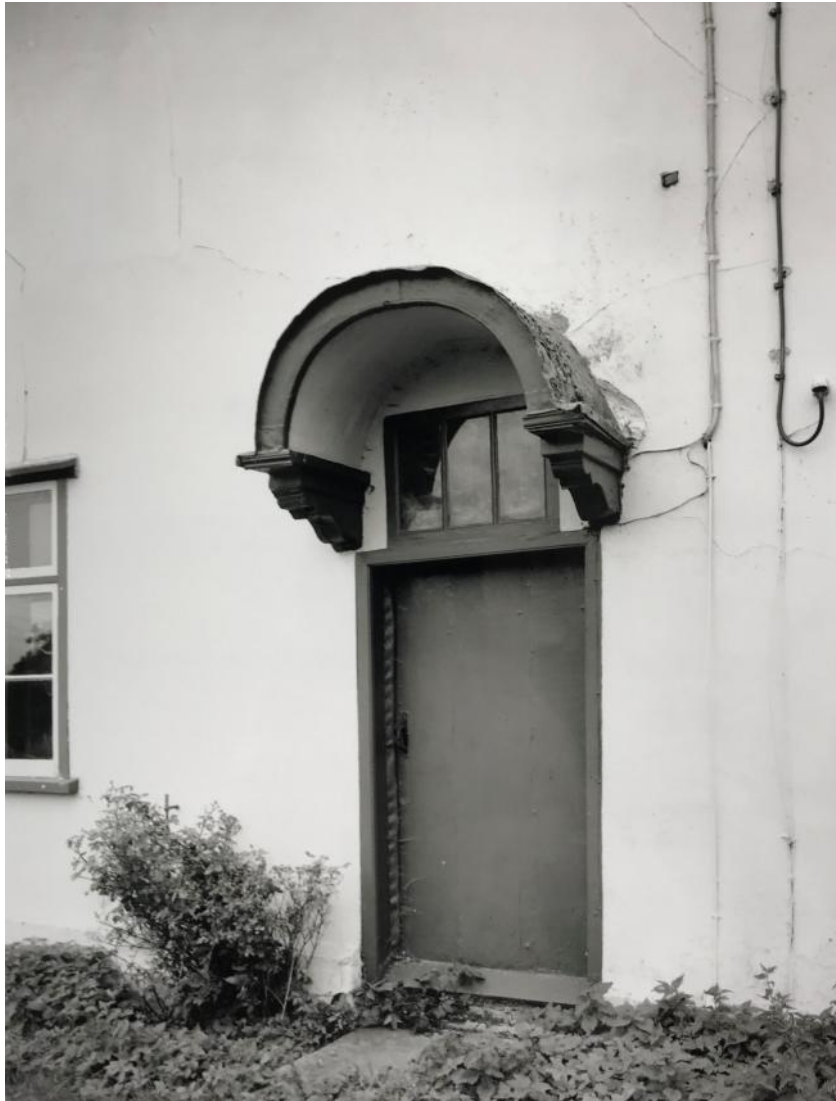
**Figure 4.5:** 1992-94 photograph (Source: Historic England Archives). Showing the canopy, moulded brackets and door on the northern (front) elevation. Also showing the historic 3-plank door in the main entrance.

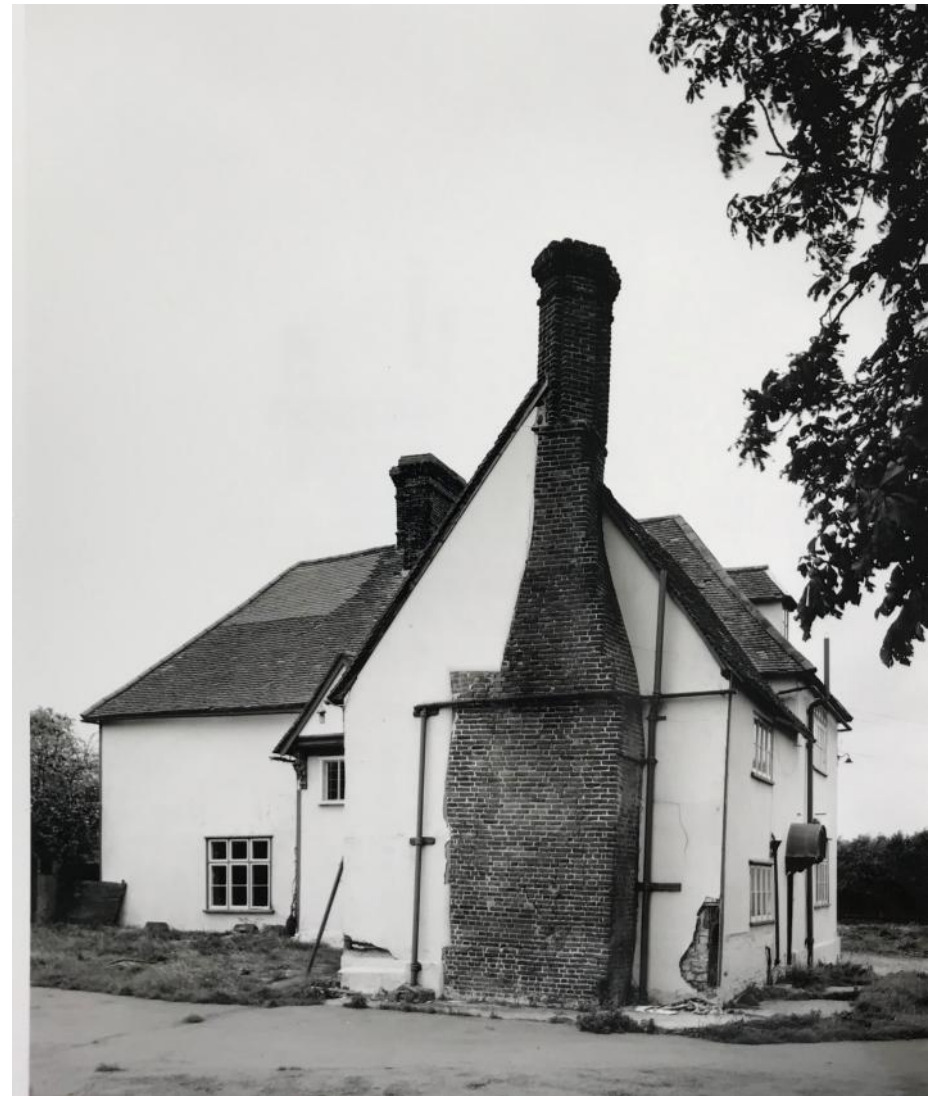
**Figure 4.6:** 1992-94 photograph (Source: Historic England Archives). Showing the southern elevation of the kitchen cross wing.

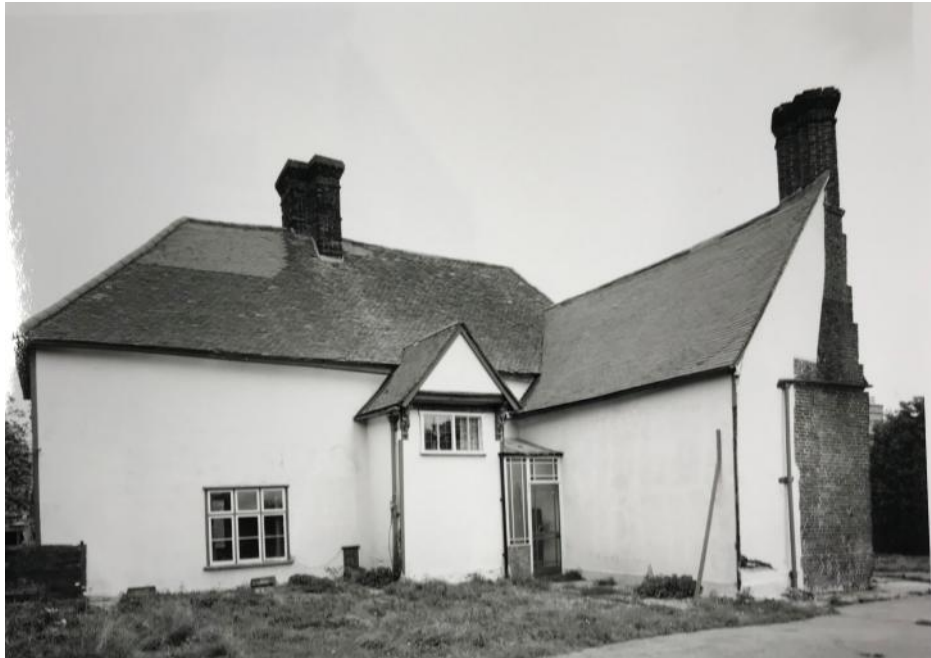
**Figure 4.7:** 1992-94 photograph showing the southern elevation of the main range and the kitchen cross wing (Source: Historic England Archives).

At the western end of the main range's ground floor are a pair of modern single glazed French windows. These were not present in 1992-94 as confirmed at Figure 4.7 where a wider window is shown in this location. The existing doors are therefore considered of no heritage value. The same photograph shows no window at first floor above and the RCHM report found no evidence of a window in this location historically. The present window at first floor is a good quality 5-light timber casement with transom, which approximately copies the style of the window previously concealed in the western gable end until the 1990s phase of works.

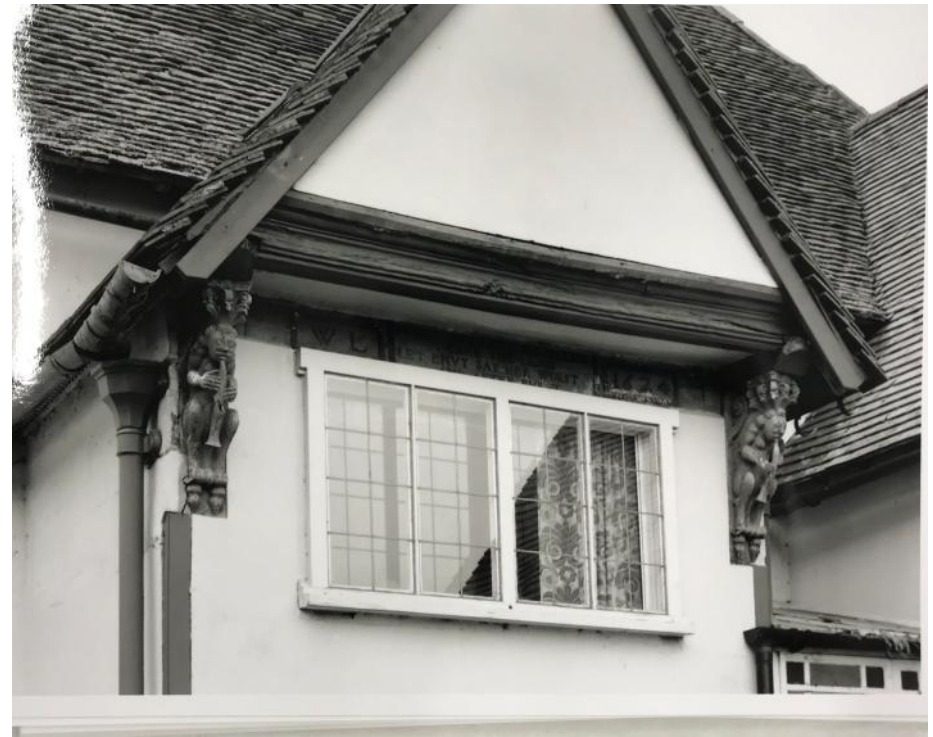
**Figure 4.8:** 1992-94 photograph showing the first floor window in the rear stair wing (Source: Historic England Archives).

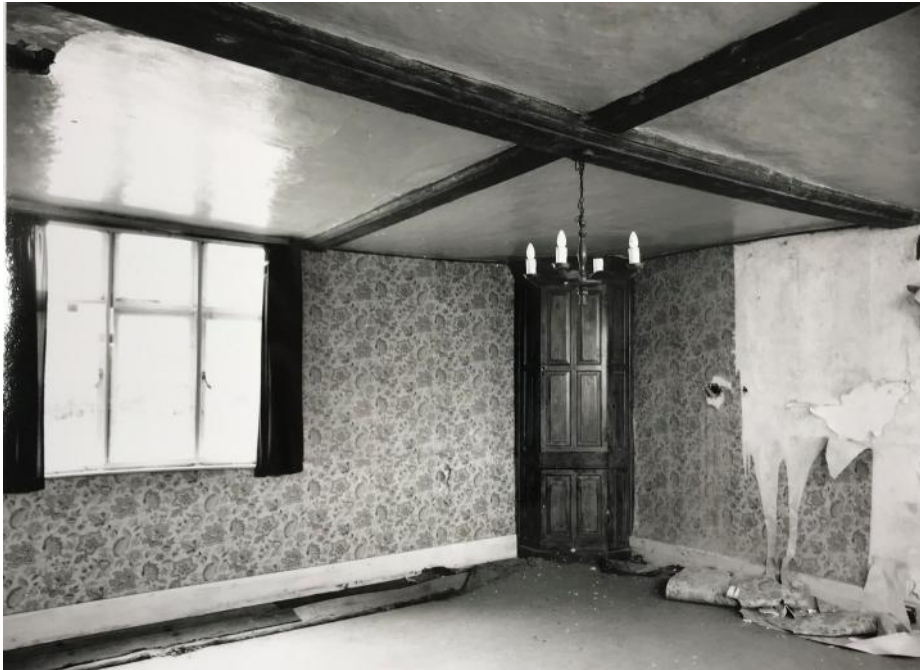
**Figure 4.11:** 1992-94 photograph showing the ground floor western room in the main range (sitting room) and its corner cupboard (Source: Historic England Archives). Note the 18th century cupboard is shown in the south-western side of the room at this time.

Figure 4.11 shows the 18th century cupboard in the south-western corner of the room in 1992. Today, the cupboard is found in the north-western side of the room and was evidently relocated as part of the 1990s phase of works to facilitate a new doorway from the sitting room into the sun room.

Figure 4.11 shows the 18th century cupboard in the south-western corner of the room in 1992. Today, the cupboard is found in the north-western side of the room and was evidently relocated as part of the 1990s phase of works to facilitate a new doorway from the sitting room into the sun room. At that time the corner cupboard had seemingly been repositioned against modern plywood after the initial internal wall works had been completed.

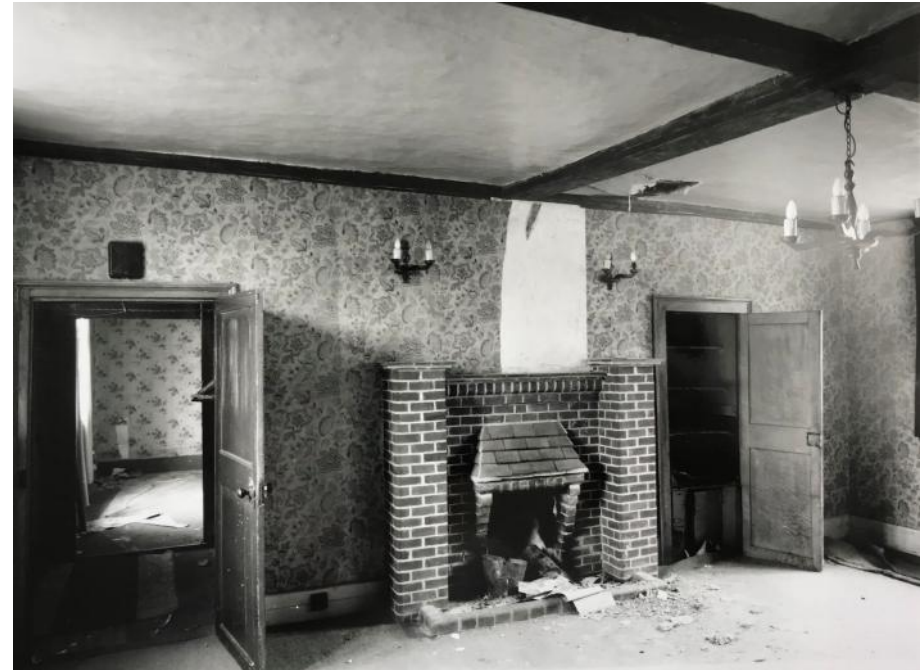
**Figure 4.12:** 1992-94 photograph showing the ground floor western room in the main range (sitting room) and its fireplace (Source: Historic England Archives). Also shown is the doorway towards the entrance lobby (left) and a door into a cupboard (right).

The narrow fireplace shown at Figure 4.12 of no heritage value was removed as part of the 1990s consent and widened. The chimneypiece is a modern addition since 1992 of no heritage value. The current fireplace has a reclaimed red brick hearth, a modern timber Classical inspired chimneypiece (of non specific order) and of no heritage value. The fireplace has been fitted with a modern wood burner.

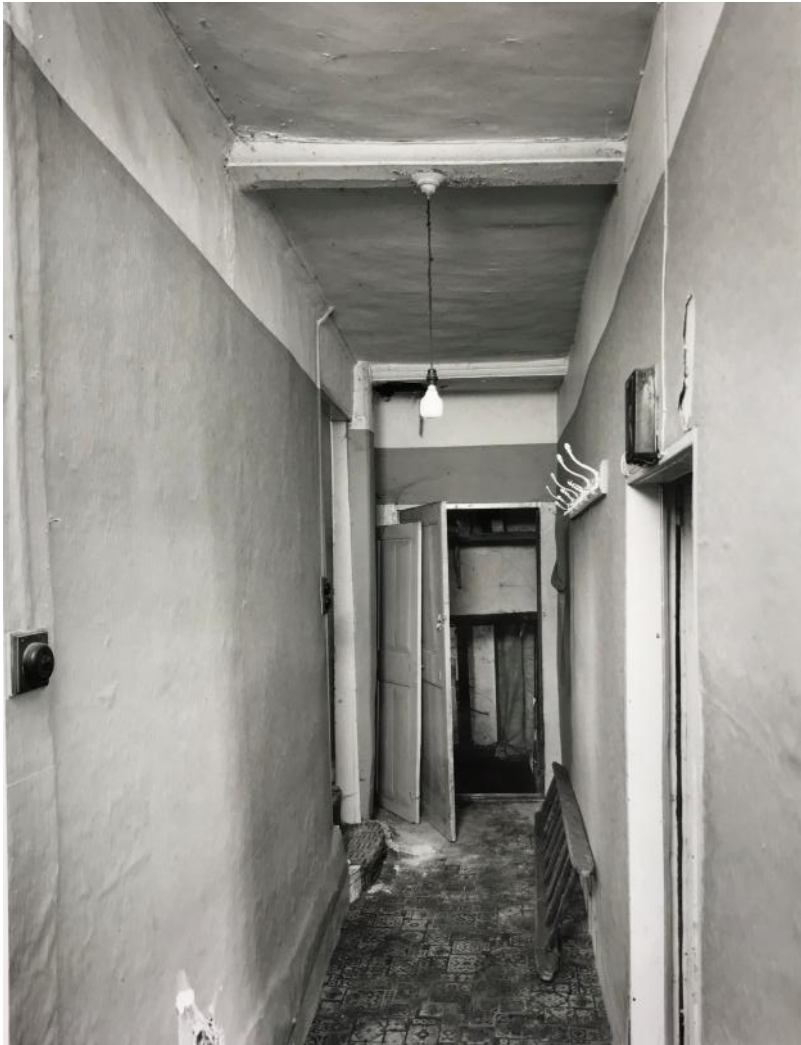
**Figure 4.13:** 1992-94 photograph showing the ground floor corridor that used to run along the southern side of the dining room looking west (Source: Historic England Archives, Reference: BB92/06146). Note the steps up to the stair wing on the left hand side.

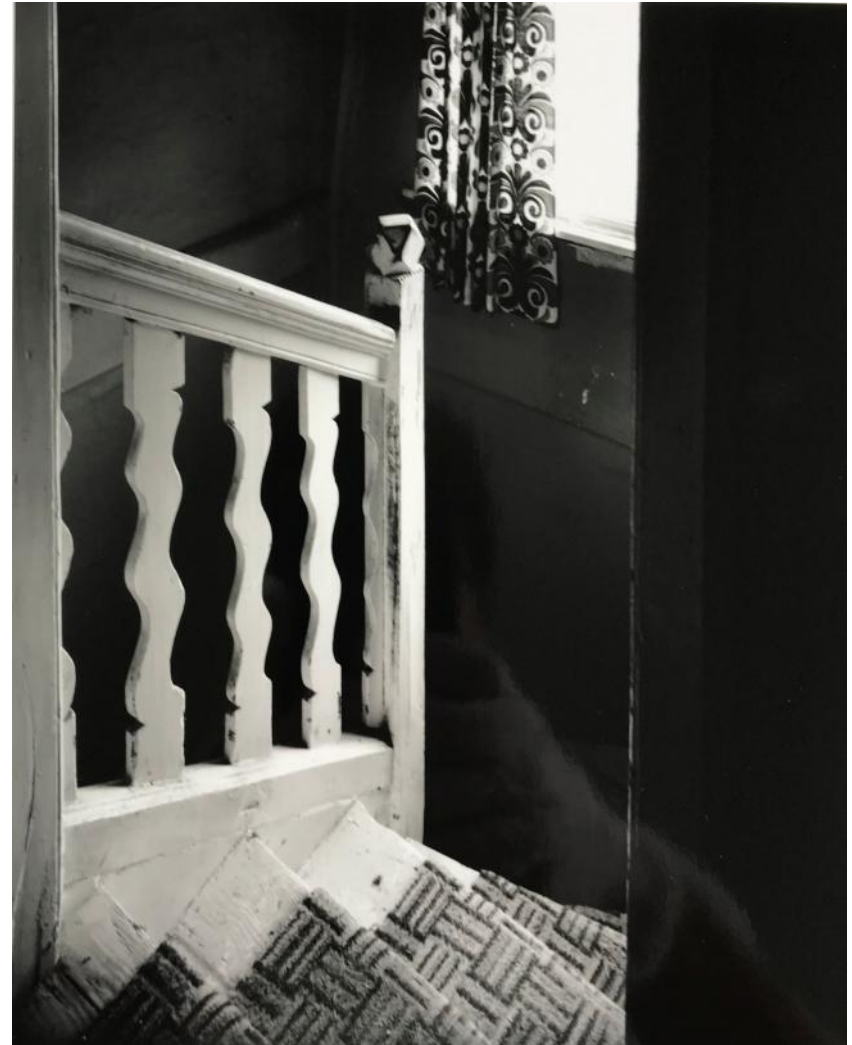
**Figure 4.14:** 1992-94 photograph showing the historic splat balusters and newel post in the stair wing (Source: Historic England Archives, Reference: BB92/06154).

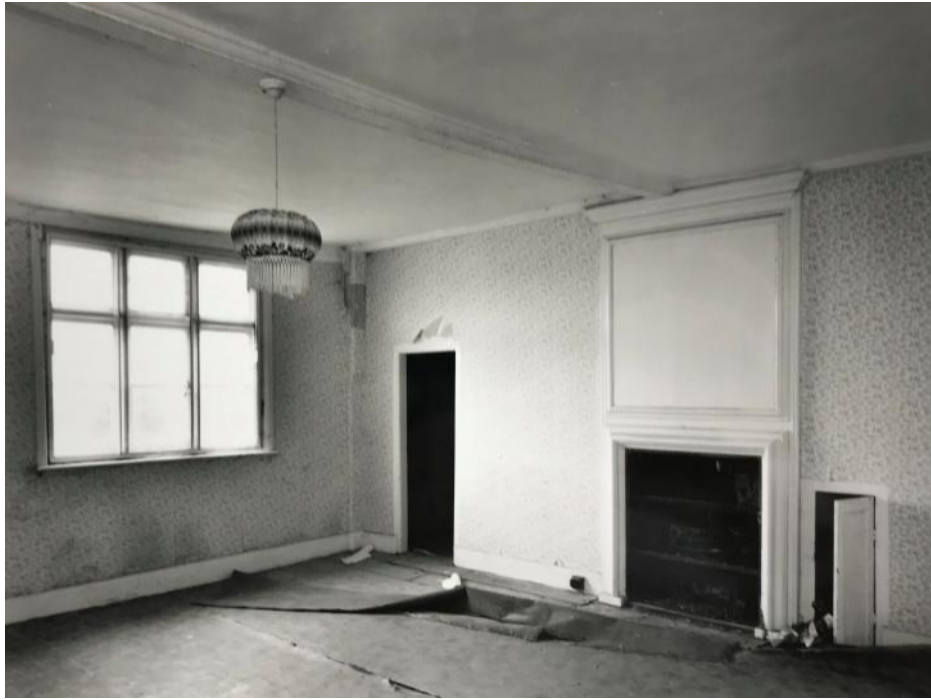
**Figure 4.15:** 1992-94 photograph showing the western bedroom at first floor (Source: Historic England Archives, Reference: BB92/06147). Note the overmantel and cornice above the fireplace.

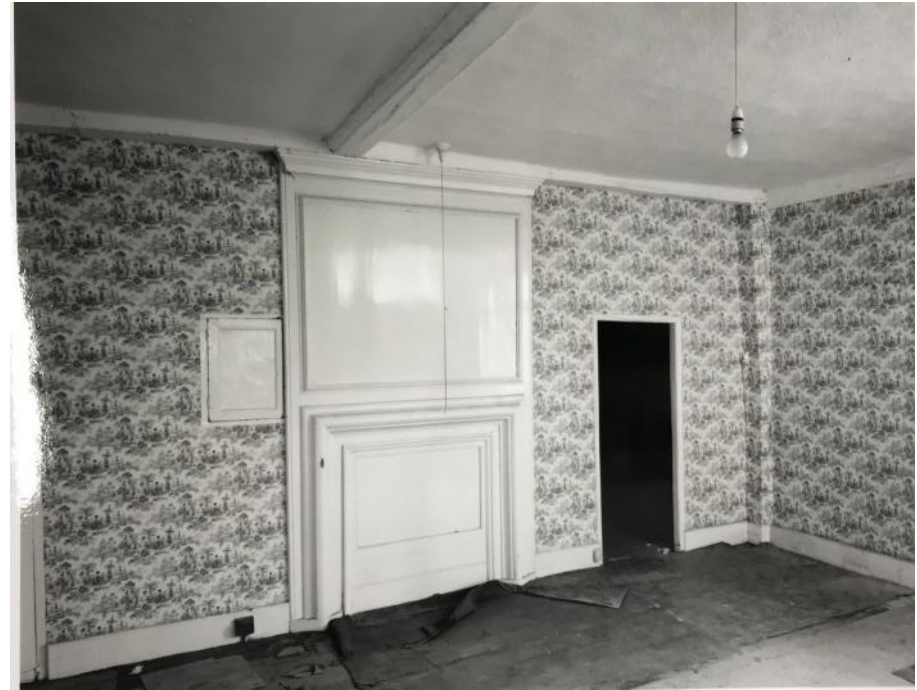
**Figure 4.16:** 1992-94 photograph showing the north-eastern bedroom at first floor (Source: Historic England Archives). Note the overmantel and cornice above the fireplace.

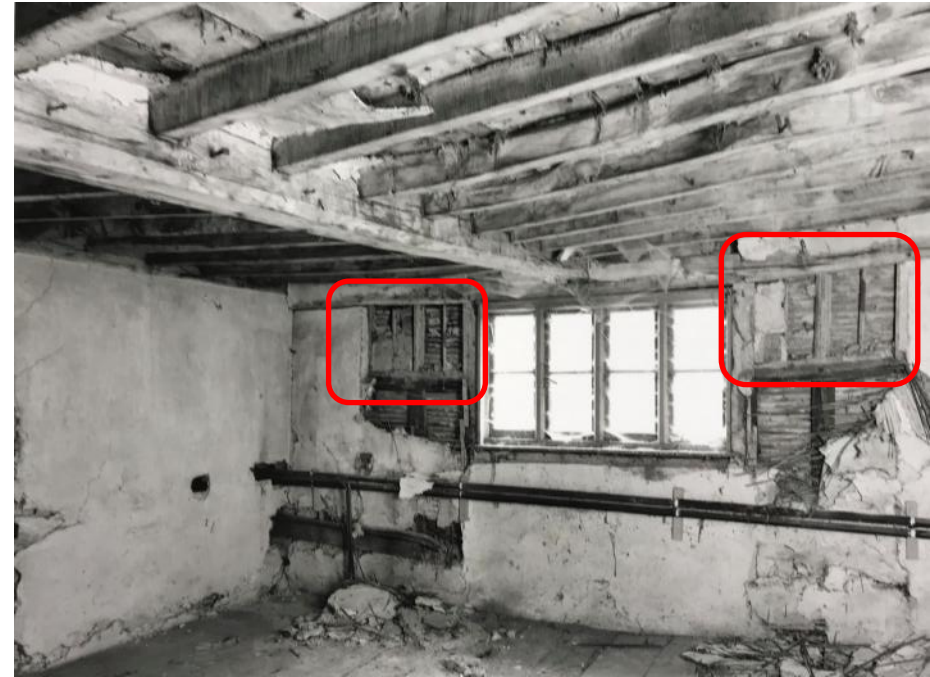
**Figure 4.20:** 1992-94 photograph showing the south-eastern bedroom at first floor level within the kitchen cross wing (Source: Historic England Archives). Note the upper parts of the historic windows visible to either side (marked in red).

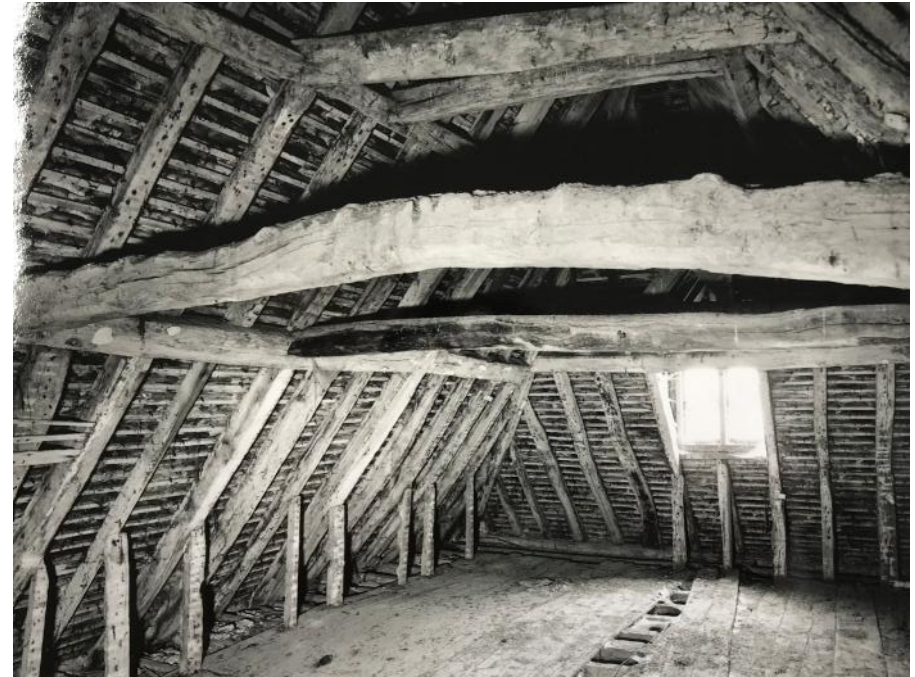
**Figure 4.22:** 1992-94 photograph showing the interior of the roof space of the main range (Source: Historic England Archives, Reference: BB92/06155). Figure 4.37 from 1992 confirms that the only location of a dormer window extant at that time was at the eastern end of the main range. Figure 4.22 therefore shows the area today known as the north-eastern bedroom at loft level in 1992.

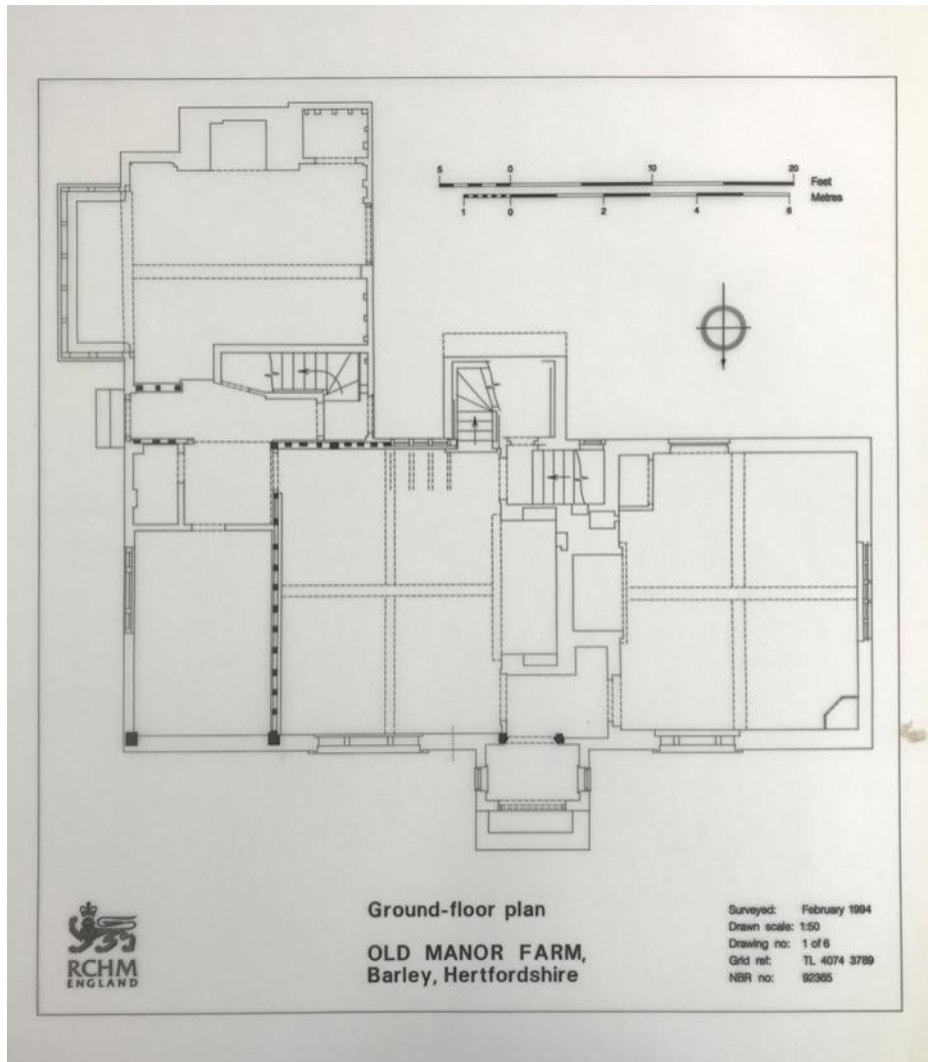
**Figure 4.23:** 1992-94 ground floor plan of house (Source: Historic England Archives).

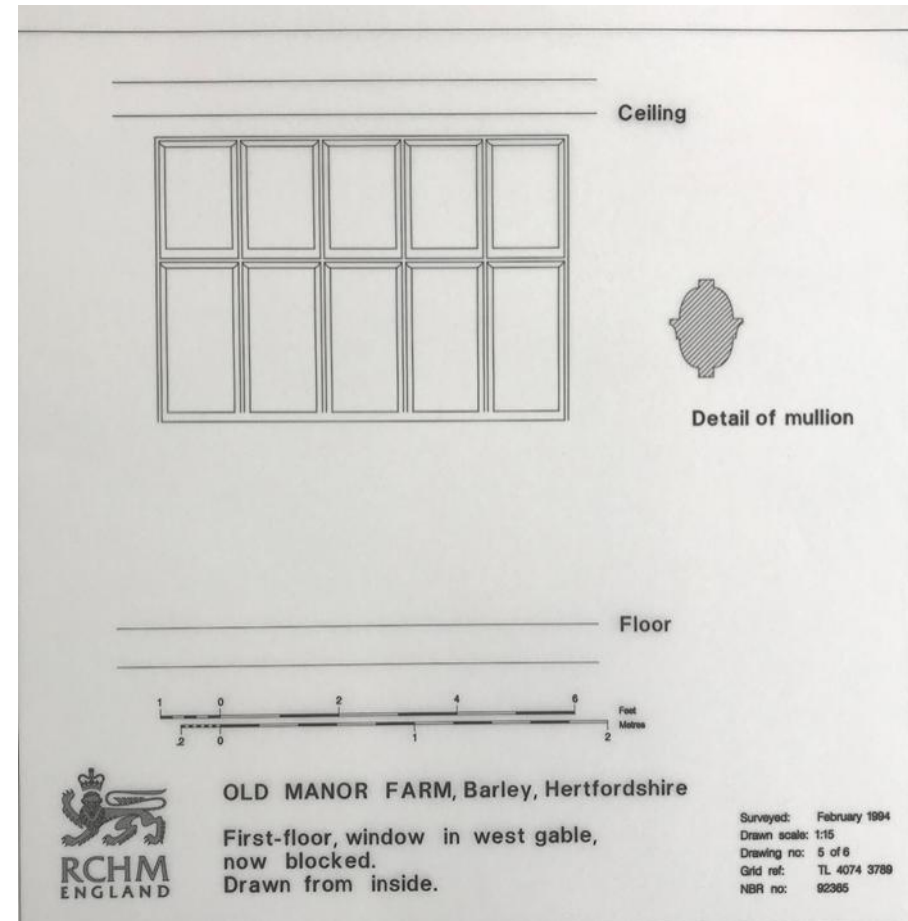
**Figure 4.24:** 1992-94 drawing of the first floor window in the western gable (Source: Historic England Archives, Reference: BB92/06155).
