Old Manor Farm House, Shaftenhoe End,  
Hertfordshire, SG8 8LD

Heritage Statement

Local Planning Authority: North Hertfordshire District Authority

September 2025

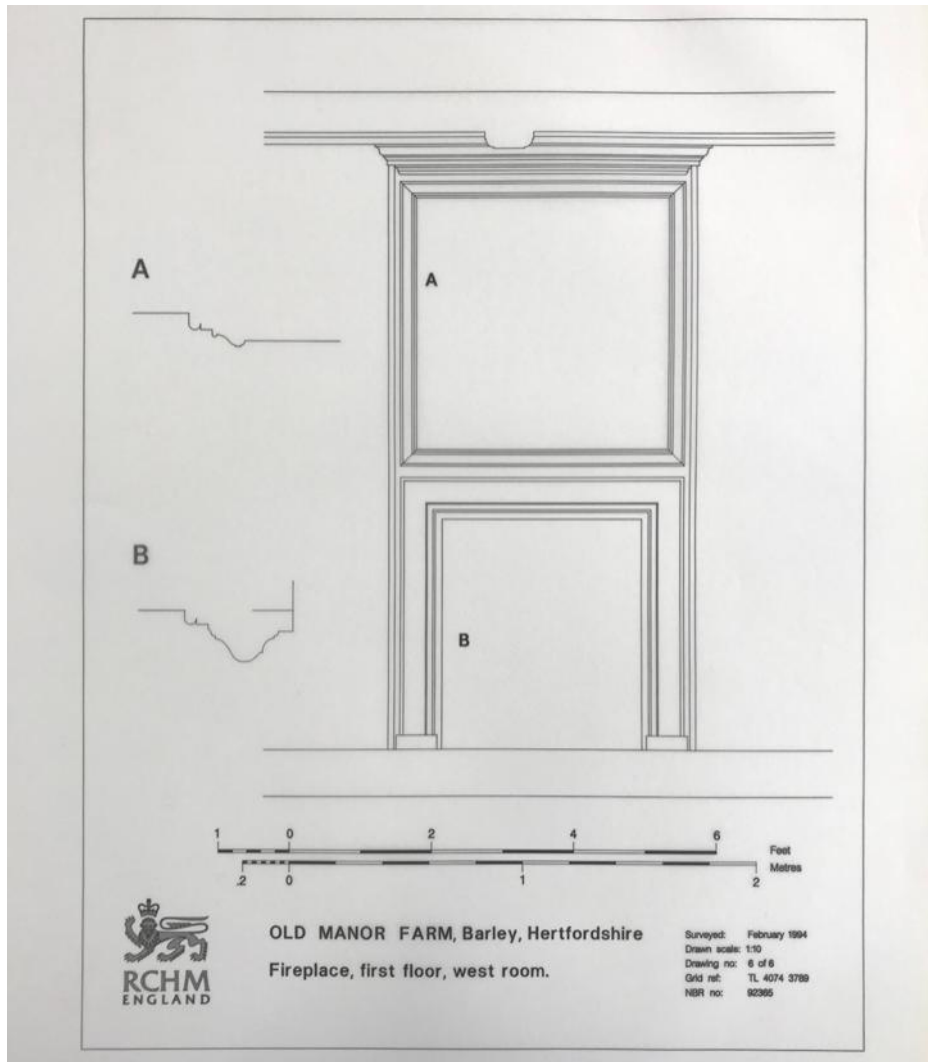
**Figure 4.25:** 1992-94 drawing of the first floor western bedroom's chimneypiece, overmantel and cornice (Source: Historic England Archives).

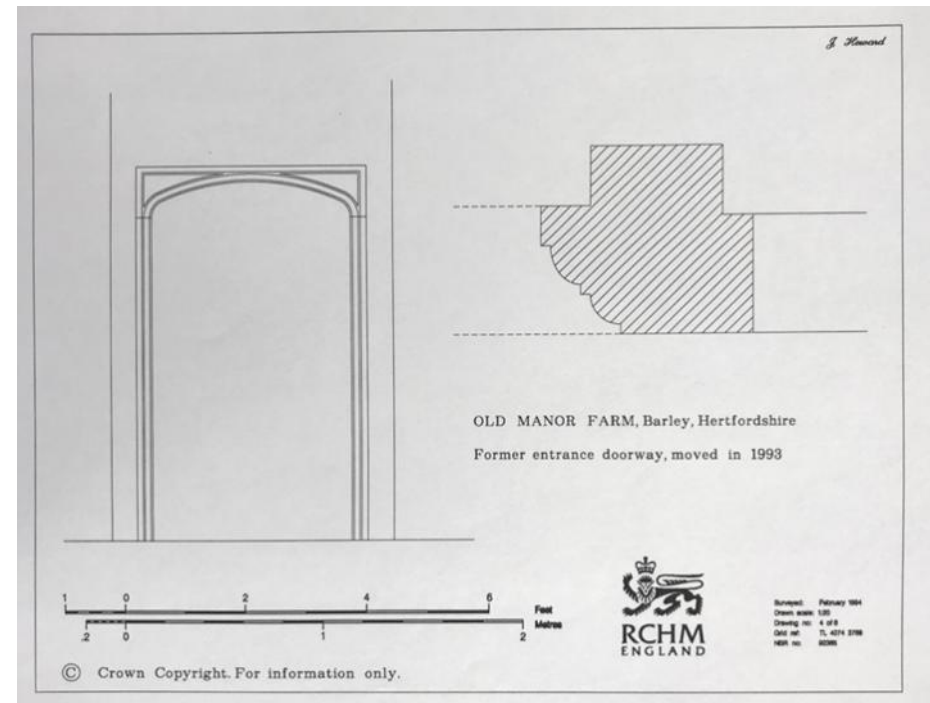
**Figure 4.26:** 1992-94 drawing of the former entrance doorway, moved in 1993 (Source: Historic England Archives).

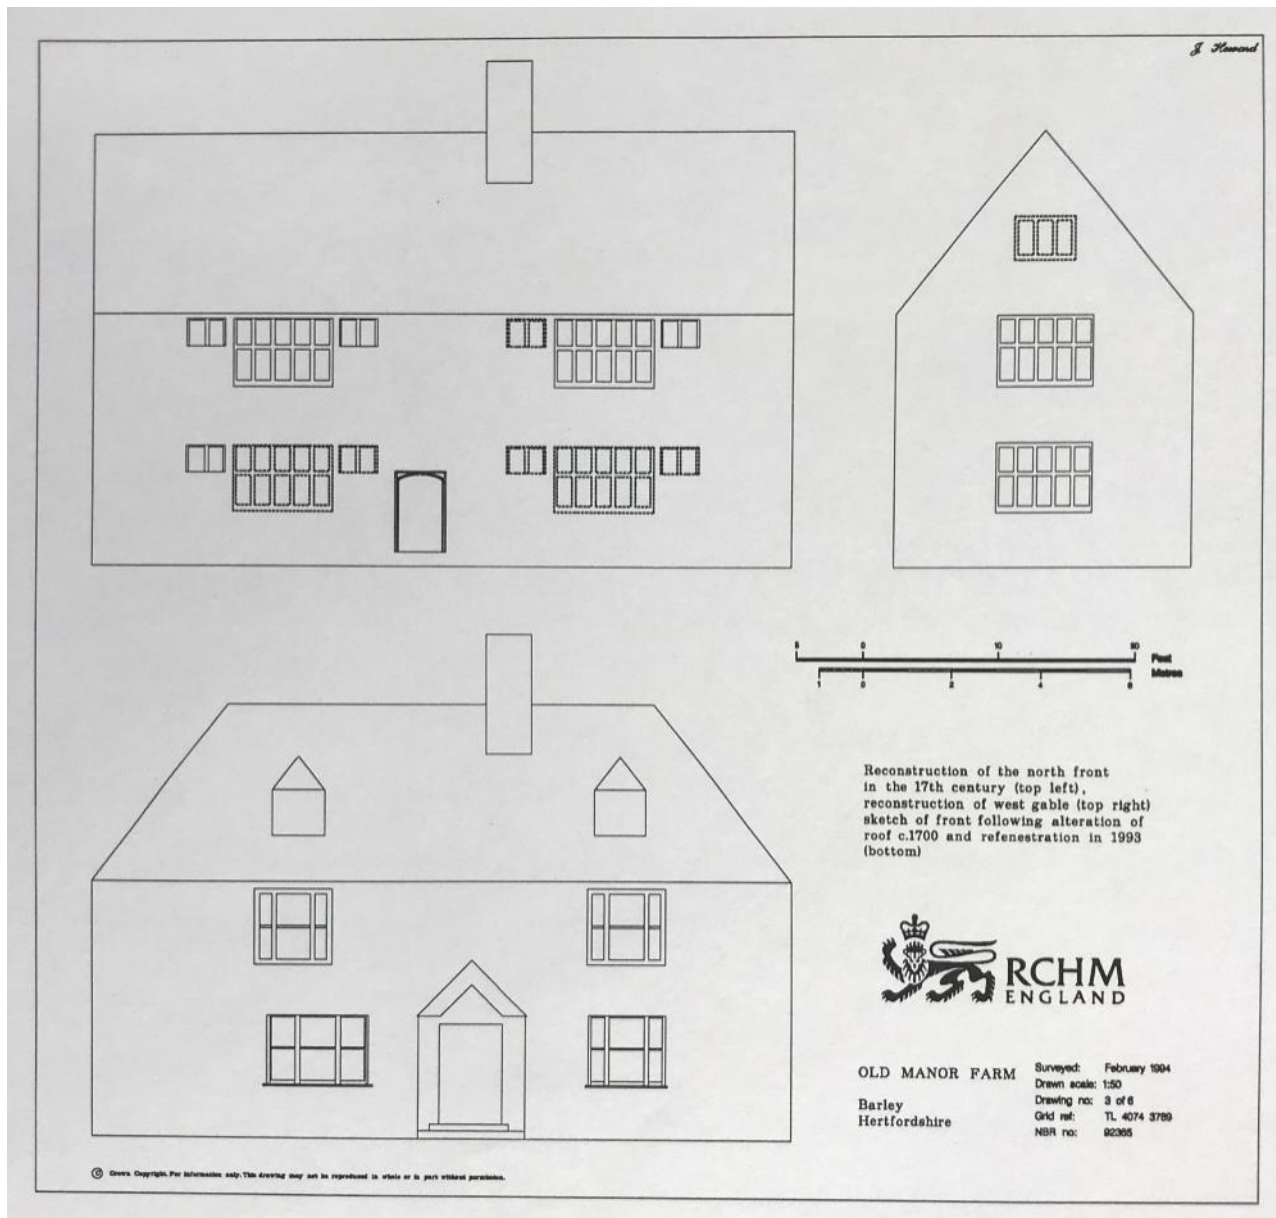
**Figure 4.27:** Showing the RCHM’s drawings of how the front elevation may have appeared in the 17th century compared to the existing (Source: Historic England Archives).

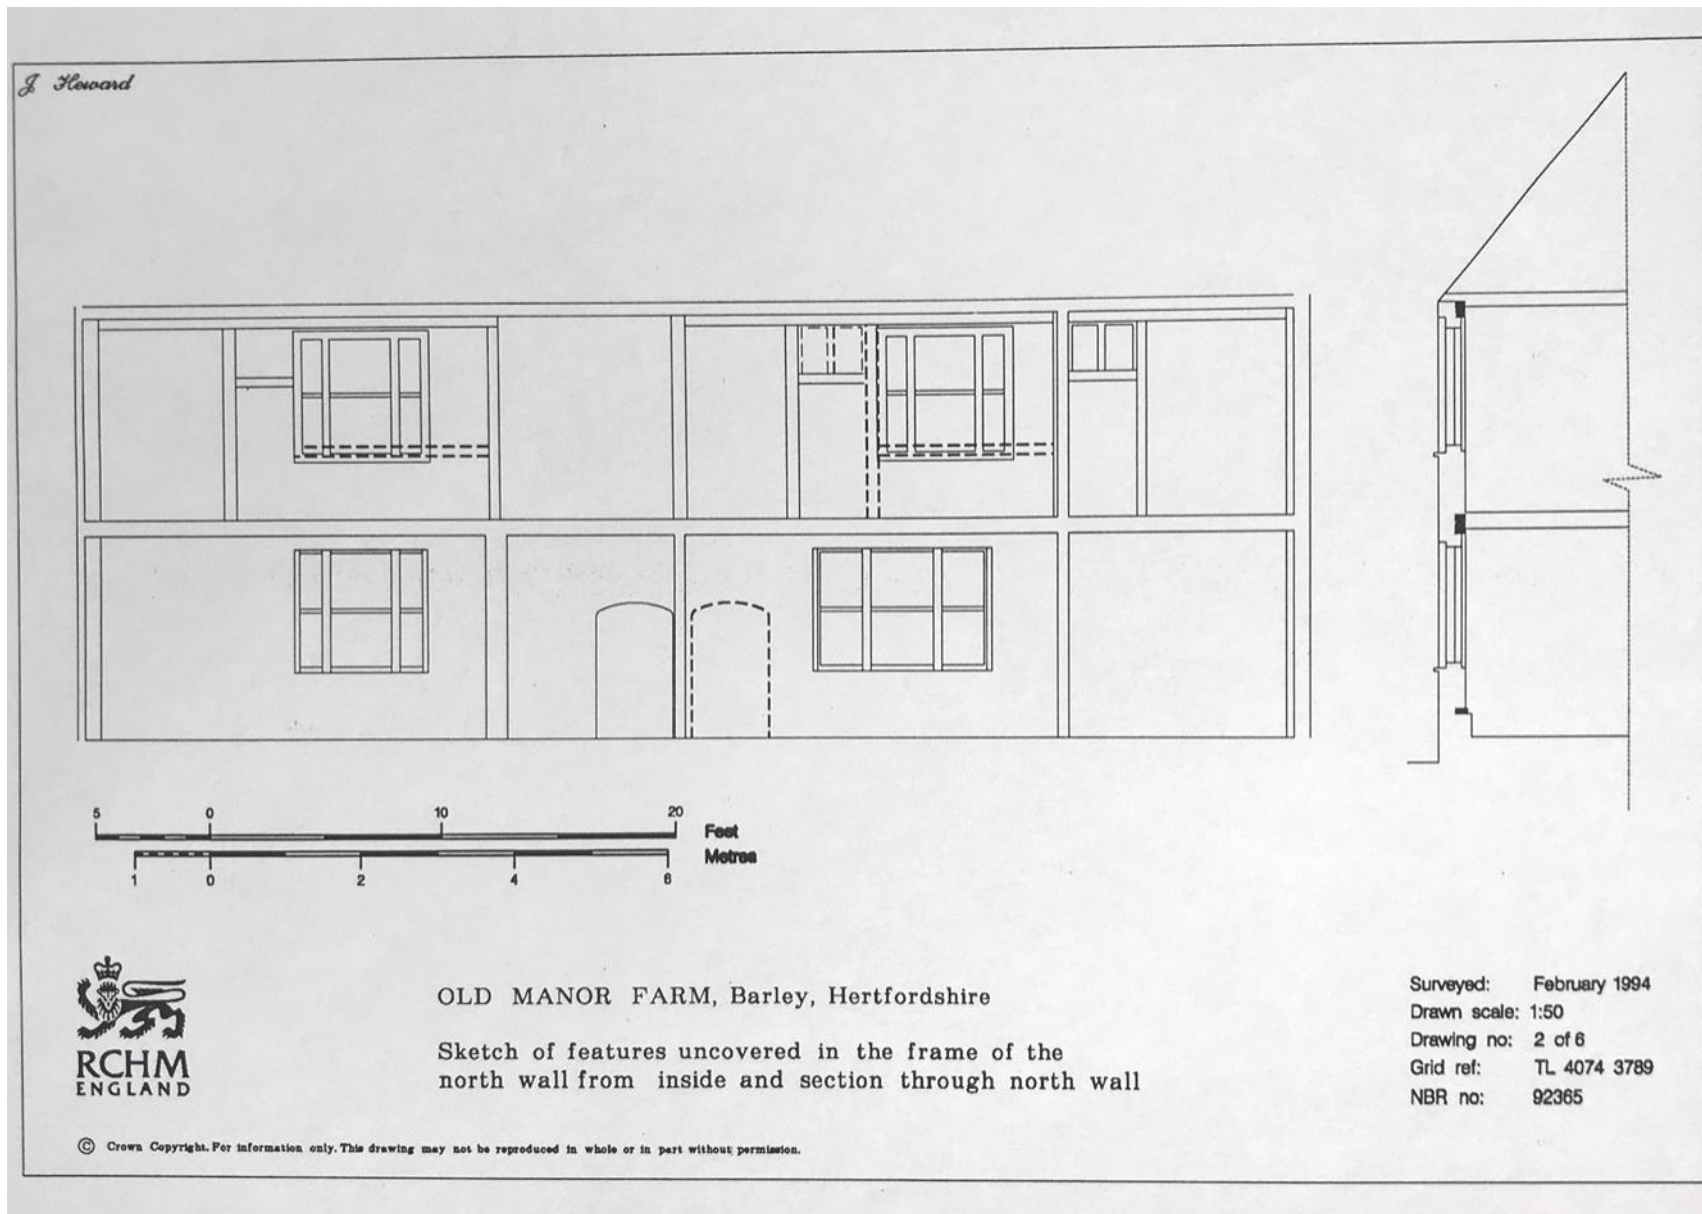
**Figure 4.28:** 1992-94 drawing showing features uncovered in the frame of the north wall from inside and section through north wall (Source: Historic England Archives).

On the northern wall of the room one can see evidence of the upper lights of the former 17th century window that once served this room (see Figure 4.28 and Figure 4.154). The glazing bars have been removed as part of the 1990s phase of works and adapted to resemble the surrounding timber framing. The other side of the window is found within the shower room on the eastern side of the bedroom (see Figure 4.158).

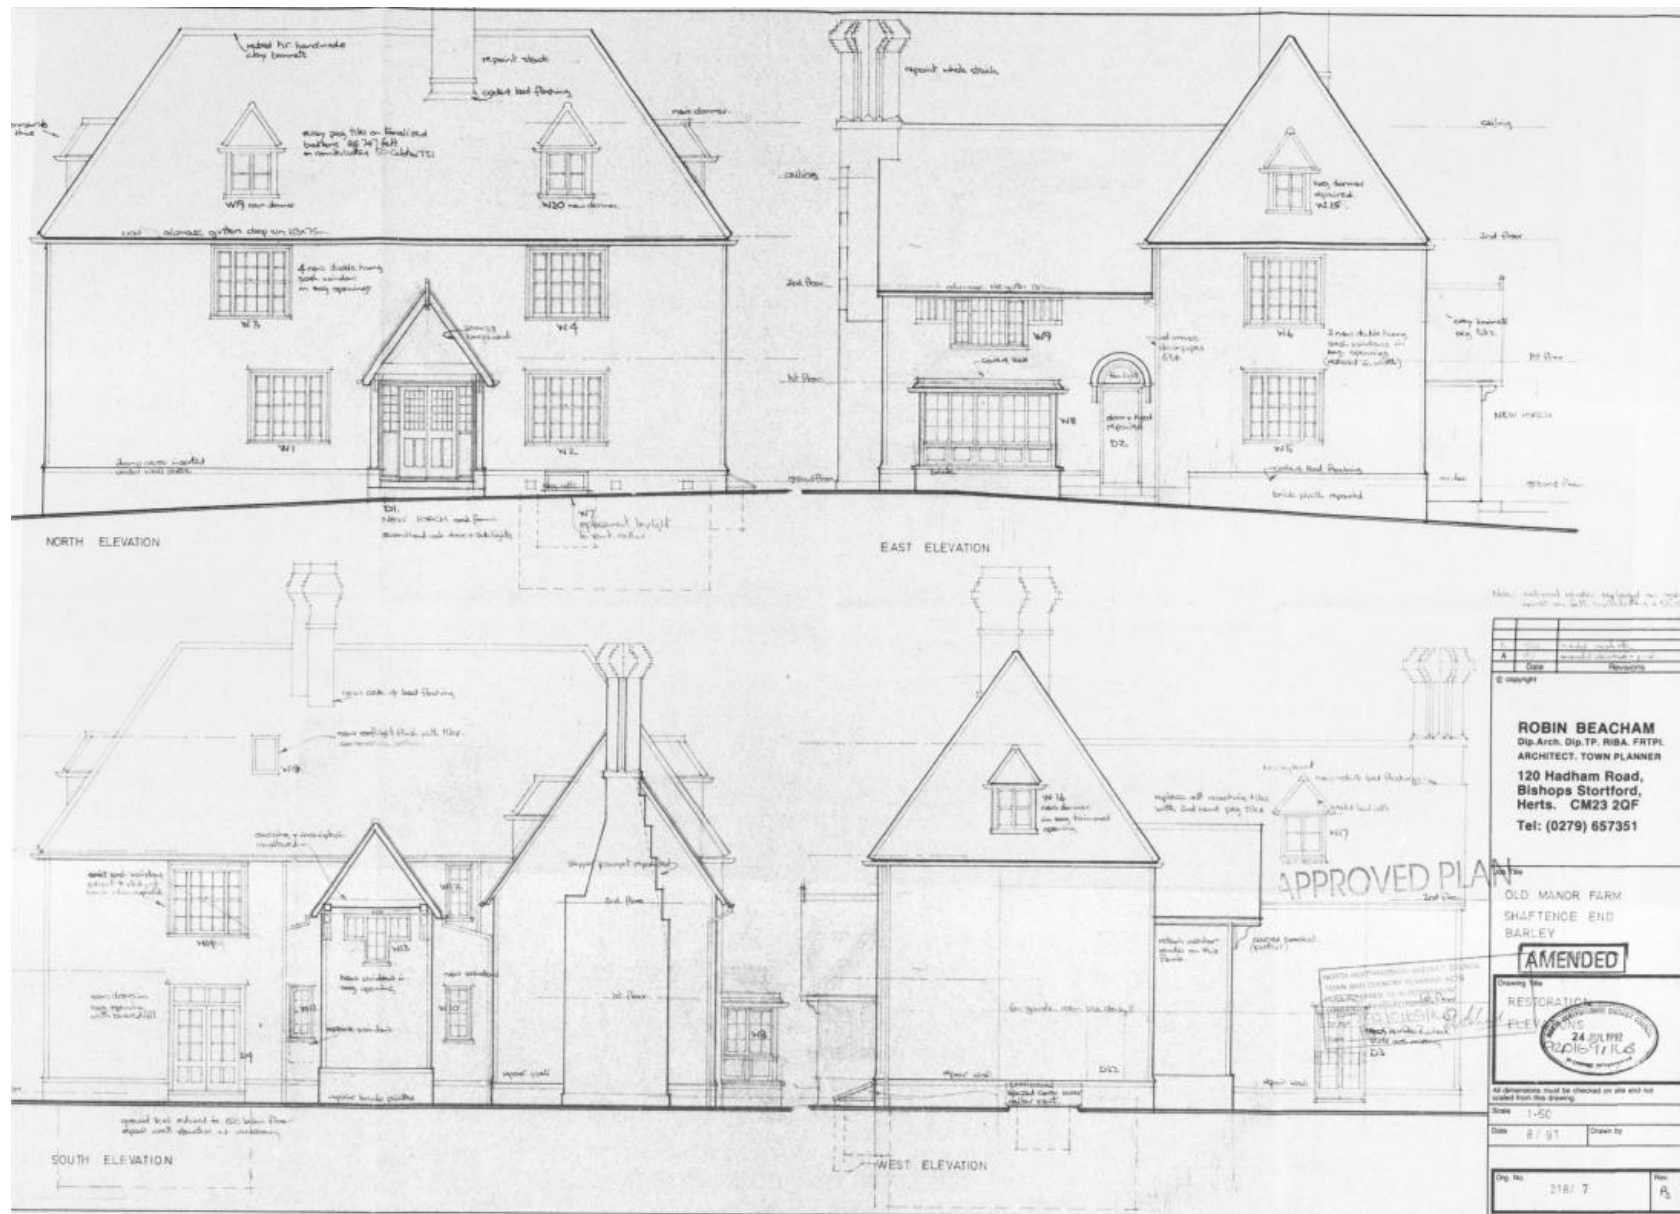
**Figure 4.38:**  
 Proposed  
 elevations for  
 Application  
 Reference:  
 92/00169/1L  
 B).

We know from Figure 4.37 and 4.38 that all windows on the front elevation of the main range date to the mid 1990s following approval of Application Reference: 92/00169/1LB). This consent also approved the construction of the existing porch and the two dormers on the front roofslope.

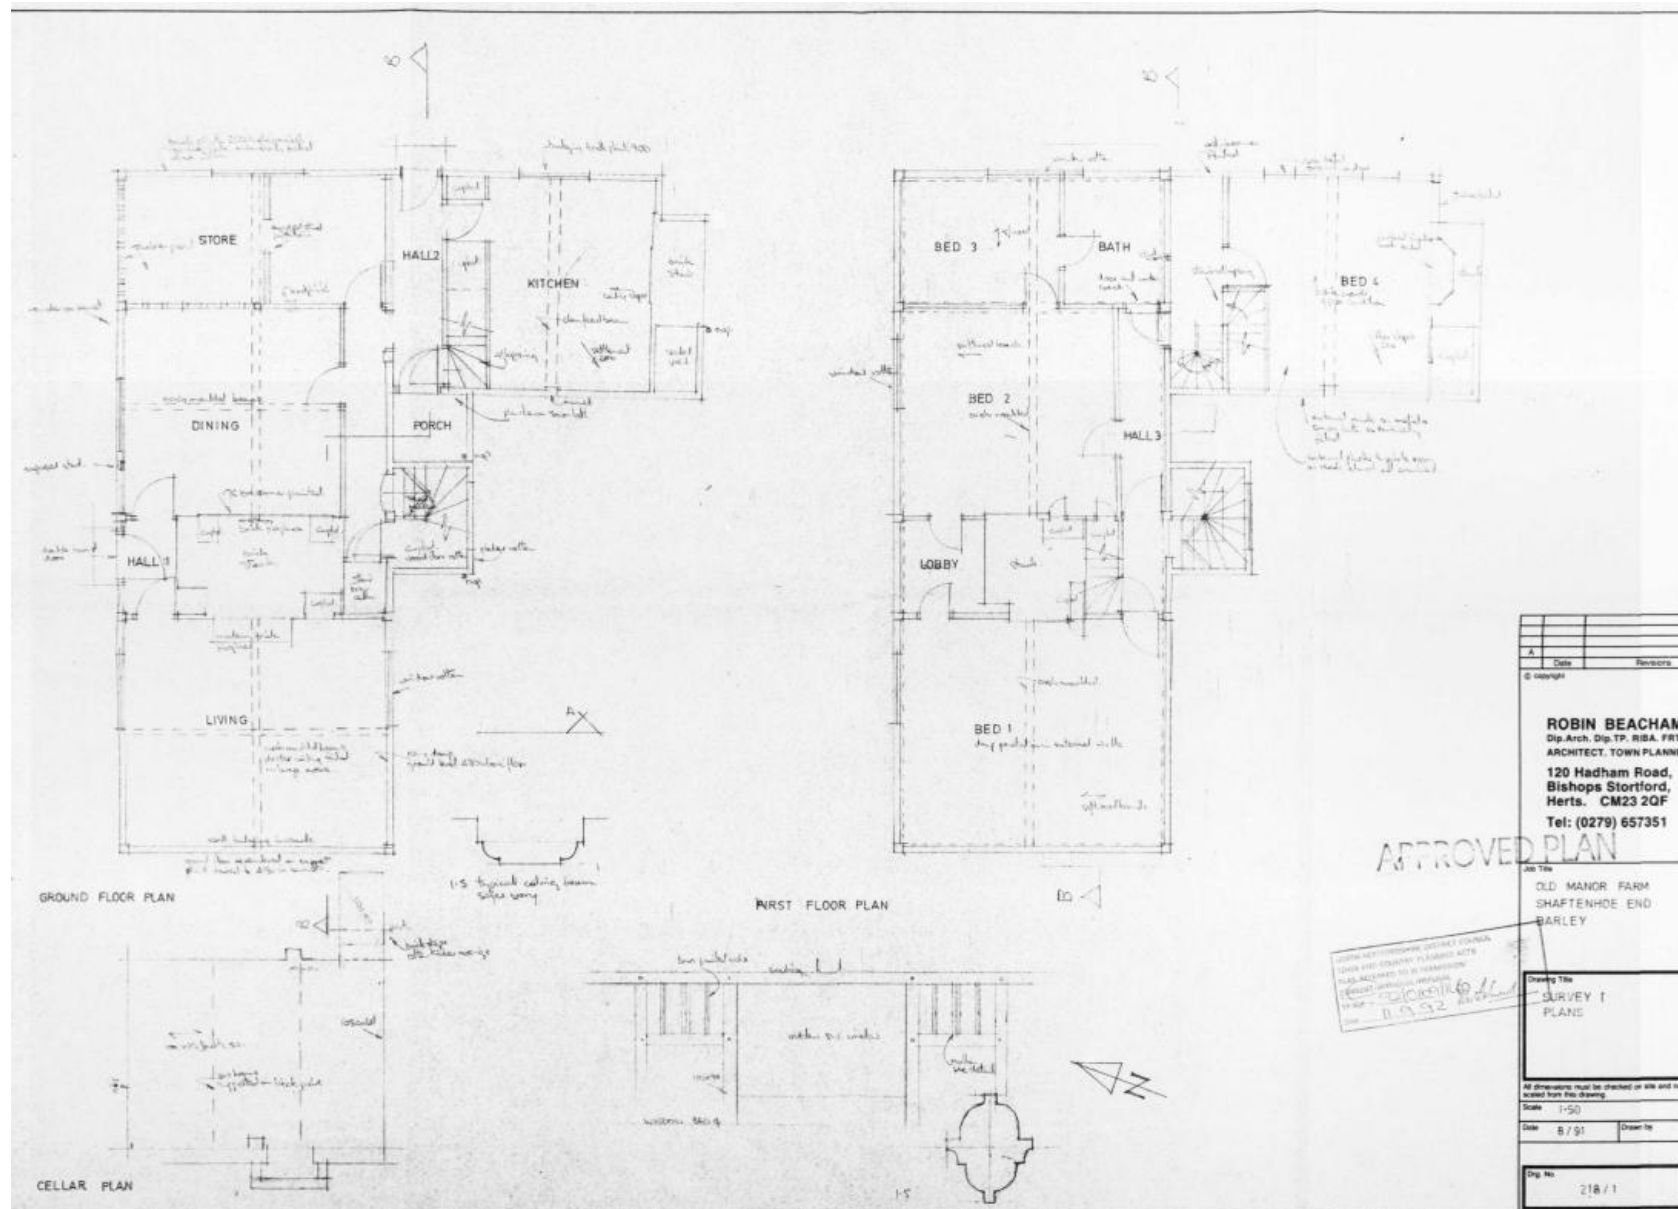
**Figure 4.39:** Existing floor plans for Application Reference: 92/00169/1LB).

The steps from the cellar have historic red brick steps, which may have been rebuilt in the 1990s phase of works. The existing plan from 1992 at Figure 4.39 comments that these steps had bricks steps with rotten timber nosings at that time. These nosings have been replaced with concrete since that time, which is a low grade material and is also incompatible with the breathability required for historic buildings constructed of traditional materials. For these reasons the concrete detracts from significance.

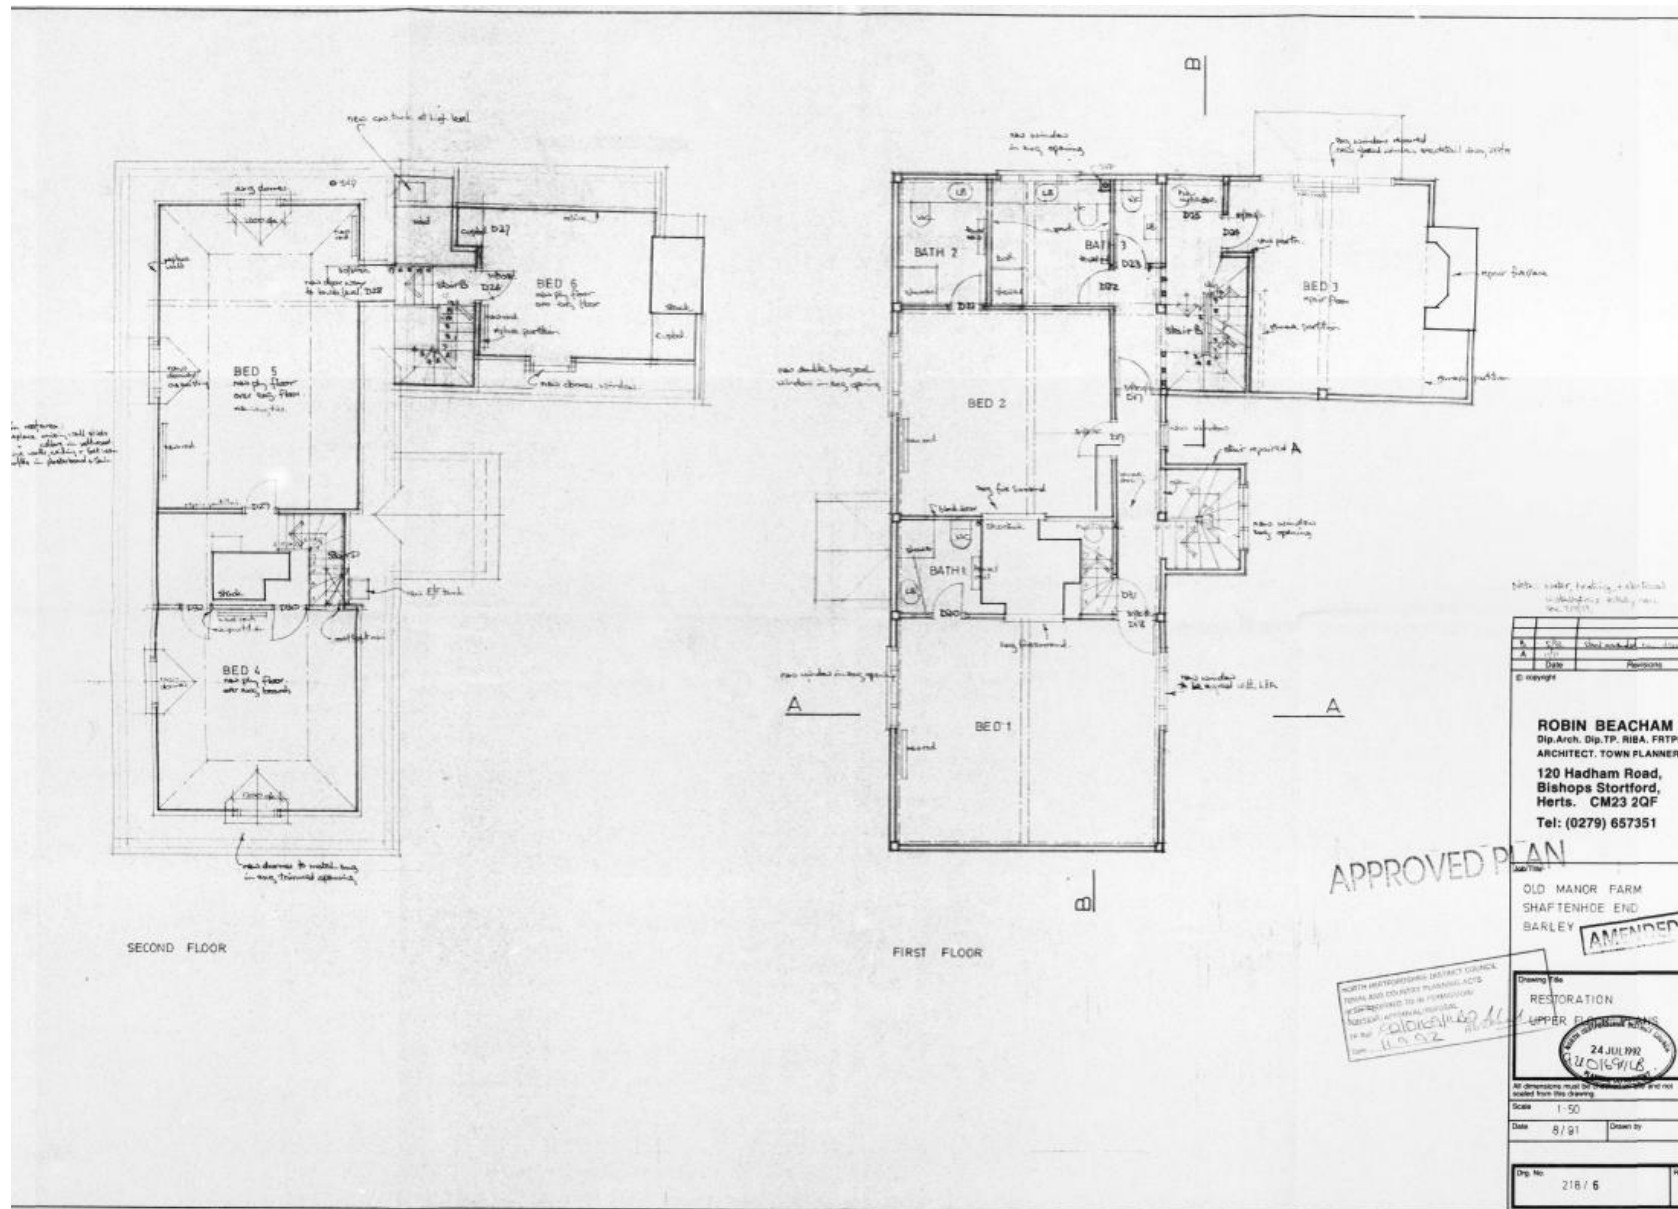
**Figure 4.41:** Proposed first and second floor plans for Application Reference: 92/00169/1LB).

In the Western Bedroom's dressing room the wall that runs from the Western Bedroom's chimneybreast to the southern elevation was found to contain lime plaster. This indicates this is an historic wall and was present on the 1992 first floor plan shown at Figure 4.41. This wall was not therefore removed as part of the strip out works.

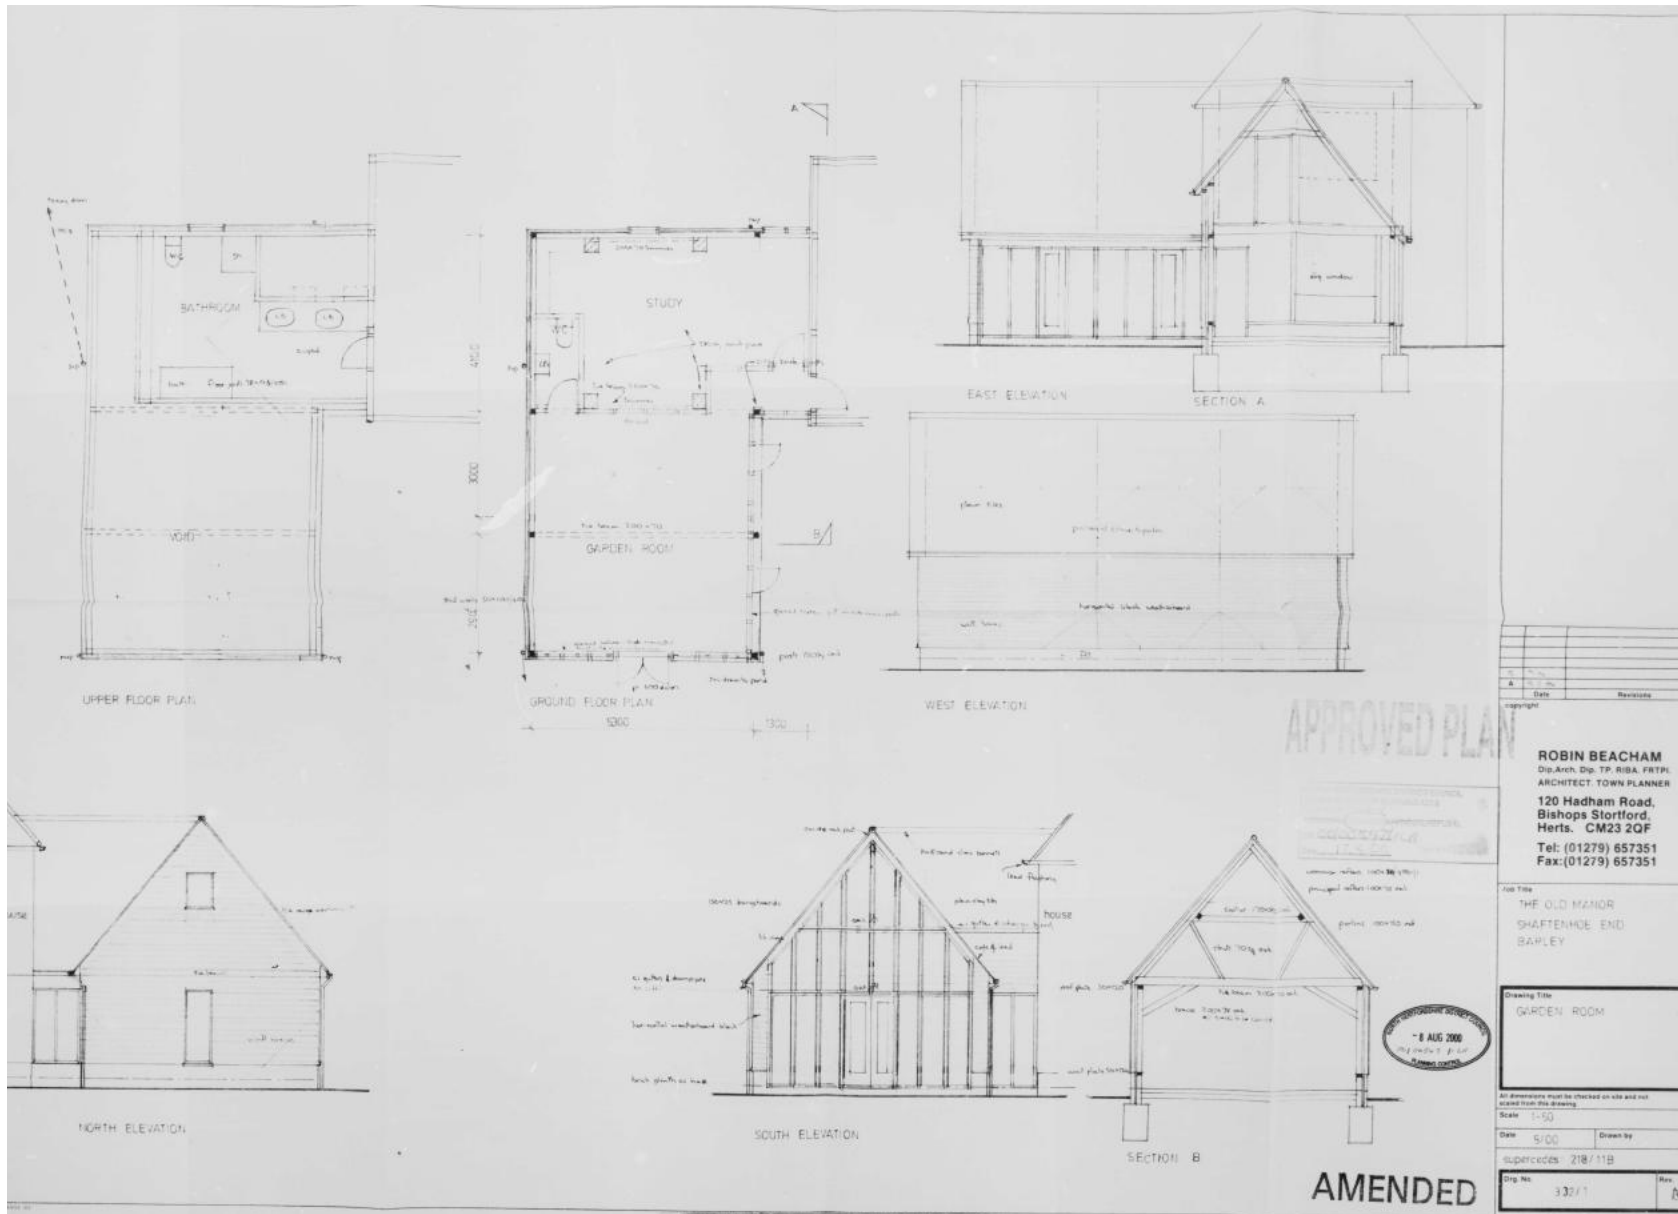
**Figure 4.43:** Proposed revised elevations for the sun/garden room under Application Reference: 00/00847/1LB.

On the western side of the main house is a 'sun room' built as part of the 1993 consent as shown by Figure 4.42 with later alterations following approved Application Reference: 00/00847/1LB). This is clad with timber weatherboarding laid horizontally and painted black in the traditional manner. This has a modern single light casement window with transom at ground floor level with large panes and a single light casement in the gable end. This garden wing is attached to the main house via a single storey element under a steeply pitched gabled roof covered with red clay plain tiles. The sun room's roof also includes a gable facing north covered with red clay plain tiles.

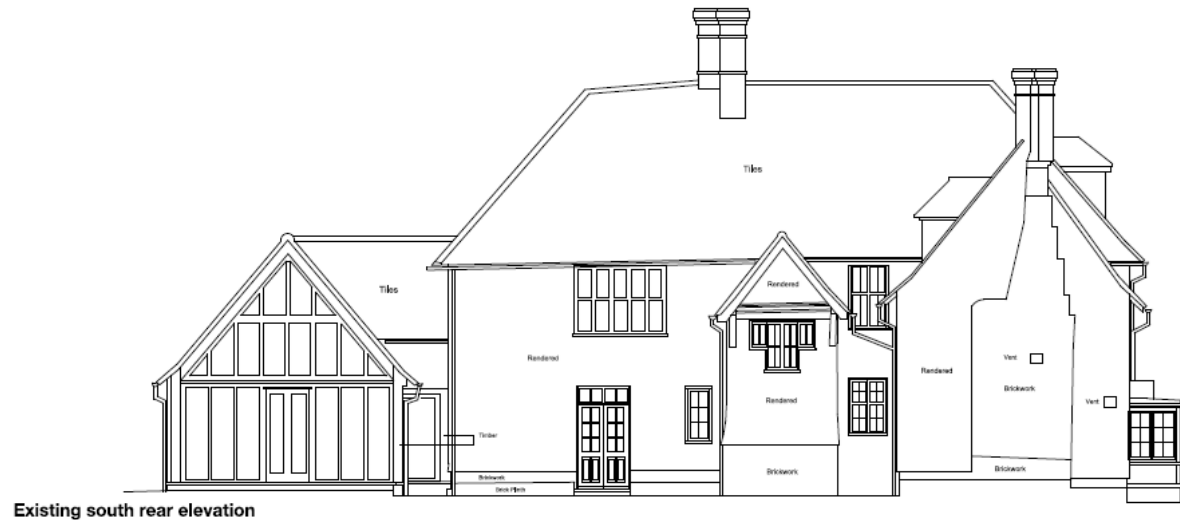
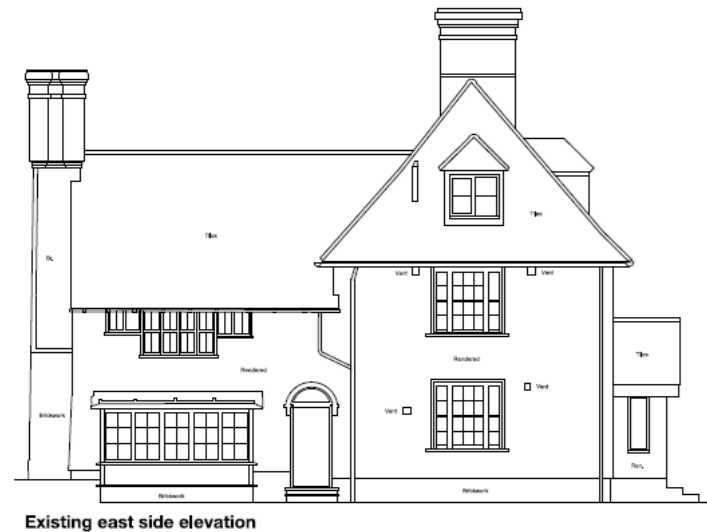
**Figure 4.44:**  
Existing east  
and south  
elevations for  
Application  
Reference:  
22/03038/  
LBC.

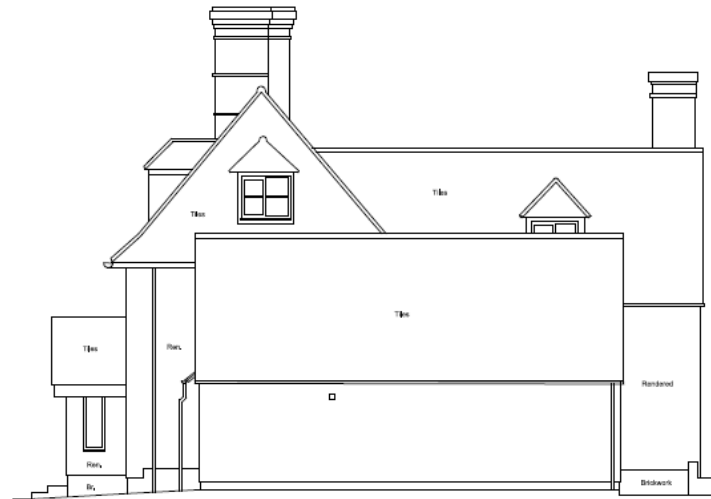
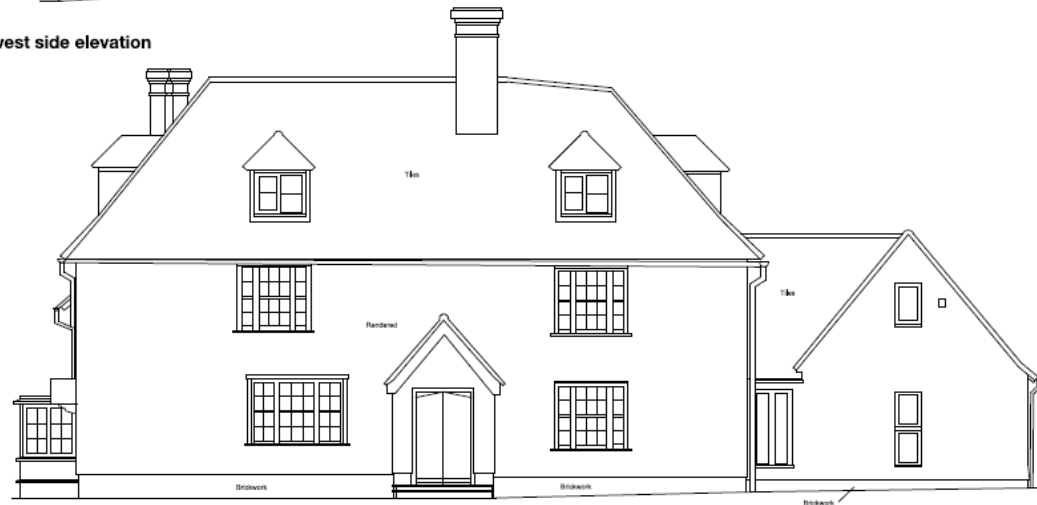
**Figure 4.45:**  
Existing west  
and north  
elevations for  
Application  
Reference:  
22/03038/  
LBC.

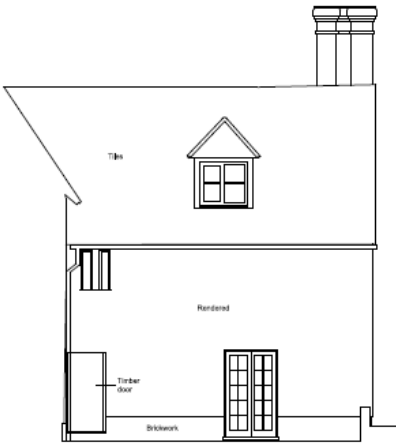
**Figure 4.46:**  
Existing  
courtyard  
elevations for  
Application  
Reference:  
22/03038/  
LBC.

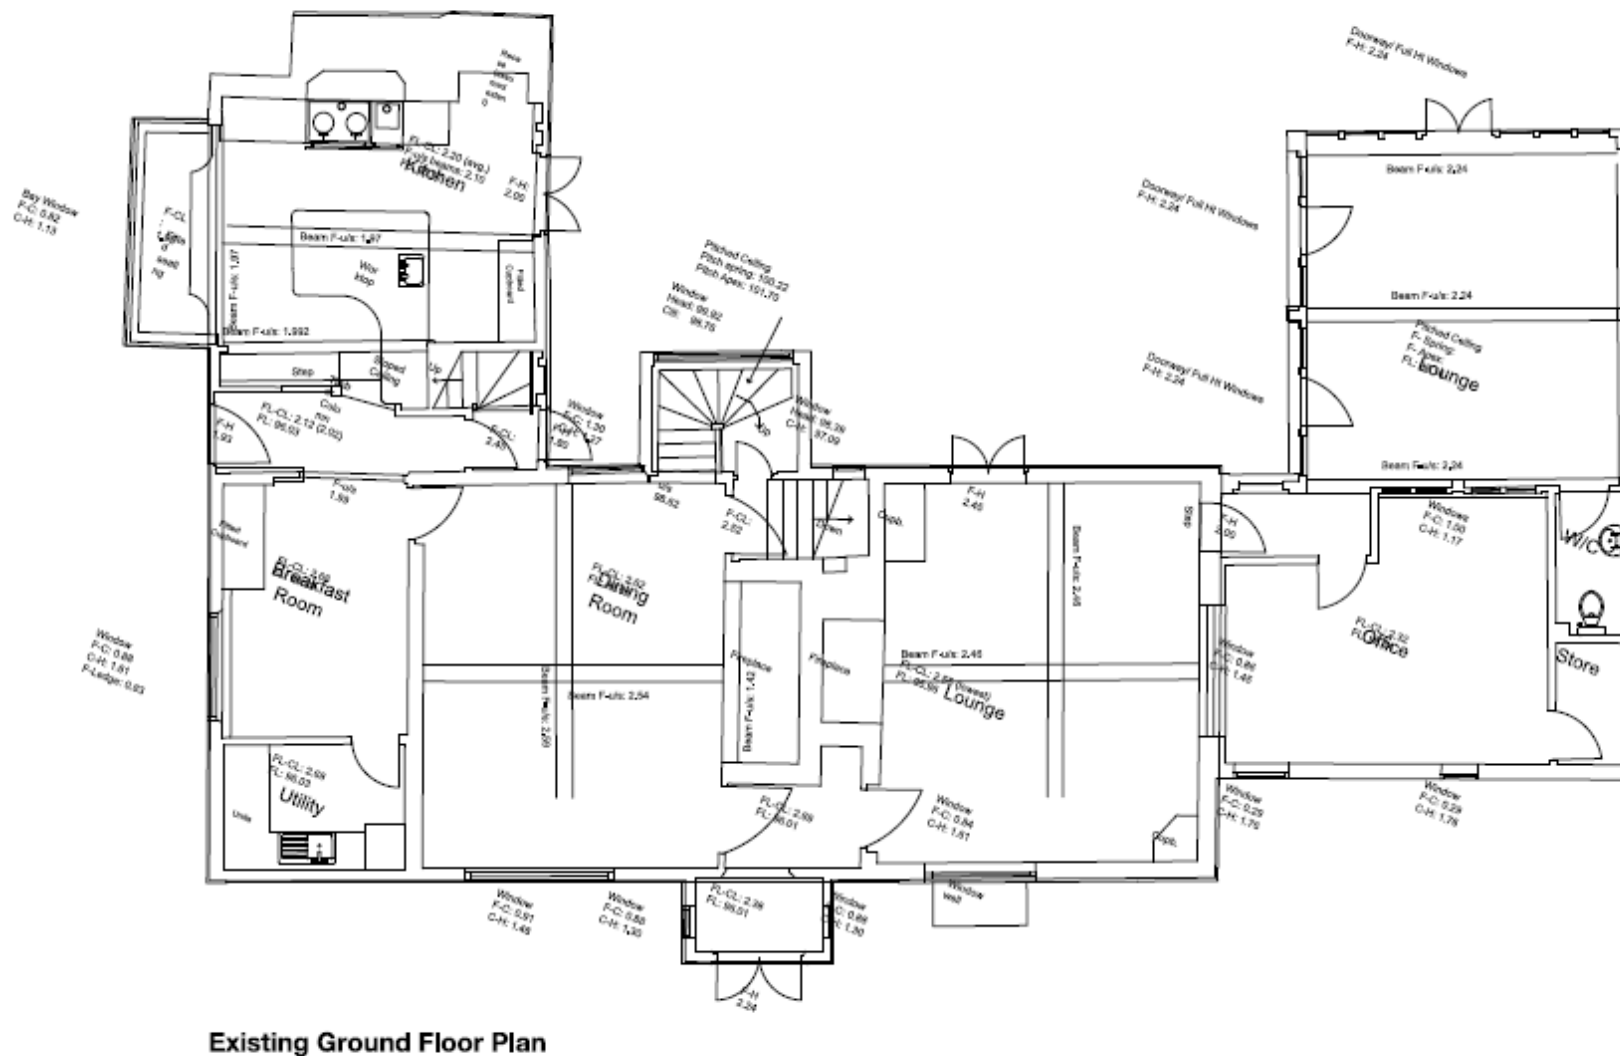
**Figure 4.47:**  
Existing  
ground floor  
plan for  
Application  
Reference:  
22/03038/  
LBC.

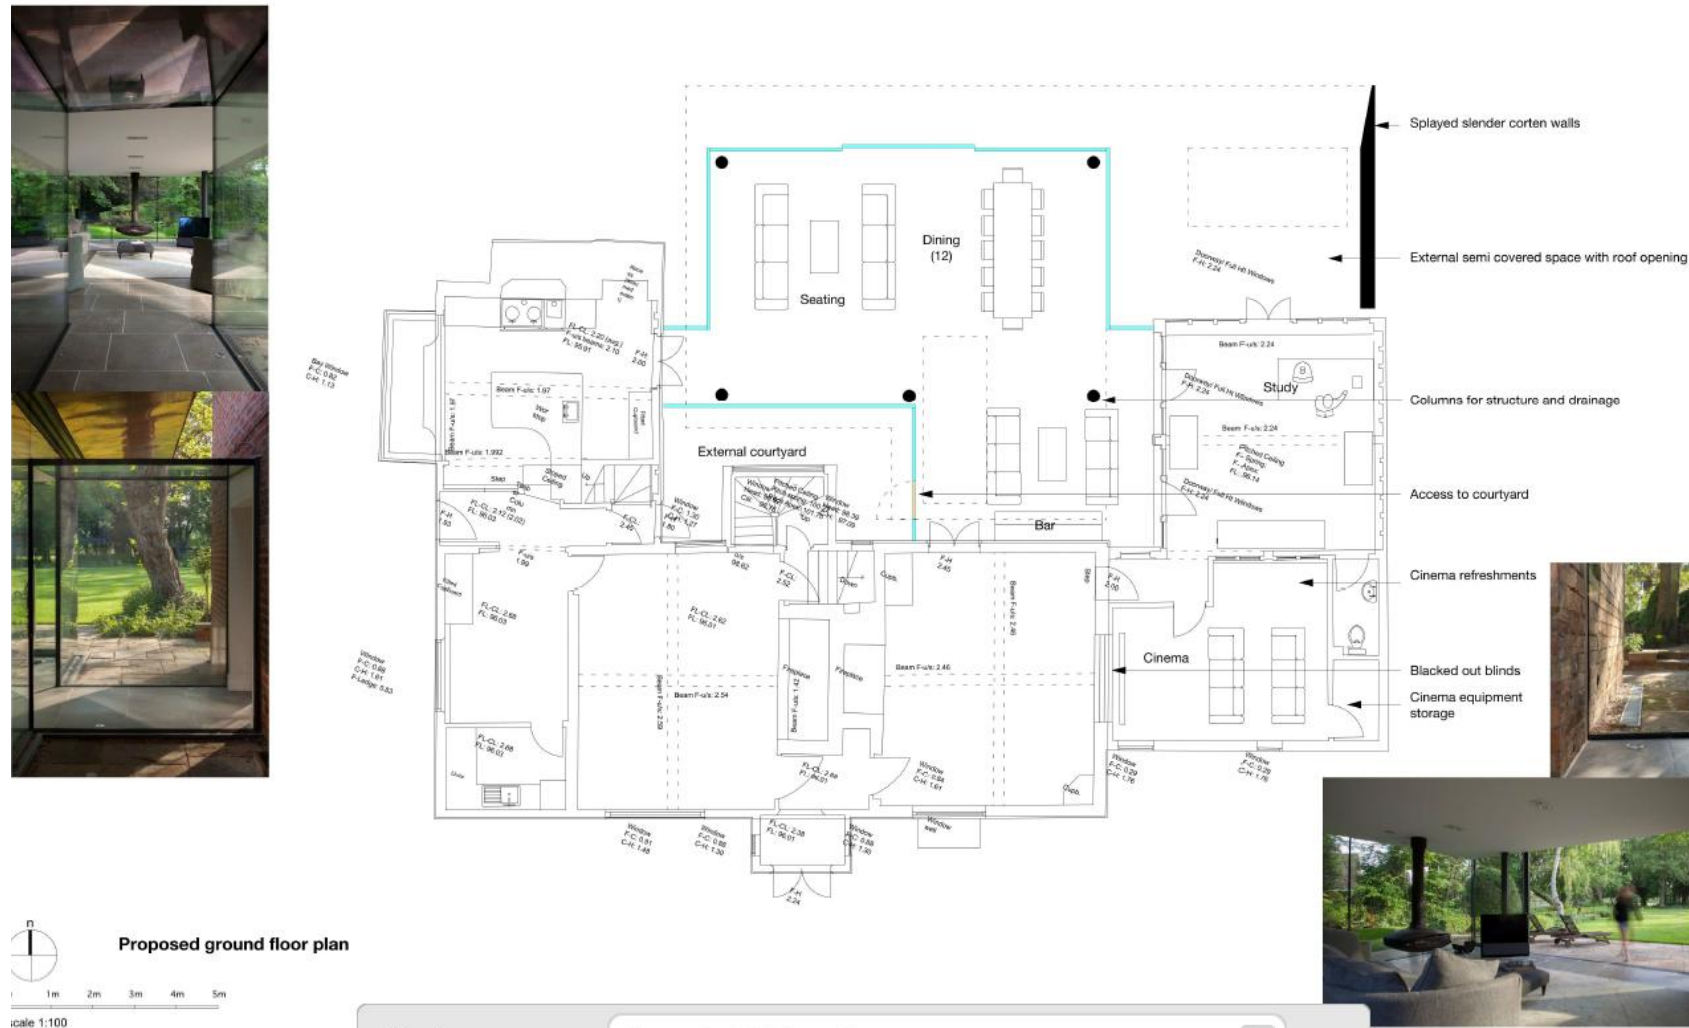
**Figure 4.48:**  
Proposed  
ground  
floor  
plan  
for  
Application  
Reference:  
22/03038/  
LBC.

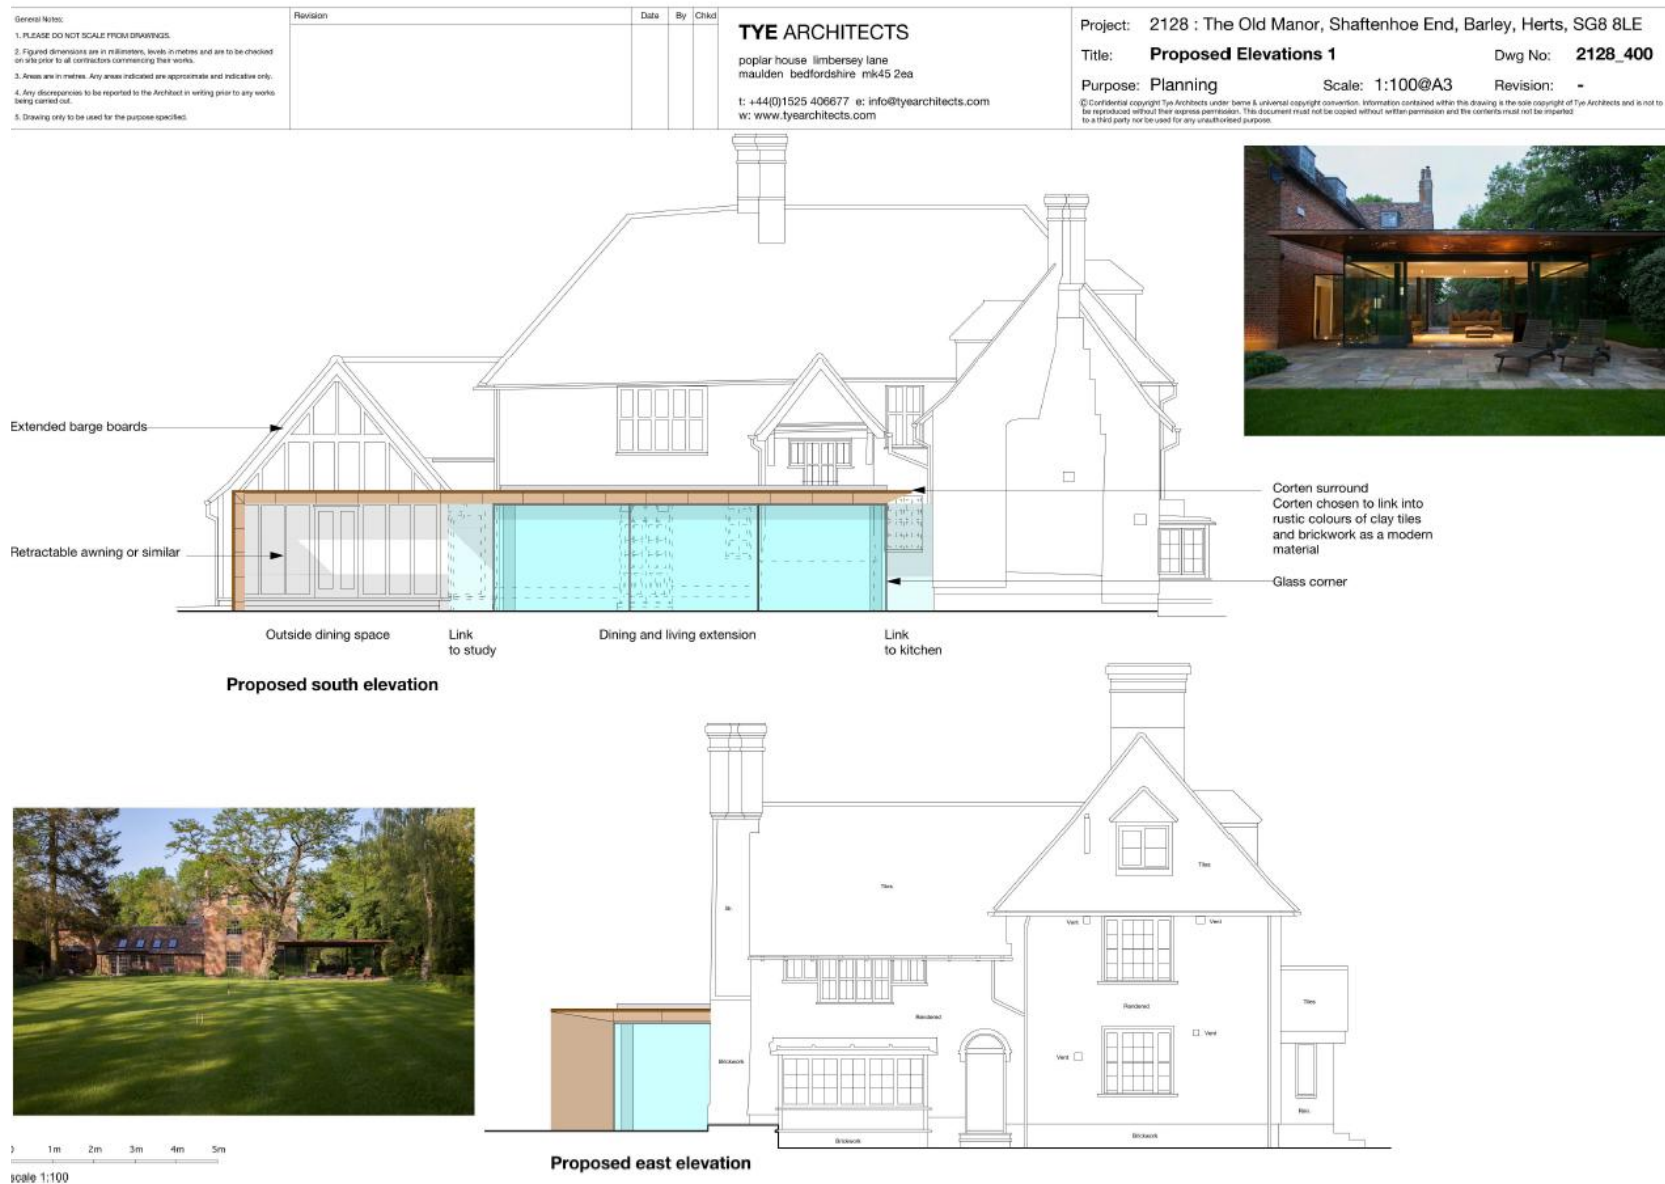
**Figure 4.49:**  
Proposed south and east elevations for Application Reference: 22/03038/LBC.
