Old Manor Farm House, Shaftenhoe End,  
Hertfordshire, SG8 8LD

Heritage Statement

Local Planning Authority: North Hertfordshire District Authority

September 2025

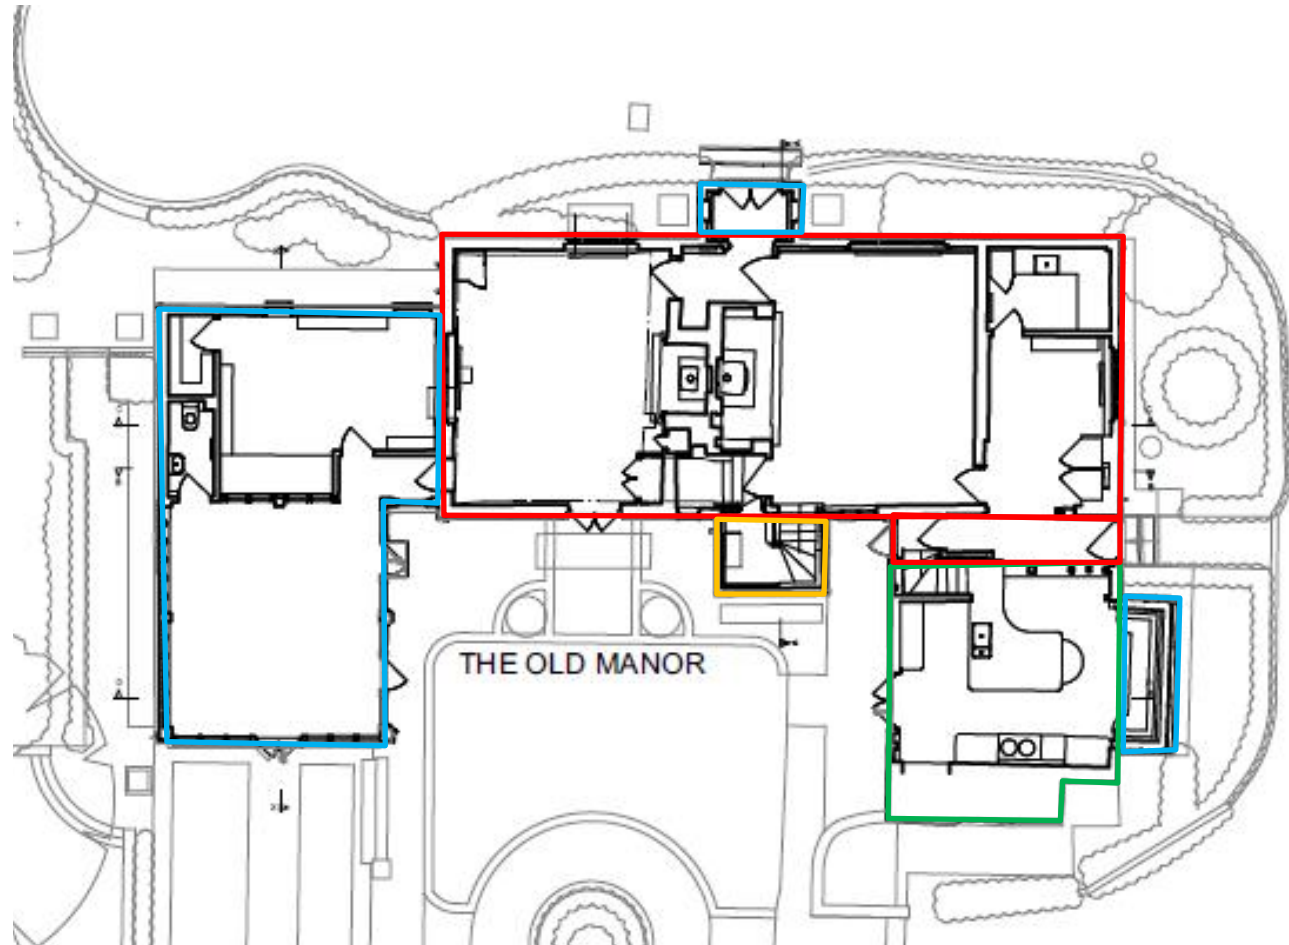
**Figure 4.50:** Showing the phasing of the house. The following key has been used:

The front elevation of the main range was built over two storeys and across two bays. The western or 'hall' bay is larger than the eastern or 'parlour' bay. The main range of the house has a lobby entrance house with an extra bay to the east which historically was unheated and may have been a service room. It is likely that the kitchen cross wing to the rear was originally a single storey and built in the 16th century, the main hall (which replaced an older hall) is likely 17th century (possibly 1624 specifically) and the stair wing addition dates to approximately 1700.

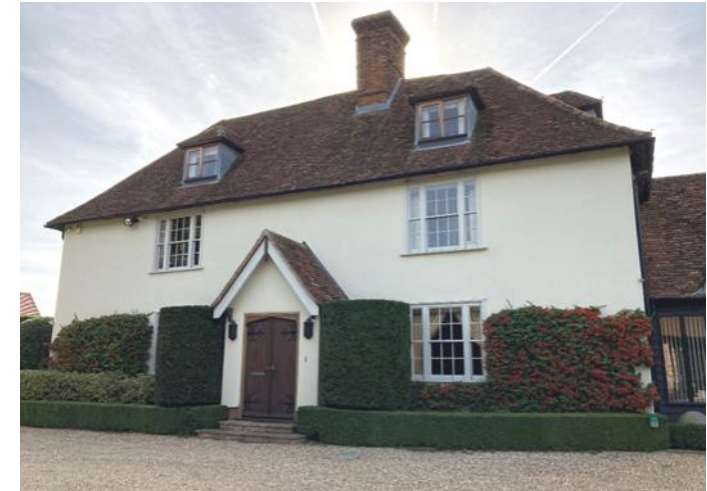
Figure 4.51: Showing the northern (front) elevation.

The roof also includes two hipped dormers from the 1990s, as discussed each with a modern 2-light timber casement of no heritage value. Their roofs are covered with red clay plain tiles and red clay hip tiles. The dormer jambs are rolled lead.

Off centre at roof level is a red brick chimneystack built of historic red brick laid in eclectic bond. The chimneystack is positioned between the two main ground floor rooms; the western room (sitting room) and the central room (dining room) at ground floor, and the western bedroom and north-eastern bedroom at first floor. The stack has a dogtooth cornice.

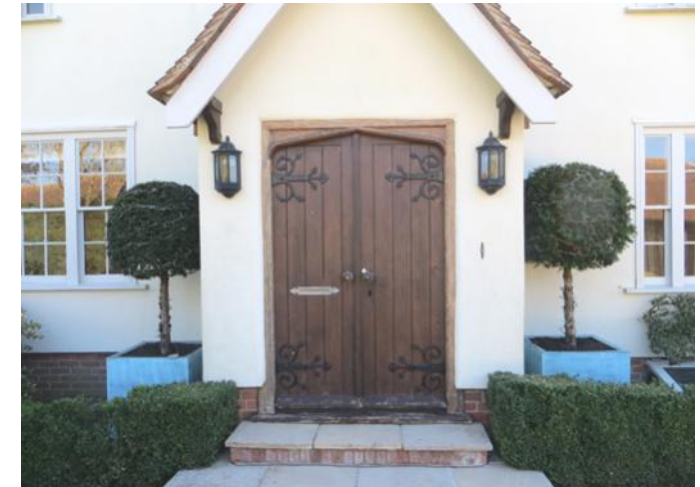
Figure 4.52: Showing the front porch.

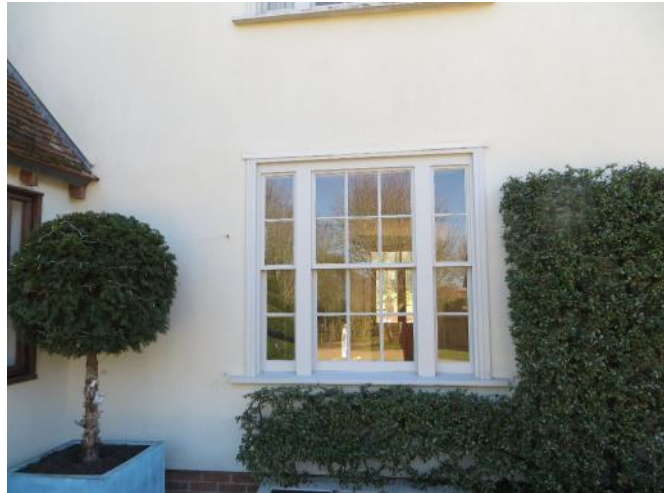
**Figure 4.53:** Showing the western ground floor window.

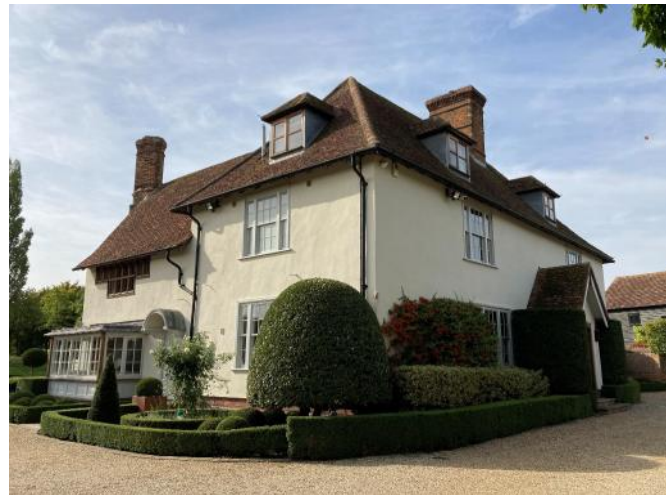
**Figure 4.57:** Showing the northern and eastern elevations.

The elevation has been rendered and painted (cream). The windows match those installed on the front elevation and also date from the 1990s, which appear somewhat out of place on the vernacular building, and replaced historic casements as part of the 1990s phase of works.

The window positions across the elevation have been brought forward in relation to their original positions due to the external insulation cladding (Celotex) that was approved as part of the 1990s consent. The bringing forward of the window position and use of non-breathable Celotex are both considered to detract from significance. The windows each have lead lipped details above to shed rainwater.

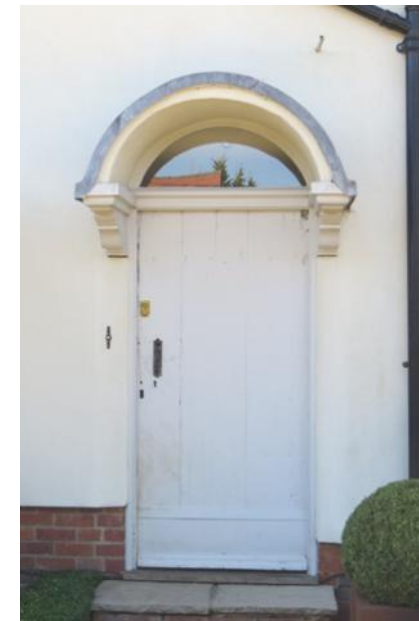
**Figure 4.60:** Showing the eastern doorway. Note the historic plank door.

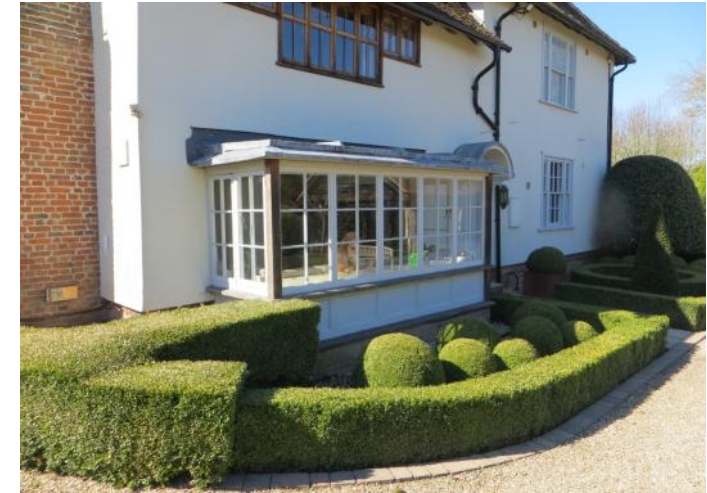
**Figure 4.62:** Showing the 1990s bay window at the southern end of the eastern elevation.

At ground floor level at the southern end of the kitchen cross wing is a large flat roofed rectangular bay window of 5-lights. Its roof is covered with rolled lead with periodic standing seams. It has a red brick plinth laid in stretcher bond and a good quality timber frame above. All these elements again date to the 1990s and replace a small 4-light casement.

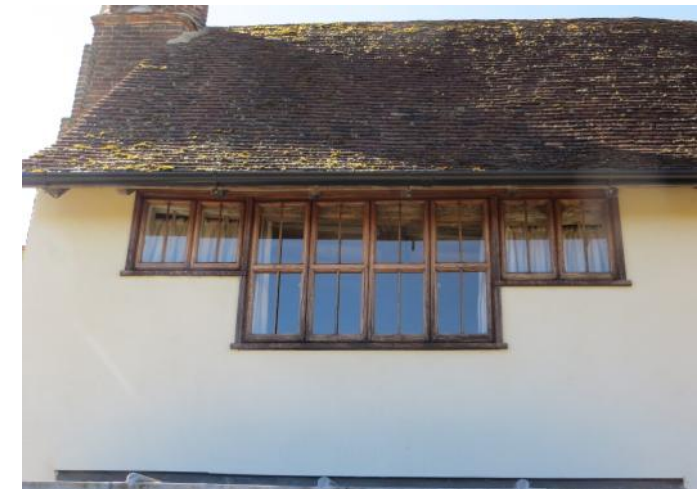
**Figure 4.63:** Showing the first floor southern window.

At first floor level is a large irregularly shaped casement window of 8-lights, with a lower pane and transom in the centre 4-lights. The window is vernacular in character and matches the original window revealed internally as part of the 1990s phase of works.

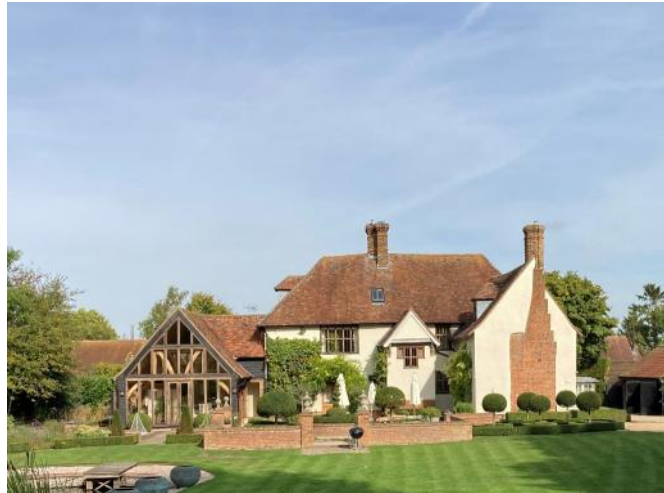
**Figure 4.64:** Showing the southern elevation.

Again the elevation above the plinth is rendered and painted (cream). The elevation is visually dominated by a large chimneystack, which tapers as it rises. The latter is an external red brick stack, tapering with crowsteps to the right hand side to conjoined diagonal shafts with a moulded base and oversailing cap, characteristic of 17th century stacks and appears to date to that period. This turned stack is evident in the 1890 drawing at Figure 4.1.

The chimneystack in the south-eastern range is external and would appear to have been added when this range was increased in height. However, if this

range was built as a kitchen it would have needed a hearth. It may have had an external stack originally but could just as easily have had an open hearth and a louvre.

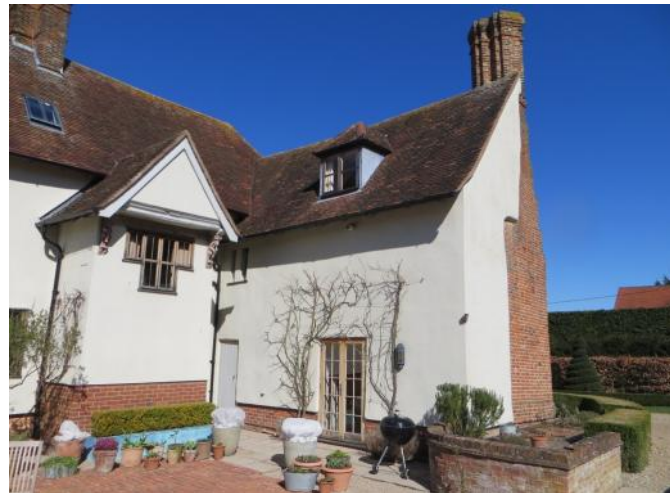
**Figure 4.67:** Showing the western elevation of the kitchen cross wing.

There is a doorway at the northern end of the kitchen cross wing's western elevation, which used to provide access to the mid-late 20th century small infill extension (the latter detracted from significance and has since been removed).

An external west doorway into the western elevation of the kitchen cross wing is visible on an historic photograph from 1911 (see Figure 4.3), at which point there was no infill between the kitchen cross wing and the stair wing. The RCHM report of 1994 comments that this doorway may have been the historic access point to the kitchen cross wing. Furthermore, along with a corresponding external doorway on the eastern elevation of the kitchen cross wing, it may indicate an original open passage between the detached kitchen cross wing and the main range (i.e. that the kitchen cross wing was detached from the main range). Such instances were not uncommon in the Tudor period due to the threat of fire. As such, this east-west movement route, and the external access into the kitchen cross wing from the west, are of some considerable historical significance. The present door on the western elevation is a good quality modern ledged boarded door.

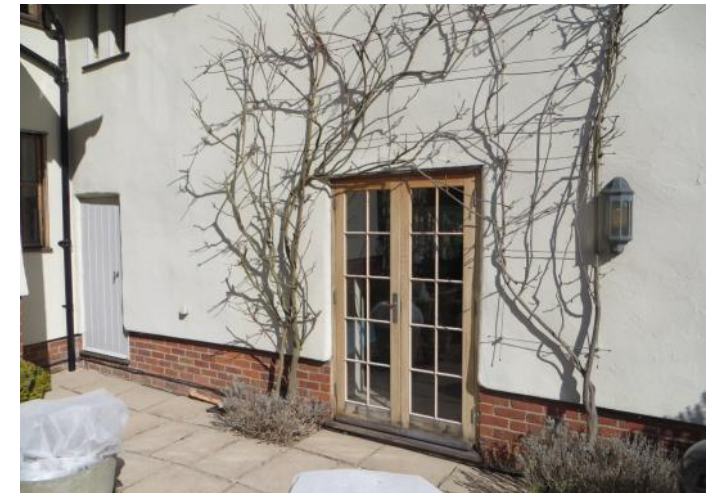
**Figure 4.68:** Showing the French windows installed on the western elevation of the kitchen cross wing.

Again the elevation above the plinth is rendered and painted (cream). At the southern end of the elevation at ground floor are a pair of good quality timber French doors installed in the 1990s of no heritage value. We know from the 1911 photograph at Figure 4.2 that there was no opening in this location at that time and a doorway was also not present in 1992-94 (see Figure 4.7). The same two historic images also show there were no dormers historically on the western roofslope of the kitchen cross wing at these times. As seen today there is a matching hipped dormer as that seen on the northern and eastern elevations including lead jambs and a modern 2-light timber casement. This dormer forms part of the 1990s phase of works.

At the southern end of the elevation at ground floor are a pair of good quality timber French doors installed in the 1990s of no heritage value. We know from the 1911 photograph at Figure 4.2 that there was no opening in this location at that time and a doorway was also not present in 1992-94 (see Figure 4.7). No historic fabric would therefore be lost here.

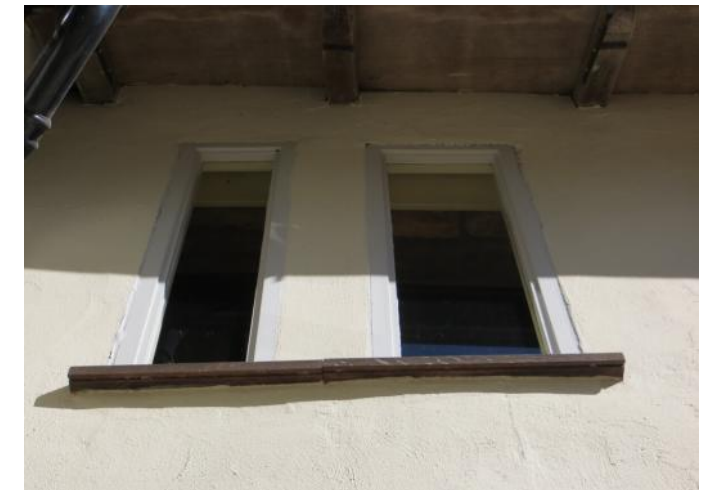
**Figure 4.69:** Showing the first floor windows at the northern end of the kitchen cross wing.

At the northern end of the kitchen cross wing are a pair of single light windows inserted in the 1990s phase of works

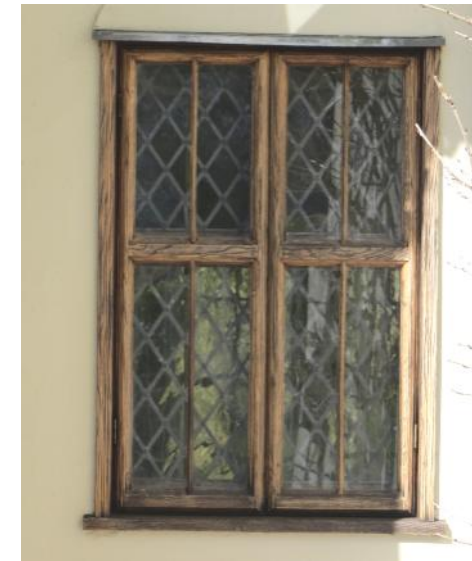
**Figure 4.71:** Showing the eastern ground floor window on the main range.

At the eastern end of the main range's ground floor is a modern 2-light timber casement with transom. The RCHM report mentions that the stair wing covers the western light of an historic 17th century 3-light casement window, which is a crucial dating tool confirming that the stair wing is later than the main wing. The modern 2-light casement set in front of it dates from the 1990s and again has been set forward from the window opening's original position due to the installation of external cladding to the building, expanding the latter's proportions. The window has a lead lipped detail above to shed rainwater.

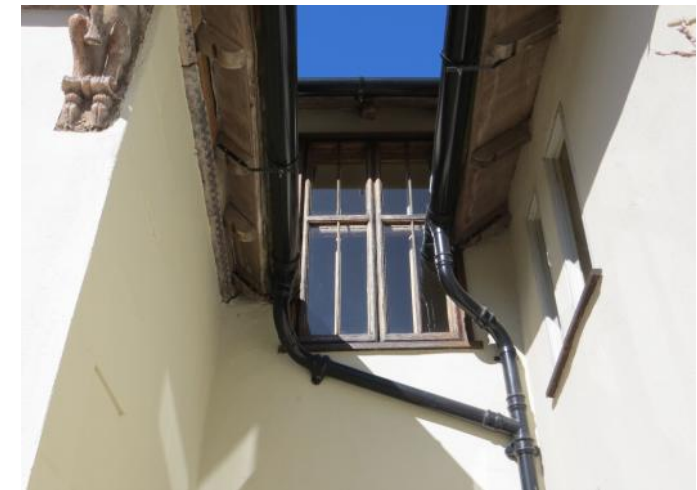
**Figure 4.72:** Showing the first floor window at the eastern end of the main range.

The 1911 historic photo at Figure 4.2 shows that there was no window at first floor at that time. The present first floor window above matches that at ground floor and also dates to the 1990s. The window has a lead lipped detail above to shed rainwater. An

historic 4-light window is present in this location internally and was evidently concealed externally in the 1911 photograph. One of the historic lights of the 4-light window is set behind the eaves of the kitchen cross wing and this also confirms that there was an open passage between the kitchen cross wing and the main range originally. Another light of the 4-light window is set behind the stair wing, confirming that the latter is later than the main range.

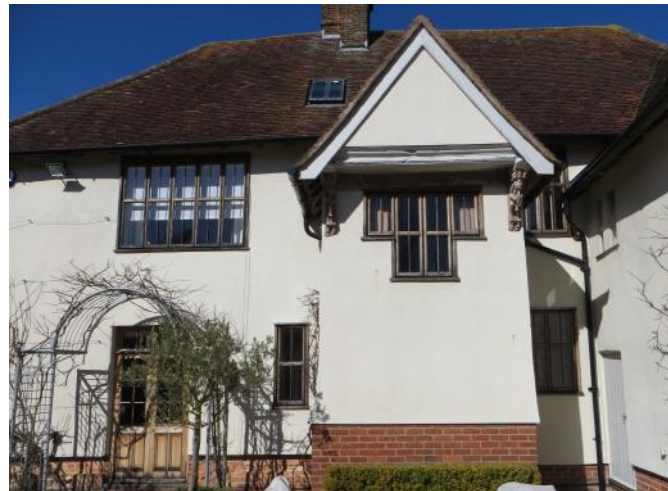
**Figure 4.73:** Showing the stair wing.

Further west is the historic rear stair wing projection. The red brick plinth has been rebuilt at low level in stretcher bond with modern bricks. Above the stair core is rendered and painted (cream). At first floor level is a 4-light timber casement, with the central 2-lights only having two panes and a transom. We know from the 1911 photograph at Figure 4.3 that the present window is not historic. Nor was it present in 1992-94 (see Figure 4.7). The stair core has a gabled roof above, which is jettied slightly from the stair core's southern elevation. The bressummer of the oversailing element is notably historic and moulded. The jettied gable is supported by two wooden brackets, each carved into a satyr playing a pipe. The wooden rail above the window bears the inscription 'SO GOD MAY STILL ME BLESSE, I CARE THE LESSE, LET ENVY SAY HER WORST, AND AFTER BURST', along with the initials 'W. L.' and the date '1624', which may represent the (re)building of the main hall. Whatever the case, the RCHM report of 1994 concluded that the inscription has been re-sited, and does not (in all probability) reflect the date of construction of the stair wing. The stair core's gable has plain timber bargeboards. Its gabled roof has red clay plain tiles and red clay ridge tiles.

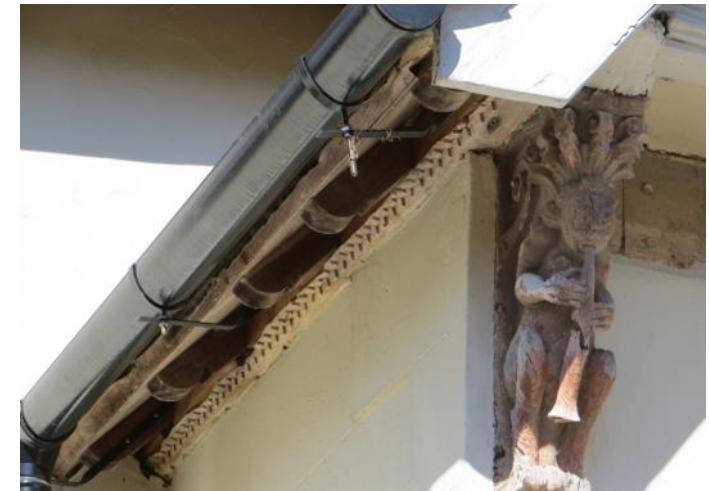
On the western and eastern elevations of the stair wing is a 16th or 17th

century dentilled timber cornice at eaves level.

**Figure 4.74:** Showing dentilled cornice on the western elevation of the stair wing. Note the carved satyr.

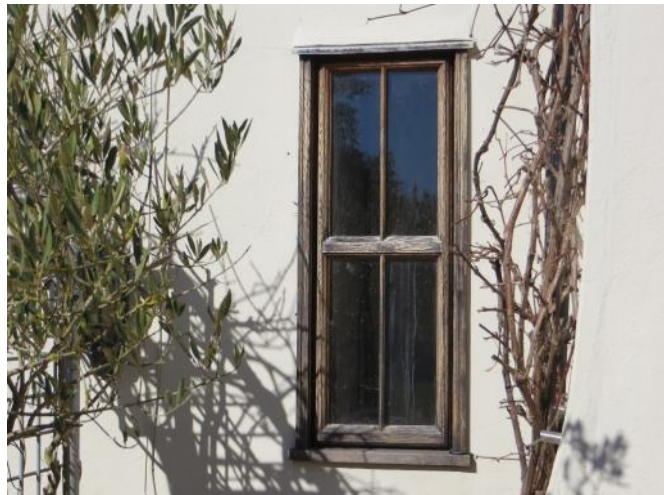
**Figure 4.76:** Showing the ground window serving the cellar stairs.

West of the stair wing is a modern timber casement window installed as part of the 1990s phase of works. This is larger than the window shown at Figure 4.3 dating from 1911. The window serves the cellar staircase and has a lead lipped detail above to shed rainwater.

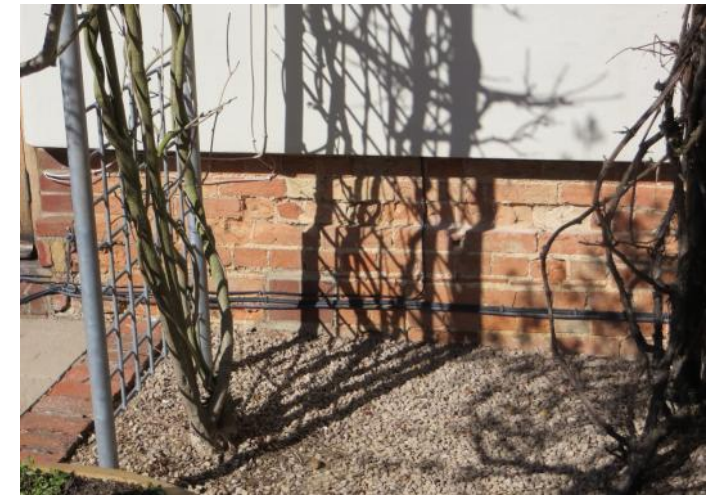
The only part of the main range's plinth that is historic is either side of the modern French doors. That said these bricks appear to be a mixture of some modern bricks, some 19th century brickwork and many are cracked. None of these bricks appear to be pre-19th century.

**Figure 4.77:** Showing the plinth brickwork east of the French windows.

At the western end of the main range's ground floor are a pair of modern single glazed French windows. These were not present in 1992-94 as confirmed at Figure 4.7 where a wider window is shown in this location. The existing doors are therefore considered of no heritage value. The only part of the main range's plinth that is historic is either side of the modern French doors. That said these bricks appear to be a mixture of some modern bricks, some 19th century brickwork and many are cracked. None of these bricks appear to be pre-19th century.

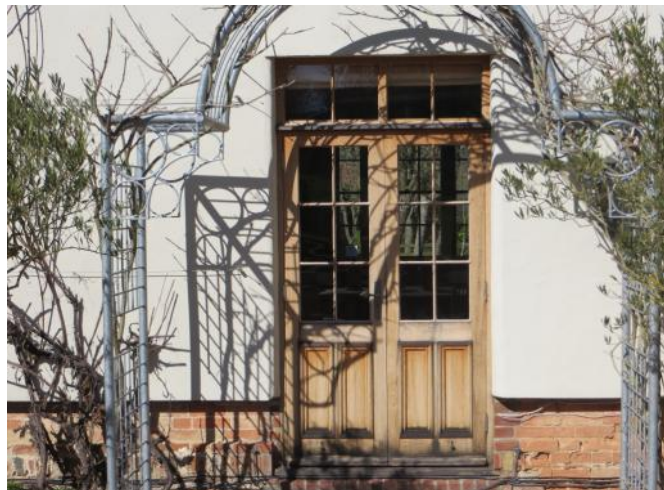
**Figure 4.78:** Showing the French doors on the southern elevation of the main range.

At the western end of the main range's ground floor are a pair of modern single glazed French windows. These were not present in 1992-94 as confirmed at Figure 4.7 where a wider window is shown in this location. The existing doors are therefore considered of no heritage value. The same photograph shows no window at first floor above and the RCHM report found no evidence of a window in this location historically. The present window at first floor is a good quality 5-light timber casement with transom, which approximately copies the style of the window previously concealed in the western gable end until the 1990s phase of works.

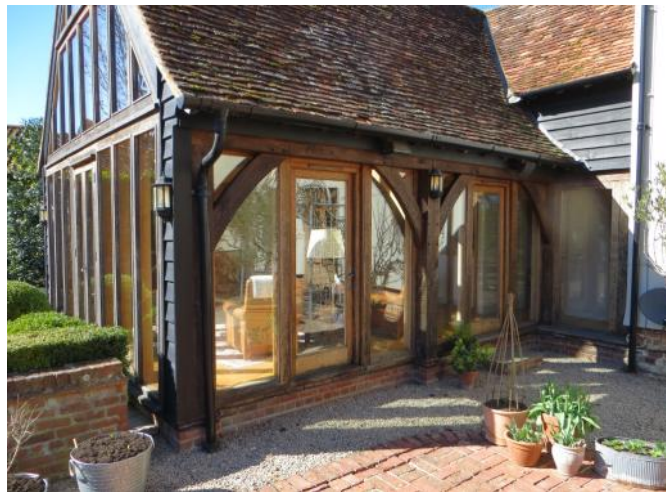
**Figure 4.82:** Showing the eastern return elevation of the sun room.

The sun room is a high quality contemporary addition dating from the early 2000s including later alterations approved Application Reference: 00/00847/1LB. The sun room blends timber framing as a nod to the construction method of the main house, gabled roofs covered with red clay plain tiles (again to match the host building), and contemporary elements such as large (double glazed) glass panes between the timber members. There are also occasional elements clad

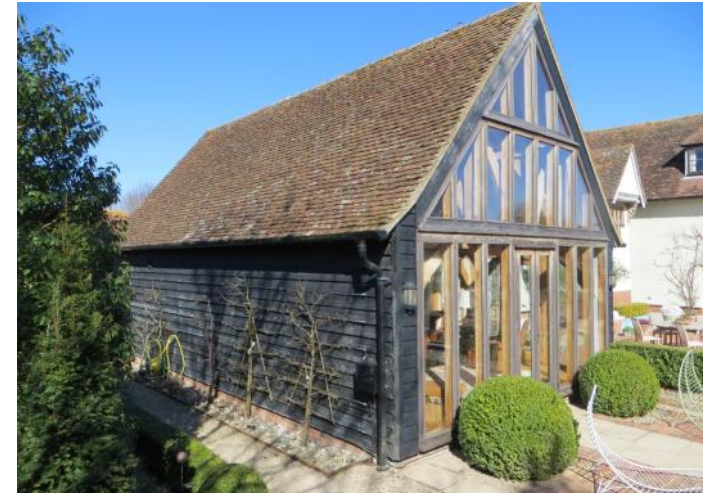
**Figure 4.85:** Showing the western and southern elevations of the sun room.

The western elevation is entirely clad with horizontal timber weatherboarding coated black in the traditional manner. The rainwater goods are sympathetic aluminium examples of no heritage value.

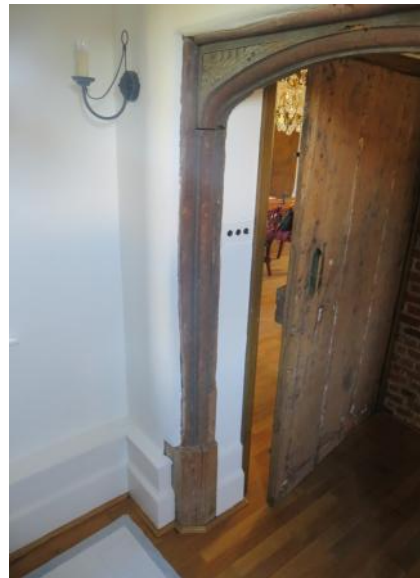
The RCHM report suggests that the present front doorway position does not match the historic entrance position (see Figure 4.28). The RCHM report suggests that from an analysis of the timber framing and evidence of

**Figure 4.86:** Showing the c. 1600 doorframe for the main entrance.

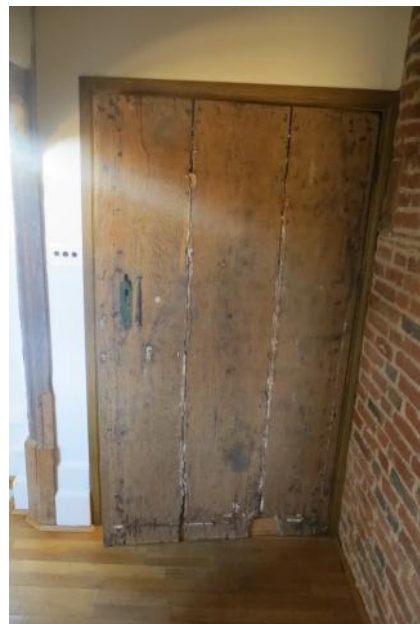
**Figure 4.88:** Showing the historic 3-plank door that once served the front entrance and today serves the doorway from the dining room into the lobby.

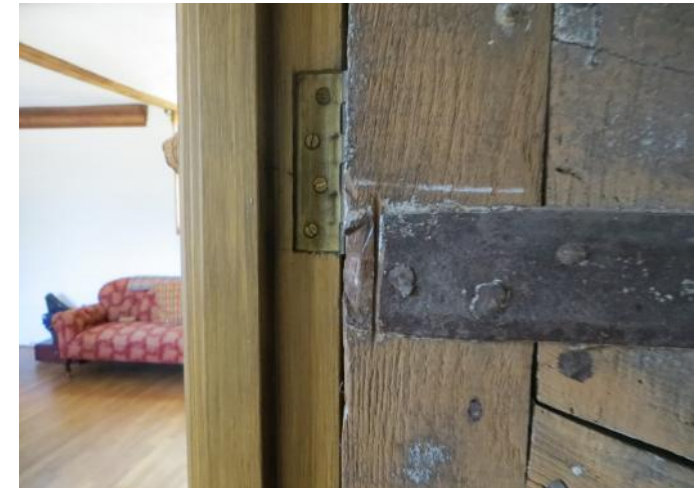
**Figure 4.89:** Showing the historic remnants of strap hinges on the dining room side of the 3-plank door.

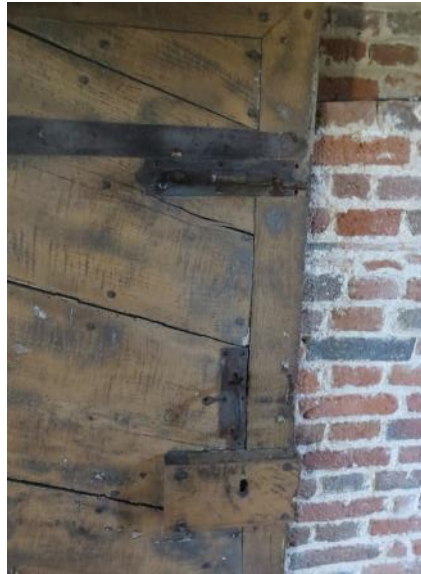
**Figure 4.90:** Showing an historic bolt and Suffolk latch on the dining room side of the 3-plank door.

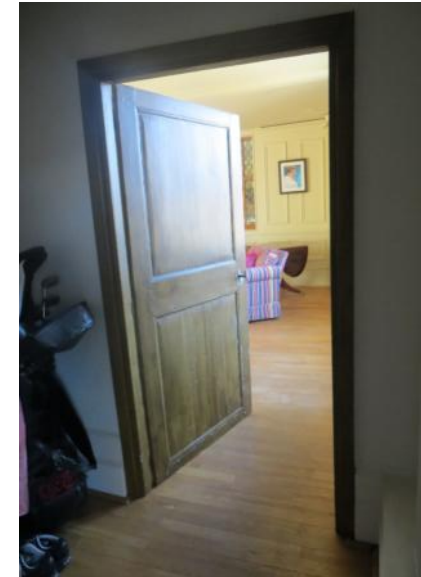
**Figure 4.91:** Showing the doorway from the lobby into the sitting room.

The door architrave on the lobby side of the doorway from the lobby into the sitting room is a modern timber example fitted in the 1900s phase of works, of no heritage value. The same is true for the lobby side of the doorway from the lobby into the dining room.

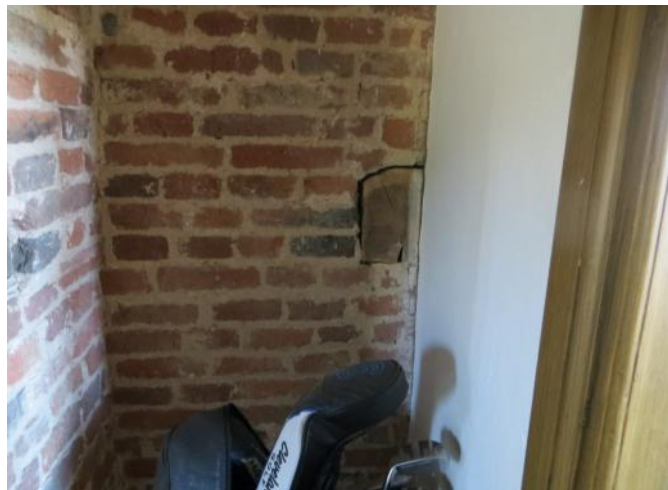
**Figure 4.92:** Showing the sitting room fireplace's bressummer as seen from the lobby.

On the western side of the lobby the bressummer for the sitting room fireplace is visible. This is broadly aligned with the wall between the sitting room and the lobby. The position of this in relation to the current fireplace chimneypiece in the sitting room shows how far the panelling on the eastern wall of the sitting room has brought the chimneypiece forward into the room.

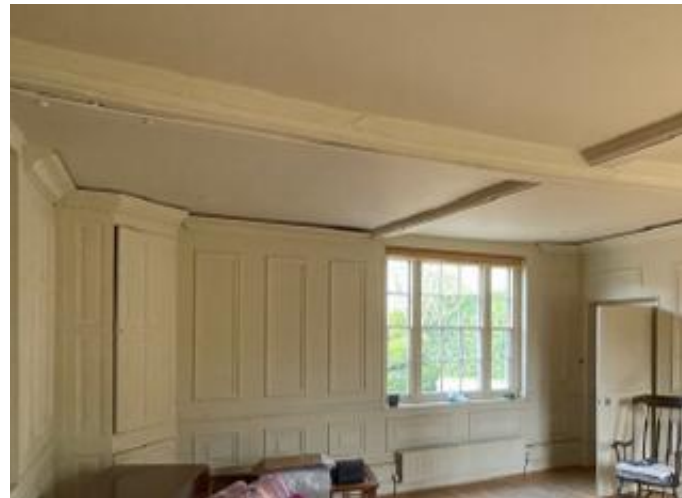
**Figure 4.93:** Showing the sitting room looking north.

Figure 4.11 shows the 18th century cupboard in the south-western corner of the room in 1992. Today, the cupboard is found in the north-western side of the room and was evidently relocated as part of the 1990s phase of works to facilitate a new doorway from the sitting room into the sun room.

In 1992 the room had two doors on the eastern wall, the southern one being into a cupboard. As seen today a cupboard now projects into the room in front of this southern doorway and blurs the legibility of the historic plan form, detracting from significance. This modern cupboard door is set further south than the historic example shown at Figure 4.11.

The room has been fitted with generic solid wood modern narrow floorboards of no heritage value.

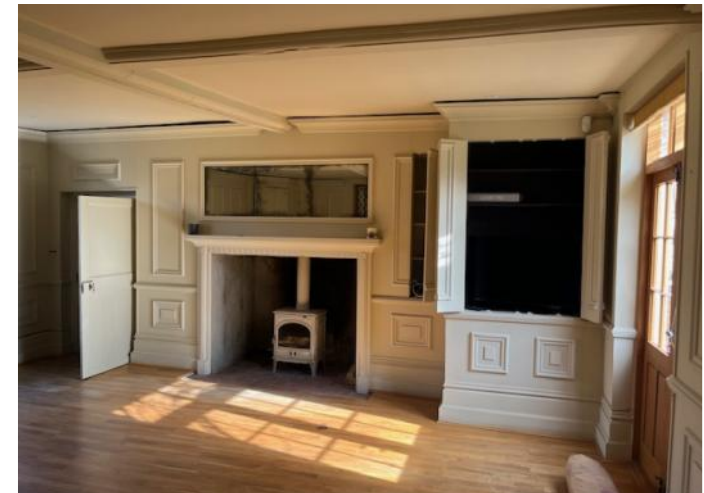
**Figure 4.94:** Showing the sitting room's fireplace and built-in modern cupboard in the south-eastern corner.

In 1992 the room had two doors on the eastern wall, the southern one being into a cupboard. As seen today a cupboard now projects into the room in front of this southern doorway and blurs the legibility of the historic plan form, detracting from significance. This modern cupboard door is set further south than the historic example shown at Figure 4.12.

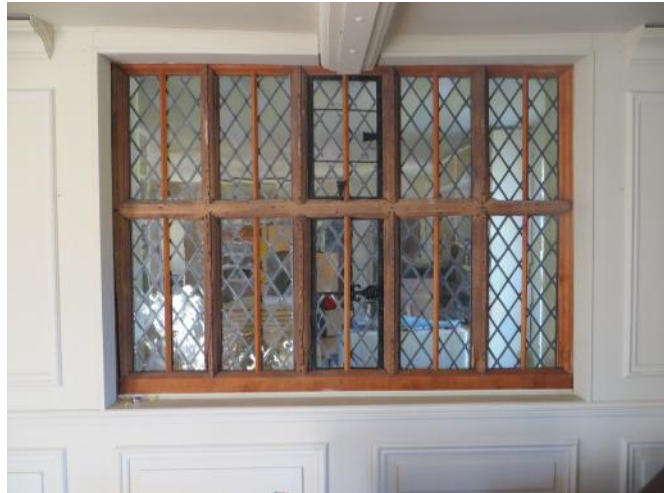
**Figure 4.97:** Showing the historic 5-light window on the western wall of the sitting room.

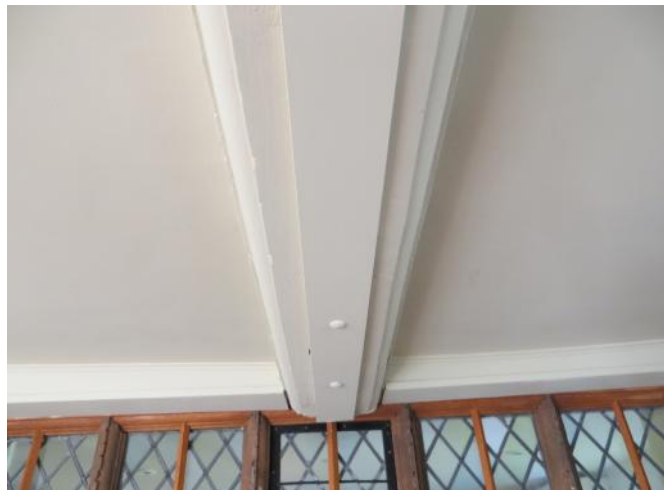
The ceiling has historic ovolo moulded beams, which date from the 17th century. We can see that a strengthening steel has been installed to the beam adjoining the fireplace. This was not visible in the 1992 photograph at Figure 4.12 and seemingly dates to the 1990s phase of works.

**Figure 4.99:** Showing one ovolo moulded ceiling beam.

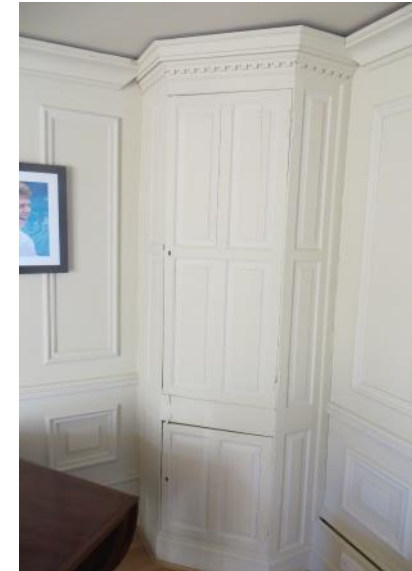
The historic corner cupboard retains its 18th century H-hinges. Figure 4.11 and Figure 4.12 show that the remainder of the room had no panelling at that time. Therefore the floor to ceiling wall panelling in this room today dates to since that time. The modern panelling reduces the legibility of the original room proportions in particular around the fireplace, where the panelling is set forward 200-300mm from the wall. The modern panelling is considered to detract from significance.

**Figure 4.98:** Showing the historic corner cupboard in the north-western corner of the room.

Figure 4.11 shows the 18th century cupboard in the south-western corner of the room in 1992. Today, the cupboard is found in the north-western side of the room and was evidently relocated as part of the 1990s phase of works to facilitate a new doorway from the sitting room into the sun room. At that time the corner cupboard had seemingly been repositioned against modern plywood after the initial internal wall works had been completed.

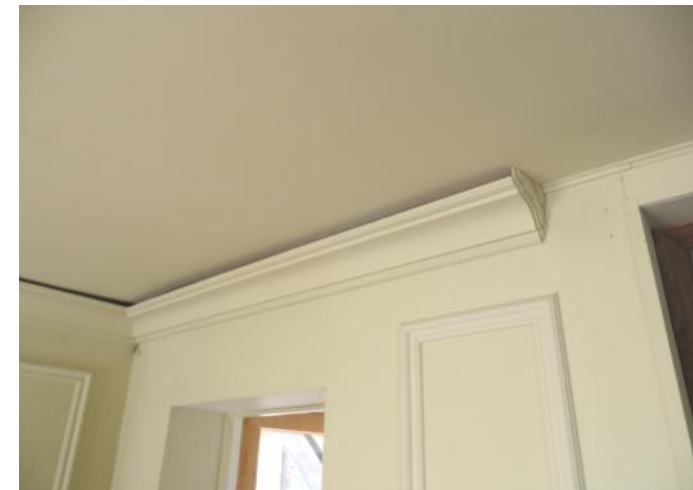
The room has been fitted with lengths of modern timber oversized cornice around the perimeter of much of the room. We know from Figure 4.11 and Figure 4.12 that the room contained no cornices historically and the horizontal detail meeting the ceiling beam above the fireplace in Figure 4.11 is likely a further ceiling beam. The current

**Figure 4.100:** Showing a length of modern cornice.

Approval was given to remove the post 1994 cornices that were entirely faux, and were obscuring historic cornices behind. The wall composition between the dining room and the Utility Room was found to include plywood (of no heritage value) on the dining room side.

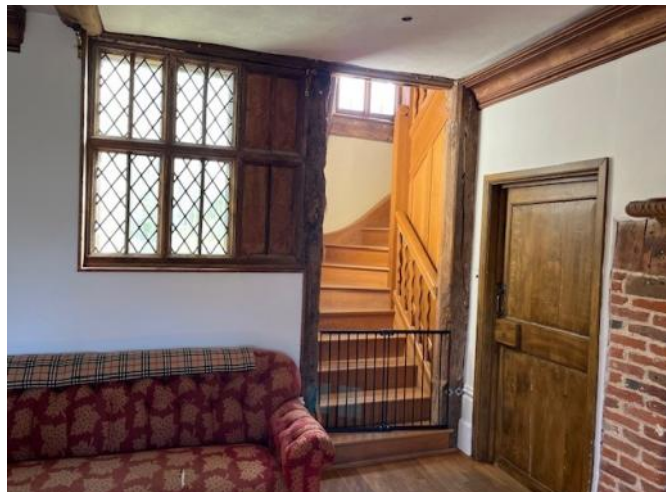
Figure 4.103 shows that the stair wing partially blocks the 3-light window on the southern elevation within this room. As discussed this shows that the c. 1700 stair wing is later than the main range.

**Figure 4.103:** Showing the dining room doorway leading to the stair wing. Also showing the historic 3-light window, with one light blocked by the stair wing.

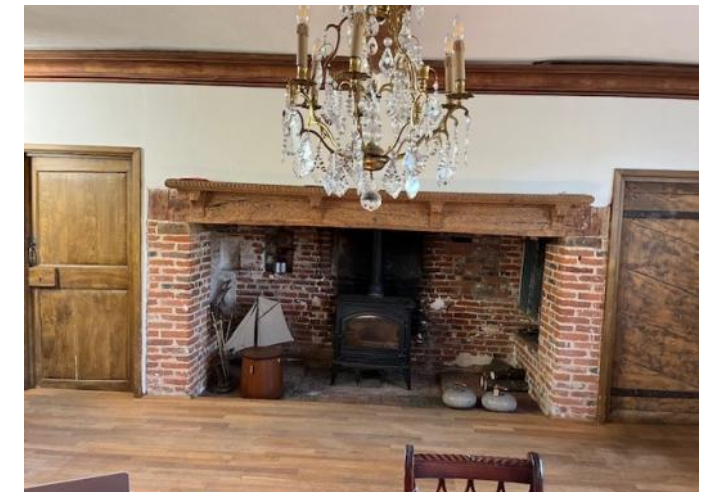
**Figure 4.104:** Showing the dining room's historic fireplace bressummer on the western wall of the room.

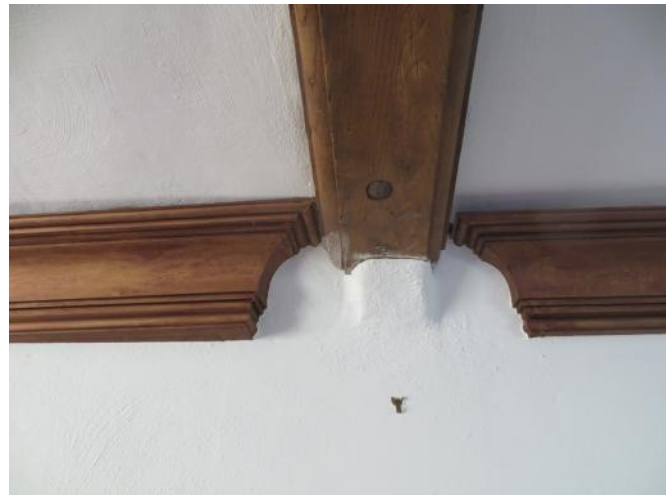
The arch supporting the hearth above in the north-eastern bedroom has been shortened as can be seen by comparing Figures 4.105 and 4.9.

**Figure 4.105:** Showing the trimmed fireplace arch above the dining room fireplace.

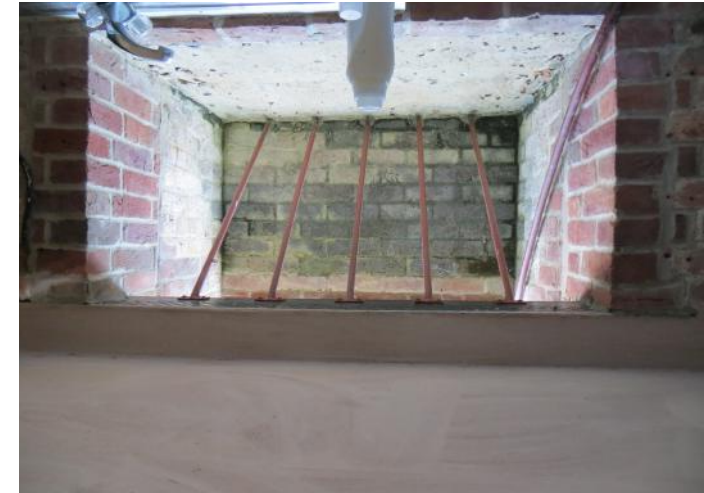
Evidence of the former window on the western wall of the cellar remains and is currently used to route ducting from the sun room.

**Figure 4.110:** Showing the window jambs of the cellar window.

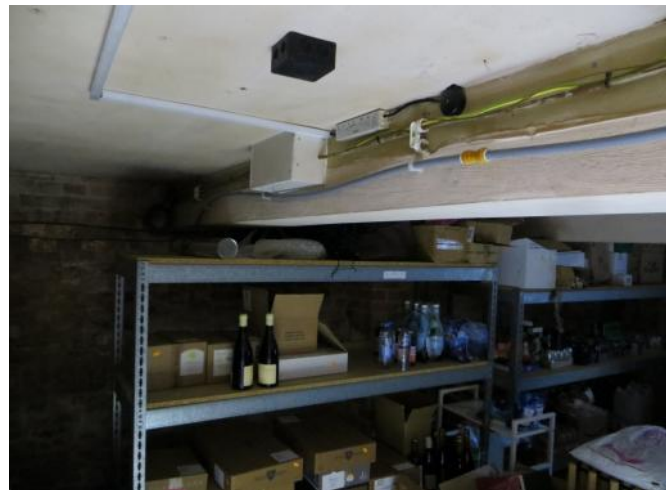
**Figure 4.111:** Showing the concrete beam in the cellar.

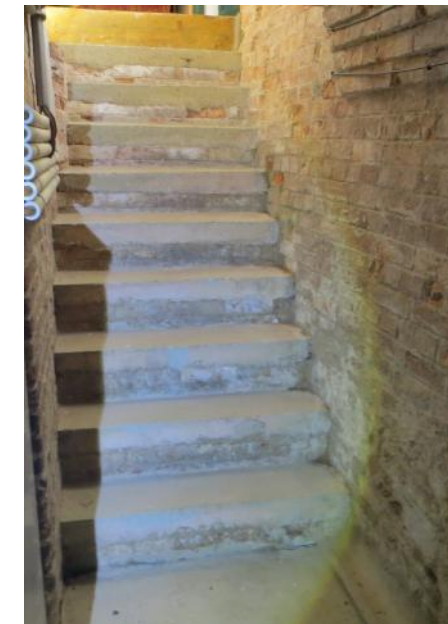
The steps from the cellar have historic red brick steps, which may have been rebuilt in the 1990s phase of works. The existing plan from 1992 at Figure 4.39 comments that these steps had bricks steps with rotten timber nosings at that time. These nosings have been replaced with concrete since that time, which is a low grade material and is also incompatible with the breathability required for historic buildings constructed of traditional materials. For these reasons the concrete detracts from significance.

**Figure 4.112:** Showing the steps from the cellar to the ground floor.

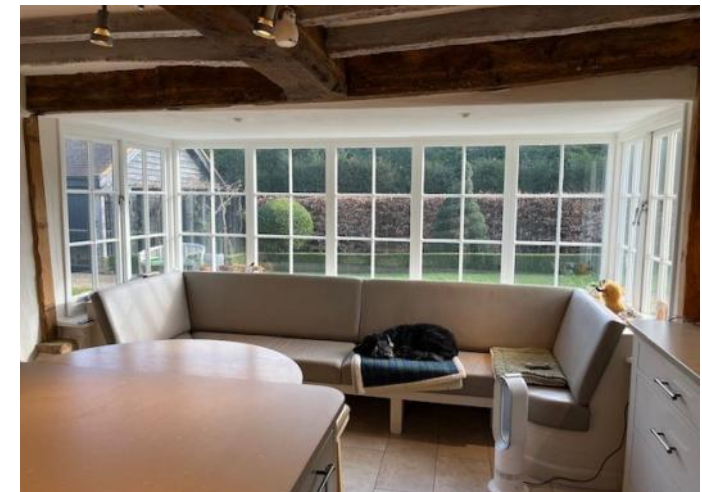
At ground floor level, much of the east wall of this bay has been removed when a large rectangular bay window

**Figure 4.119:** Showing the rectangular bay window on the eastern side of the kitchen.

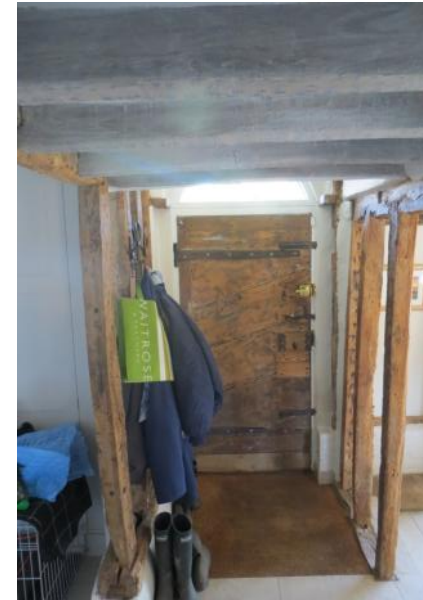
The historic open passage between the kitchen cross wing and the main range remains legible today by some surviving exposed historic timber members (see Figure 4.121).

**Figure 4.121:** Showing the view towards the eastern doorway.

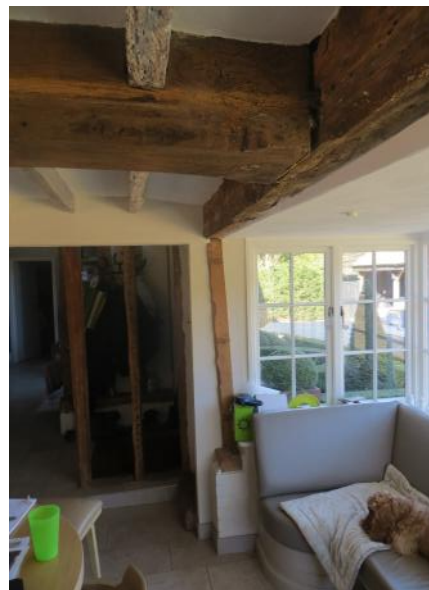
The beam that adjoining the 1990s bay window on the eastern elevation of the kitchen cross wing is substantial. The RCHM report mentions that the beam has no mortices on its underside, confirming therefore that there historically have never been posts extending from the underside of the beam to the sole plate. Therefore from the date of this beam there has always been an opening here, albeit of different widths. This beam appears to date to the 17th century when the kitchen cross wing was heightened.

**Figure 4.122:** Showing the beam adjoining the bay window on the kitchen cross wing's eastern elevation.

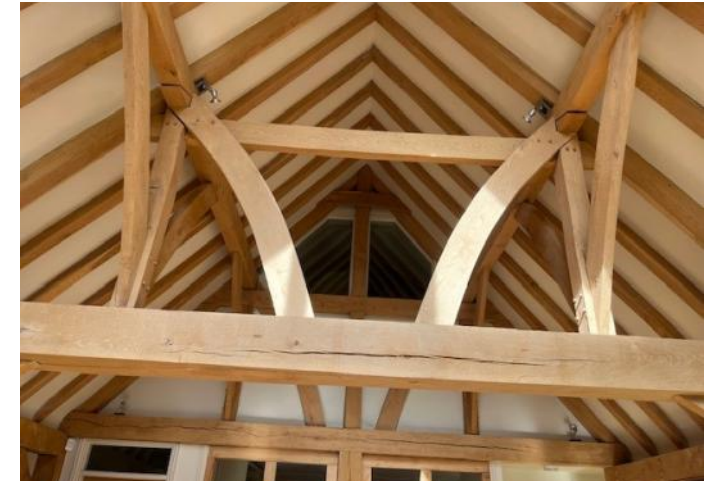
The sun room was constructed following the 1993 consent with later alterations following approved Application Reference: 00/00847/1LB. It contains numerous hand made traditional timber members constructed in a traditional timber framed manner. The roof has a series of purlin trusses and all joints are pegged in the traditional manner.

**Figure 4.124:** Showing a typical purlin roof truss within the interior of the sun room.

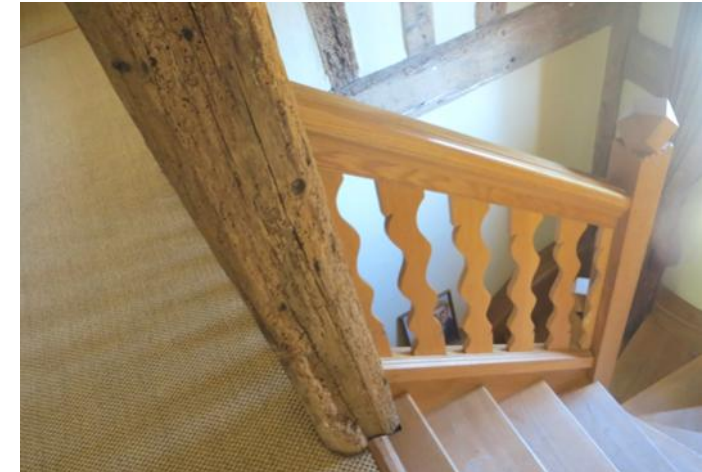
The proposed plans from 1992 state that the treads and risers of the staircase would be replaced and the remainder of the staircase would be repaired. As seen today the newel posts and splat balusters have been replaced in recent years, perhaps these works took place in the 1990s as they appear the same age as the modern treads and risers.

**Figure 4.128:** Showing the new splat balusters in the stair wing.

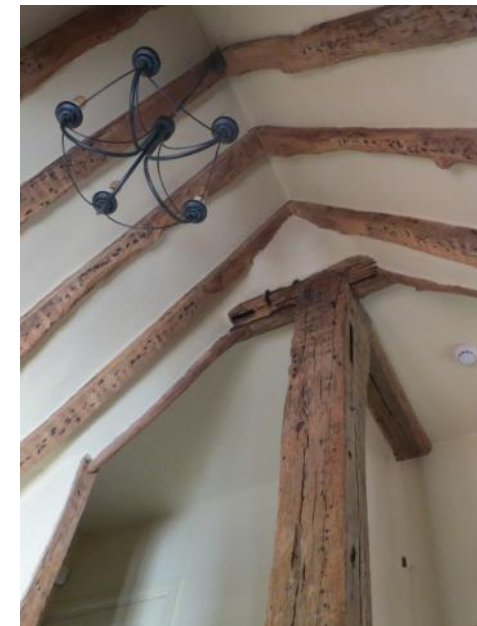
Numerous historic timber members are visible on the walls and roof structure of the stair wing.

**Figure 4.130:** Showing the historic rafters in the stair wing's roof.

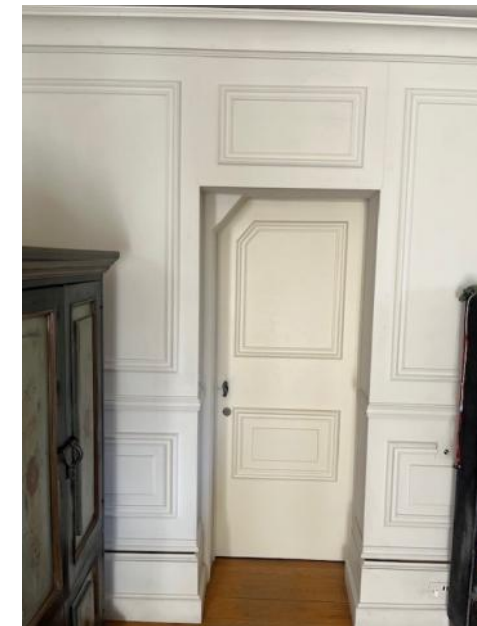
**Figure 4.134:** Showing the doorway from the western bedroom into the bathroom at first floor level within the sun room.

The doorway from the western bedroom to the dressing room retains an 18th century 2-panelled door hung on wrought iron strap hinges. It also retains an historic rim lock.

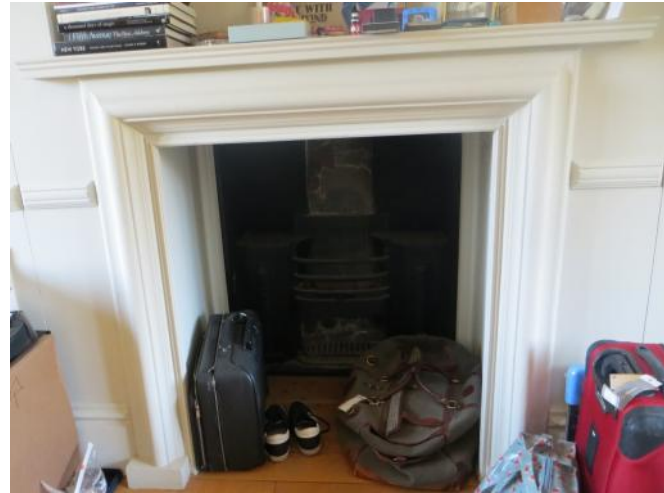
**Figure 4.135:** Showing the chimneypiece and hob grate.

In the Western Bedroom at first floor level it was found that the 18th century chimneypiece had indeed been dismantled and moved forward as part of the modern fit out of the room in the early 21st century.

Inspecting the rear side of the chimneypiece, it was found that it had been secured to modern plywood and modern standard lengths of pine as part of the early 21st century works.

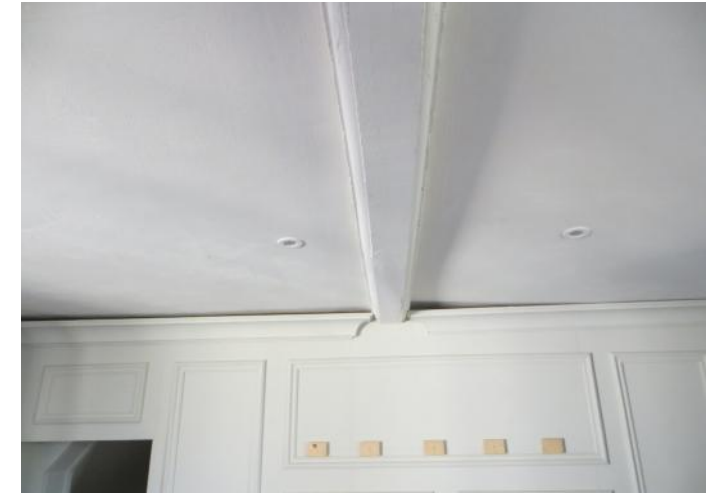
**Figure 4.136:** Showing the historic ceiling beam and the modern downlighters.

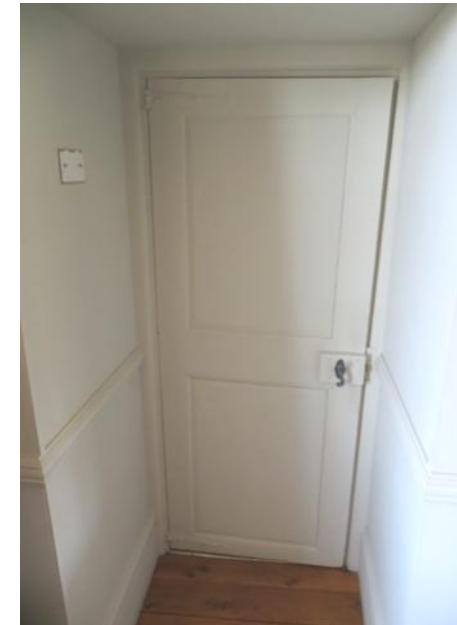
**Figure 4.138:** Showing the doorway into the dressing room adjoining the western bedroom.
