Old Manor Farm House, Shaftenhoe End,  
Hertfordshire, SG8 8LD

Heritage Statement

Local Planning Authority: North Hertfordshire District Authority

September 2025

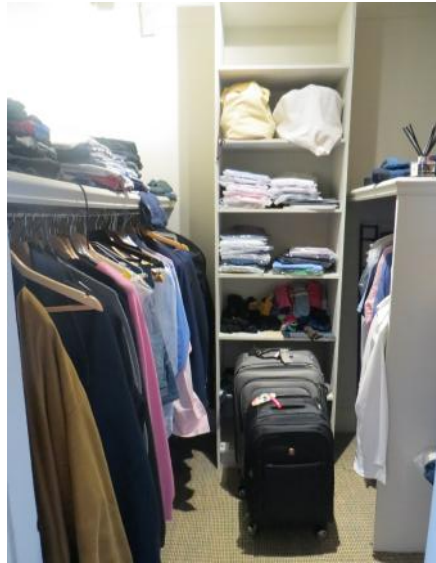
The room was tightly packed with clothes on inspection and it was not possible to inspect the space fully. However, it appears to have no visible historic fabric, save for one historic timber frame rail on the northern wall. The RCHM comments about other historic timber members surviving in 1992, which presumably remains the case concealed behind plaster.

**Figure 4.139:** Showing the small dressing room adjoining the western bedroom.

The scheme proposes the conversion of the existing dressing room to become a shower room. We can see that a bathroom was consented as part of the 1990s consent (see Figure 4.41). The change of use of the room is not therefore considered contentious. Figure 4.39 shows the existing first floor plan in 1992 and this shows a doorway from the current dressing room into the first floor Eastern Bedroom. The current scheme proposes an opening in this same location and therefore we know that the doorway infilled following the 1990s consent is only modern fabric dating from the 1990s onwards, and of no heritage value.

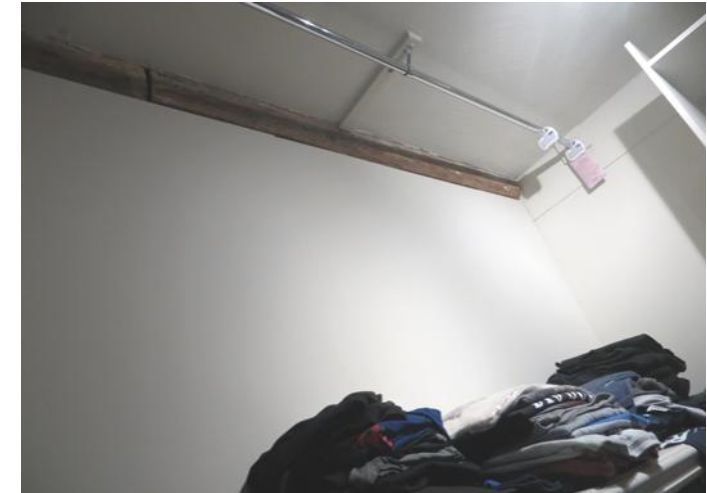
**Figure 4.140:** Showing the historic timber rail/wallplate on the northern wall of the dressing room.

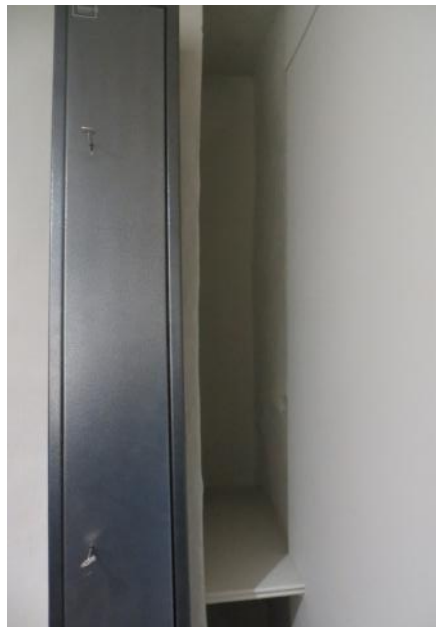
**Figure 4.141:** Showing the void between the chimneystack and the western wall of the dressing room.

In the Western Bedroom's dressing room the wall that runs from the Western Bedroom's chimneybreast to the southern elevation was found to contain lime plaster. This indicates this is an historic wall and was present on the 1992 first floor plan shown at Figure 4.41. This wall was not therefore removed as part of the strip out works.

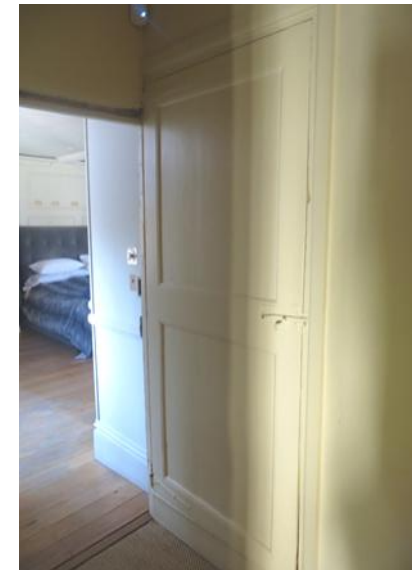
At the western end of the corridor is an 18th century 2-panelled door hung on wrought iron strap hinges. This door leads to the western loft staircase.

**Figure 4.143:** Showing the doorway leading to the western loft attic staircase.

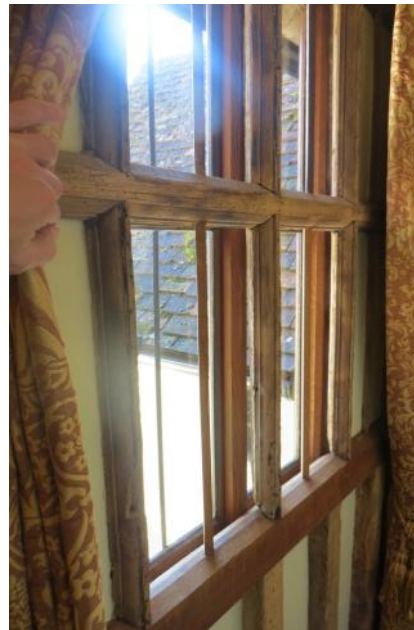
To the eastern side of the stair wing on the southern elevation, is an historic 4-light window that appears to date to at least the 17th century. The eastern and western lights are obscured. This historic window is retained and a 1990s 2-light timber casement with transom was installed in line with the enlarged proportions of the southern elevation once the external cladding was installed.

**Figure 4.144:** Showing the historic and modern casement windows east of the stair wing. Note the curtains conceal some of the windows.

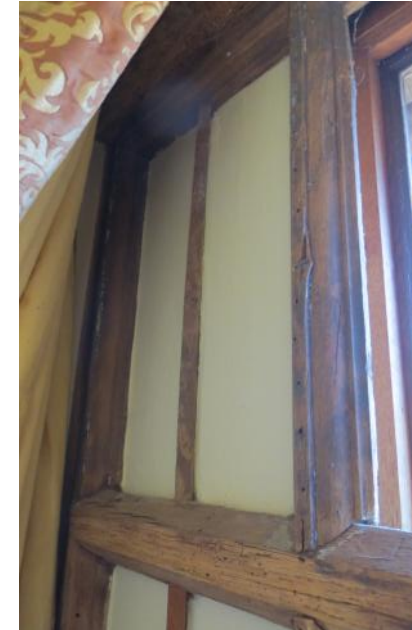
**Figure 4.145:** Showing the eastern obscured light of the 17th century window.

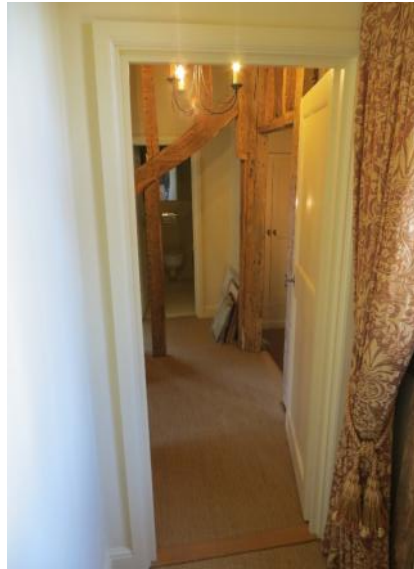
An historic 18th century 2-panelled door survives adjoining this window. The architrave on both sides of the doorway is a modern plain timber architrave from the 1990s phase of works, of no heritage value. An historic rim lock survives on the eastern side of the door.

**Figure 4.146:** Showing the 2-panelled door and doorway adjoining the 17th century 4-light window.

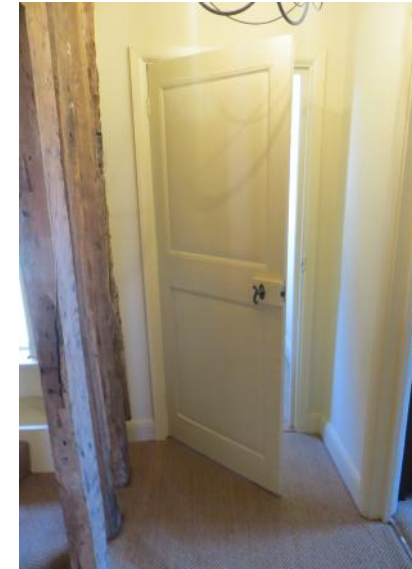
**Figure 4.147:** Showing the same door as seen at Figure 4.146 as shown from the opposing side.

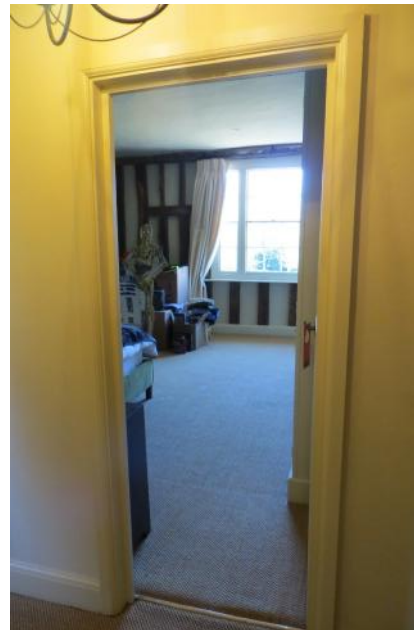
A modern plain timber door architrave into the north-eastern bedroom was also installed in the 1990s phase of works, of no heritage value. The door into the north-eastern bedroom is again 18th century 2-panel door. A modern door architrave and 18th century 2-panel door are also present for the door into the W.C. at the eastern end of the corridor.

**Figure 4.148:** Showing the doorway into the north-eastern bedroom.

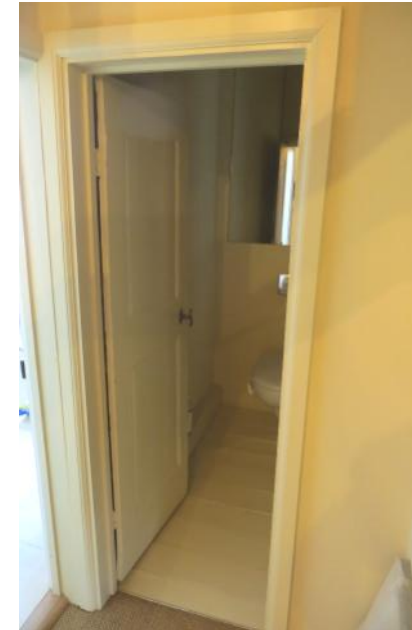
**Figure 4.149:** Showing the doorway into the first floor W.C.

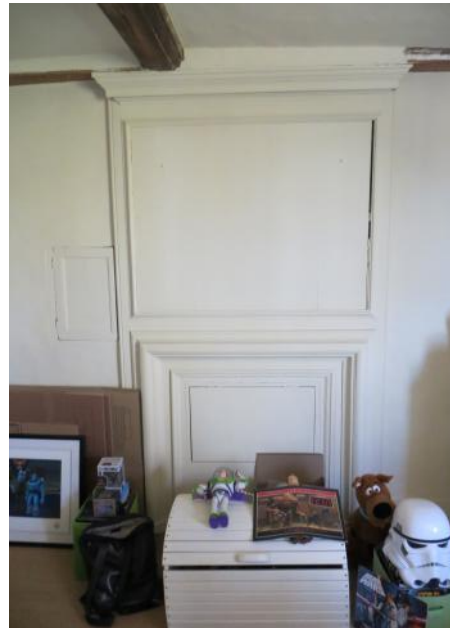
Figure 4.16 shows a 1992 photograph of the room including its bolection moulded chimneypiece and overmantel. The room retains these elements. On the southern side of the chimneypiece is a small historic cupboard, which appears to provide access into the historic smoke hood, that predated the installation of the 18th century chimneypiece and overmantel. On the southern side of the western wall is a small 2-panelled door from approximately the 18th century that serves an understairs cupboard.

**Figure 4.152:** Showing the 18th century chimneypiece and overmantel.

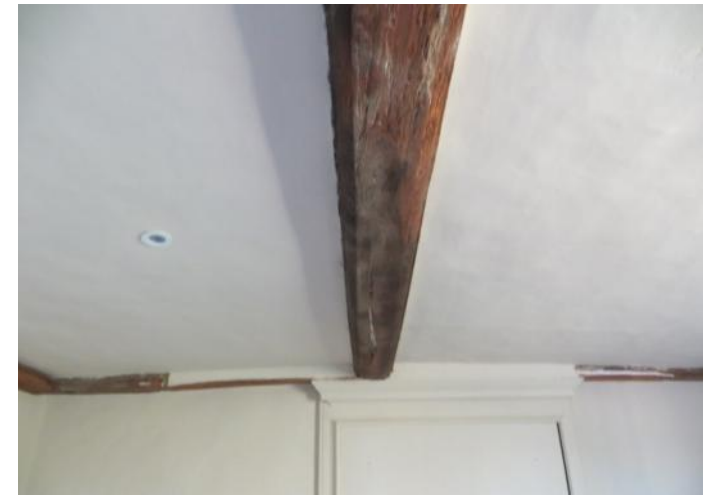
**Figure 4.151:** Showing an historic ceiling beam in the room.

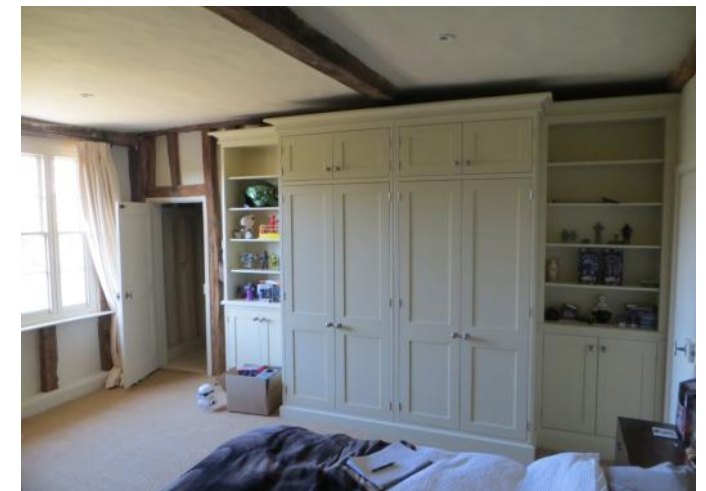
On the eastern side of the room are built-in wardrobes from the late 20th century of no heritage value.

**Figure 4.153:** Showing the eastern wall of the north-eastern bedroom.

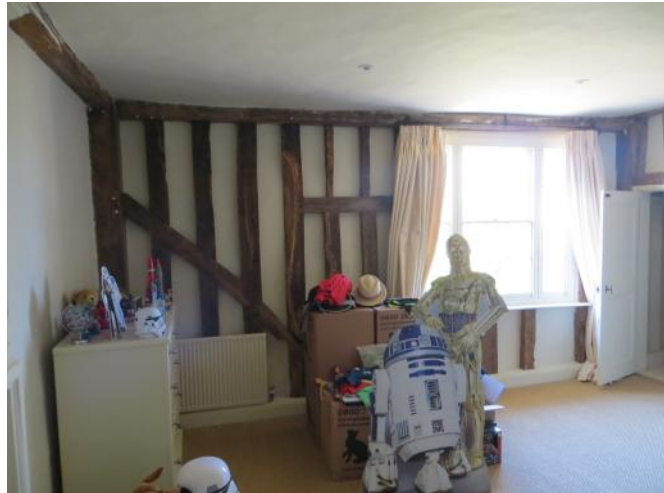
**Figure 4.154:** Showing the northern wall of the north-eastern bedroom.

On the northern wall of the room one can see evidence of the upper lights of the former 17th century window that once served this room (see Figure 4.28 and Figure 4.154). The glazing bars have been removed as part of the 1990s phase of works and adapted to resemble the surrounding timber framing. The other side of the window is found within the shower room on the eastern side of the bedroom (see Figure 4.158).

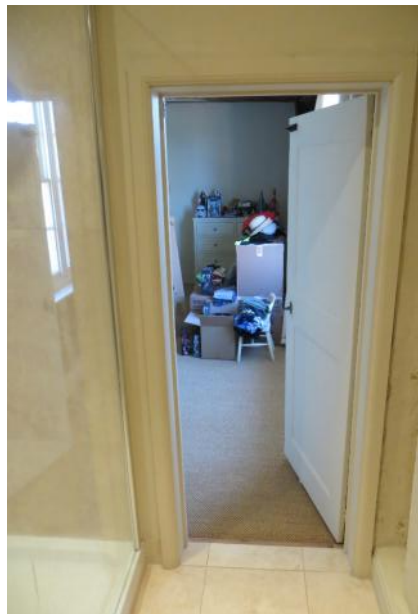
The door architrave on the shower room side of the doorway is a modern plain timber example and appears to date from the 1990s phase of work (of no heritage value).

**Figure 4.159:** Showing the doorway from the shower room adjoining the north-eastern bedroom into the north-eastern bedroom.

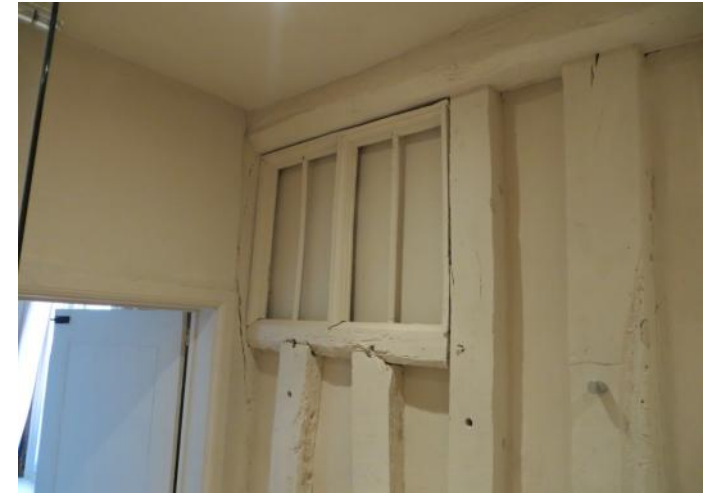
On the western side of the northern wall are two former lights belonging to part of the first floor eastern window on the front elevation (see Figure 4.158 and cross reference with Figure 4.28).

**Figure 4.158:** Showing northern wall of the north-eastern shower room. Note the former window (part).

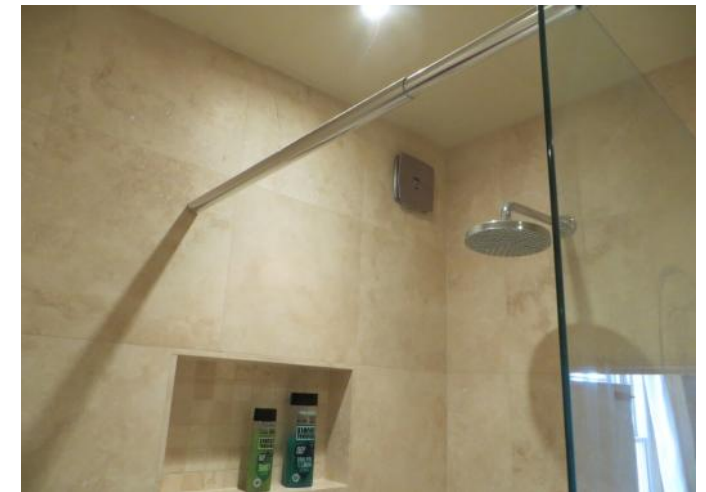
**Figure 4.160:** Showing the modern shower and shower screen.

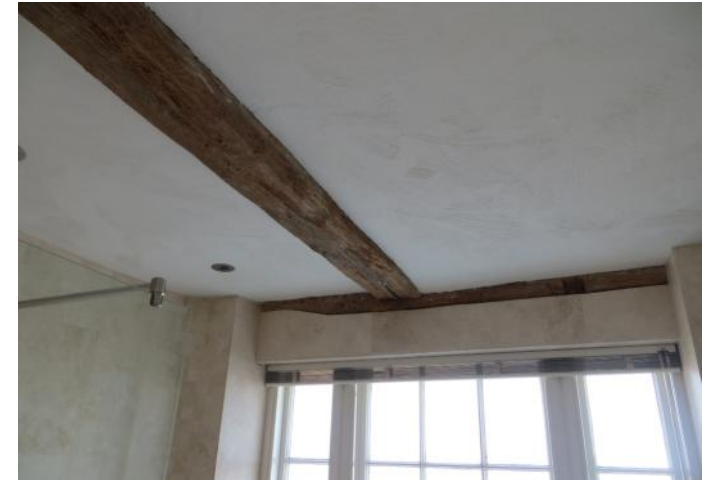
**Figure 4.162:** Showing historic ceiling beam and part of the wallplate in the north-eastern bathroom.

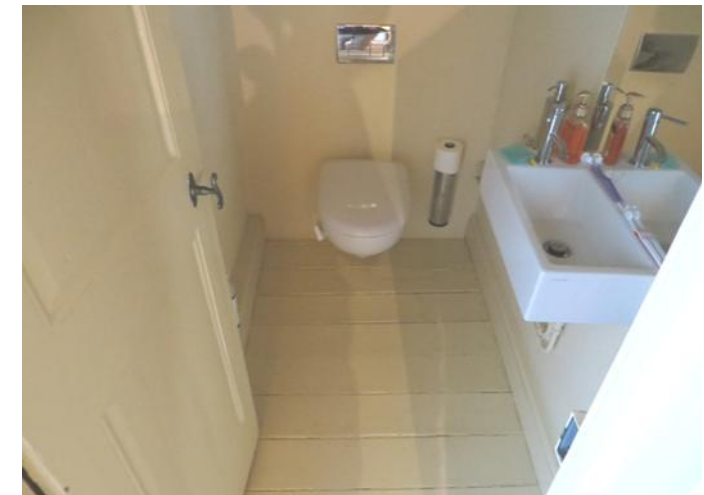
The adjoining W.C. contains modern sanitary fittings of no heritage value.

**Figure 4.164:** Showing the W.C. adjoining the north-eastern bathroom.

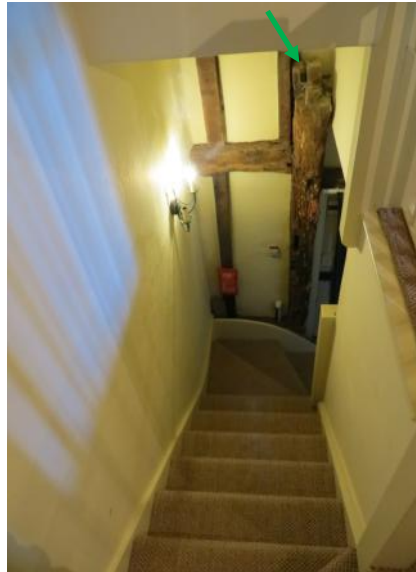
The historic staircase that leads from the former open passage at the northern end of the kitchen cross wing to the kitchen cross wing's first floor level survives. This has various parts of the historic timber frame exposed.

Adjoining the doorway at the northern end of the kitchen cross wing's western elevation is a jowl post, which indicates a 16th century date for the kitchen cross wing.

**Figure 4.165:** Showing the staircase from first floor down to ground floor level within the kitchen cross wing. Just visible at the base of the stairs is the doorway at the northern end of the kitchen cross wing's western elevation. Note the jowl post marked in green.

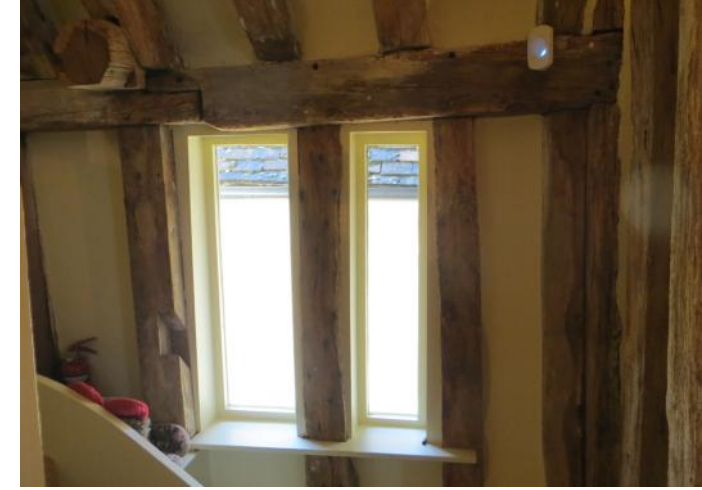
**Figure 4.168:** Showing the modern pair of single light windows inserted at first floor level adjoining the staircase.

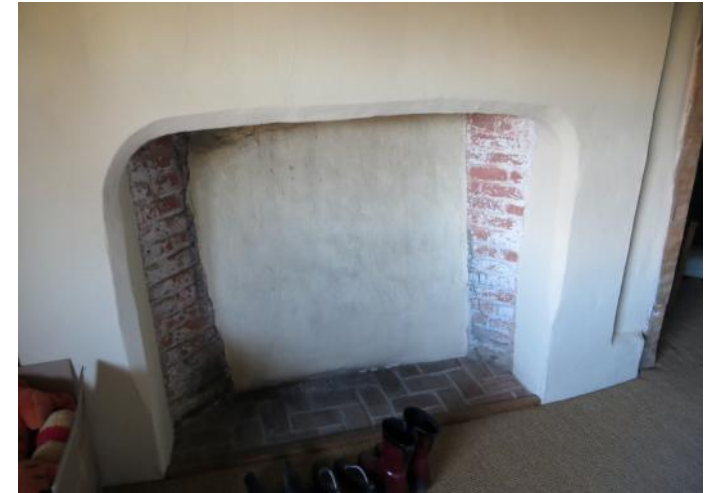
In style the first floor fireplace, which is of brick with a chamfered, horseshoe shaped arch and run out stops, may be late-17<sup>th</sup> century and may date the heightening of this range. The fireplace appears to have been partially infilled and is slightly hollow when tapped.

**Figure 4.170:** Showing the fireplace in the south-eastern bedroom.

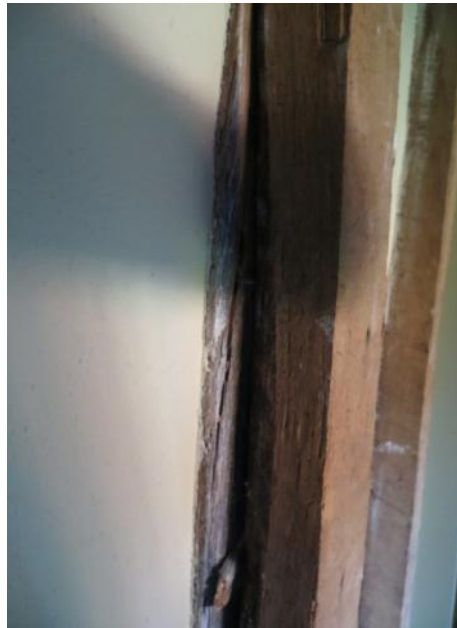
The timbers used are not modern and this could be an historic repair. No works are noted of this nature on the 1990s consent and therefore these works are likely an historic repair.

**Figure 4.175:** Showing the western wall and one of its partnered posts.

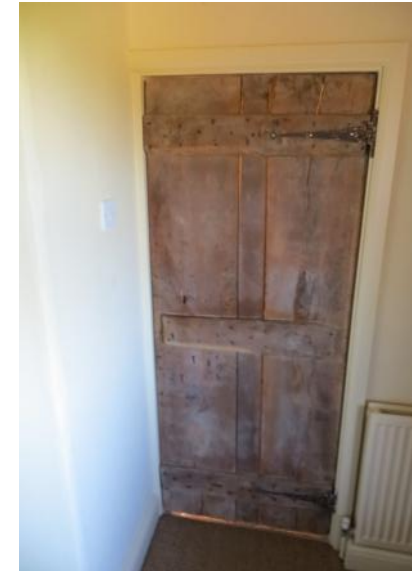
**Figure 4.174:** Showing the 3-plank door into the room.

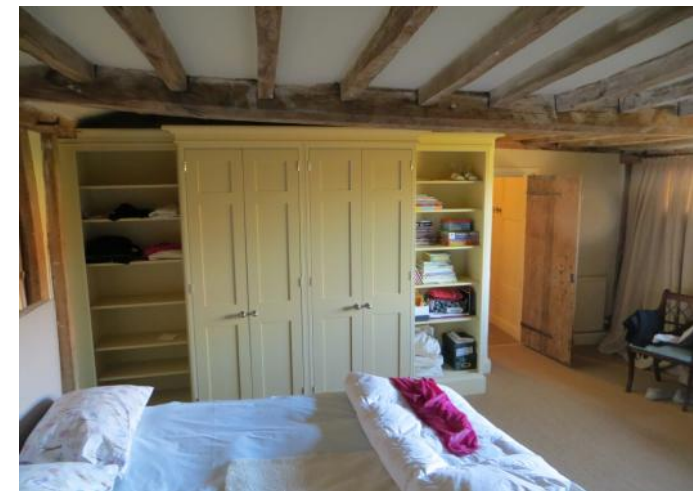
**Figure 4.176:** Showing the northern wall of the south-eastern bedroom.

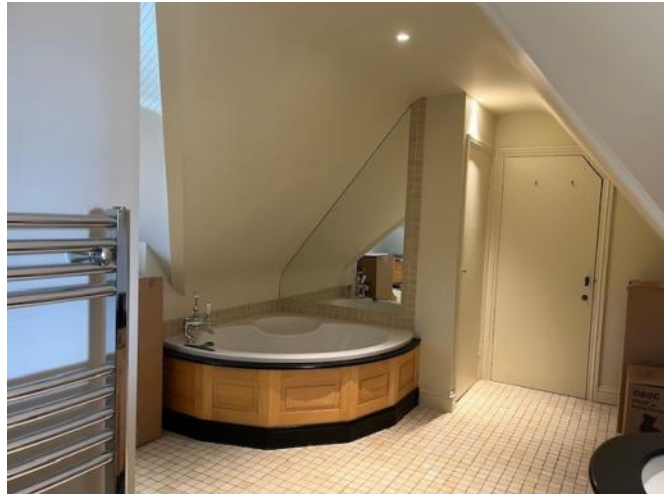
The first floor of the sun room has been fitted with a modern bath, shower, sinks and ceramic tiles all of no heritage value.

**Figure 4.177:** Showing the sun room's first floor bathroom adjoining the western bedroom, looking east.

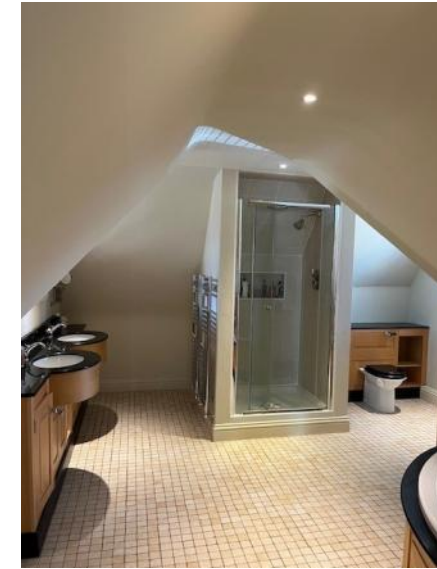
**Figure 4.178:** Showing the sun room's first floor bathroom adjoining the western bedroom, looking west.

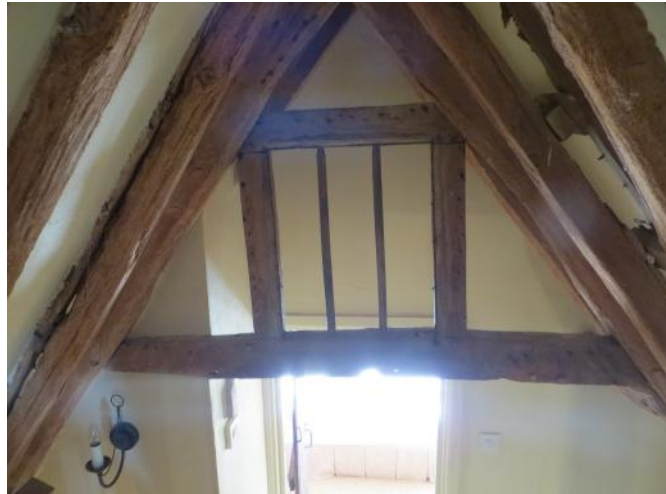
**Figure 4.179:** Showing the 16th century window on the northern wall of the south-eastern bedroom at loft level.

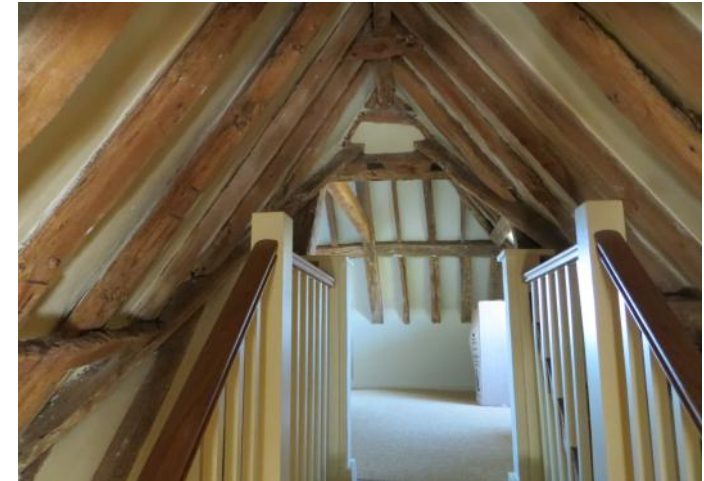
The former hipped roof structure of the south-eastern corner of the main range is also visible (see Figure 4.180), on the northern side of the former open passage.

**Figure 4.180:** Showing the former hipped roof at the south-eastern corner of the main range. Note the mortice holes.

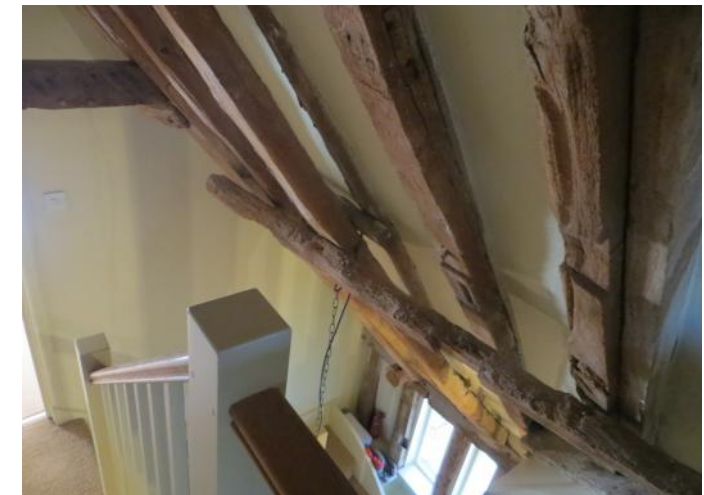
The roof structure in this area has partnered rafters showing that the historic roof was potentially structurally weak and required reinforcement at that time.

**Figure 4.181:** Showing an incomplete purlin and the partnered rafter used in this part of the building.

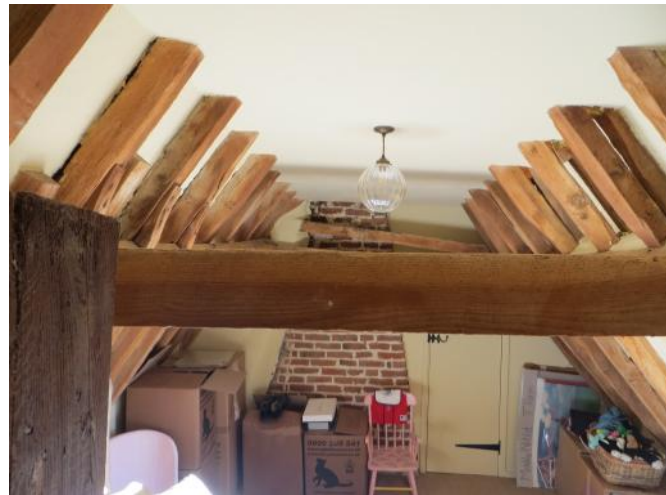
**Figure 4.182:** Showing the southern wall of the south-eastern bedroom at loft level.

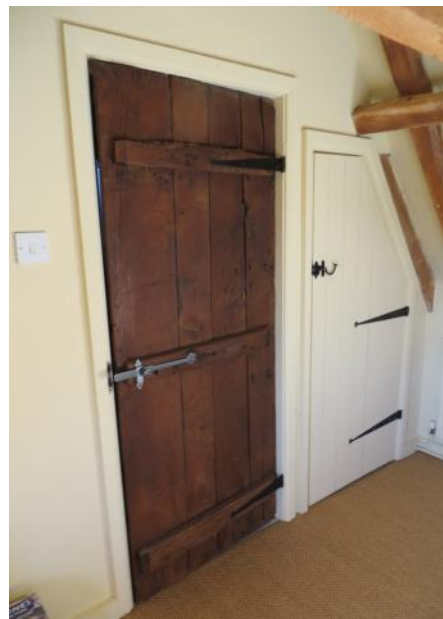
The door into the room has a 4-plank door that appears to date from the 17th century. This is hung on modern strap hinges.

**Figure 4.184:** Showing an historic plank door into the south-eastern bedroom at loft level.

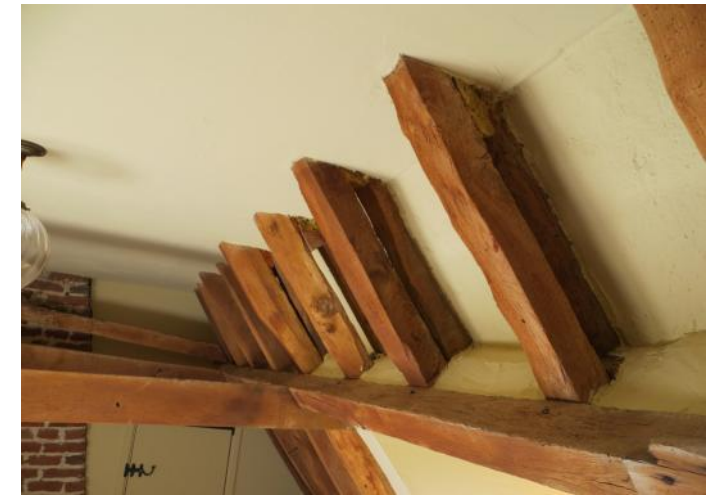
This room also has partnered rafters indicating structural works to strengthen the roof historically. The timbers used are not modern and this could be an historic repair. No works are noted of this nature on the 1990s consent and therefore these works are likely an historic repair.

**Figure 4.183:** Showing partnered rafters in the south-eastern bedroom at loft level.

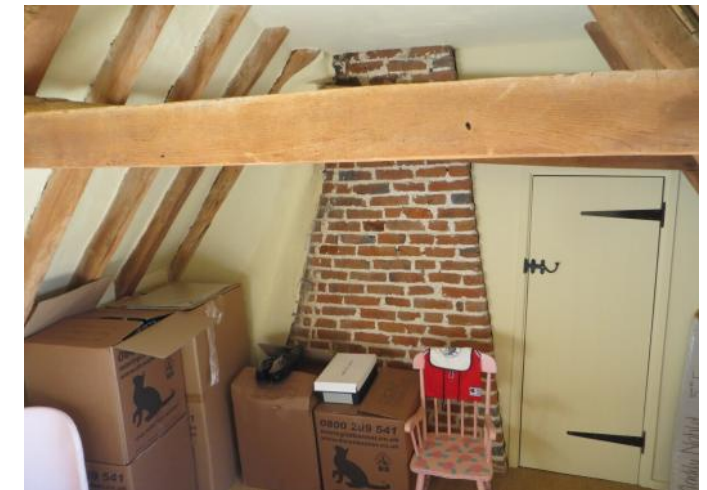
**Figure 4.185:** Showing the chimneybreast on the western wall does not have a fireplace.

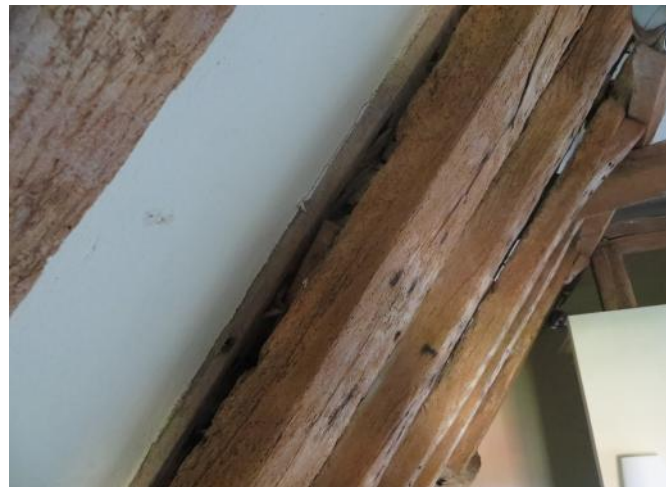
The roof structure in this part of the building is much damaged by woodworm, death watch beetle, has partnered rafters showing structural strengthening works historically and has been altered from a gabled roof to a hipped roof historically. It is therefore heavily altered and the most historic timbers are almost decorative with the structural role seemingly now performed by later timbers.

**Figure 4.188:** Showing some partnered rafters in the south-eastern bedroom at loft level.

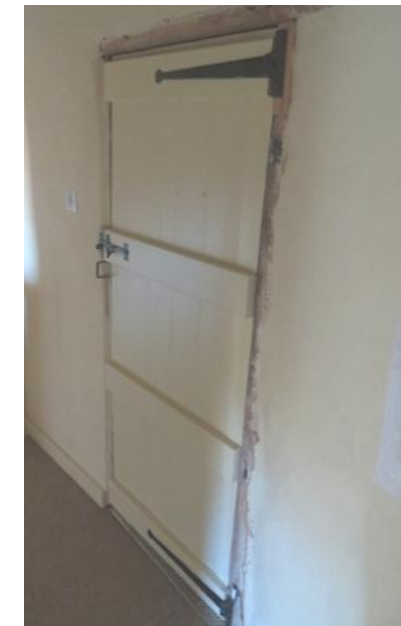
Between the western and north-eastern bedroom is a modern, sympathetic ledged boarded door.

**Figure 4.189:** Showing the door between the western and north-eastern bedroom at loft level.

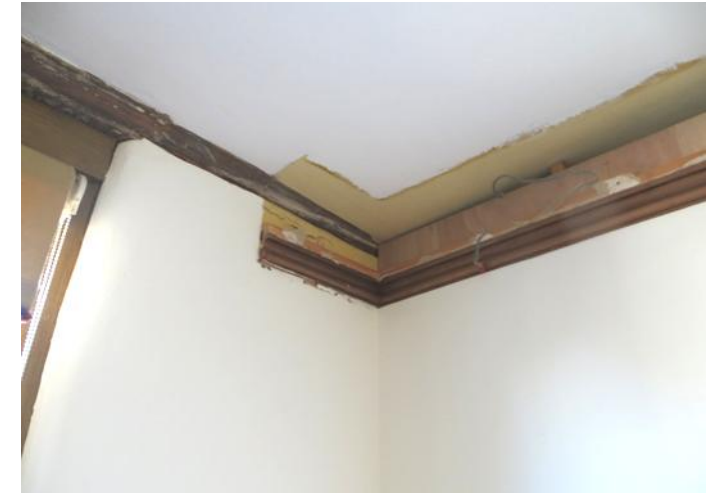
Approval was given to remove the post 1994 cornices that were entirely faux, and were obscuring historic cornices behind. The wall composition between the dining room and the Utility Room was found to include plywood (of no heritage value) on the dining room side.

**Figure 4.194:** Showing the part of the historic cornice above and the modern cornice below (latter prior to removal).

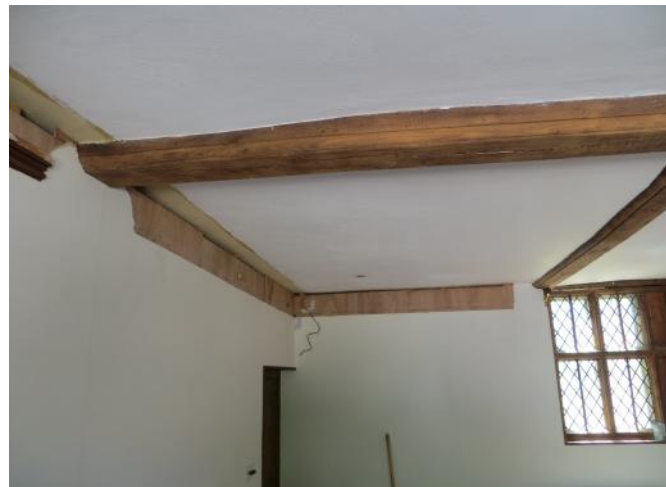
**Figure 4.195:** Showing the after modern cornices had been removed from the western side of the room.

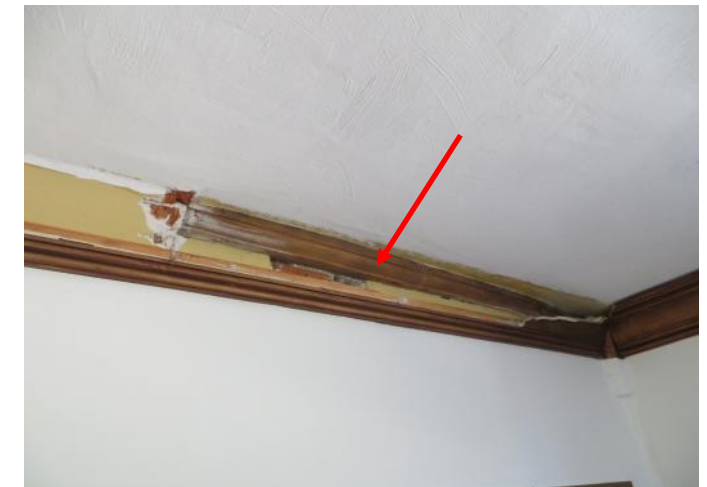
On the eastern wall of the room an original 17th century ceiling cornice was revealed.

**Figure 4.196:** Showing an original 17th century cornice (marked in red) revealed.

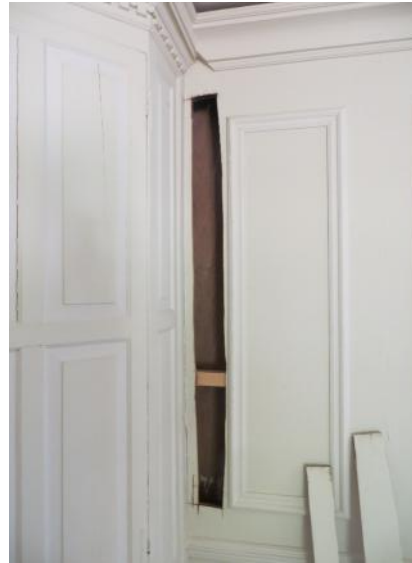
**Figure 4.197:** Showing the historic corner cupboard in the sitting room. A channel was cut in the modern panelling alongside.

Figure 4.11 shows the 18th century cupboard in the south-western corner of the room in 1992. Today, the cupboard is found in the north-western side of the room and was evidently relocated as part of the 1990s phase of works to facilitate a new doorway from the sitting room into the sun room. At that time the corner cupboard had seemingly been repositioned against modern plywood after the initial internal wall works had been completed.

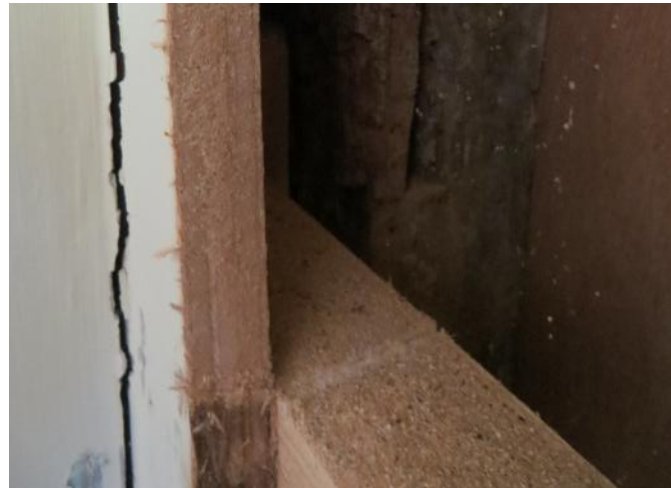
**Figure 4.199:** Showing the plywood and modern batten behind the historic corner cupboard.

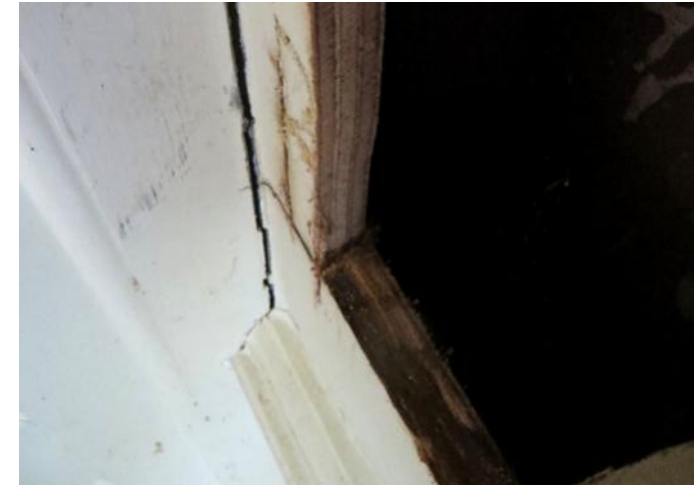
**Figure 4.198:** Showing the plywood behind the historic corner cupboard.

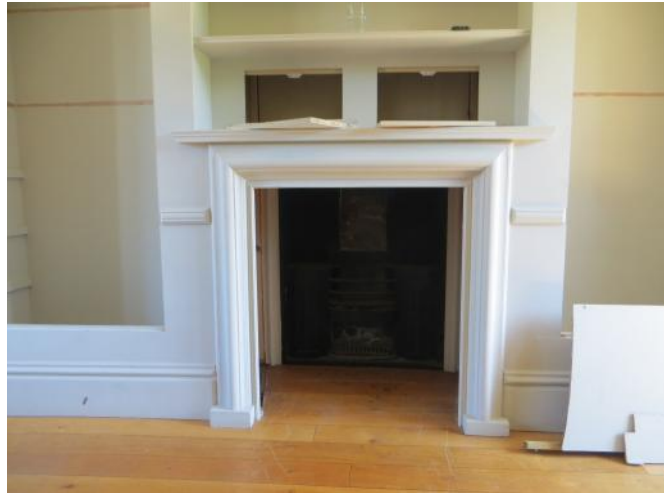
**Figure 4.200:** Showing the Western Bedroom's chimneypiece.

In the Western Bedroom at first floor level it was found that the 18th century chimneypiece had indeed been dismantled and moved forward as part of the modern fit out of the room in the early 21st century.

Inspecting the rear side of the chimneypiece, it was found that it had been secured to modern plywood and modern standard lengths of pine as part of the early 21st century works.

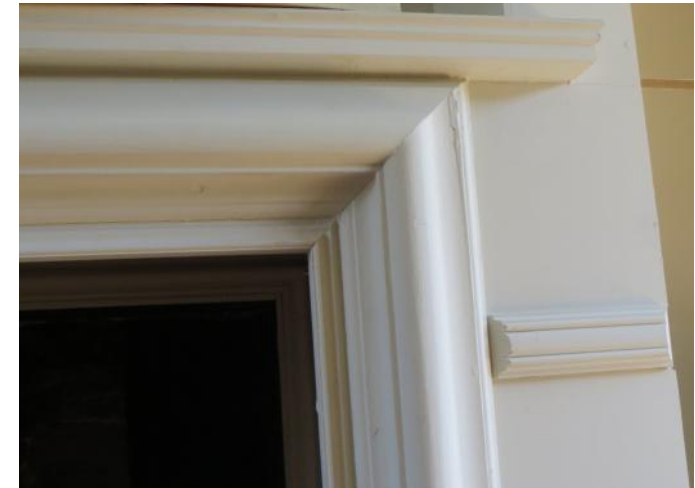
**Figure 4.201:** Showing the bolection moulding.

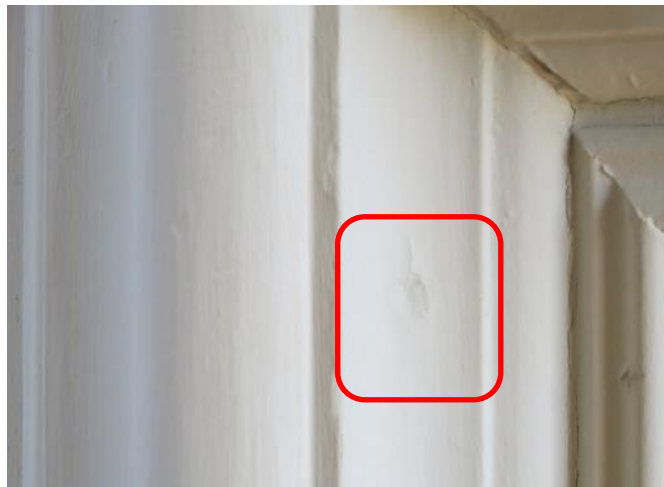
**Figure 4.202:** Showing a screw hole infilled with filler.

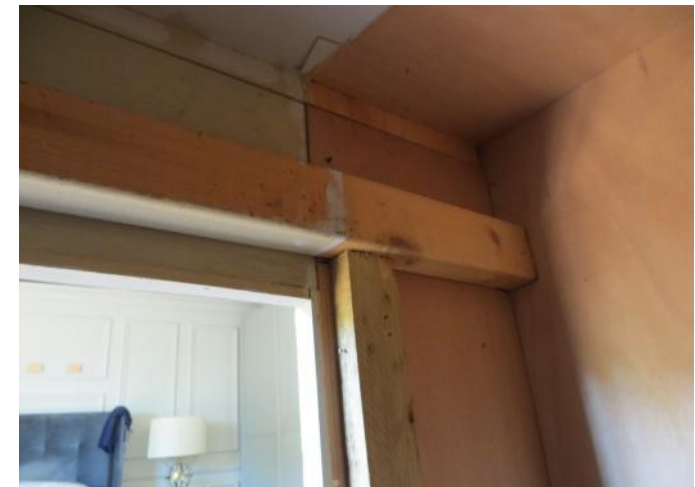
**Figure 4.203:** Showing the rear side of the chimneypiece.

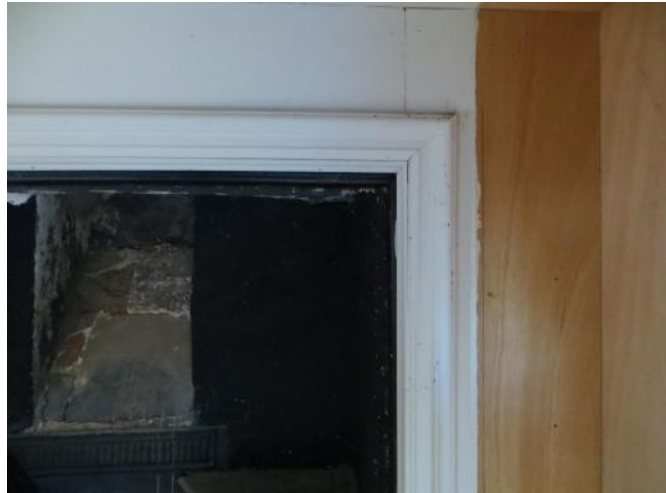
**Figure 4.204:** Showing the modern fire surround in the original position of the 18th century chimneypiece.

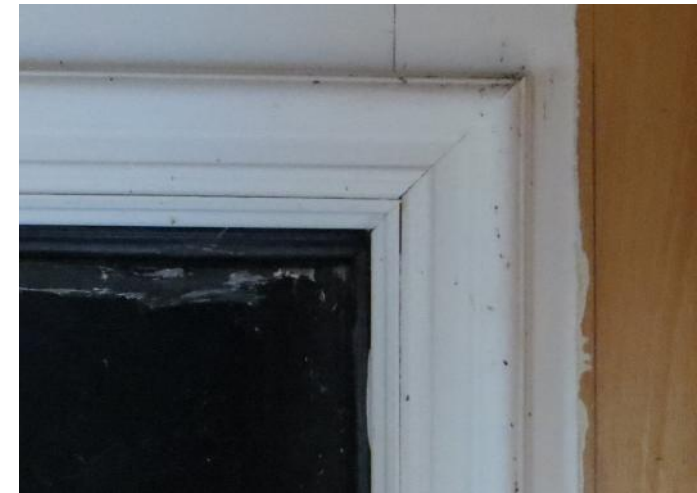
**Figure 4.205:** Showing a close-up of Figure 4.204.

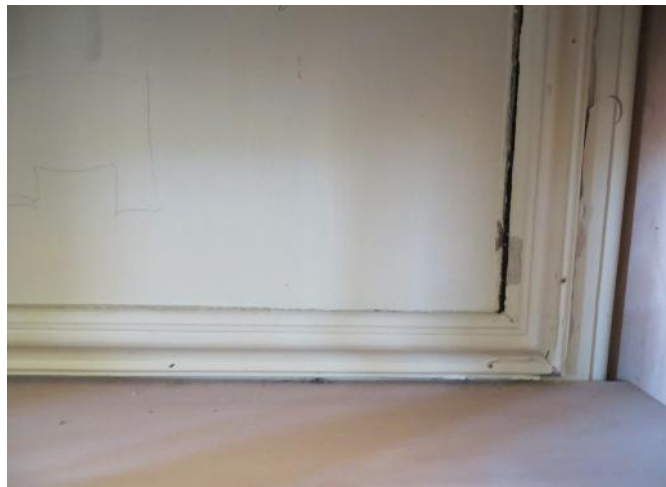
Figure 4.200 shows that inspection holes were made in the modern panelling above the chimneypiece to ascertain if the 18th century overmantel survived above. Figure 4.206 shows that it does.

**Figure 4.206:** Showing part of the 18th century overmantel that survives behind the modern panelling.

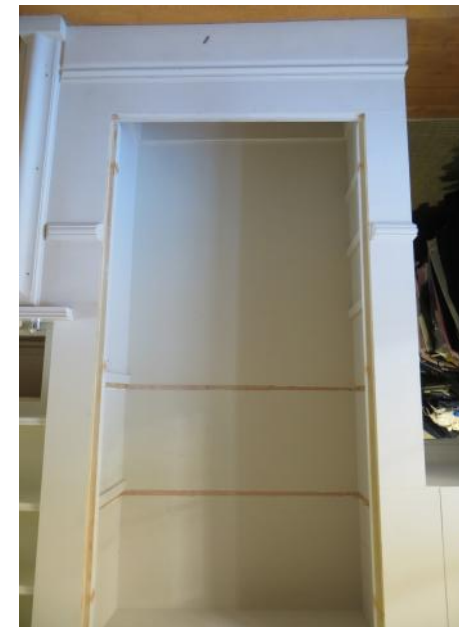
Figure 4.207 shows the modern built-in wardrobe on the southern side of the chimneybreast. We can see that its rear wall is formed of plywood. Figure 4.209 shows that an historic wall lies behind this so only the modern wardrobe was removed.

**Figure 4.207:** Showing the modern built-in wardrobe on the southern side of the chimneybreast. We can see that its rear wall is formed of plywood.

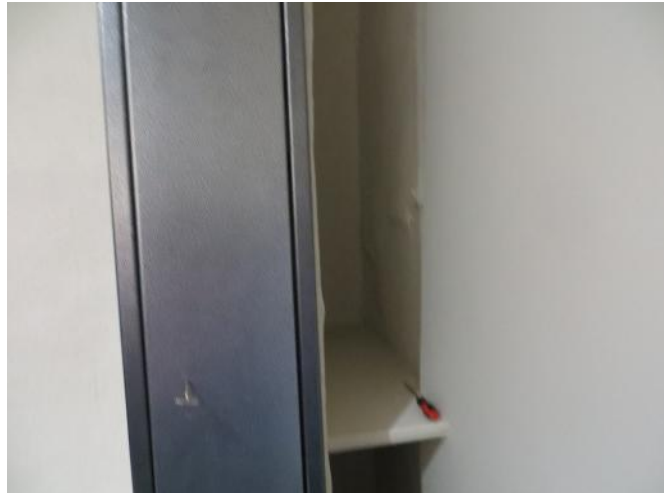
**Figure 4.208:** Showing the view within the Dressing Room towards the dividing wall behind the wardrobe shown in Figure 4.207.

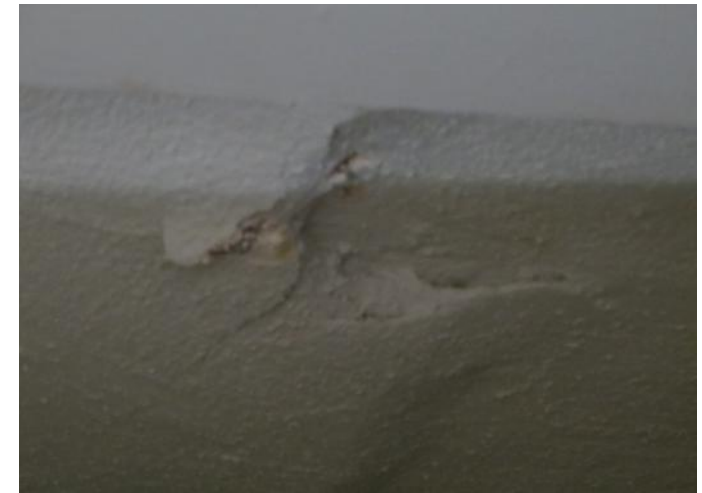
**Figure 4.209:** Showing a close-up of Figure 4.208.

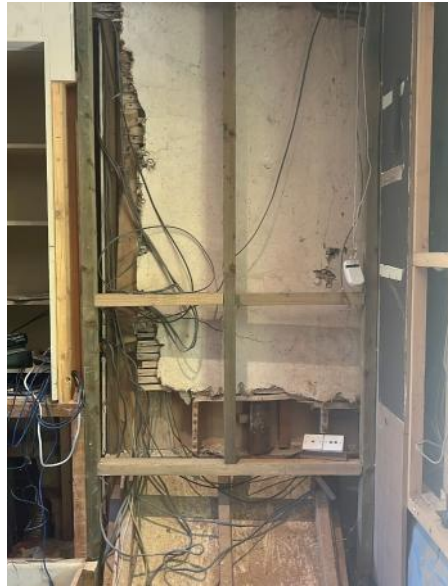
**Figure 4.210:** Showing the lath and plaster wall found on the wall between the Sitting Room and the cellar staircase wall.

Opening up works were undertaken on the wall between the Sitting Room and the cellar staircase wall. A historic lath and plaster wall was found.

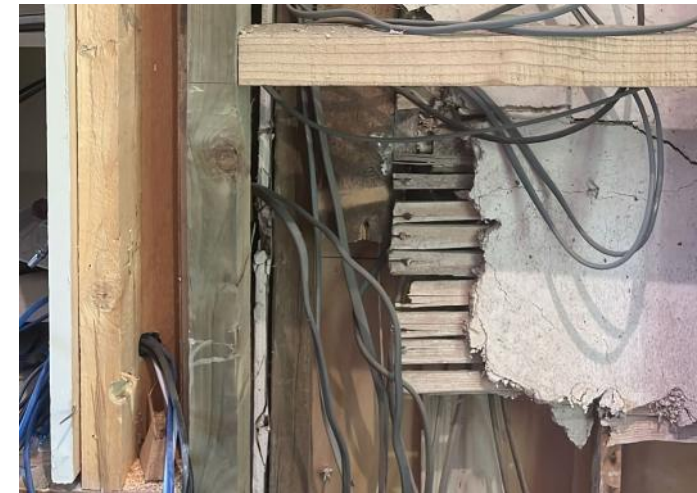
**Figure 4.211:** Showing the lath and plaster shown in Figure 4.210 in detail.

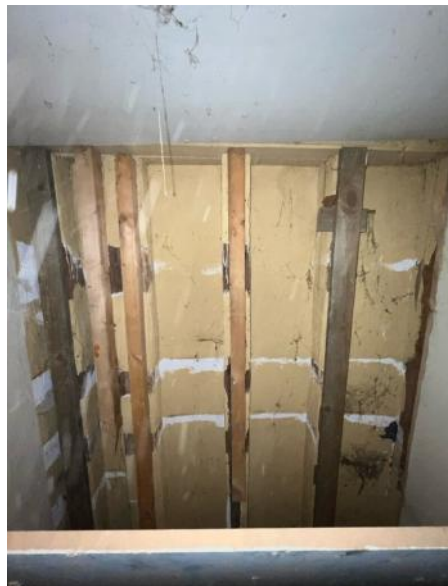
**Figure 4.212:** Showing the historic timber frame studs revealed on the southern wall of the existing kitchen. Modern battens had been affixed to their northern sides.

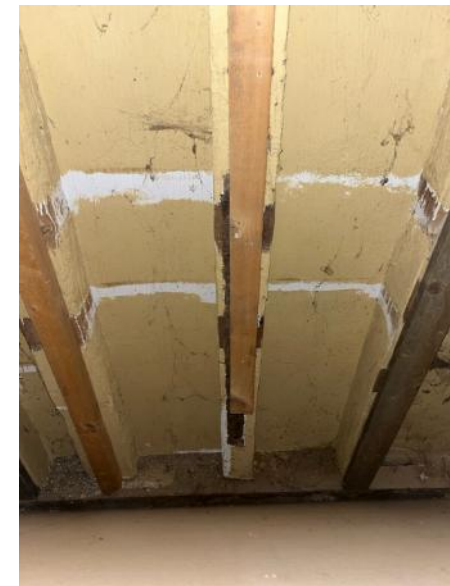
**Figure 4.213:** Showing a close-up photograph of Figure 4.212.

Opening up works were undertaken on the southern wall of the kitchen, on its western side as shown at Figure 4.213. Historic studs were located, which form part of the original/historic timber frame of the building. Affixed to these were modern battens of no heritage value.

The scheme proposes the installation of a new glazed panels (double glazed) between the existing historic studs. This would create additional daylight for the Library/Study. Figure 4.213 suggests that there is no historic fabric between the historic studs, with only the externally clad insulation and render being visible. The inclusion of a window here would use the same approach seen at the northern end of the kitchen cross wing where there are a pair of single light windows inserted in the 1990s phase of works between the historic timber frame members (see Figure 4.69). No historic fabric would be lost in this scheme element.

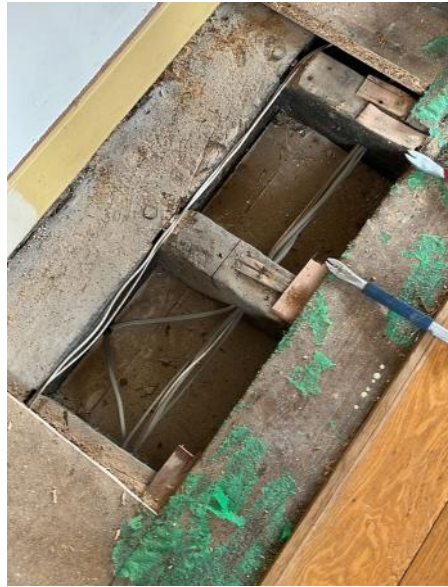
We understand that opening up works below the existing modern floor in the first floor Western Bedroom revealed historic floorboards. These were of a consistent width, of 12.5cm. The consistent width of the floorboards and an actual width of 12.5cm suggests these floorboards are Victorian.

**Figure 4.214:** Showing the historic boards revealed below the modern floor in the first floor Western Bedroom.

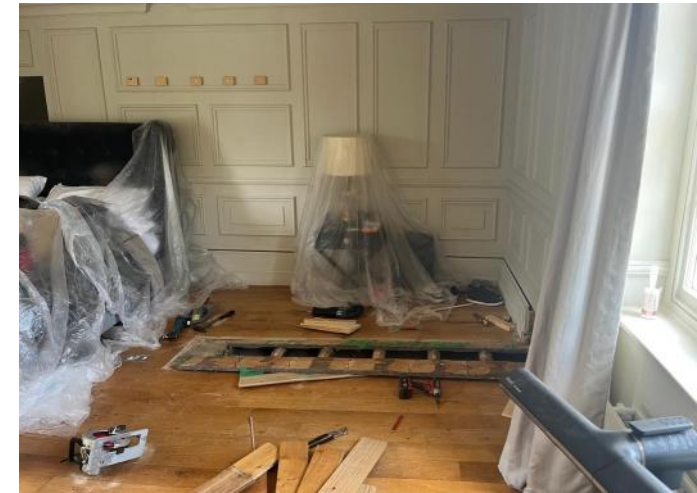
**Figure 4.215:** Showing the location of the opening up works in the first floor Western Bedroom floor.

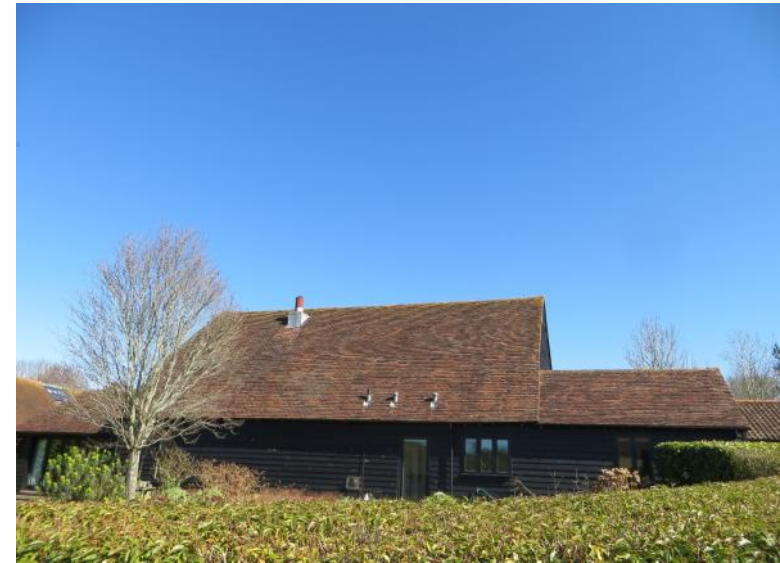
A vernacular timber framed barn from the 16th century, with alterations in the early-mid 20th century and again in the 1990s when it was converted to residential use. Vernacular construction is shown by the timber framed construction and the aisled construction in

**Figure 5.1:** Showing the aisled barn west of the Old Manor Farm House.

particular, of which surviving examples are relatively rare. The vernacular materials are also shown by the use of traditional weatherboarding, red clay tiles, and a red brick plinth. The principal element of significance is the age of the building. It is considered to be of special architectural interest.
