Old Manor Farm House, Shaftenhoe End,  
Hertfordshire, SG8 8LD

Heritage Statement

Local Planning Authority: North Hertfordshire District Authority

September 2025

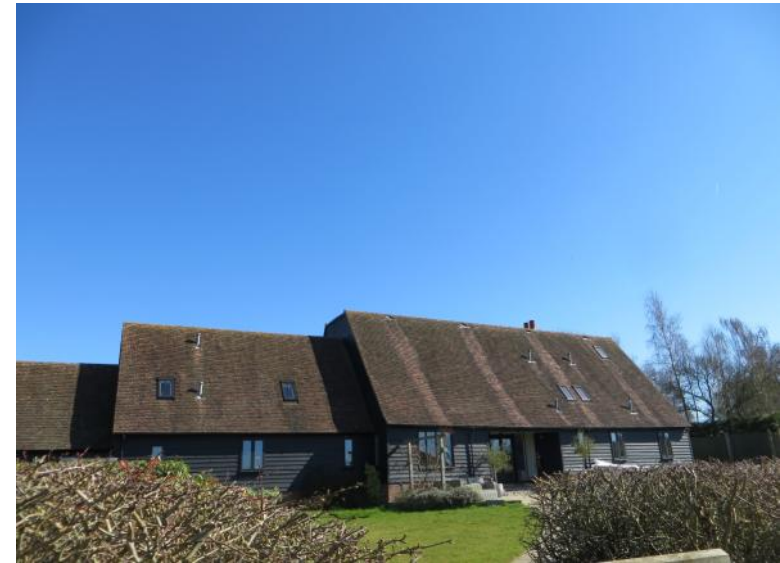
A vernacular timber framed barn from the 18th century, perhaps with an earlier core, and much altered in the 1990s when it was converted to residential. Vernacular construction is shown by the timber framed construction and the aisled construction in particular, of which surviving examples are relatively rare. The vernacular materials are also shown by the use of traditional weatherboarding, red clay tiles, and a red brick plinth. The principal element of significance is the age of the building. It is considered to be of special architectural interest.

**Figure 5.2:** Showing the aisled barn and sheds south west of the Old Manor Farm House.

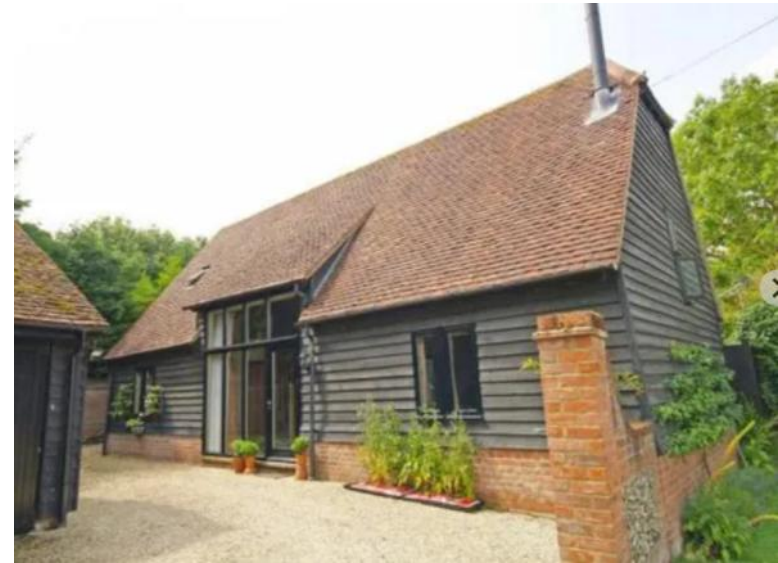
A former aisled barn dating from the 17th or 18th century. It was built above a red brick and flint plinth and is timber framed, and horizontally clad in timber weatherboarding stained black in the traditional manner. The north-eastern end has a steeply pitched half hipped roof, whilst the south-western end is gabled. The roof is covered with red clay plain tiles. The Historic England list entry confirms that the barn's roof was covered with corrugated iron in 1987 at the date of listing, but was evidently changed to tiles as part of the 1990s conversion to residential.

The barn is three bays in length internally and is aisled on both sides. There is monopitched roofed porch on the south-eastern elevation, which historically would have contained a pair of large doors. These have been replaced by a large 4-light window with transom as part of the 1990s conversion to residential.

**Figure 5.3:** Showing the aisled barn north of the Old Manor Farm House (Source: Move Market, n.d.).

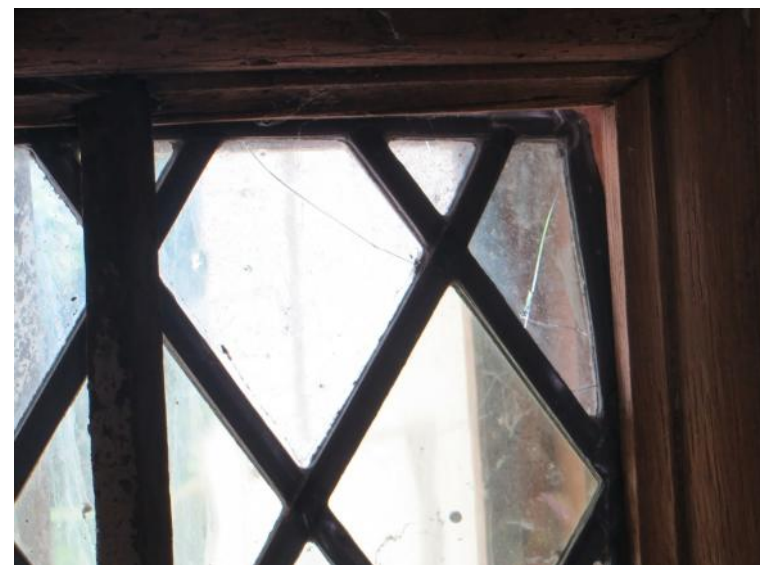
**Figure 6.1:** Showing an example of the broken glass panes in the historic leaded light casement in the existing dining room.

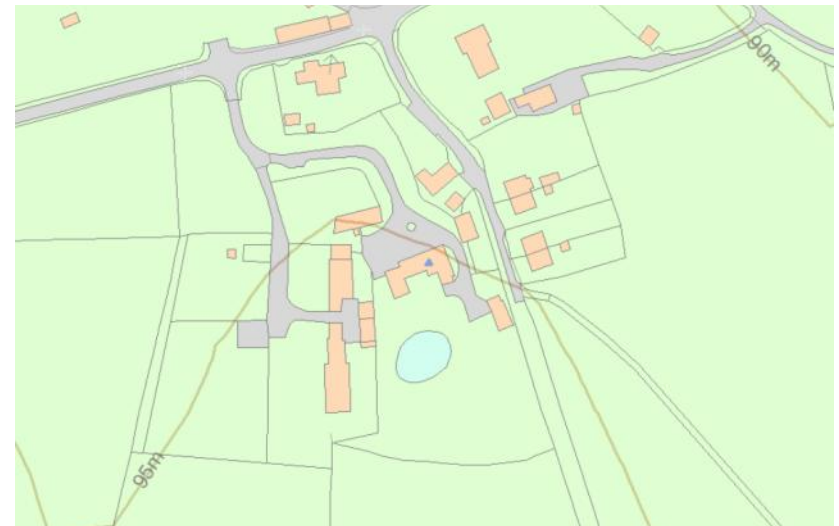
### AISLED BARN ABOUT 20 METRES WEST OF OLD MANOR FARM HOUSE

Aisled barn. 'P.H. 1795' on tie beam, altered C20. Timber frame on brick base. Weatherboarded. Corrugated sheet roofing. 3 unequal bays with a single aisle to rear. Central double doors. Interior: jowled posts with arched braces to tie beams and arcade plate, renewed above tie beam with angled struts to principals. Included for group value.

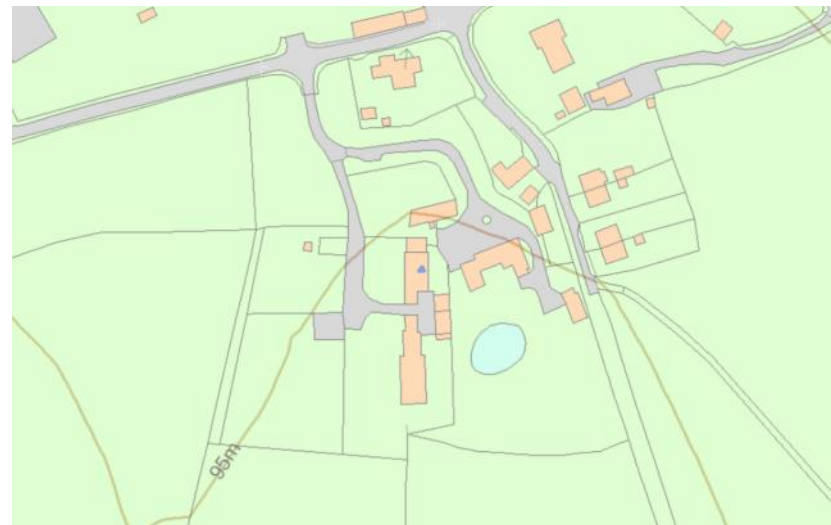
### AISLED BARN AND ATTACHED SHEDS ABOUT 40 METRES SOUTH WEST OF OLD MANOR FARM HOUSE

Aisled barn and attached sheds. C18. Timber frame on brick base. Weatherboarded. Corrugated sheet roofing rounded over ridge. 4 bays with a single aisle to rear. Second bay from house is open to yard, window in left end. Interior: jowled posts with arched braces to tie beams and arcade plate, angled struts to principals, collars clasp purlins, tension braces and studding in walling. Attached to right end is a 3 bay cart shed, open to front, steeply pitched corrugated sheet roof. Jowled posts with arched braces to wall plate and tie beams, clasped purlin roof. Further to right and yet lower are 3 bays of former cow sheds, now piggeries, doors to yard, steeply pitched corrugated sheet roofing.

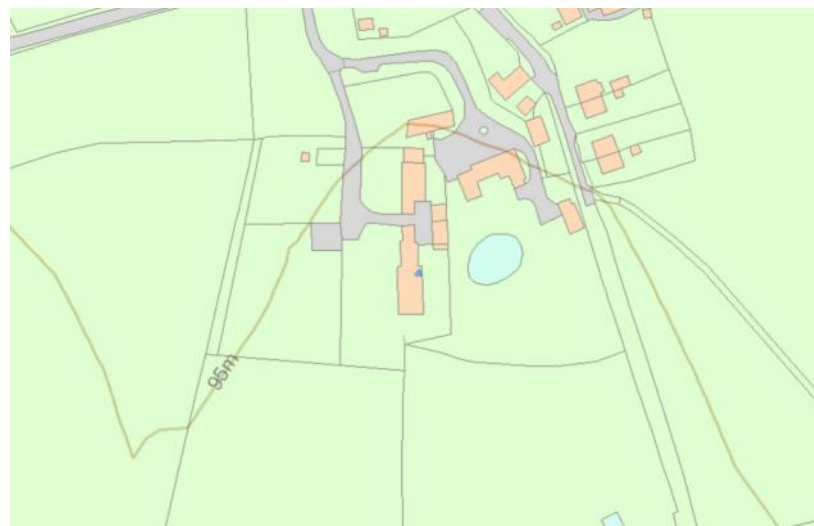
### AISLED BARN ABOUT 20 METRES NORTH OF OLD MANOR FARM HOUSE

Former aisled barn, now used as a storage shed. C17 or C18. Timber frame on flint and brick base. Weatherboarded. Steeply pitched corrugated sheet roof. 3 bays with aisles on both sides. Central doors to yard. Interior: jowled arcade posts with arched braces to tie beams and arcade plates. Collars clasp purlins, some curved windbraces. Included for group value.
