**Dean's Yard, South Road,  
Baldock**

## **PHASE ONE ENVIRONMENTAL ASSESSMENT REPORT (PRELIMINARY RISK ASSESSMENT)**

IN25198 CL 001

September 2025

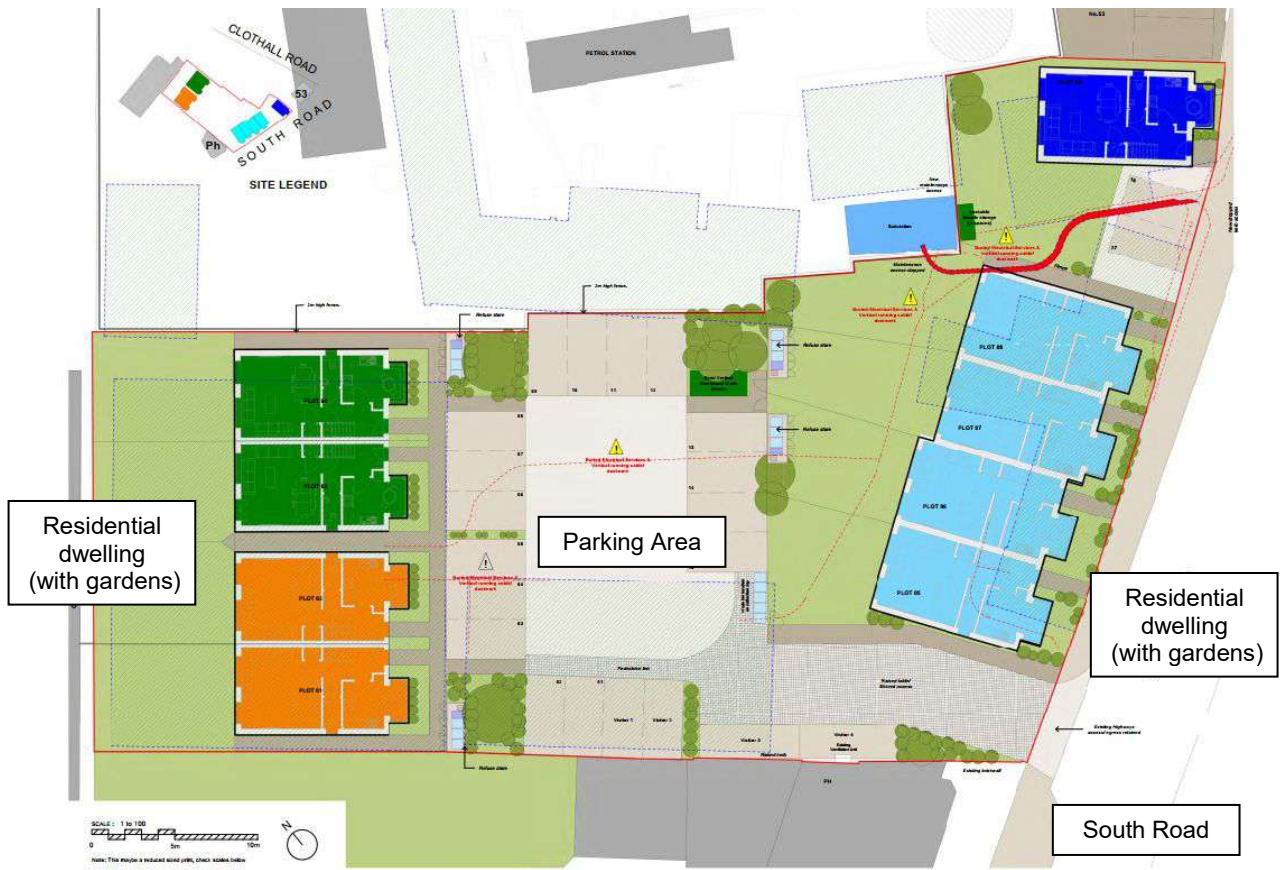
Table One: Proposed Development Plans

| Proposed Developments | We understand that Baldock Operations Ltd proposes to demolish the existing building and redevelop the site for residential end use. The development will include 9 no. dwellings, with associated access, parking, and landscaping/gardens. A site plan showing the proposed development plan is provided below. |

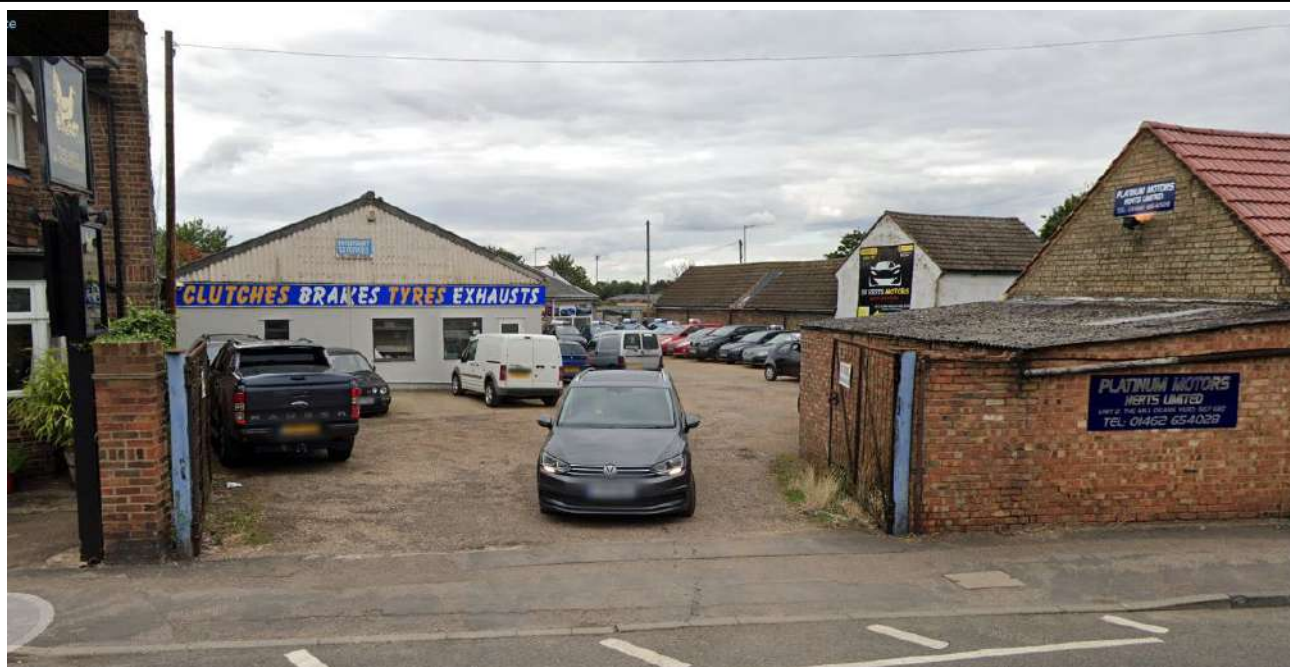
**Photograph One:** Site view from South Road, with main workshop on left hand side.

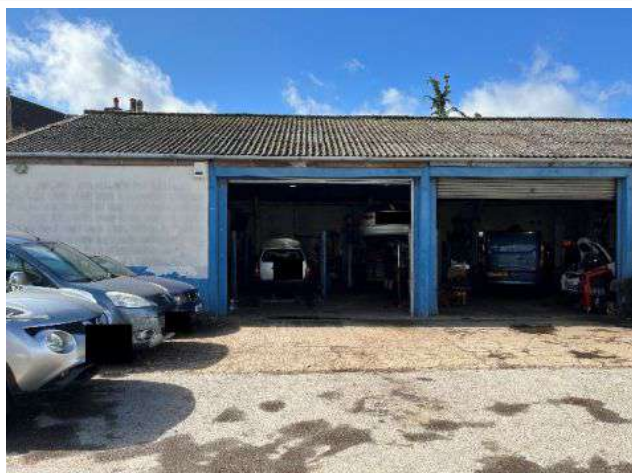
**Photograph Two:** Main workshop building, currently in use for vehicle maintenance / repair, located towards the western end of the site.

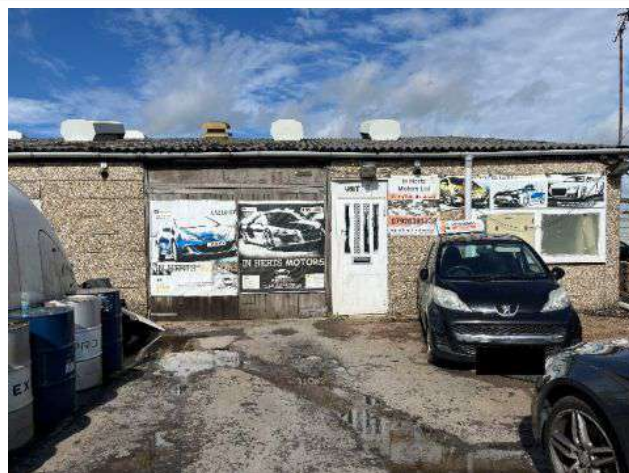
**Photograph Three:** Workshop building located to the rear (northern end) of the site. Currently no obvious signs of use.

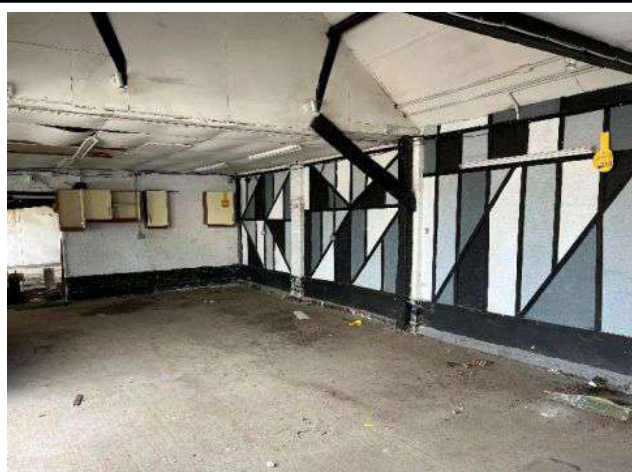
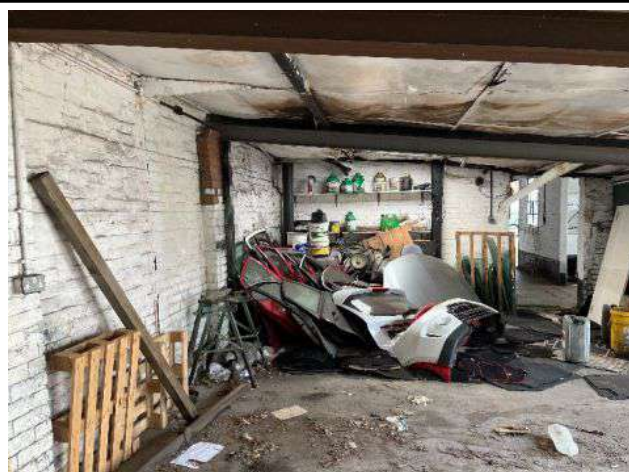
**Photograph Four / Five:** Interior of workshop building nearest South Road (towards eastern corner of the site). Currently not in use, other than for storage of old car parts (waste?).

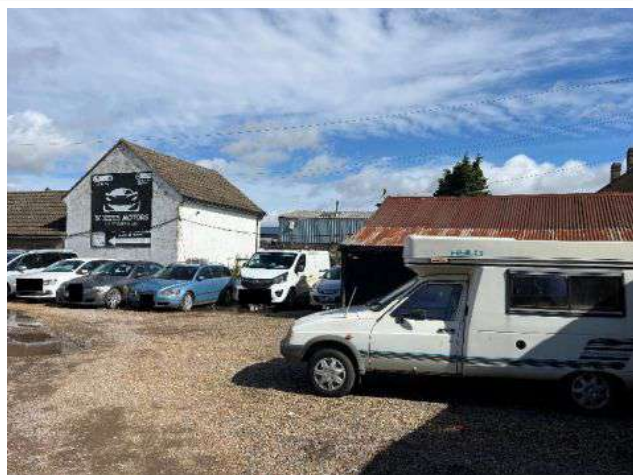
**Photograph Six:** Courtyard area in centre of site.  
Covered with gravel (i.e. No hardstanding)

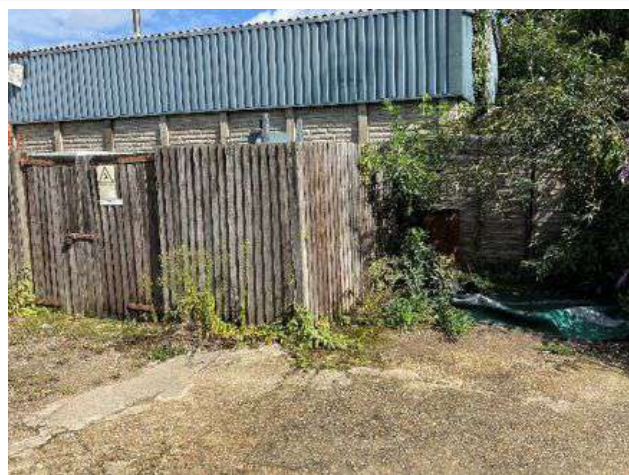
**Photograph Seven:** Electrical sub-station, just  
beyond site boundary.

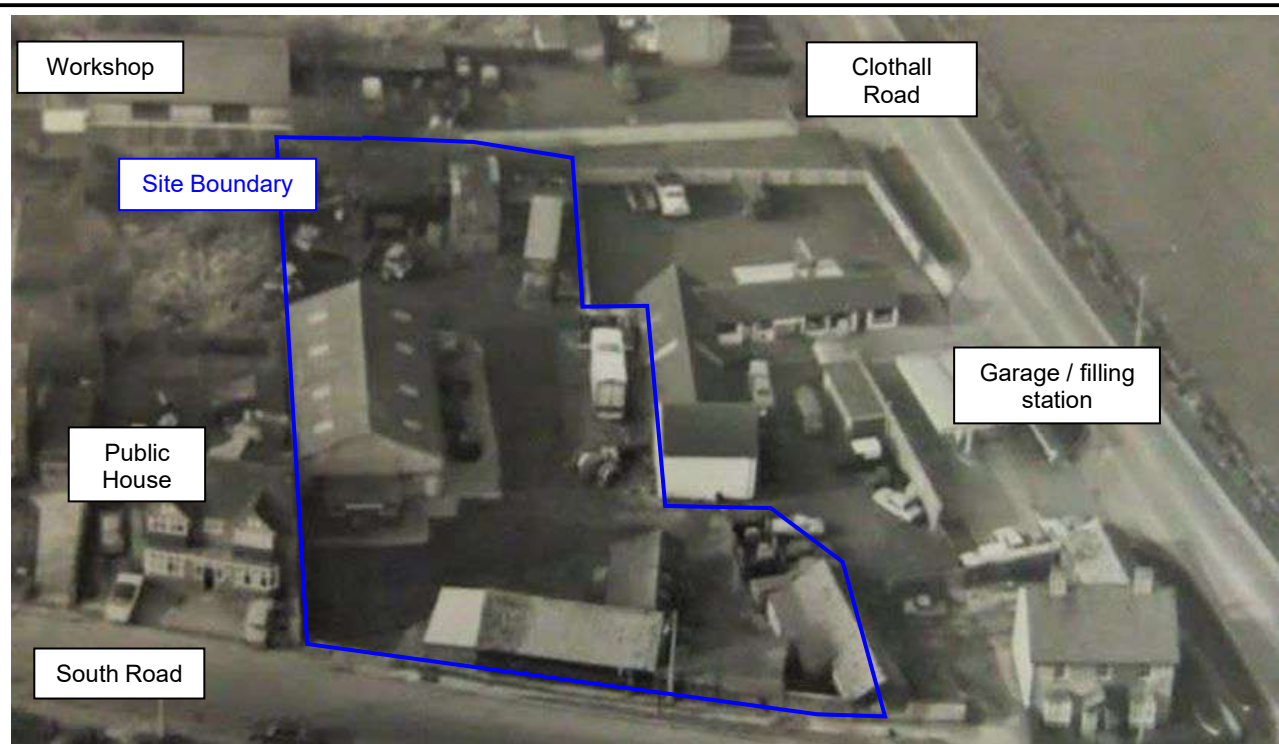
**Figure Three Aerial Photograph Showing Site in 1960s**

We have identified the following aerial photograph, reported to have been taken in the 1960s, which shows the site as an engineering works. Several of the existing site buildings are shown, including the workshops along the southern and western boundaries. Various wagons / trucks are present also.

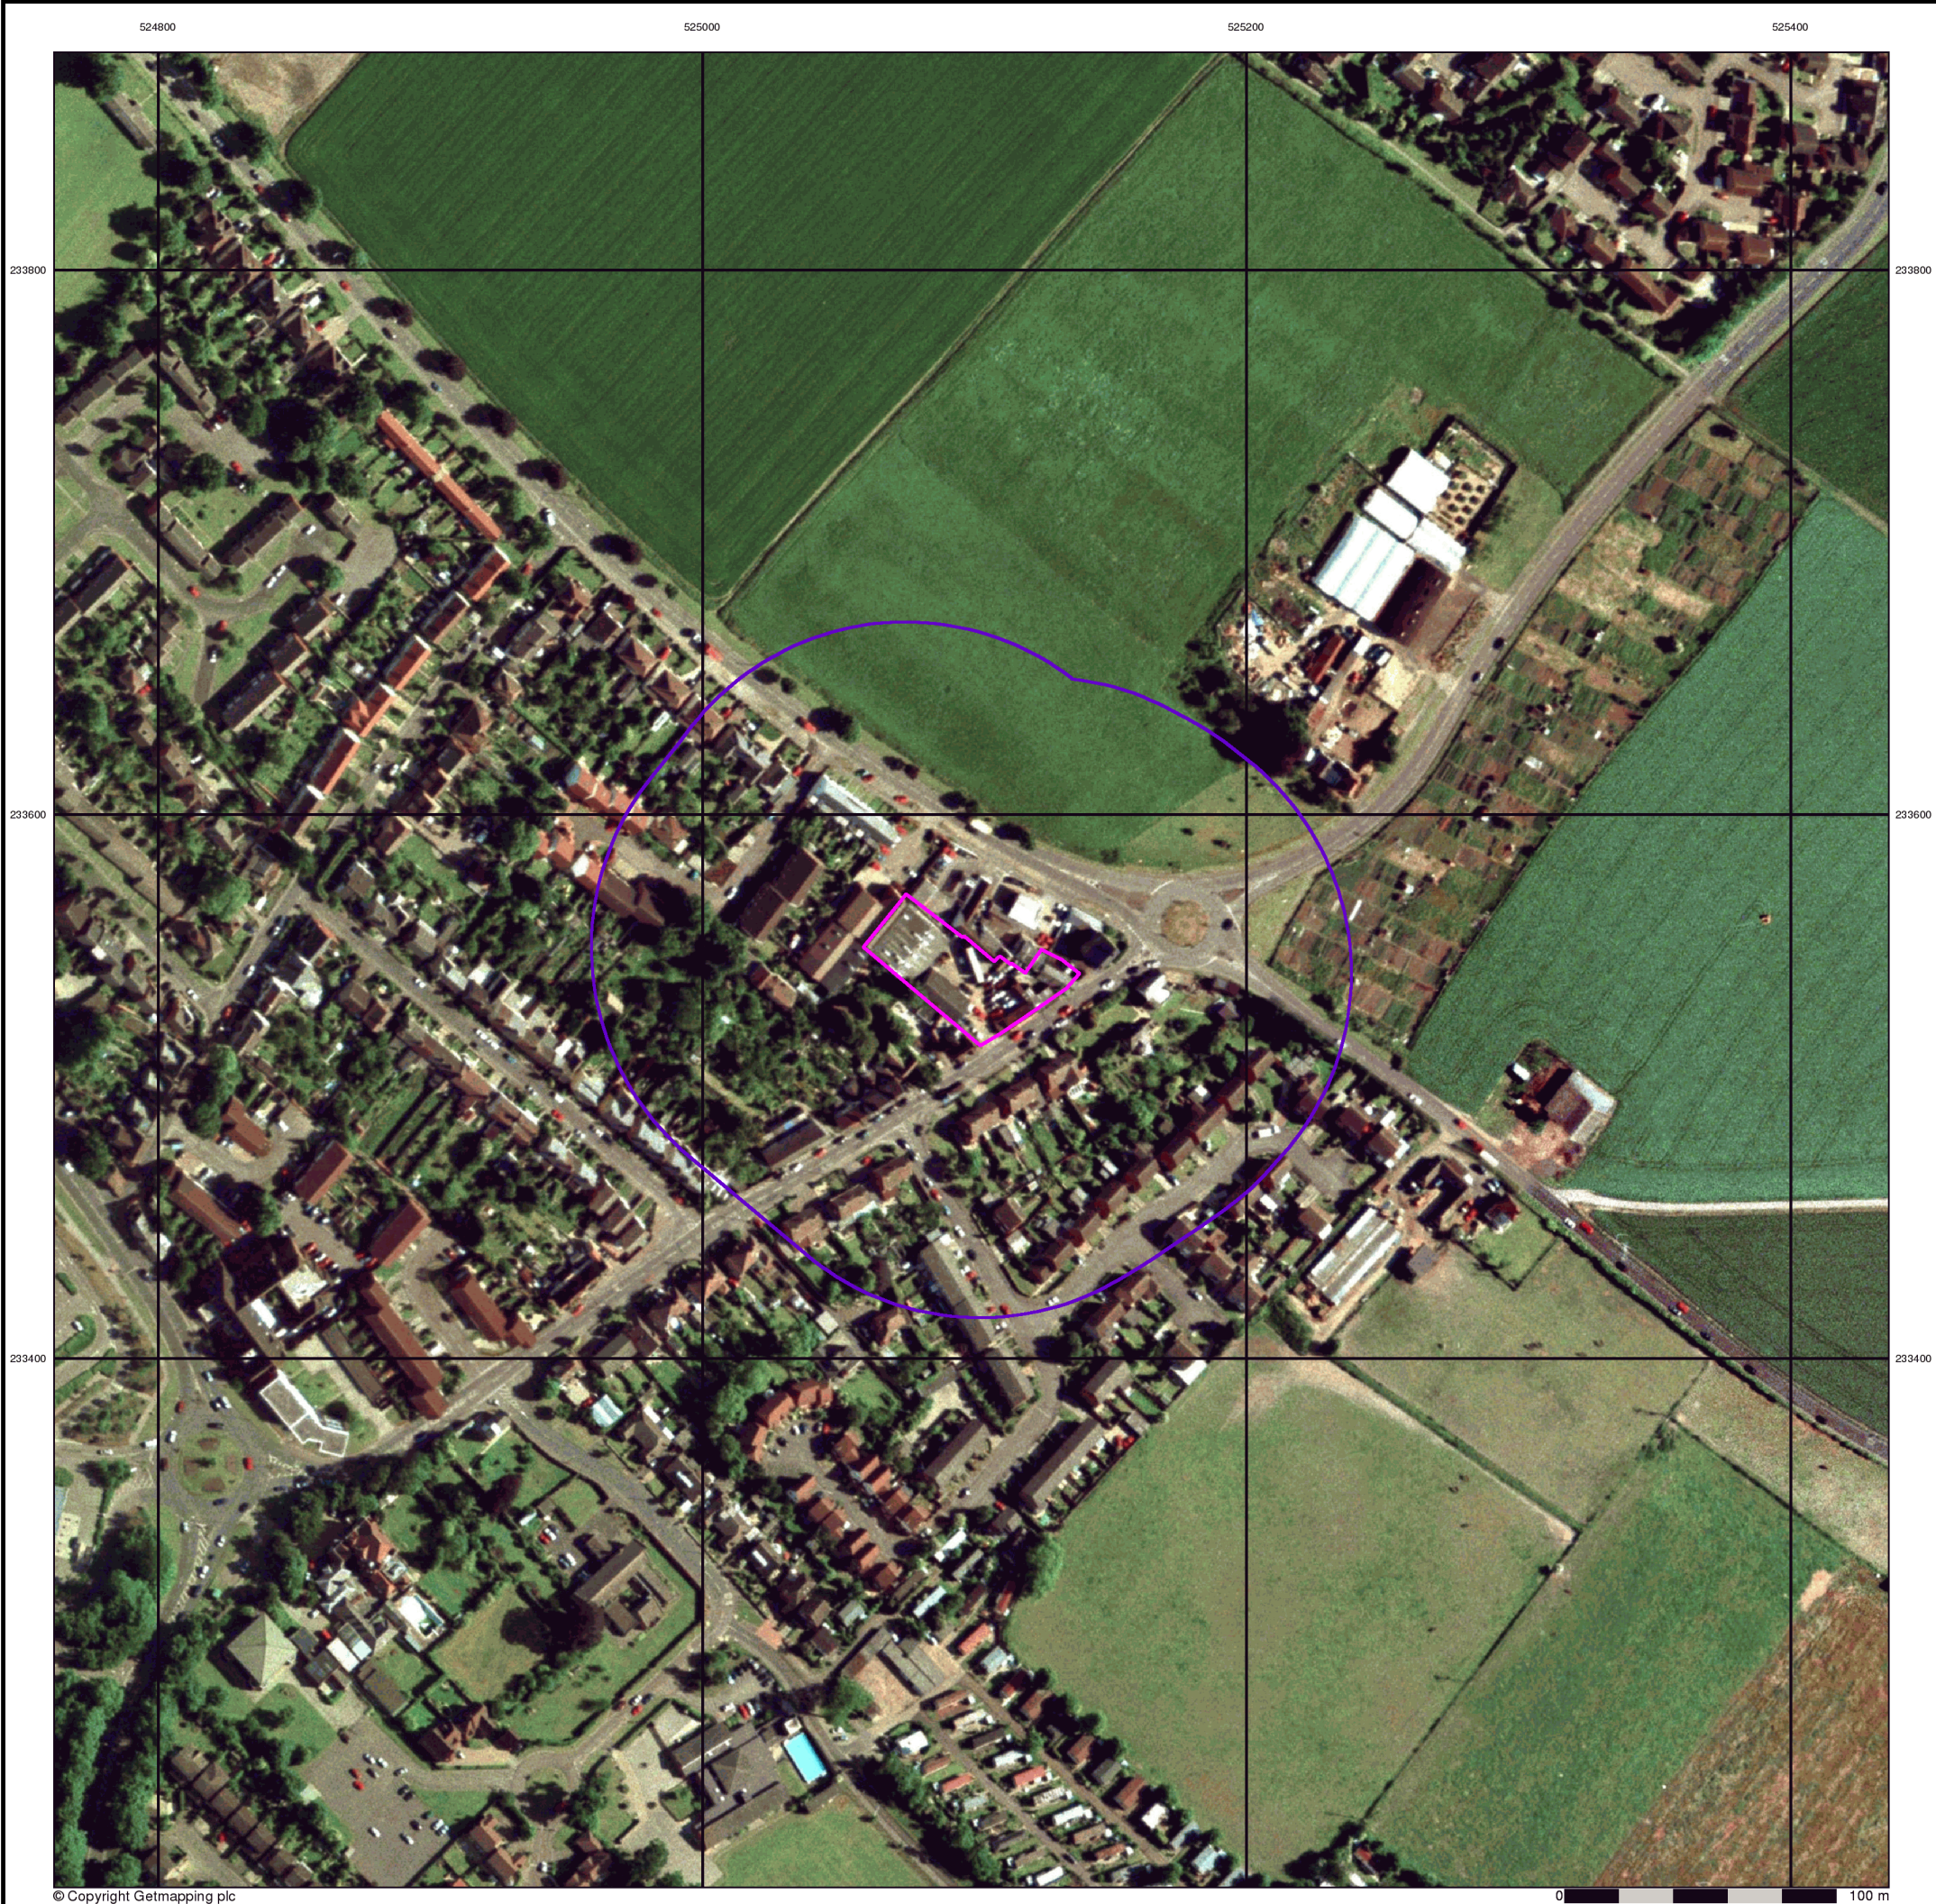
## Historical Aerial Photography

### Published 1999

| Date | Review of Map – Description of Land Use at Site and in the Immediate Surrounding Area | Potentially Contaminative Land-use | |
|---|---|---|---|
| 1988, 1993<br>(1:2,500 Scale)<br><br>1999<br>(Aerial photo) | The buildings along the southern and eastern boundary remain present, but the small building to the rear of the site has been replaced with a new large square building (the workshop exists today).<br><br>The garage to the north-east remains present, although there have been some minor changes to building size / layout etc. By 1993 the land to the south of South Road has been extensively developed with residential housing. | | |
