9-10 High Street, Hitchin, SG5 1EH

## Preliminary UXO Risk Assessment

| <b>Project</b> | 9-10 High Street, Hitchin |
| <b>Report Reference</b> | PA17193-00 |

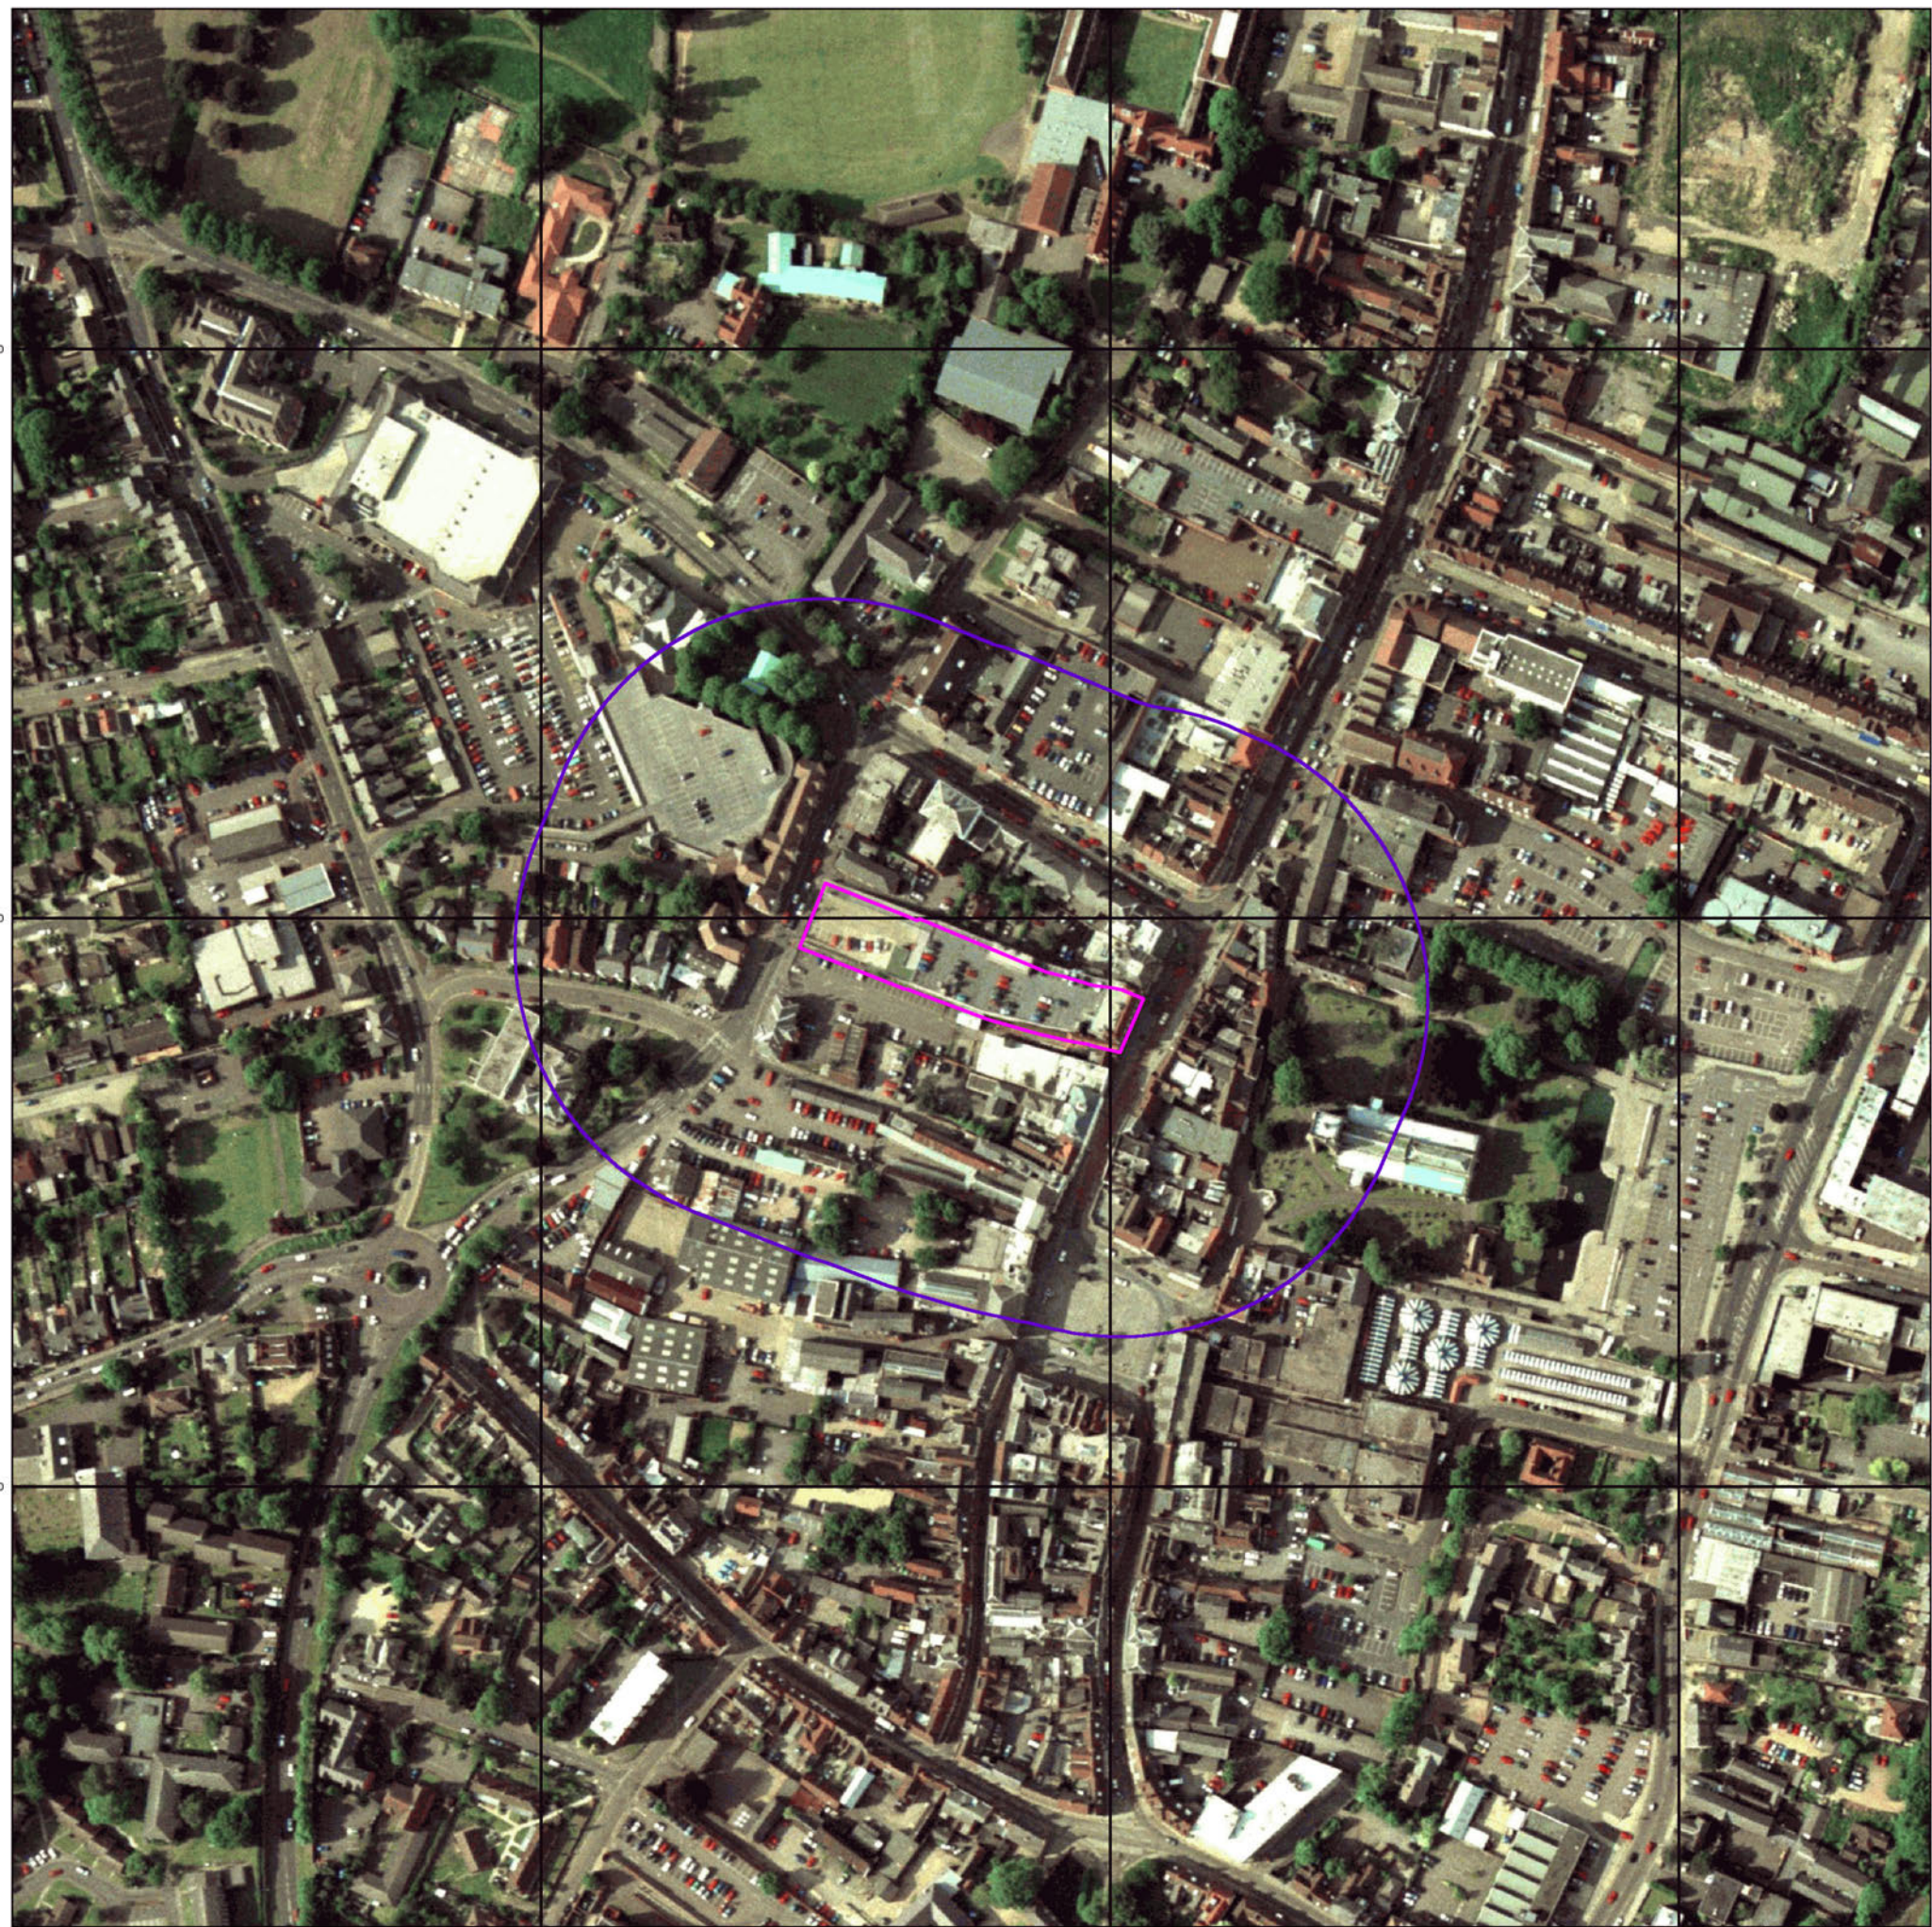
### Historical Aerial Photography - Segment A13

This aerial photography was produced by Getmapping, these vertical aerial photographs provide a seamless, full colour survey of the whole of Great Britain

| Is there any evidence of bomb damage on/close to the site? | A comparison of pre- and post-WWII OS mapping does not suggest any changes within, or in the immediate vicinity of the site boundary, such as missing or 'ruined' properties. Available post-WWII aerial photography corroborates this, with no obvious signs of bombing damage to structures or indications of cratering or scattered earth. |

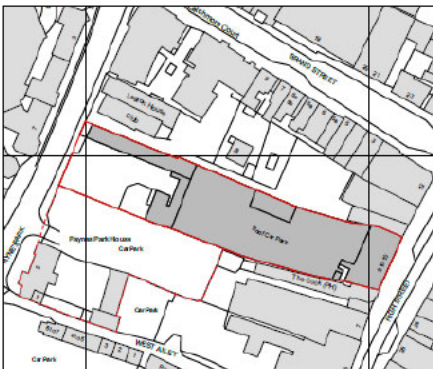
| Risk Assessment Considerations | |
|---|---|
| <p>Site location and description/current use</p> | <p>The site is located in High Street, Hitchin in Hertfordshire.</p> <p>Recent aerial photography shows the site to comprise large commercial structures with a hardstanding carpark in the west.</p> <p>The site is bound by an access road, structures and hardstanding carparks to the north, High Street and structures to the east, structures and a hardstanding carpark to the south and the A505 Paynes Park to the west.</p> <p>The site is approximately centred on the OS grid reference: <b>TL 18349 29185</b>.</p> |
