# **Bat Emergence Survey Report**

**The Lodge, Preston Road, Gosmore, Hertfordshire**

**212025**

**August 2025**

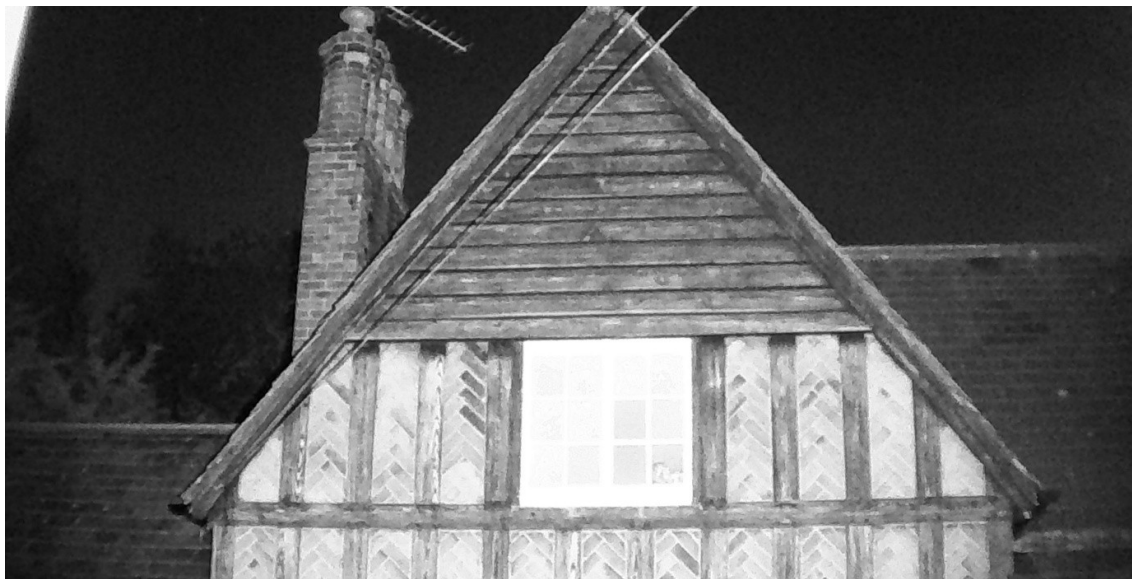
*Darkest point: position 2*

There was some restriction to the NVA field of view on position 2. The NVA was accordingly slightly repositioned during the survey and observation supplemented with a handheld NVA (see methods).
