April 2025

# 227: 31 Manor Crescent

Manor Crescent, Hitchin  
Design and Access Statement

**Michael Collins Architects LLP**

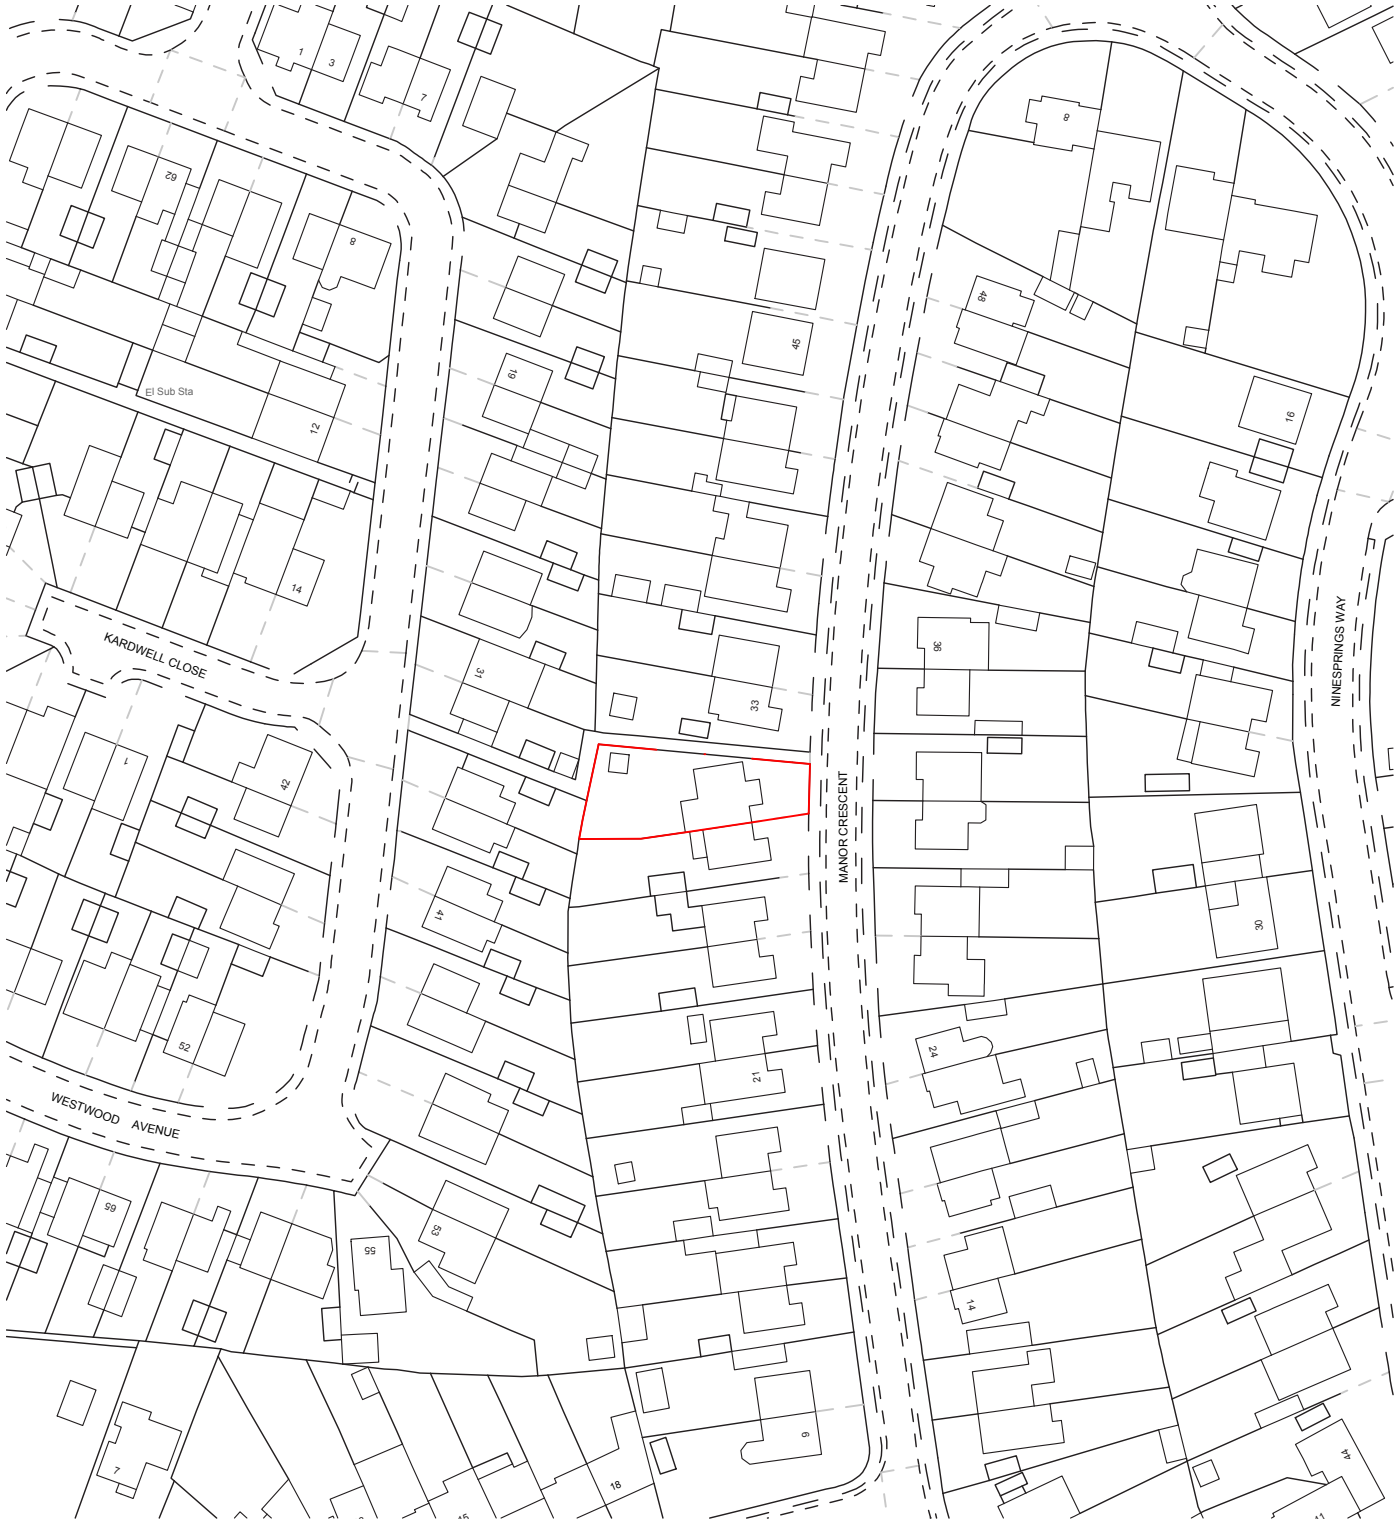
Job No. 227 Location Plan

Ownership boundary  
(Indicative, refer to title deed)

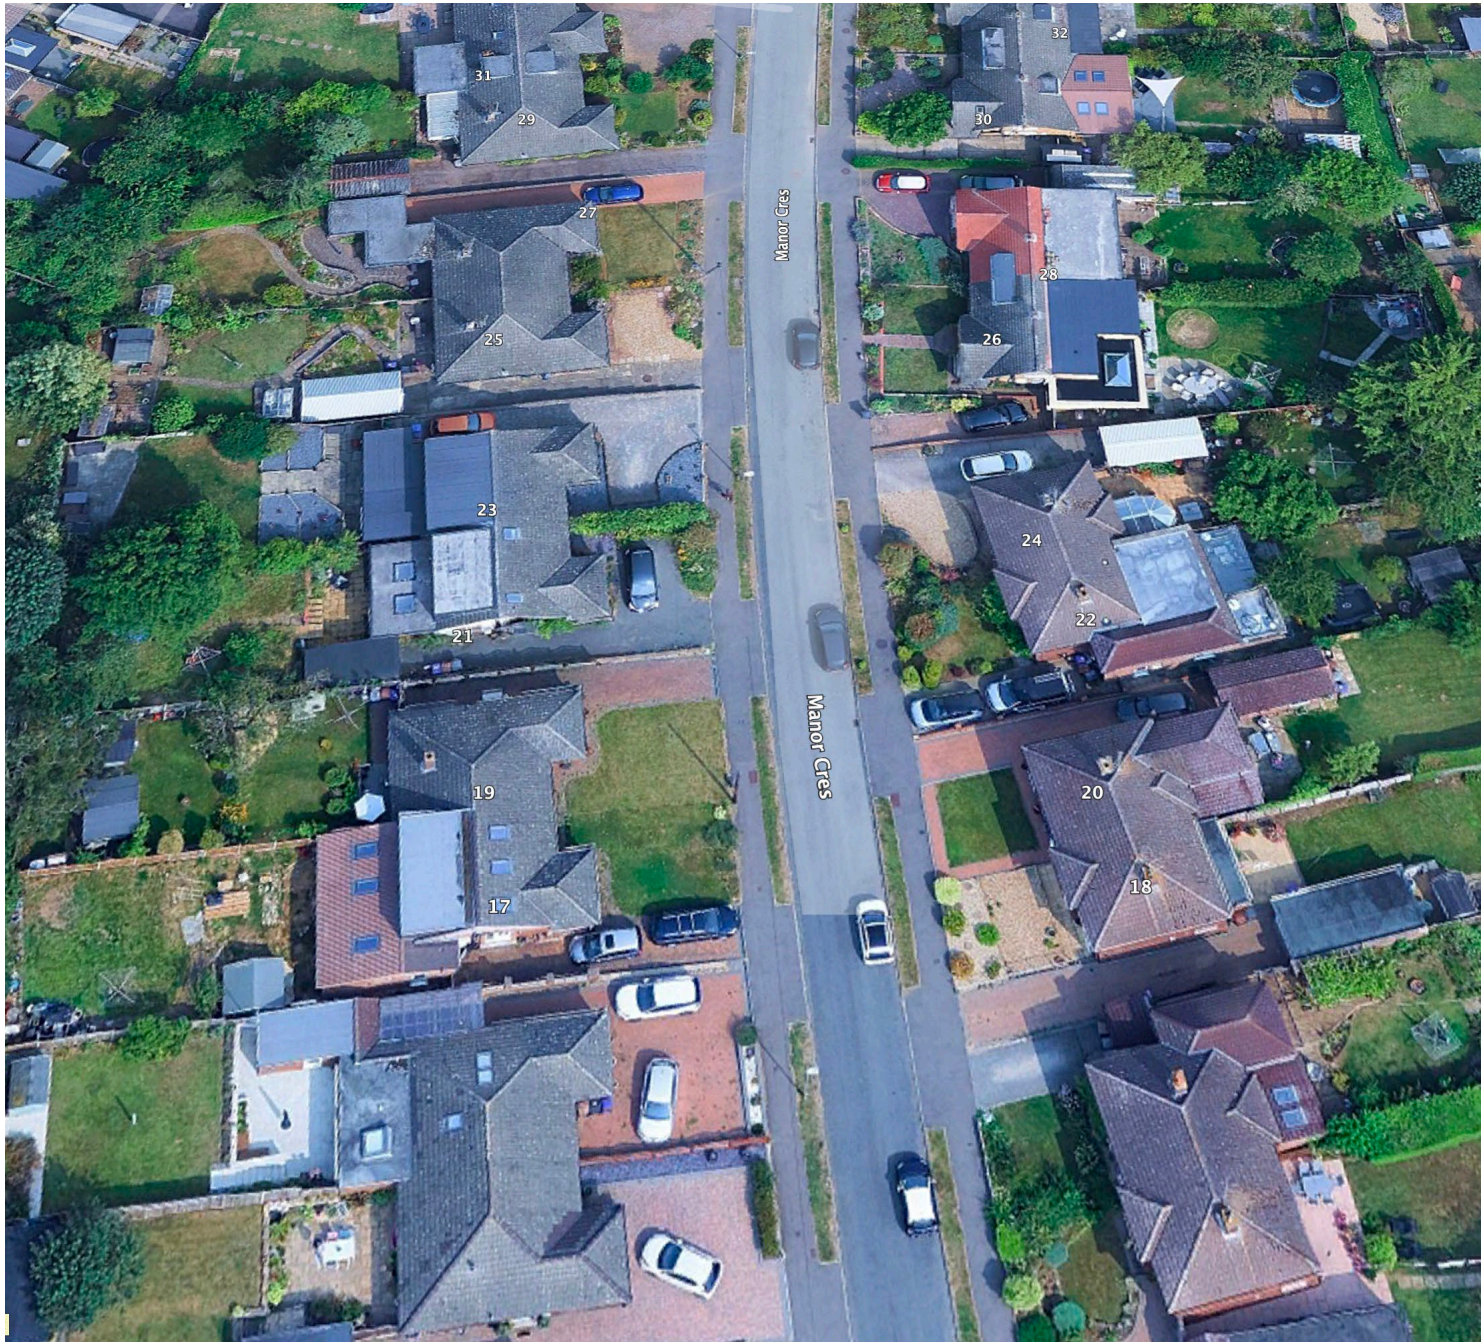
Ariel image of Manor Crescent, illustrating numerous large rear extensions of varying forms, materials and massing. (C) Google

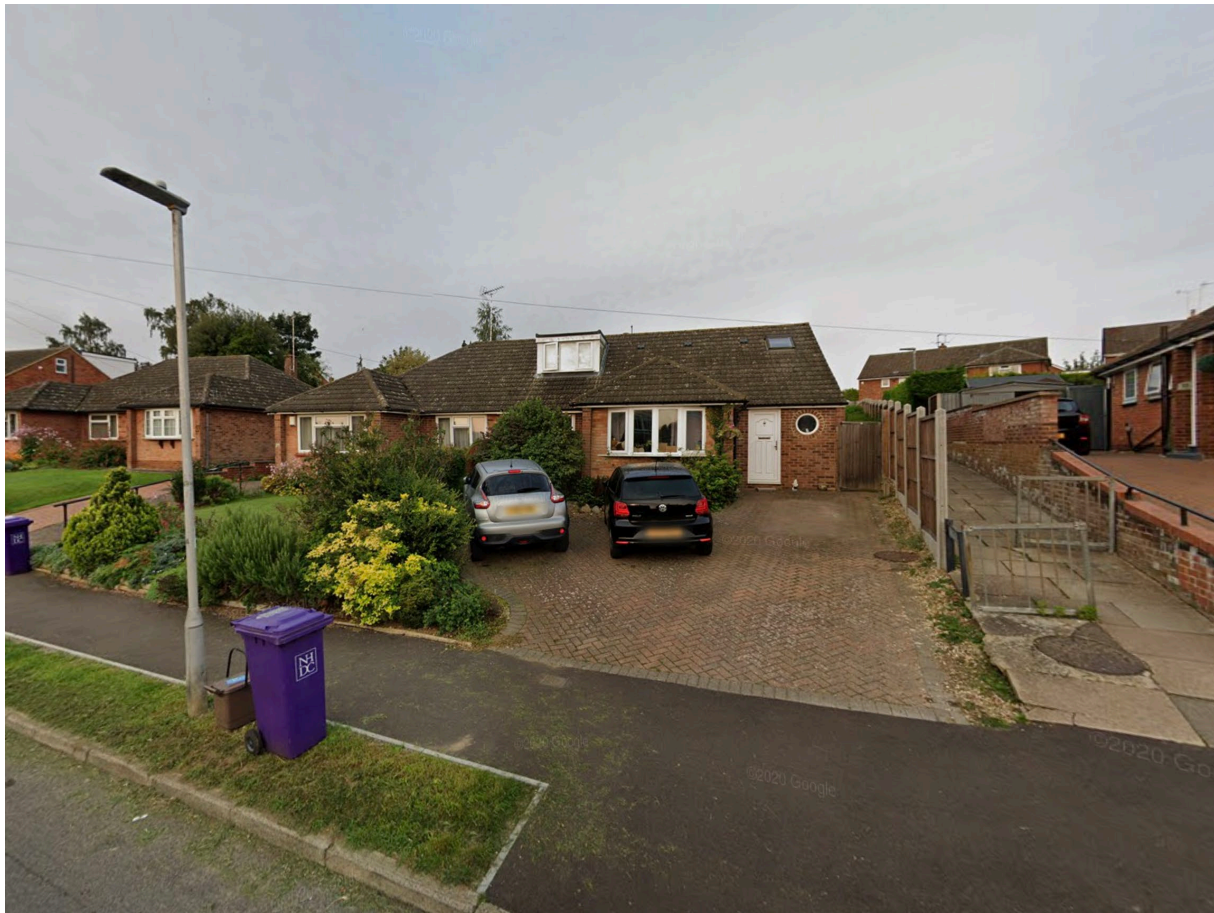
- The front and rear of the property is composed of red facing brick with the existing extension and hip-to-gable conversion closely matching the original brickwork, both in a fair condition but with some localised areas of repair required.

a. View of the Front facing west showing the adjacent property and Riddy Lane path.  
Street View (C) Google 2020

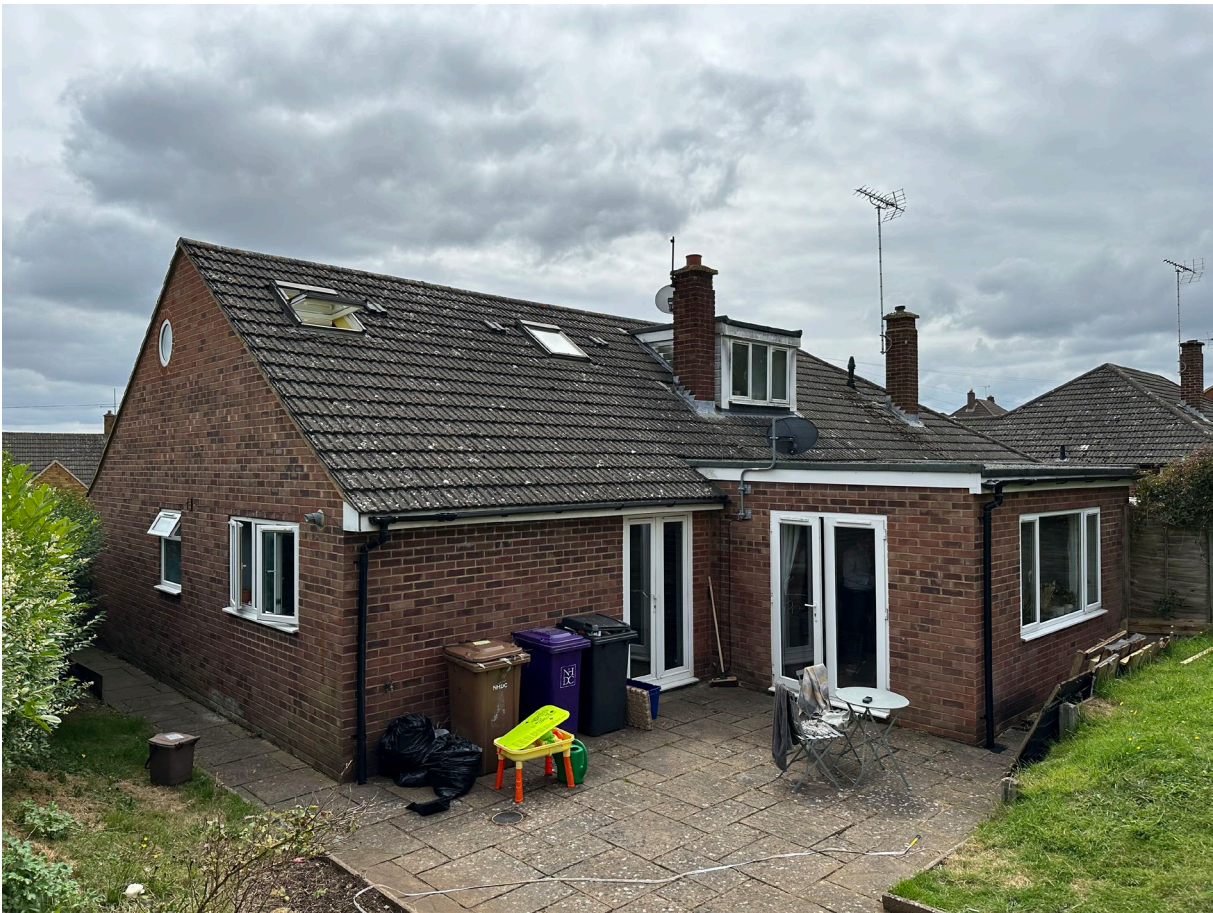
- The existing main roof pitches use concrete tiles, which are in a fair condition.
- The existing dormers are clad in white UPVC, which is in need of replacement.

- Both dormers and extension flat roof use a bituminous felt covering, which is in need of replacement.
- Existing Velux windows show signs of rot (visible internally), requires replacement.

b. View of the rear elevation from the bottom of the garden

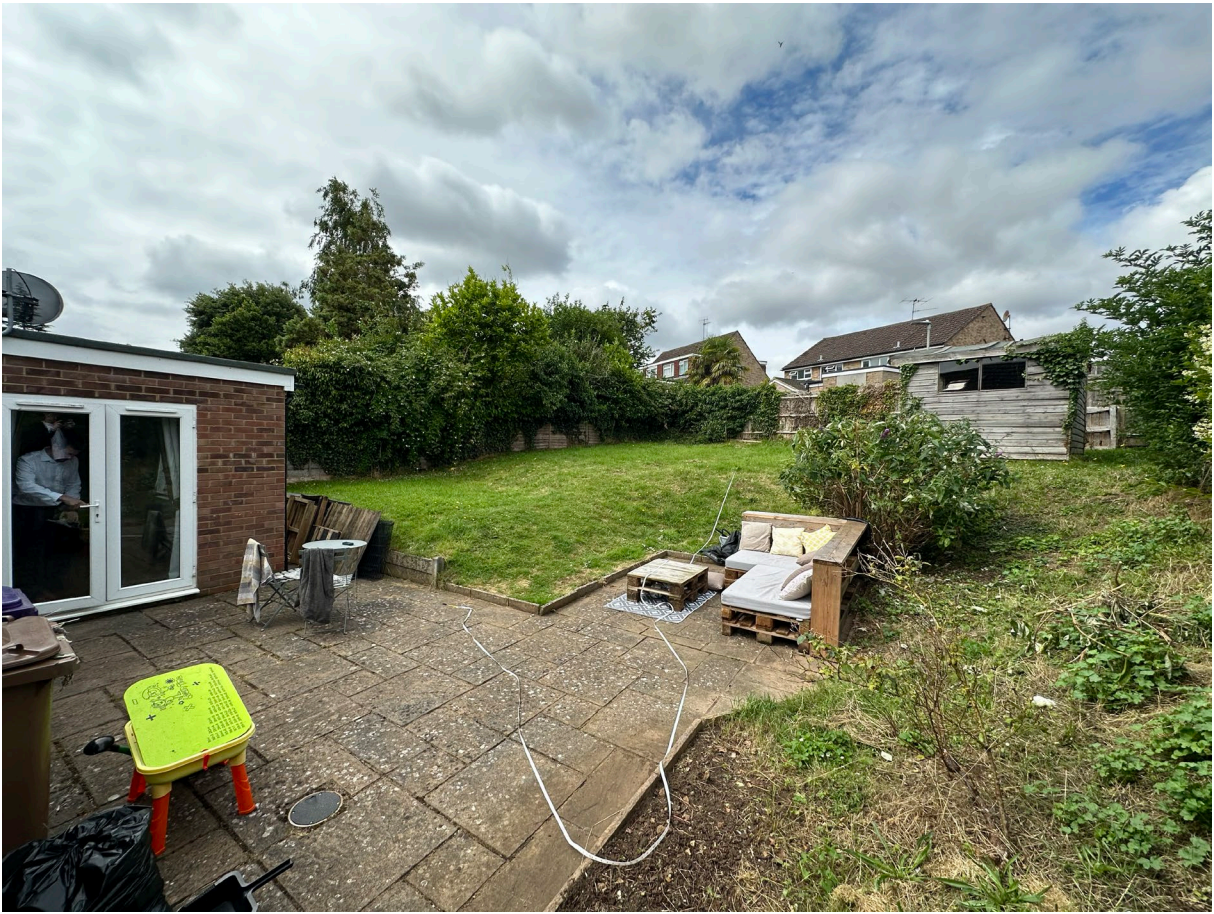
- There is a level change across the site of approximately 300-400mm, from the road level to the bottom of the garden.
- Existing storage shed has access issues due to site slope.

c. View from the rear elevation to the garden facing south

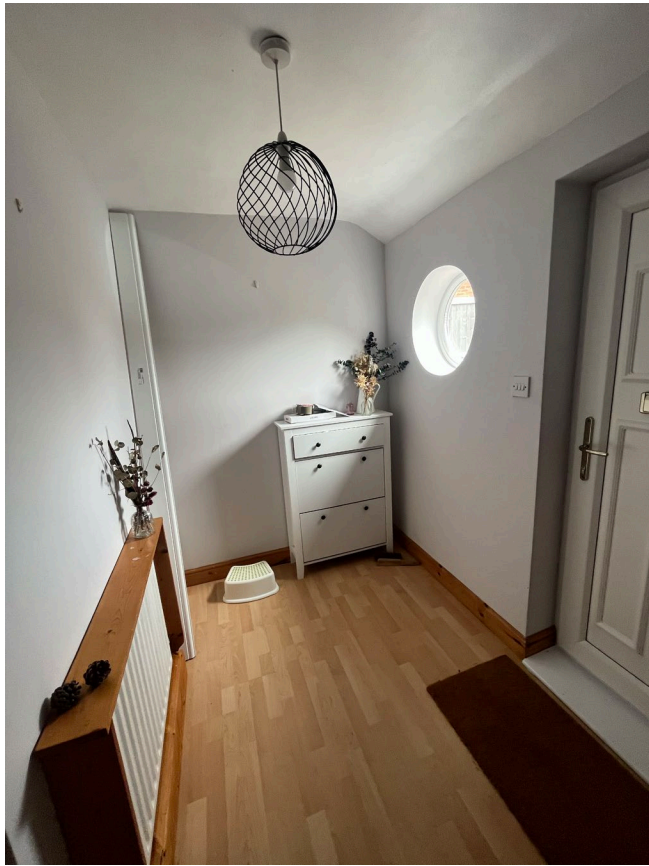
- Front entrance hall is inefficient with indirect access to main living areas, requiring a long doglegged hallway
- Dark living area due to room depth.

d. Front entrance hallway

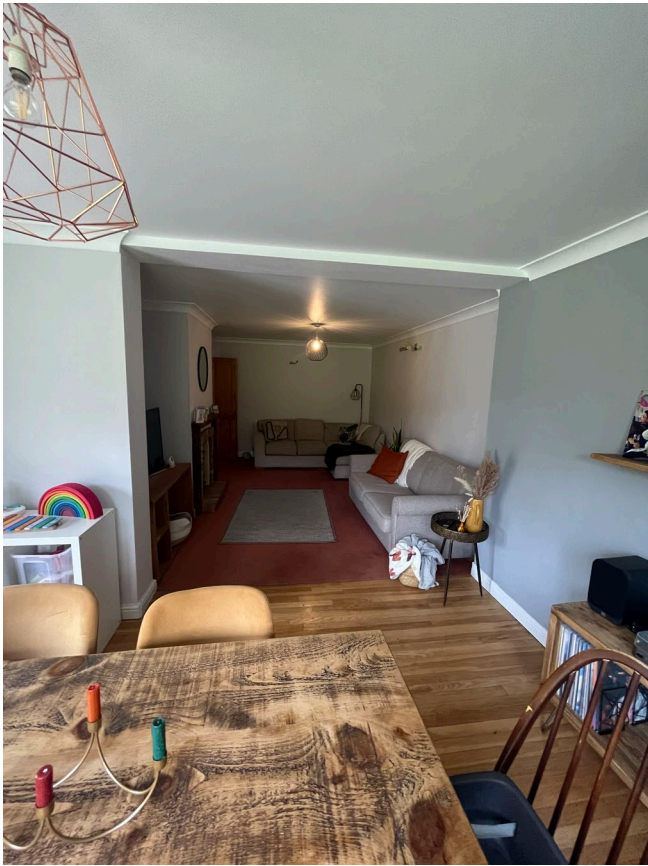
- Existing living area has no direct relationship to garden.
- Existing kitchen has limited access to dining room.
- Existing staircase is narrow and steep creating access issues.

e. Living area, view from dining room

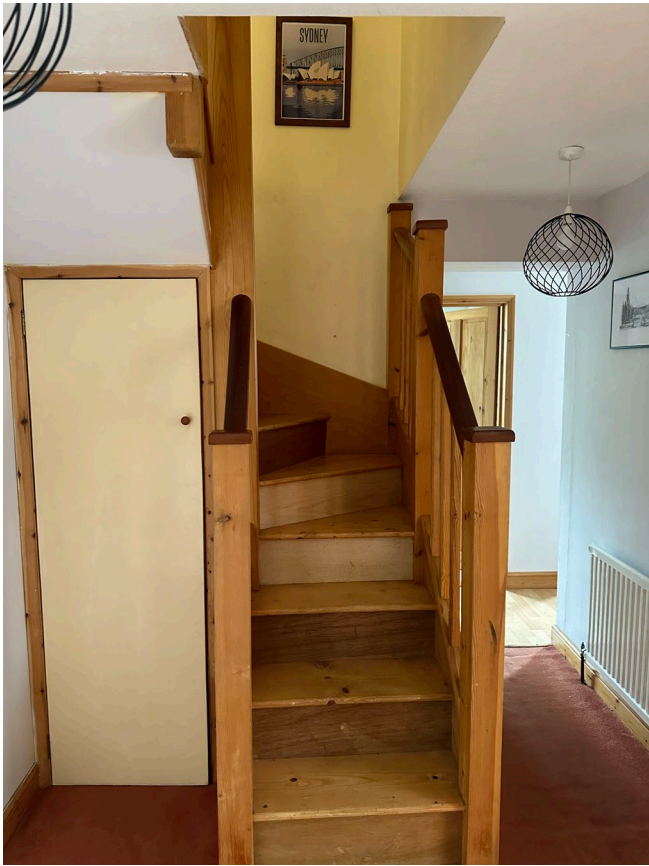
f. Staircase

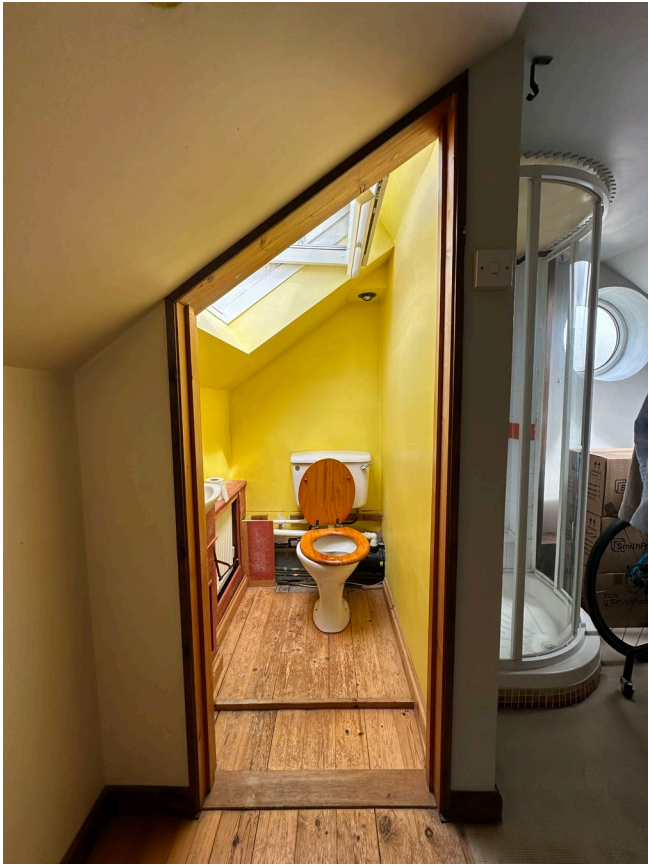
- Existing en-suite arrangement is confused and in need of remedial works to make functional, including covering exposed pipework and electrical cables, and adequate ventilation to shower area.

h. Loft en-suite

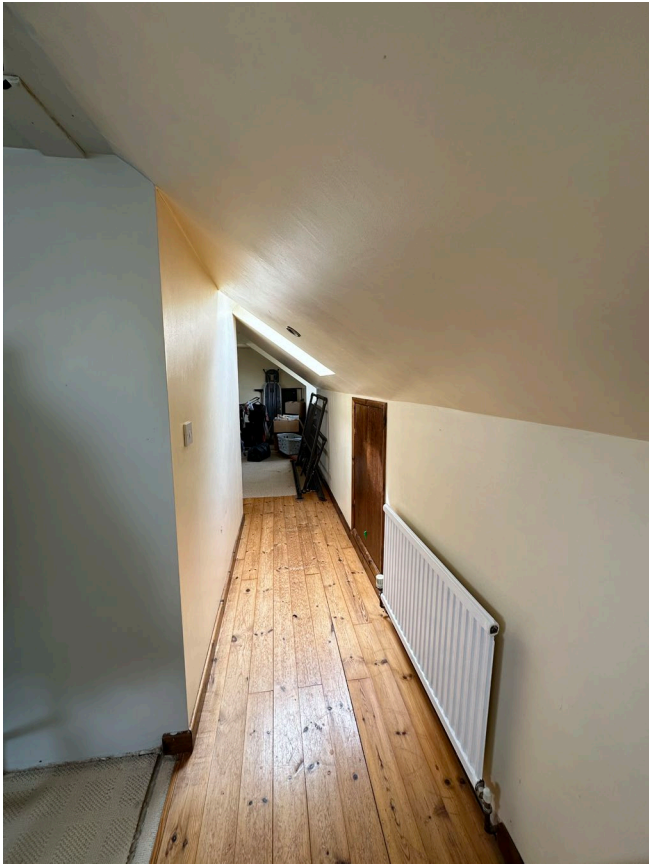
i. Corridor between loft bedroom & en-suite

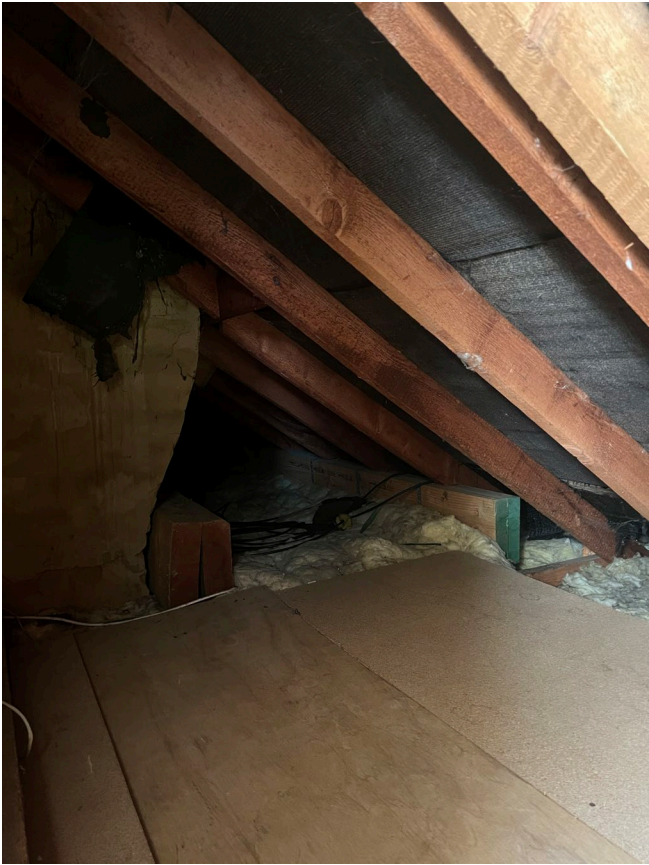
- Differing floor and ceiling levels present in loft area.
- Difficult access to en-suite via narrow corridor with very limited headroom.
- Existing roof structure uninsulated.

- Existing roofing membrane damaged in places with light visible through.

j. Existing roof structure

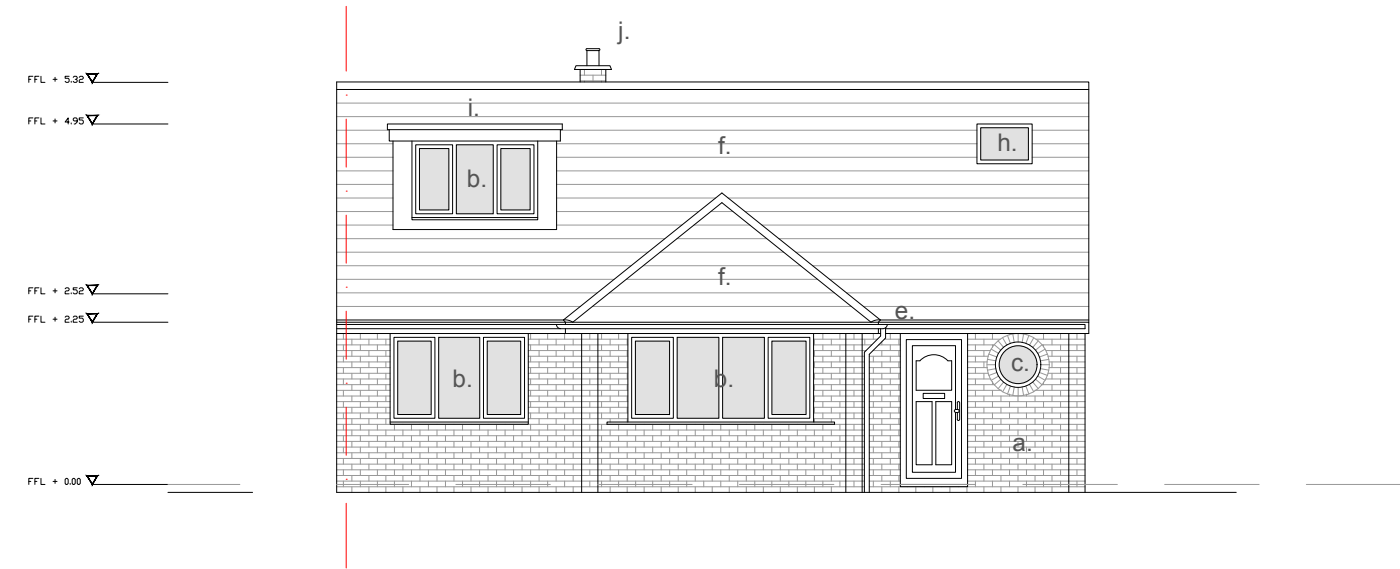
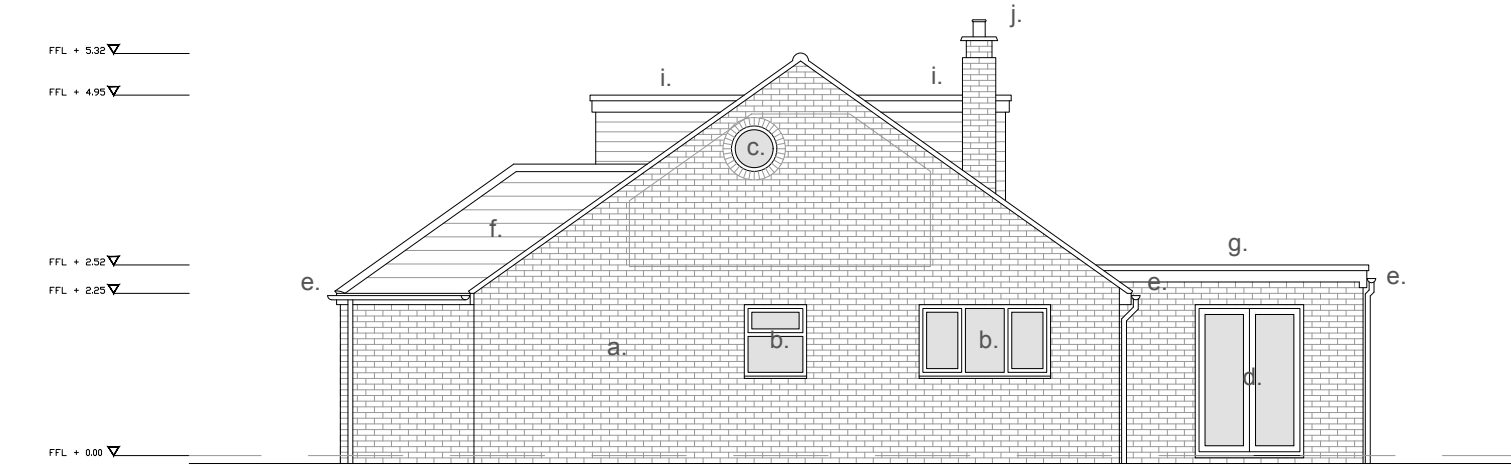
Job No. 227 Existing Elevations

- a. Brickwork
- b. White UPVC window
- c. White painted timber framed portal window
- d. White UPVC doors
- e. Black UPVC rainwater goods
- f. Concrete tiled roof
- g. Flat felt roof
- h. White UPVC cladding
- i. Dormer
- j. Chimney

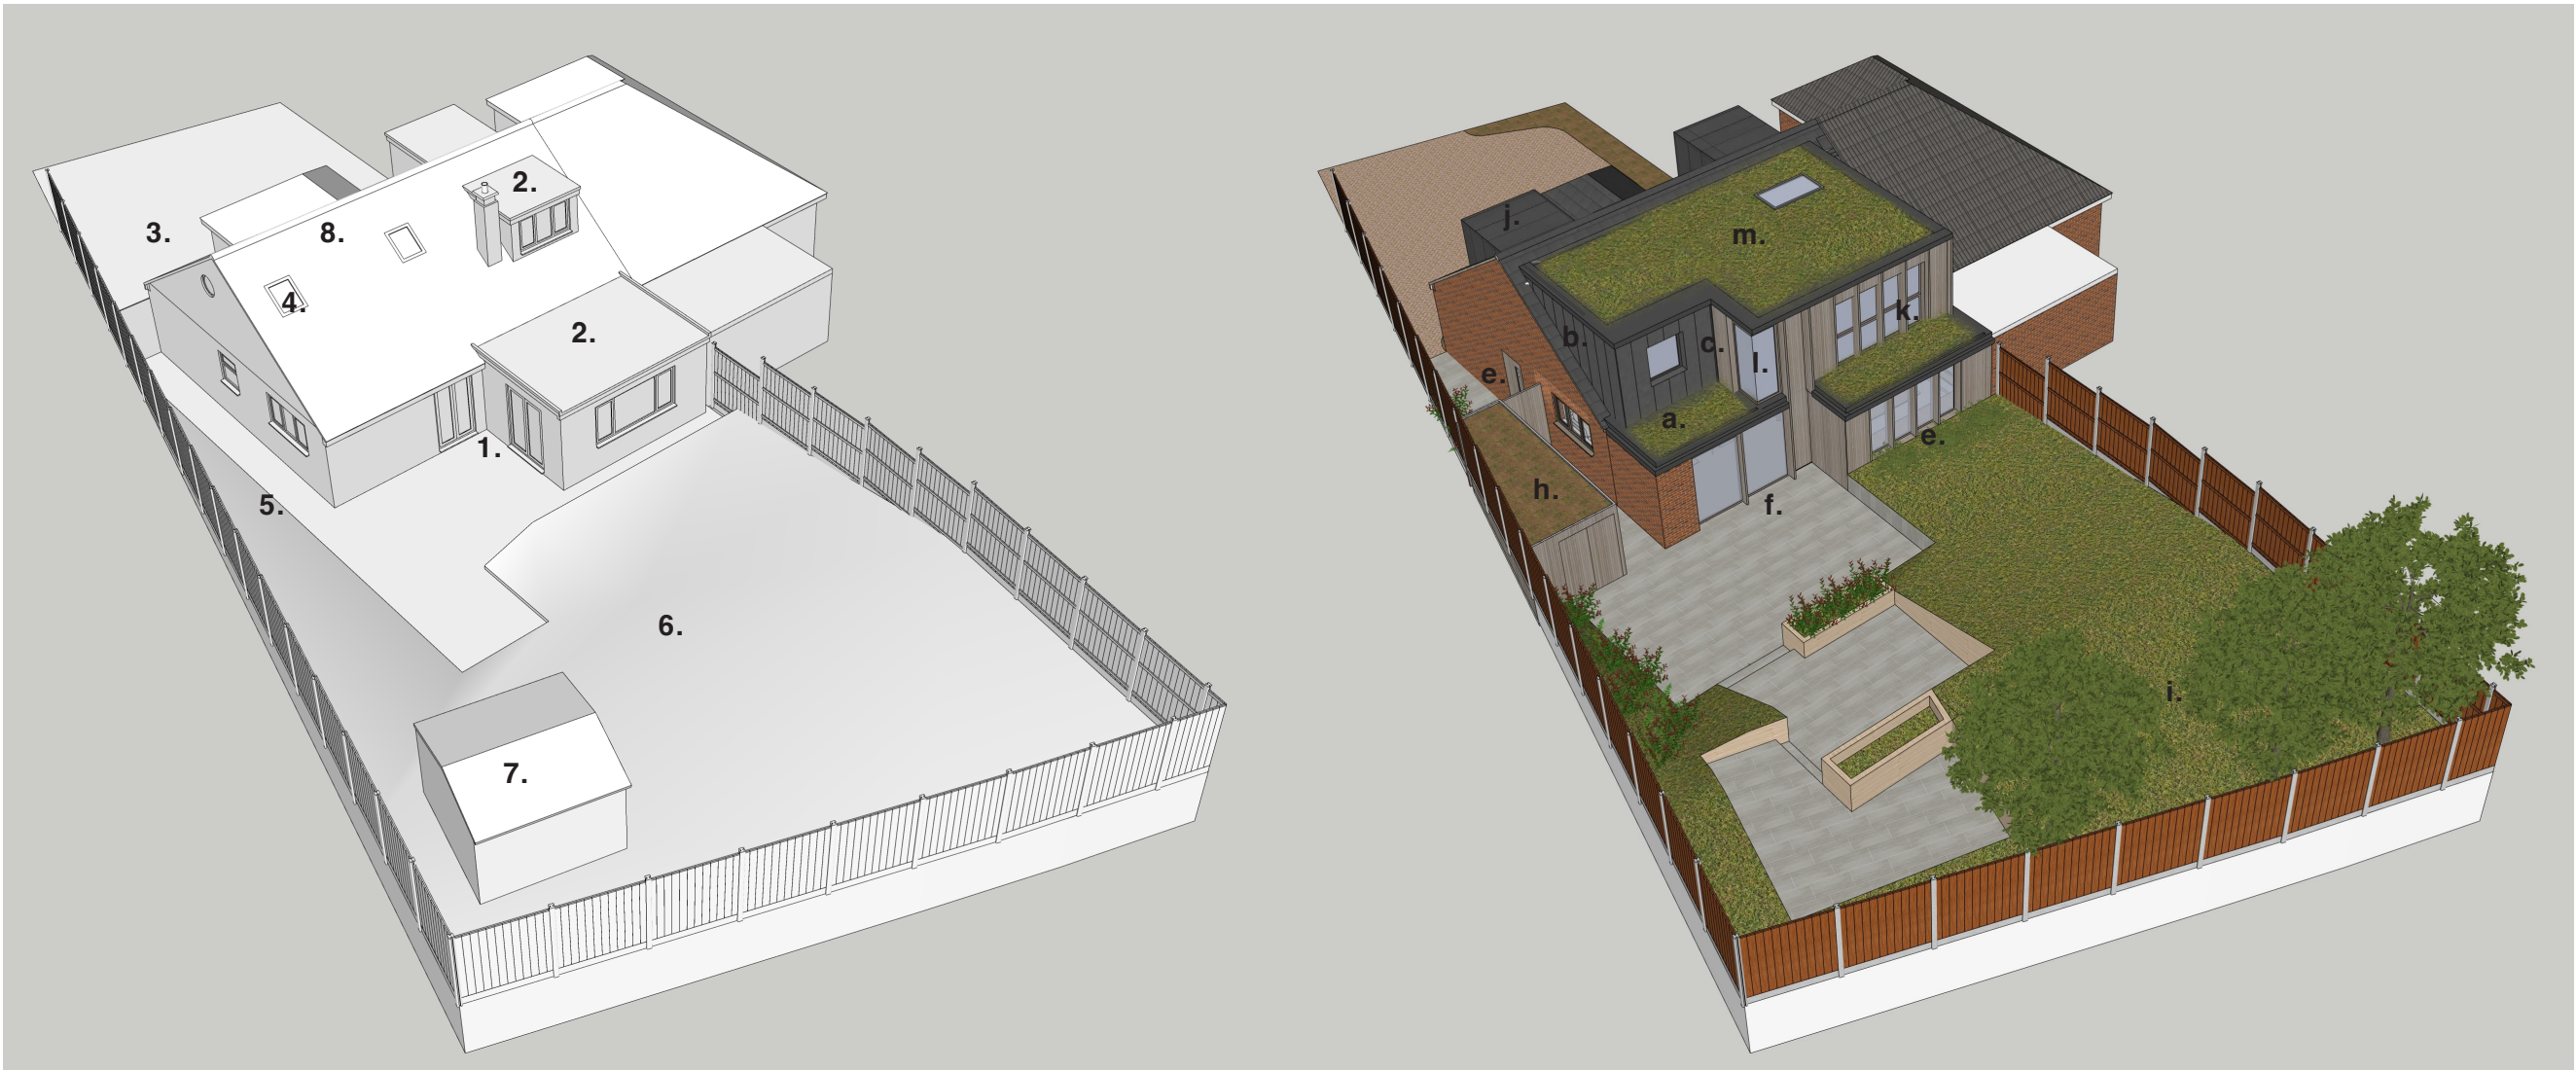
3.1 Design Principals

- 1. Limited connection from living areas to garden.
- 2. Existing extensions do not contribute positively to the composition of the rear facade.
- 3. Front entrance access creates convoluted internal circulation.
- 4. Existing rooflights in need of repair.
- 5. Under-utilised space to the side of dwelling.
- 6. Steep slope of garden prevents easy use, limited definition of functions for each garden area.
- 7. Garden storage is difficult to access.
- 8. Limited light into the centre of the dwelling plan, at ground and loft floor level.

- a. The extension creates a stepped relationship to the existing gable reducing its mass when viewed from the street scape.
- b. Dormer set in to be read as a secondary element.
- c. The use of fiber cement board cladding blends with the existing roofscape whilst the use of timber and the fenestration presents a softer facade to the garden.
- d. Moving the staircase improves internal circulation and gallery space connects the first floor with living areas.
- e. A new side entrance to the utility room.
- f. A reconfigured garden-facing elevation that helps define the use of the rear garden area, incorporating: space to sit and view the garden from a sunken level in the dining area, level access from living area to the patio which terraces up the slope creating a series of areas for outdoor dining, relaxing and gardening

- g. Creating an open plan sequence of spaces, existing living space connected to a new kitchen / hallway.
- h. Garden storage relocated for better access, incorporating bin store.
- i. New tree planting to improve sense of privacy from Riddy Lane path.
- j. New/re-clad front dormers related to existing character in the area.
- k. British Larch mullion detailing around windows narrows viewing splays maintaining privacy for neighbouring dwellings and for internal spaces.
- l. Allowing light into the centre of the plan through the staircase/gallery.
- m. New seedum roofs to promote biodiversity and relate building form to the garden.

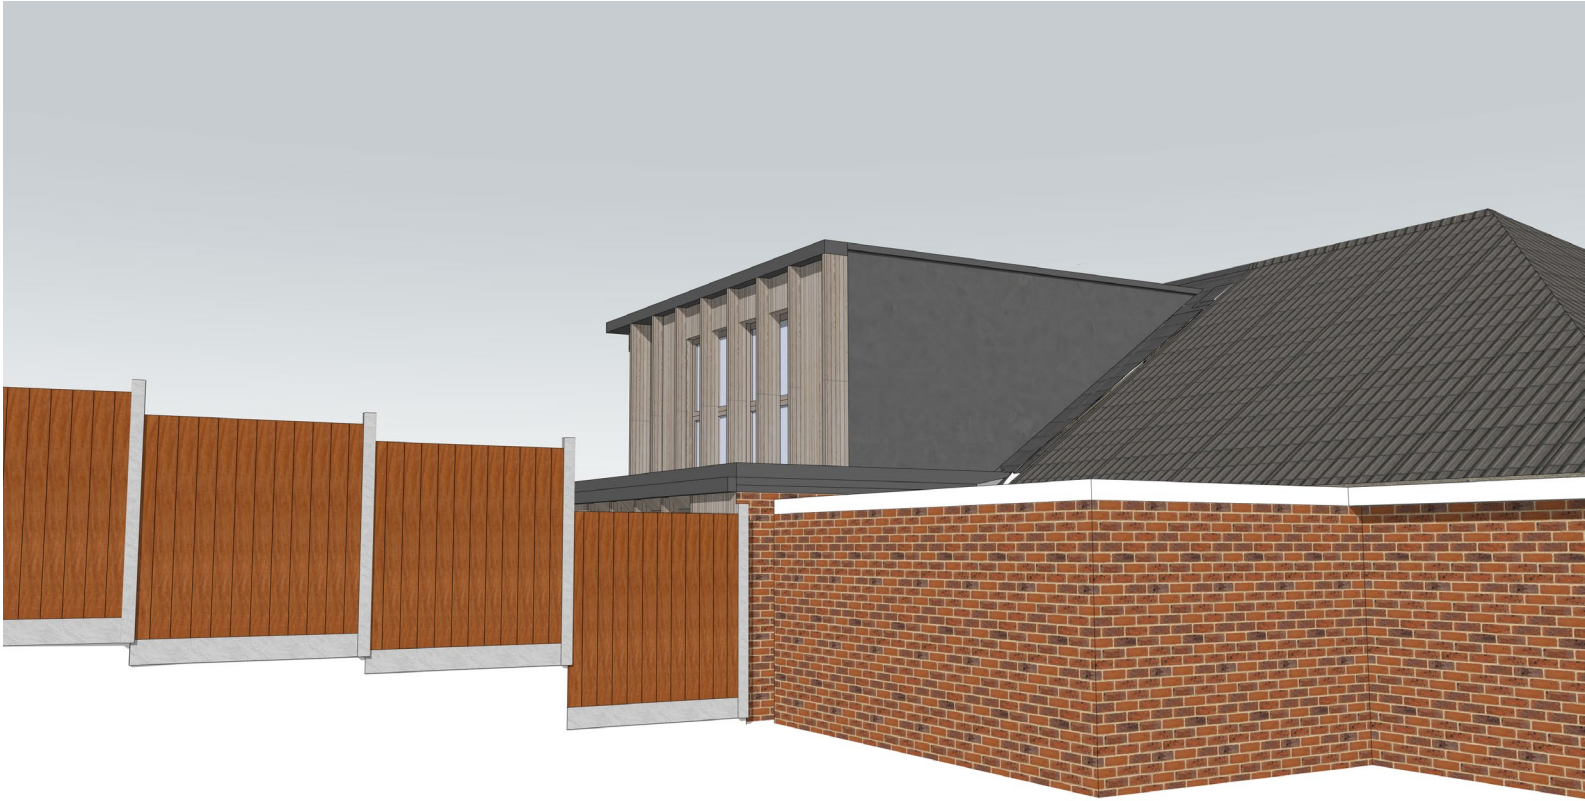
In addition to creating a rhythm of bays that help to define the design, the larch mullion detail to the first floor windows narrows the visibility splay to ensure privacy to the neighbouring dwelling. This process also works in reverse. A limited amount of glazing will be viewable from the garden of the adjoining neighbour, or from Riddy Lane path.

View from no. 29 garden, glazing is obscured by timber mullions

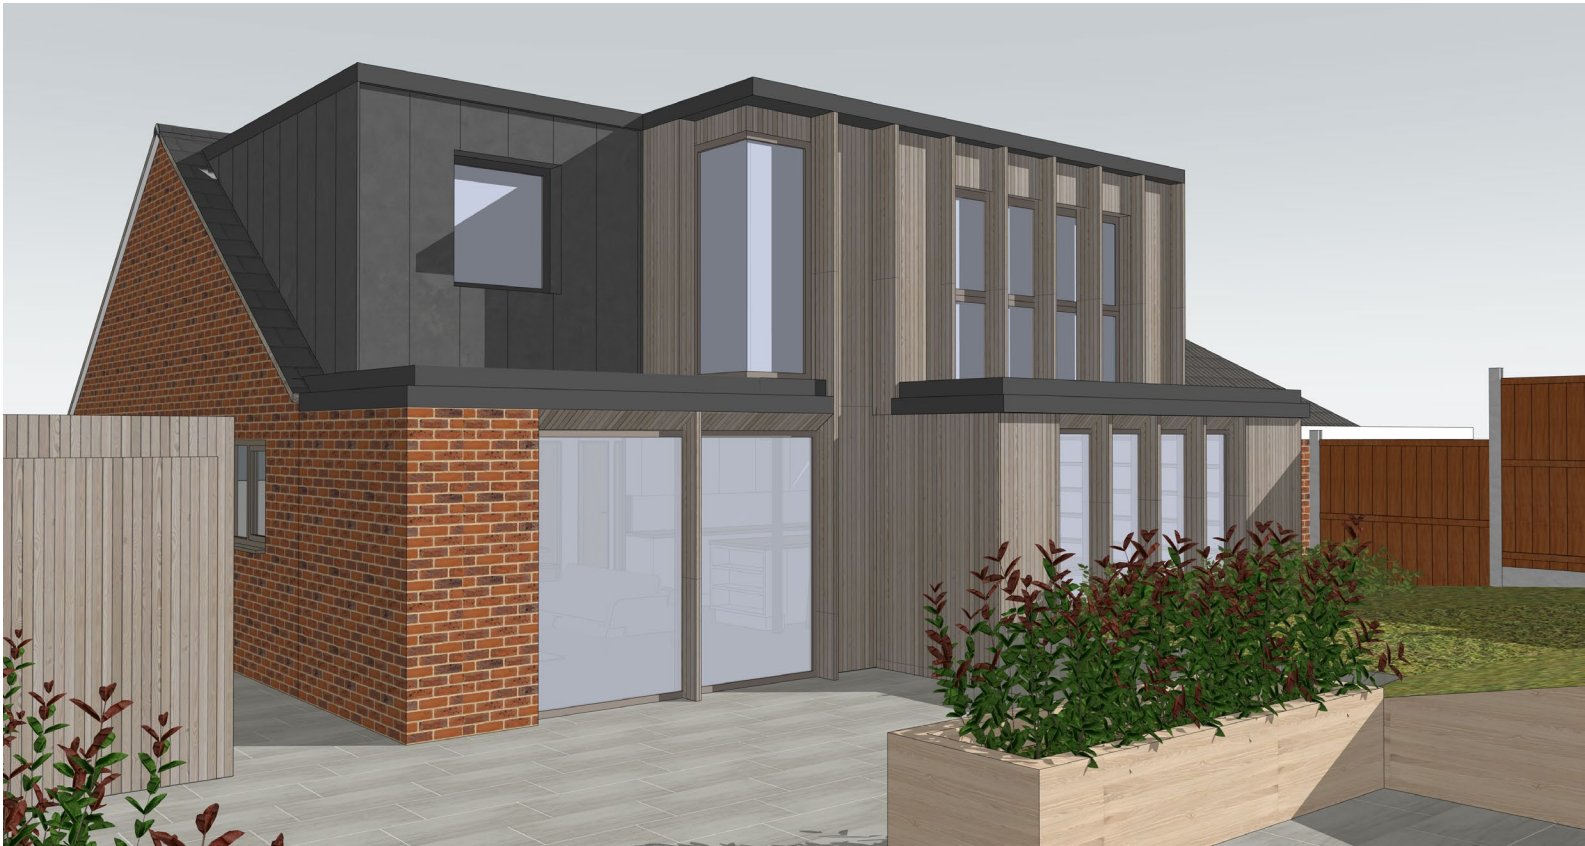
View from garden, looking South-East

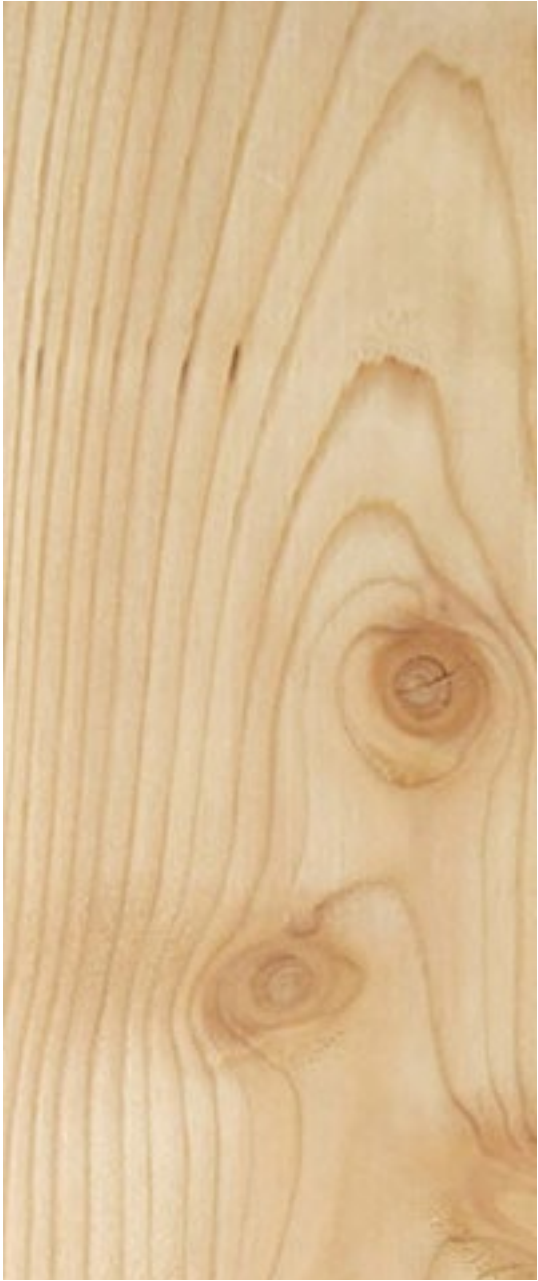
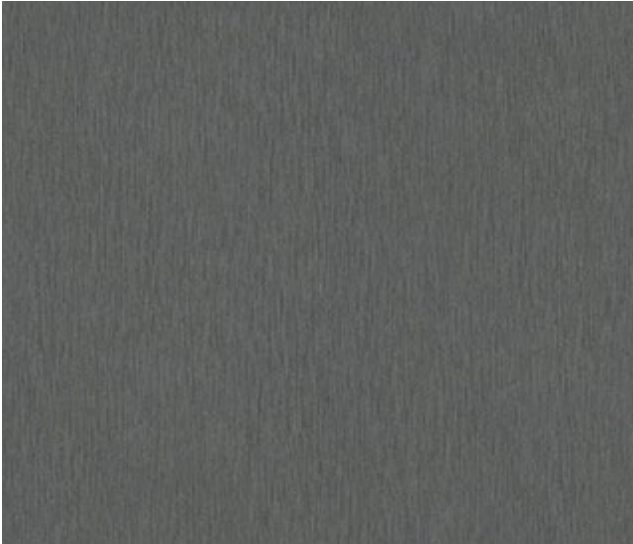
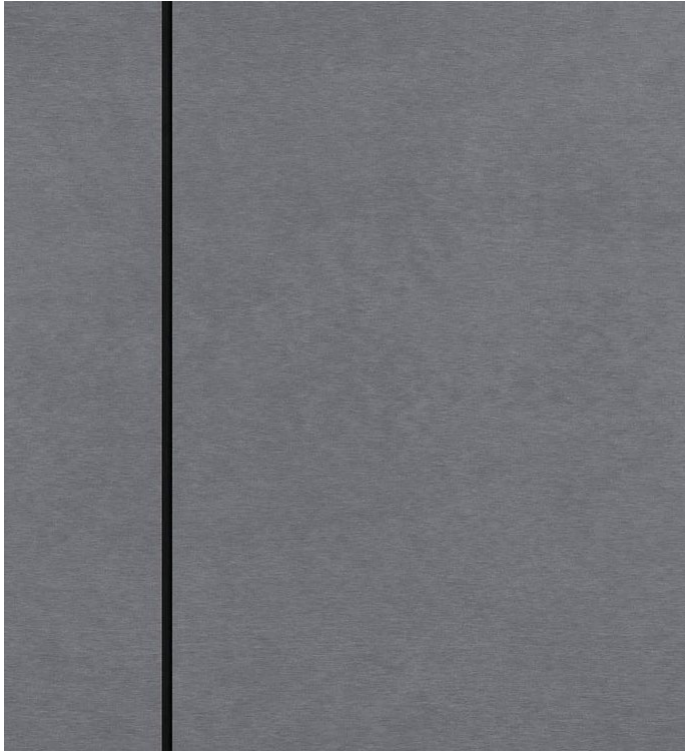
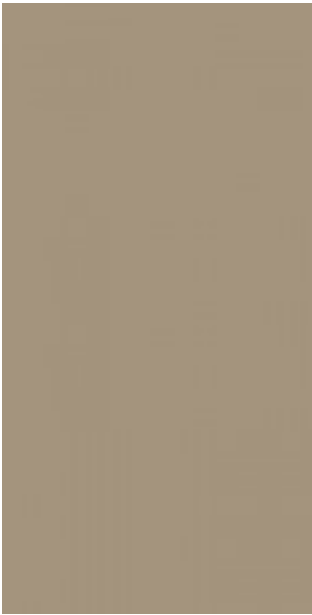
3.3 Material Palette

- a. British Larch cladding
- b. Aluminium cappings
- c. Fiber cement cladding boards
- d. Fiber cement tiles
- e. Glazing frame finish colours
- f. Exposed pine structural elements
- g. Porcelain/Limestone paving
- h. Green seedum roof and wildflower planting
