## Charnwood House, Hitchin (former Museum)

### **Proposed works:**

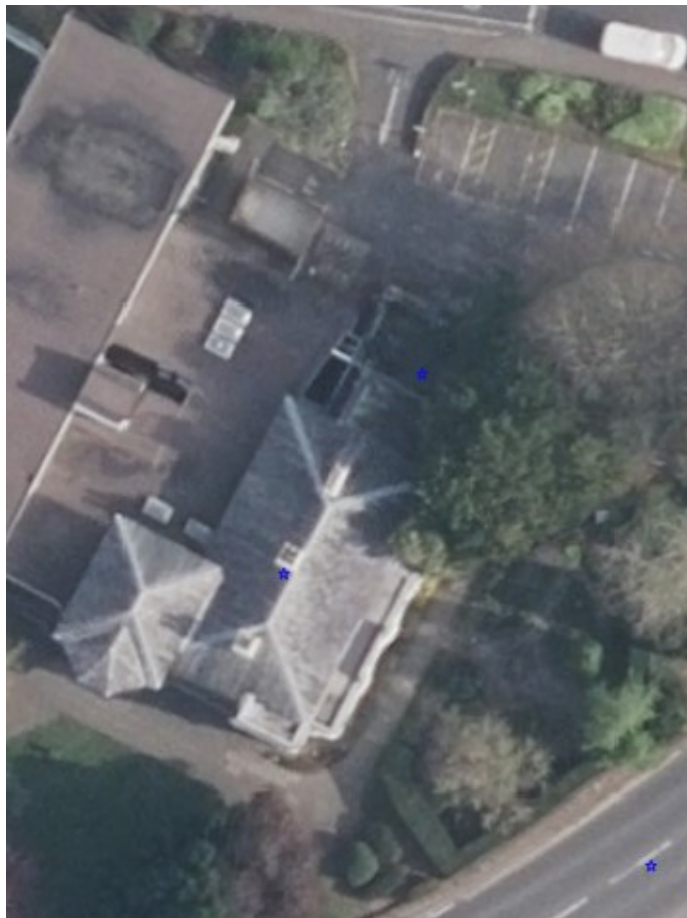
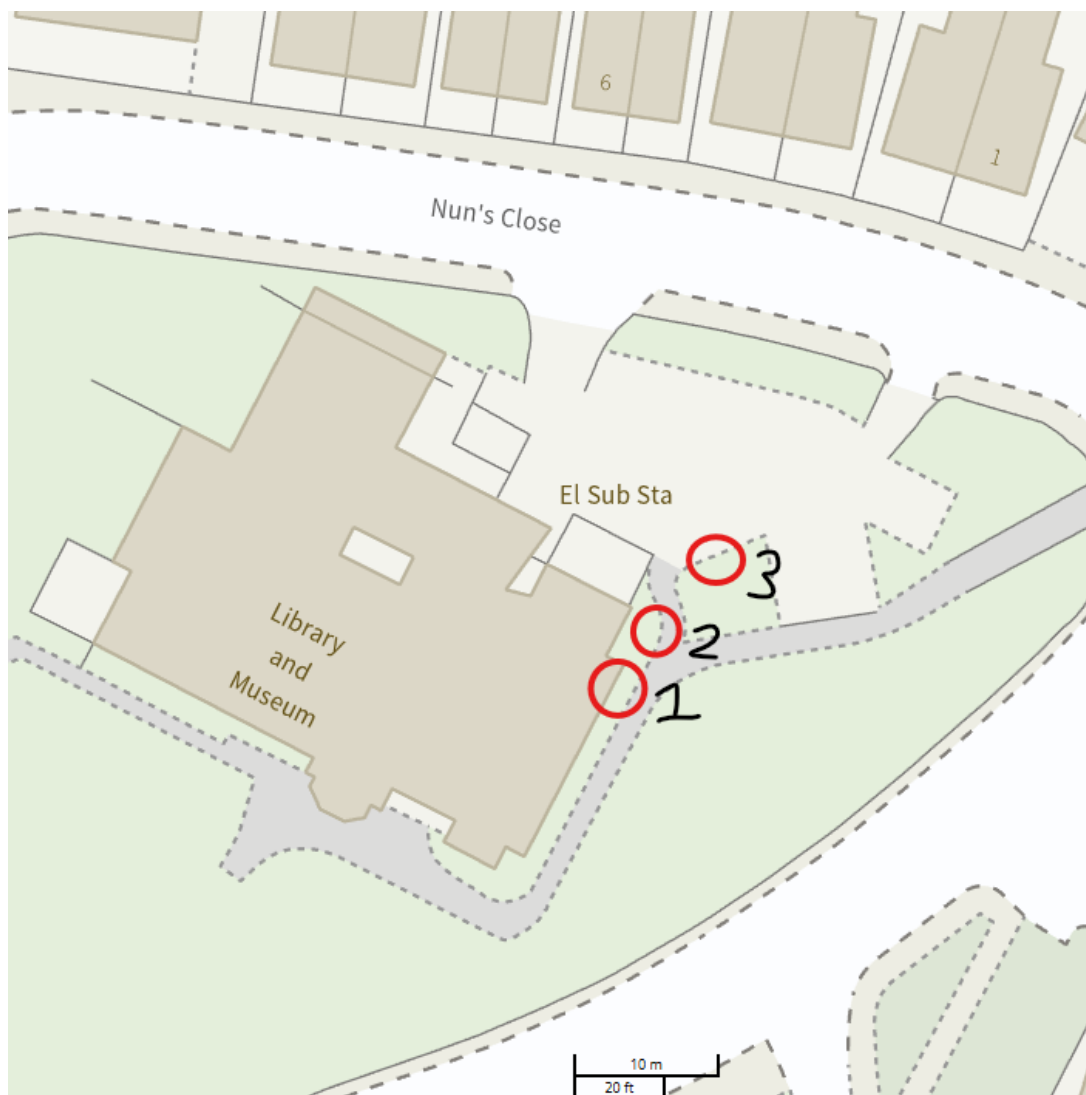
- 1) Holly tree
- 2) Yew tree
- 3) Yew tree

T1 - Holly tree growing in very close proximity to grade 2 listed building, known as Charnwood House (Former Hitchin Museum). The tree is growing inches from the building wall and the trunk leans extensively towards the building over the lower-level roof and main roof where vegetation is impacting onto the property. It is proposed that the tree is removed to preserve the building and remove any further potential damage.

T2 & T3 – 2 mature Yew trees to have selective branch reductions by 2.5 metres on property side. This pruning will reduce overhang to the roof of the building and the electric substation located at the front of the building and retain the visual perspective of the trees. The crowns to be lifted to 4 metres to give lower branch clearance.
