23 Tilehouse Street

206 Proposed gallery Level Plan

Stage: Stage 2  
Status: Preliminary

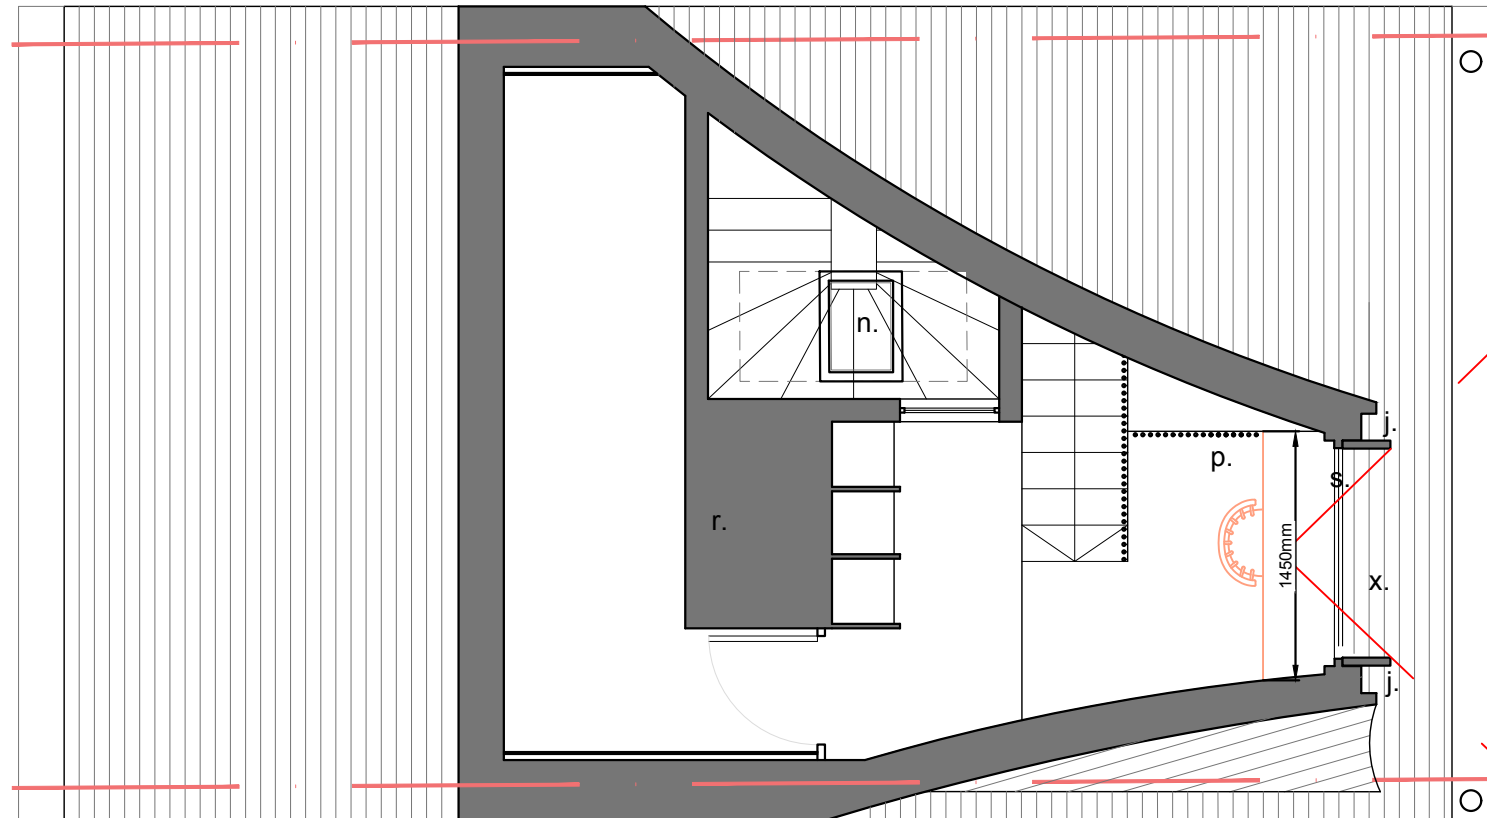
| a. Existing coal chute opened and glazed | m. Ceiling opened over existing stair |
| b. New basement office | n. Rooflight over |
| c. New stud partitions | o. New sash and case window |
| d. Existing tanking membrane retained | p. New office and gallery |
| e. Newtanking system and underpinning | q. New lightweight stair |
| f. Rooflight over | r. Existing chimney retained |
| g. Existing stone steps retained | s. new aluminum framed window with oak surround |
| h. existing timber beam/ceiling over retained | t. Existing plaster and lath ceiling retained |
| i. New glazed light well | u. oxidised copper cladding to match new clay tiles |
| j. Oxidised copper edgings | v. replacement handmade clay tiles |
| k. existing gate retained | w. zinc cladding |
| l. new low level window below | x. Timber blinkers |
