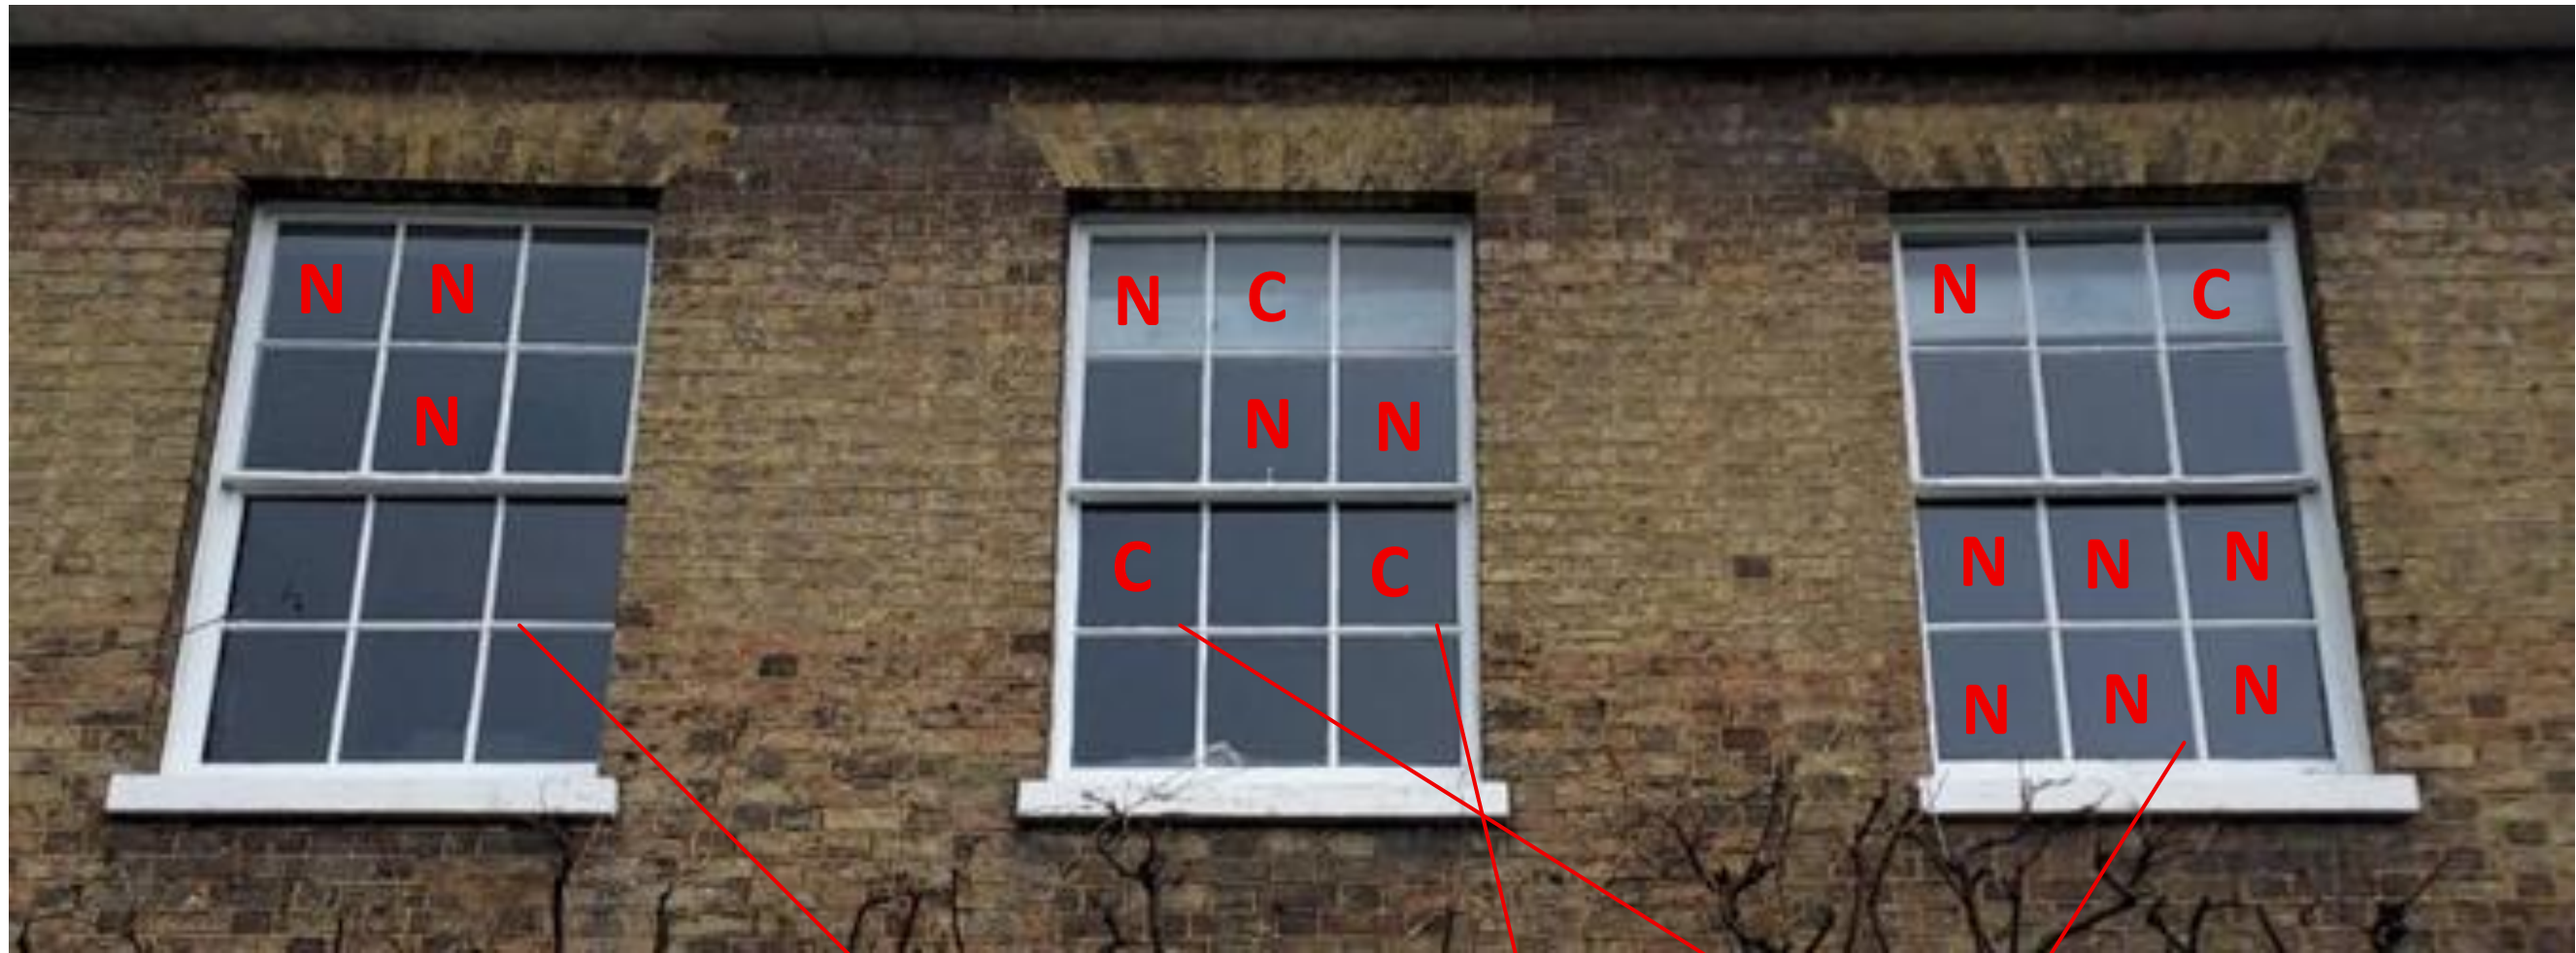
Rear windows 11-13

Bottom sash has been replaced  
& with different beading

Bottom sash written and  
has lost its section shape

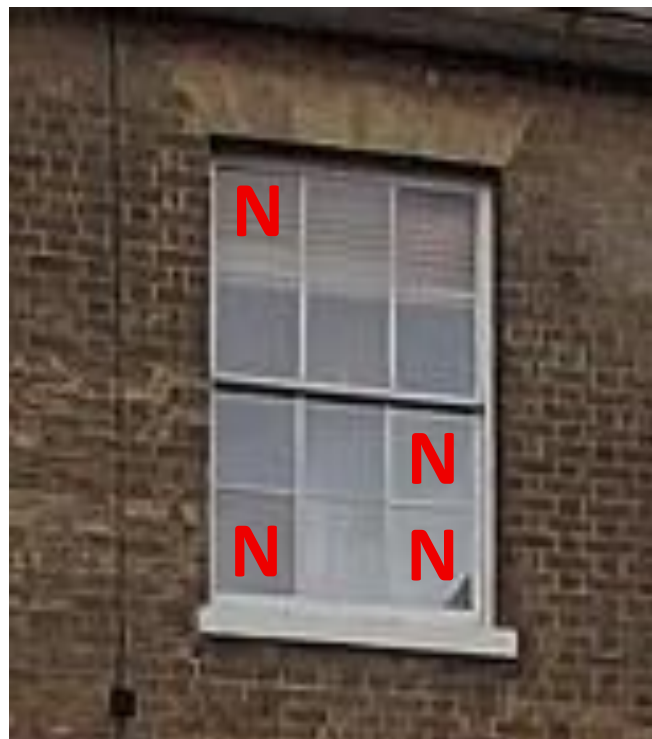
Side window no. 10

**C:**  
Cracked glazing

**N:**  
Replacement glazing
