# Growing Baldock

Appendix 12.4 Ground Investigation Interpretive Report BA3 Area

**Ground Investigation Interpretive  
Report – Land at West of Clothall Road  
(Area BA3)  
Urban and Civic**

Project Reference: 2899

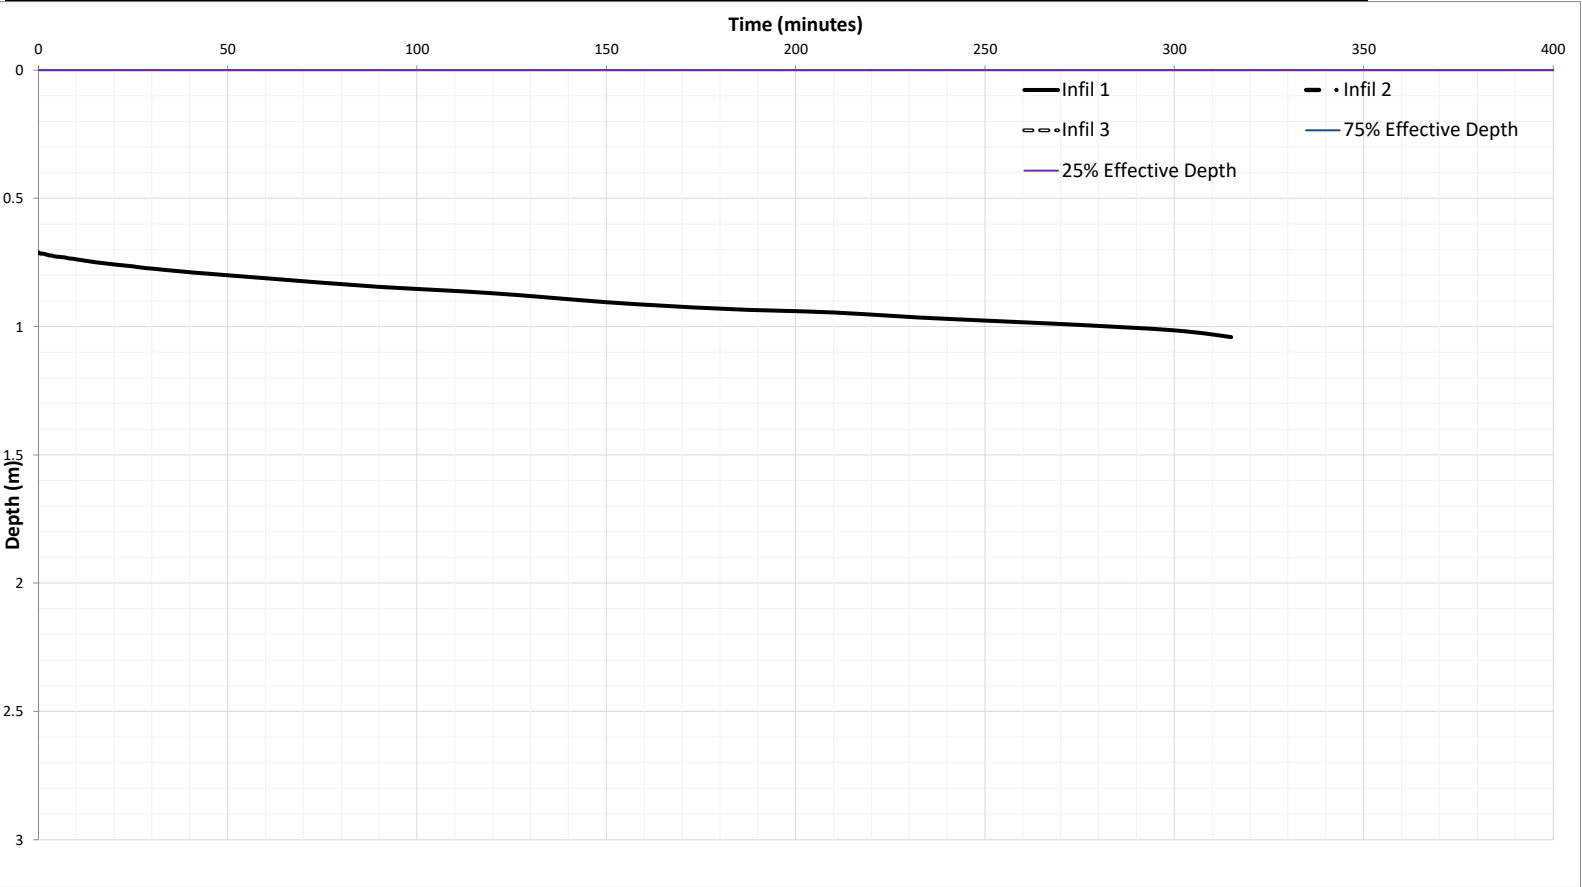
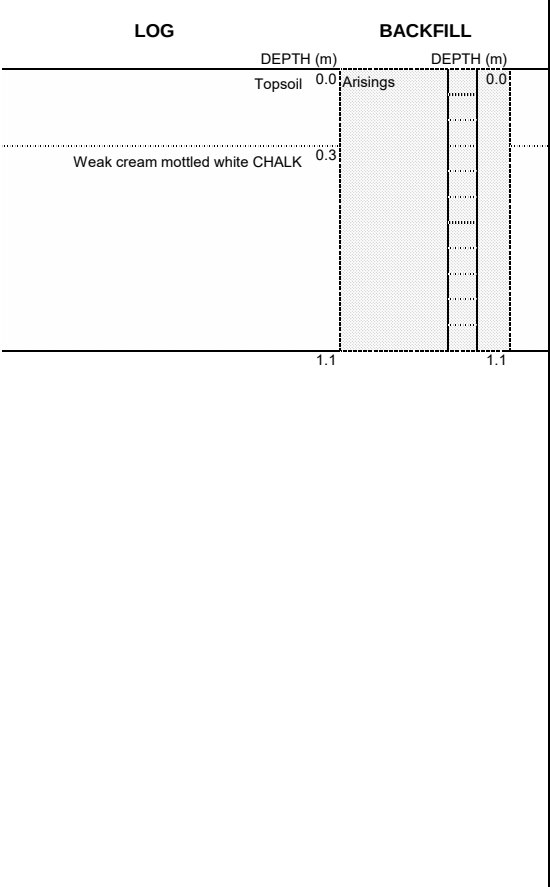
| Recommended soil infiltration rate | |
| 9.31E-06 | m/s |

Infiltration testing was carried out adjacent to trial pits TP-176 (SA-03) and TP-161 (SA-04) indicated rates in the order of 9.31\*10<sup>-6</sup>m/s and 2.97\*10<sup>-6</sup>m/s respectively. The full infiltration testing data is presented within **Appendix B**.

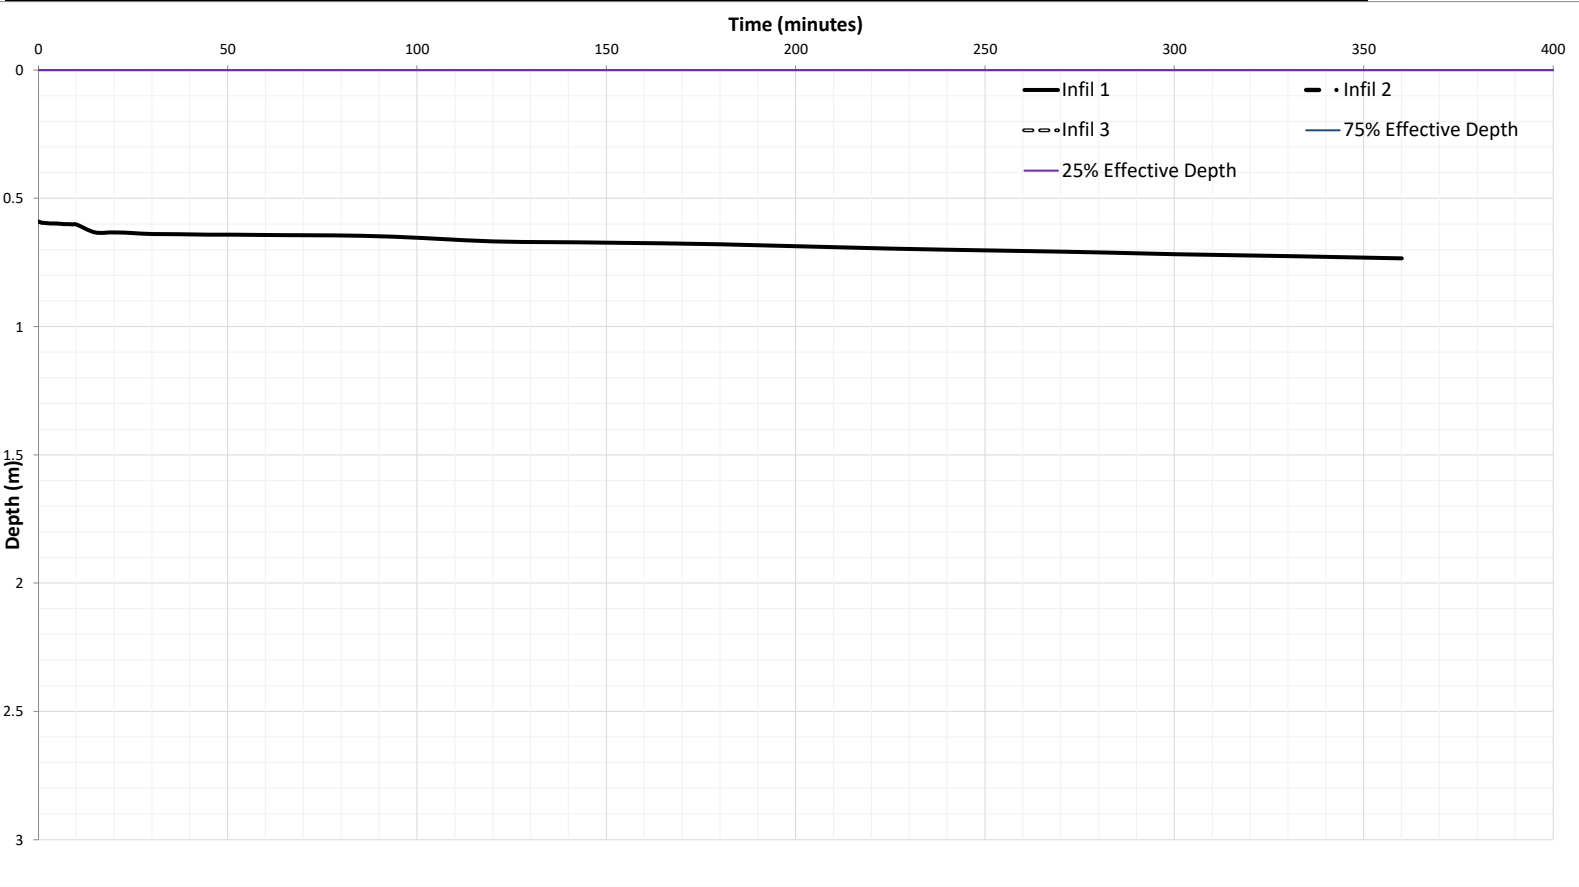
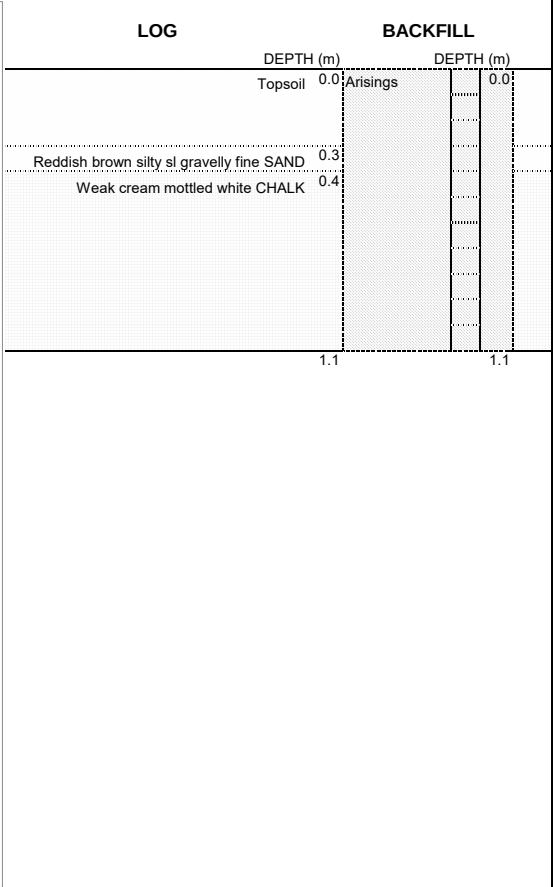
NOTE:

Water level did not fall to below the 25% full level within 24 hrs for fill 1 - Soil infiltration rate based on effective drainage only

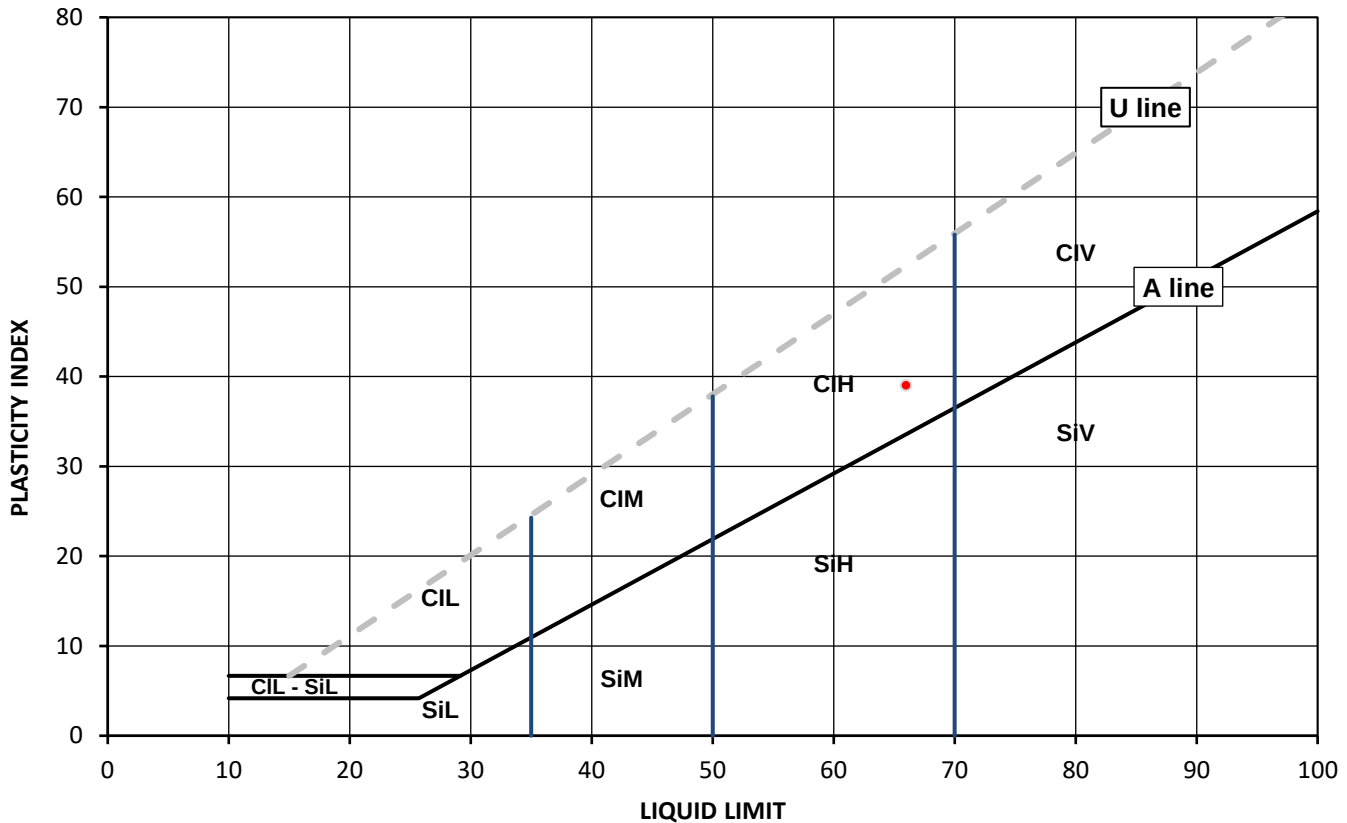
| As Received Water Content [ W ] % | Liquid Limit [ WL ] % | Plastic Limit [ Wp ] % | Plasticity Index [ Ip ] % | % Passing 425µm BS Test Sieve |
| 24 | 66 | 27 | 39 | 87 |

Legend, based on BS EN ISO 14688 2:2018 Geotechnical investigation and testing – Identification and classification of soil

| Method | Strata | Parameter | Comments |
|---|---|---|---|
| Atterberg Limits | Superficial Cohesive deposits | Moisture Content 24%<br>Liquid Limit 66%<br>Modified Plasticity Index 34% | Slightly sandy slightly gravelly Clay, of Medium volume change potential |

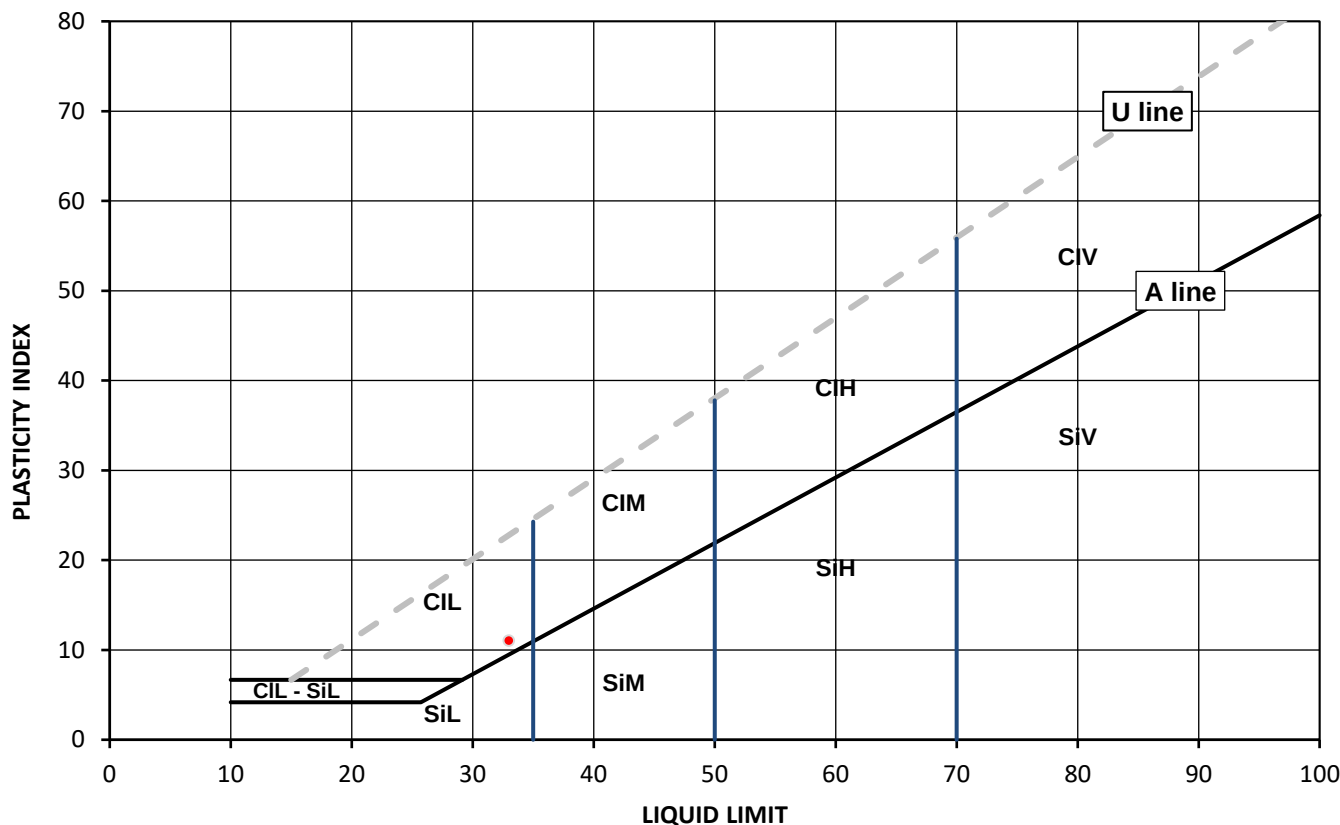
| As Received Water Content [ W ] % | Liquid Limit [ WL ] % | Plastic Limit [ Wp ] % | Plasticity Index [ Ip ] % | % Passing 425µm BS Test Sieve |
| 27 | 33 | 22 | 11 | 17 |

Legend, based on BS EN ISO 14688 2:2018 Geotechnical investigation and testing – Identification and classification of soil

| Method | Strata | Parameter | Comments |
|---|---|---|---|
| Atterberg Limits | Solid deposits | Moisture Content 27%<br>Liquid Limit 33%<br>Modified Plasticity Index 2% | Recovered as clayey Chalk, of Low volume change potential. |

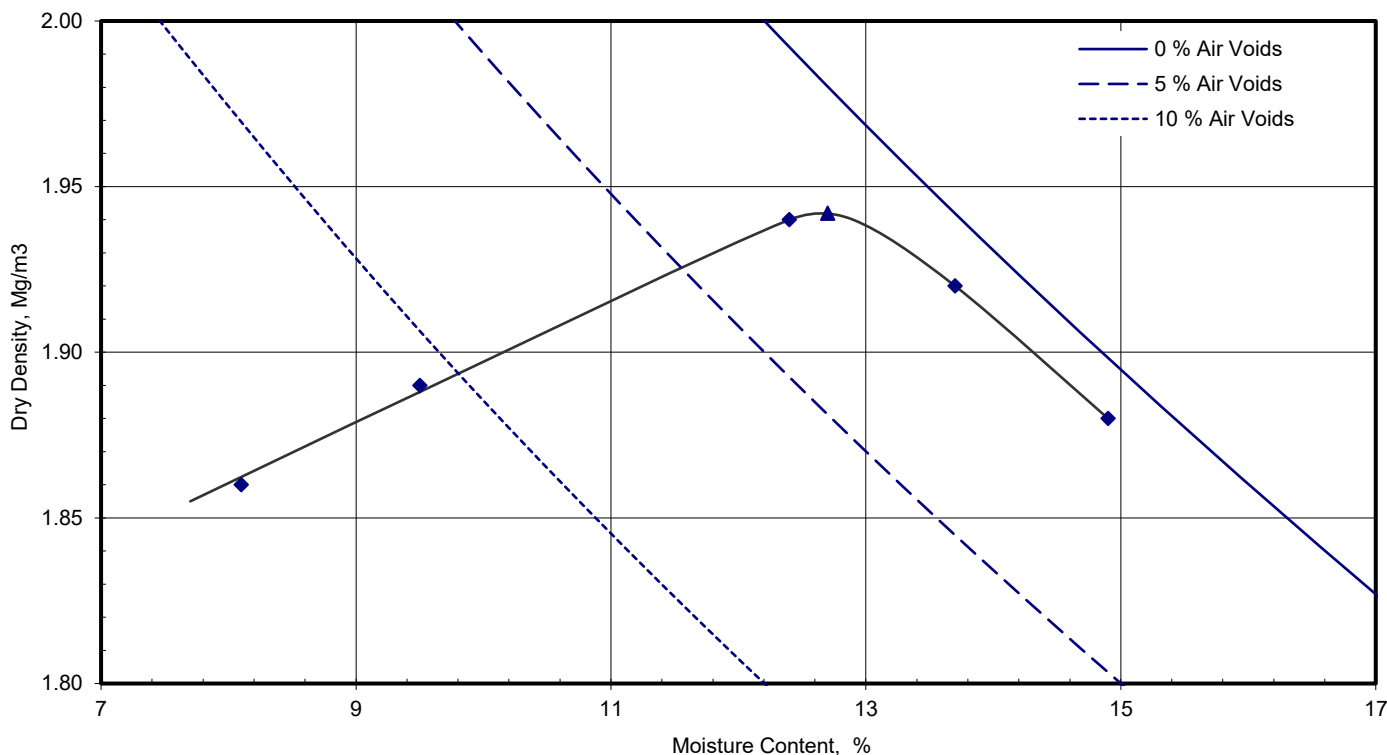
Laboratory Reference: 2928228  
Hole No.: TP-151  
Sample Reference: Not Given  
Sample Description: White slightly clayey CHALK  
Sample Preparation: Sample was quartered and broken down by hand. Material used was natural.

Depth Top [m]: 1.60  
Depth Base [m]: 1.70  
Sample Type: B

| Compaction (Dry Density - Moisture Content Relationship) | Bedrock deposits (Chalk)<br>1.10m to 1.80m | Moisture Content as received was 12-29%<br>Optimum Moisture Content is 13-18% | Materials are typically a Class 3 material (SHW Series 600) and will be detrimentally affected by elevated moisture. Cohesive material generally 8.6% wet of optimum. Some drying of material may be required. |

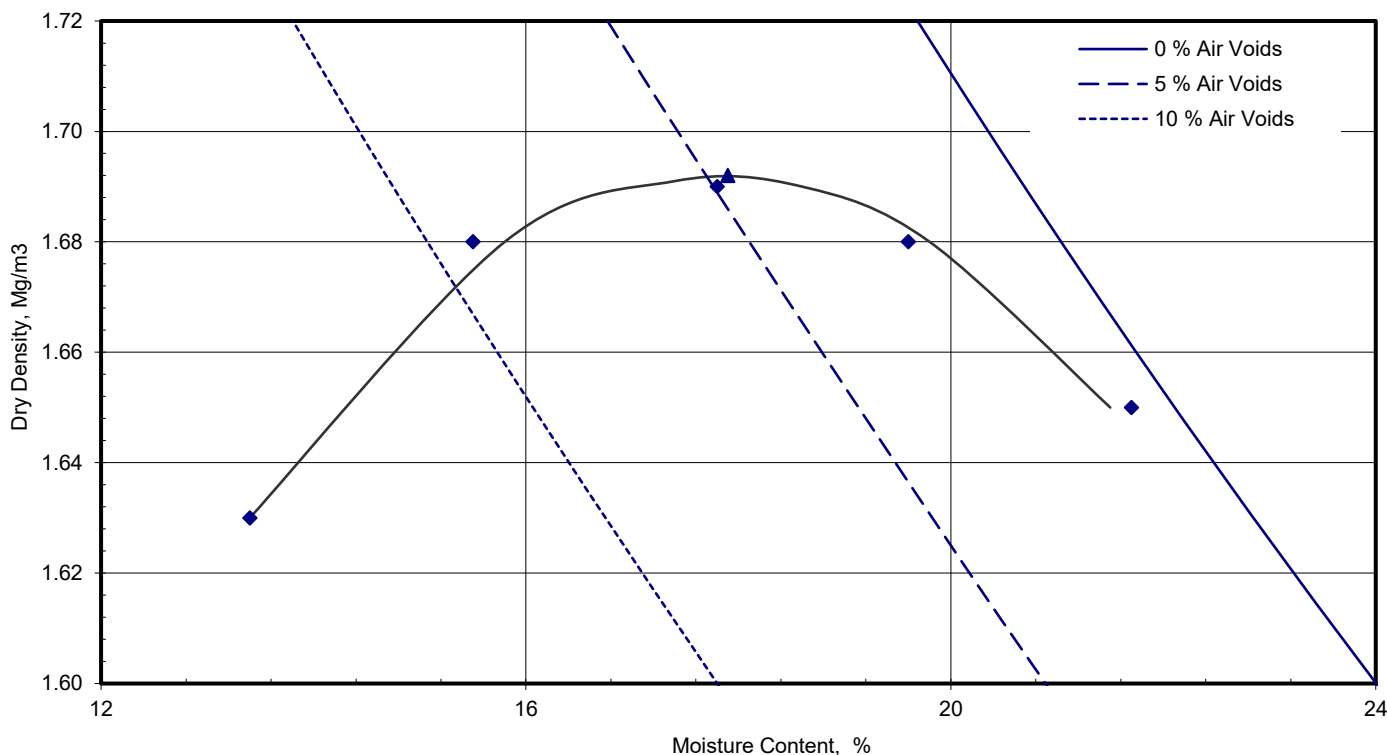
Laboratory Reference: 2928229  
Hole No.: TP-153  
Sample Reference: Not Given  
Sample Description: White CHALK  
Sample Preparation: Sample was quartered and broken down by hand. Material used was natural.

Depth Top [m]: 1.70  
Depth Base [m]: 1.80  
Sample Type: B

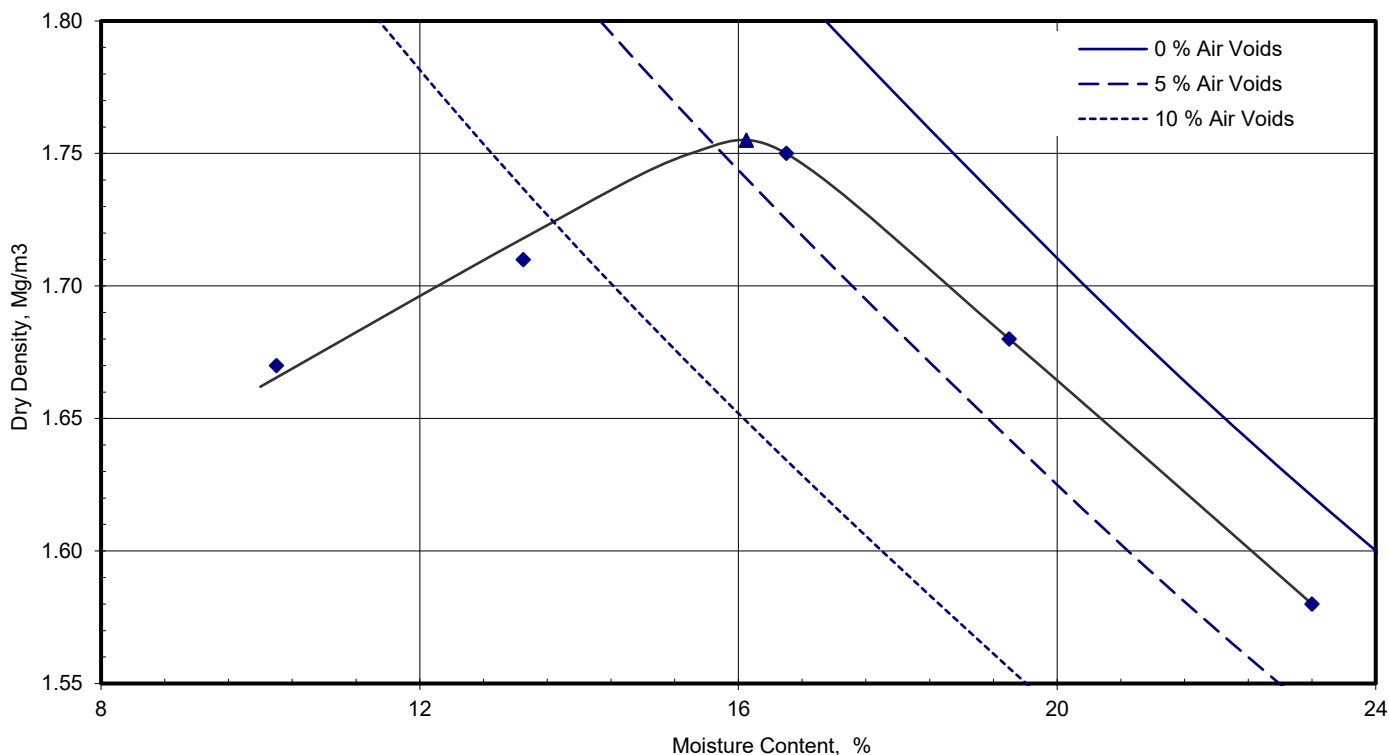
Laboratory Reference: 2928230  
Hole No.: TP-154  
Sample Reference: Not Given  
Sample Description: Light grey clayey CHALK with fragments of flintstones  
Sample Preparation: Sample was quartered and broken down by hand. Material used was natural.

Depth Top [m]: 1.10  
Depth Base [m]: 1.20  
Sample Type: B

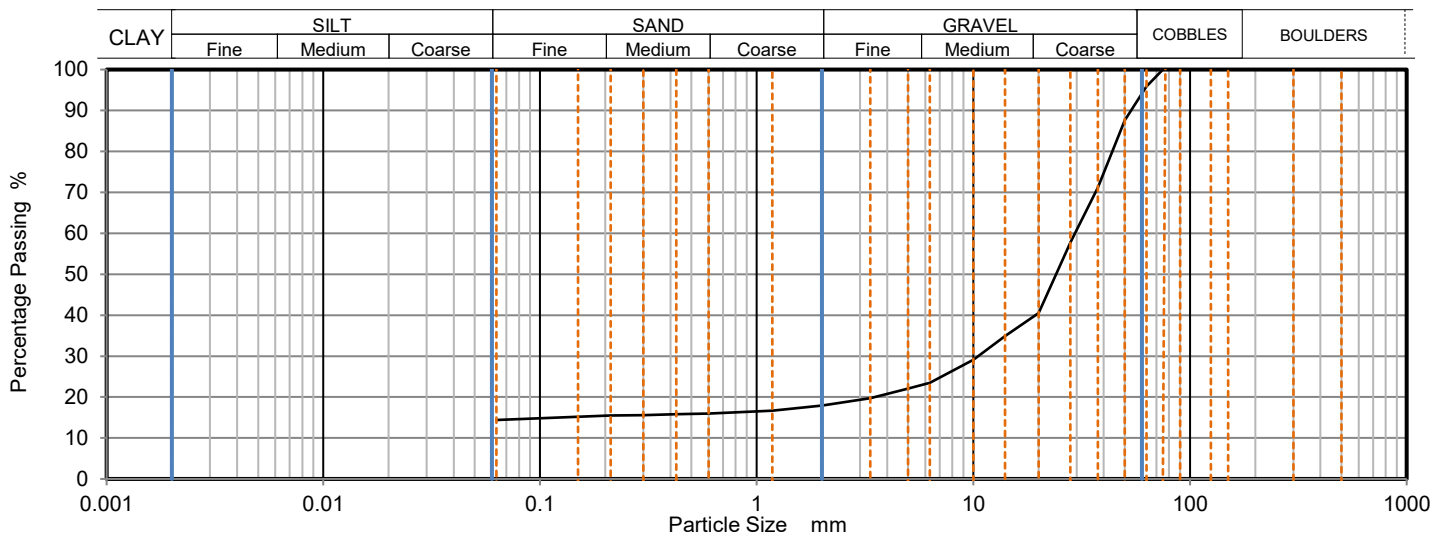
Laboratory Reference: 172915  
Hole No.: TP-143  
Sample Reference: Not Given  
Sample Description: White CHALK  
Sample Preparation: Sample was quartered, oven dried at 106.4 °C and broken down by hand.

Depth Top [m]: 1.60  
Depth Base [m]: 1.70  
Sample Type: B

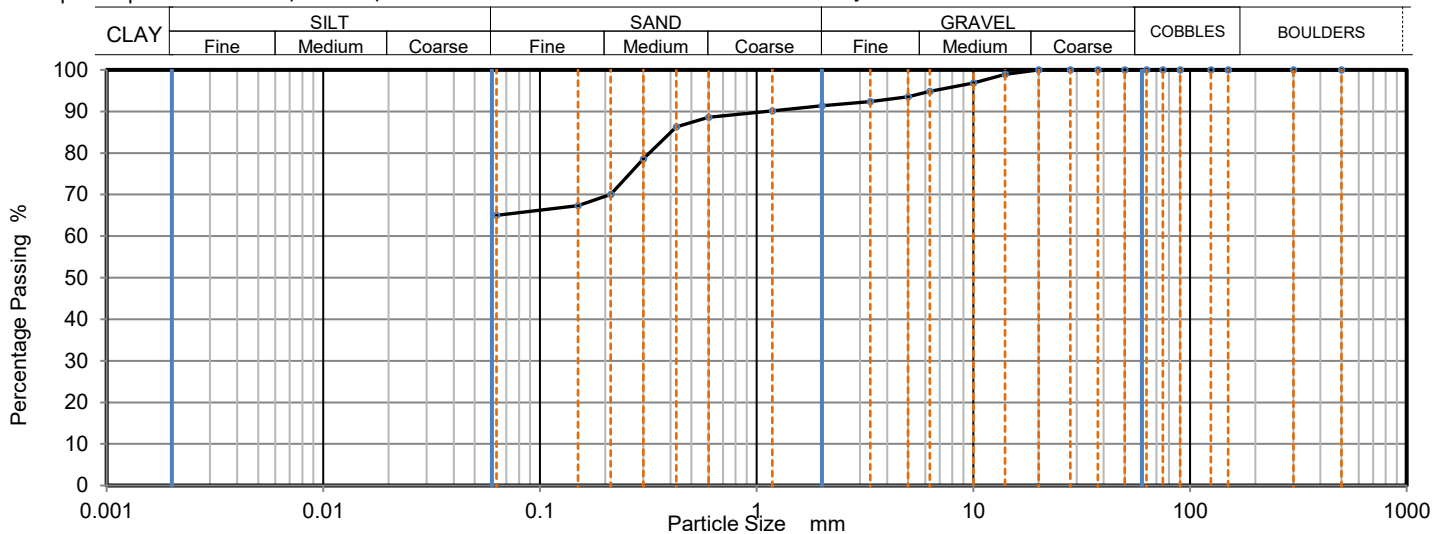
Laboratory Reference: 2928226  
Hole No.: TP-146  
Sample Reference: Not Given  
Sample Description: Yellowish brown slightly gravelly slightly sandy CLAY with fragments of chalk  
Sample Preparation: Sample was quartered, oven dried at 109 °C and broken down by hand.

Depth Top [m]: 0.60  
Depth Base [m]: 0.70  
Sample Type: B

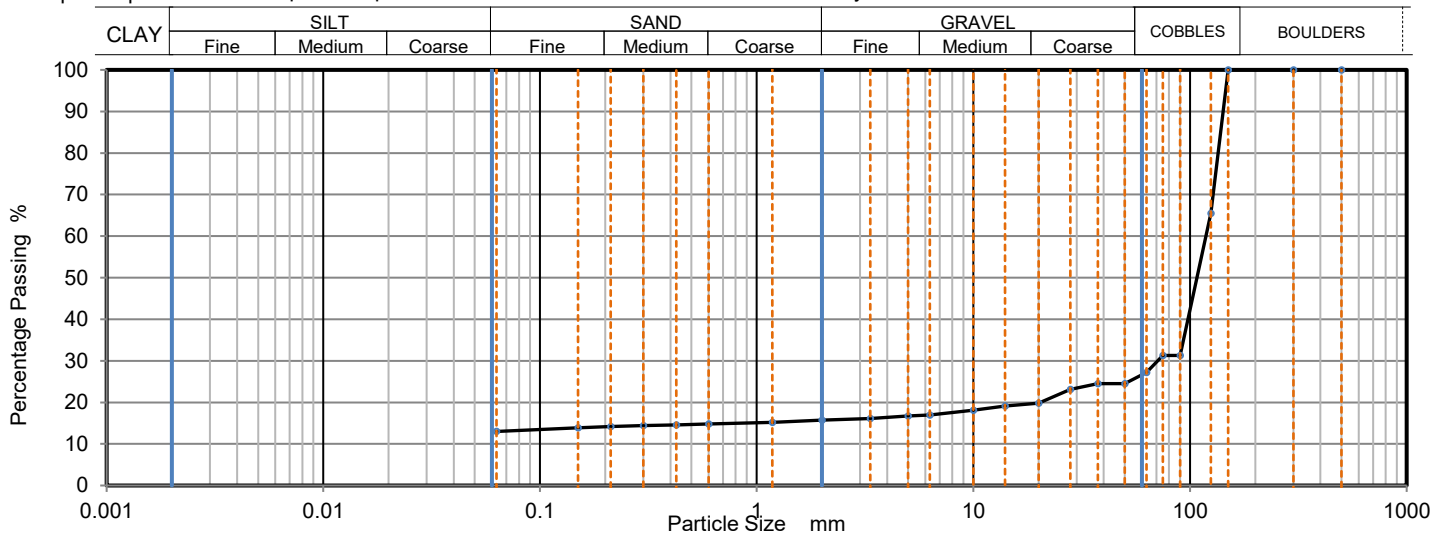
Laboratory Reference: 2928230  
Hole No.: TP-154  
Sample Reference: Not Given  
Sample Description: Light grey clayey CHALK with fragments of flintstones  
Sample Preparation: Sample was quartered, oven dried at 106 °C and broken down by hand.

Depth Top [m]: 1.10  
Depth Base [m]: 1.20  
Sample Type: B

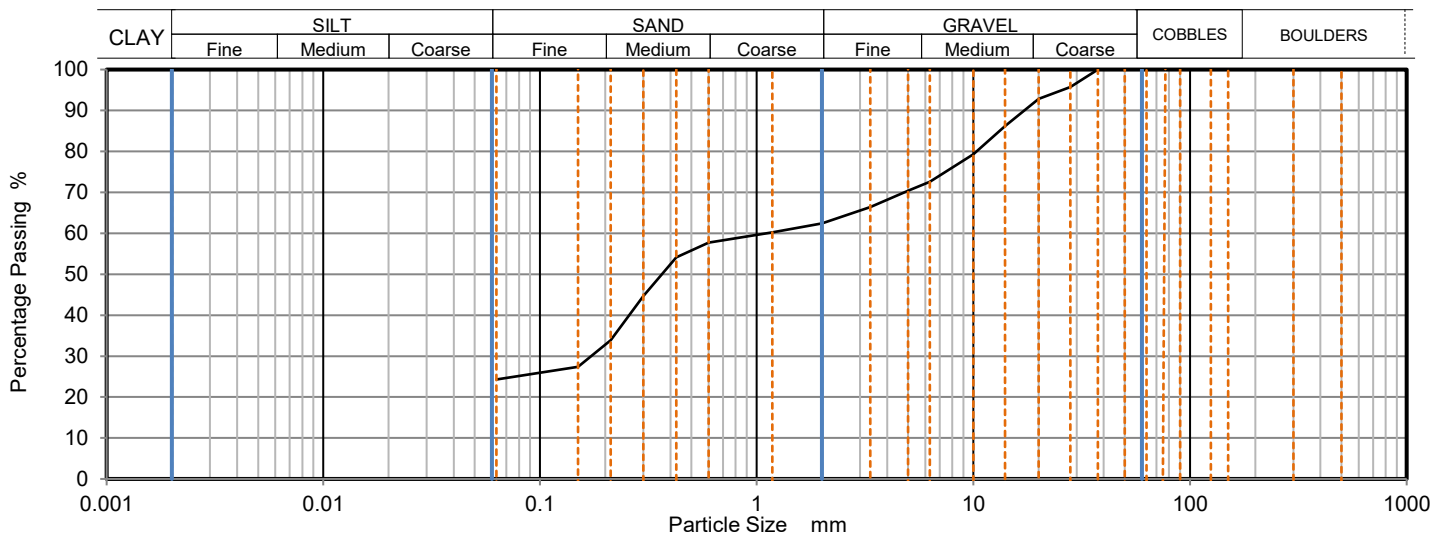
Laboratory Reference: 172918  
Hole No.: TP-162  
Sample Reference: Not Given  
Sample Description: Brown very clayey GRAVEL and SAND  
Sample Preparation: Sample was quartered, oven dried at 106.4 °C and broken down by hand.

Depth Top [m]: 0.90  
Depth Base [m]: 1.00  
Sample Type: B

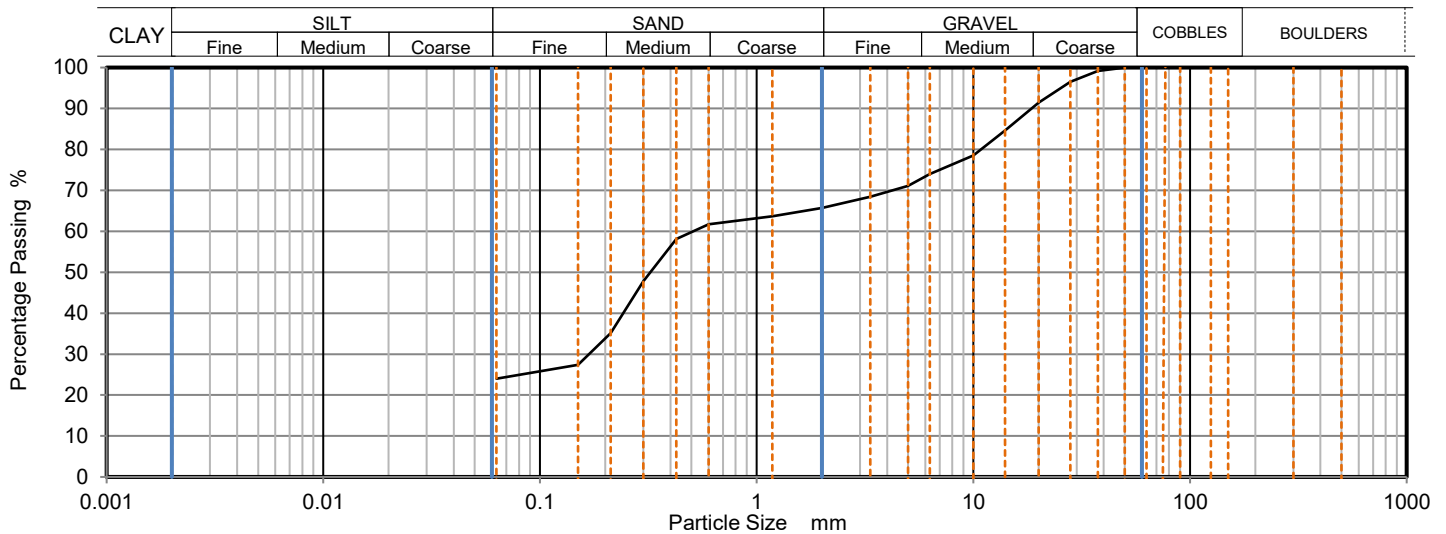
**Test Results:**Laboratory Reference: 172919  
Hole No.: TP-162  
Sample Reference: Not Given  
Sample Description: Yellowish brown very gravelly very clayey SAND with fragments of chalk  
Sample Preparation: Sample was quartered, oven dried at 106.4 °C and broken down by hand.Depth Top [m]: 1.60  
Depth Base [m]: 1.70  
Sample Type: B

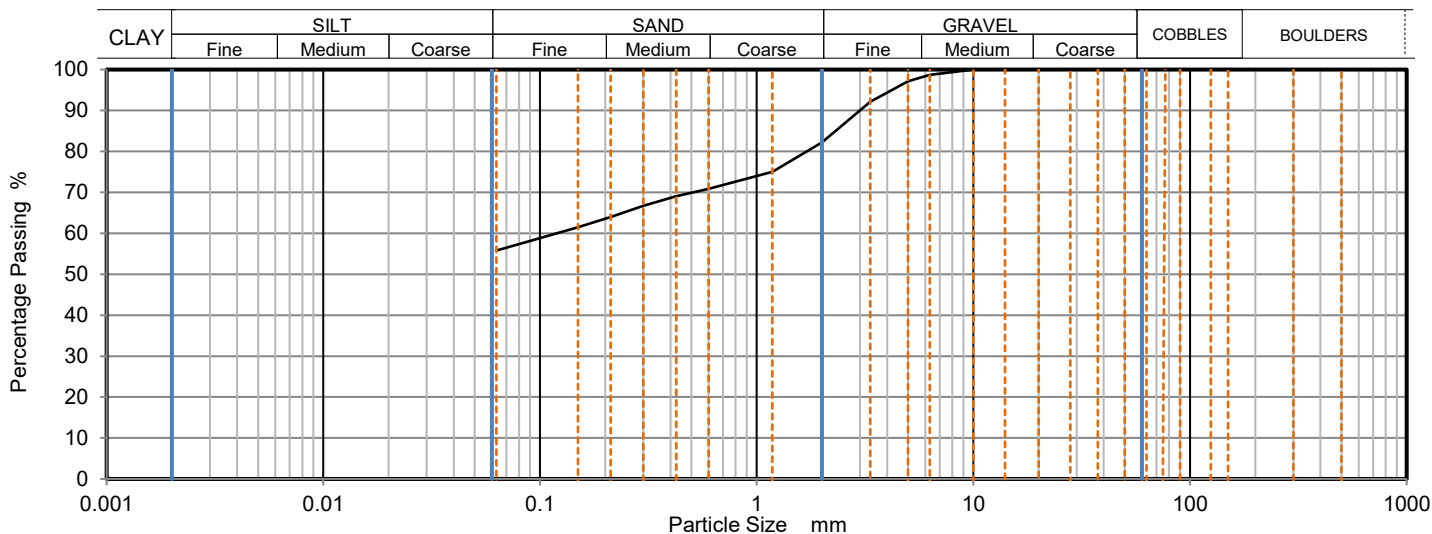
**Test Results:**Laboratory Reference: 172924  
Hole No.: TP-170  
Sample Reference: Not Given  
Sample Description: Brown slightly gravelly slightly sandy CLAY  
Sample Preparation: Sample was quartered, oven dried at 106.2 °C and broken down by hand.Depth Top [m]: 0.80  
Depth Base [m]: 0.90  
Sample Type: B

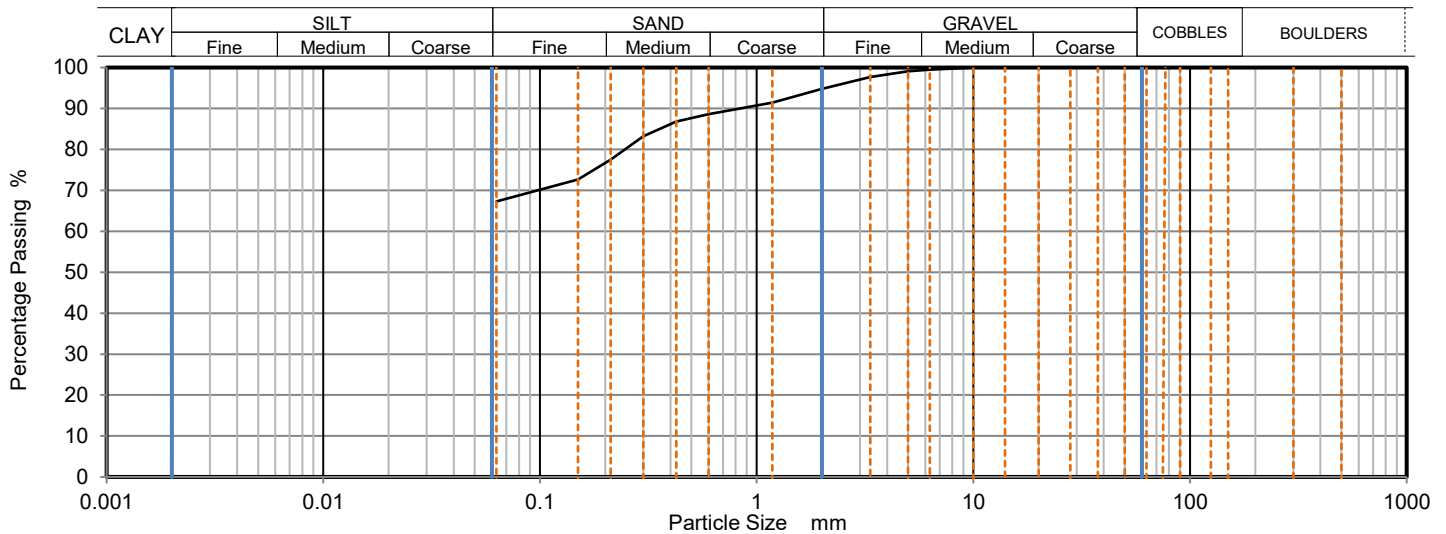
**Test Results:**Laboratory Reference: 172926  
Hole No.: TP-174  
Sample Reference: Not Given  
Sample Description: Brown slightly gravelly slightly sandy CLAY  
Sample Preparation: Sample was quartered, oven dried at 106.2 °C and broken down by hand.Depth Top [m]: 1.00  
Depth Base [m]: 1.20  
Sample Type: B

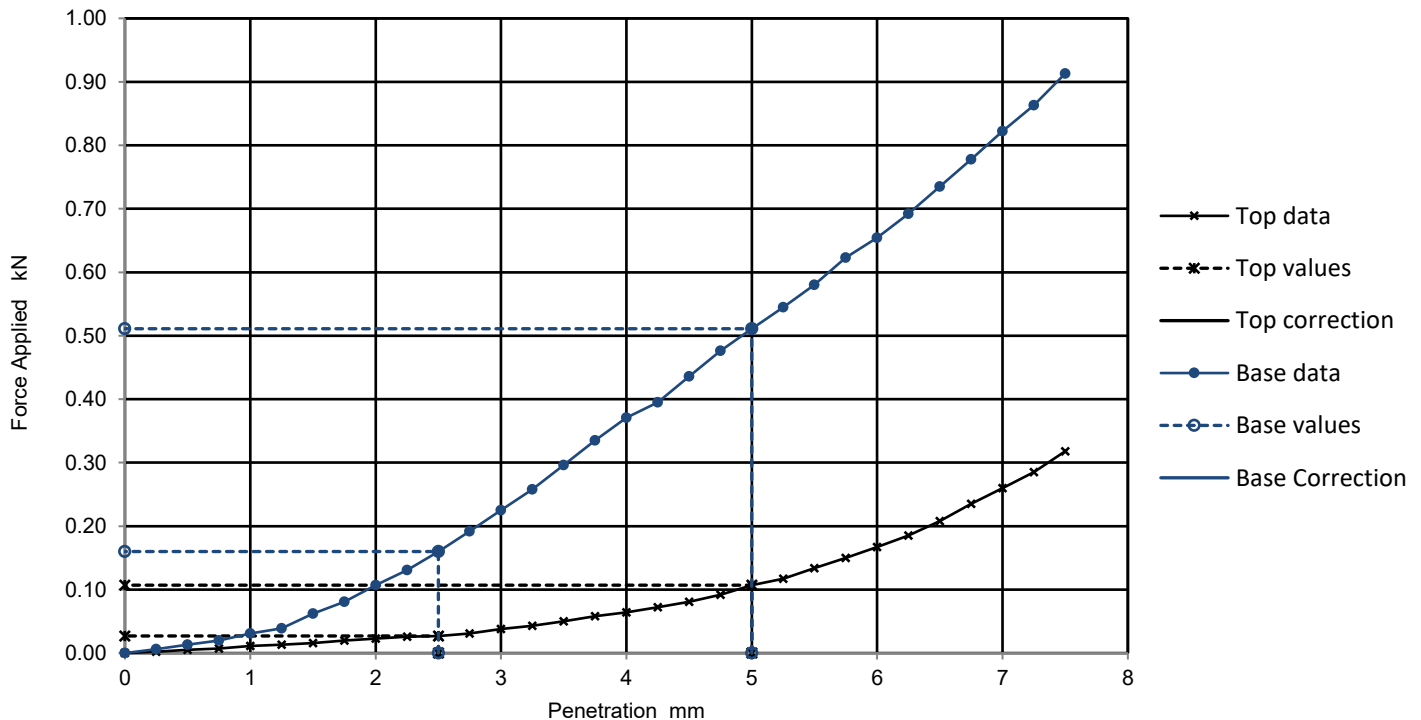
Material retained on 20mm sieve removed 24 %

Initial Specimen details Bulk density 1.89 Mg/m<sup>3</sup>  
Dry density 1.44 Mg/m<sup>3</sup>  
Water content 31 %  
Surcharge applied 8 kg  
4.9 kPa**Force v Penetration Plots**
