# Growing Baldock

Appendix 12.6 Technical Documentation Road and Bridge – Option 1

CD 622 Technical Documentation  
Road and Bridge – Option 1

Road and Bridge – Option 1

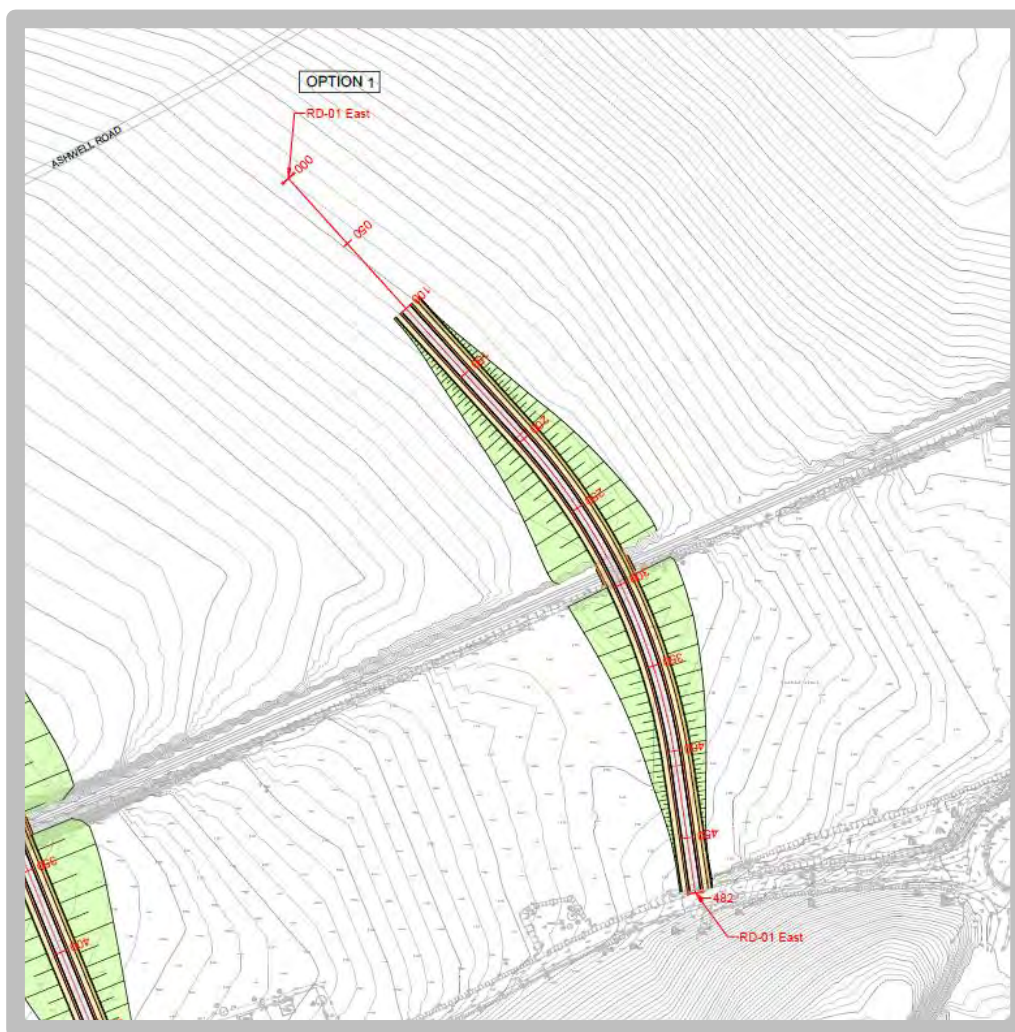
Figure 1 – Approximate Location of Proposed New Road and Bridge Crossing – Option 1

A vehicular road and bridge crossing the existing railway is proposed as part of the wider development to provide access between the new proposed development areas to the north and south of the railway line. There are currently five options being considered for the route of the vehicular road. The current report considers Option 1 only, the approximate location of which is indicated on Figure 1 below.
