# Growing Baldock

Appendix 12.8 Technical Documentation Roads 2 and 3 and Pedestrian Bridge

CD 622 Technical Documentation  
Pedestrian Bridge and Vehicular Road and Bridge – Options 2/3

Issue V1  
February 2024

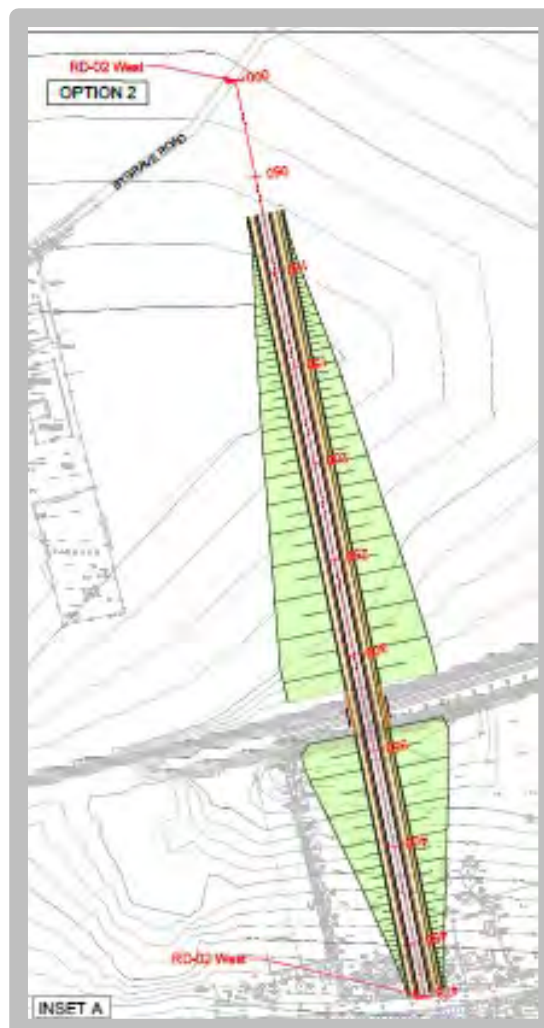
Figure 1A – Approximate Location of Proposed New Road and Bridge Crossing – Option 2

A vehicular road and bridge crossing the existing railway and a pedestrian crossing are both proposed as part of the wider development to provide access between the new proposed development areas to the north and south of the railway line. There are currently five options being considered for the route of the vehicular road. The current report considers Options 2 and 3 for the road and vehicular crossing and the pedestrian crossing all of which follow a similar route, the approximate location of which is indicated on Figures 1A to 1C below.

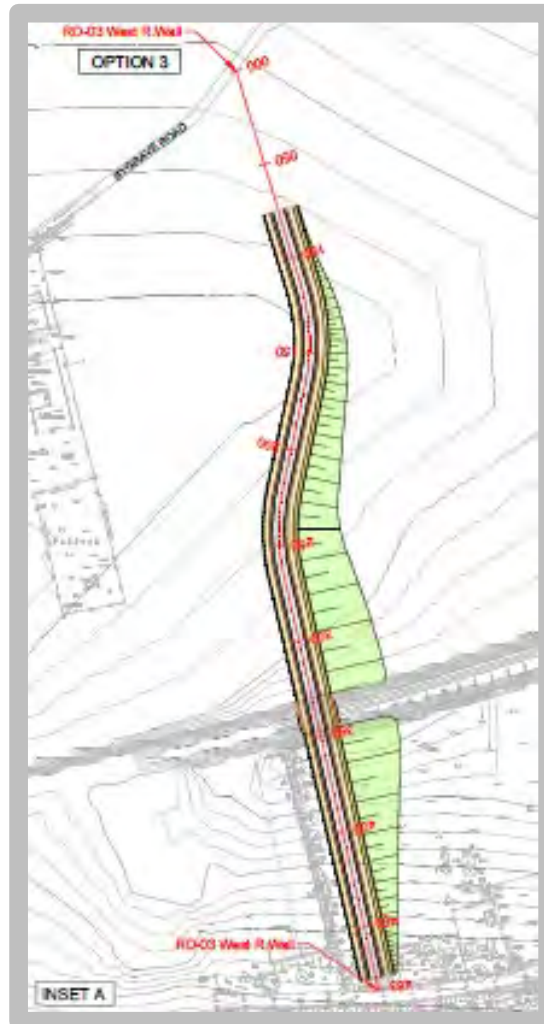
Figure 1B – Approximate Location of Proposed New Road and Bridge Crossing – Option 3

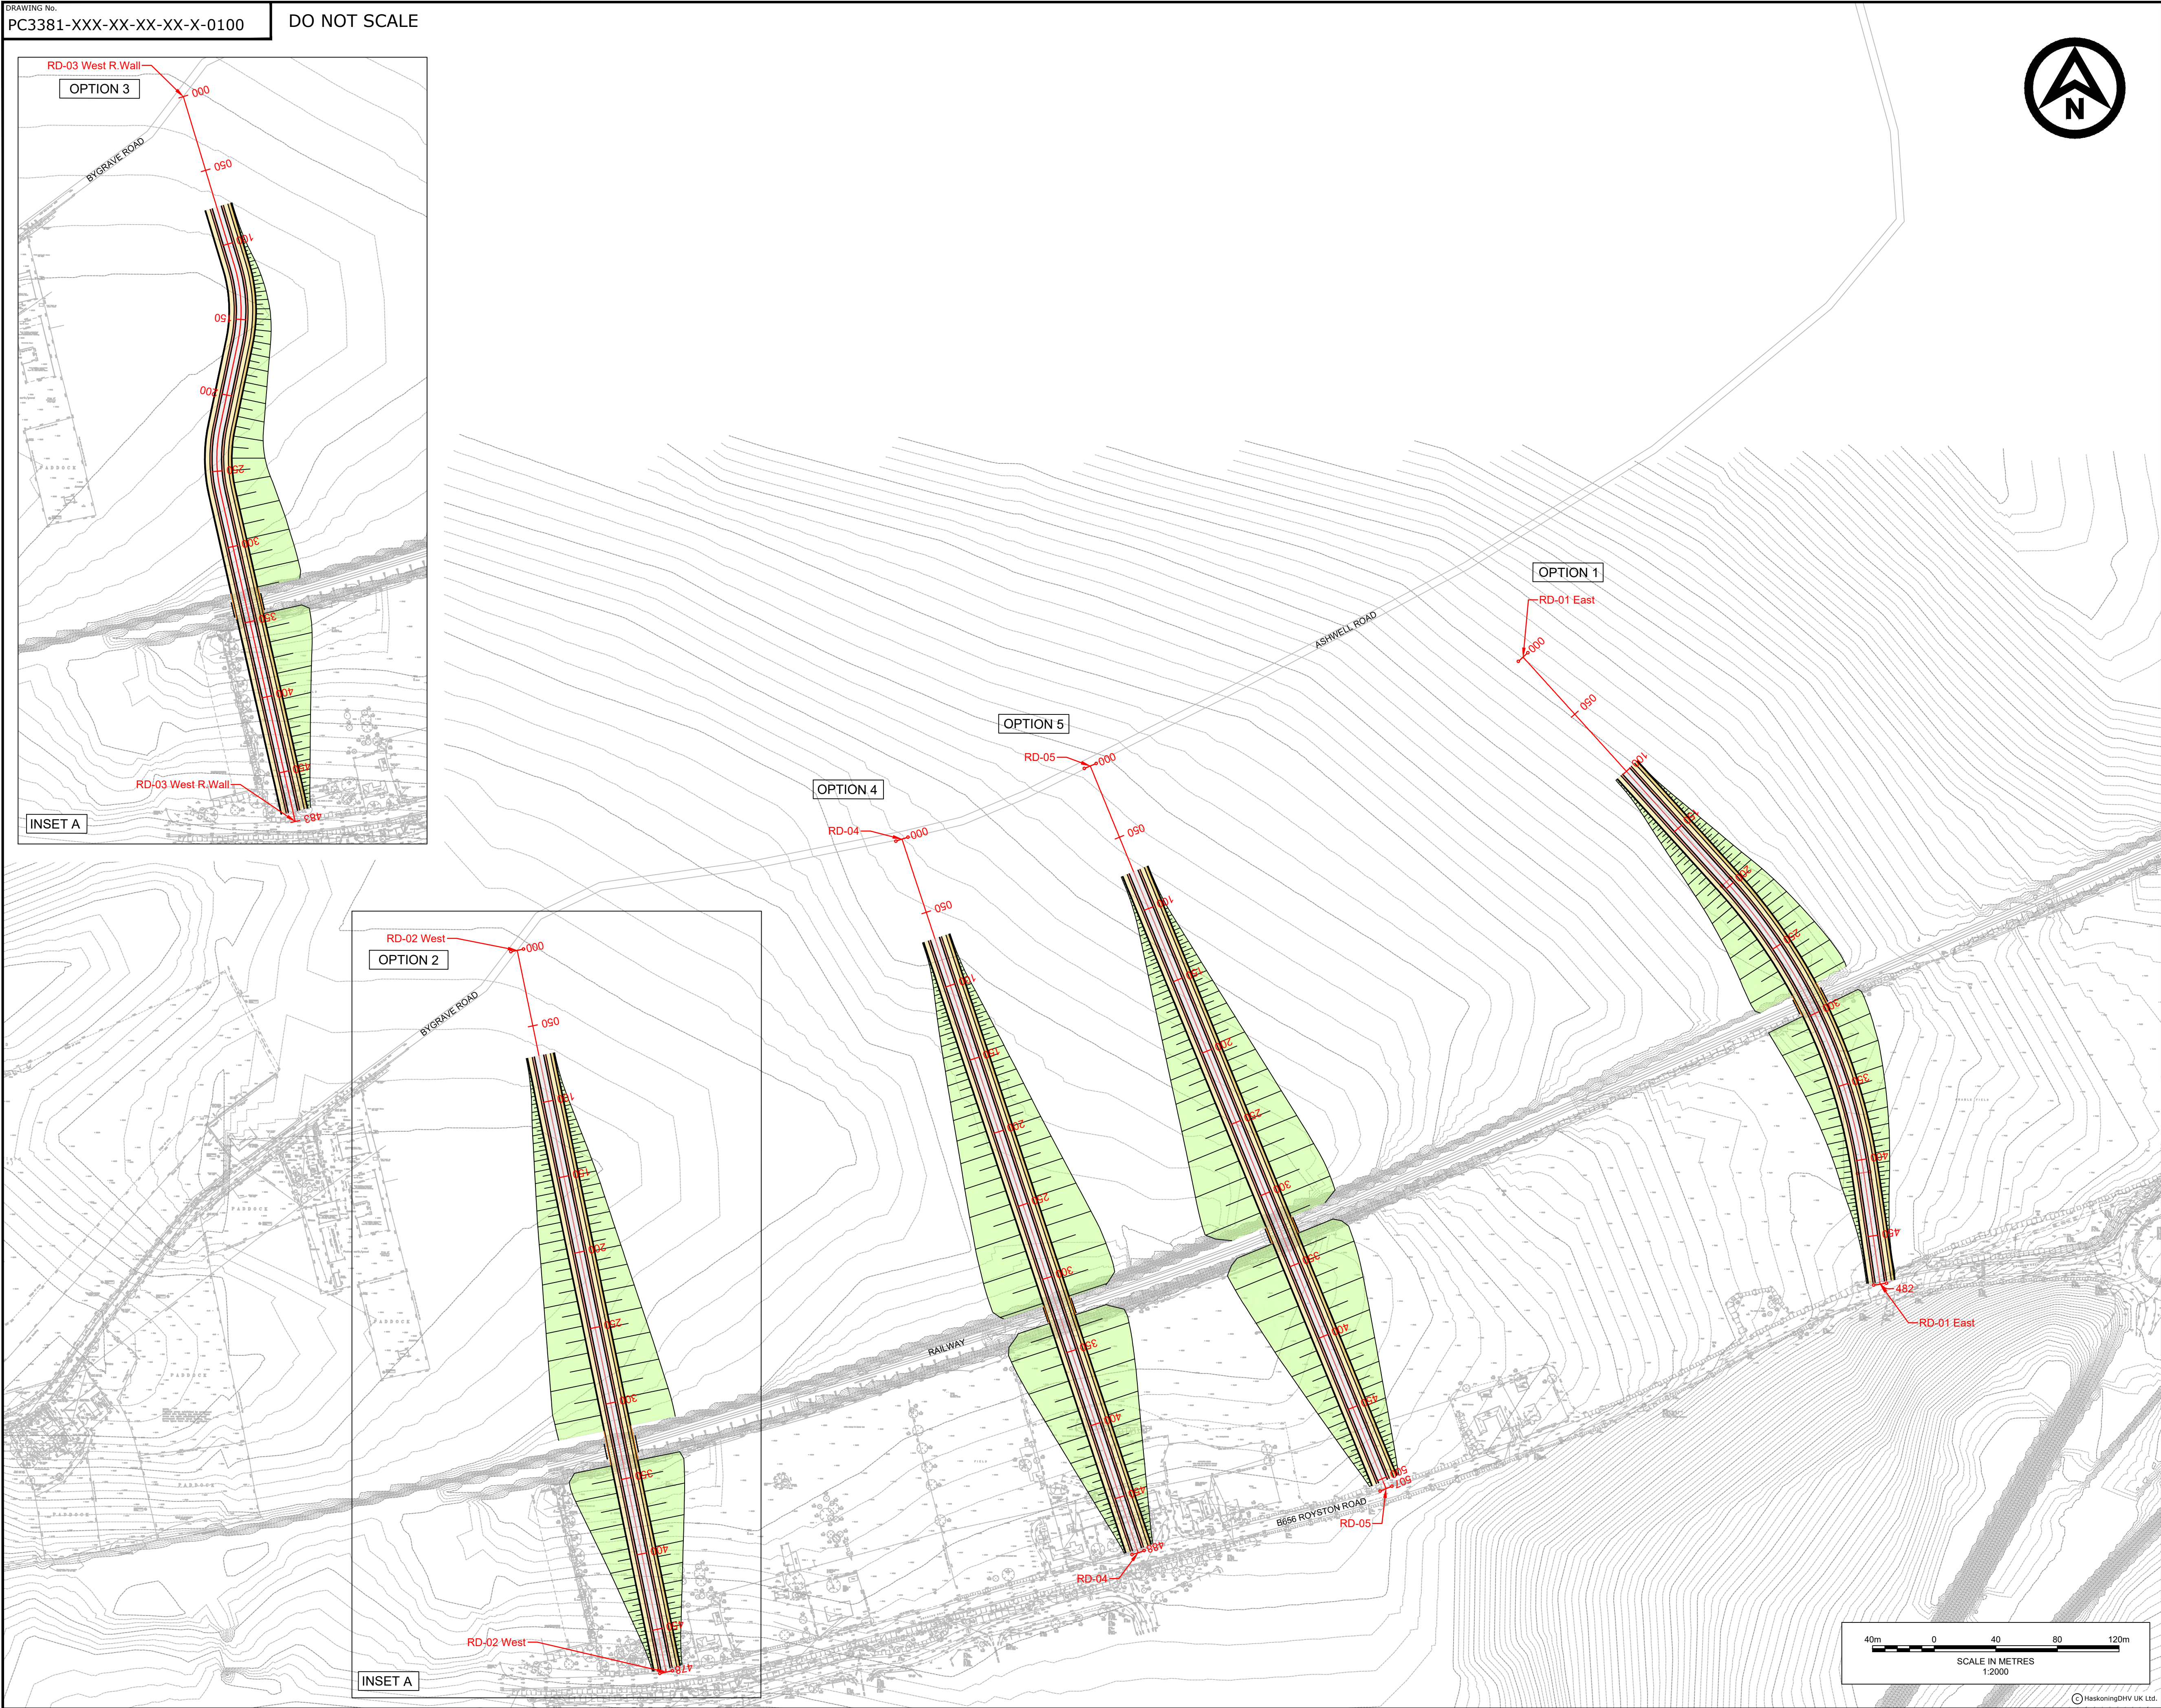
LOCATION PLAN

The proposed options for the proposed road and bridge railway crossing are shown on Royal Haskoning DHV Drawing Ref. PC3381-XXX-XX-XX-XX-X-0100 rev P01, "Location Plan". The route for the proposed pedestrian railway crossing are shown on David Lock Associates Drawing Ref. UAC080-079, "Baldock Sustainable Extension N-S Active Travel Rail Crossing - Conceptual Exploration Sketch (03-08-23)". Copies of both drawings are presented in **Appendix B** for reference.

The proposed options for the proposed road and bridge railway crossing are shown on Royal Haskoning DHV Drawing Ref. PC3381-XXX-XX-XX-XX-X-0100 rev P01, "Location Plan". The route for the proposed pedestrian railway crossing are shown on David Lock Associates Drawing Ref. UAC080-079, "Baldock Sustainable Extension N-S Active Travel Rail Crossing - Conceptual Exploration Sketch (03-08-23)". Copies of both drawings are presented in **Appendix B** for reference.
